# PRELIMINARY SITE ASSESSMENT

**SR 1997 (FAYETTEVILLE ROAD) WIDENING  
TIP NO. U-5797, WBS NO. 44367.1.1**

**NCDOT PARCEL NO. 02**

## METALLIC UST INVESTIGATION: PARCEL 2 NCDOT PROJECT U-5797

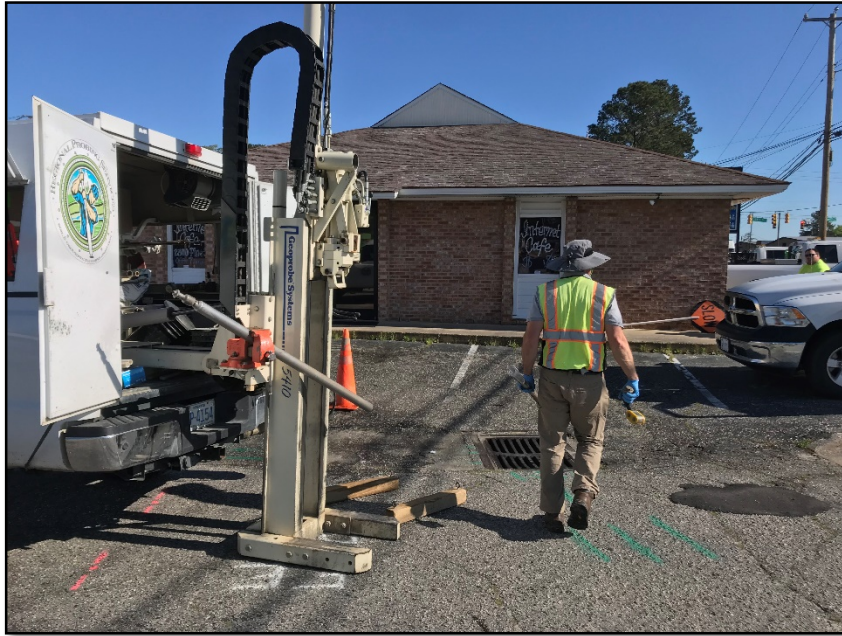
Photograph No. 1: General view of B-1.  
View is to the north toward the parcel building.

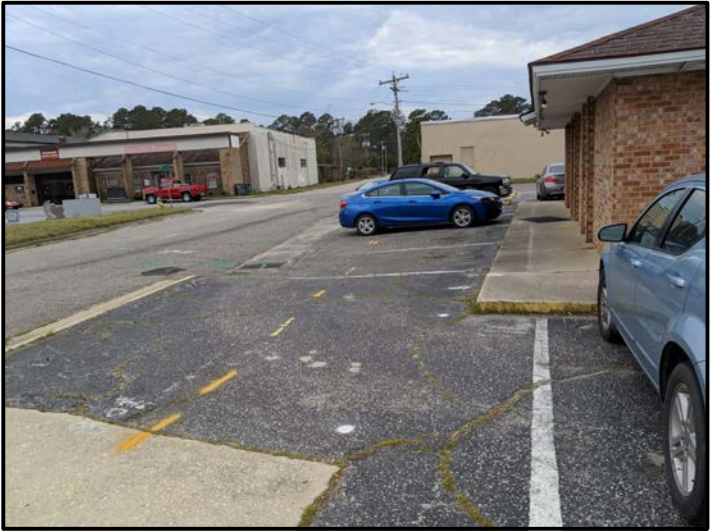
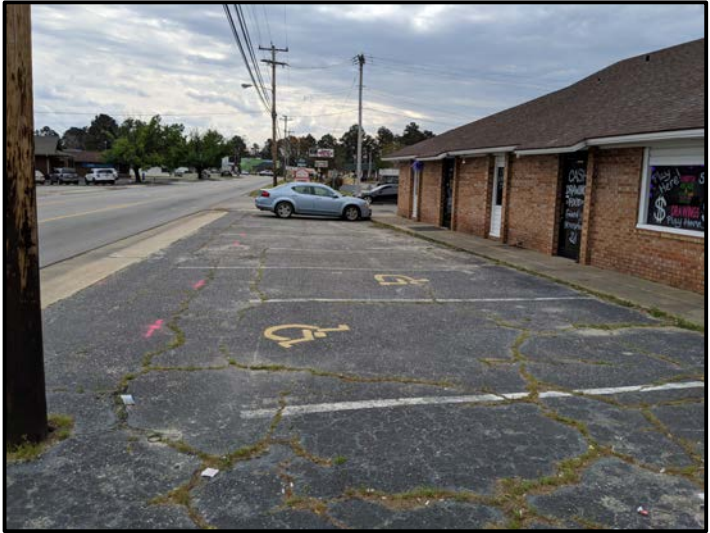
CLIENT  
FALCON ENGINEERS  
**FIGURE 1**

The site included a commercial building surrounded by concrete and asphalt surfaces. An aerial photograph showing the survey area boundaries and ground-level photographs are shown in **Figure 1**.

View of Survey Area  
(Facing Approximately West)

View of Survey Area  
(Facing Approximately South)

TITLE  
PARCEL 2 - GEOPHYSICAL  
SURVEY BOUNDARIES AND SITE PHOTOGRAPHS

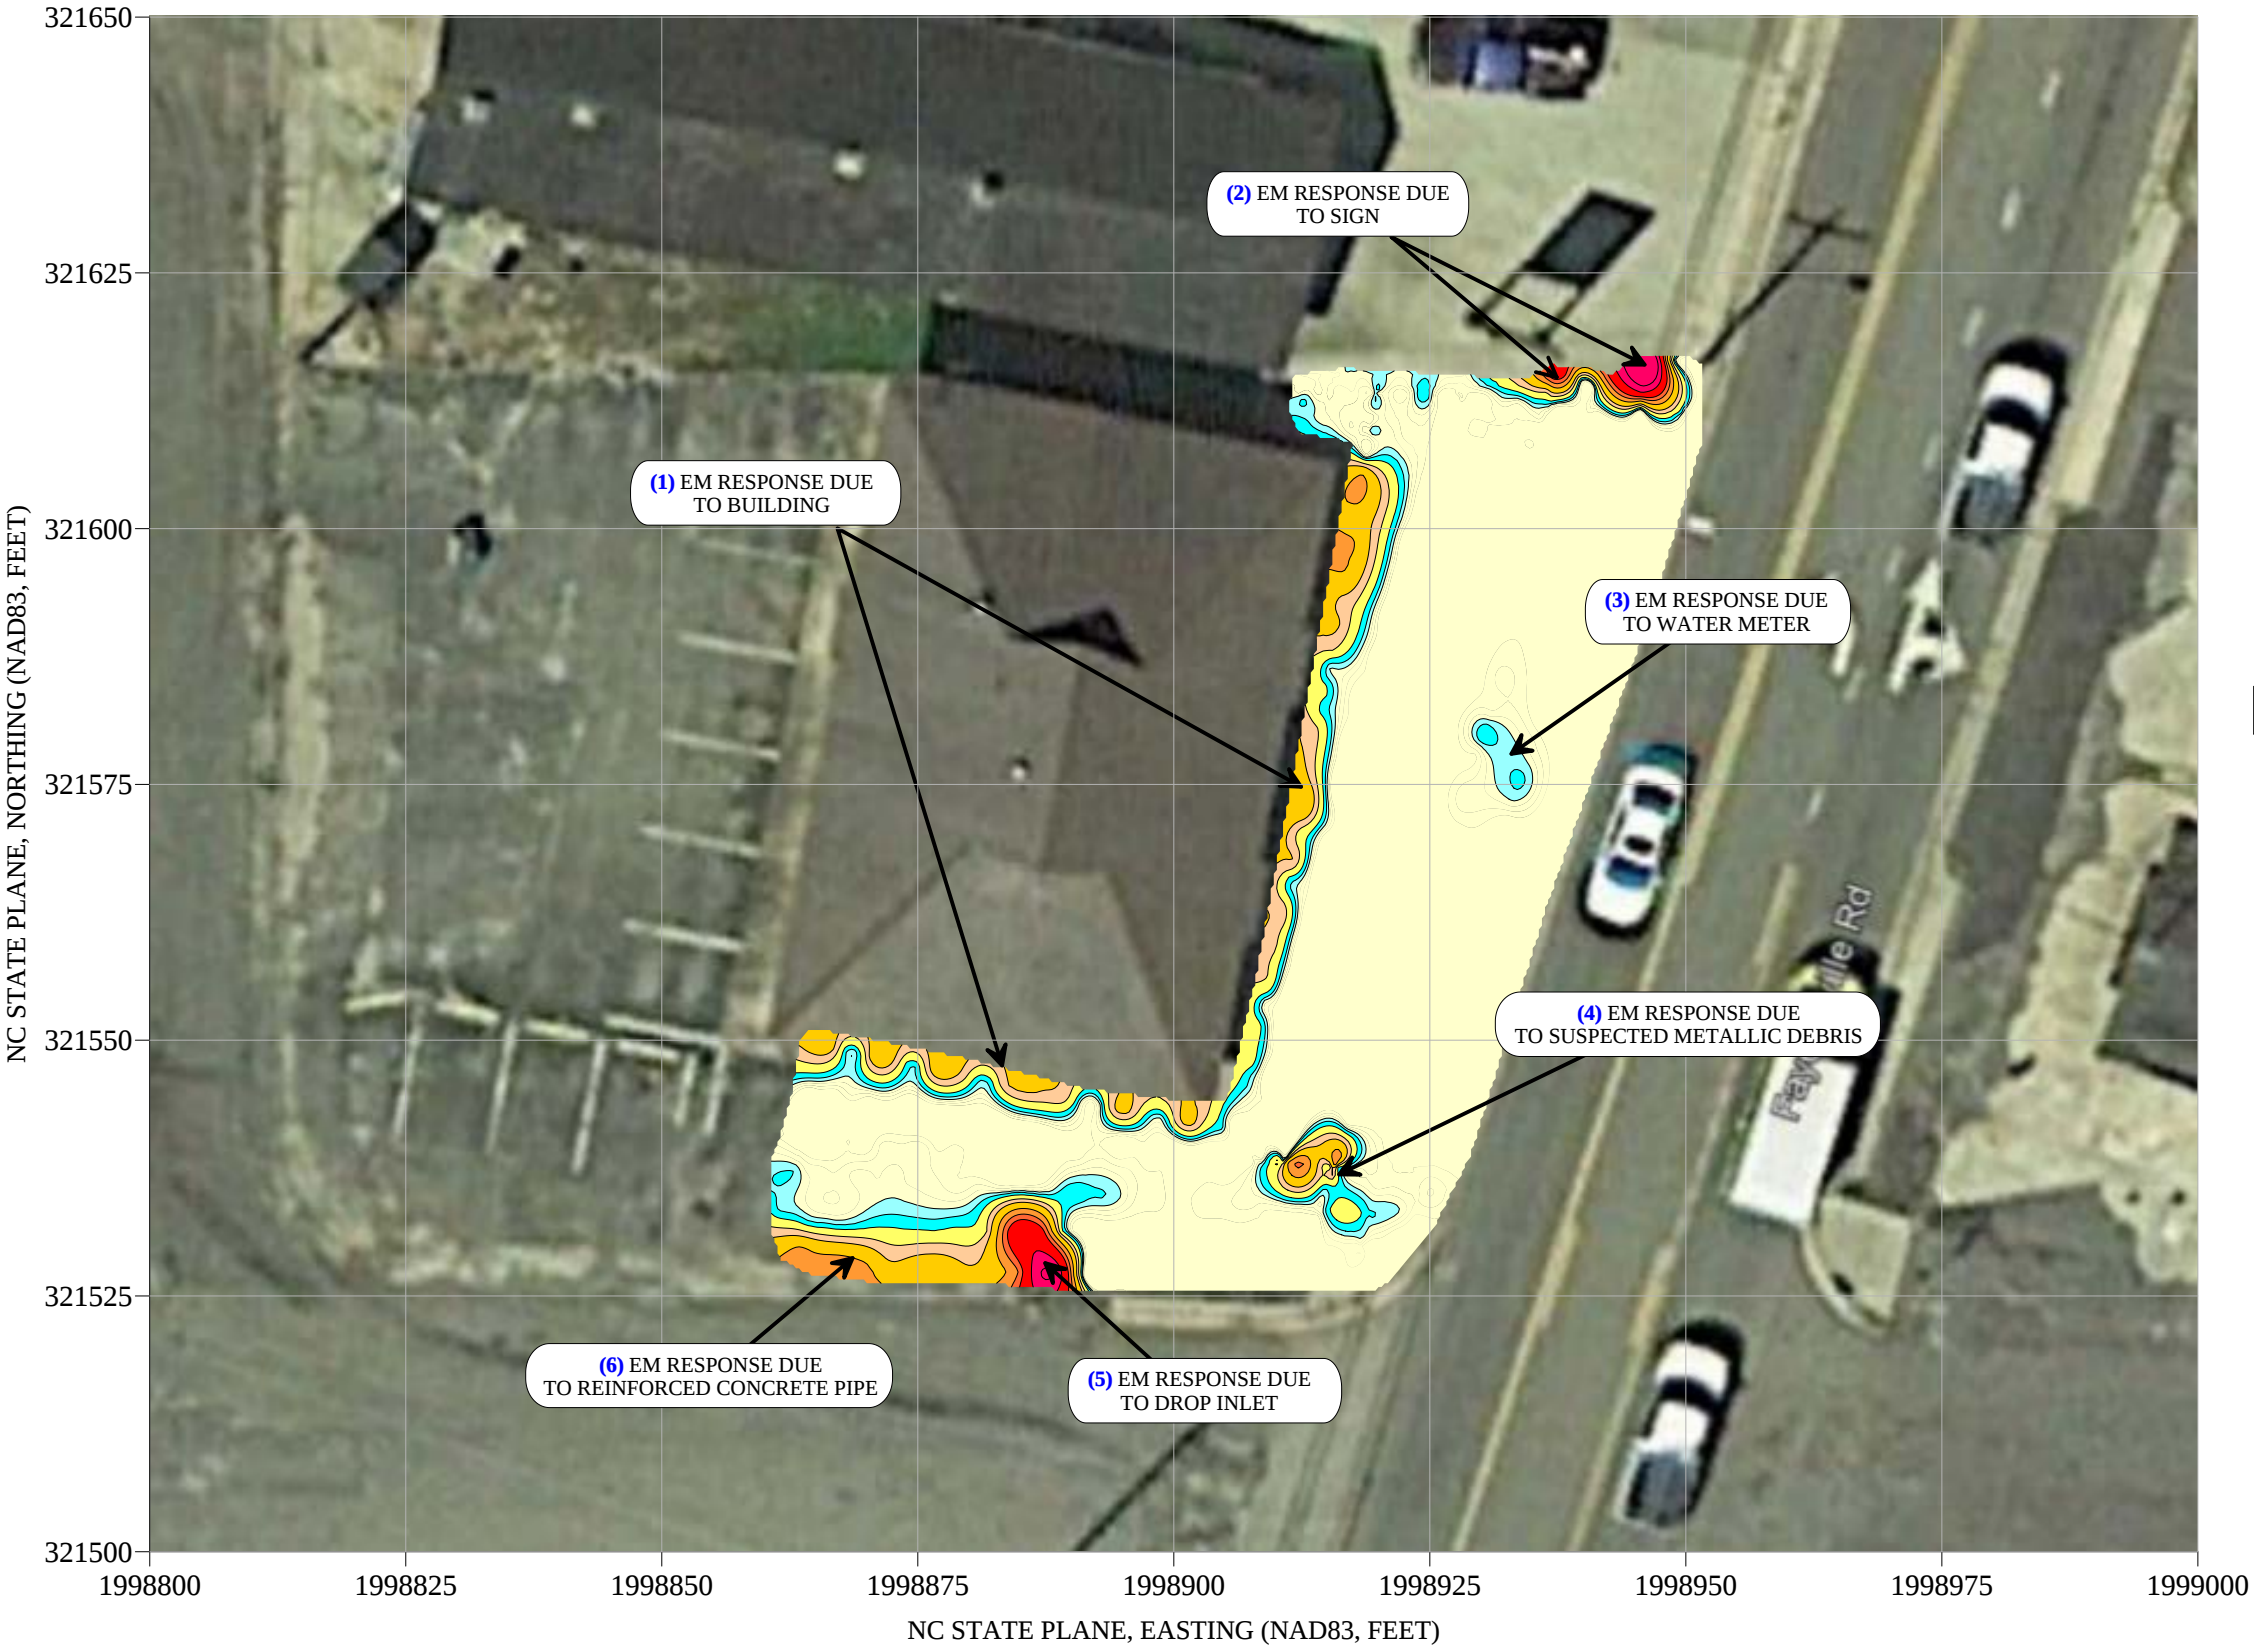
CLIENT  
FALCON ENGINEERS  
**FIGURE 2**

A contour plot of the EM61 results obtained across the survey area at the property is presented in **Figure 2**. Each EM anomaly is numbered for reference in the figure. The following table presents the list of EM anomalies and the cause of the metallic response, if known:

The majority of the EM anomalies were directly attributed to visible cultural features at the ground surface, including the building, a sign, a water meter, a drop inlet, and reinforced concrete pipe. EM Anomaly 4 was associated with suspected buried metallic debris and was further investigated with GPR.

NO EVIDENCE OF METALLIC  
USTs OBSERVED.

The contour plot shows the differential results of the EM61 instrument in millivolts (mV). The differential results focus on larger metallic objects such as USTs and drums. The EM data were collected on March 20, 2019, using a Geonics EM61-MK2 instrument. Verification GPR data were collected using a GSSI UtilityScan DF instrument with a dual frequency 300/800 MHz antenna on March 25, 2019.

TITLE  
PARCEL 2 -  
EM61 METAL DETECTION CONTOUR MAP

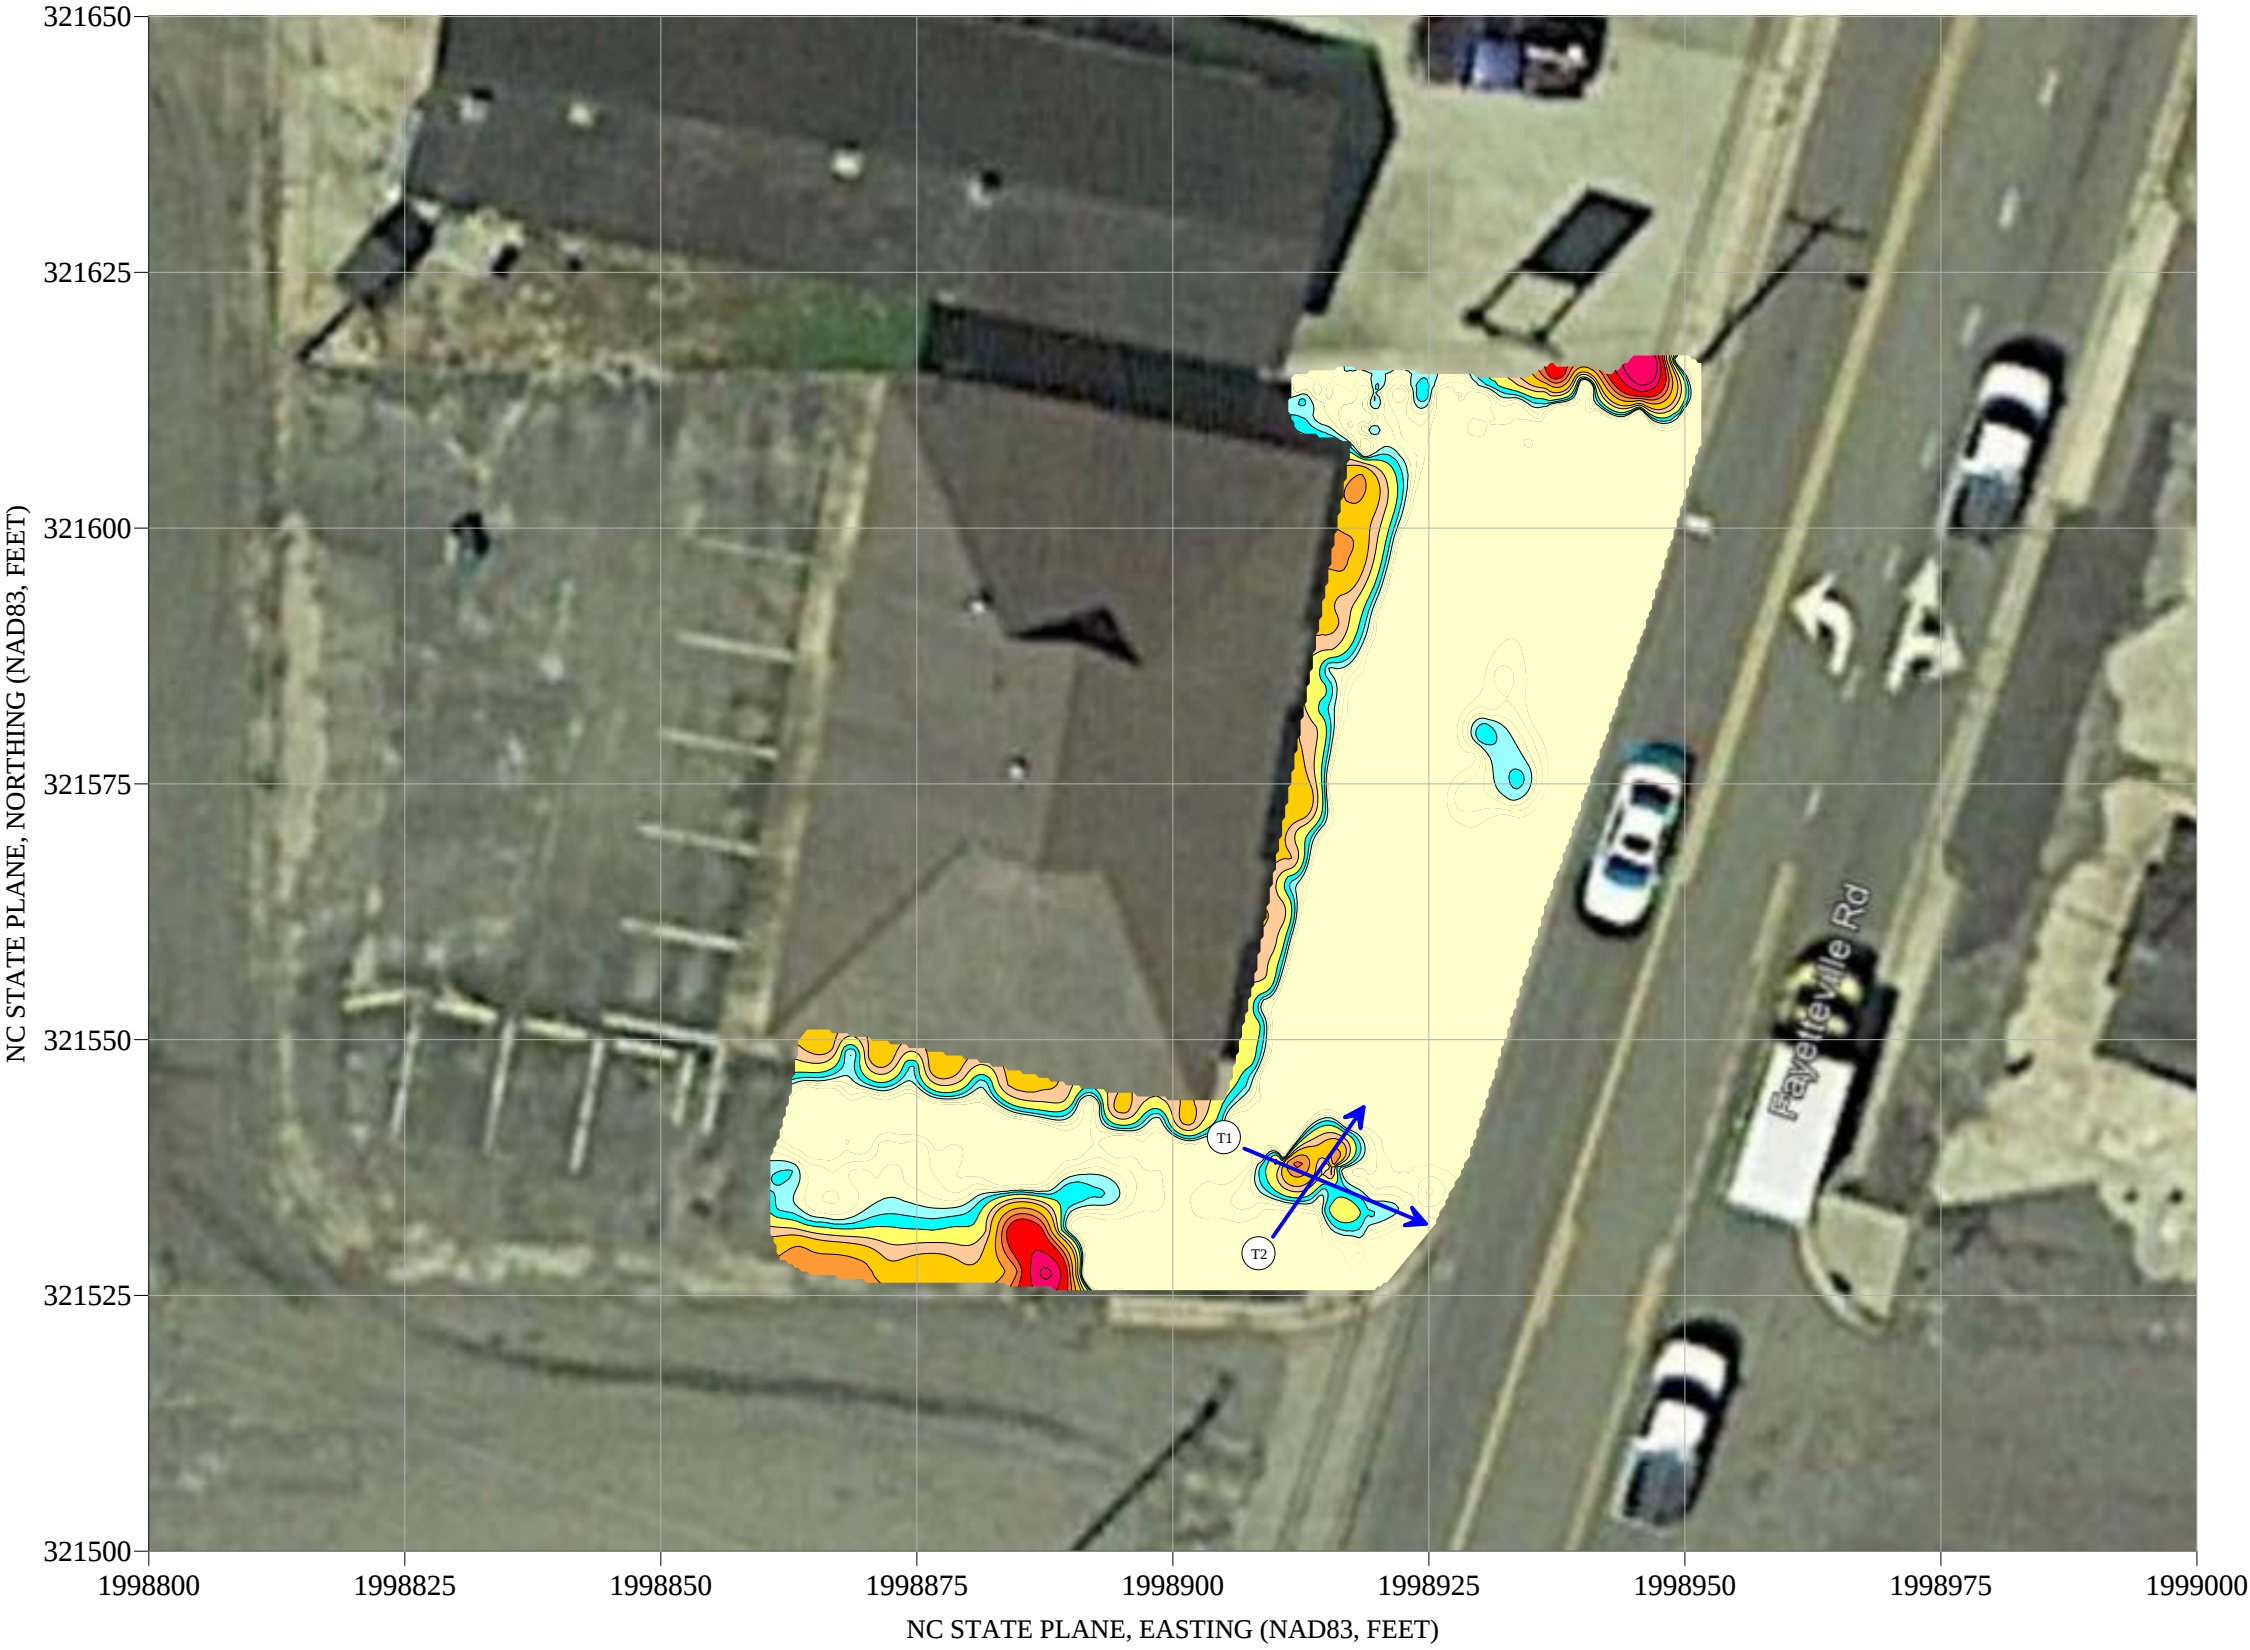
CLIENT  
FALCON ENGINEERS  
**FIGURE 3**

**Figure 3** presents the locations of the formal GPR transects performed at the property as well as the transect images. A total of two formal GPR transects were performed at the site. GPR Transects 1-2 were performed across EM Anomaly 4. These transects recorded minor reflectors that were suggestive of possible buried metallic debris. No evidence of any larger structures such as USTs was observed.

LOCATIONS OF GPR TRANSECTS

GPR TRANSECT 1 (T1)

GPR TRANSECT 2 (T2)
