**Reference: Preliminary Site Assessment for the Barnes Family Property (Revision 1)
13726 Buffalo Road
Clayton, Johnston County, North Carolina
State Project: W-5704E
WBS Element 44850.1.5
DAA Project No. 18110172-010701**

PYRAMID GEOPHYSICAL SERVICES
(PROJECT 2018-256)

METALLIC UST INVESTIGATION: PARCEL 64 NCDOT PROJECT W-5704E

GEOPHYSICAL INVESTIGATION REPORT
Parcel 64 - 13726 Buffalo Road
Clayton, Johnston County, North Carolina

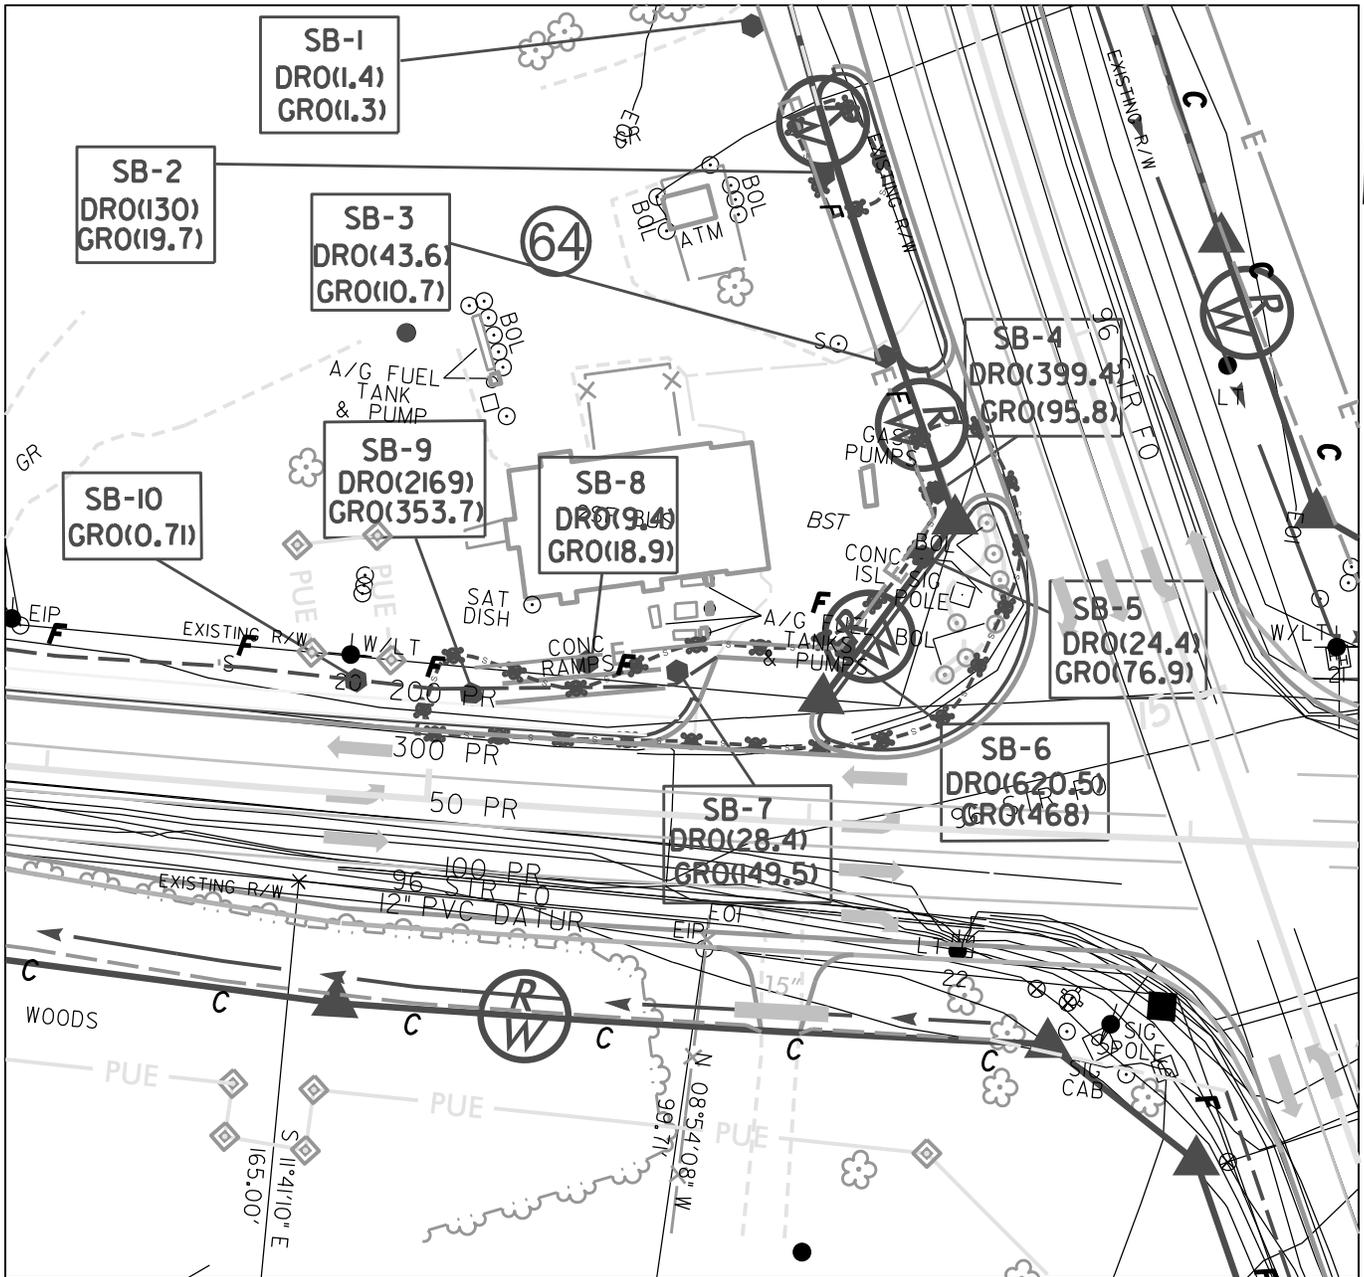
SOIL ANALYTICAL RESULTS MAP

The UVF analytical results (**Table 1**) of the soil samples collected on July 1, 2019, indicate that six of the soil samples contained DRO and/or GRO concentrations above the action level. Therefore, DAA made an estimate of the volume of soil requiring possible remediation.

To estimate the volume of soil requiring possible remediation, DAA considered only the soil samples that contained a DRO and/or GRO concentration above the respective action levels. The thickness of the potentially contaminated soil was estimated from the UVF results and field screening, which indicated a thickness of 2 feet at a depth of 8 to 10 ft bgs (**Table 1**). Two areas of the site contained soil contamination above the action levels. After estimating the potential contamination geometry using field observations and experience with similar sites and geology, DAA measured the affected sections on **Figure 3** by using CAD software, which indicated an area of approximately 460 ft² on the north side of the study area and 4,660 ft² on the east and south sides of the study area. Estimating a 2-foot contamination thickness, this calculates to a volume of about 35 bank cubic yards (cy) on the north side and 345 cy on the east and south sides, for an estimated total of 379[380] bank cy.

- SB-1 SOIL SAMPLE LOCATION AND IDENTIFICATION
- DRO(123) DETECTED DIESEL RANGE ORGANICS IN (MG/KG)
- GRO(123) DETECTED GASOLINE RANGE ORGANICS IN (MG/KG)
- ESTIMATED EXTENT OF SOIL CONTAMINATION IN RIGHT-OF-WAY

Ten soil borings were advanced to evaluate the subsurface soil conditions within the site. Six of the 10 soil samples analyzed contained a GRO or DRO concentration above the respective action level resulting in an estimated total contaminated soil volume of 380 cy (refer to note above regarding risk-based closure). The contaminated soil occurs at a depth of approximately 10 ft bgs. According to the NCDOT plan sheets (see **Figure 2**), the site is within a fill section for construction. As a result, no exposure to potentially contaminated soil is anticipated during road construction.

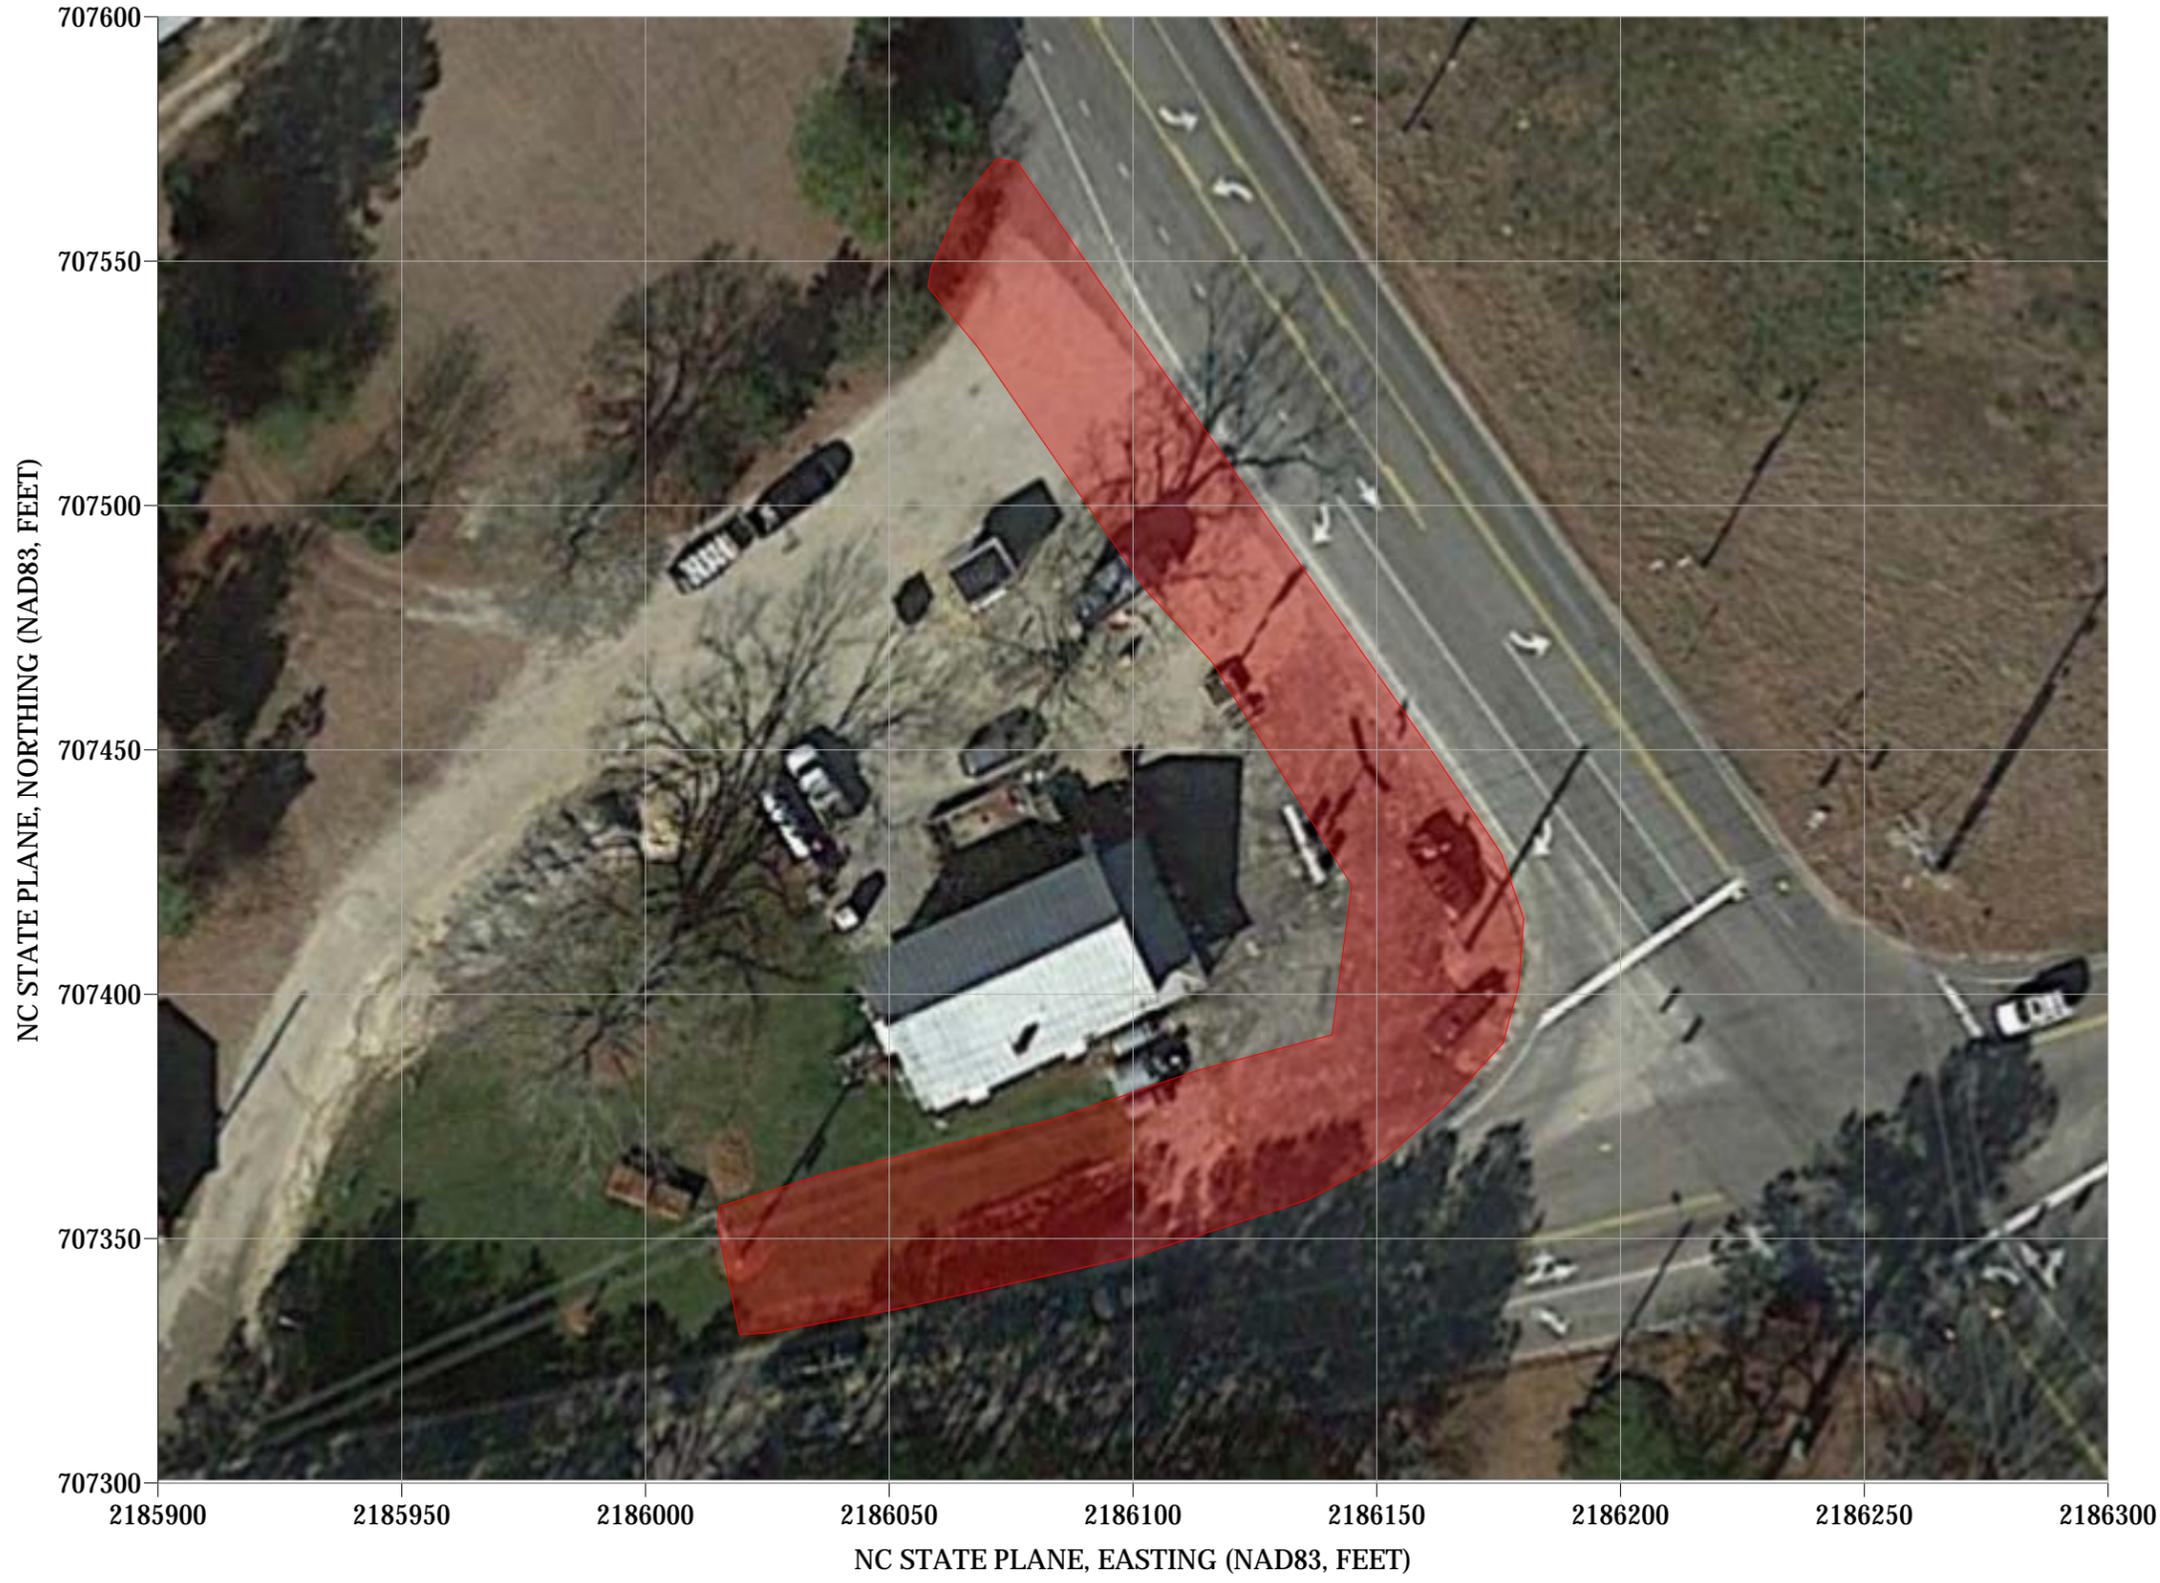
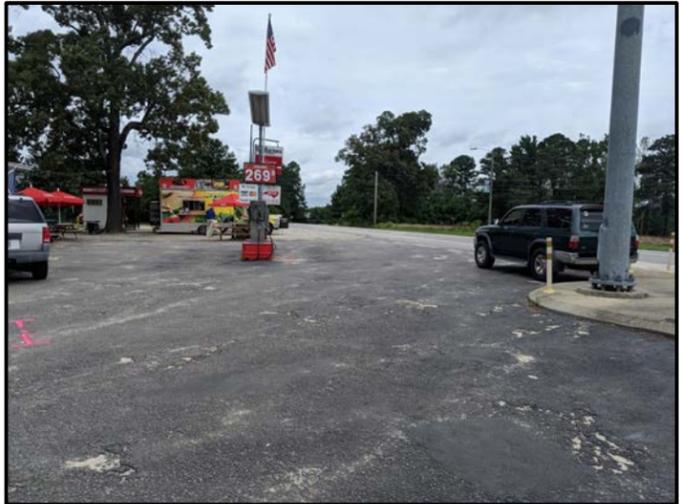
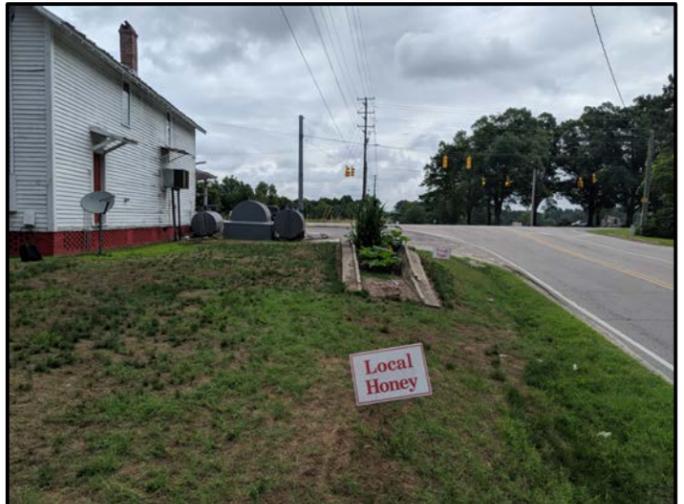
APPROXIMATE BOUNDARIES OF GEOPHYSICAL SURVEY AREA

The site included a gas station surrounded by grass, gravel, and asphalt surfaces. A tank pit containing active USTs was located outside of the survey area. An aerial photograph showing the survey area boundaries and ground-level photographs are shown in **Figure 1**.

View of Survey Area
(Facing Approximately North)

View of Survey Area
(Facing Approximately East)

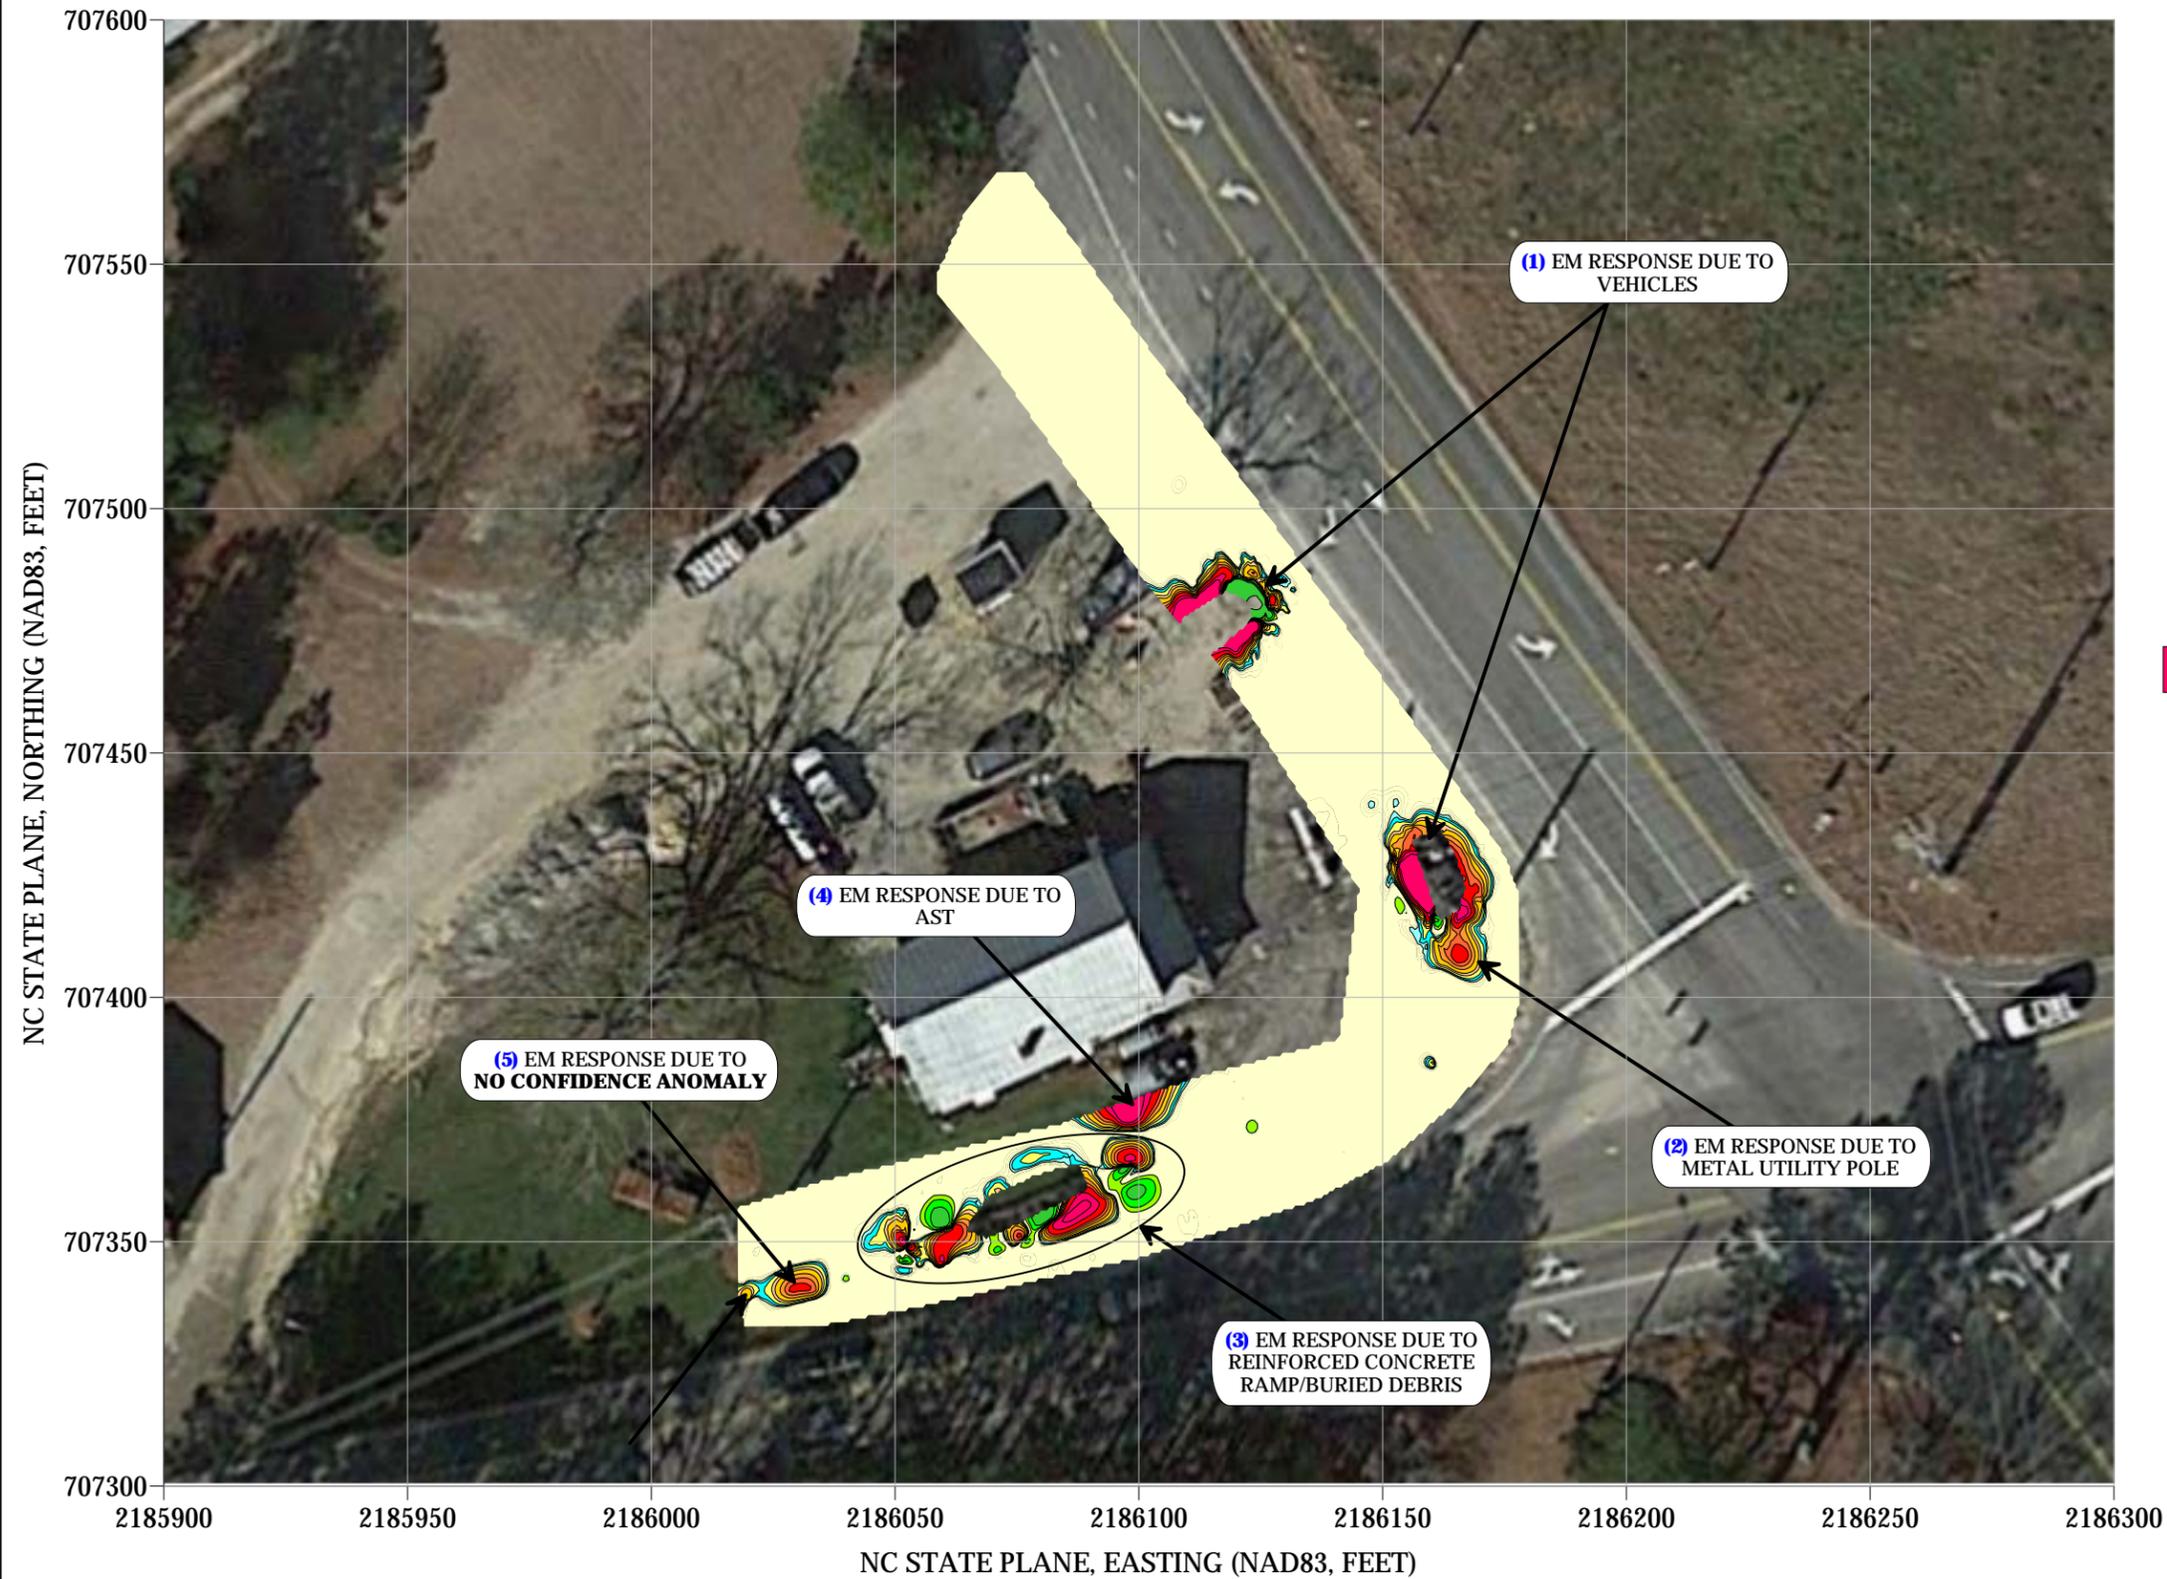
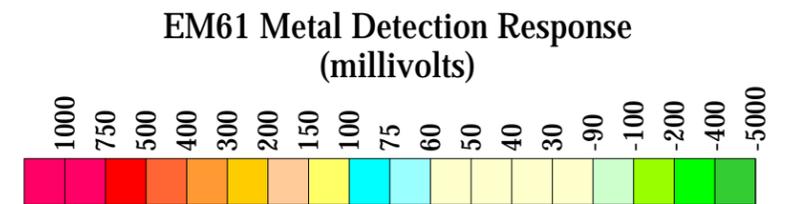
EM61 METAL DETECTION RESULTS

A contour plot of the EM61 results obtained across the survey area at the property is presented in **Figure 2**. Each EM anomaly is numbered for reference in the figure. The

Metallic Anomaly #	Cause of Anomaly	Investigated with GPR
1	Vehicles	✓
2	Metal Utility Pole	
3	Reinforced Concrete Ramp/Buried Debris	✓
4	AST	✓
5	No Confidence Anomaly	✓

The majority of the EM anomalies were directly attributed to visible cultural features at the ground surface, including vehicles, a metal utility pole, a reinforced concrete ramp, and an AST. EM Anomaly 5 was a medium- to high-amplitude elongated anomaly and was further investigated with GPR to investigate for the presence of a UST. GPR was performed around the areas of vehicles, the AST, and the reinforced concrete ramp to verify that the interference from the surface metal did not obscure any evidence of USTs.

EVIDENCE OF ONE NO CONFIDENCE ANOMALY WAS OBSERVED.

The contour plot shows the differential results of the EM61 instrument in millivolts (mV). The differential results focus on larger metallic objects such as USTs and drums. The EM data were collected on June 19, 2019, using a Geonics EM61-MK2 instrument. Verification GPR data were collected using a GSSI UtilityScan DF instrument with a dual frequency 300/800 MHz antenna on June 19, 2019.

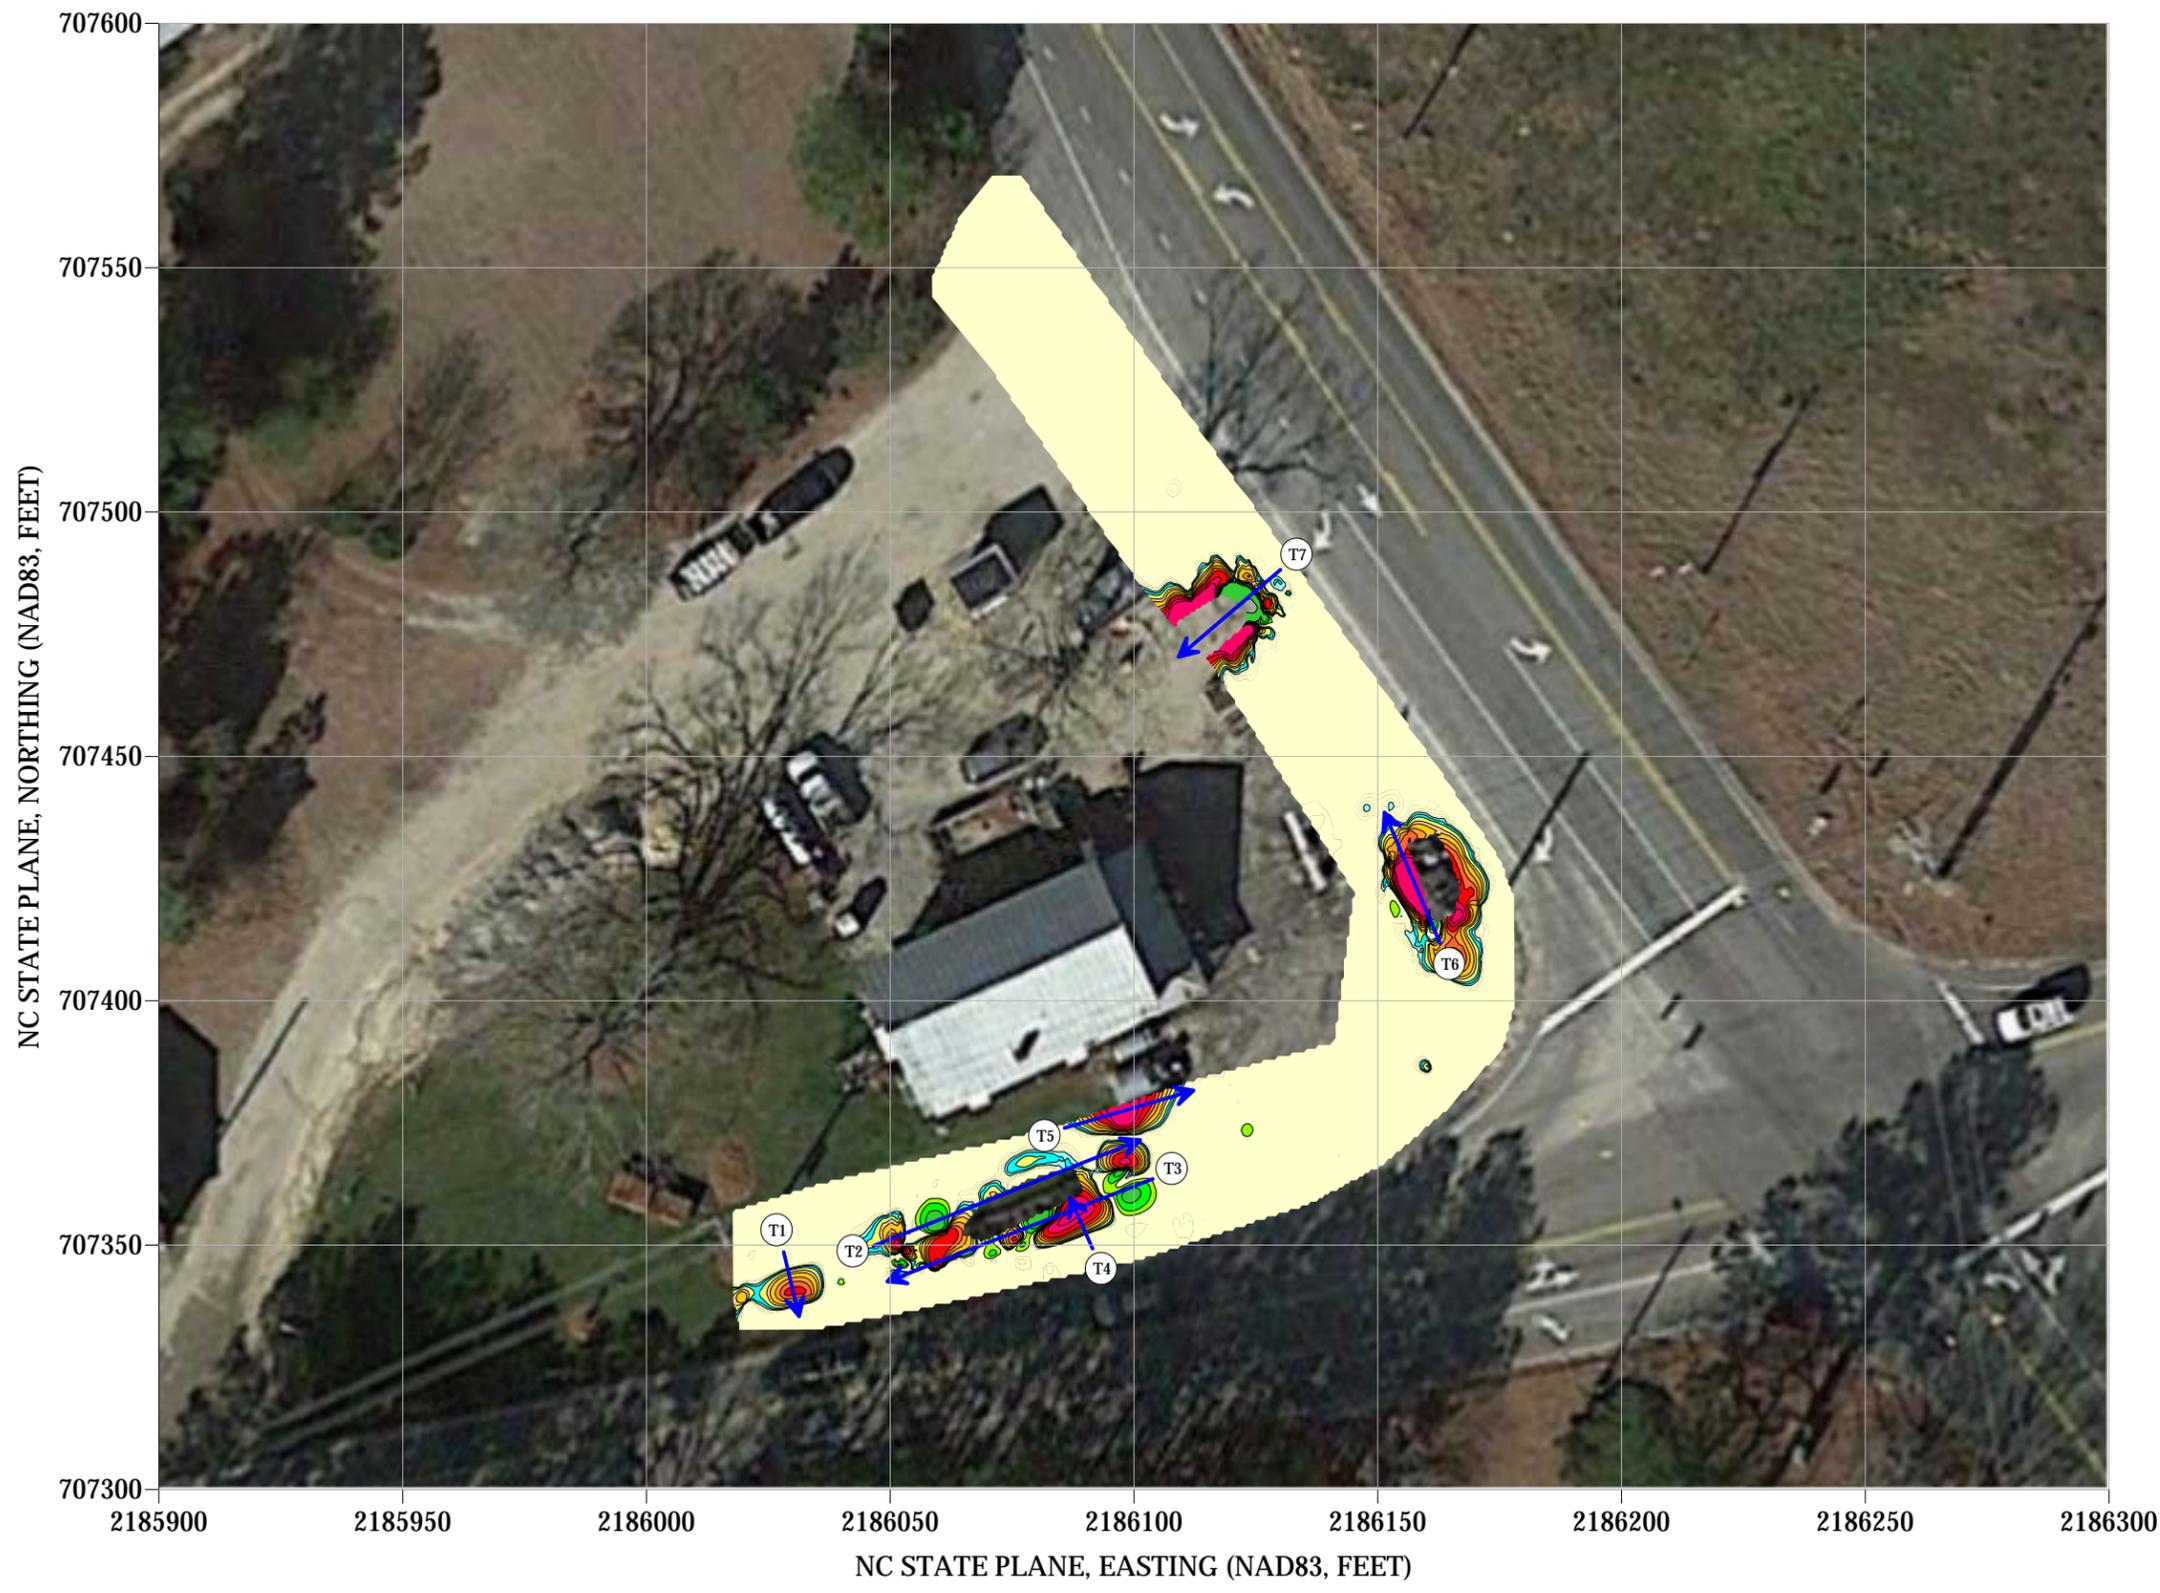
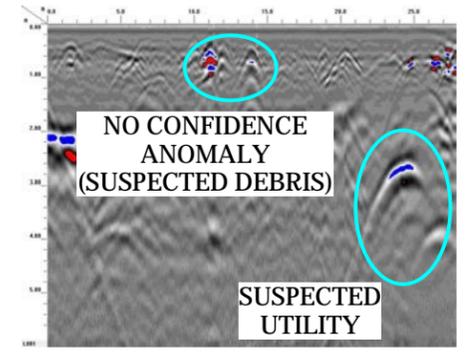
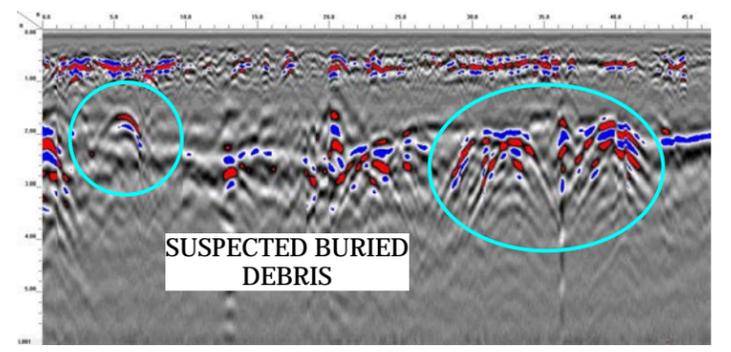
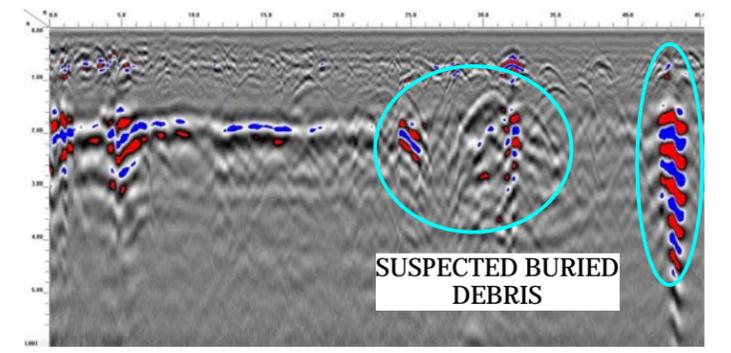
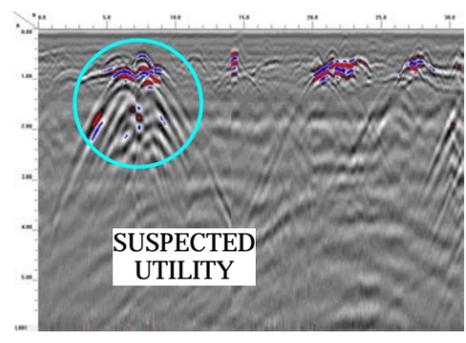
LOCATIONS OF GPR TRANSECTS

Figure 3 presents the locations of the formal GPR transects performed at the property as well as select transect images. All of the transect images are included in **Appendix A**. A total of seven GPR transects were performed at the property. GPR Transect 1 was performed across EM Anomaly 5. This transect showed discrete hyperbolic reflectors, indicative of utilities, on the margins of the anomaly. Due to the evidence of buried metal in the EM data and the lack of GPR evidence of a buried structure, this anomaly is classified as a no confidence anomaly. This anomaly is likely a result of smaller buried metallic debris.

The remaining transects were performed around areas of significant surface metal (vehicles, an AST, and the reinforced concrete ramp). No evidence of USTs was observed. GPR Transects 2-4 were performed around the reinforced concrete ramp (EM Anomaly 3) and showed scattered hyperbolic and repeating reflectors consistent with buried debris. No evidence of USTs was observed.

GPR TRANSECT 1 (T1)

GPR TRANSECT 2 (T2)

GPR TRANSECT 3 (T3)

GPR TRANSECT 7 (T7)

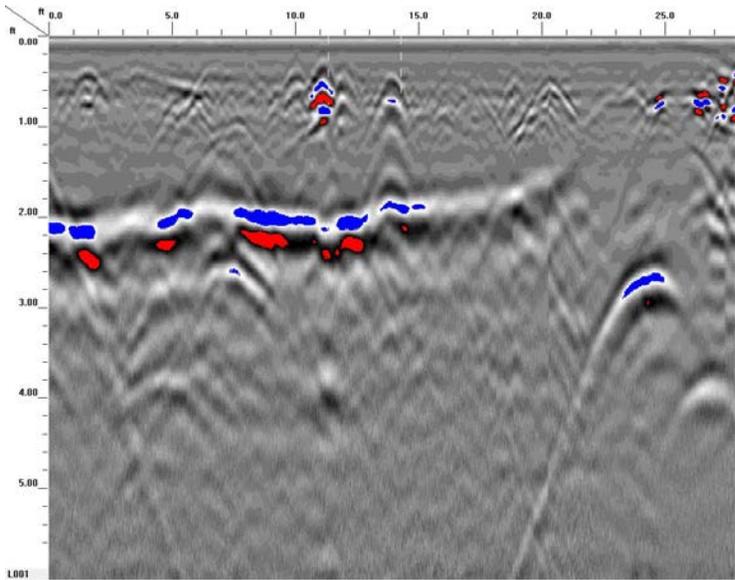
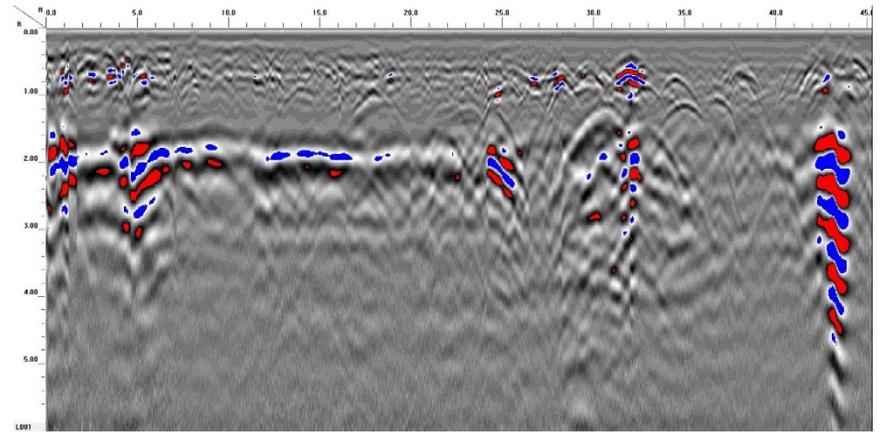
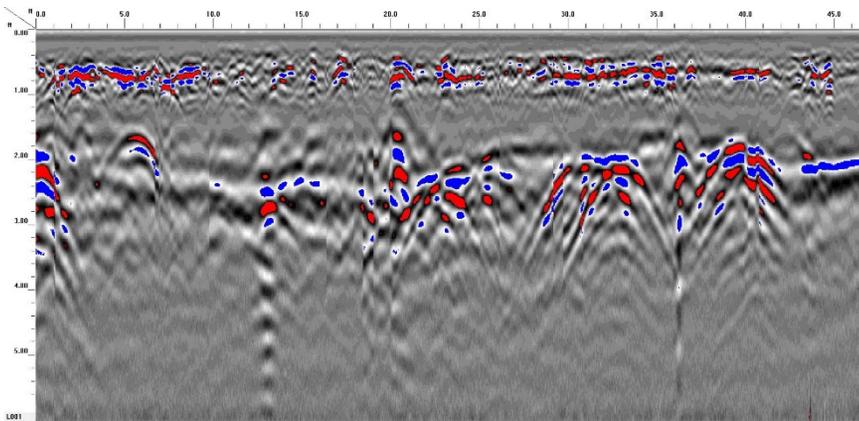
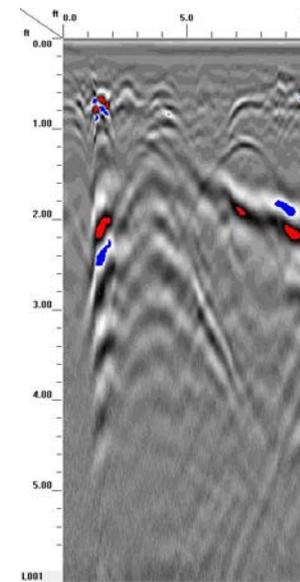
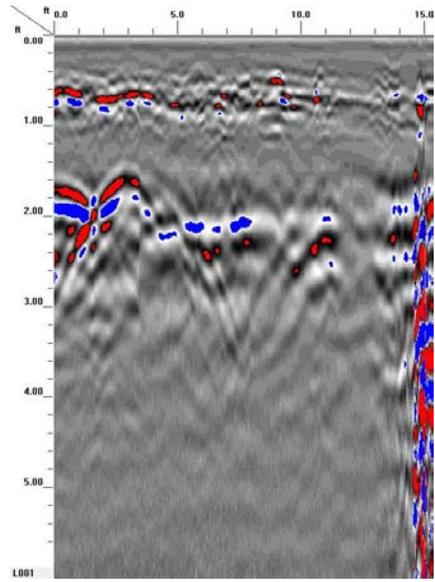
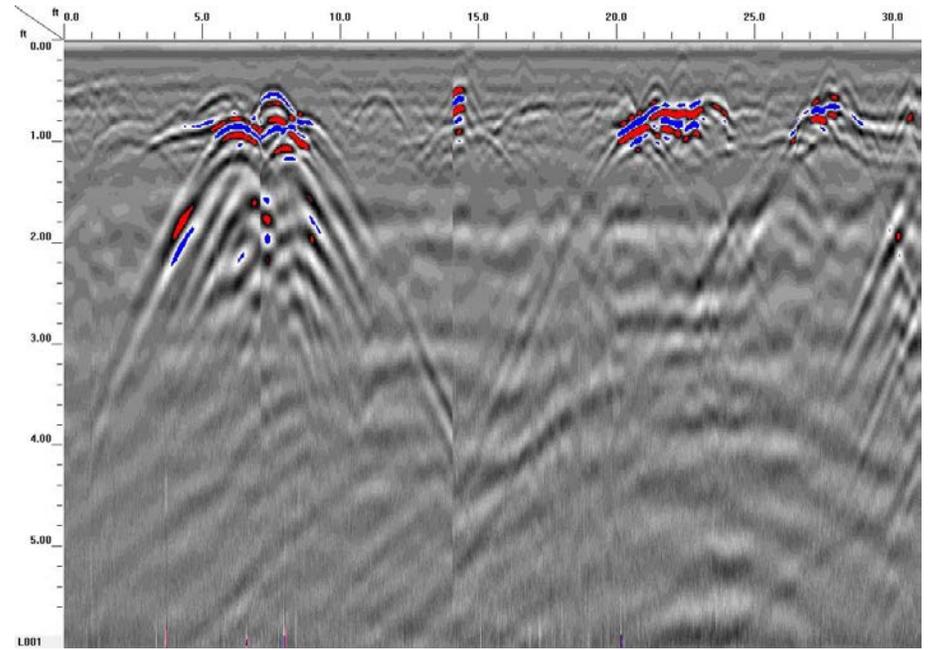
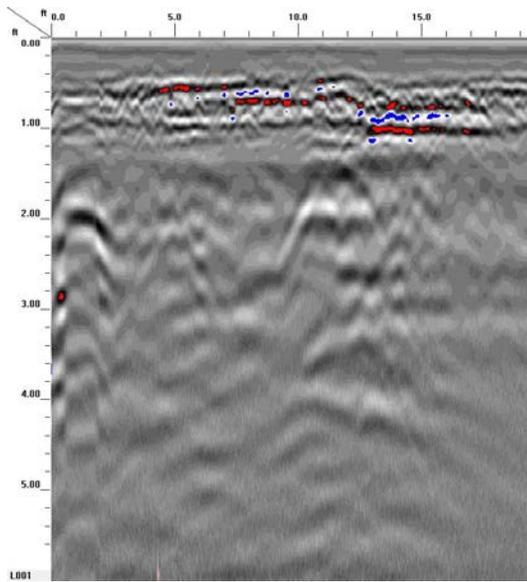
Appendix A – GPR Transect Images

GPR TRANSECT 1

GPR TRANSECT 3

GPR TRANSECT 2

GPR TRANSECT 4

GPR TRANSECT 5

GPR TRANSECT 7

GPR TRANSECT 6
