**Reference: Preliminary Site Assessment for the Barnes Family Property (Revision 1)
13726 Buffalo Road
Clayton, Johnston County, North Carolina
State Project: W-5704E
WBS Element 44850.1.5
DAA Project No. 18110172-010701**

PYRAMID GEOPHYSICAL SERVICES
(PROJECT 2018-256)

METALLIC UST INVESTIGATION: PARCEL 64 NCDOT PROJECT W-5704E

GEOPHYSICAL INVESTIGATION REPORT
Parcel 64 - 13726 Buffalo Road
Clayton, Johnston County, North Carolina

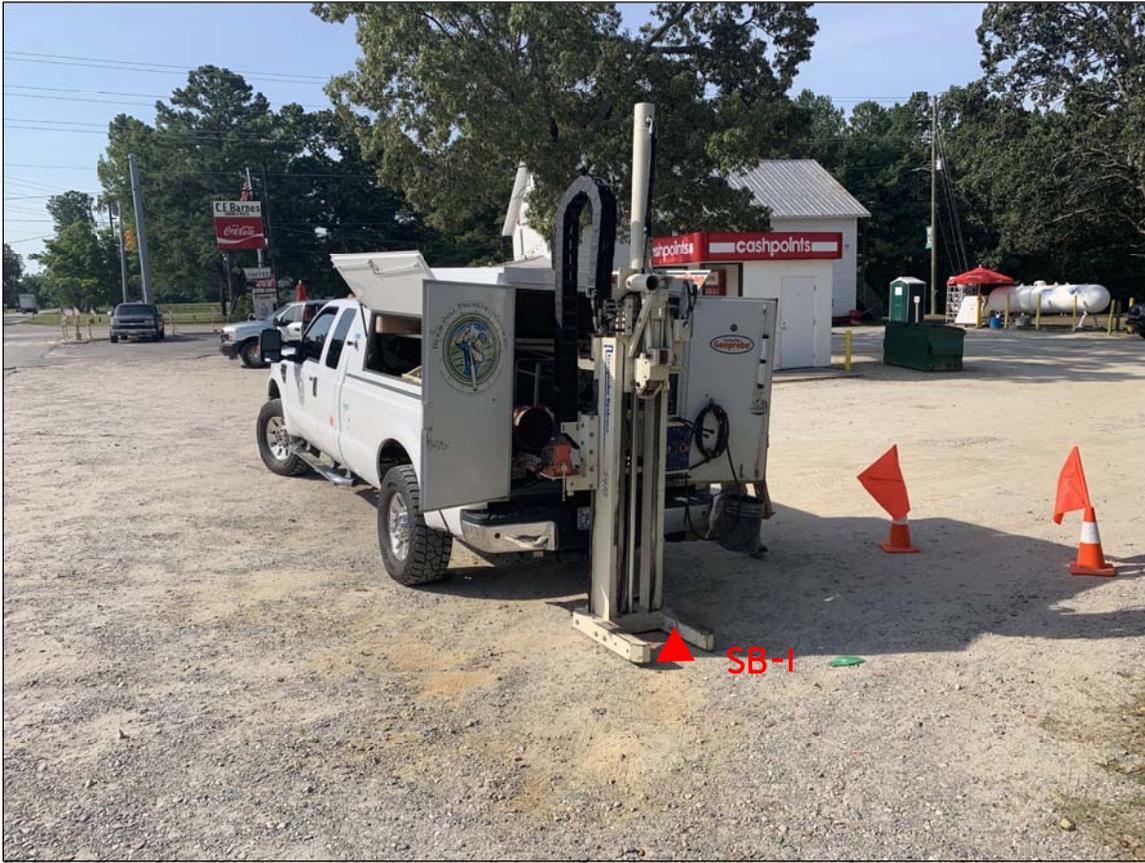
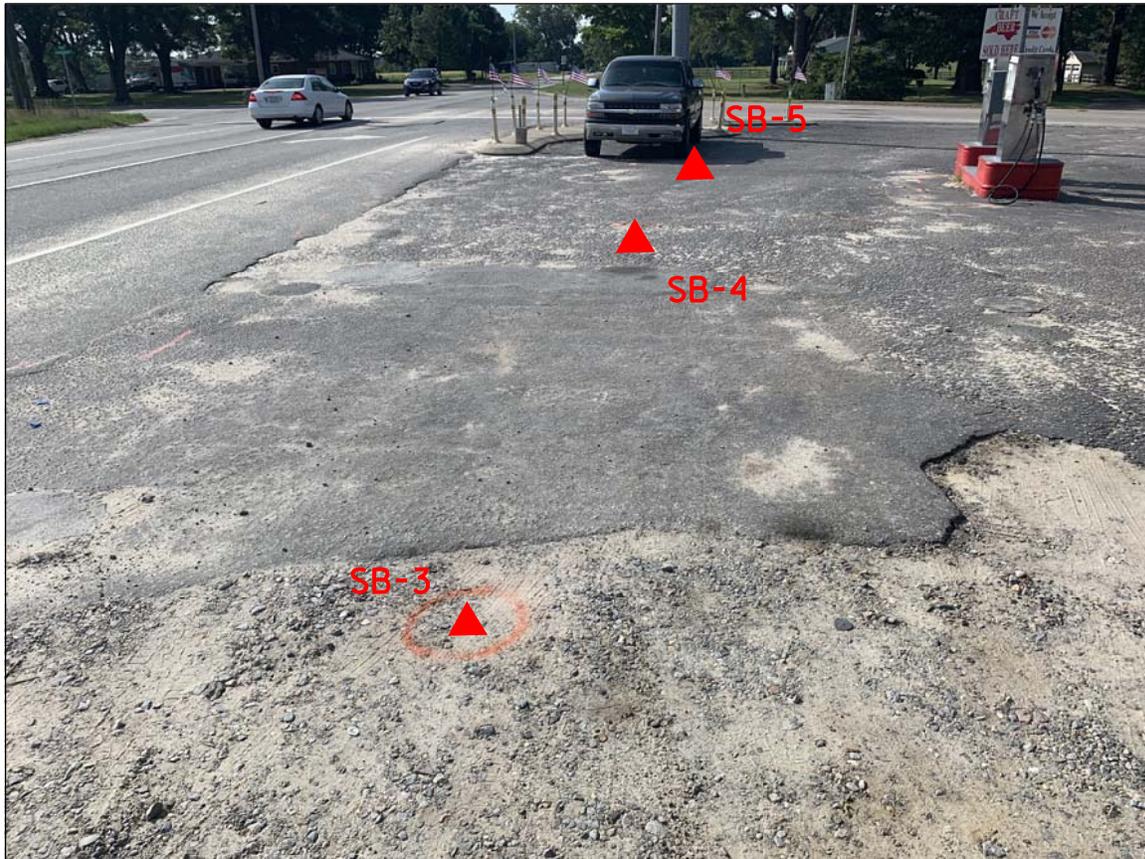
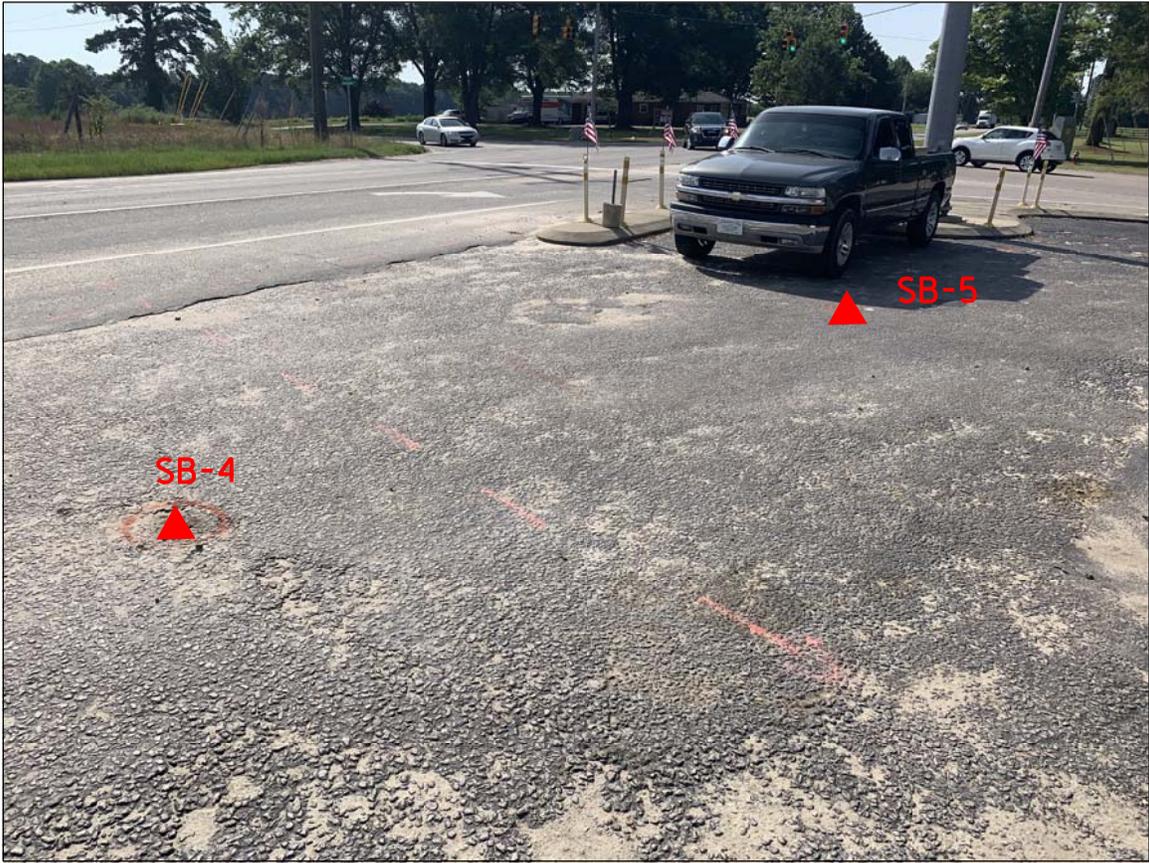
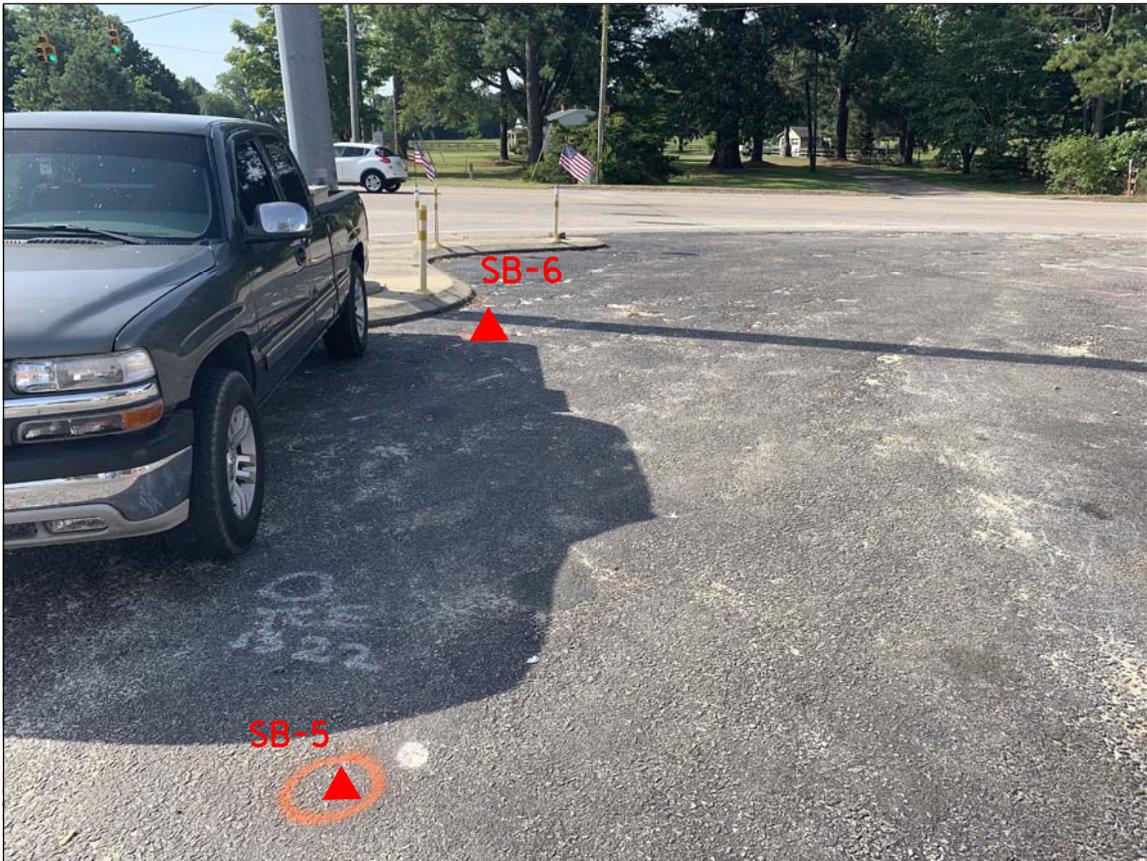
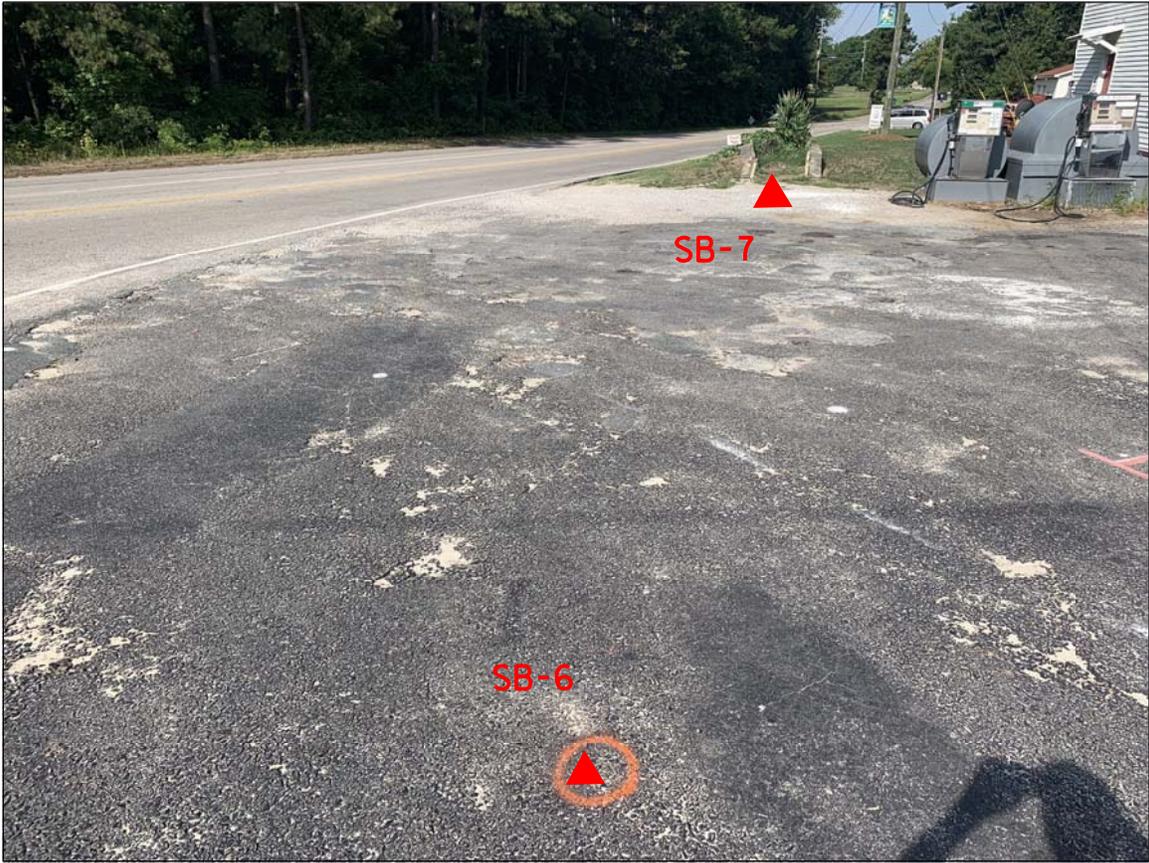
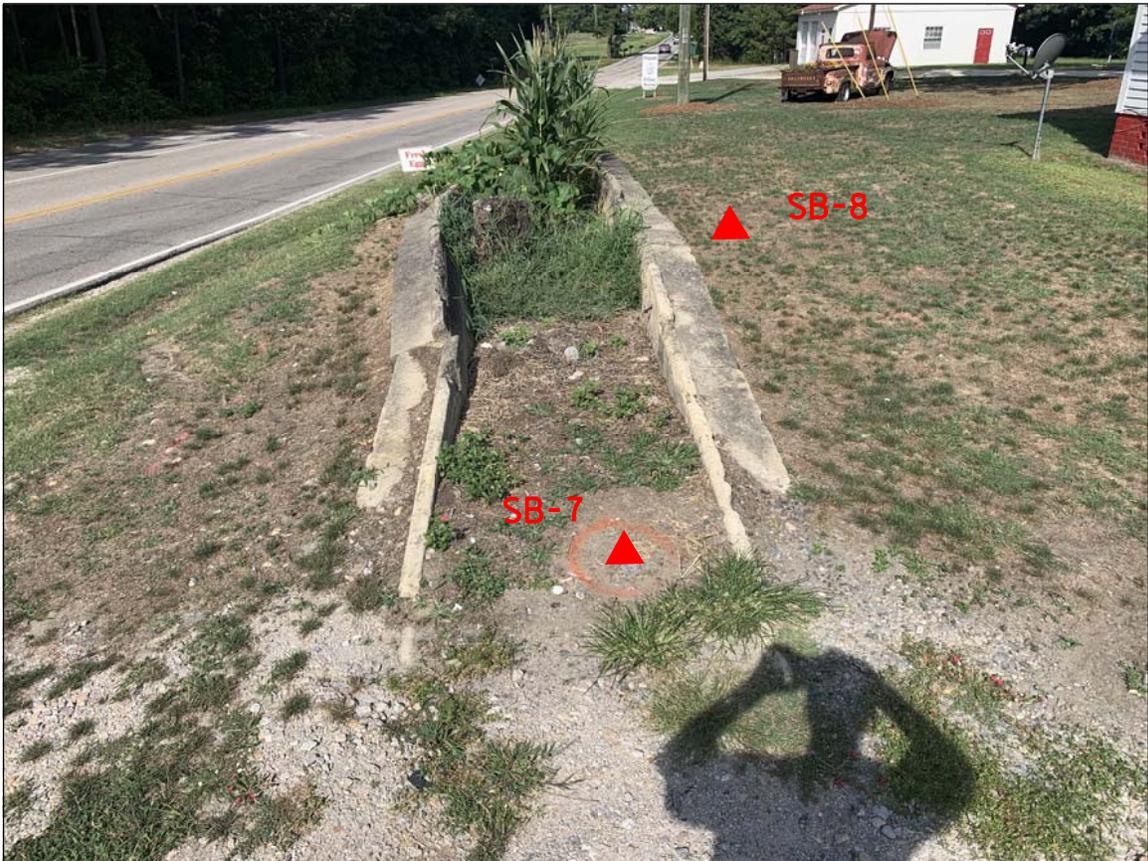
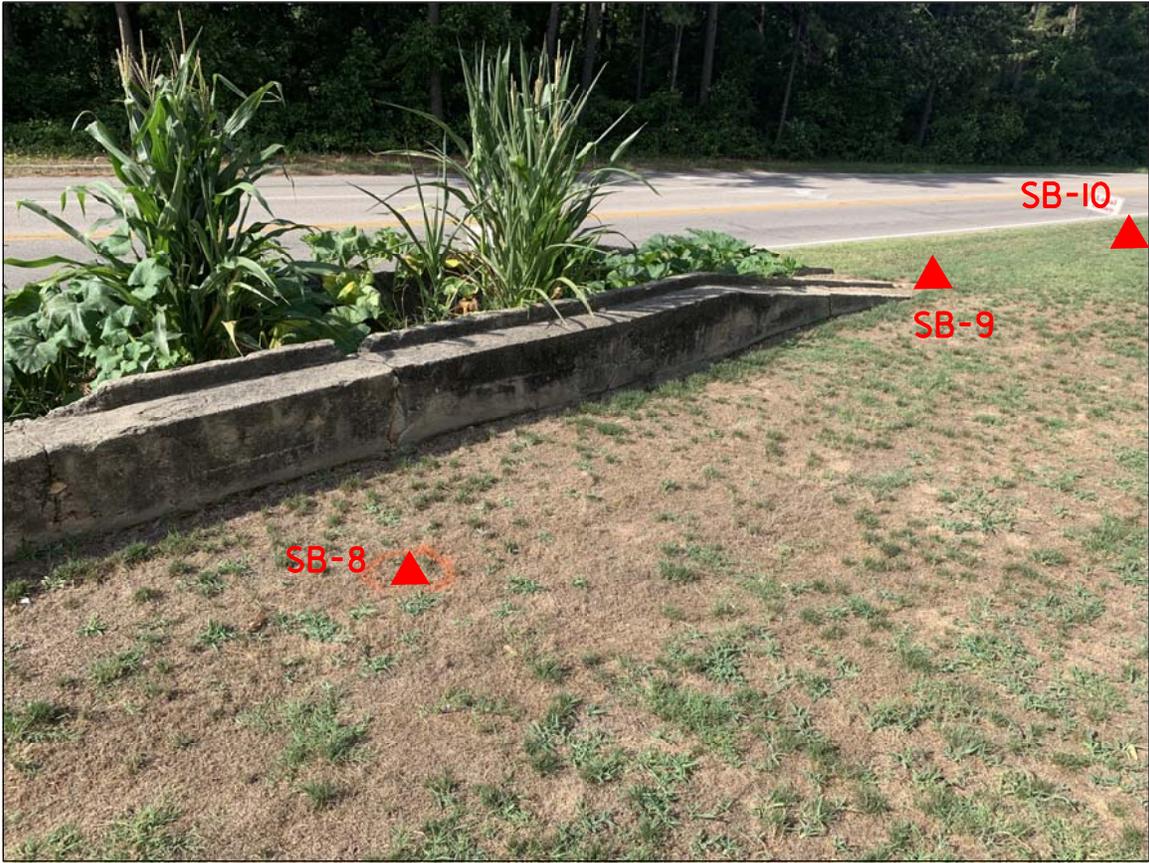
Photographs

On July 1, 2019, DAA mobilized to the site to conduct a Geoprobe® direct-push investigation to evaluate subsurface soil and groundwater conditions on the property to a depth of 10 feet below ground surface (ft bgs) or groundwater, whichever was shallower. Prior to DAA's mobilization, Pyramid and NC One Call located the underground utilities within the study area. DAA advanced 10 direct-push holes (SB-1 through SB-10) at select locations throughout the proposed right-of-way (**Figure 2**). The soil boring logs are included as **Attachment B**. The borings were located to evaluate the subsurface conditions in the study area (see digital images in **Attachment C**).

PHOTO 1 - VIEW OF SOIL BORING LOOKING SOUTH

PHOTO 2 - VIEW OF SOIL BORING LOOKING SOUTH

PHOTO 3 - VIEW OF SOIL BORING LOOKING SOUTHEAST

PHOTO 4 - VIEW OF SOIL BORING LOOKING SOUTH

PHOTO 5 - VIEW OF SOIL BORING LOOKING WEST

PHOTO 6 - VIEW OF SOIL BORING LOOKING WEST

PHOTO 7- VIEW OF SOIL BORING LOOKING SOUTHWEST

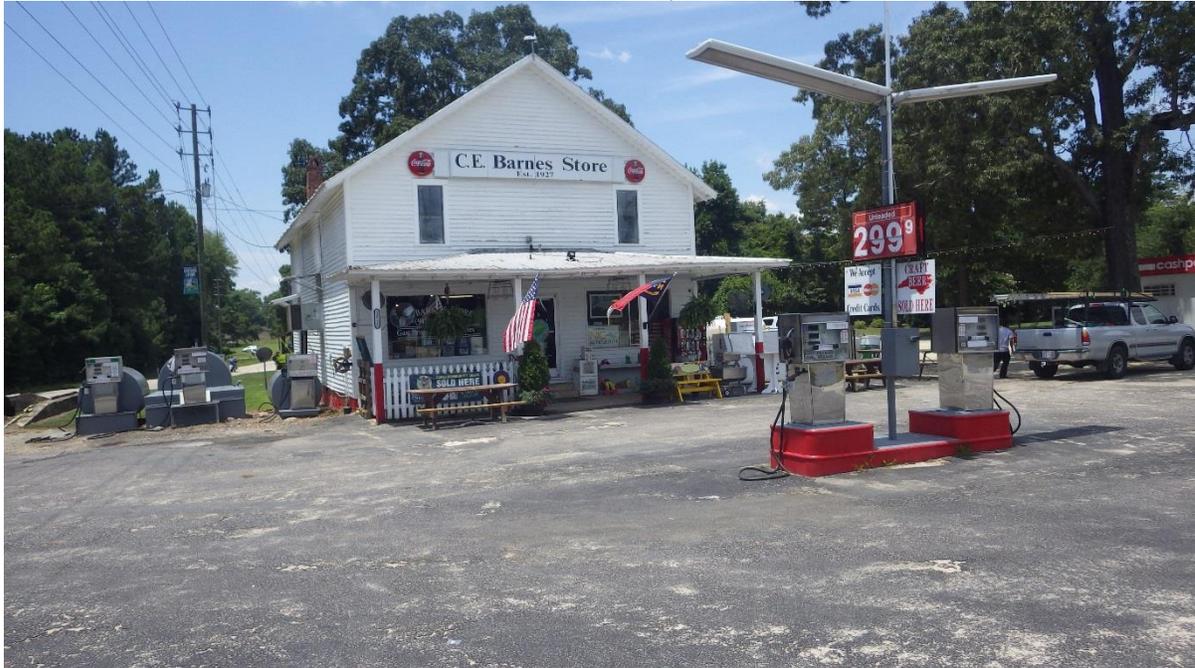
This facility is an active gas station/convenience store. It is located on the northwest quadrant of Buffalo Rd and Covered Bridge Rd. According to the UST Section Registry there are two (2) UST currently in use. There are also three (3) ASTs currently in use. The USTs are located on the north side of the building. The ASTs are located on the south side of the building with the dispensers directly in front of them. The pump island for the USTs is located in front of the building approximately 40 feet from the edge of pavement on Buffalo Rd. There are no known incidents associated with this facility.
