***PRELIMINARY SITE ASSESSMENT***

**PARCEL 7 – WGT PROPERTIES, LLC  
102 BELL FORK RD.  
JACKSONVILLE, ONSLOW COUNTY, NORTH CAROLINA**

**TIP NUMBER. U-5728  
WBS NUMBER: 54019.1.1  
DESCRIPTION: US 17 BUSINESS (MARINE BLVD.) TO SR 1308 (BELL FORK  
RD.) INTERSECTION IMPROVEMENTS**

**CATLIN PROJECT NO. 218123**

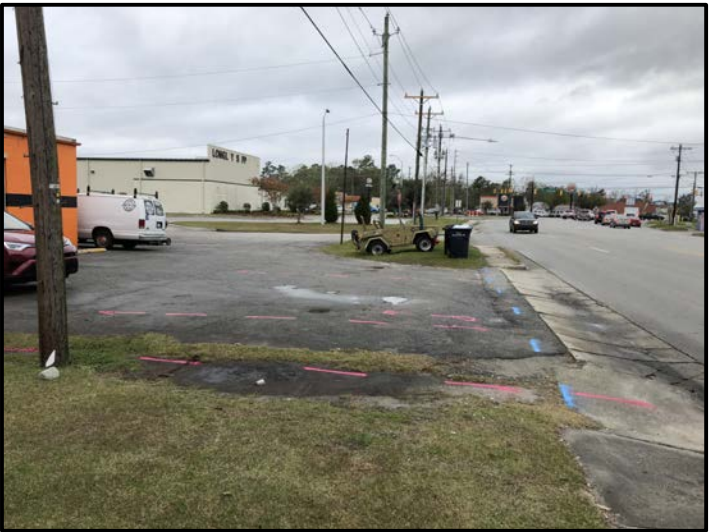
View of Survey Area  
(Facing Approximately West)

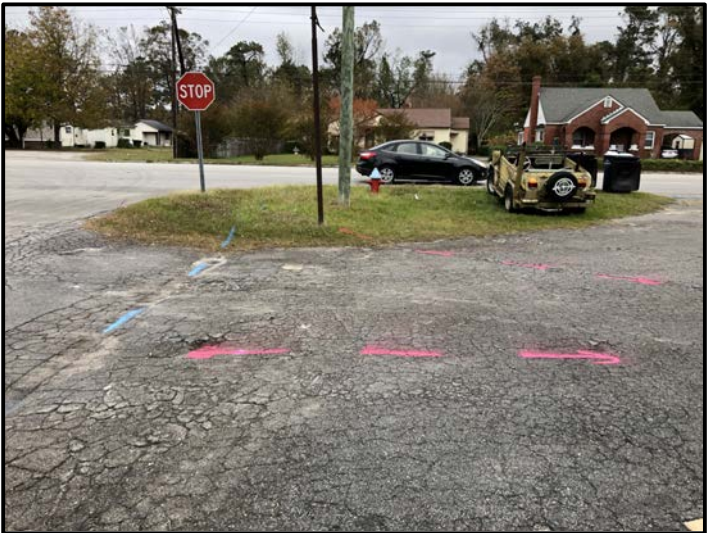
View of Survey Area  
(Facing Approximately North)

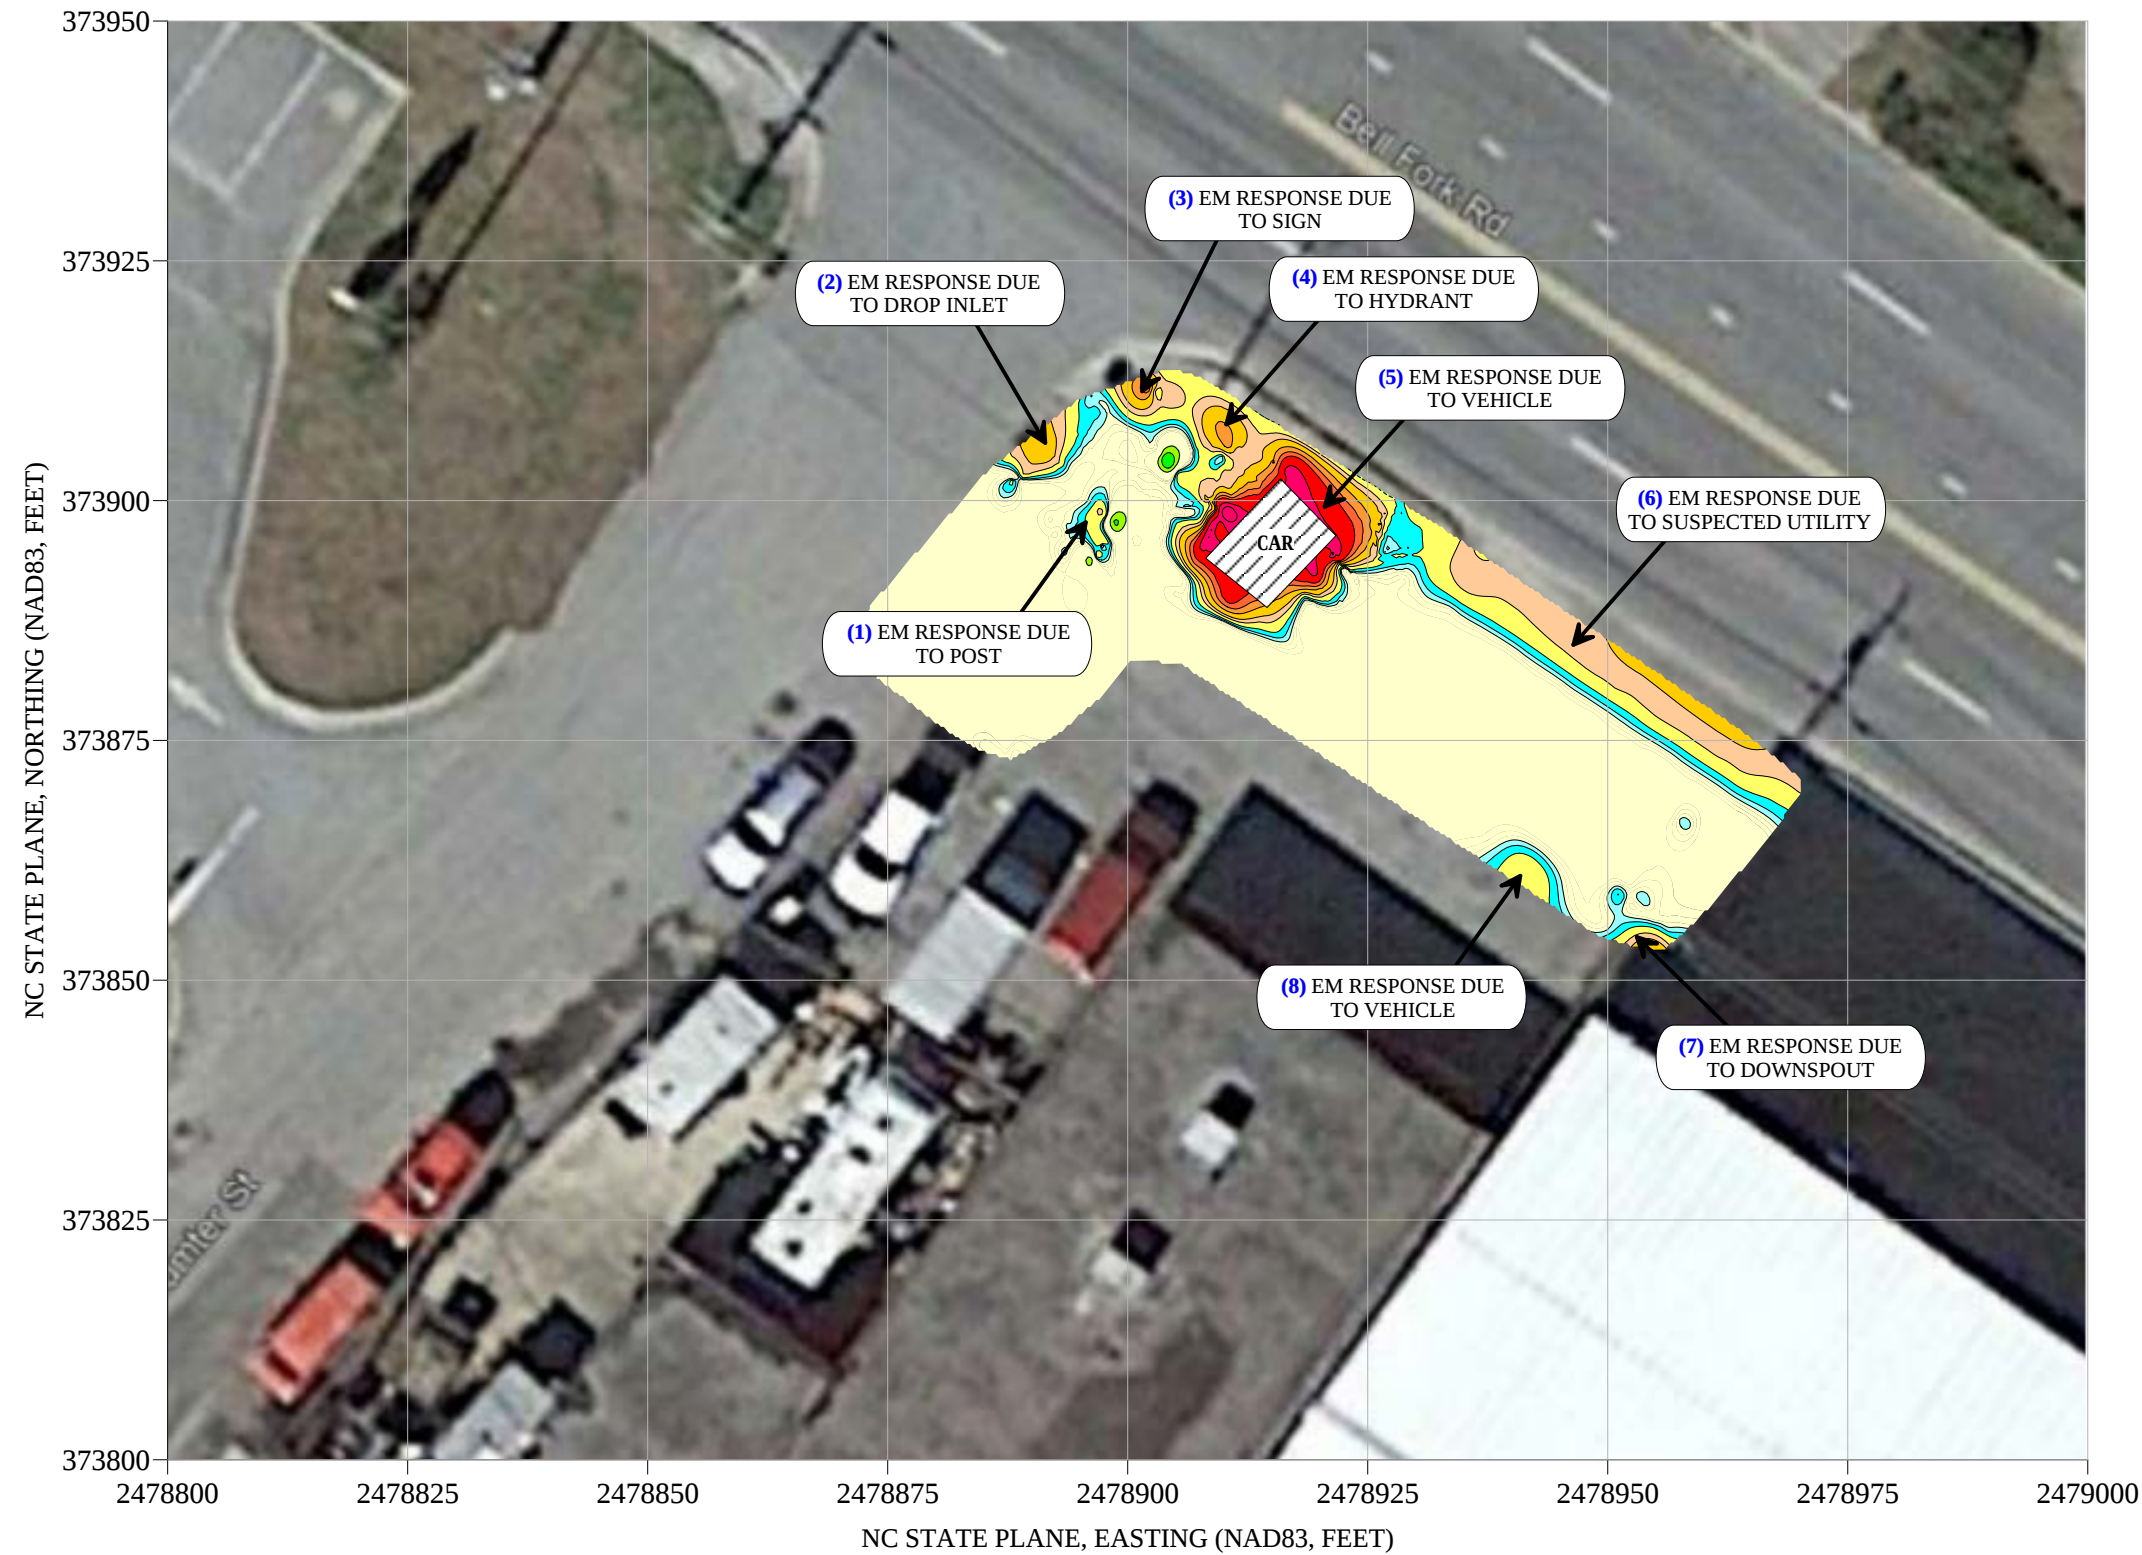
EM61 METAL DETECTION RESULTS

A contour plot of the EM61 results obtained across the survey area at the property is presented in **Figure 2**. Each EM anomaly is numbered for reference in the figure. The following table presents the list of EM anomalies and the cause of the metallic response, if known:

The majority of the EM anomalies were directly attributed to visible cultural features at the ground surface, including a post, a drop inlet, a sign, a hydrant, vehicles and a downspout. EM Anomalies 5, 7, and 8 were associated with vehicles and an adjacent downspout at the site. These anomalies were further investigated with GPR to confirm that the EM interference observed was a result of the vehicles and downspout and did not obscure any significant structures, such as USTs.

NO EVIDENCE OF METALLIC  
USTs OBSERVED.

The contour plot shows the differential results of the EM61 instrument in millivolts (mV). The differential results focus on larger metallic objects such as USTs and drums. The EM data were collected on November 26, 2018, using a Geonics EM61-MK2 instrument. Verification GPR data were collected using a GSSI UtilityScan DF instrument with a dual frequency 300/800 MHz antenna on November 26, 2018.

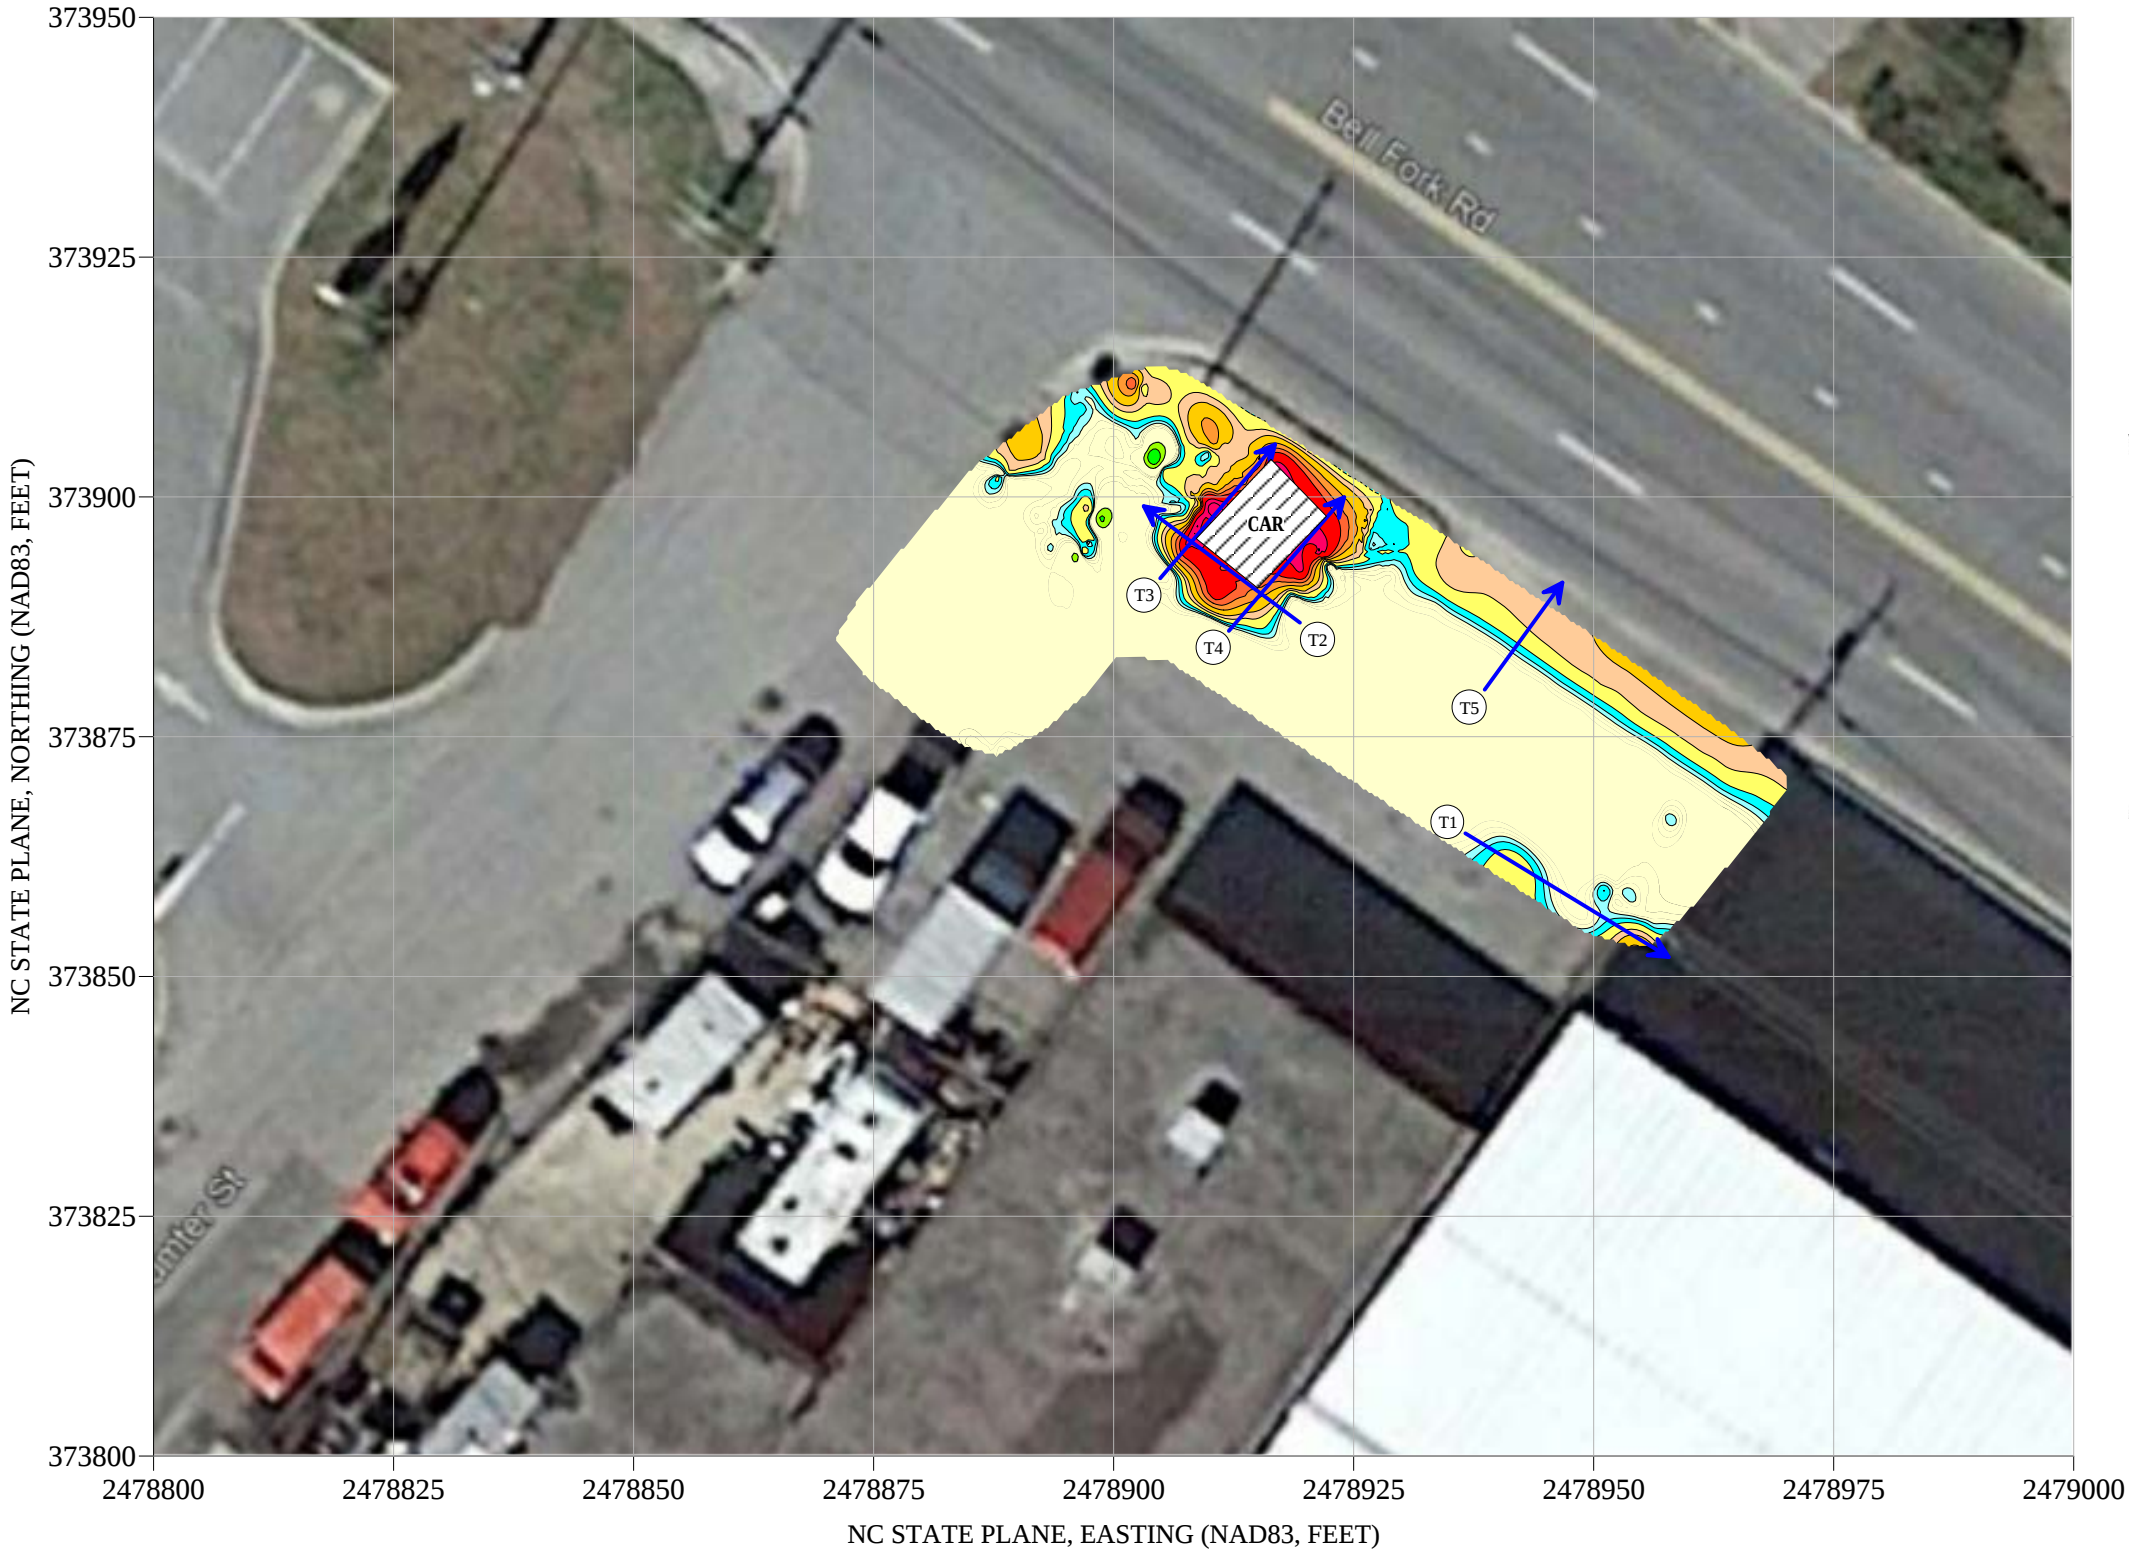
LOCATIONS OF GPR TRANSECTS

**Figure 3** presents the locations of the formal GPR transects performed at the property as well as the transect images. A total of five formal GPR transects were collected at the site. GPR Transects 1-4 were performed across EM Anomalies 5, 6, 7, and 8 to investigate whether the vehicles and adjacent downspout obscured any significant structures, such as USTs. No evidence of significant structures was observed.

GPR Transect 5 observed a low-amplitude reflector consistent with a potential utility. It should be noted that, as per the MicroStation utility maps provided by Catlin, this anomaly is in the vicinity of a water line.
