*Pyramid Environmental & Engineering, P.C. Project # 2019-084  
GeoEnvironmental Phase II Investigation (PHASE II) – Parcel 051 – Richardson, J L*

## **GEOENVIRONMENTAL PHASE II INVESTIGATION**

**PARCEL 051 – RICHARDSON, J L  
2432 N. FAYETTEVILLE STREET  
ASHEBORO, RANDOLPH COUNTY, NORTH CAROLINA  
STATE PROJECT: U-5711  
WBS ELEMENT: 50160.1.1  
APRIL 12, 2019**

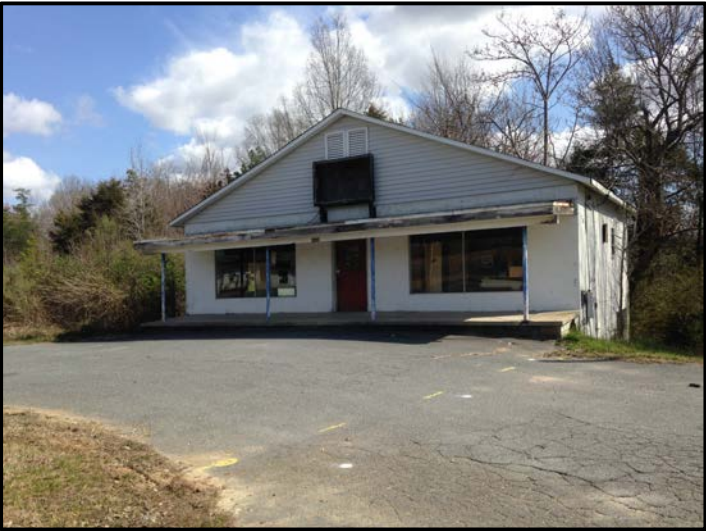
View of Survey Area  
(Facing Approximately East)

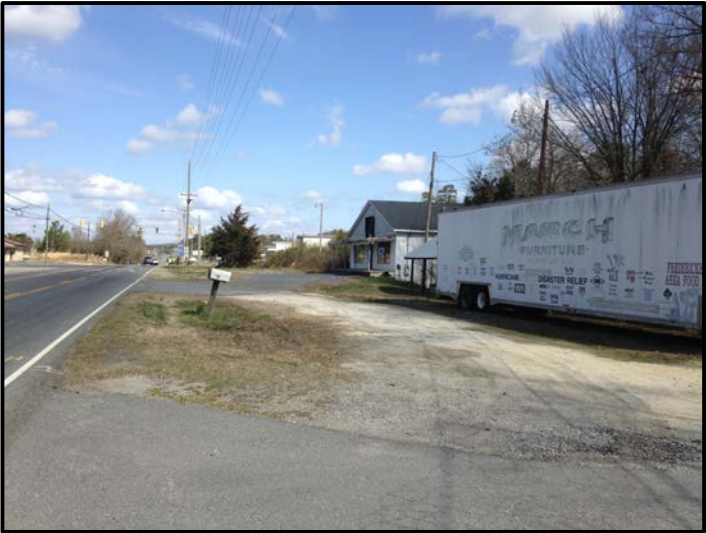
View of Survey Area  
(Facing Approximately North)

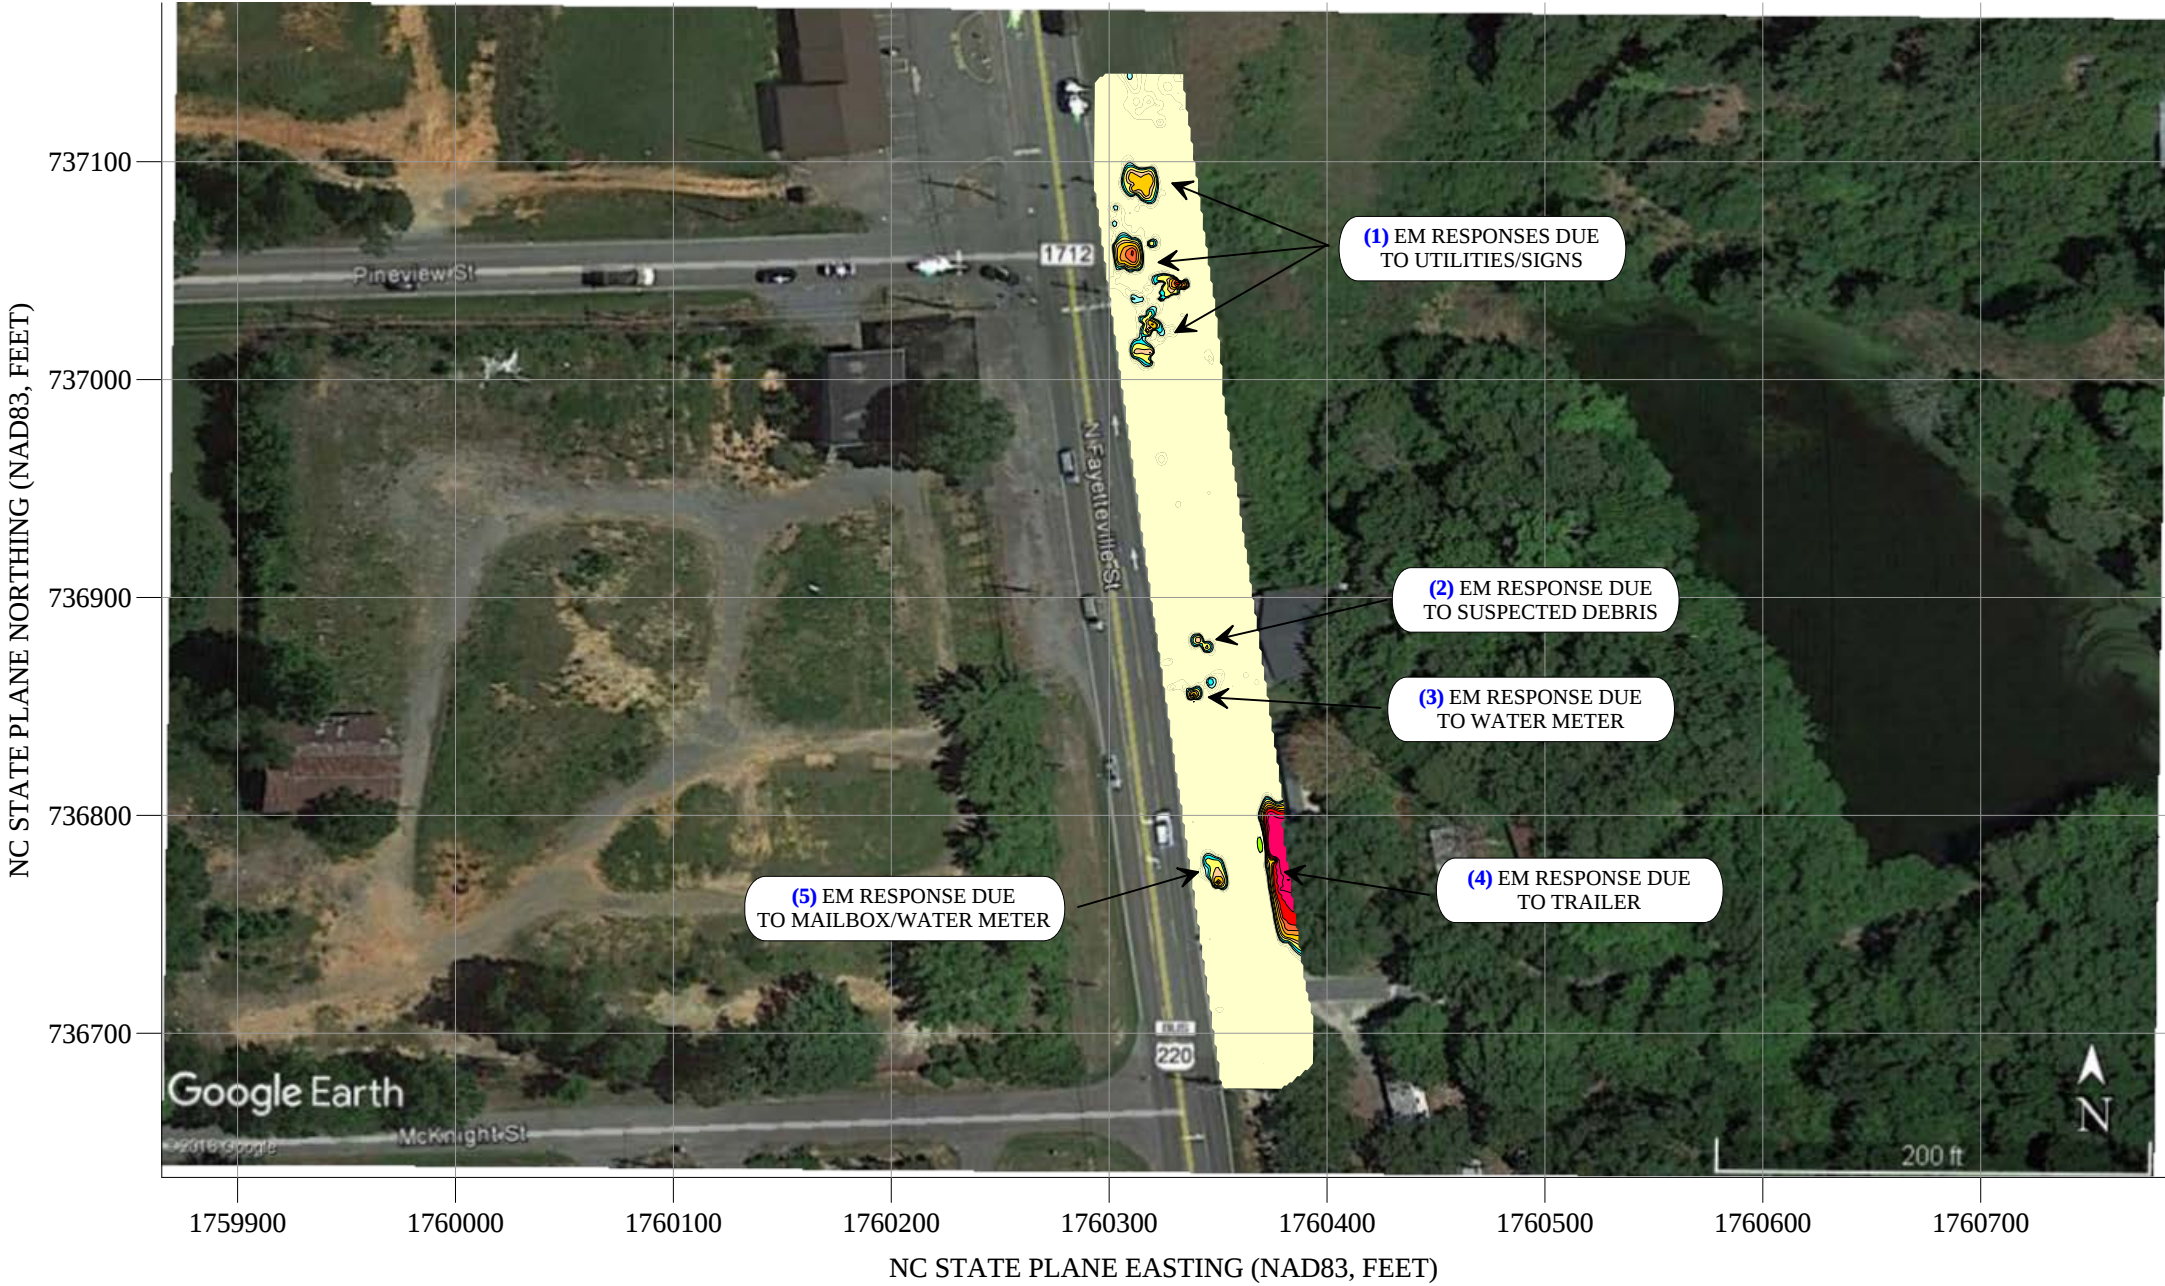
EM61 METAL DETECTION RESULTS

NO EVIDENCE OF METALLIC USTs WAS OBSERVED.

The contour plot shows the differential results of the EM61 instrument in millivolts (mV). The differential results focus on larger metallic objects such as USTs and drums. The EM61 data were collected on March 12, 2019, using a Geonics EM61 instrument. Verification GPR data were collected using a GSSI UtilityScan DF instrument with a dual frequency 300/800 MHz antenna on April 1, 2019.

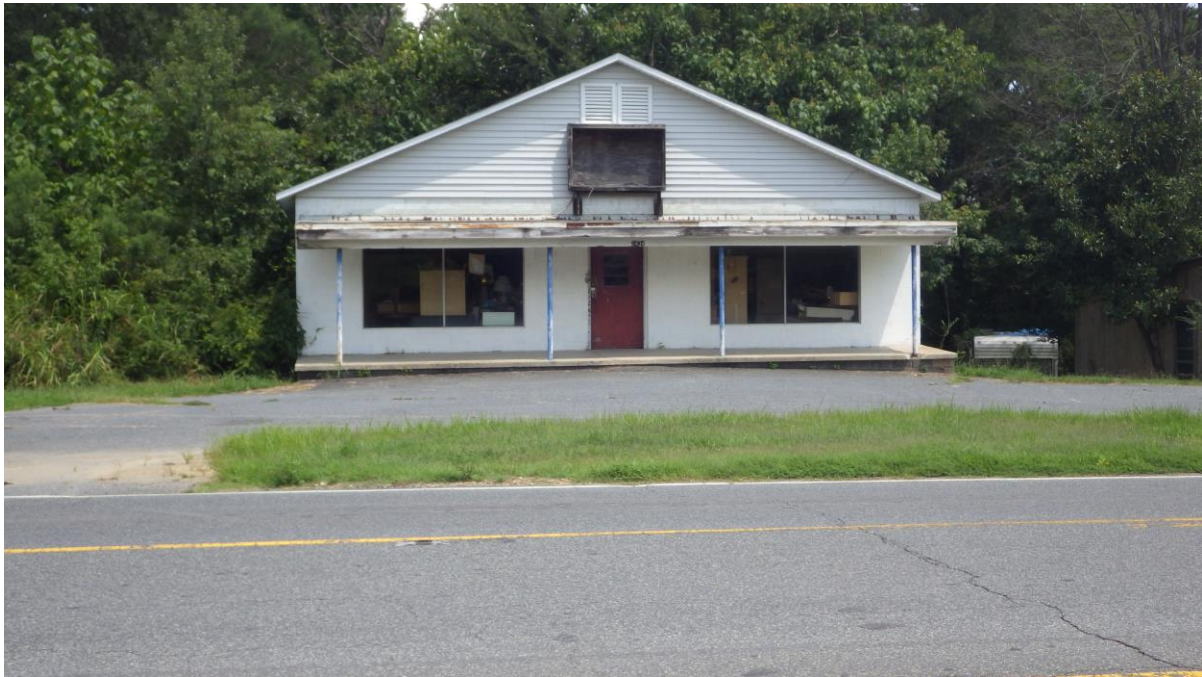
**Anticipated Impacts: LOW**

A vacant store building full of items inside. It is possible a former old country store or a gas station at one time. No USTs or monitoring wells observed on site. No record can be located in NEDEQ's incident database.

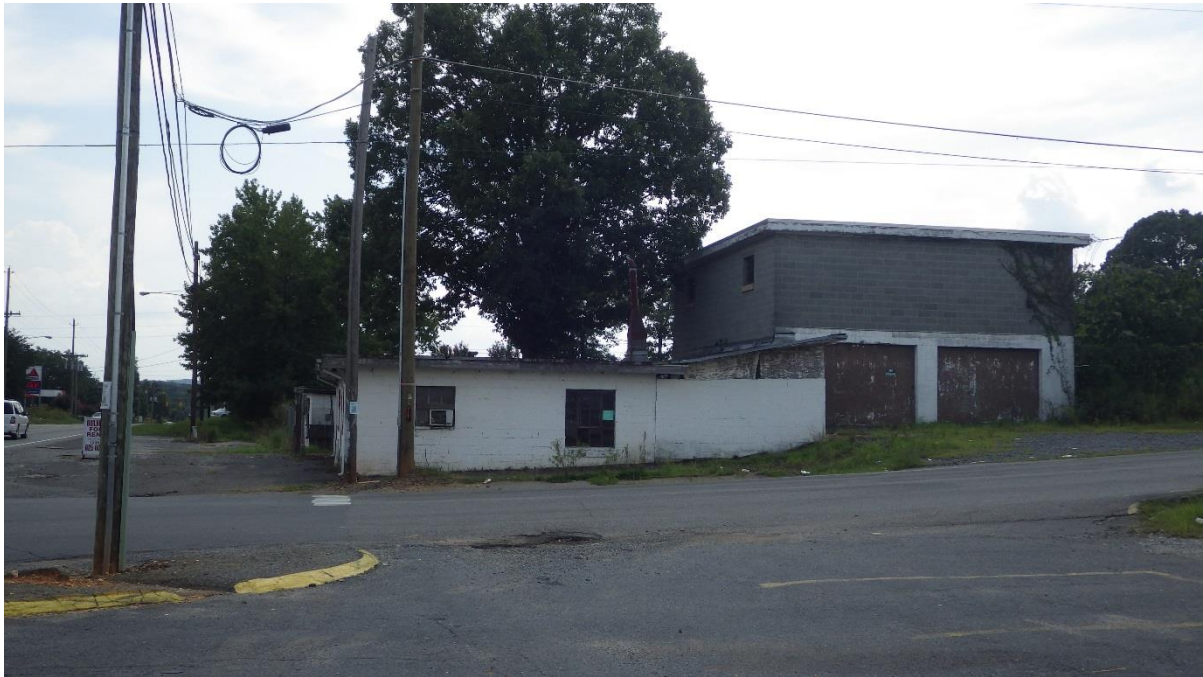
**Anticipated Impacts:** LOW

A vacant building along with a vacant land in the back. It was possible once a service garage and former gas station, part of land in the back have been used as a junk yard and all of junk cars have been removed within the past 12 months. No USTs or monitoring wells observed on site. No record can be located in NEDEQ's incident database

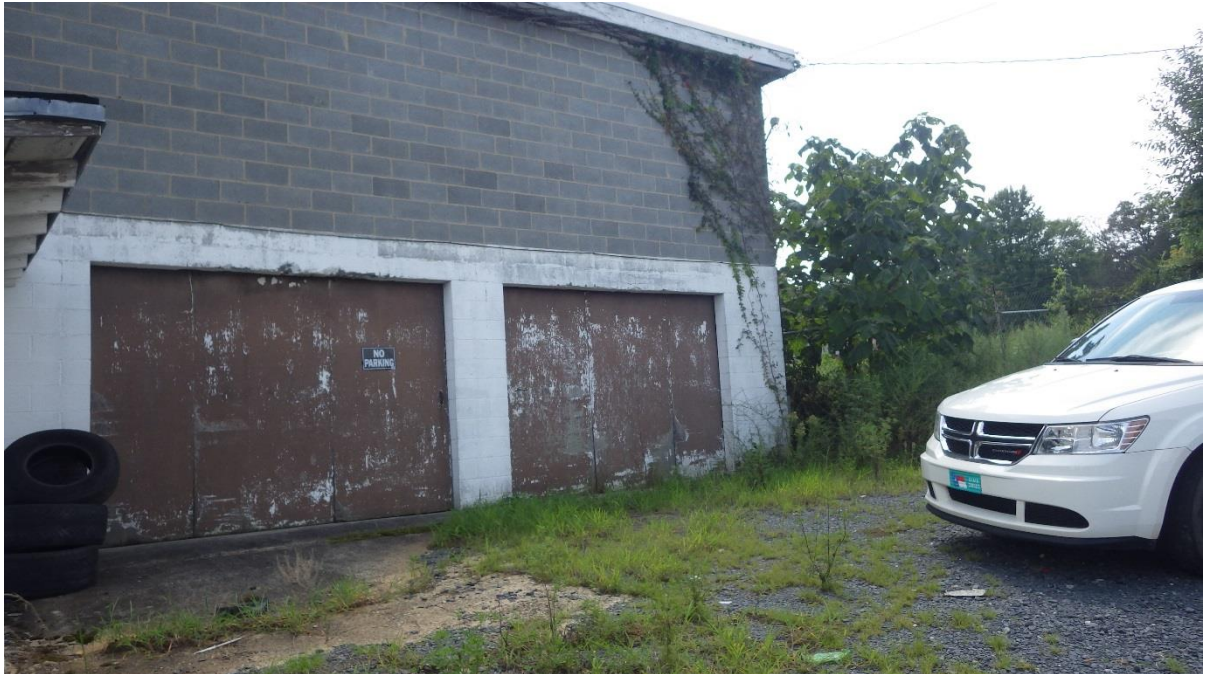
Service garages.

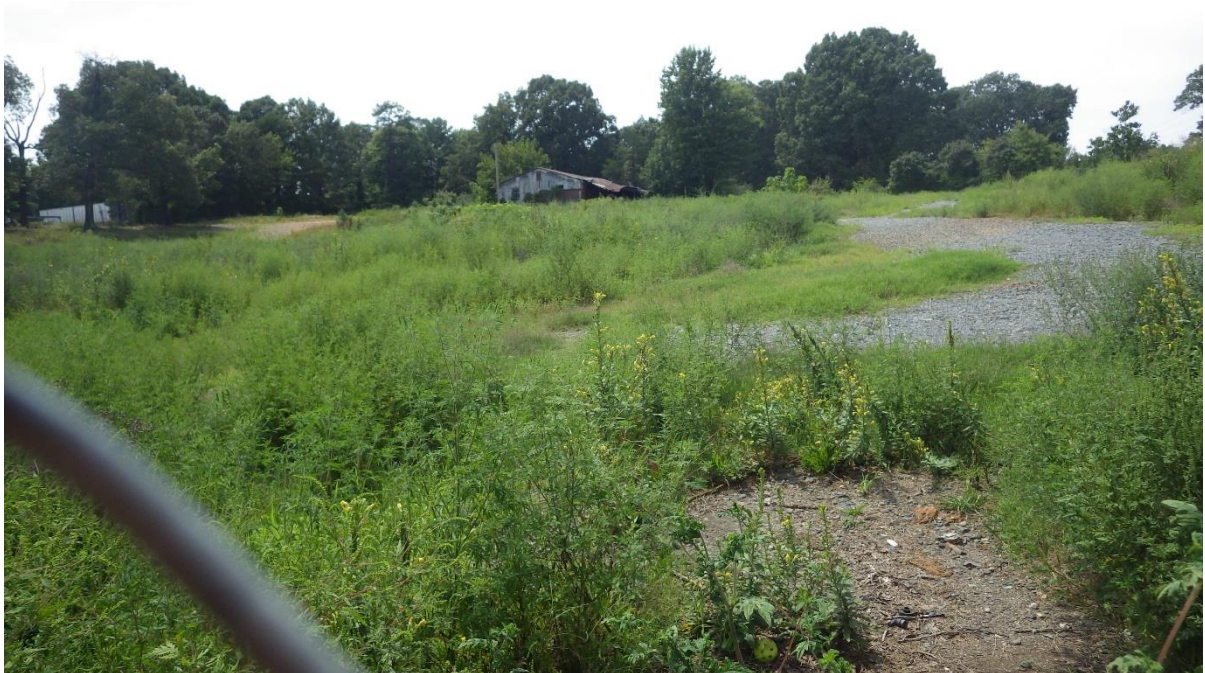
Overgrown vacant land in the back, there were junk cars in this land based on the area photos and google map/street view. NCDOT geotechnical crew visited the area 6 month earlier, there were still junk cars noted on the lot.

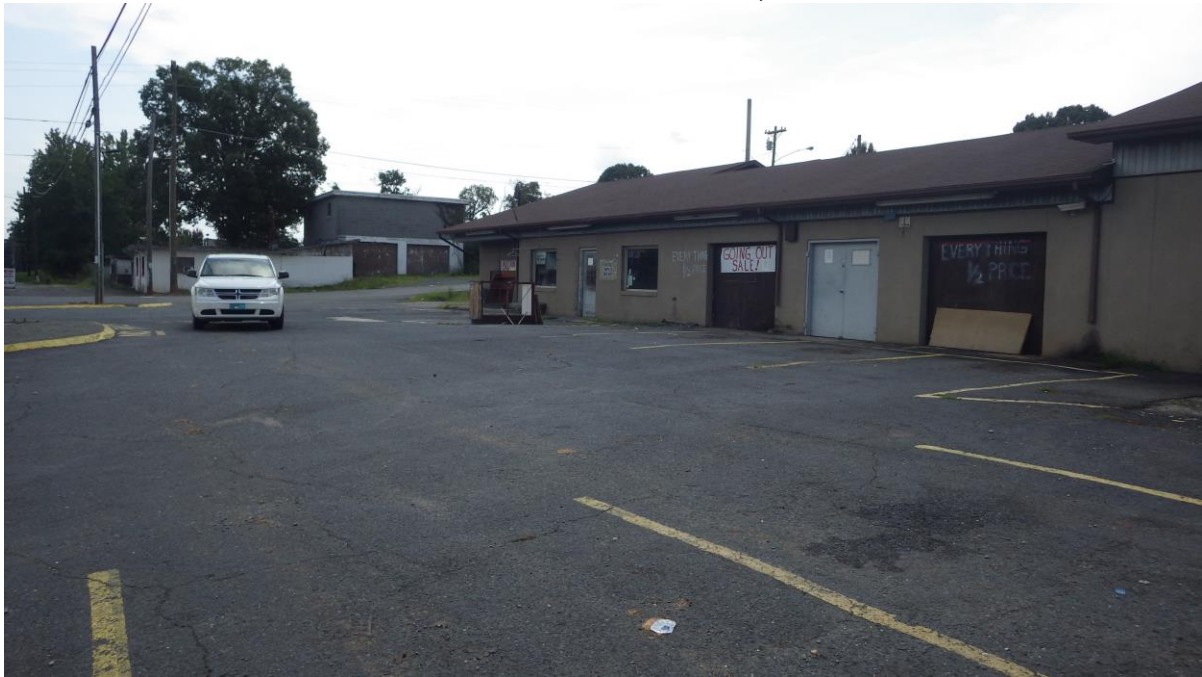
**Anticipated Impacts: LOW**

Former Service Garage or gas station. No USTs or monitoring wells observed on site. 5 USTs were reportedly permanently closed in 1992. Three of them were reportedly removed and two others were filled in place. GWI incident 13619 was recorded in 1992 and closed out 1n 1995.

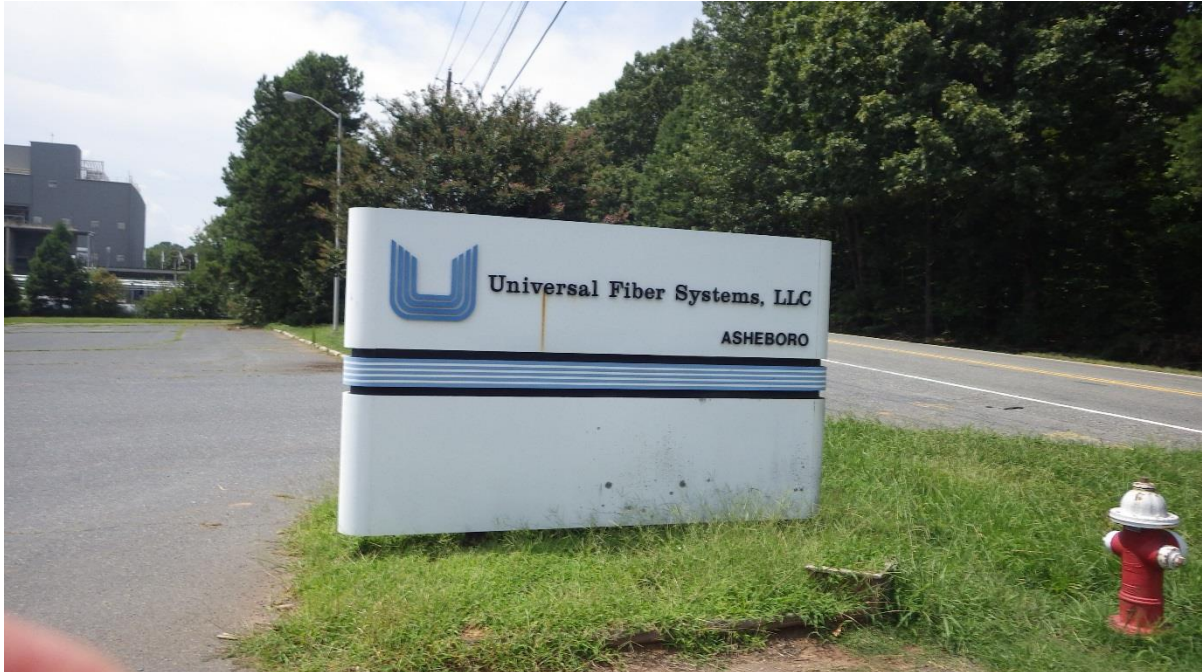
**Anticipated Impacts:** LOW

A well secured warehouse/manufacture facility. A UST containing #5 fuel oil were reportedly removed in 1994 with minor contamination. The incident 13606 was recorded in 1995, prioritized in 1998 and closed out in 1999. No USTs or monitoring wells observed on site during this visit.

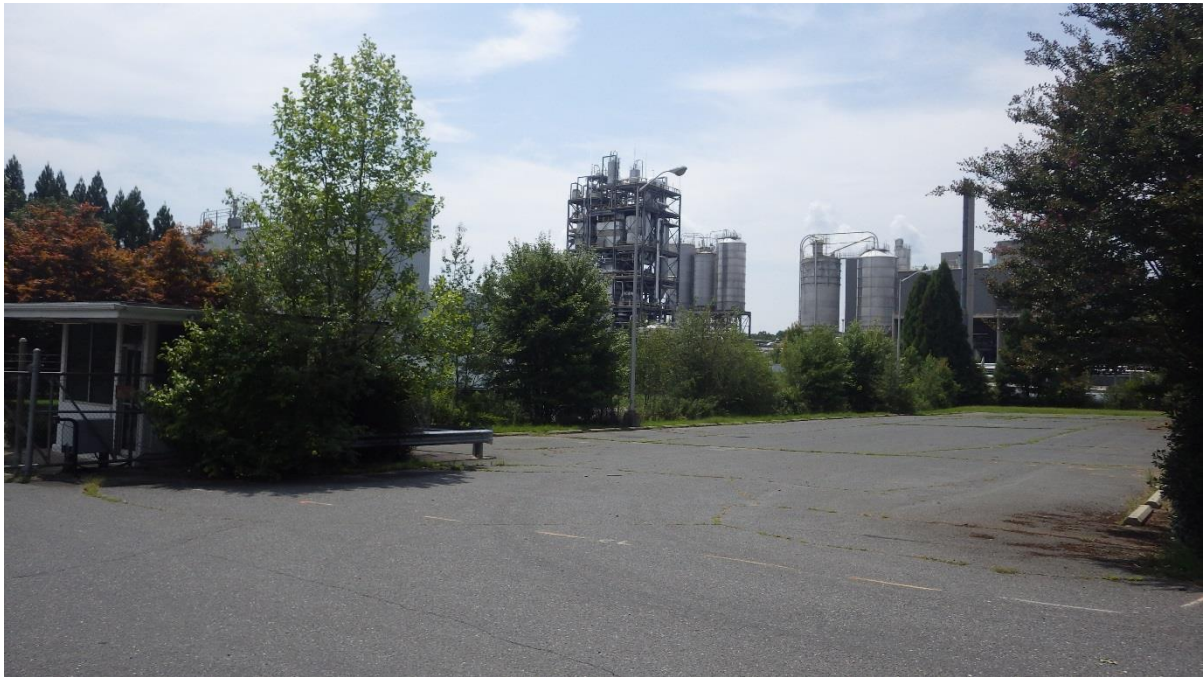
**Anticipated Impacts:** Medium

A large manufacture facility and an NCDEQ listed large industrial waste generator NCR 000004218. No USTs or monitoring wells observed on site. No incident recorded in NCDEQ's database.
