## **Phase II Site Assessment Report**

**State Project: R-5759**

**Parcel #002**

**Flynn Harrold Property**

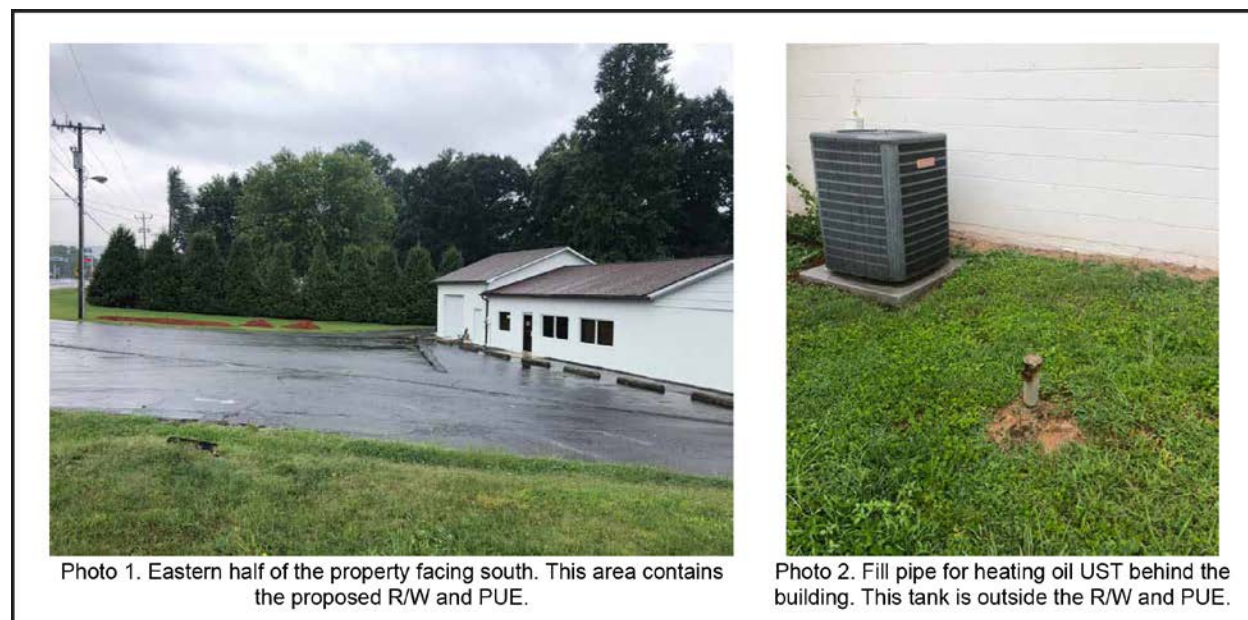
### 2.3 Plate 1 – Photographs of Parcel #002

SAPC personnel made a pedestrian reconnaissance of the property during the initial site visit on June 29, 2021. No evidence of a UST system or typical gas station infrastructure was observed within the R/W or PUE. One heating oil UST was observed on the west side of the building out of the R/W and PUE. It is not known if this tank is still in use. Should a release have occurred from this UST, it would have migrated downgradient to the west and would not affect soil quality in the R/W and/or PUE.

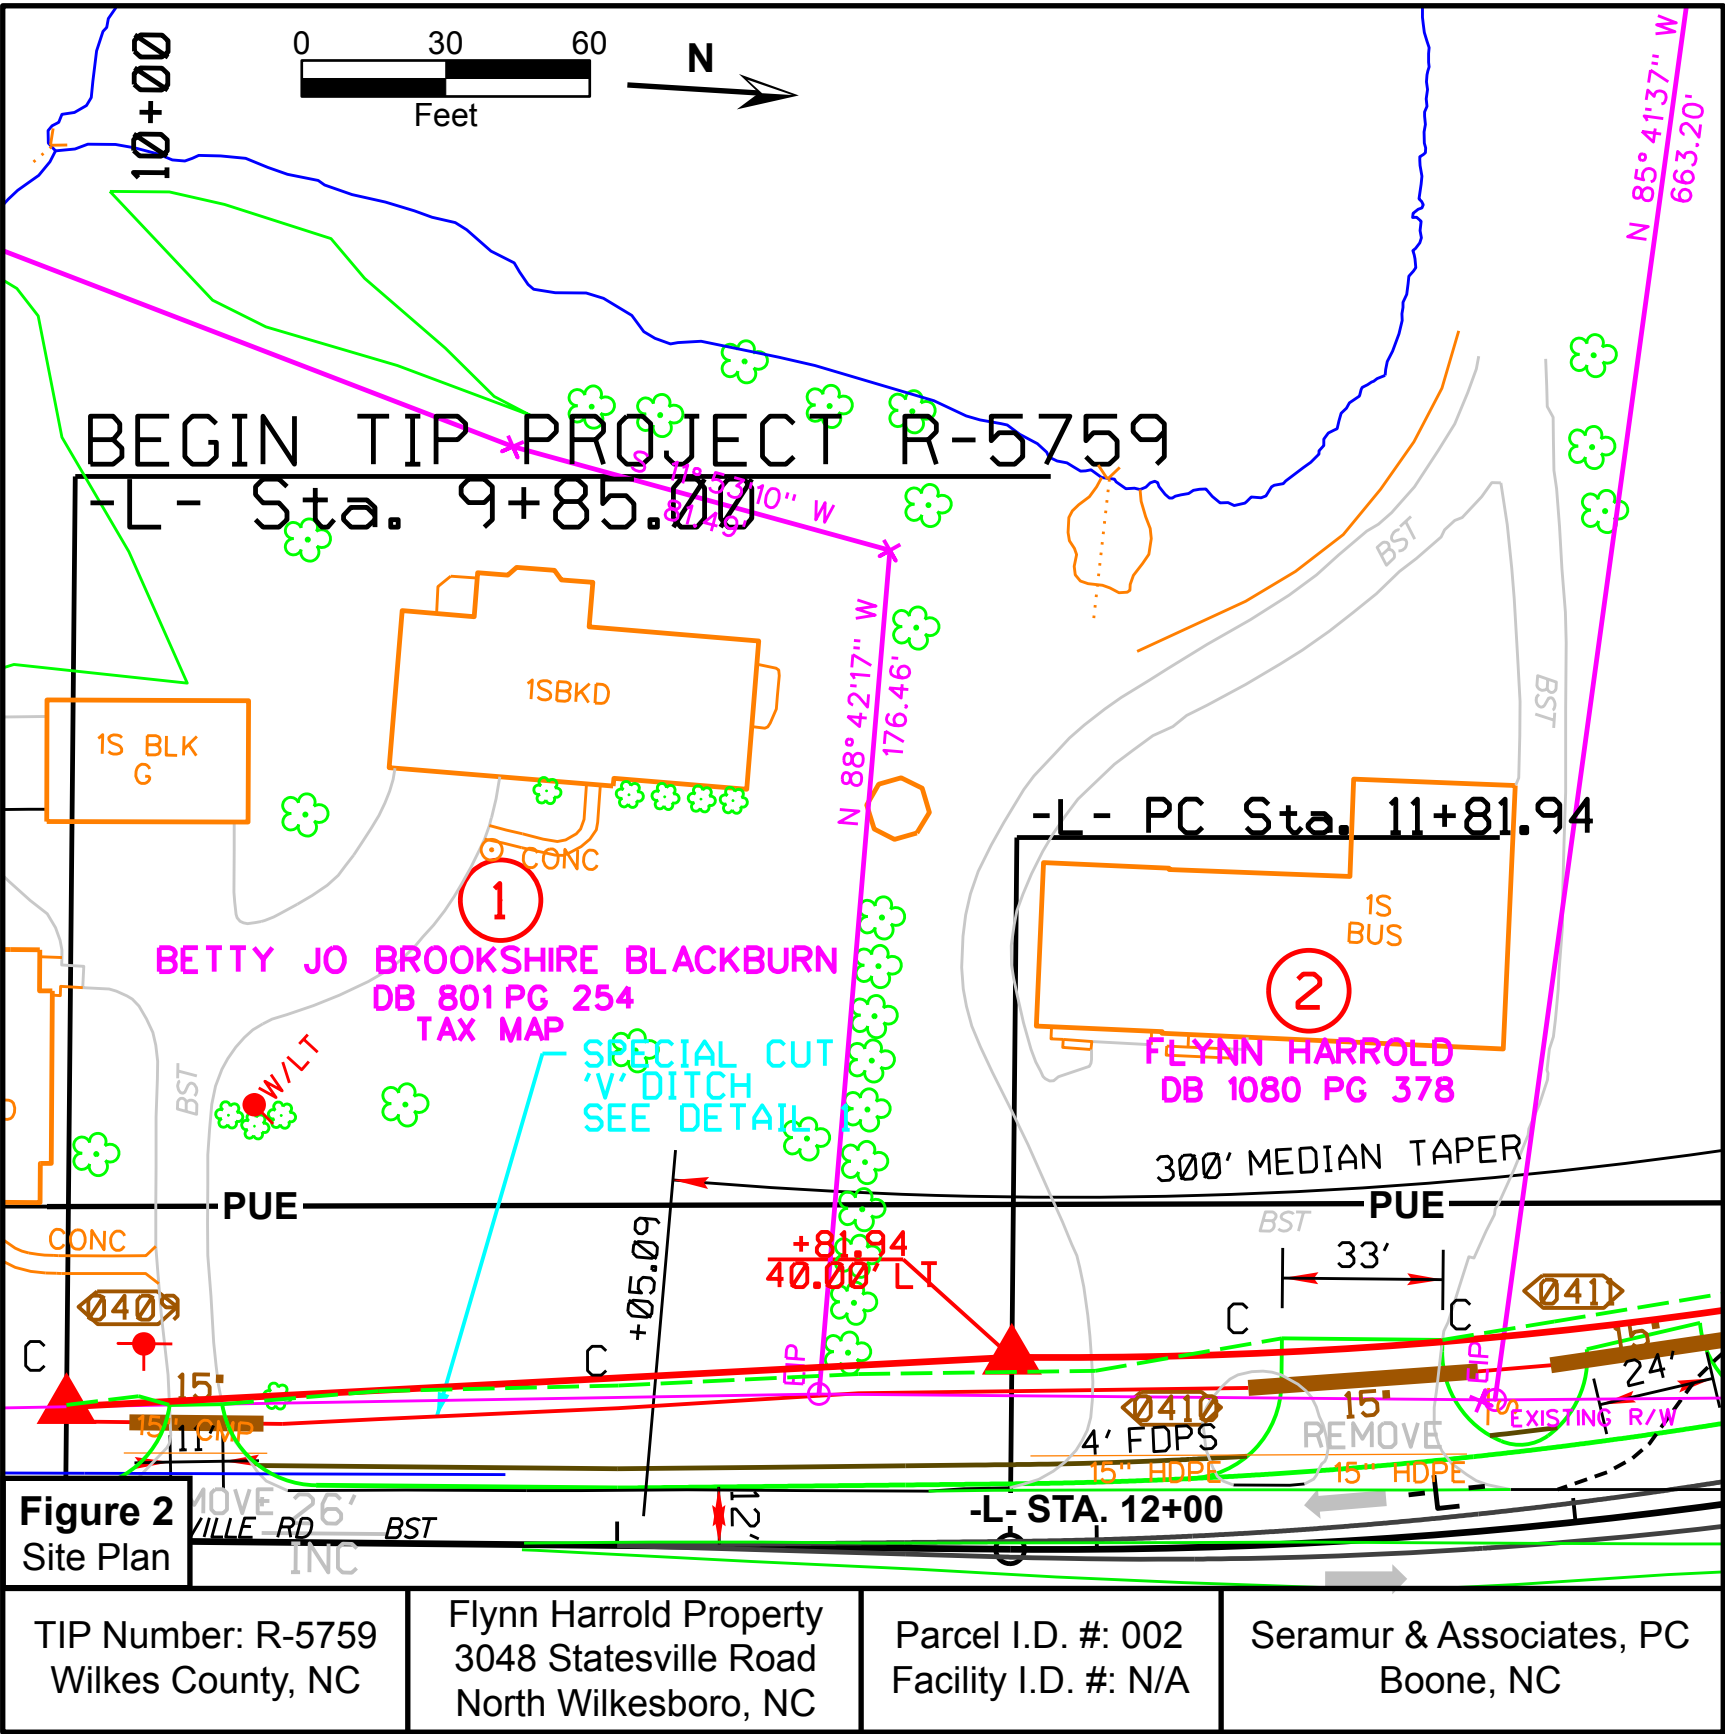
Seramur & Associates used the Pythagorean Theorem to establish one rectangular grid across the proposed easement for a geophysical survey at Parcel #002 (Figure 3). Grid 1 extends along the east edge of the property, bordering Statesville Road. Geophysical grid data was collected along transects at a two-foot spacing.

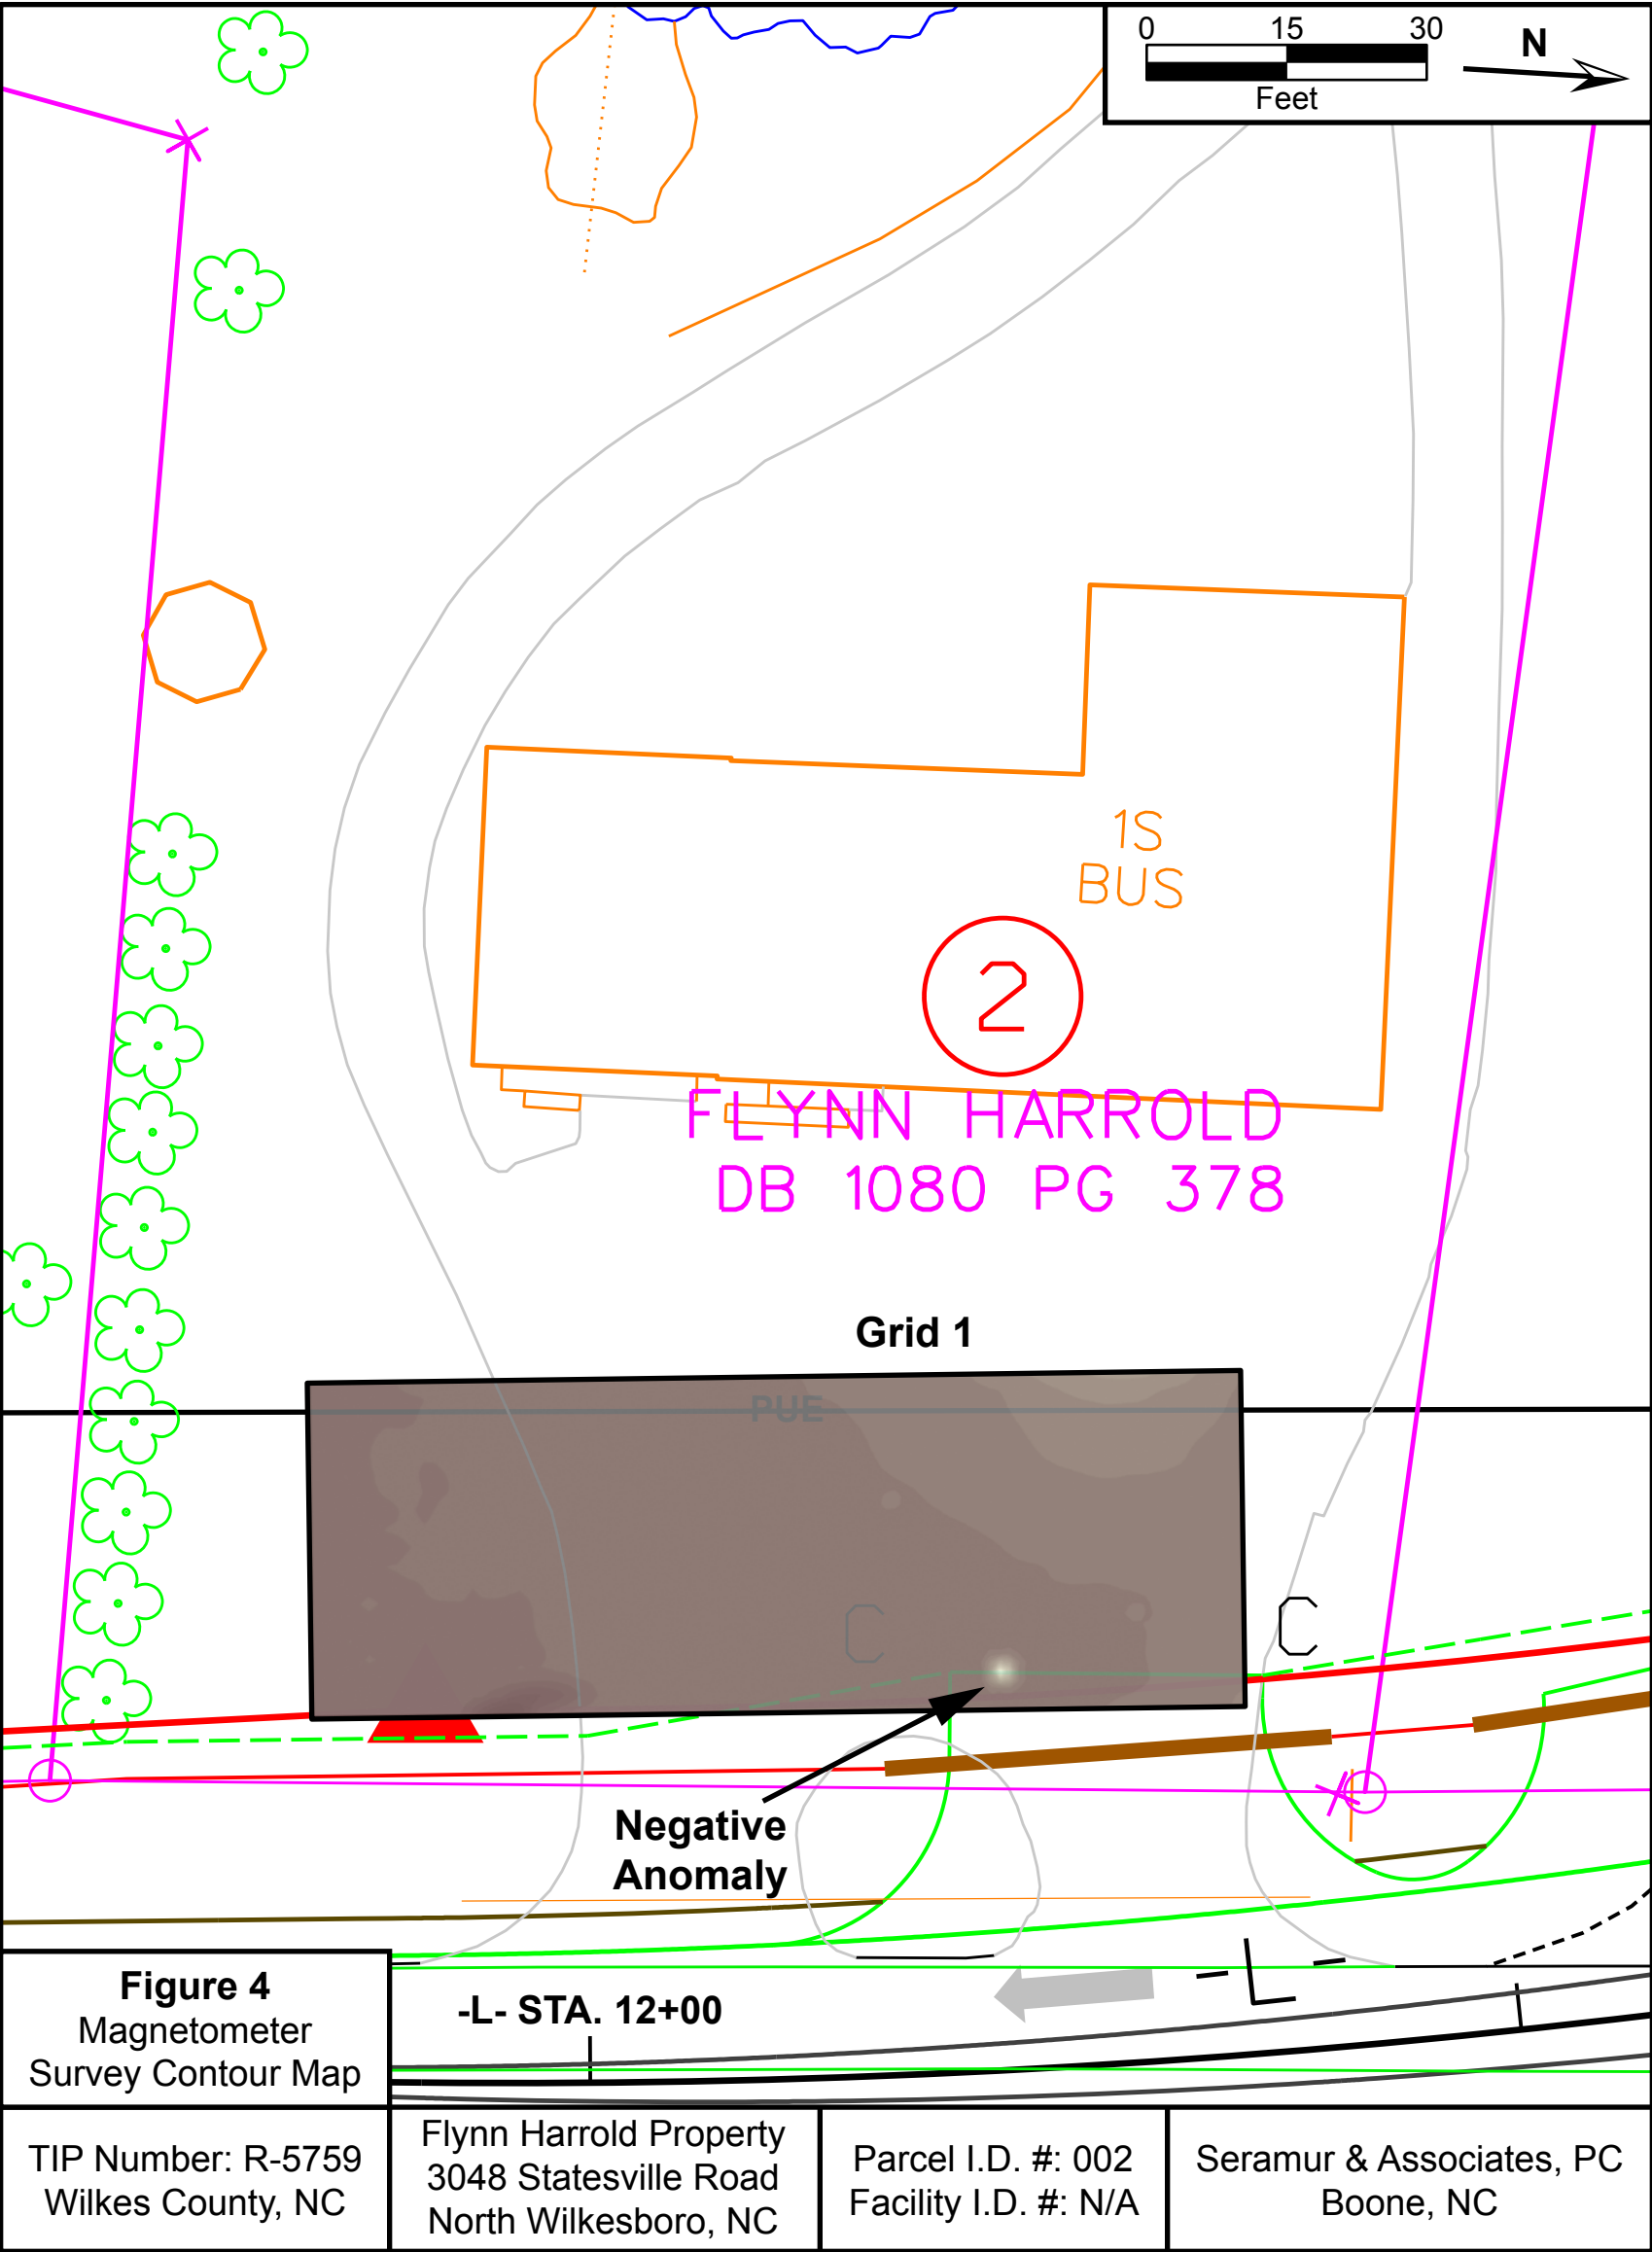
The magnetometer data was collected with a GEM Systems GSM-19W Walking Overhauser Gradiometer. This data was compiled in an Excel spreadsheet and a contour map of the magnetometer data was drafted using Golden Software's Surfer® modeling program (Figure 4). The lighter shades are lower magnetic readings and the darker shades are higher magnetic readings (Figure 4). Ferrous objects in the subsurface are more magnetic than the surrounding soil and can produce positive and negative magnetic anomalies on the contour maps.

A grid of magnetometer data was collected parallel to Statesville Road (Figure 5). One localized negative magnetic anomaly was detected near the eastern edge of the grid (Figure 5). This anomaly turned out to be a piece of scrap metal. Magnetic anomalies characteristic of a UST were not detected at Parcel #002.

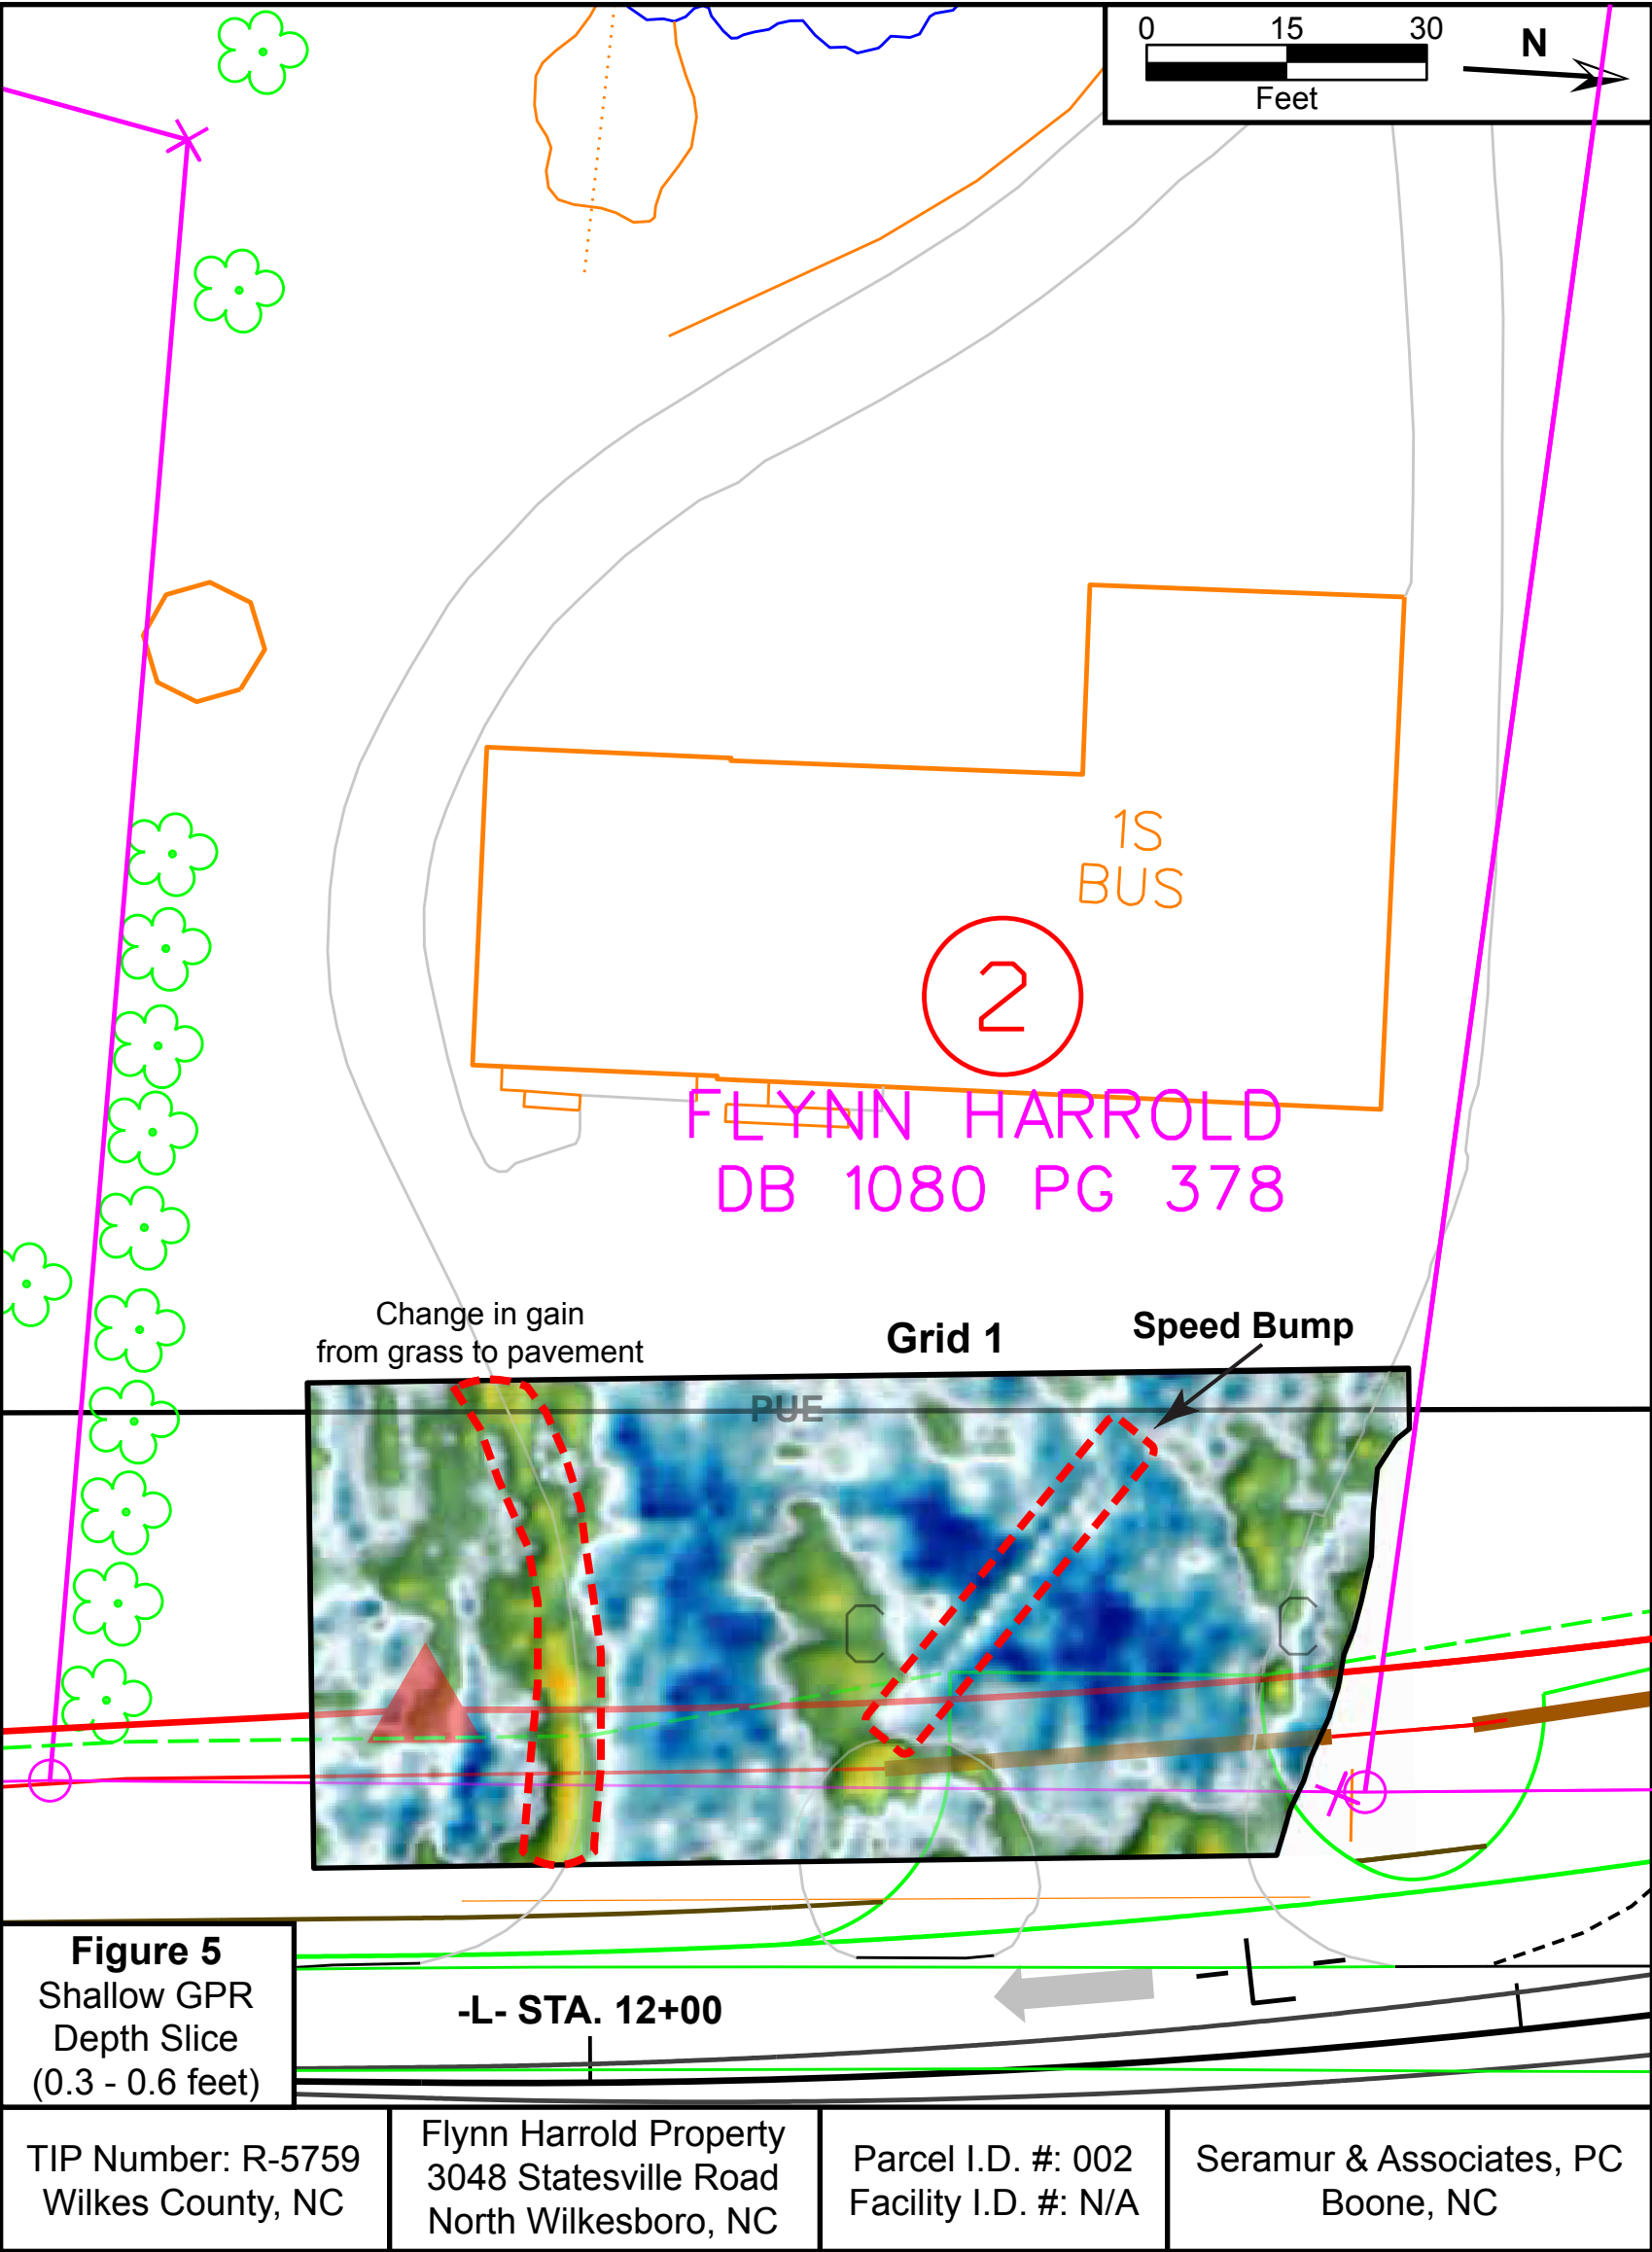
The shallow GPR depth slice (0.3-0.6 feet) for Grid 1 shows one linear set of high amplitude reflections extending east to west across the grid and another along the eastern edge of the grid (Figure 5). These reflections show the change from lawn to the paved parking lot. A faint linear set of reflections extending from the northwest side of the grid towards the southeast were produced by a speed bump on the pavement. There are a few other areas where medium amplitude reflections (green) appear, but they are not consistent with any type of buried infrastructure.

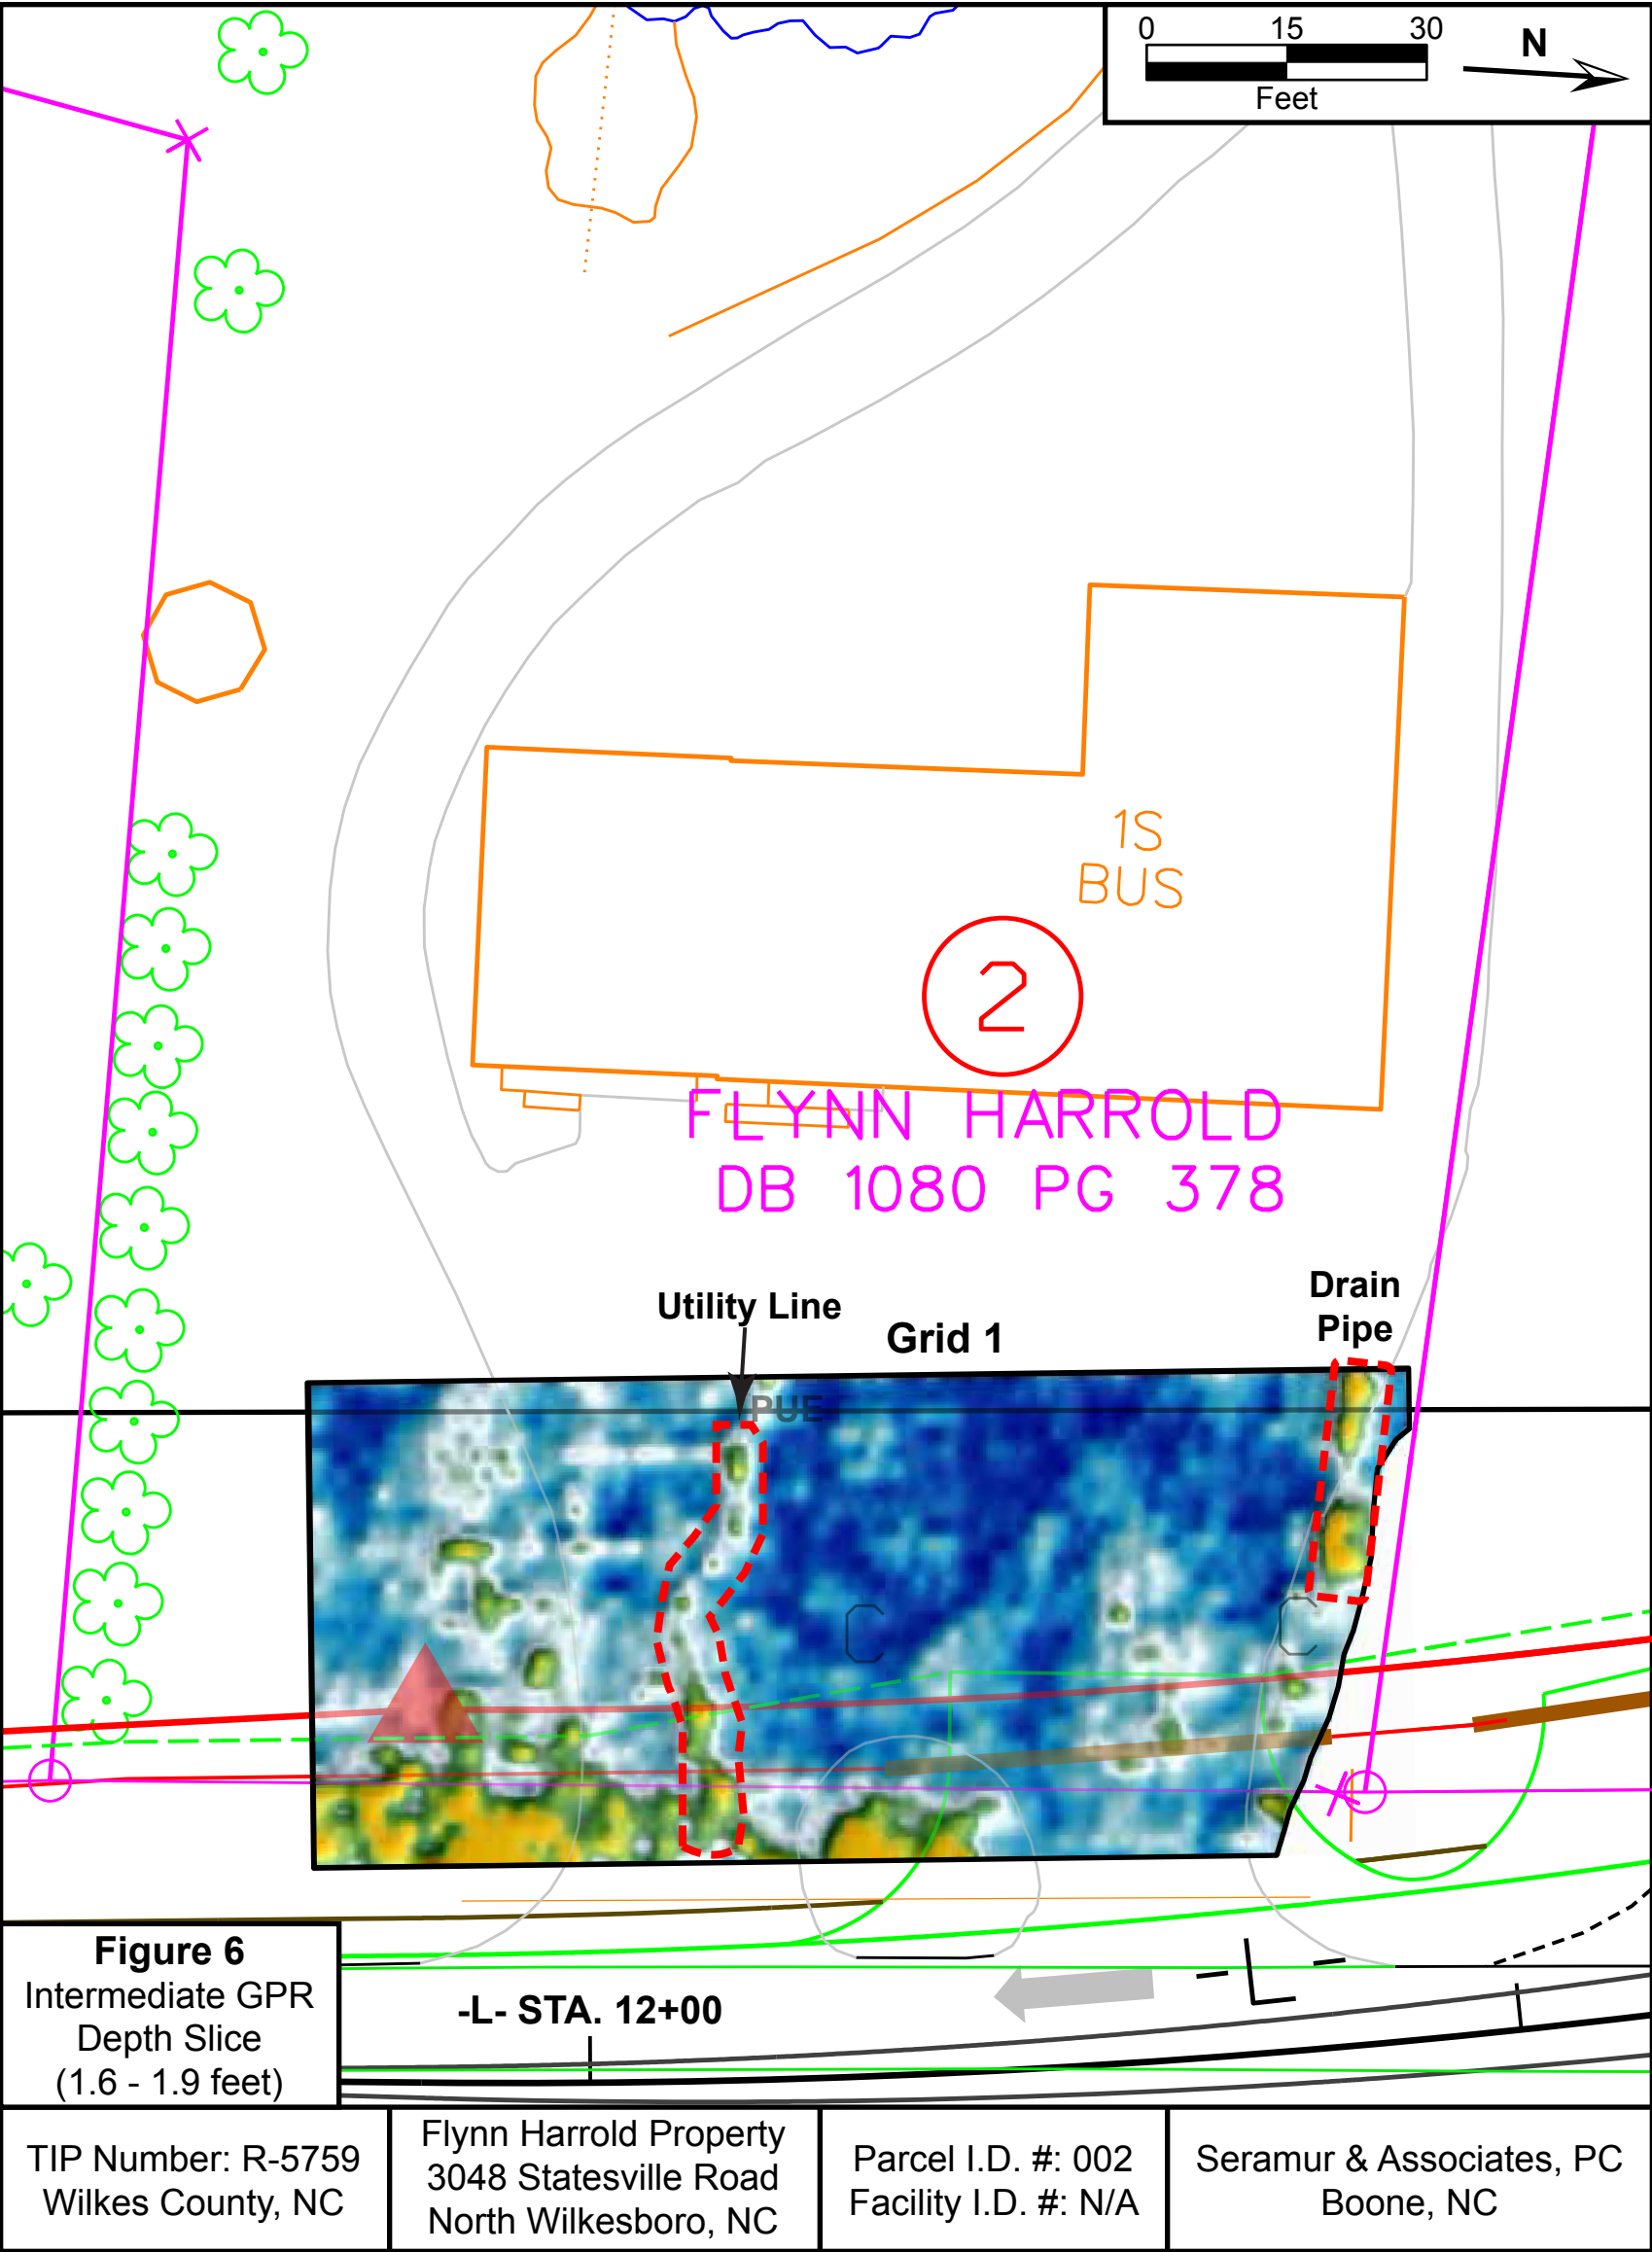
There are two linear higher amplitude sets of reflections on the 1.6-1.9 feet intermediate depth slice (Figure 6). The set of reflections in the northwest corner of the grid is related to a drain pipe (storm drain?) observed near the northeast corner of the grid. The other linear set of reflections follows a meandering path and is likely some type of utility line.

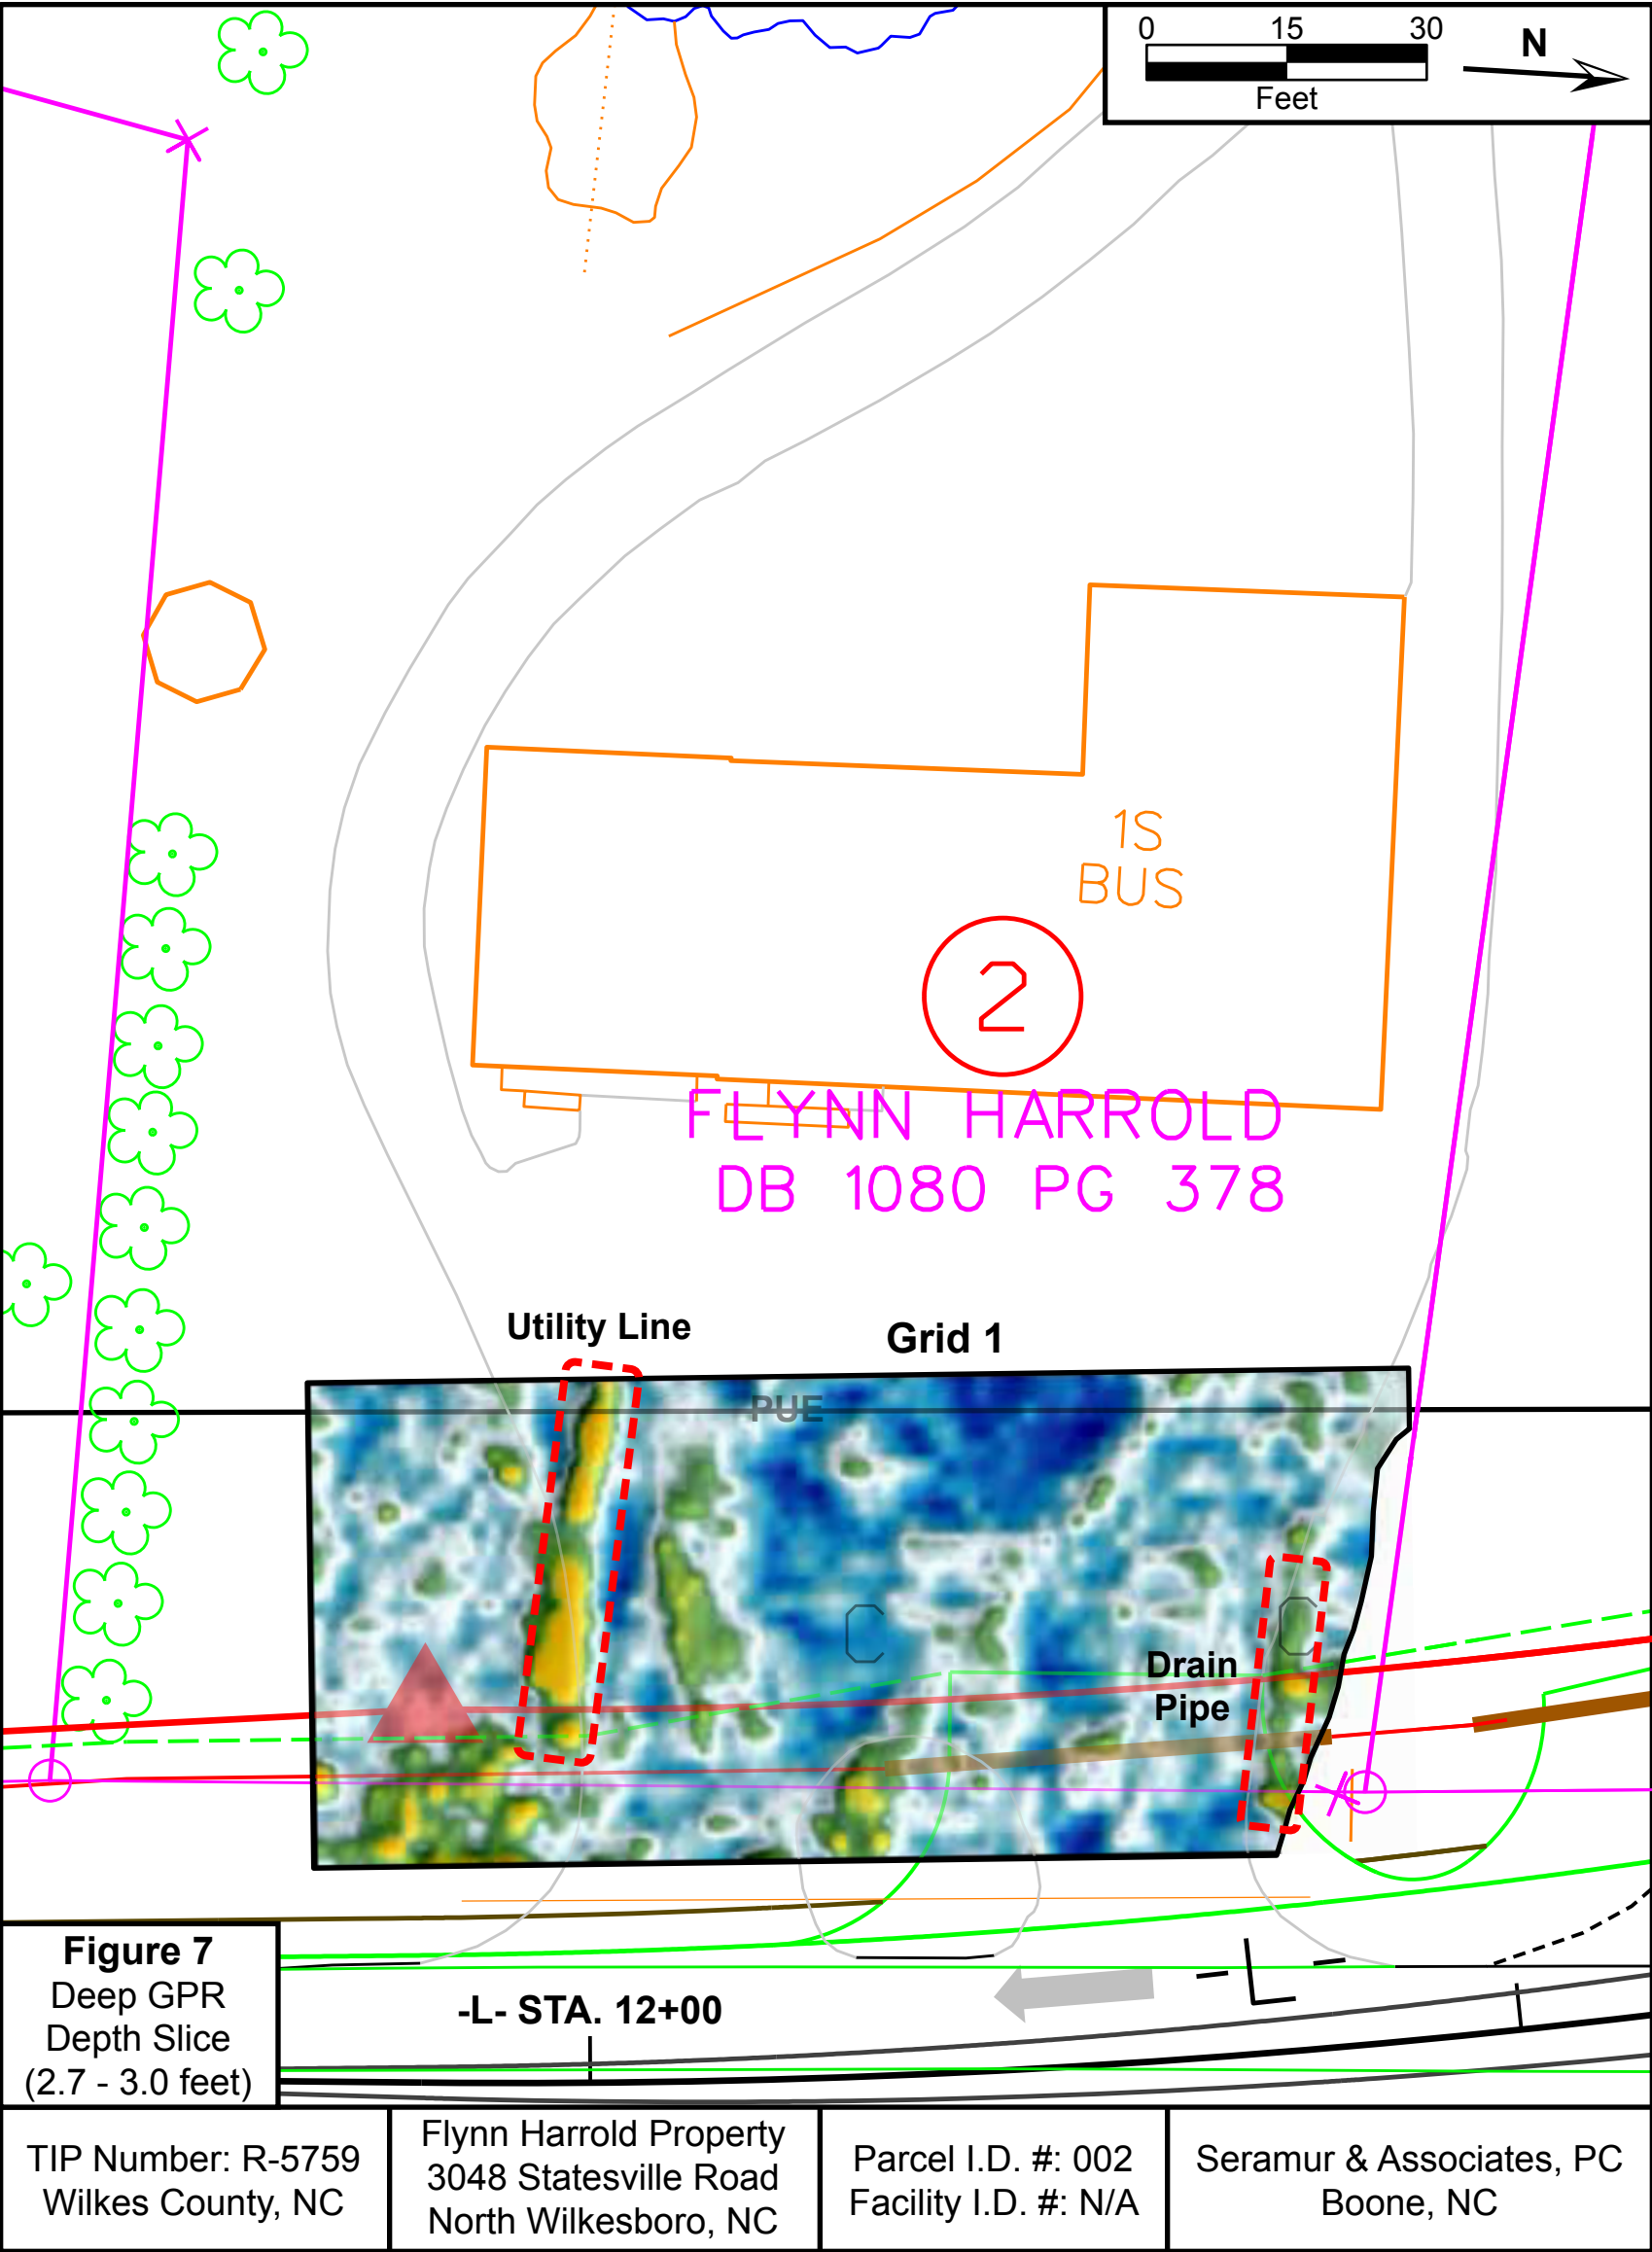
The deep GPR depth slice (2.7 to 3.0 feet) shows a linear set of high amplitude reflections extending across the grid from east to west (Figure 7). This anomaly is related to the ditch for an electric line as a line of red paint was observed on the pavement at this location. The eastern end of the drain pipe is also observed along the northern edge of the grid.
