**Phase II Site Assessment Report**

**State Project: R-5759**

**Dennis M. Brown Property**

**Parcel #014**

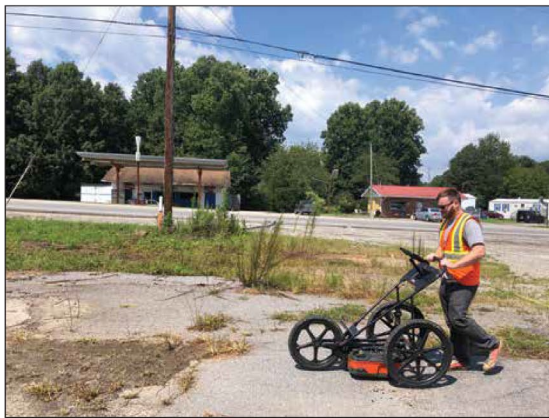
Photo 1. Collecting GPR data at Parcel #014.

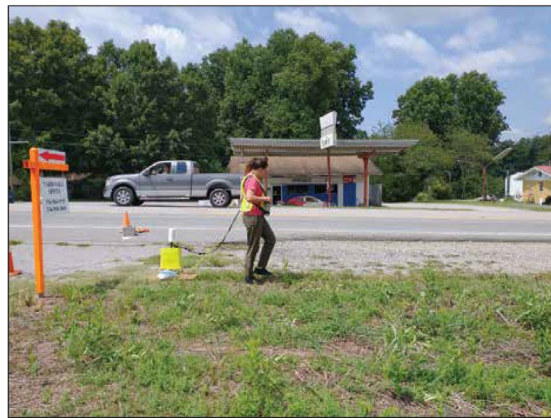
Photo 2. Collecting magnetometer data at Parcel #014.

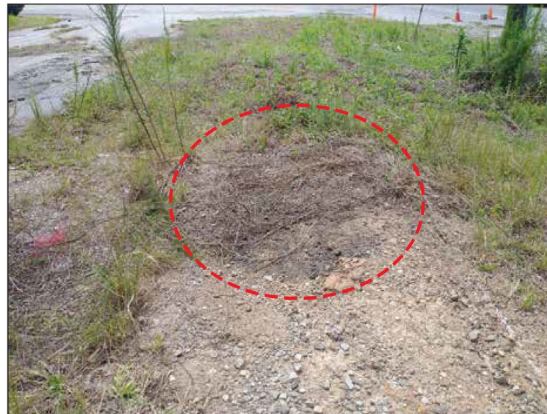
Photo 3. Large area of stained soil located on the northern side of Grid 2.
