**Phase II Site Assessment Report**

**State Project: R-5759**

**Thurman & Jewel Brown Property**

**2698 Statesville Road; North Wilkesboro, NC, 28659**

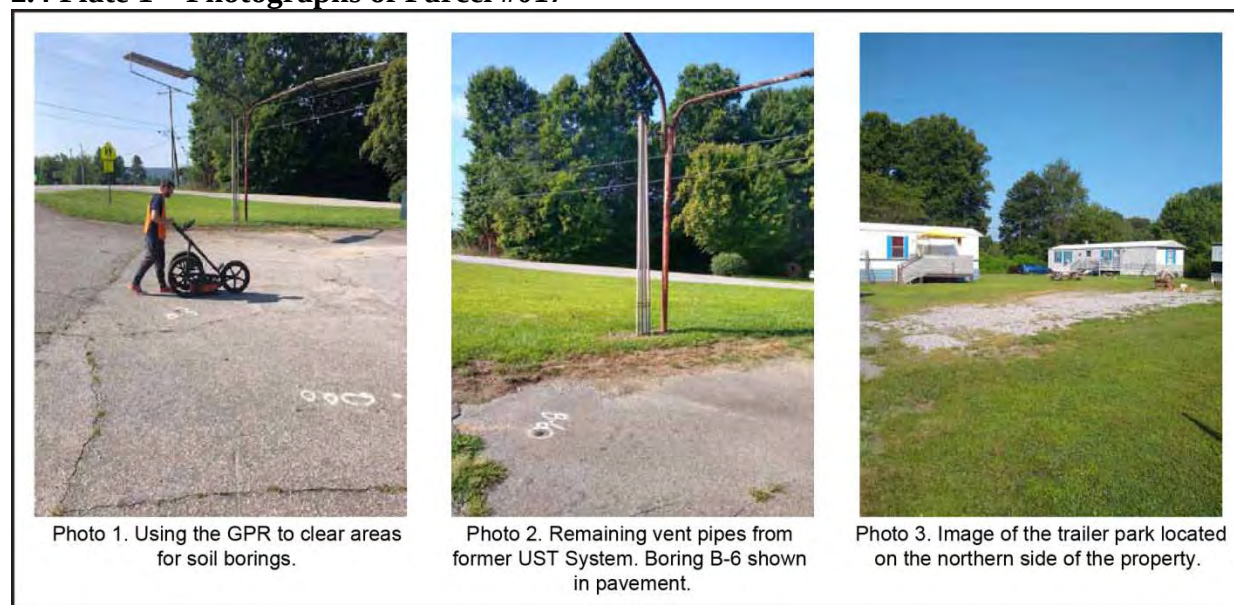
#### 2.4 Plate 1 – Photographs of Parcel #017

SAPC personnel made a pedestrian reconnaissance of the property during the initial site visit on June 29, 2021. Evidence of an active UST system was not observed on the property, though the vent lines remain in place from the former UST system.
