**Phase II Site Assessment Report**

**State Project: R-5759**

**Redmond Real Estate, LLC**

**2633 Statesville Road; North Wilkesboro, NC, 28659**

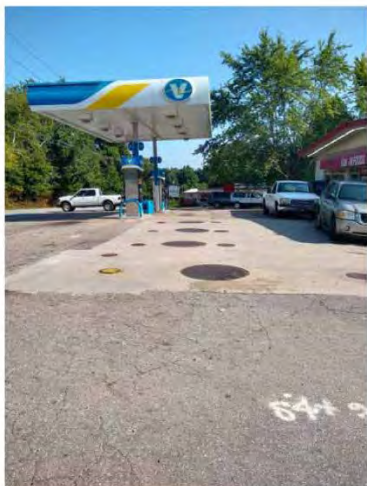
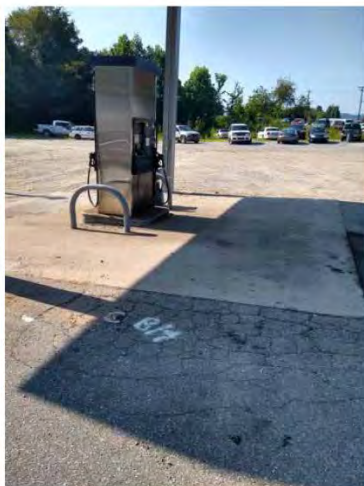
Photos 1 & 2. Images of the current fuel pumps, both gasoline (left) and diesel (right).  
Transect starting points (left) and Boring B-14 (right) are also visible.

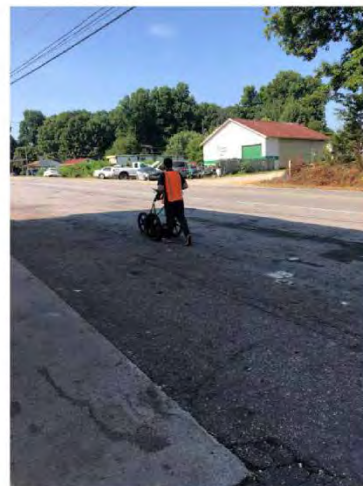
Photo 3. Using the GPR to clear locations for potential borings

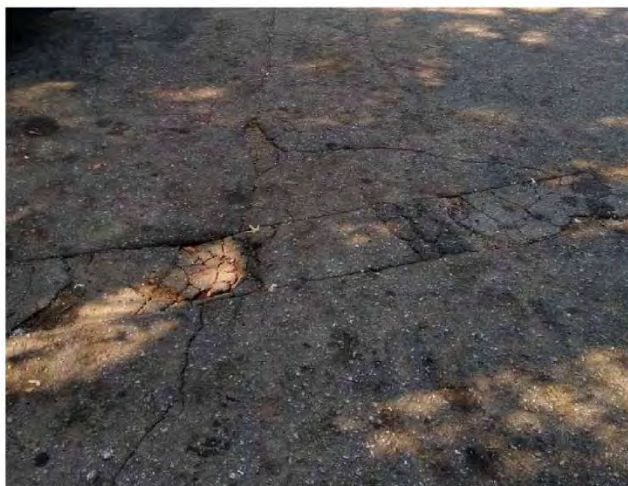
Photo 4. Location of probable product lines from former likely UST system  
originating from Parcel #027.

The only anomalies of interest imaged in Transects 1, 2 and 11 were utility lines (Figure 7a, 7b and 7e). The four existing USTs were imaged on Transect 4 and remnant product lines from the former UST system were imaged on Transects 3 and 5 (Figure 7c). The former product lines extend to the north onto Parcel 27 (Figure 6). The diesel dispenser is south of the existing USTs. The diesel product lines and a sewer line were imaged on Transects 7, 8 and 9 (Figure 7d). Utility lines and the sewer line were imaged on Transect 10 (Figure 7e). The Schonstedt magnetic locator did not produce readings indicative of an unknown UST within the PUE or R/W.

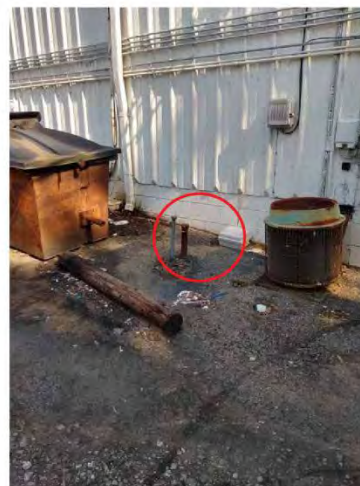
Photo 5. Additional fuel oil UST on the south side  
of the gas station. Tank is outside of the R/W and PUE.

SAPC personnel made a pedestrian reconnaissance of the property during the initial site visit on June 29, 2021. The existing UST system was observed west of the store and the fill and vent pipes for an apparent heating oil UST were observed on the south side of the building (Photo 5 on Plate 1).
