**Phase II Site Assessment Report**

**State Project: R-5759**

**Robert E. & Janice G. Ashley Property**

**2609 Statesville Road; North Wilkesboro, NC, 28659**

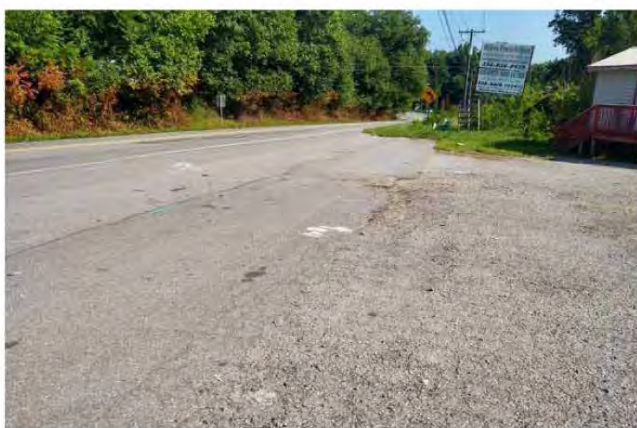
Photo 1. View of Parcel #027 looking north.

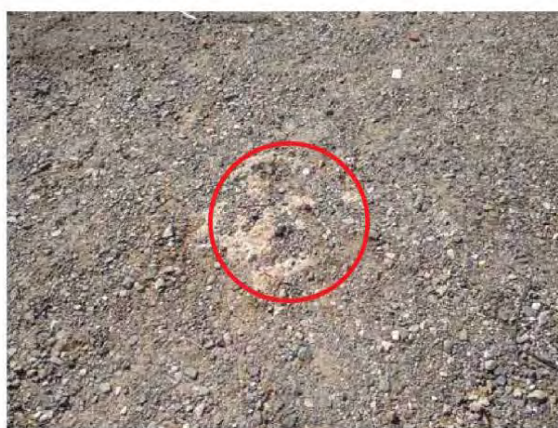
Photo 2. Remains of a post for possible sign or some sort of canopy on the south side of the property.

The contour map of the magnetometer survey data (Figure 6) shows a linear set of negative magnetometer readings near the eastern edge of the grid. These negative magnetometer readings appear to be related to metal bolts in the foundation of the former post. This could have been a sign post or a canopy support.

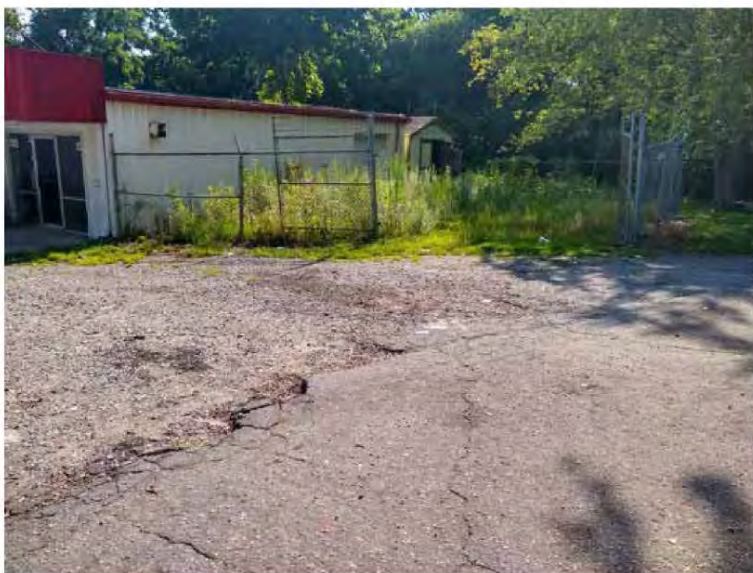
Photo 3. Possible location of former UST System on the south side of the property.

The shallow GPR depth slice (0.0-0.3 feet) for Grid 1 shows a linear reflection free area along the western edge of the grid. This is an excavation for the sewer line (Figure 7). A curved, linear, reflection-free anomaly originates at the telephone pole of the west side of the property and extends to the east side of the grid. This is most likely the excavation for an electric line. A quasi-rectangular area of low amplitude reflections and an oval-shaped reflection-free area in the southeast corner of the grid could outline the former UST excavation. The former product lines from Parcel #026 extend over to this area of Parcel #027. This is interpreted as the location of the former UST system.

Seramur & Associates does not recommend any further assessment work for Parcel #027. If soil disturbance near the southeast edge of the PUE is required, the old set of product lines may be encountered.

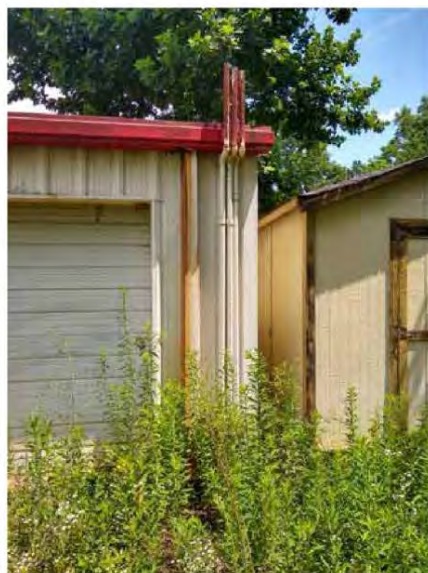
Photo 4. Vent pipes attached to the Pool & Spa building.

SAPC personnel made a pedestrian reconnaissance of the property during the initial site visit on June 29, 2021. No evidence of an active UST system was observed on the property. However, three vent pipes attached to the abandoned Pool and Spa building is evidence that there previously was a UST system in the southern portion of the property. A concrete slab appears to lead from the dispenser island on Parcel #026 to a depression in the southeast corner of the R/W and PUE. It appears that this concrete pad extends over product lines leading from a former UST system to Parcel #026.
