## **Phase II Site Assessment Report**

**August 16, 2021**  
**WBS Element: 44691.1.1**  
**State Project: R-5759**  
**Wilkes County**

**Parcel #060**  
**James D. & Shirley A. Johnson Et Al. Property**  
**2065 Statesville Road, North Wilkesboro, NC 28659**  
**PIN #: 3877-79-6463**  
**Facility ID No.: N/A**  
**Groundwater Incident No.: N/A**

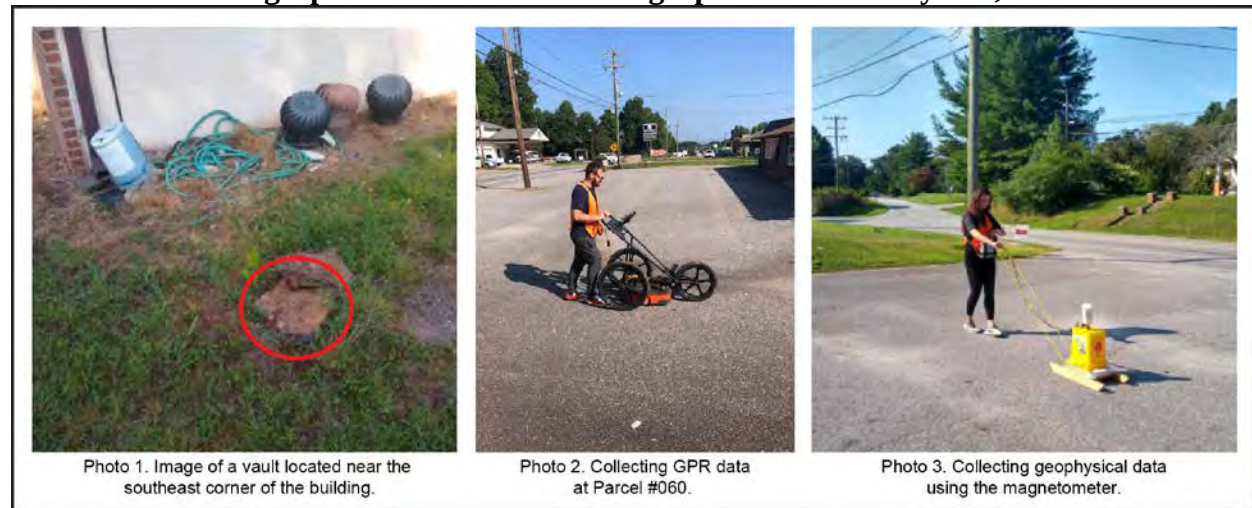
### 2.3 Plate 1 – Photographs of Parcel #060 Photographs taken on July 11<sup>th</sup>, 2021

SAPC personnel made a pedestrian reconnaissance of the property during the initial site visit on July 11, 2021. No evidence of a UST system was observed. A vault was observed off the southeast corner of the building. The Schonstedt locator did not detect ferrous objects in the subsurface at this location.

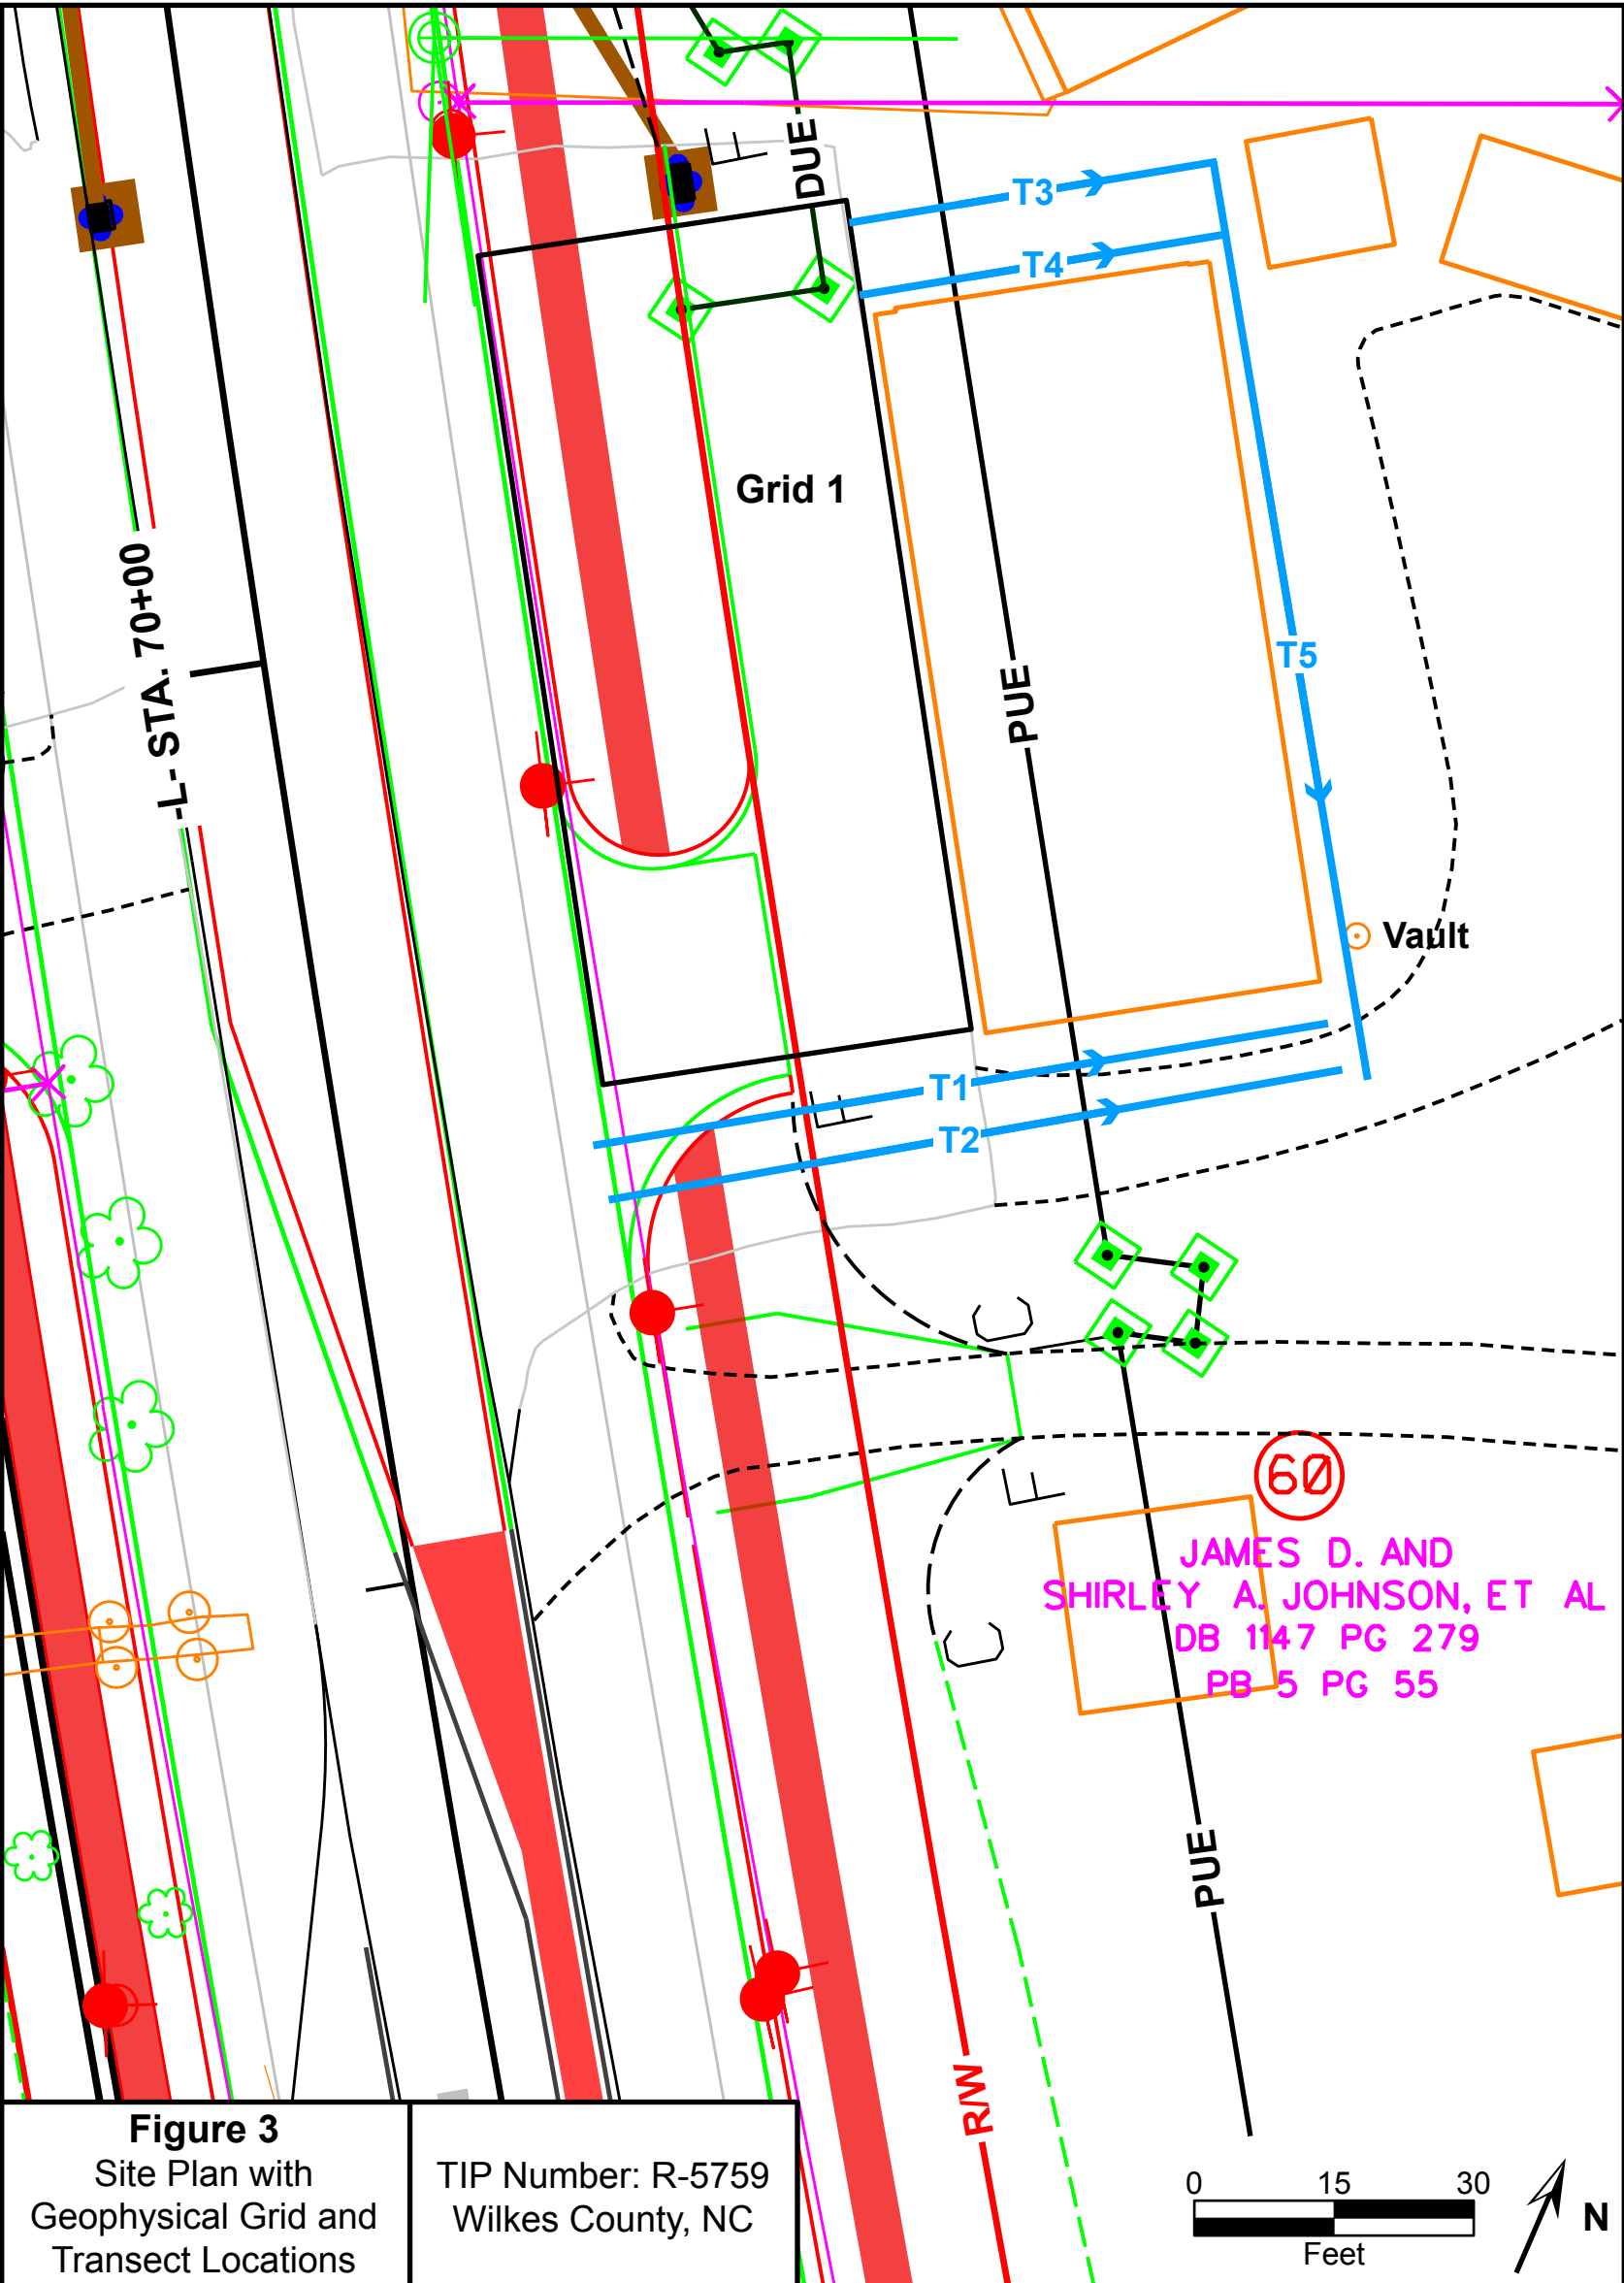
| <b>Figure 3</b><br>Site Plan with<br>Geophysical Grid and<br>Transect Locations | TIP Number: R-5759<br>Wilkes County, NC | | 0 15 30<br>Feet<br>N |

Seramur & Associates used the Pythagorean Theorem to establish one rectangular grid across the proposed R/W and easements for a geophysical survey at Parcel #060 (Figure 3). Grid 1 extends along the east edge of the property along Statesville Road. Geophysical grid data was collected along transects at a two-foot spacing. Additionally, five GPR transects were collected around the building.

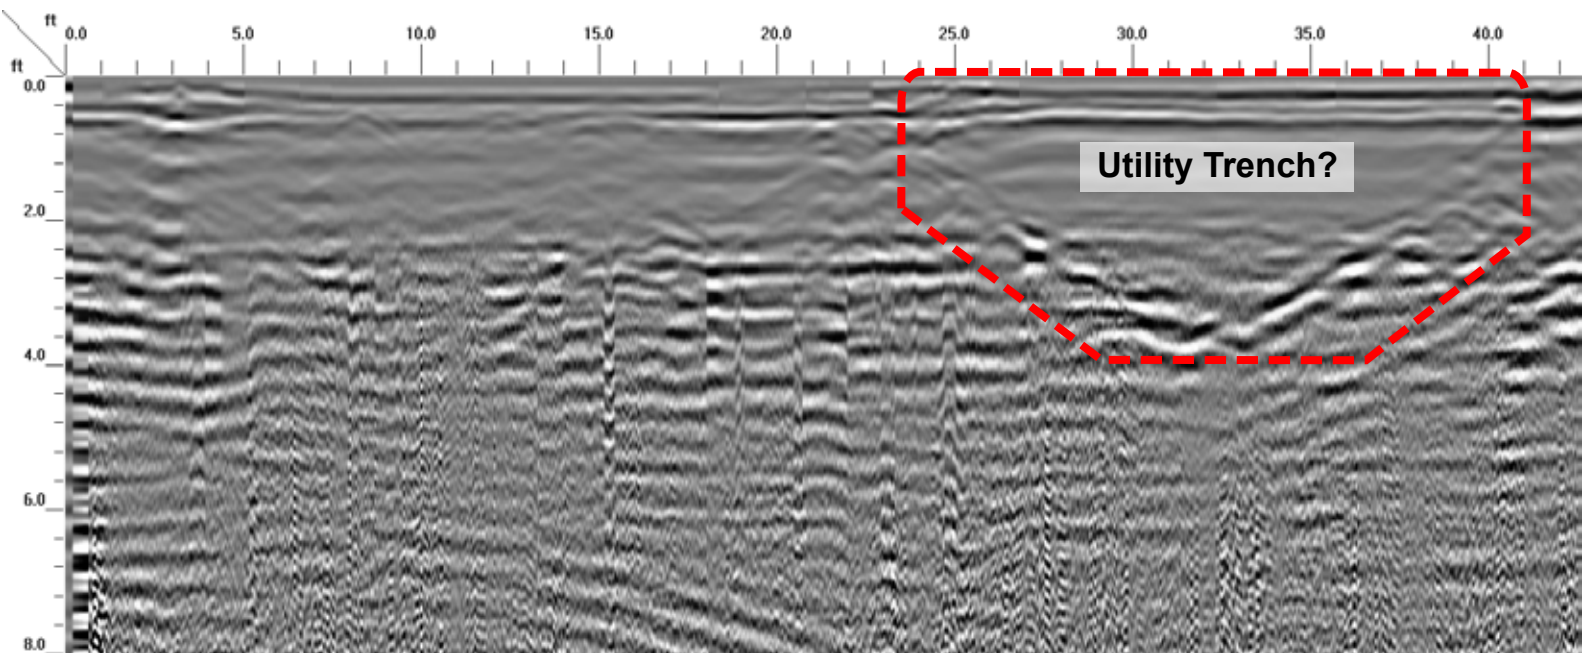
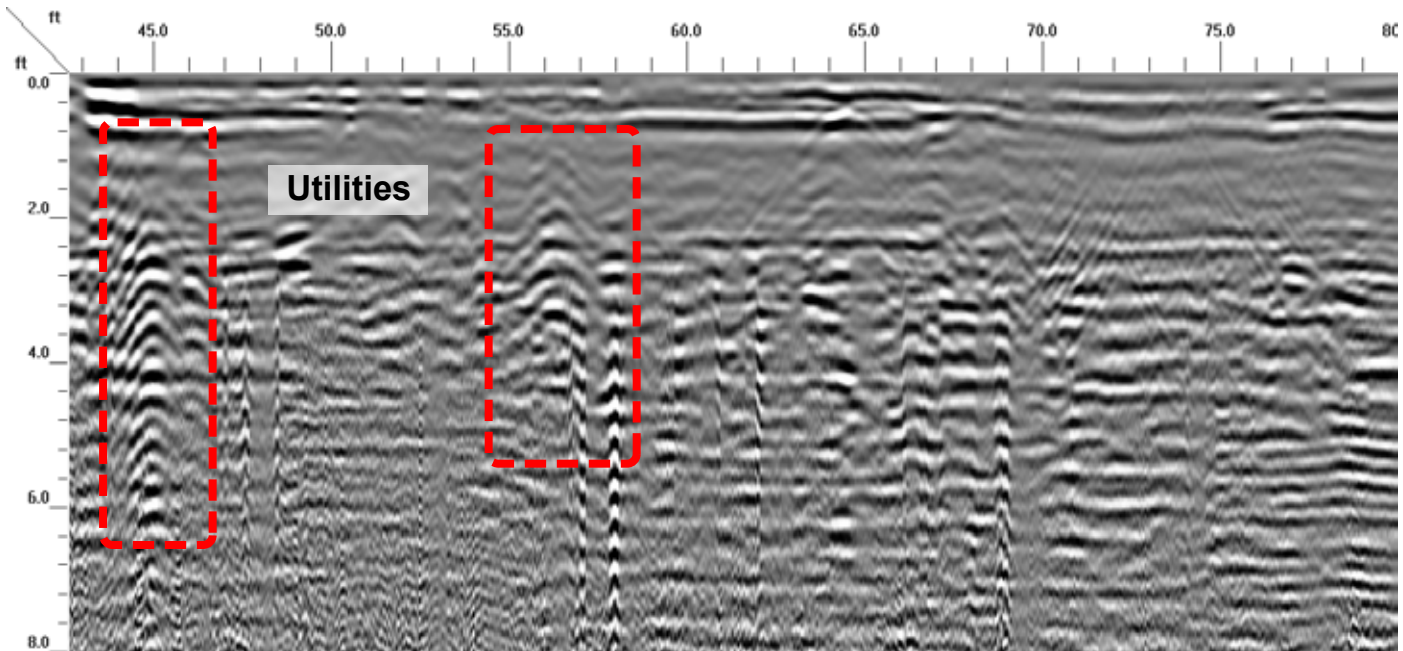
| <b>Figure 8a</b><br>GPR Transects<br>1 and 2 | TIP Number: R-5759<br>Wilkes County, NC | J.D. and S.A. Johnson,<br>et al. Property<br>2065 Statesville Road<br>North Wilkesboro, NC | Parcel I.D. #: 060<br>Facility I.D. #: N/A | Seramur & Associates, PC<br>Boone, NC |

The GPR transect data has been processed and modeled using Radan® software. The GPR data processing included adjusting time zero, completing a background removal and adjusting the time variable gain to enhance deep reflections. The profiles of the GPR transects are shown in Figures 8a and 8b. Significant anomalies are notated on the profile images.

Five transects of GPR data were collected around the building at Parcel 60 (Figures 8a and 8b). Transects 1 and 2 were collected on the south side of the building. A possible utility trench is observed on both of these profiles between about 25 and 40 feet. Additionally, a few hyperbolae were observed on both of these profiles near the south side of the building and are likely utility lines. Transects 3 and 4 were collected on the north side of the building. A few hyperbolae were imaged on these transects. The magnetometer did not detect ferrous objects in the subsurface at this location. Numerous utility meters are located on this side of the building, so these hyperbolae are interpreted as underground utilities. Transect 5 was collected along the rear (east) side of the building and across the area near the subsurface vault. Evidence of a UST was not imaged at this location (Figure 9b). The GPR passed over an exposed electric wire at the surface around 76 feet through the transect and this produced “ringing” through the entire depth of the profile at this location.
