**SUBJECT: Preliminary Site Assessment Report  
Parcel 84, Hamby, William H & Jennifer W  
WBS Element No. 44691.1.1, TIP No. R-5759  
Proposed widening of NC 115 from US 421 to 2<sup>nd</sup> Street in Wilkesboro and  
North Wilkesboro, Wilkes County, NC  
Kleinfelder Project No. 20221238.001A**

**PRELIMINARY SITE ASSESSMENT REPORT  
PARCEL 84, HAMBY, WILLIAM H & JENNIFER W  
PIN 2200405  
1524 STATESVILLE ROAD  
NORTH WILKESBORO, WILKES COUNTY, NORTH CAROLINA**

**NCDOT WBS ELEMENT 44691.1.1  
STATE PROJECT R-5759  
PROPOSED WIDENING OF NC 115 FROM US 421 TO 2<sup>ND</sup>  
STREET IN WILKESBORO AND NORTH WILKESBORO**

## PRELIMINARY SITE ASSESSMENT REPORT

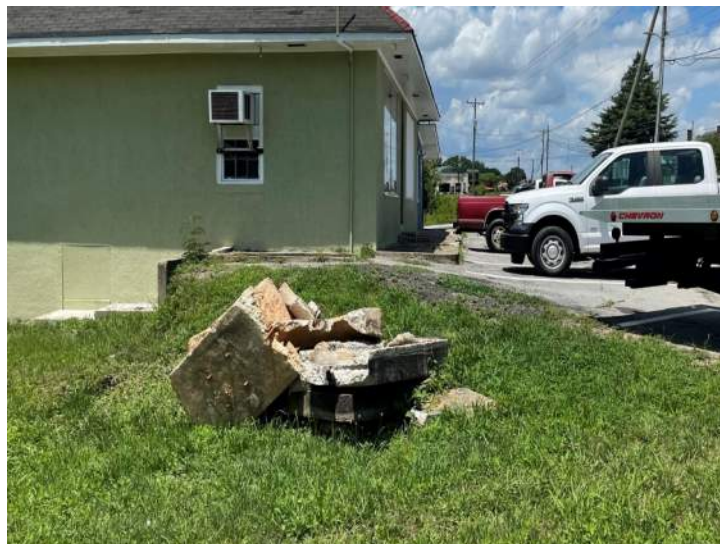
View facing northwest from the southwestern corner of the Project Study Area, towards a pile of metal and concrete debris, an inactive earthen oil pit, and the former UST bed in front of the convenience store.

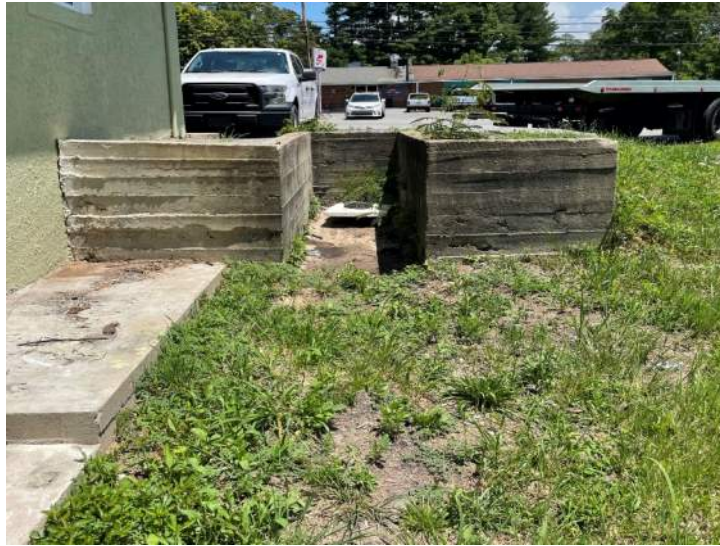
View facing northeast towards NC 115 along the southeastern side of the convenience store, depicting an earthen oil pit.

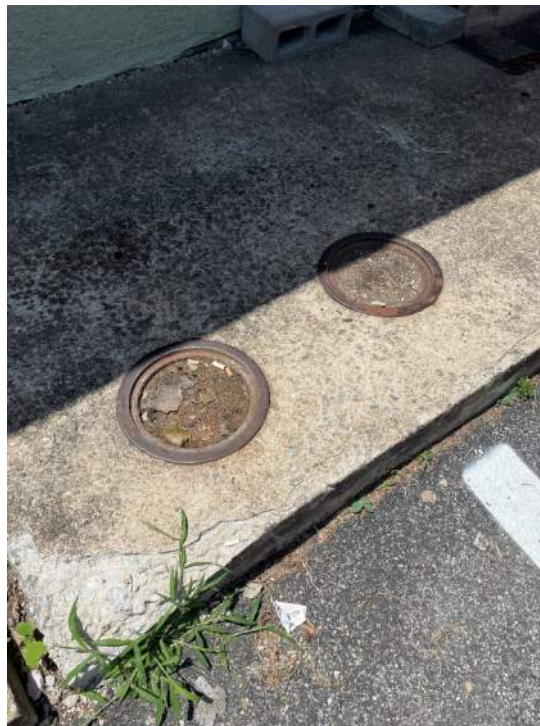
Former fuel ports associated with an inactive UST bed in front of the convenience store facing NC 115.

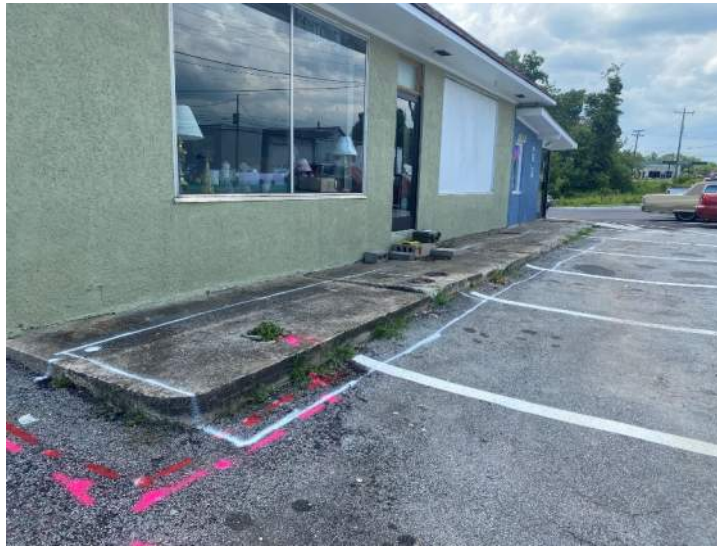
The former UST bed with three probable USTs outlined with white spray paint on the northern side of the convenience store facing NC 115.

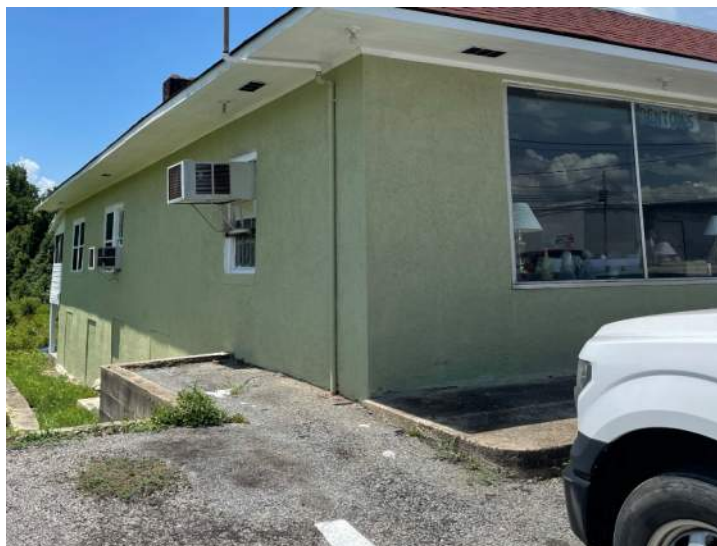
View facing west towards depicting the convenience store, the southern corner of the former UST bed, and the top of an inactive earthen oil pit.

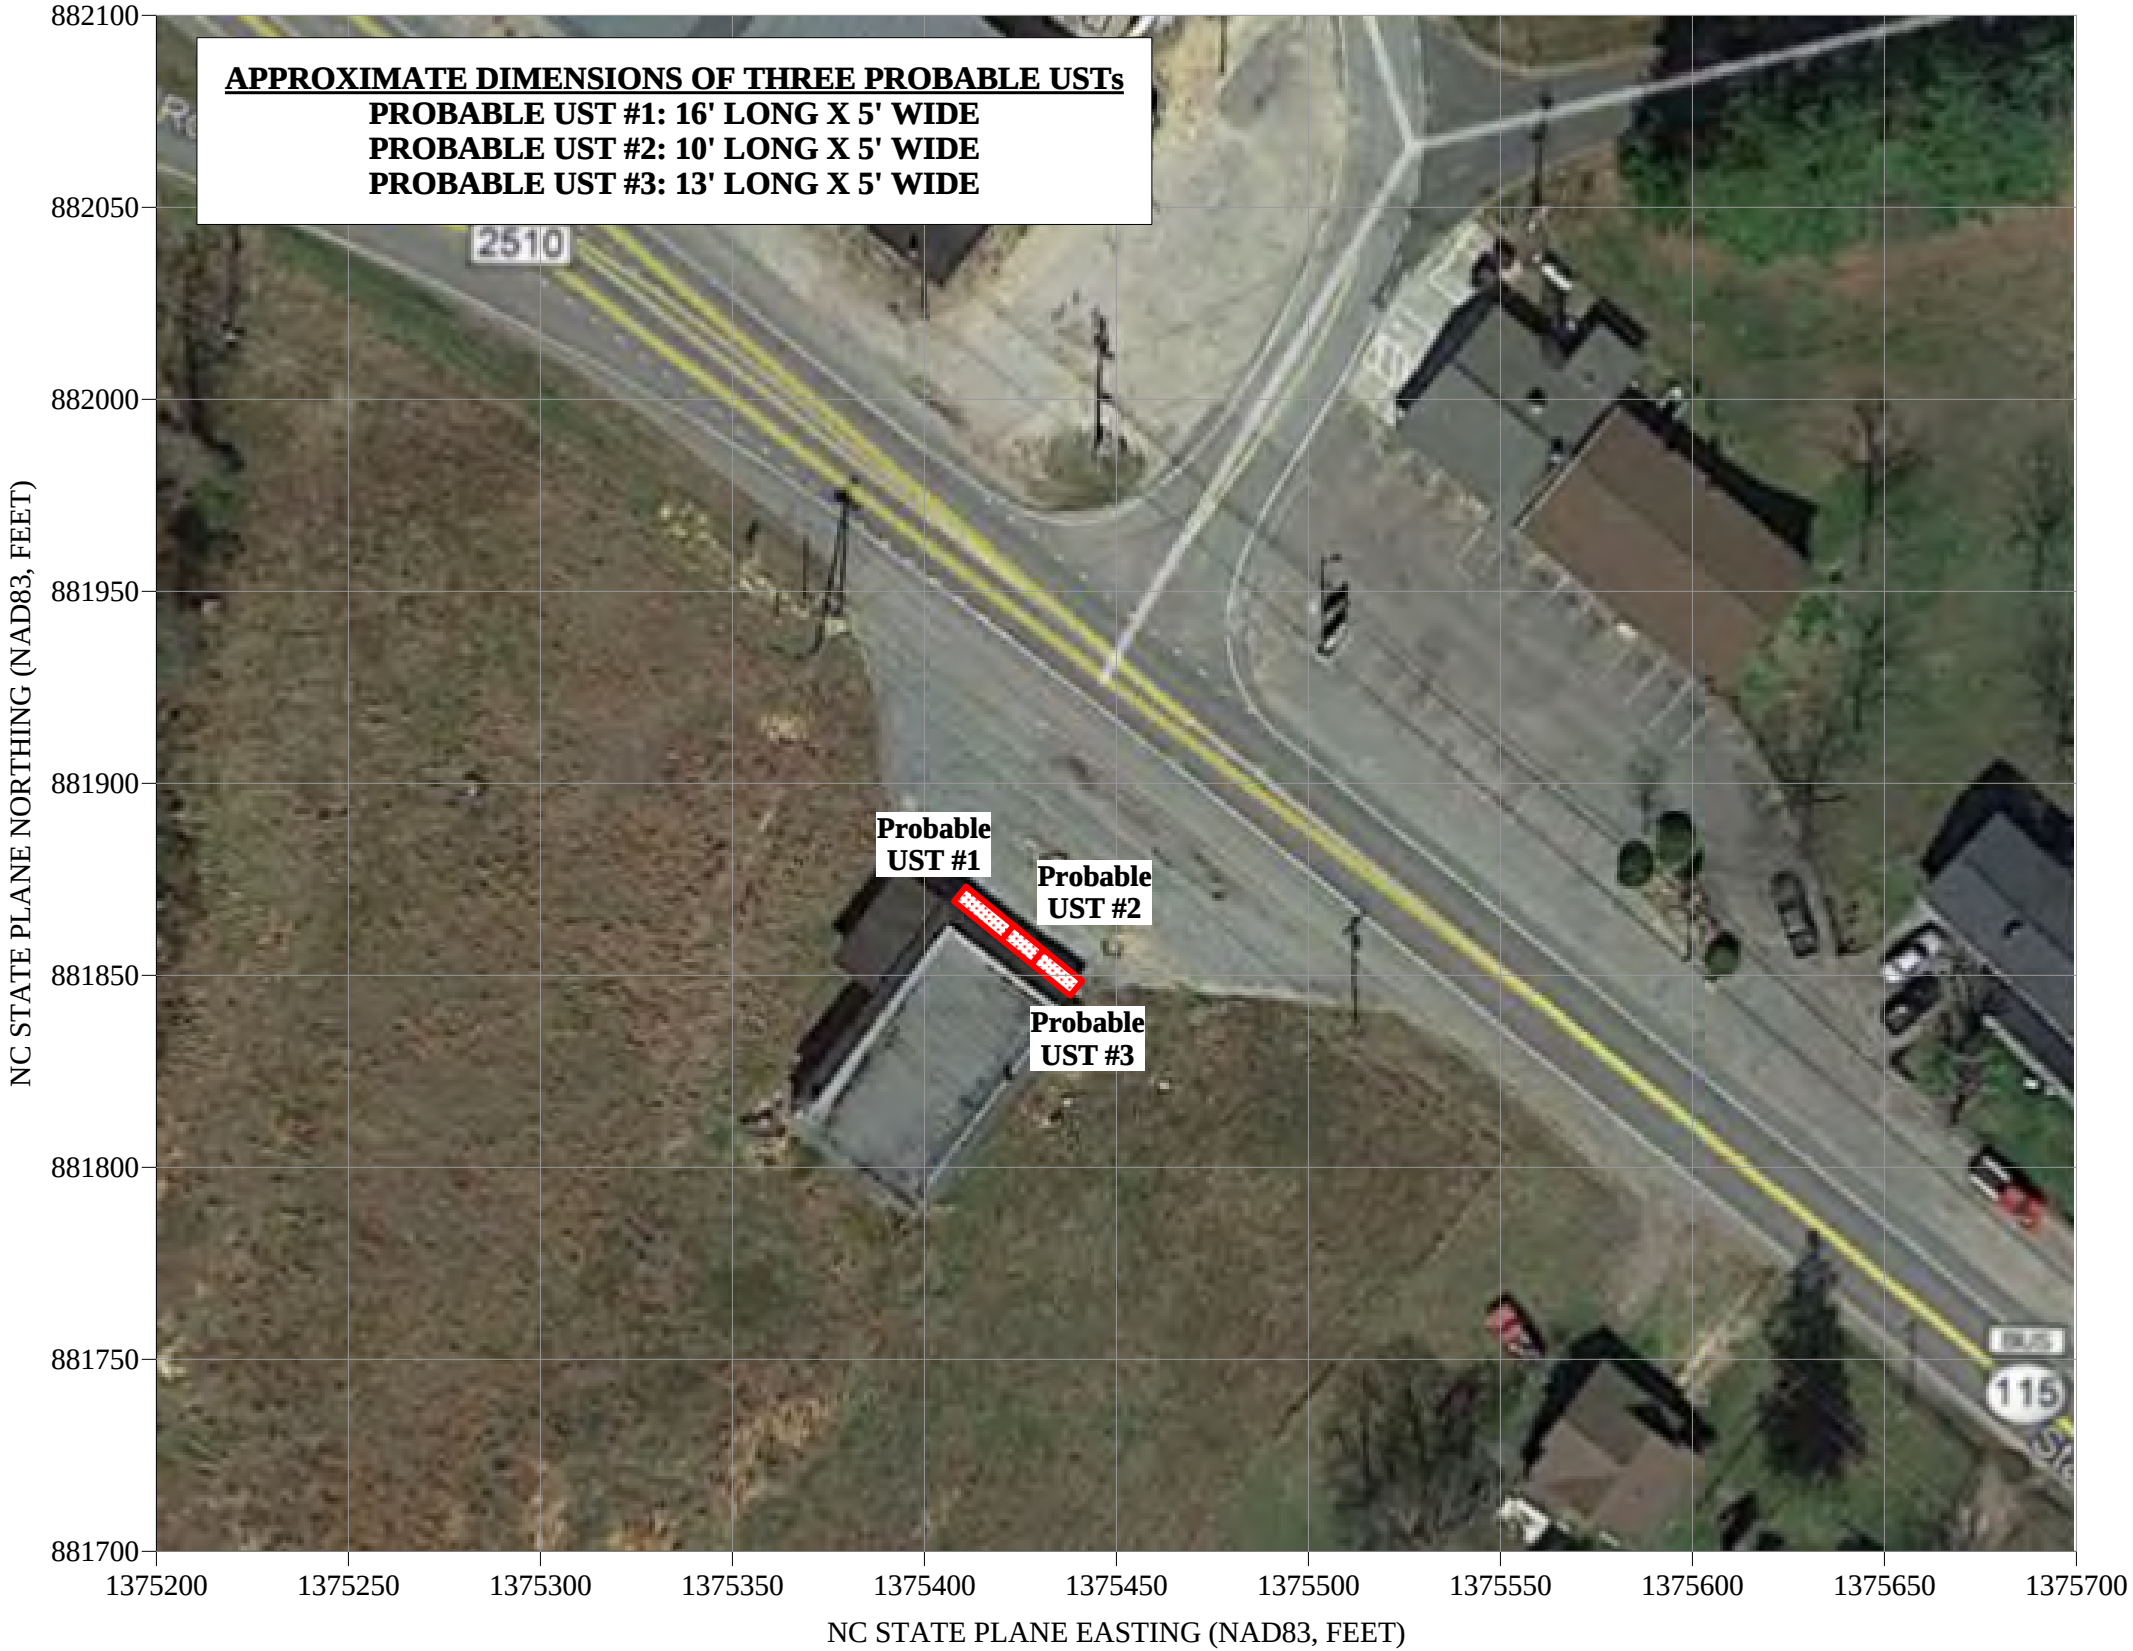
LOCATIONS OF THREE PROBABLE USTs

A total of eight (8) EM anomalies were identified, of which six (6) were directly attributed to visible cultural features at the ground surface, reinforced concrete, or known utilities. One (1) EM anomaly was associated with metal and concrete debris in the southeastern portion of the Project Study Area. One (1) EM anomaly was associated with three (3) probable USTs located beneath the concrete sidewalk along the northeastern side of the office building facing NC 115. Probable UST #1 is approximately 16-ft long by 5-ft wide, Probable UST #2 is approximately 10-ft long by 5-ft wide, and Probable UST #3 is approximately 13-ft long by 5-ft wide.
