**PRELIMINARY SITE ASSESSMENT REPORT  
PARCEL 92, HAYES & FAYE YATES REYNOLDS AKA  
REYNOLDS, HAYES  
PIN 2202460  
1411 STATESVILLE ROAD  
NORTH WILKESBORO, WILKES COUNTY, NORTH CAROLINA**

**NCDOT WBS ELEMENT 44691.1.1  
STATE PROJECT R-5759  
PROPOSED WIDENING OF NC 115 FROM US 421 TO 2<sup>ND</sup>  
STREET IN WILKESBORO AND NORTH WILKESBORO**

## PRELIMINARY SITE ASSESSMENT REPORT

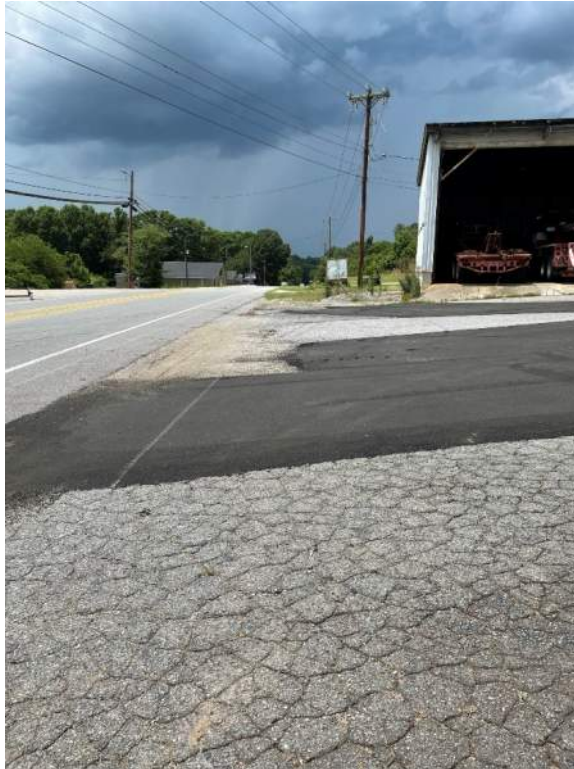
View facing northwest from the southern portion of the Project Study Area along NC 115.

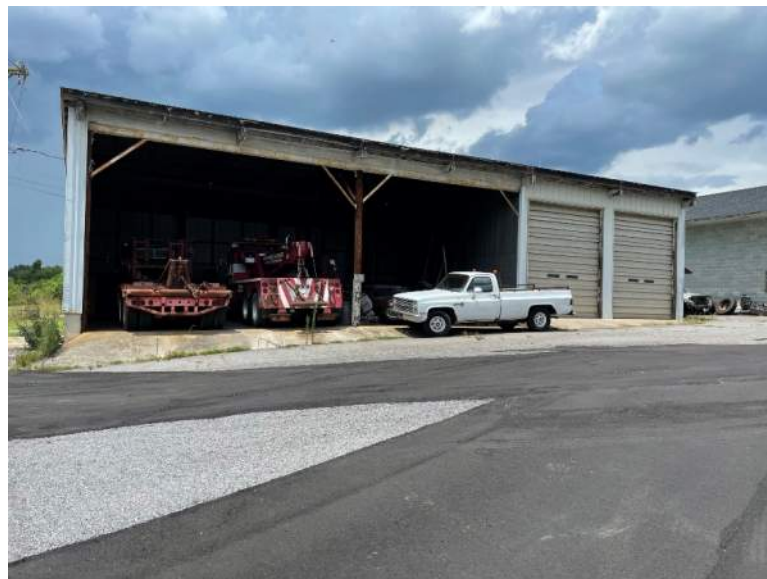
View facing north from the southern portion of the Project Study Area, depicting the automotive garage.

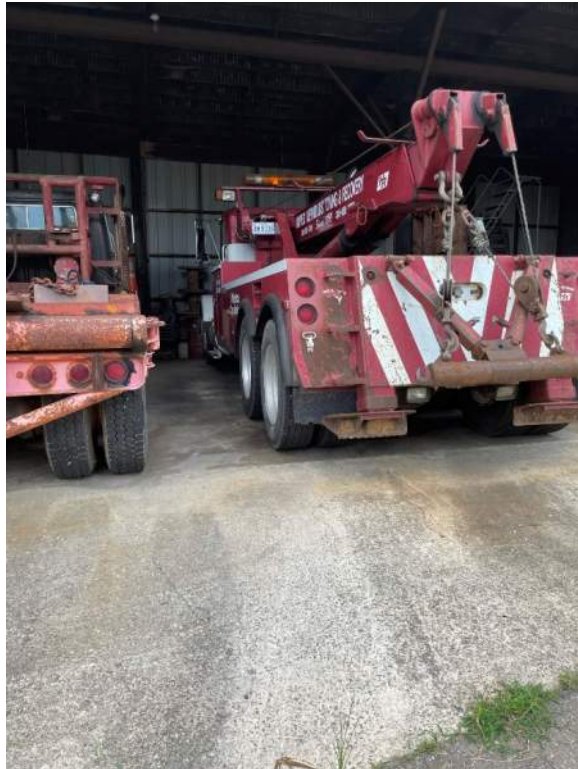
View facing into the garage bay along the southwestern side of the automotive garage building in the central portion of the Project Study Area.

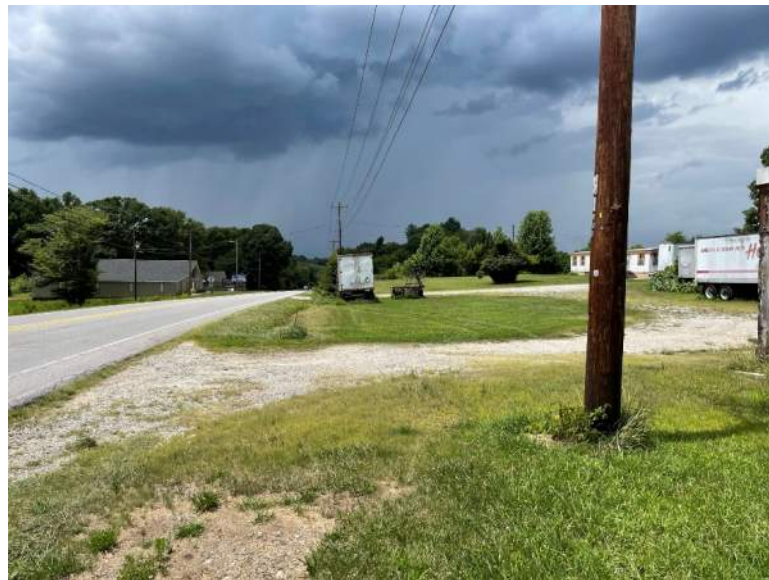
View facing northwest from the central portion of the Project Study Area north of the automotive garage building, along NC 115.

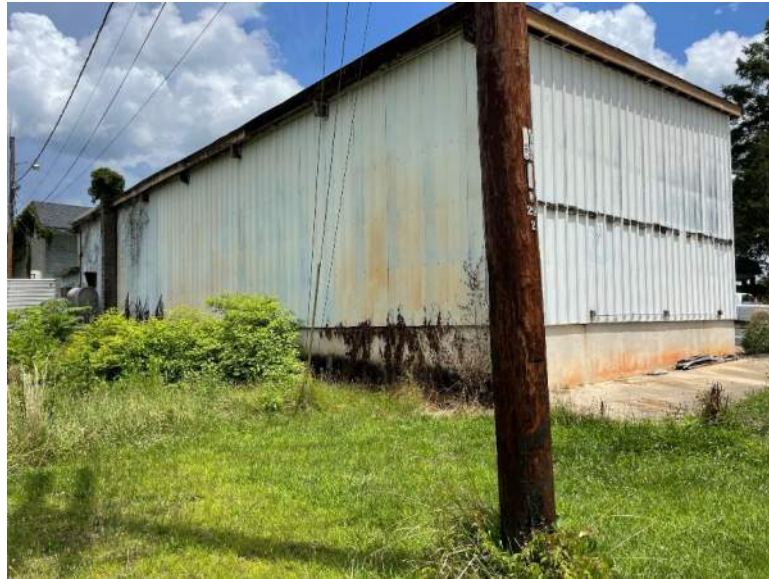
View facing east along the northern side of the automotive garage building in the central portion of the Project Study Area.

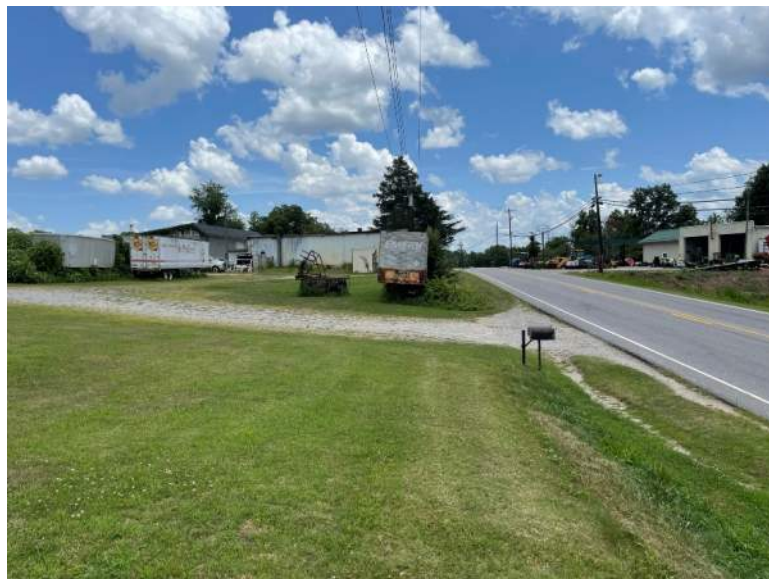
View facing southeast from the northwestern portion of the Project Study Area, along NC 115.

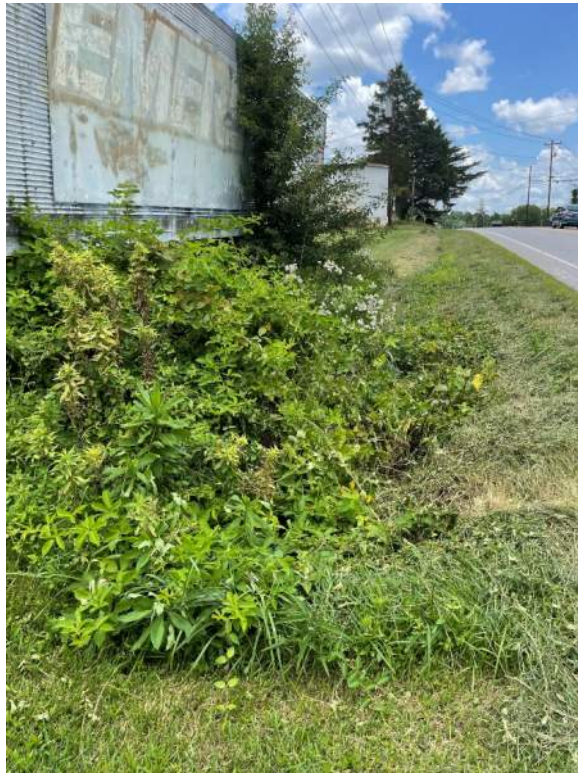
View facing southeast from the northwestern corner of the Project Study Area, along NC 115.
