**SUBJECT: Preliminary Site Assessment Report  
Parcel 117, Gregory Allen and Brenda Kay Stewart AKA Stuart, Brenda  
Anderson  
WBS Element No. 44691.1.1, TIP No. R-5759  
Proposed widening of NC 115 from US 421 to 2<sup>nd</sup> Street in Wilkesboro and  
North Wilkesboro, Wilkes County, NC  
Kleinfelder Project No. 20221238.001A**

**PRELIMINARY SITE ASSESSMENT REPORT  
PARCEL 117, GREGORY ALLEN AND BRENDA KAY STEWART  
AKA STUART, BRENDA ANDERSON  
PIN 2202113 & 2207614  
1055 STATESVILLE ROAD  
NORTH WILKESBORO, WILKES COUNTY, NORTH CAROLINA**

**NCDOT WBS ELEMENT 44691.1.1  
STATE PROJECT R-5759  
PROPOSED WIDENING OF NC 115 FROM US 421 TO 2<sup>ND</sup>  
STREET IN WILKESBORO AND NORTH WILKESBORO**

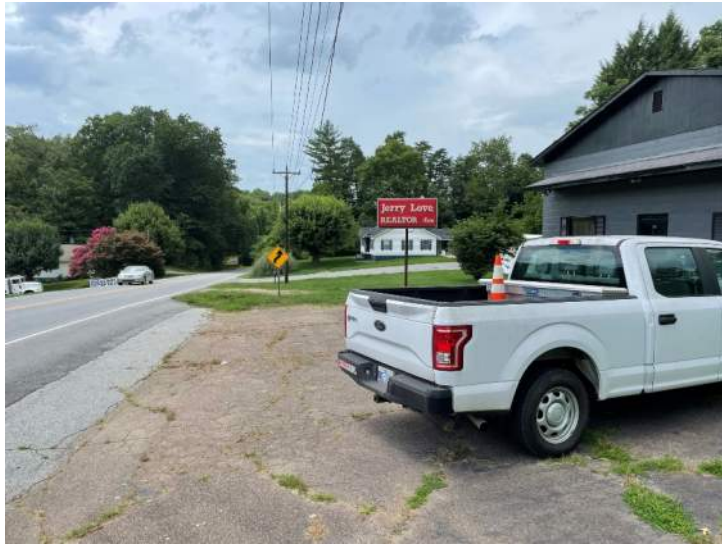
View facing northwest from the southern corner of the Project Study Area, along NC 115 at the corner of NC 115 and Cedar Lane and depicting the office building of Jerry Love Realtor.

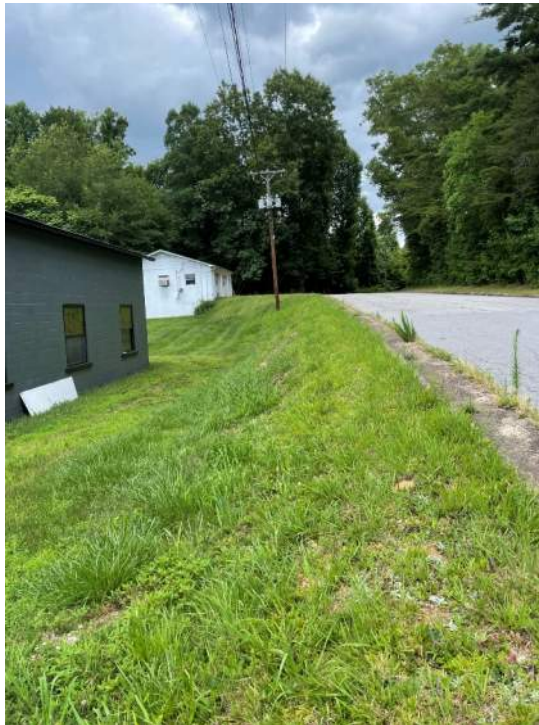
View facing northeast from the southern corner of the Project Study Area, along Cedar Lane at the intersection of Cedar Lane and NC 115.

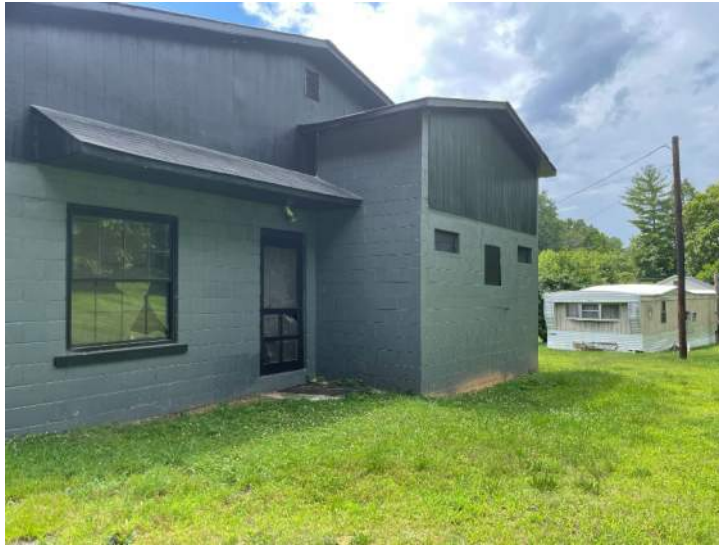
View facing west from the eastern portion of the Project Study Area, depicting the northeastern side of the gray-painted cinderblock building.

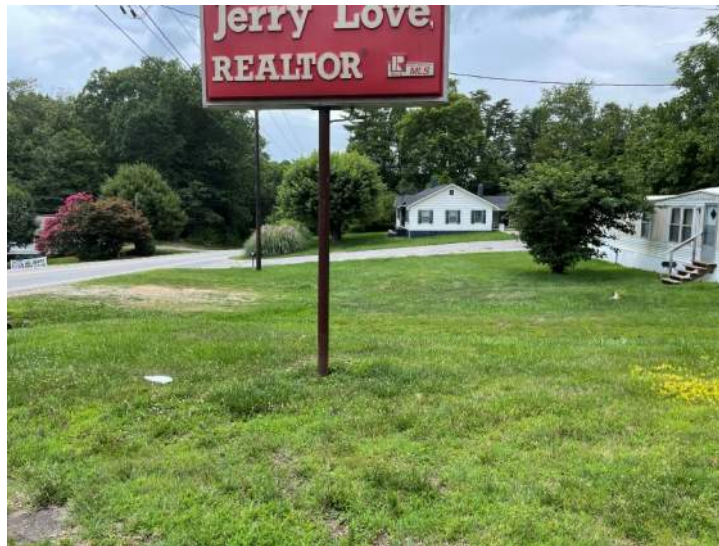
View facing northwest from the southern portion of the Project Study Area, west of the gray-painted cinderblock building and along NC 115.

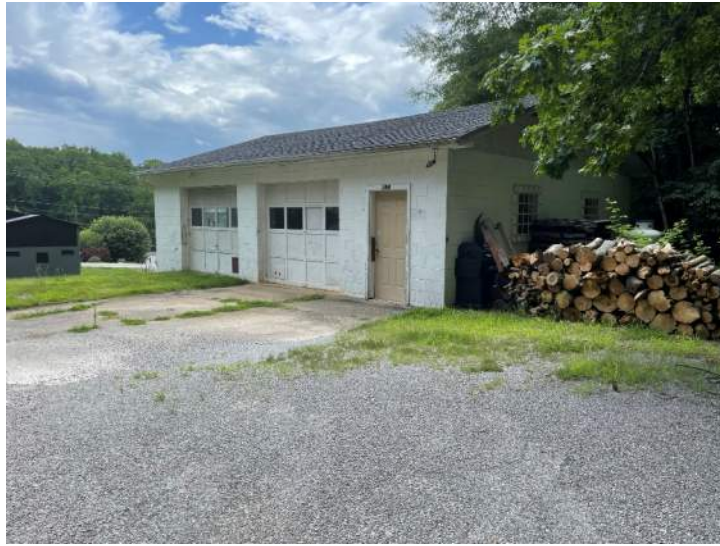
View facing southwest from the northeastern corner of the Project Study Area, depicting the garage with two bay doors located along Cedar Lane.

Kleinfelder was not able to observe the interior of the garage building on Parcel 117 to evaluate for the presence of in-ground hydraulic lifts, as Kleinfelder had not received entry authorization from the NCDOT Right of Way Agent by the time of site exploration, Thursday, August 5, 2021.

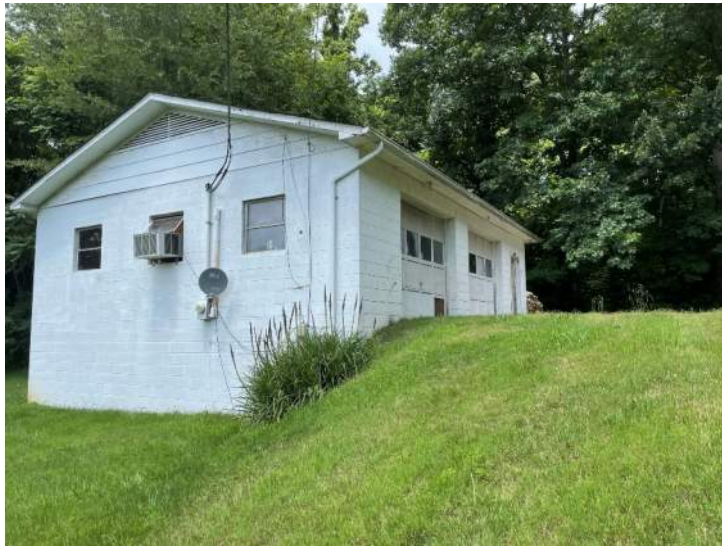
View facing north from the northeastern portion of the Project Study Area, depicting the garage with two bay doors located along Cedar Lane.

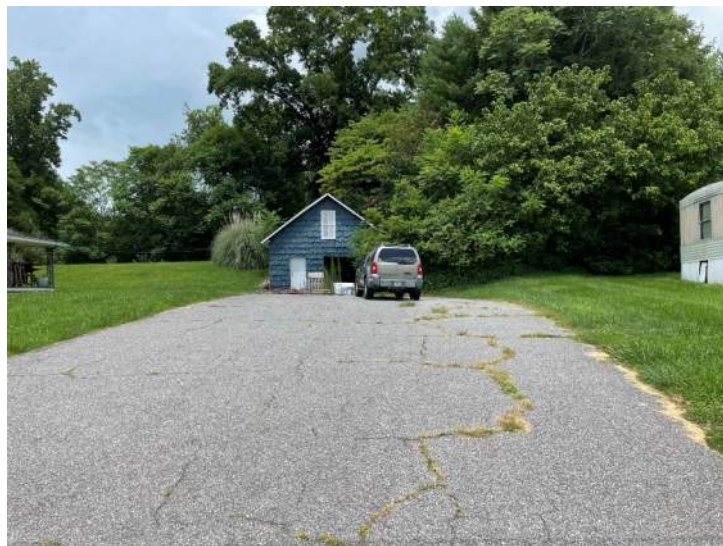
View facing northeast from the northwestern portion of the Project Study Area, depicting a shed adjacent to the blue and white painted house along the northernmost portion of the parcel.

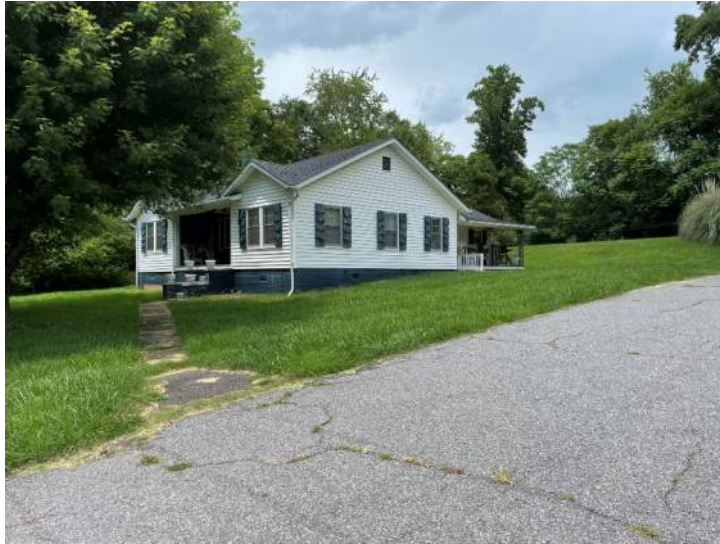
View facing north from the northwestern portion of the Project Study Area, depicting the blue and white painted house along the northernmost portion of the parcel (1055 Statesville Road).

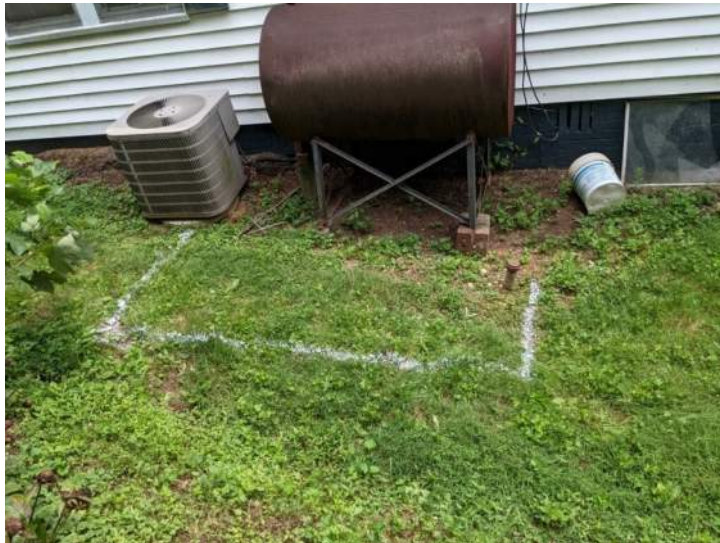
View facing east from the northwestern corner of the Project Study Area, depicting a 500-gallon AST (likely heating oil) along the northern side of the blue and white painted house in the northernmost portion of the parcel. One (1) probable heating oil UST adjacent to the AST was observed as part of the geophysical survey and was outlined with white spray paint.

Based on review of the NCDEQ UST database, site visits and previous reports, there is one (1) probable UST along the northern side of the blue and white painted residential home in the northernmost portion of the Project Study Area. The probable UST is likely inactive, but this could not be confirmed at the time of site exploration, August 5, 2021. A photograph of the probable UST area is provided in Appendix A.

- An approximately 500-gallon AST that may contain heating oil was observed along the northern side of the blue and white painted residential home in the northernmost portion of the Project Study Area adjacent to Probable UST #1, with stressed vegetation noted at the time of site exploration, August 5, 2021.

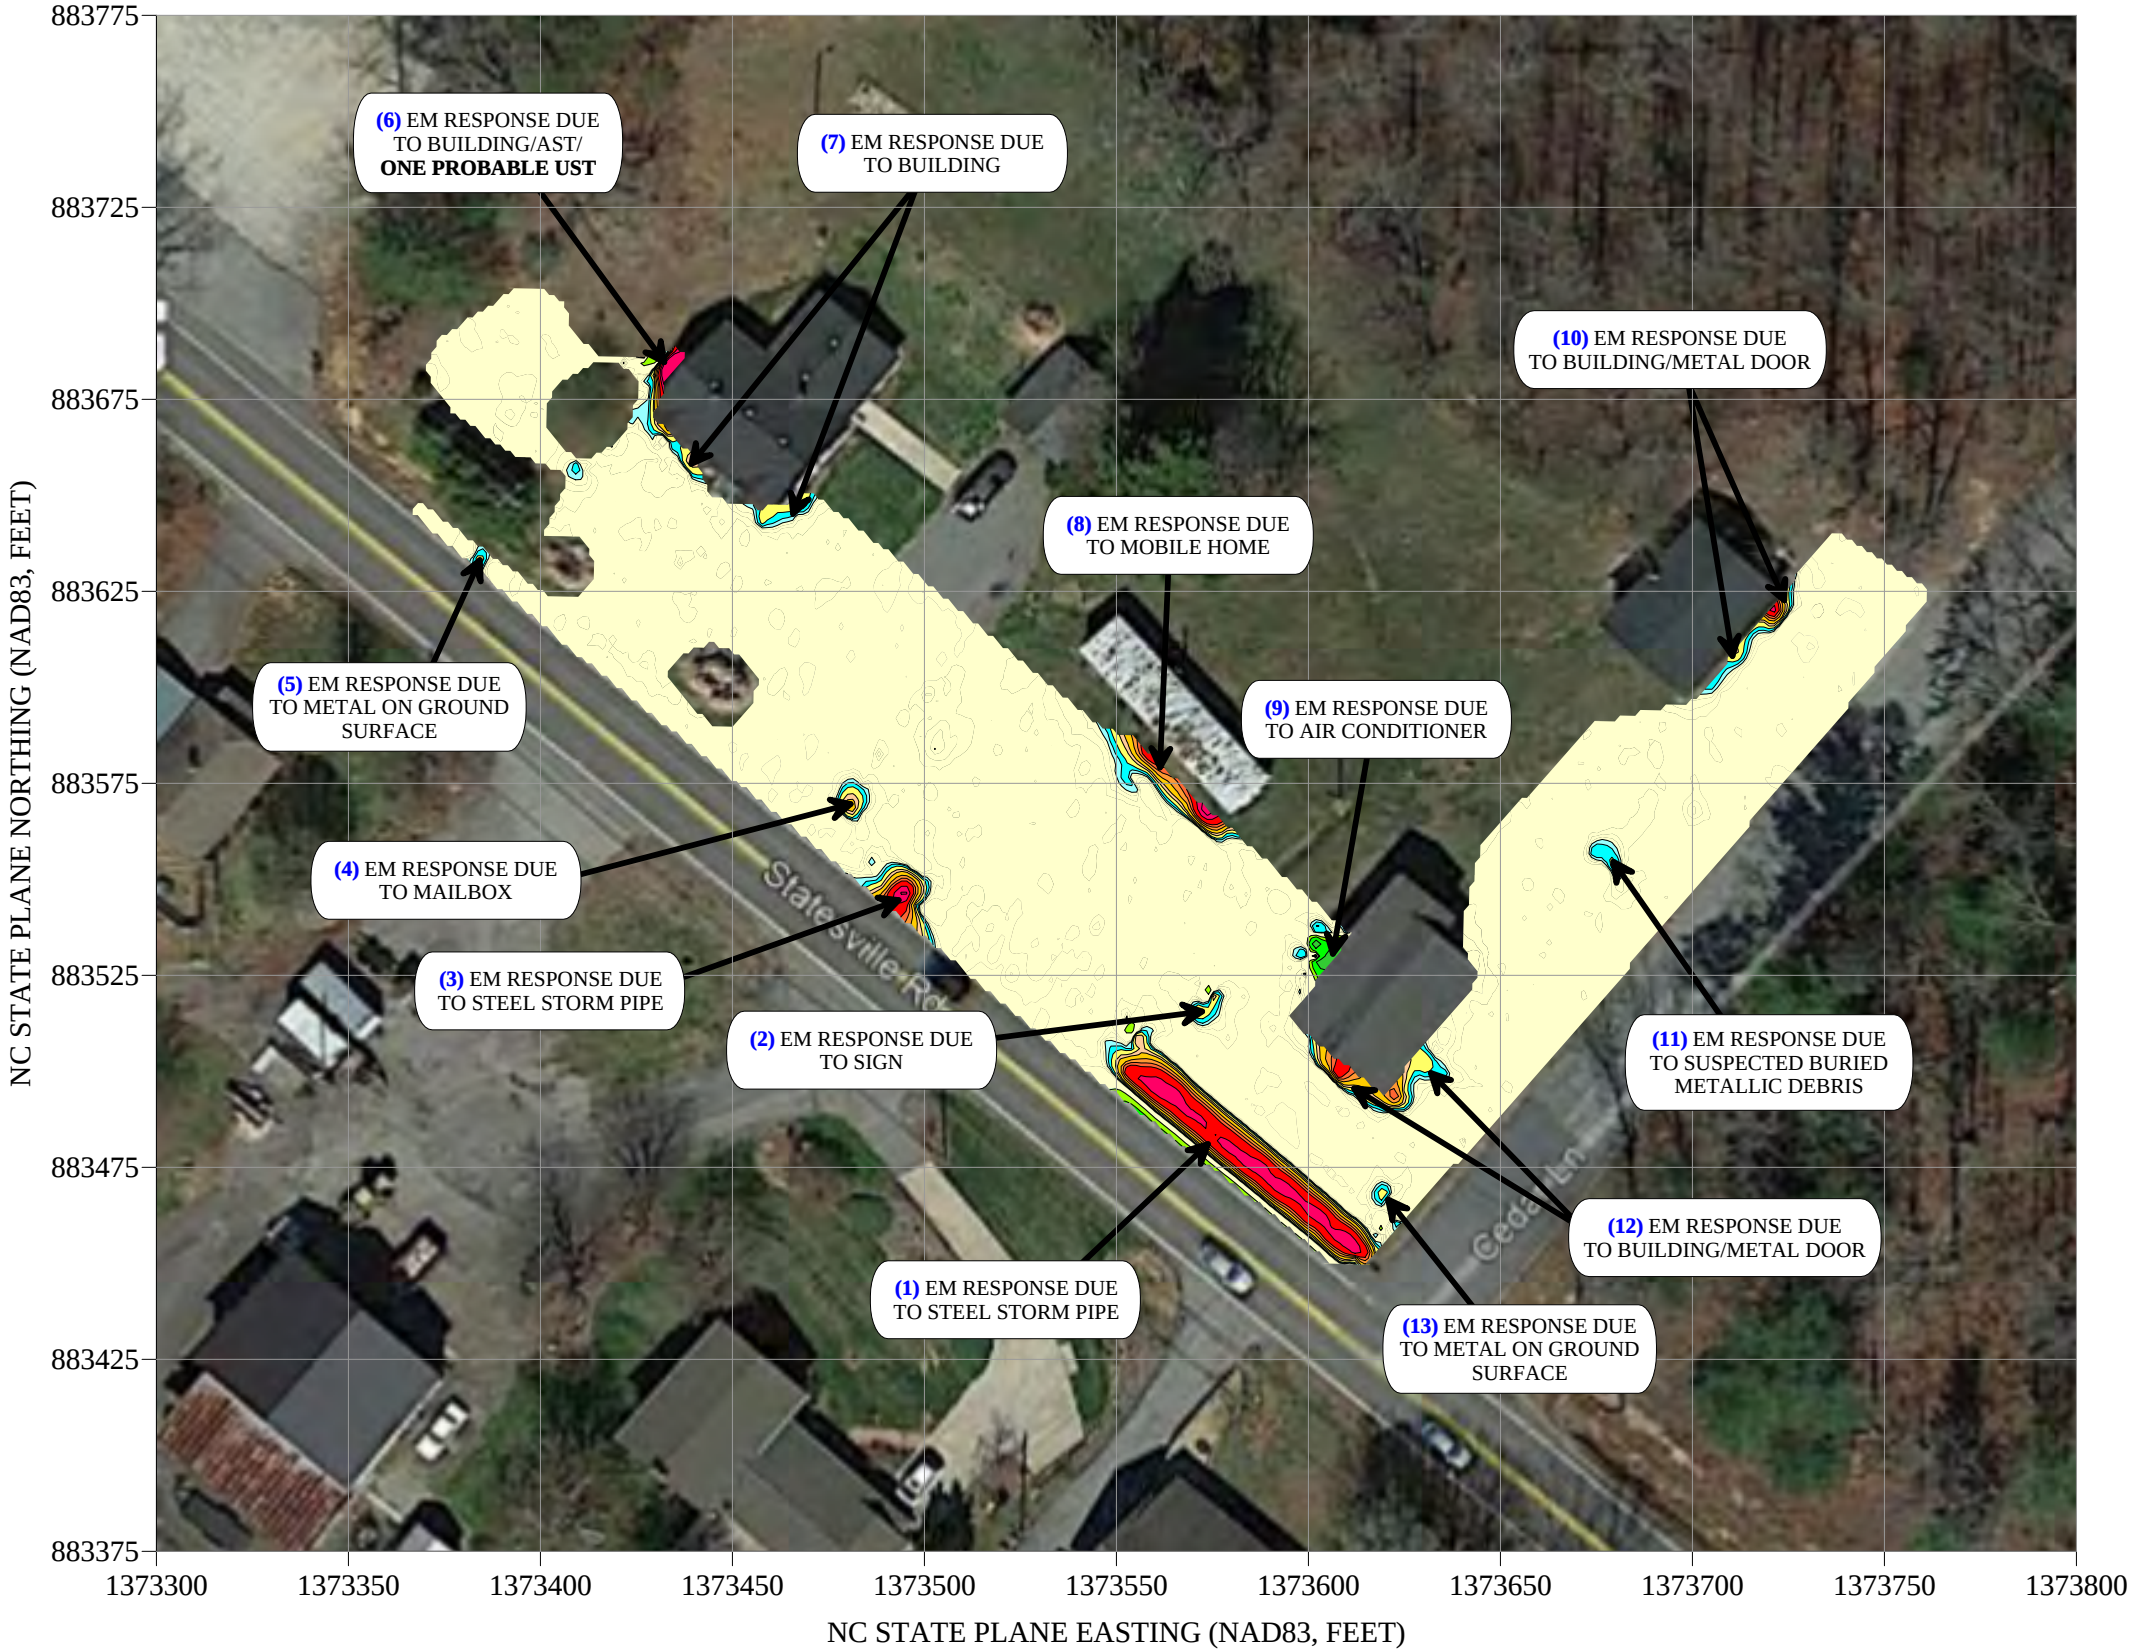
EM61 METAL DETECTION RESULTS

EVIDENCE OF ONE PROBABLE METALLIC UST WAS OBSERVED.

The contour plot shows the differential results of the EM61 instrument in millivolts (mV). The differential results focus on larger metallic objects such as USTs and drums. The EM data were collected on July 14, 2021, using a Geonics EM61-MK2 instrument. Verification GPR data were collected using a GSSI SIR 4000 instrument with a 350 MHz HS antenna on July 20, 2021.

A contour plot of the EM61 results obtained across the survey area at the property is presented in **Figure 2**. Each EM anomaly is numbered for reference in the figure. The following table presents the list of EM anomalies and the cause of the metallic response, if known:

The majority of the EM anomalies were directly attributed to visible cultural features at the ground surface, including steel storm pipes, a sign, a mailbox, metal on the ground surface, buildings, an AST, a mobile home, an air conditioner, and metal doors. EM Anomalies 6 and 11 were investigated with GPR to examine whether the anomalies were the result of significant structures such as a USTs. GPR was also performed around areas of significant metallic interference to confirm that the metallic interference did not obscure any significant structures such as USTs.

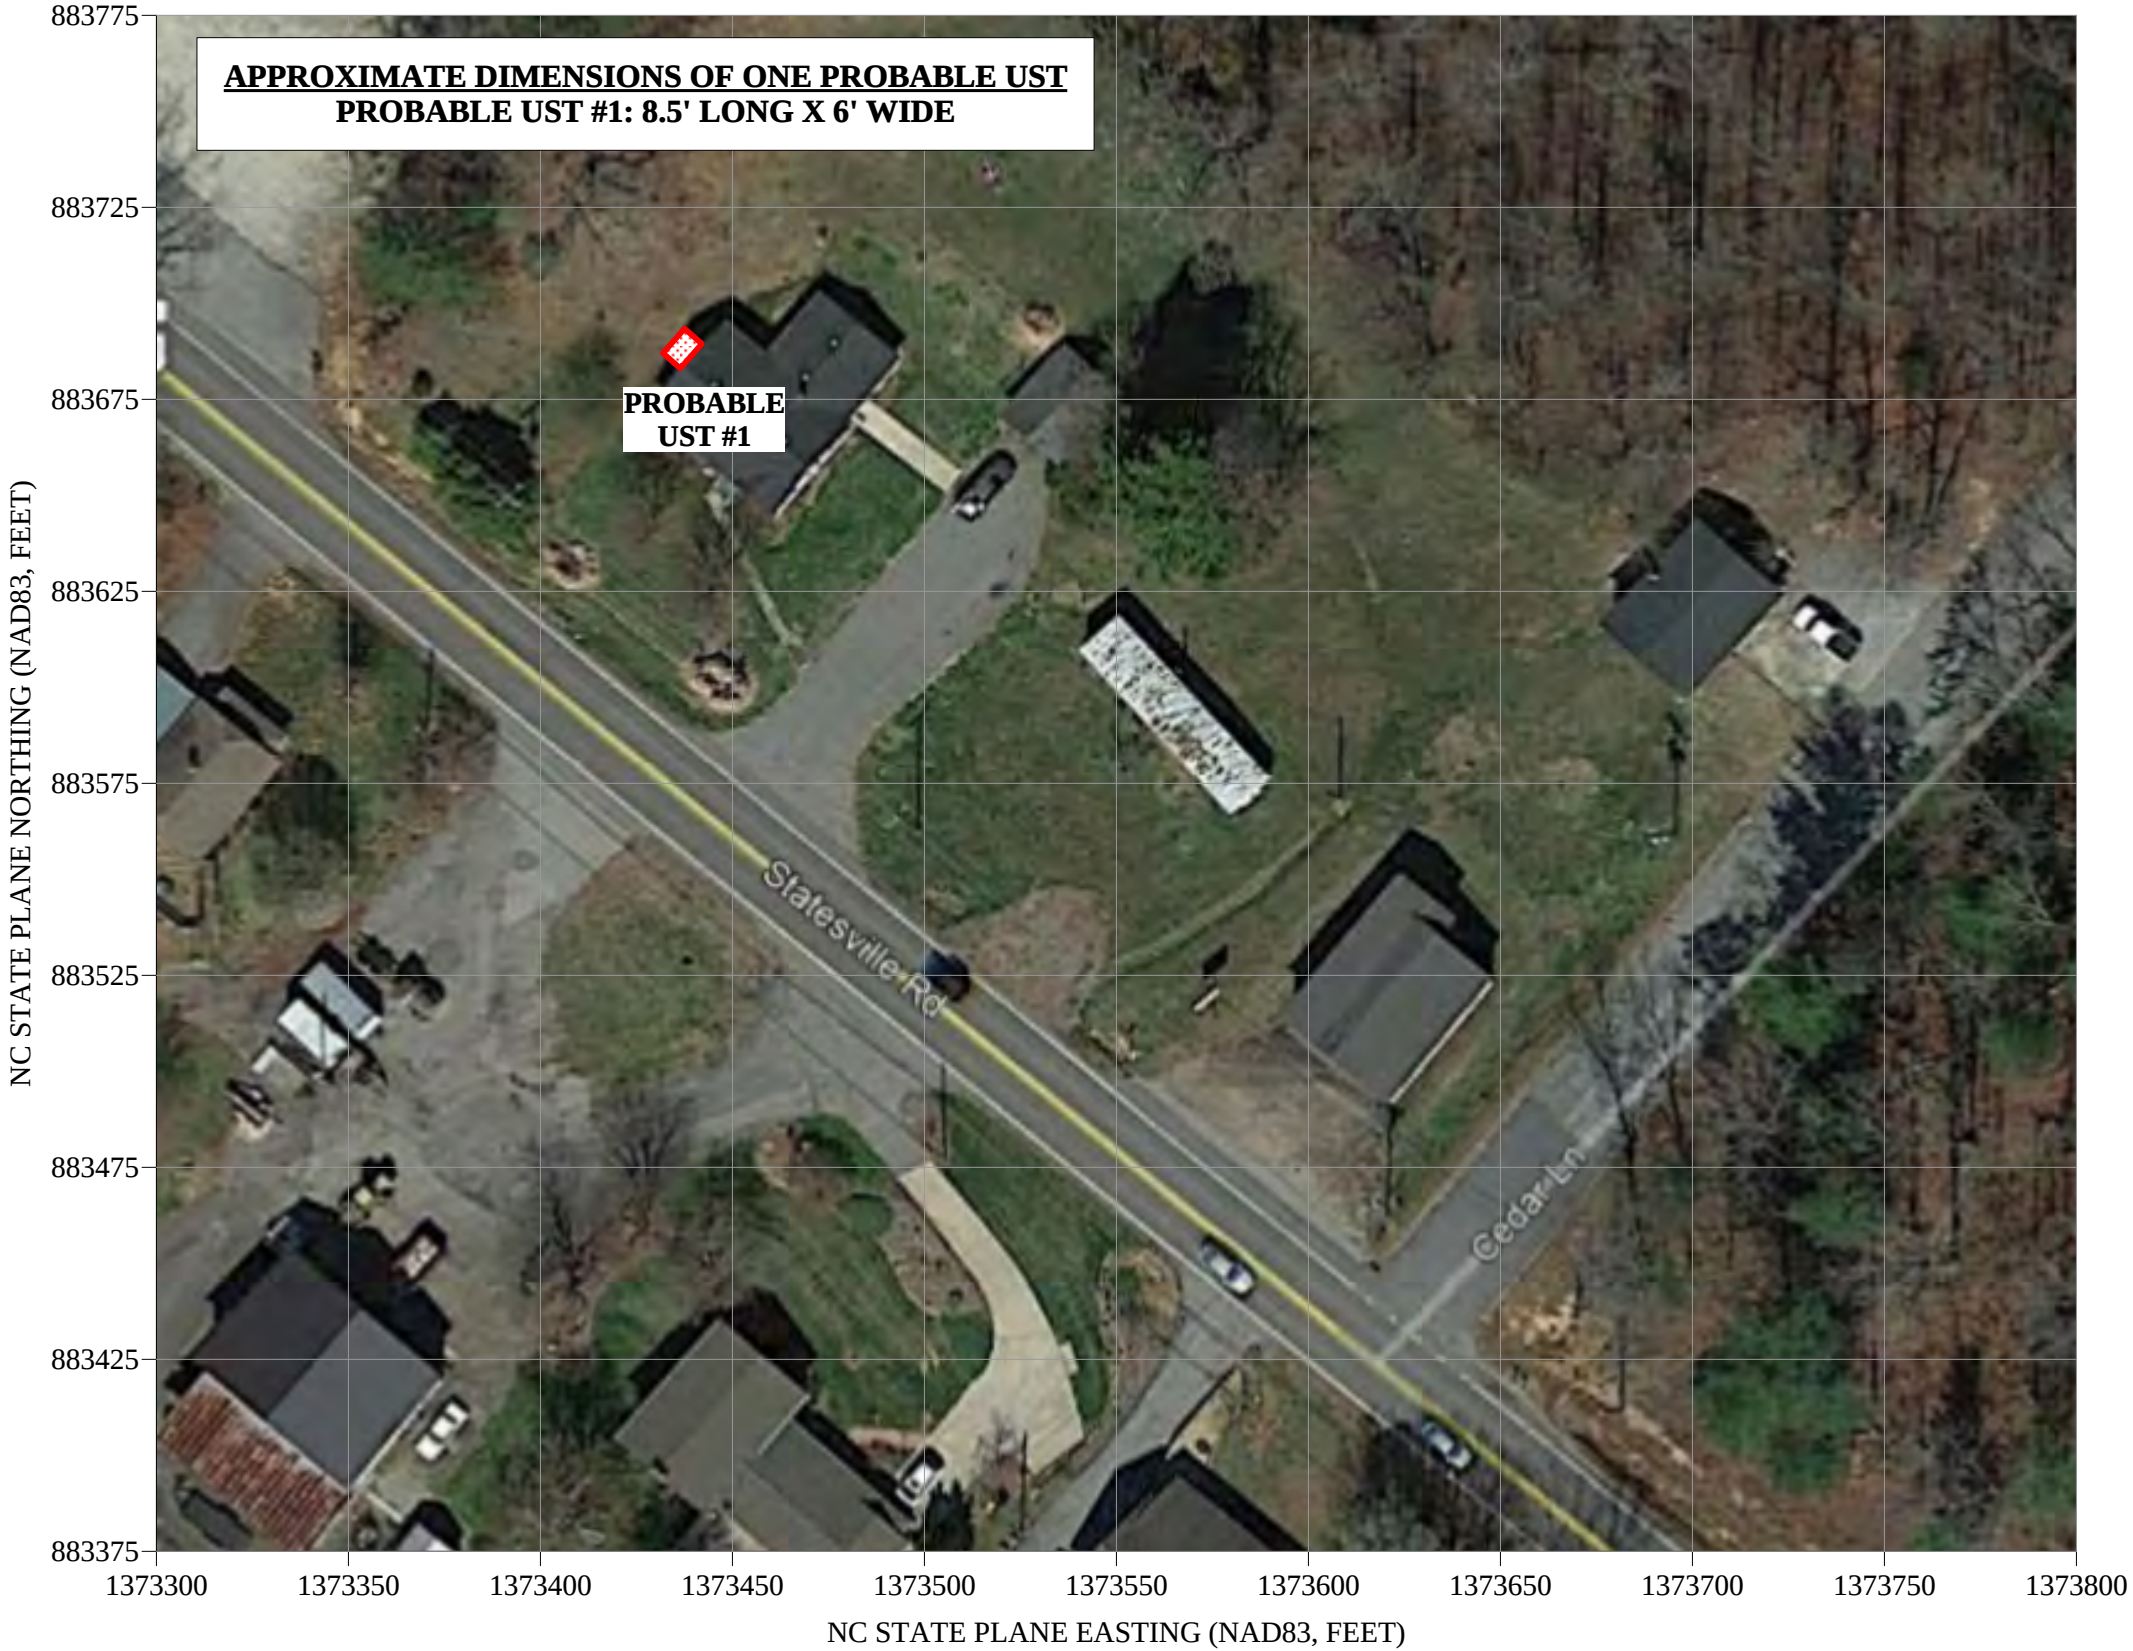
LOCATION OF ONE PROBABLE UST

The EM and GPR surveys did not identify unknown geophysical anomalies within the Project Study Area. One (1) probable UST was identified along the northern side of the blue and white painted residential home in the northernmost portion of the Project Study Area. Probable UST #1 is approximately 8.5-ft long by 6-ft wide.

- The GPR and EM investigation did not identify unknown features. The GPR and EM investigation identified one (1) probable UST along the northern side of the blue and white painted residential home in the northernmost portion of the Project Study Area. Probable UST #1 is approximately 8.5-ft long by 6-ft wide.

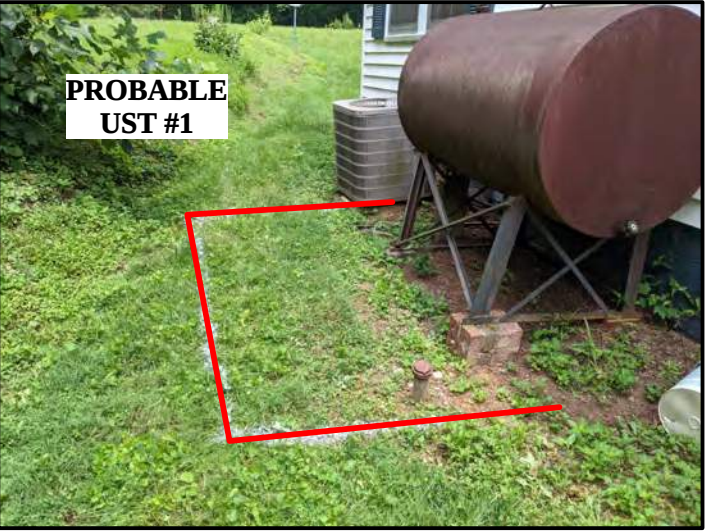
View of One Probable UST  
(Facing Approximately North)
