**SUBJECT: Preliminary Site Assessment Report  
Parcel 121, Randy V. and Sandra J. Bell AKA Parker, James L  
WBS Element No. 44691.1.1, TIP No. R-5759  
Proposed widening of NC 115 from US 421 to 2<sup>nd</sup> Street in Wilkesboro and  
North Wilkesboro, Wilkes County, NC  
Kleinfelder Project No. 20221238.001A**

**PRELIMINARY SITE ASSESSMENT REPORT  
PARCEL 121, RANDY V. AND SANDRA J. BELL AKA PARKER,  
JAMES L  
PIN 1402990  
909 STATESVILLE ROAD  
NORTH WILKESBORO, WILKES COUNTY, NORTH CAROLINA**

**NCDOT WBS ELEMENT 44691.1.1  
STATE PROJECT R-5759  
PROPOSED WIDENING OF NC 115 FROM US 421 TO 2<sup>ND</sup>  
STREET IN WILKESBORO AND NORTH WILKESBORO**

## METALLIC UST INVESTIGATION: PARCEL 121 NCDOT PROJECT U-5759

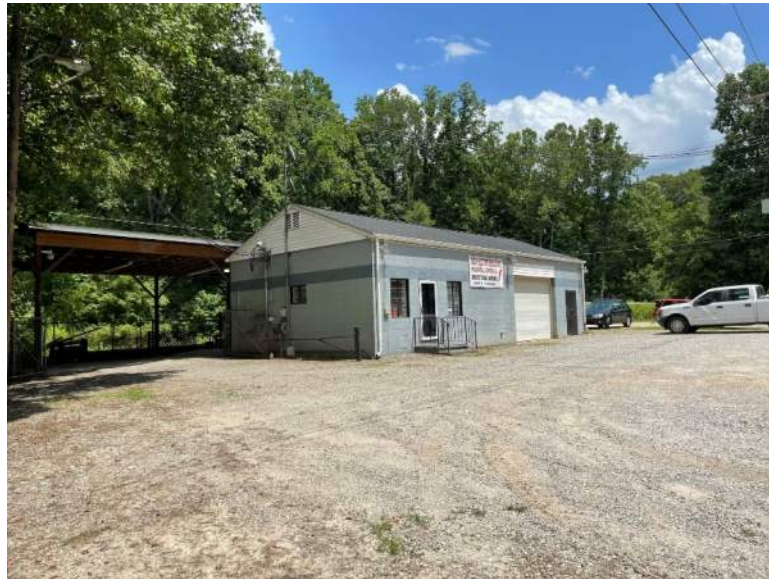
View facing southeast from the northwestern corner of the Project Study Area along NC 115.

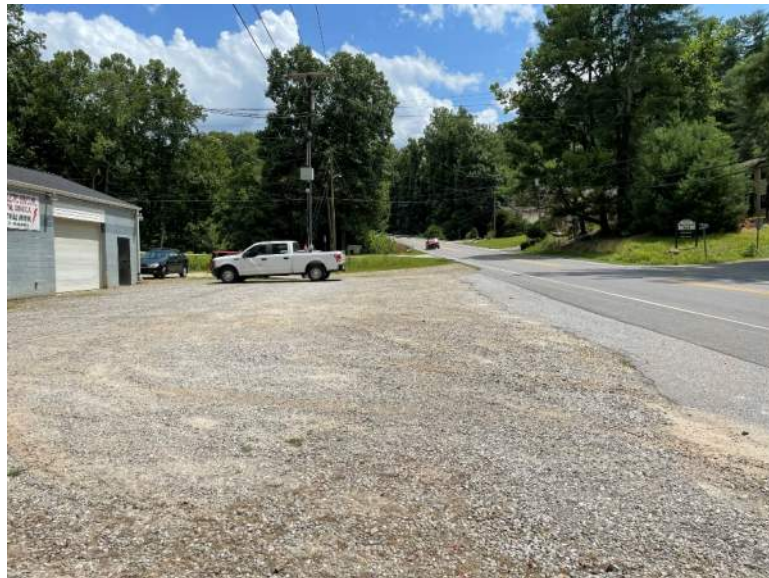
View facing south from the northwestern corner of the Project Study Area along NC 115.

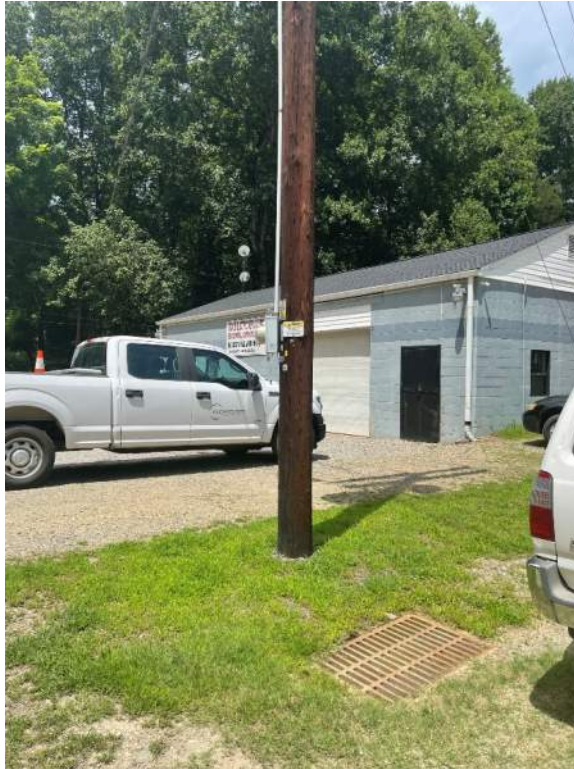
View facing northeast from the southwestern corner of the Project Study Area along NC 115.

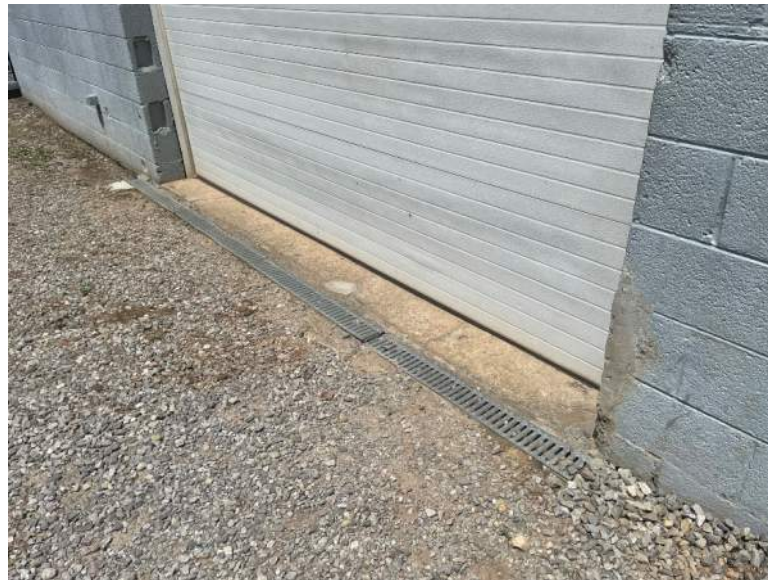
Floor drains in front of the bay door on the western side of the building facing NC 115.

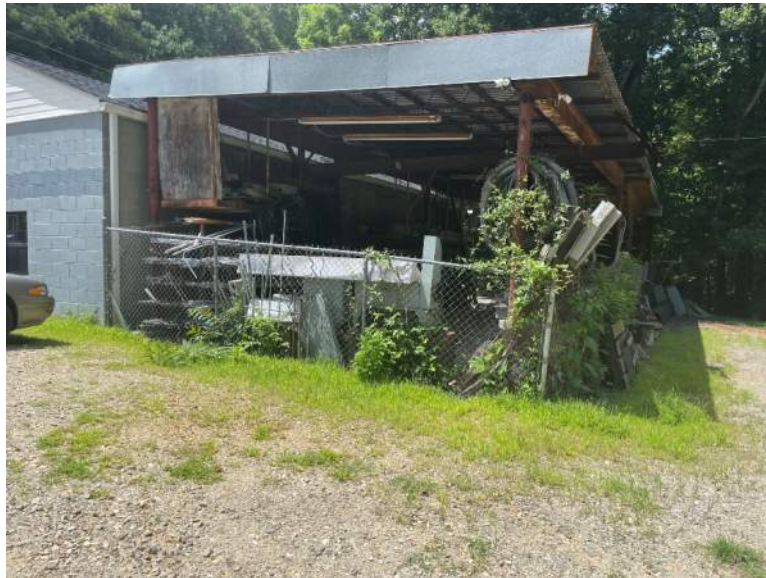
View facing north from the eastern portion of the Project Study Area, depicting the equipment storage area located along the eastern side of the building and outside of the Project Study Area.

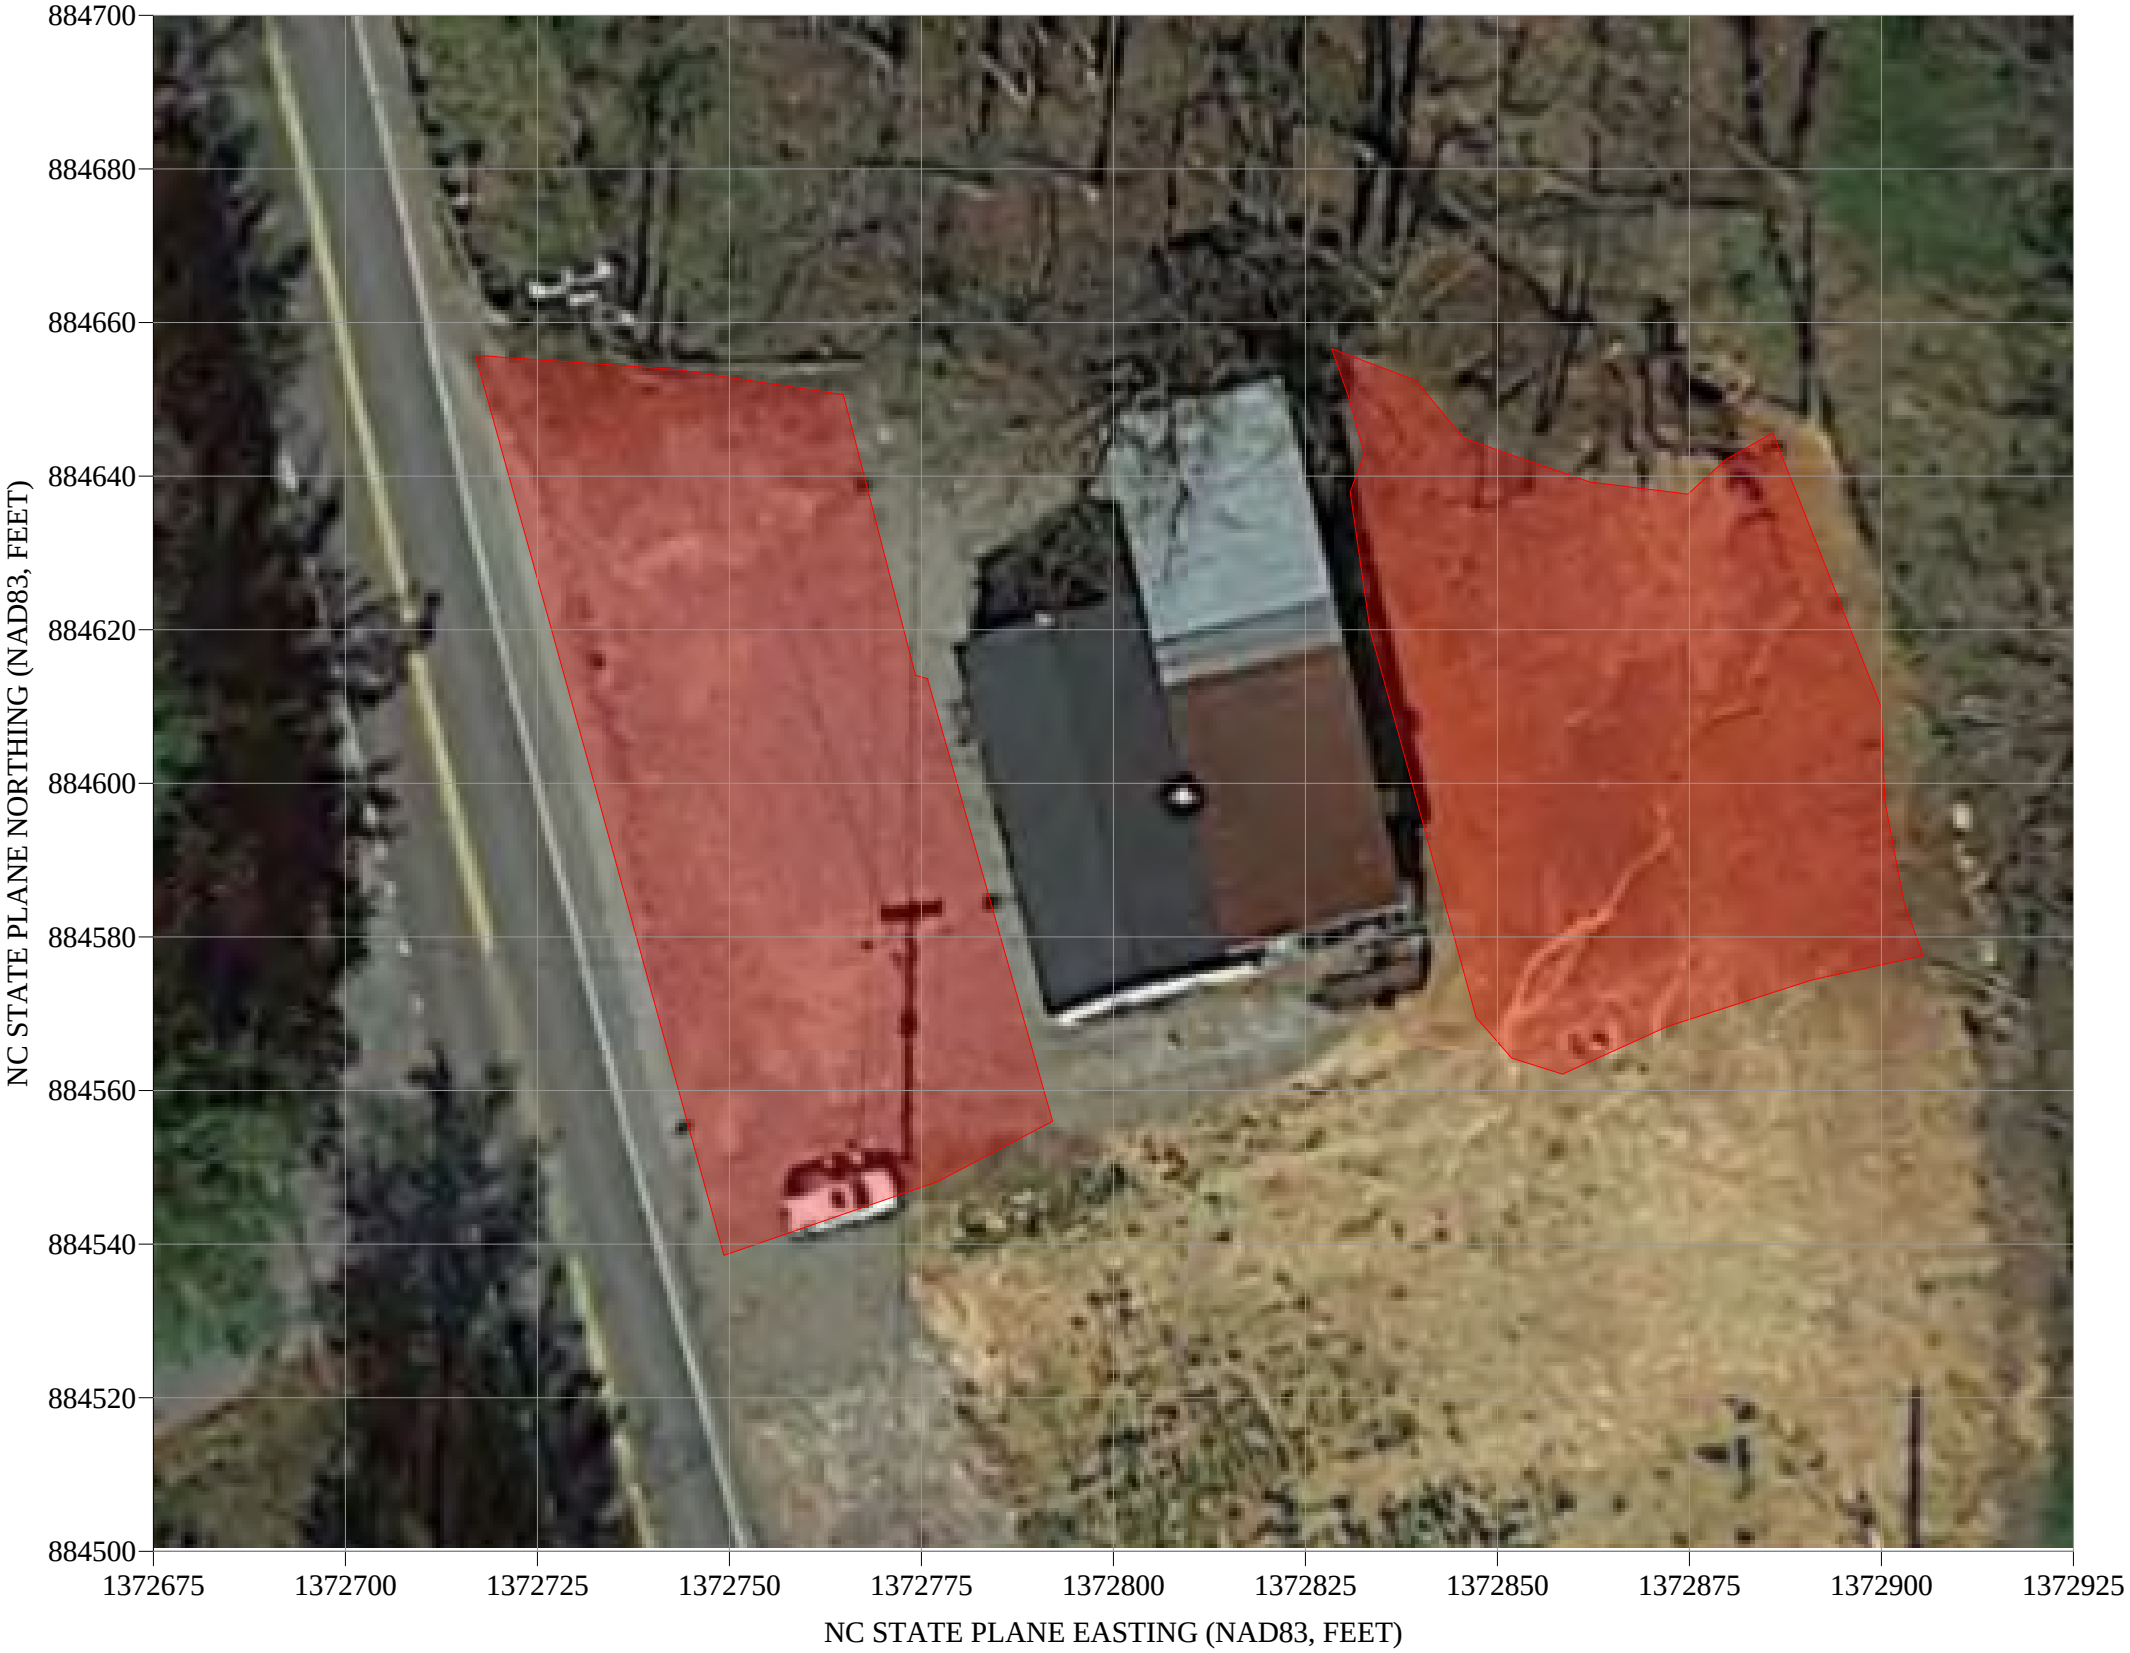
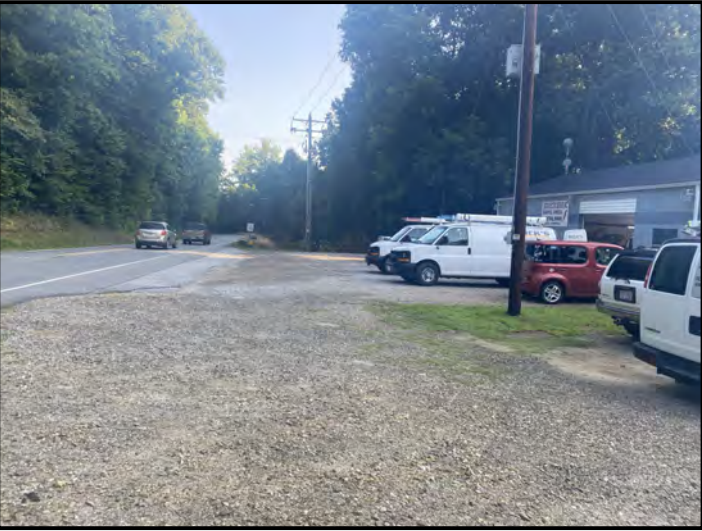
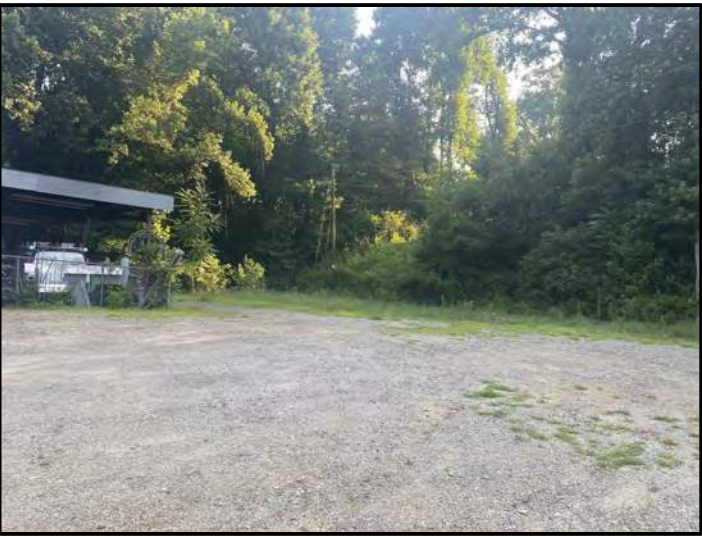
**FIGURE 1**

The site consisted of a commercial building surrounded by asphalt, gravel, and grass surfaces. An aerial photograph showing the survey area boundaries and ground-level photographs are shown in **Figure 1**.

APPROXIMATE BOUNDARIES OF GEOPHYSICAL SURVEY AREA

View of Survey Area (Facing Approximately North)

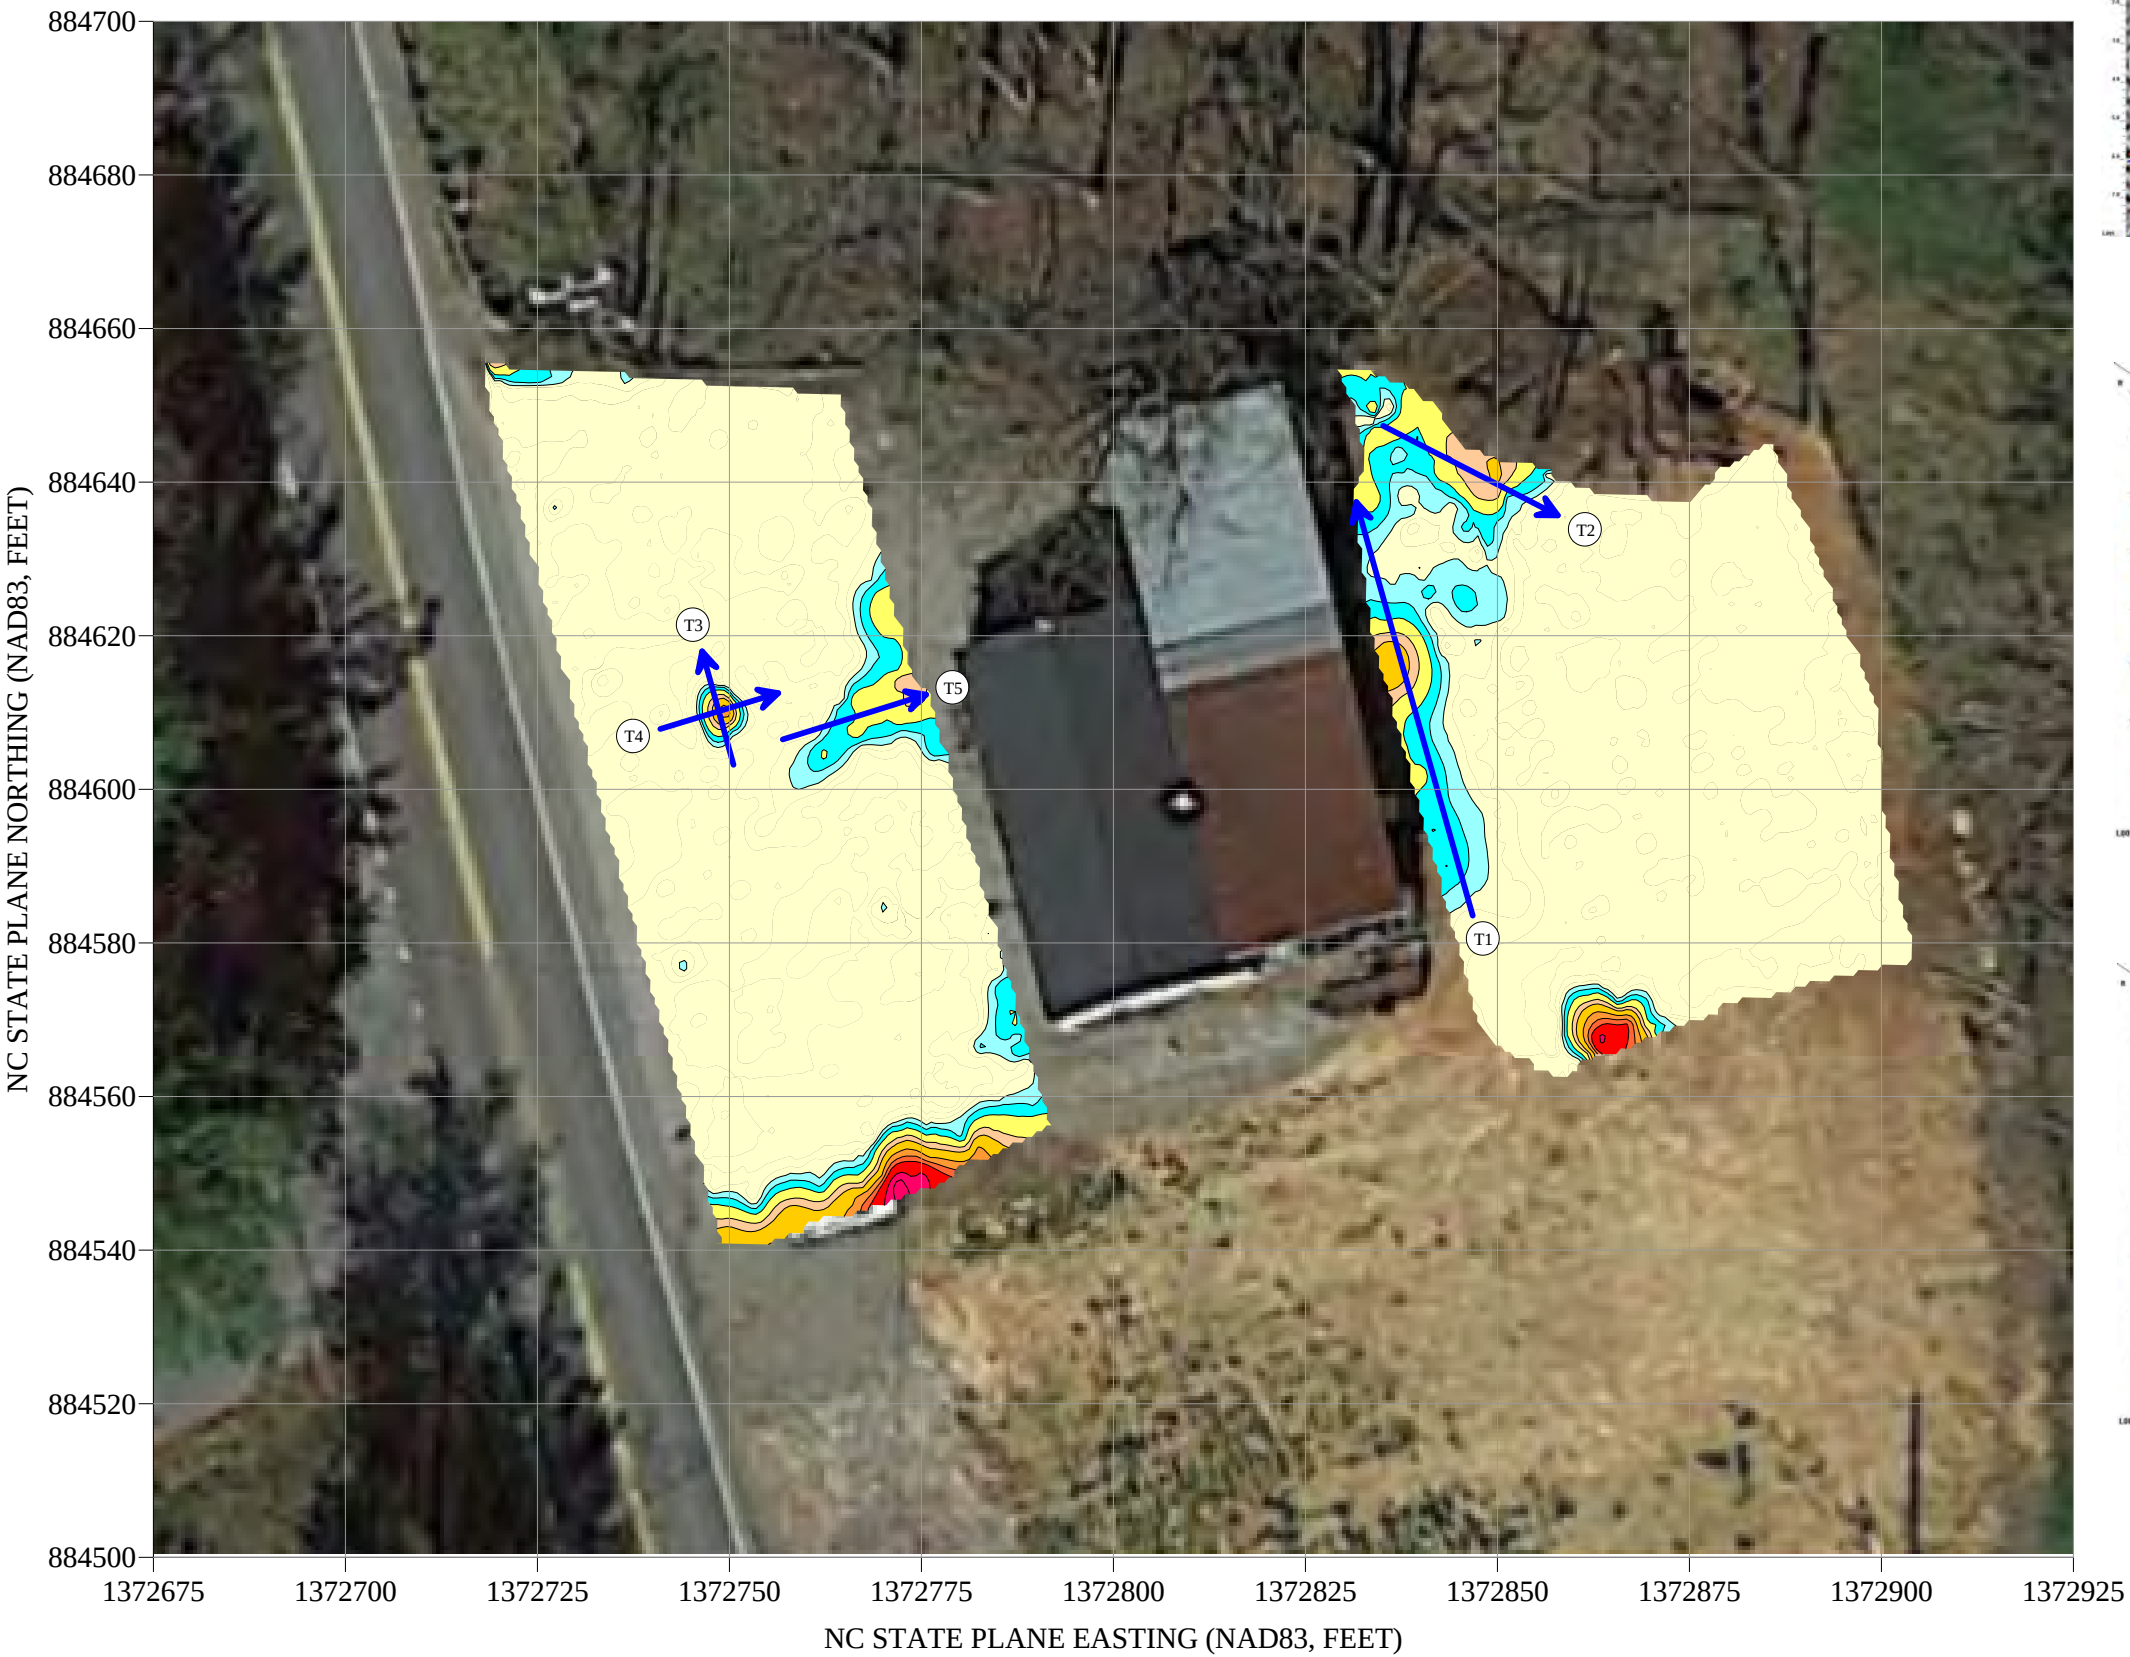
GPR TRANSECT LOCATIONS

**Figure 3** presents the locations of the formal GPR transects performed at the property as well as the images. A total of five formal GPR transects were performed at the site.
