## **Phase II Site Assessment Report**

**State Project: R-5759**

**Parcel #002**

**Flynn Harrold Property**

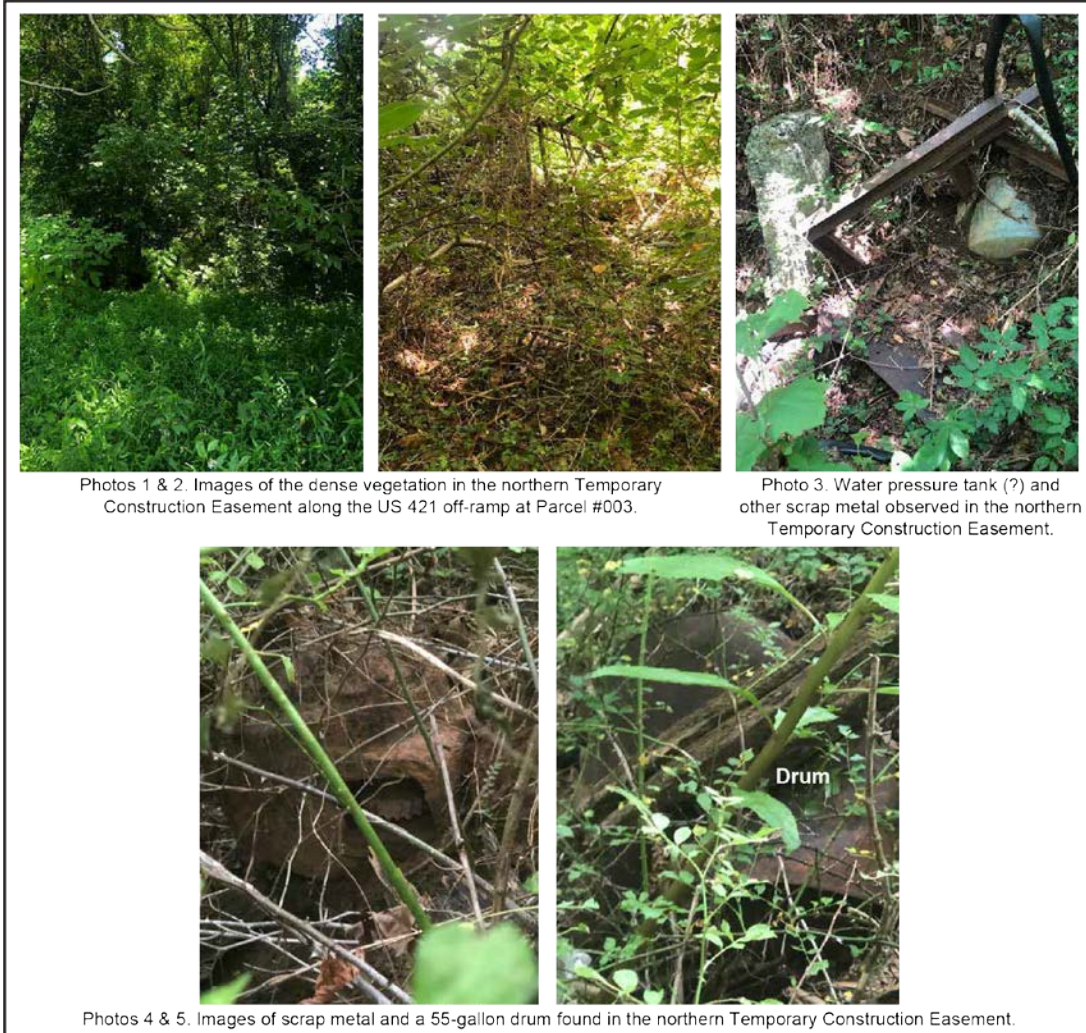
### 3.5 Plate 3 – Photographs of Parcel #003

Photos 1 and 2 in Plate 3 show an example of some of the dense vegetation encountered within the E. Photos 3, 4 and 5 show examples of discarded scrap metal, what appears to be a water pressure tank, a 55-gallon drum and old vehicle parts. It is possible that these objects have been dumped here from the off ramp over the last few decades, but it would seem likely that these objects are material discarded when the property was used as a junk yard. Photo 2 in Plate 1 shows what may be a house and possibly a chicken house in the vicinity of the E.

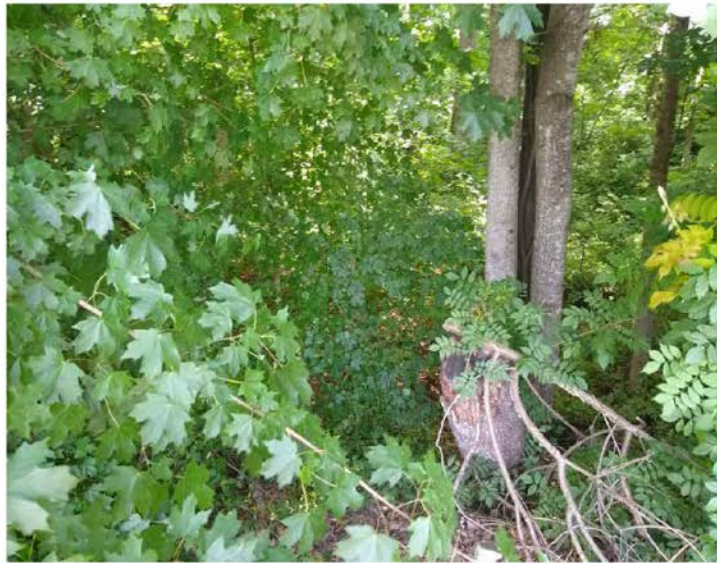
Photo 2. Dense vegetation along the northeast property line.

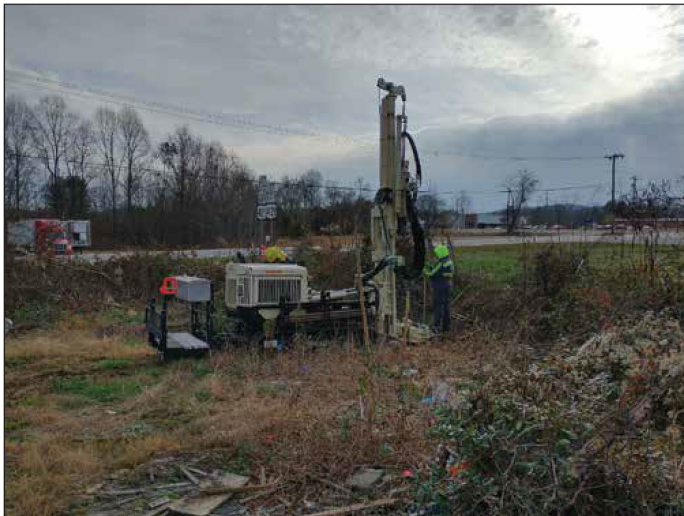
Photo 4. Carolina Soil Investigations drilling boring B-1.

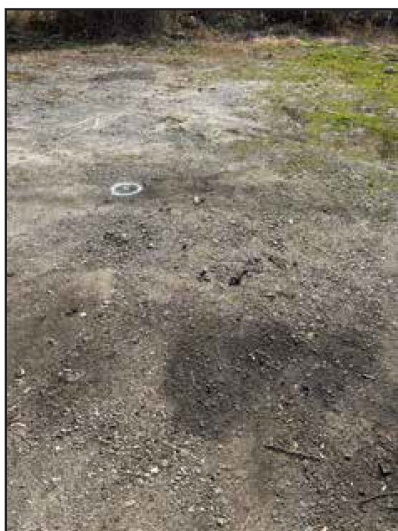
Photo 3. Example of surface staining at the property.

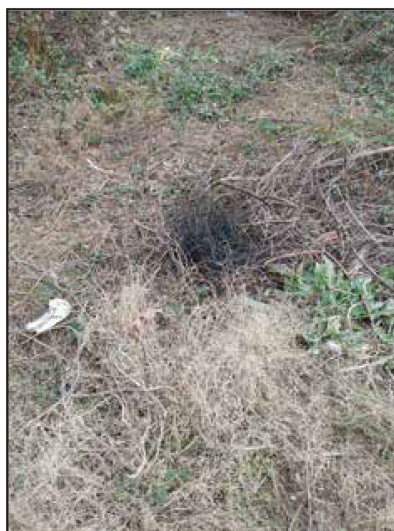
Photo 4. Another example of surface staining.
