**Phase II Site Assessment Report**

**State Project: R-5759**

**Robert E. and Janice G. Ashley Property**

**Parcel #025**

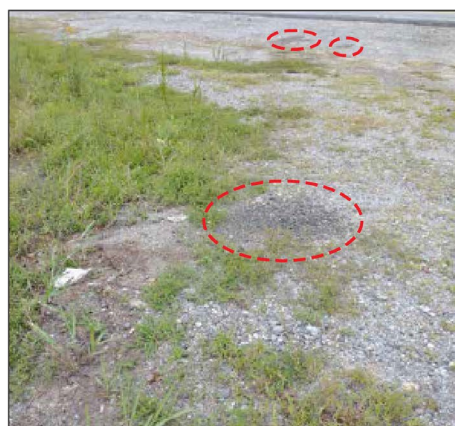
Photo 1. Petroleum stains located on the southern edge of the property.

Parcel #025 is not currently active as a commercial business. It is being used to store tractor trailers along the east side of the property. Historical research has not shown that the property has ever operated as a gas station. The property is adjacent to an active gas station. Dozens of junk cars were recently removed from the property. A few areas of stained soil, likely from oil and fuel leaking from the cars, are present across the property. This petroleum impacted soil is likely limited to the surface.
