## **Phase II Site Assessment Report**

**August 16, 2021**  
**WBS Element: 44691.1.1**  
**State Project: R-5759**  
**Wilkes County**

**Parcel #060**  
**James D. & Shirley A. Johnson Et Al. Property**  
**2065 Statesville Road, North Wilkesboro, NC 28659**  
**PIN #: 3877-79-6463**  
**Facility ID No.: N/A**  
**Groundwater Incident No.: N/A**

**NCDOT WBS ELEMENT 44691.1.1  
STATE PROJECT R-5759  
PROPOSED WIDENING OF NC 115 FROM US 421 TO 2<sup>ND</sup>  
STREET IN WILKESBORO AND NORTH WILKESBORO**

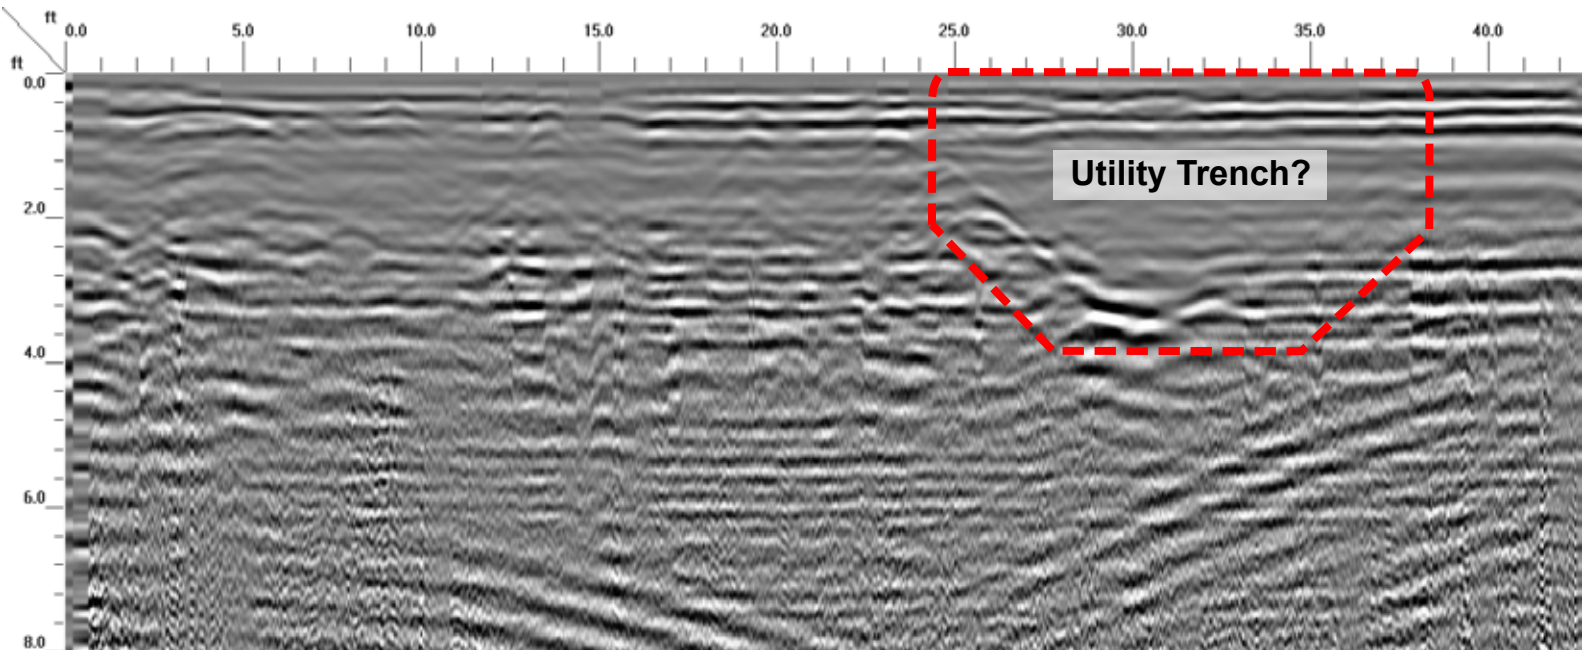
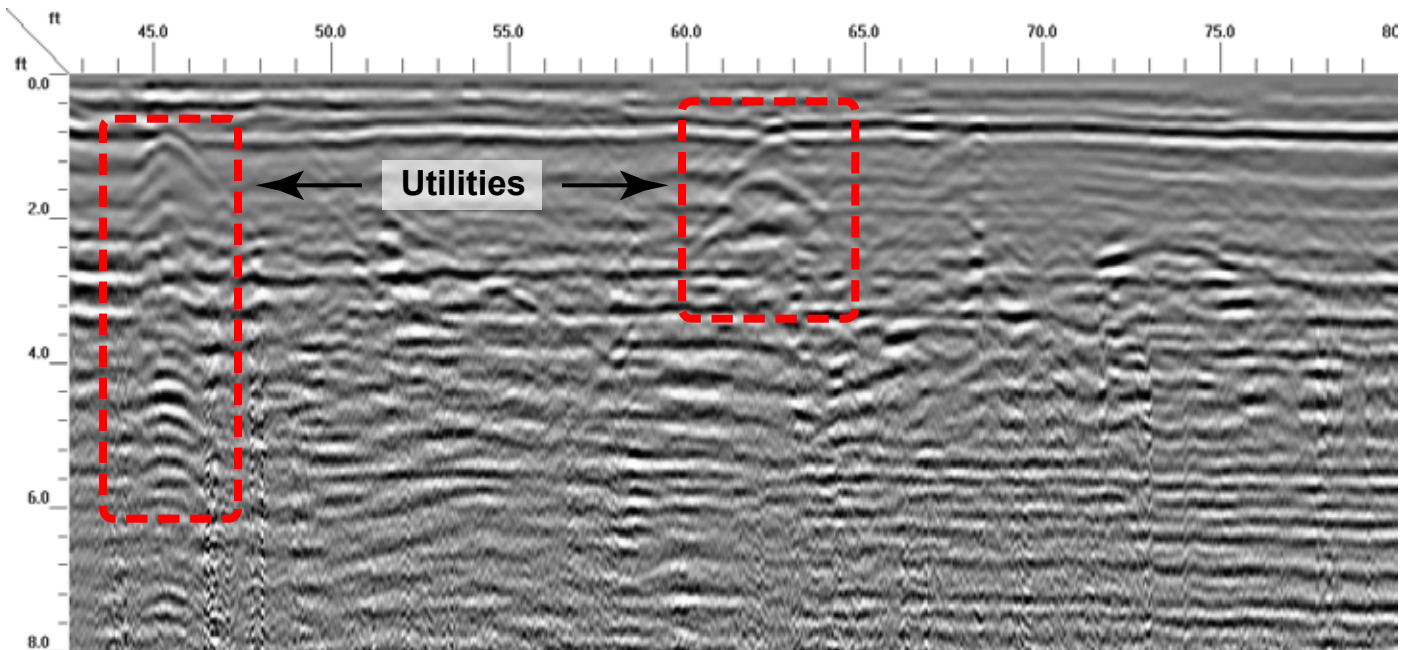
| <b>Figure 8a</b><br>GPR Transects<br>1 and 2 | TIP Number: R-5759<br>Wilkes County, NC | J.D. and S.A. Johnson,<br>et al. Property<br>2065 Statesville Road<br>North Wilkesboro, NC | Parcel I.D. #: 060<br>Facility I.D. #: N/A | Seramur & Associates, PC<br>Boone, NC |

Five transects of GPR data were collected around the building at Parcel 60 (Figures 8a and 8b). Transects 1 and 2 were collected on the south side of the building. A possible utility trench is observed on both of these profiles between about 25 and 40 feet. Additionally, a few hyperbolae were observed on both of these profiles near the south side of the building and are likely utility lines. Transects 3 and 4 were collected on the north side of the building. A few hyperbolae were imaged on these transects. The magnetometer did not detect ferrous objects in the subsurface at this location. Numerous utility meters are located on this side of the building, so these hyperbolae are interpreted as underground utilities. Transect 5 was collected along the rear (east) side of the building and across the area near the subsurface vault. Evidence of a UST was not imaged at this location (Figure 9b). The GPR passed over an exposed electric wire at the surface around 76 feet through the transect and this produced “ringing” through the entire depth of the profile at this location.

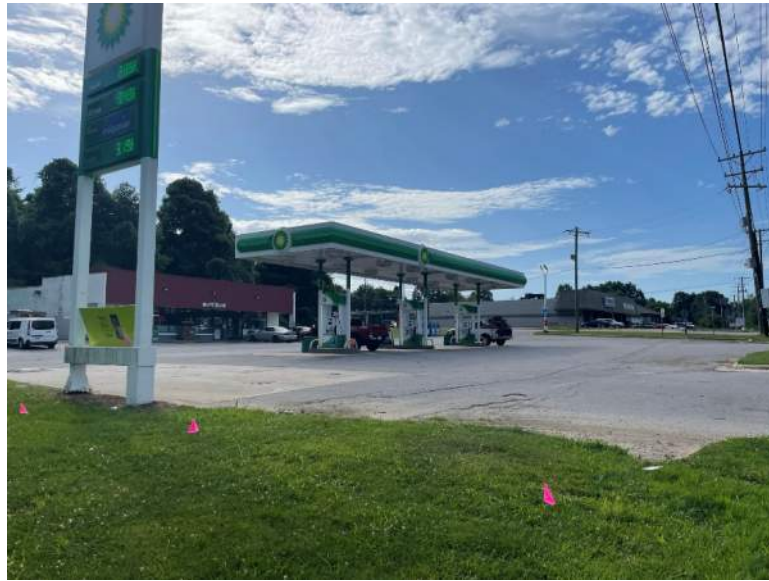
View facing southeast from the northwestern corner of the Project Study Area along US 421 northbound, towards a UST bed containing four USTs, fuel islands, and convenience store of the BP gas station that occupies the parcel.

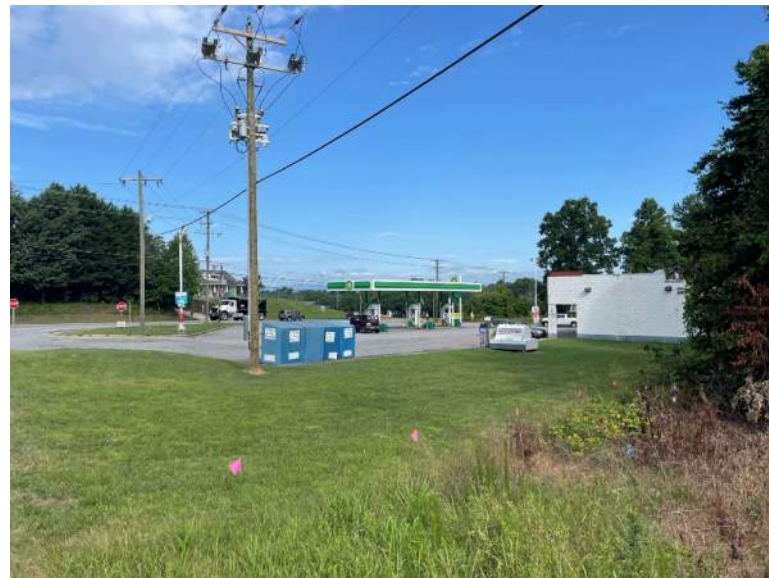
View facing northwest from the southeastern corner of the Project Study Area, facing power lines, water and sewer lines, and a decrepit kerosene tank.

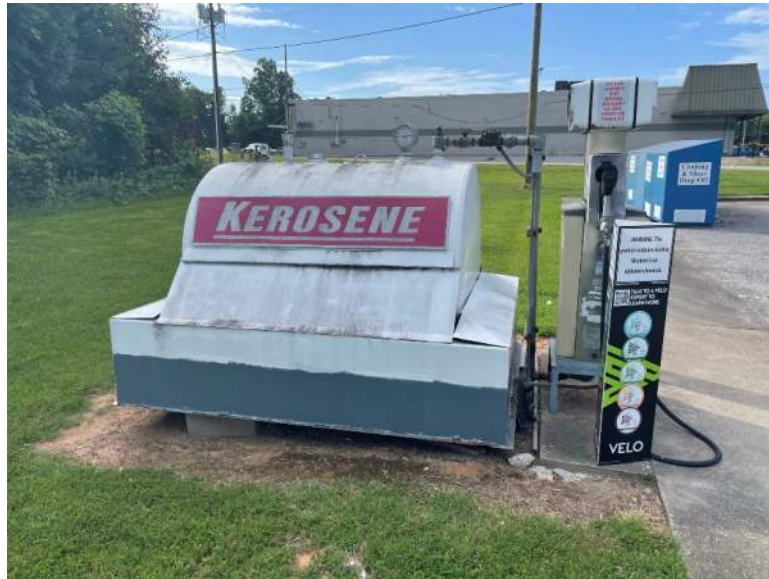
An approximately 500-gallon kerosene AST in the eastern area of the Project Study Area adjacent to the BP parking lot. Stressed vegetation and a slight petroleum odor were noted in the vicinity of the AST.

Based on results of this Preliminary Site Assessment, Kleinfelder recommends no additional sampling or special handling of soils be performed within the Project Study Area on Parcel 63 in North Wilkesboro, Wilkes County, North Carolina.

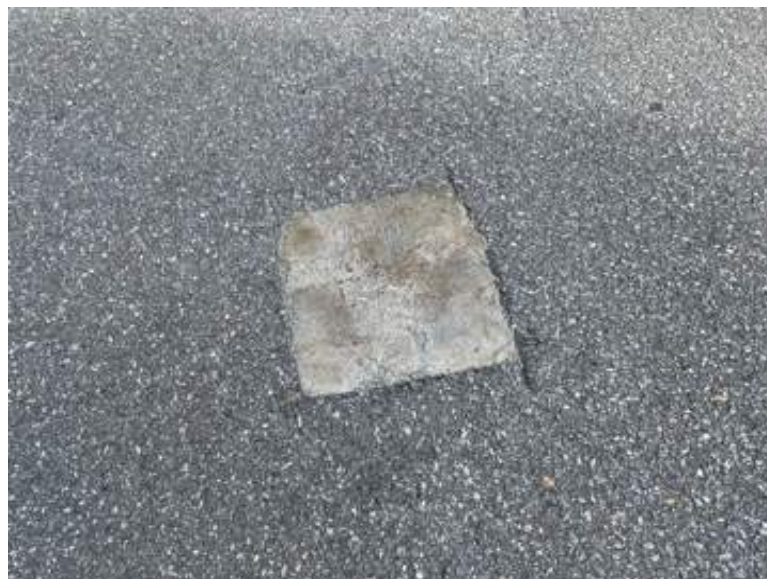
Likely closed groundwater monitoring well located in the northern area of the Project Study Area parking lot between the fuel islands and the UST bed.

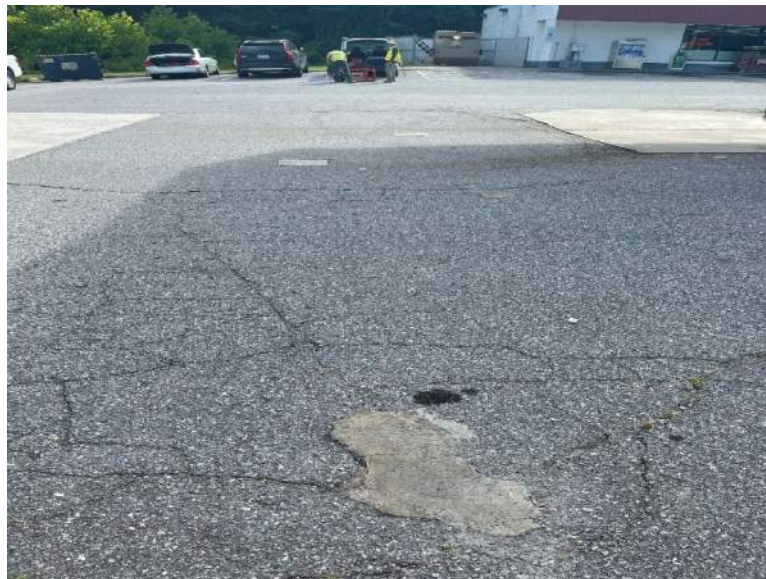
View facing east from the northwestern area of the Project Study Area between the UST bed and the fuel islands. Concrete fill purpose is unknown.

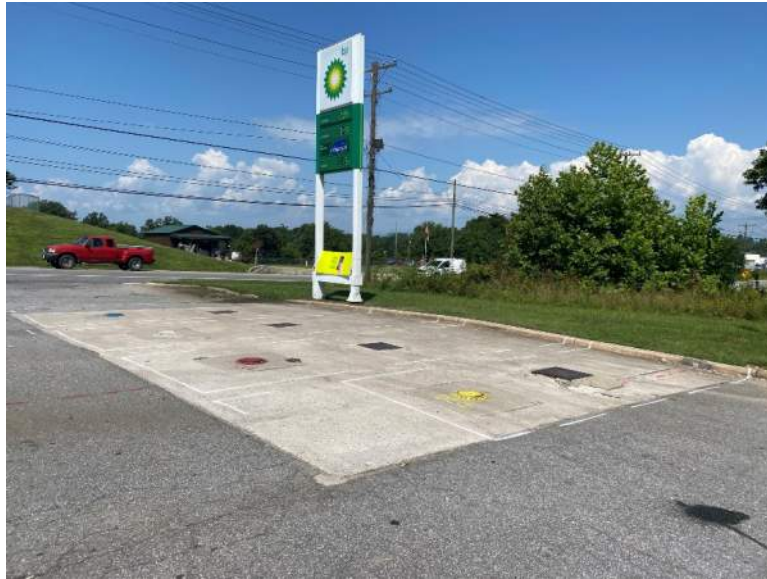
View facing northwest from the western portion of the Project Study Area, depicting four known USTs outlined with white spray paint.

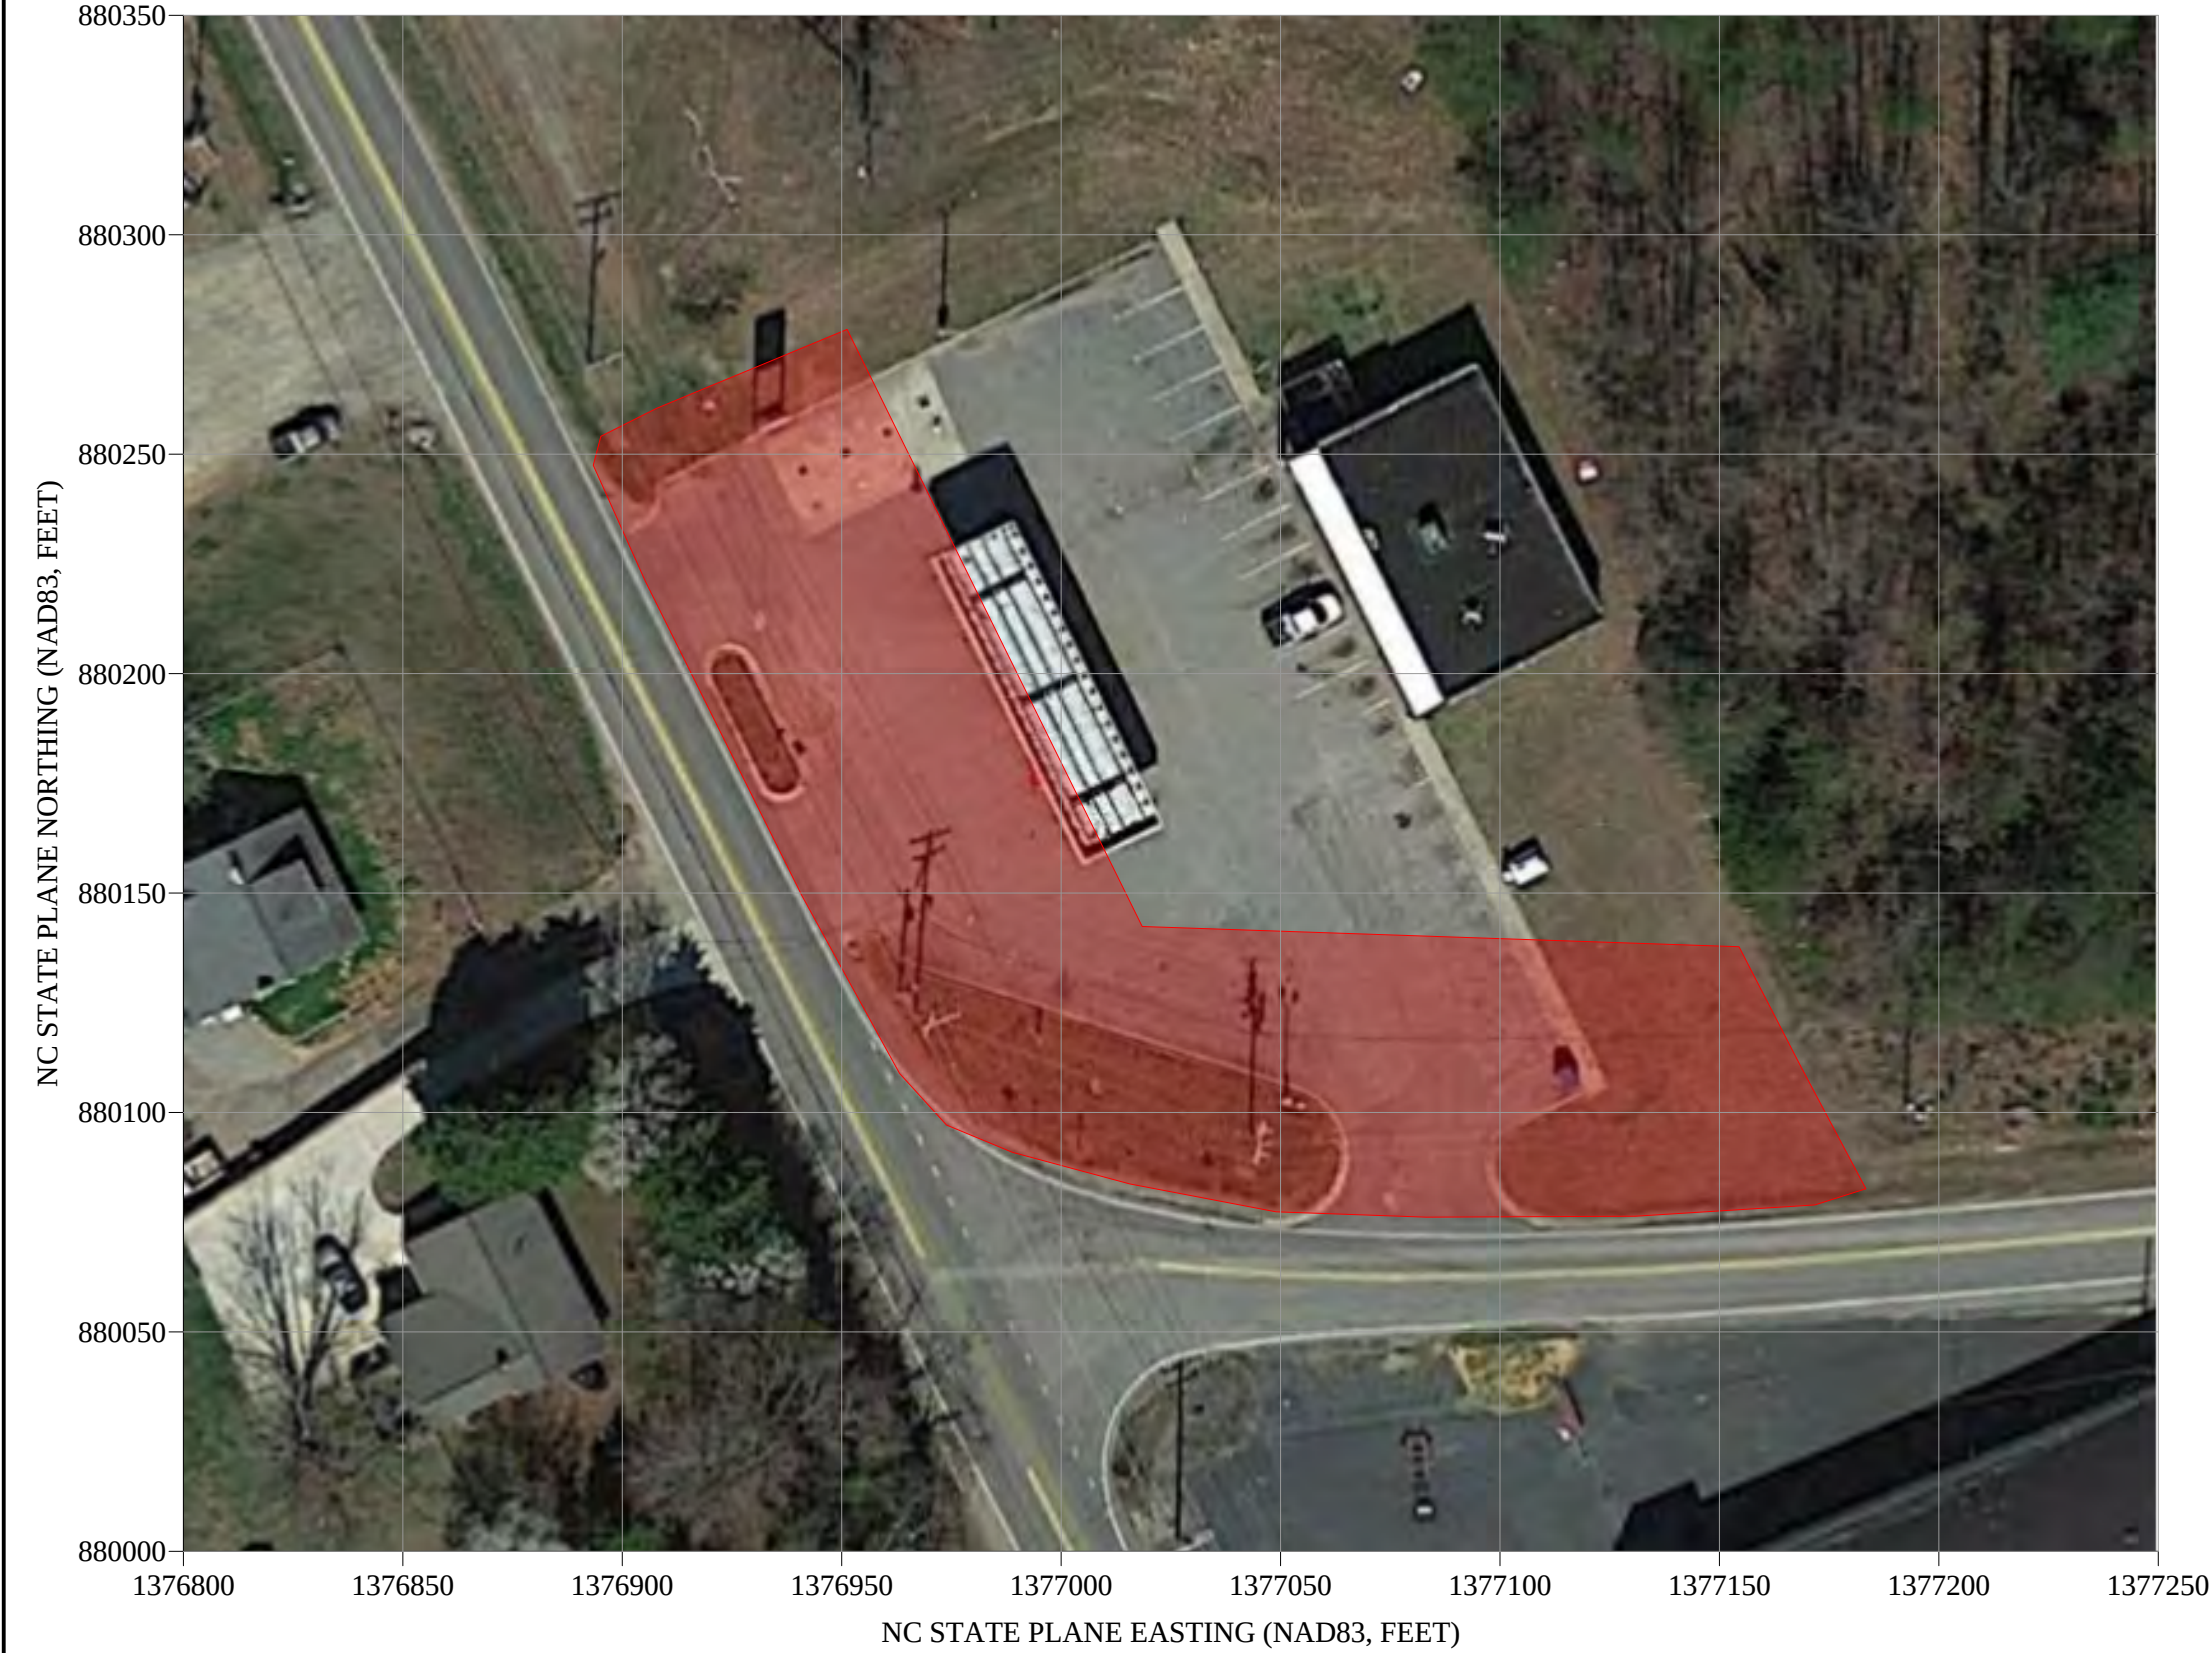
APPROXIMATE BOUNDARIES OF GEOPHYSICAL SURVEY AREA

The site consisted of an active gas station surrounded by asphalt, concrete, and grass surfaces. Four known USTs were observed in an active UST pit servicing the station pumps. An aerial photograph showing the survey area boundaries and ground-level photographs are shown in **Figure 1**.

**EVIDENCE OF FOUR KNOWN USTs WAS OBSERVED. NO EVIDENCE OF UNKNOWN METALLIC USTs WAS OBSERVED.**

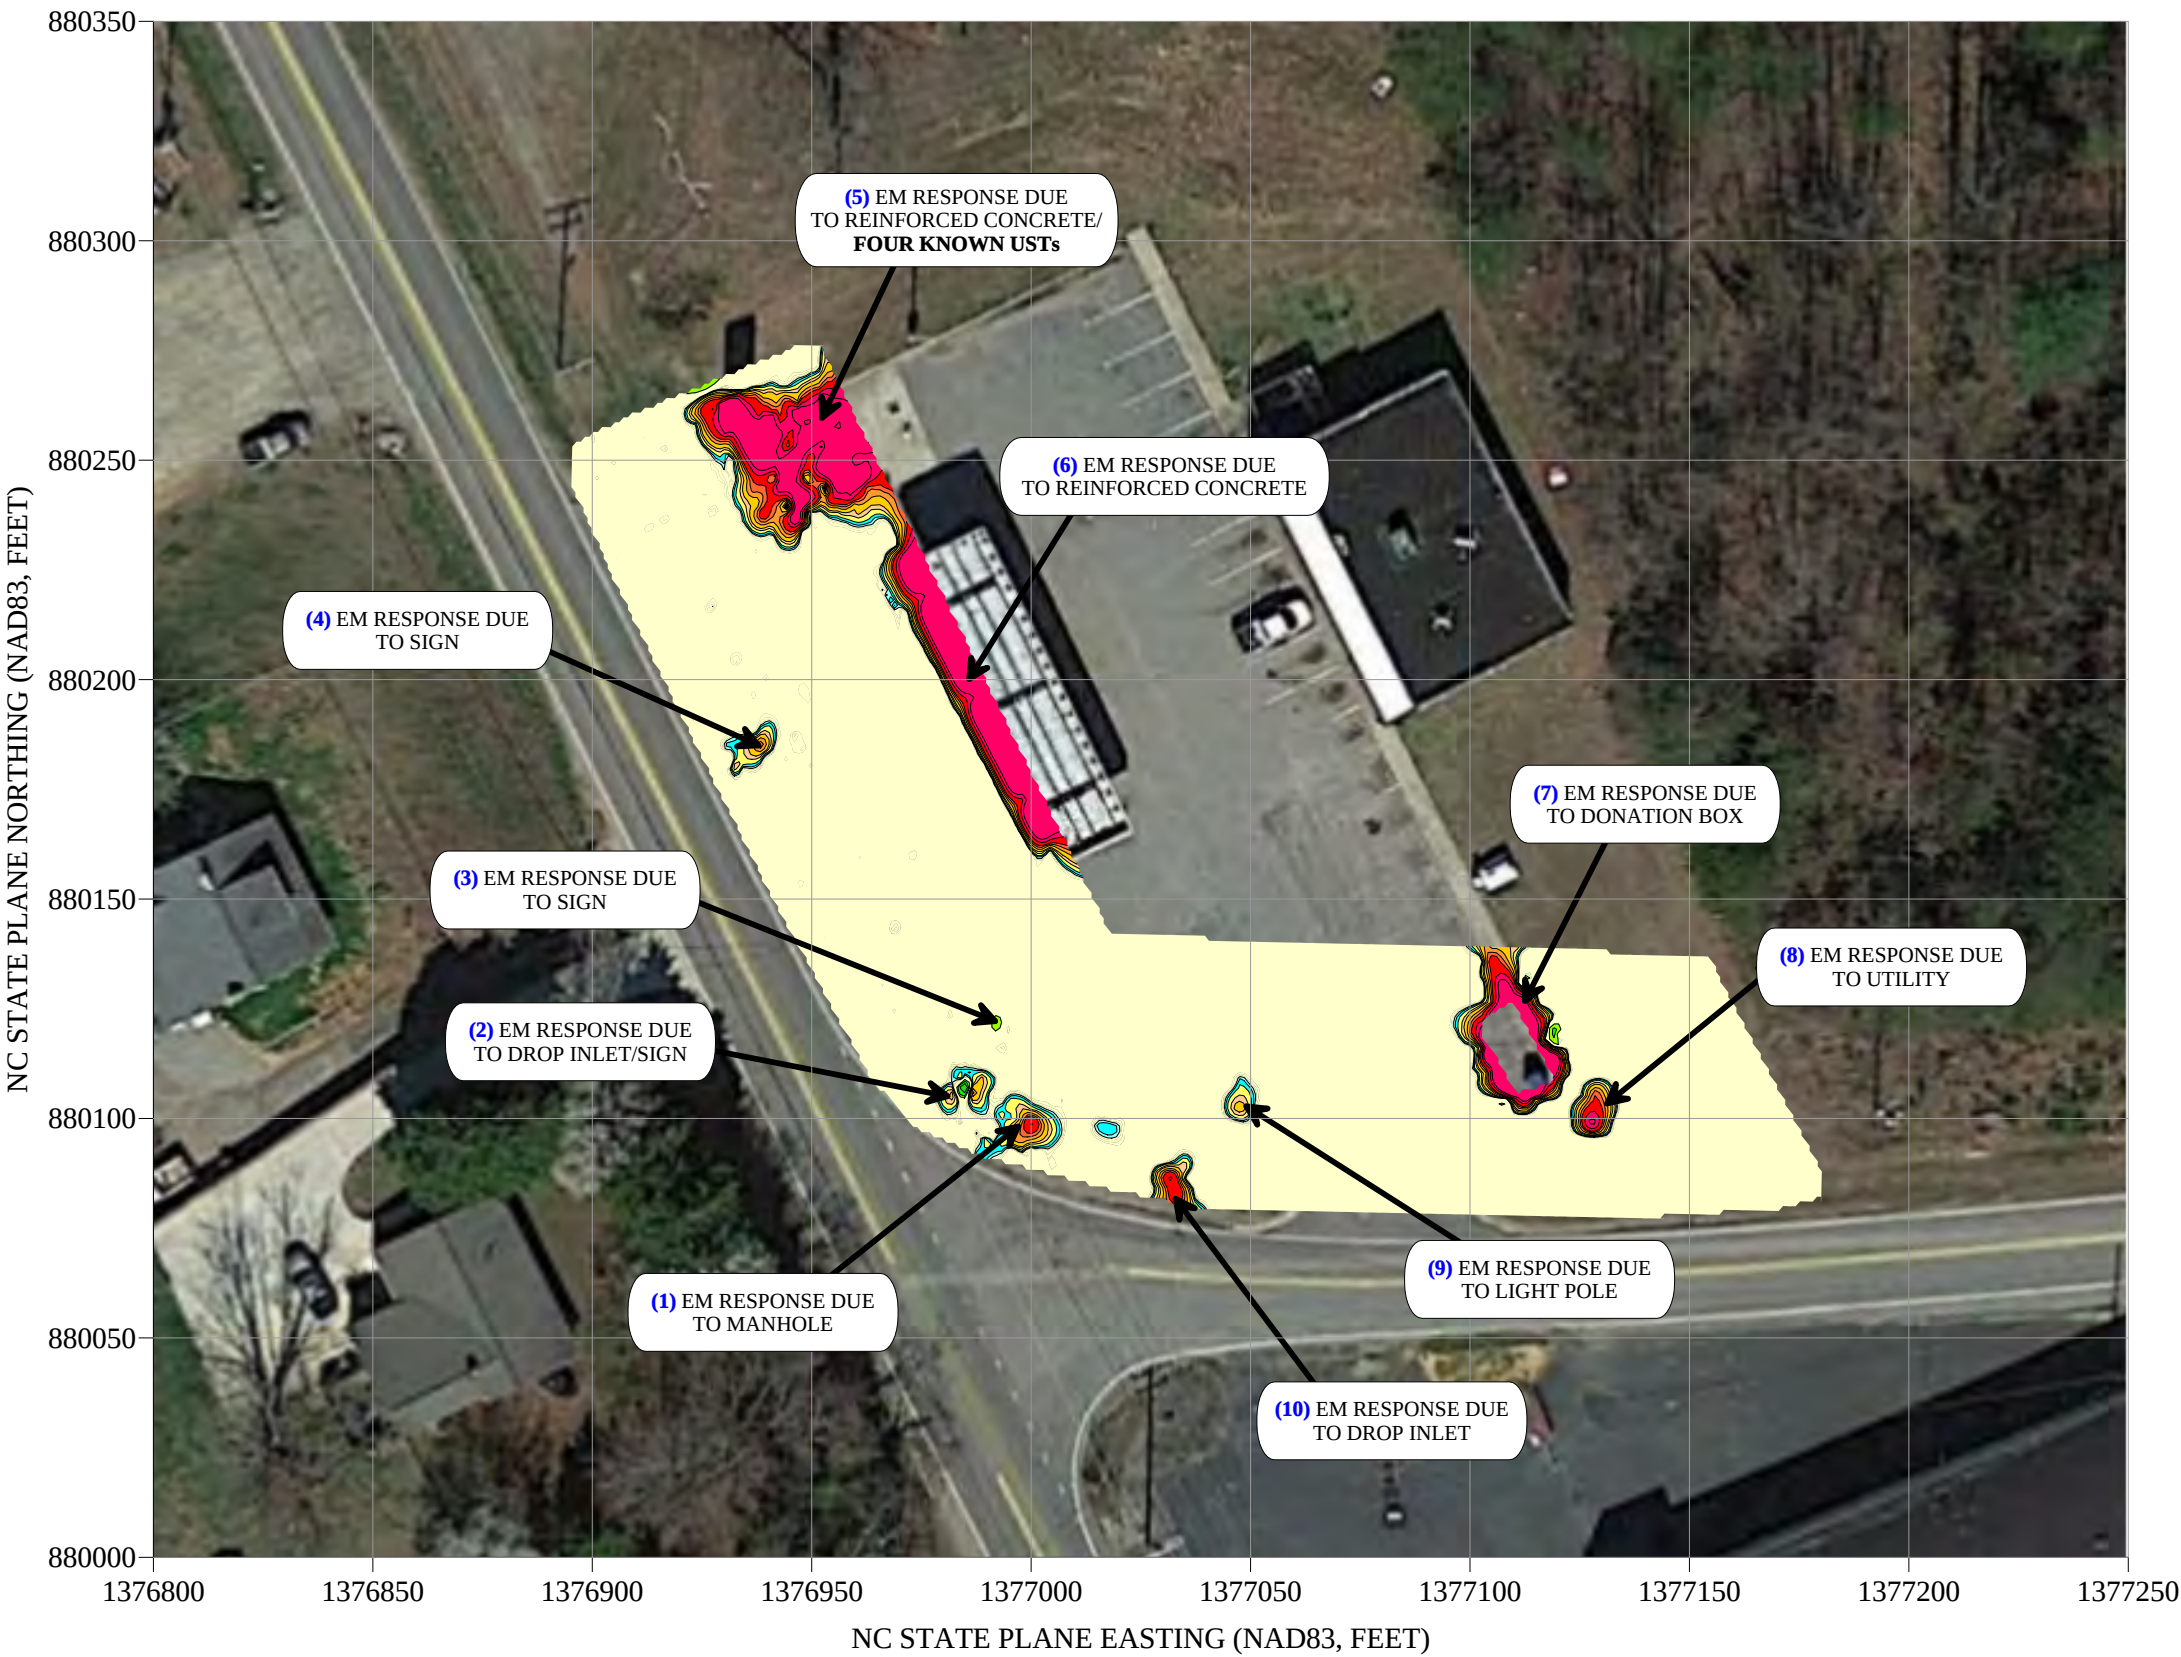
EM61 METAL DETECTION RESULTS

The contour plot shows the differential results of the EM61 instrument in millivolts (mV). The differential results focus on larger metallic objects such as USTs and drums. The EM data were collected on July 14, 2021, using a Geonics EM61-MK2 instrument. Verification GPR data were collected using a GSSI SIR 4000 instrument with a 350 MHz HS antenna on July 16, 2021.

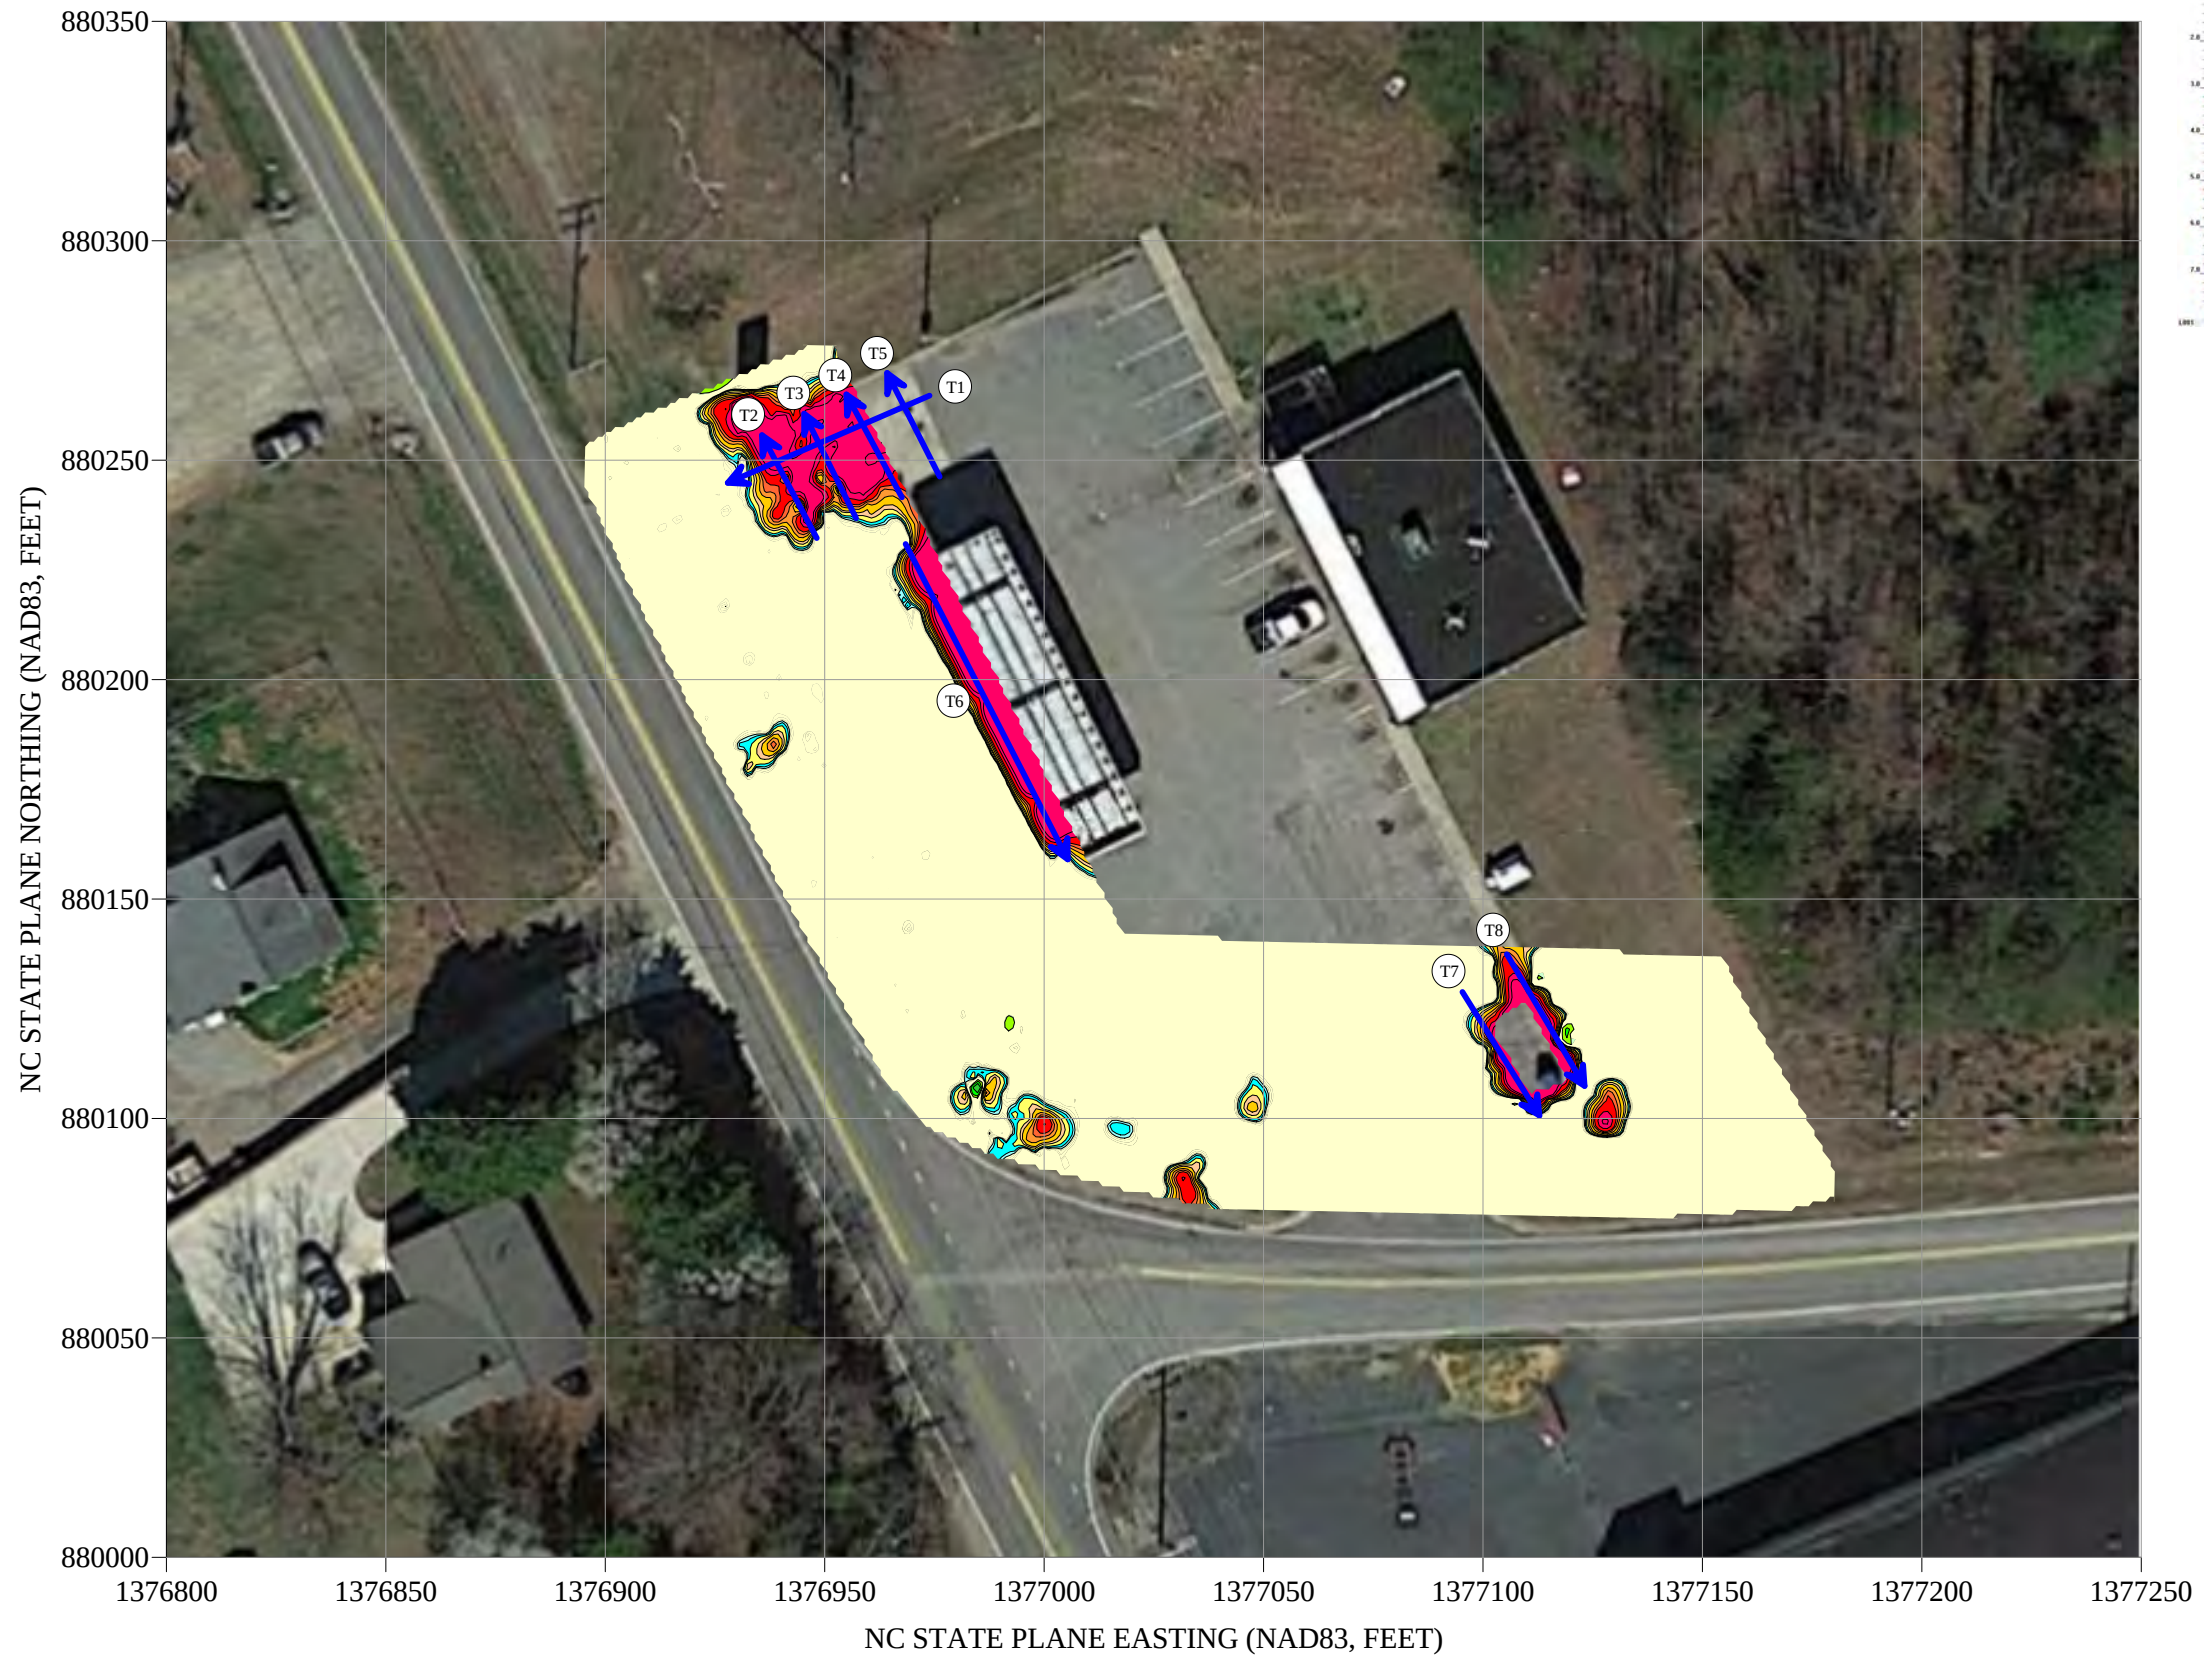
**FIGURE 2**

of the four known USTs, overlain on an aerial, along with ground-level photographs. Transects 1-6 confirmed the presence of reinforcement within the concrete. Transects 6-8 showed no evidence of significant structures such as USTs. Evidence of utilities and/or smaller fragments of buried debris was also observed.

GPR TRANSECT LOCATIONS

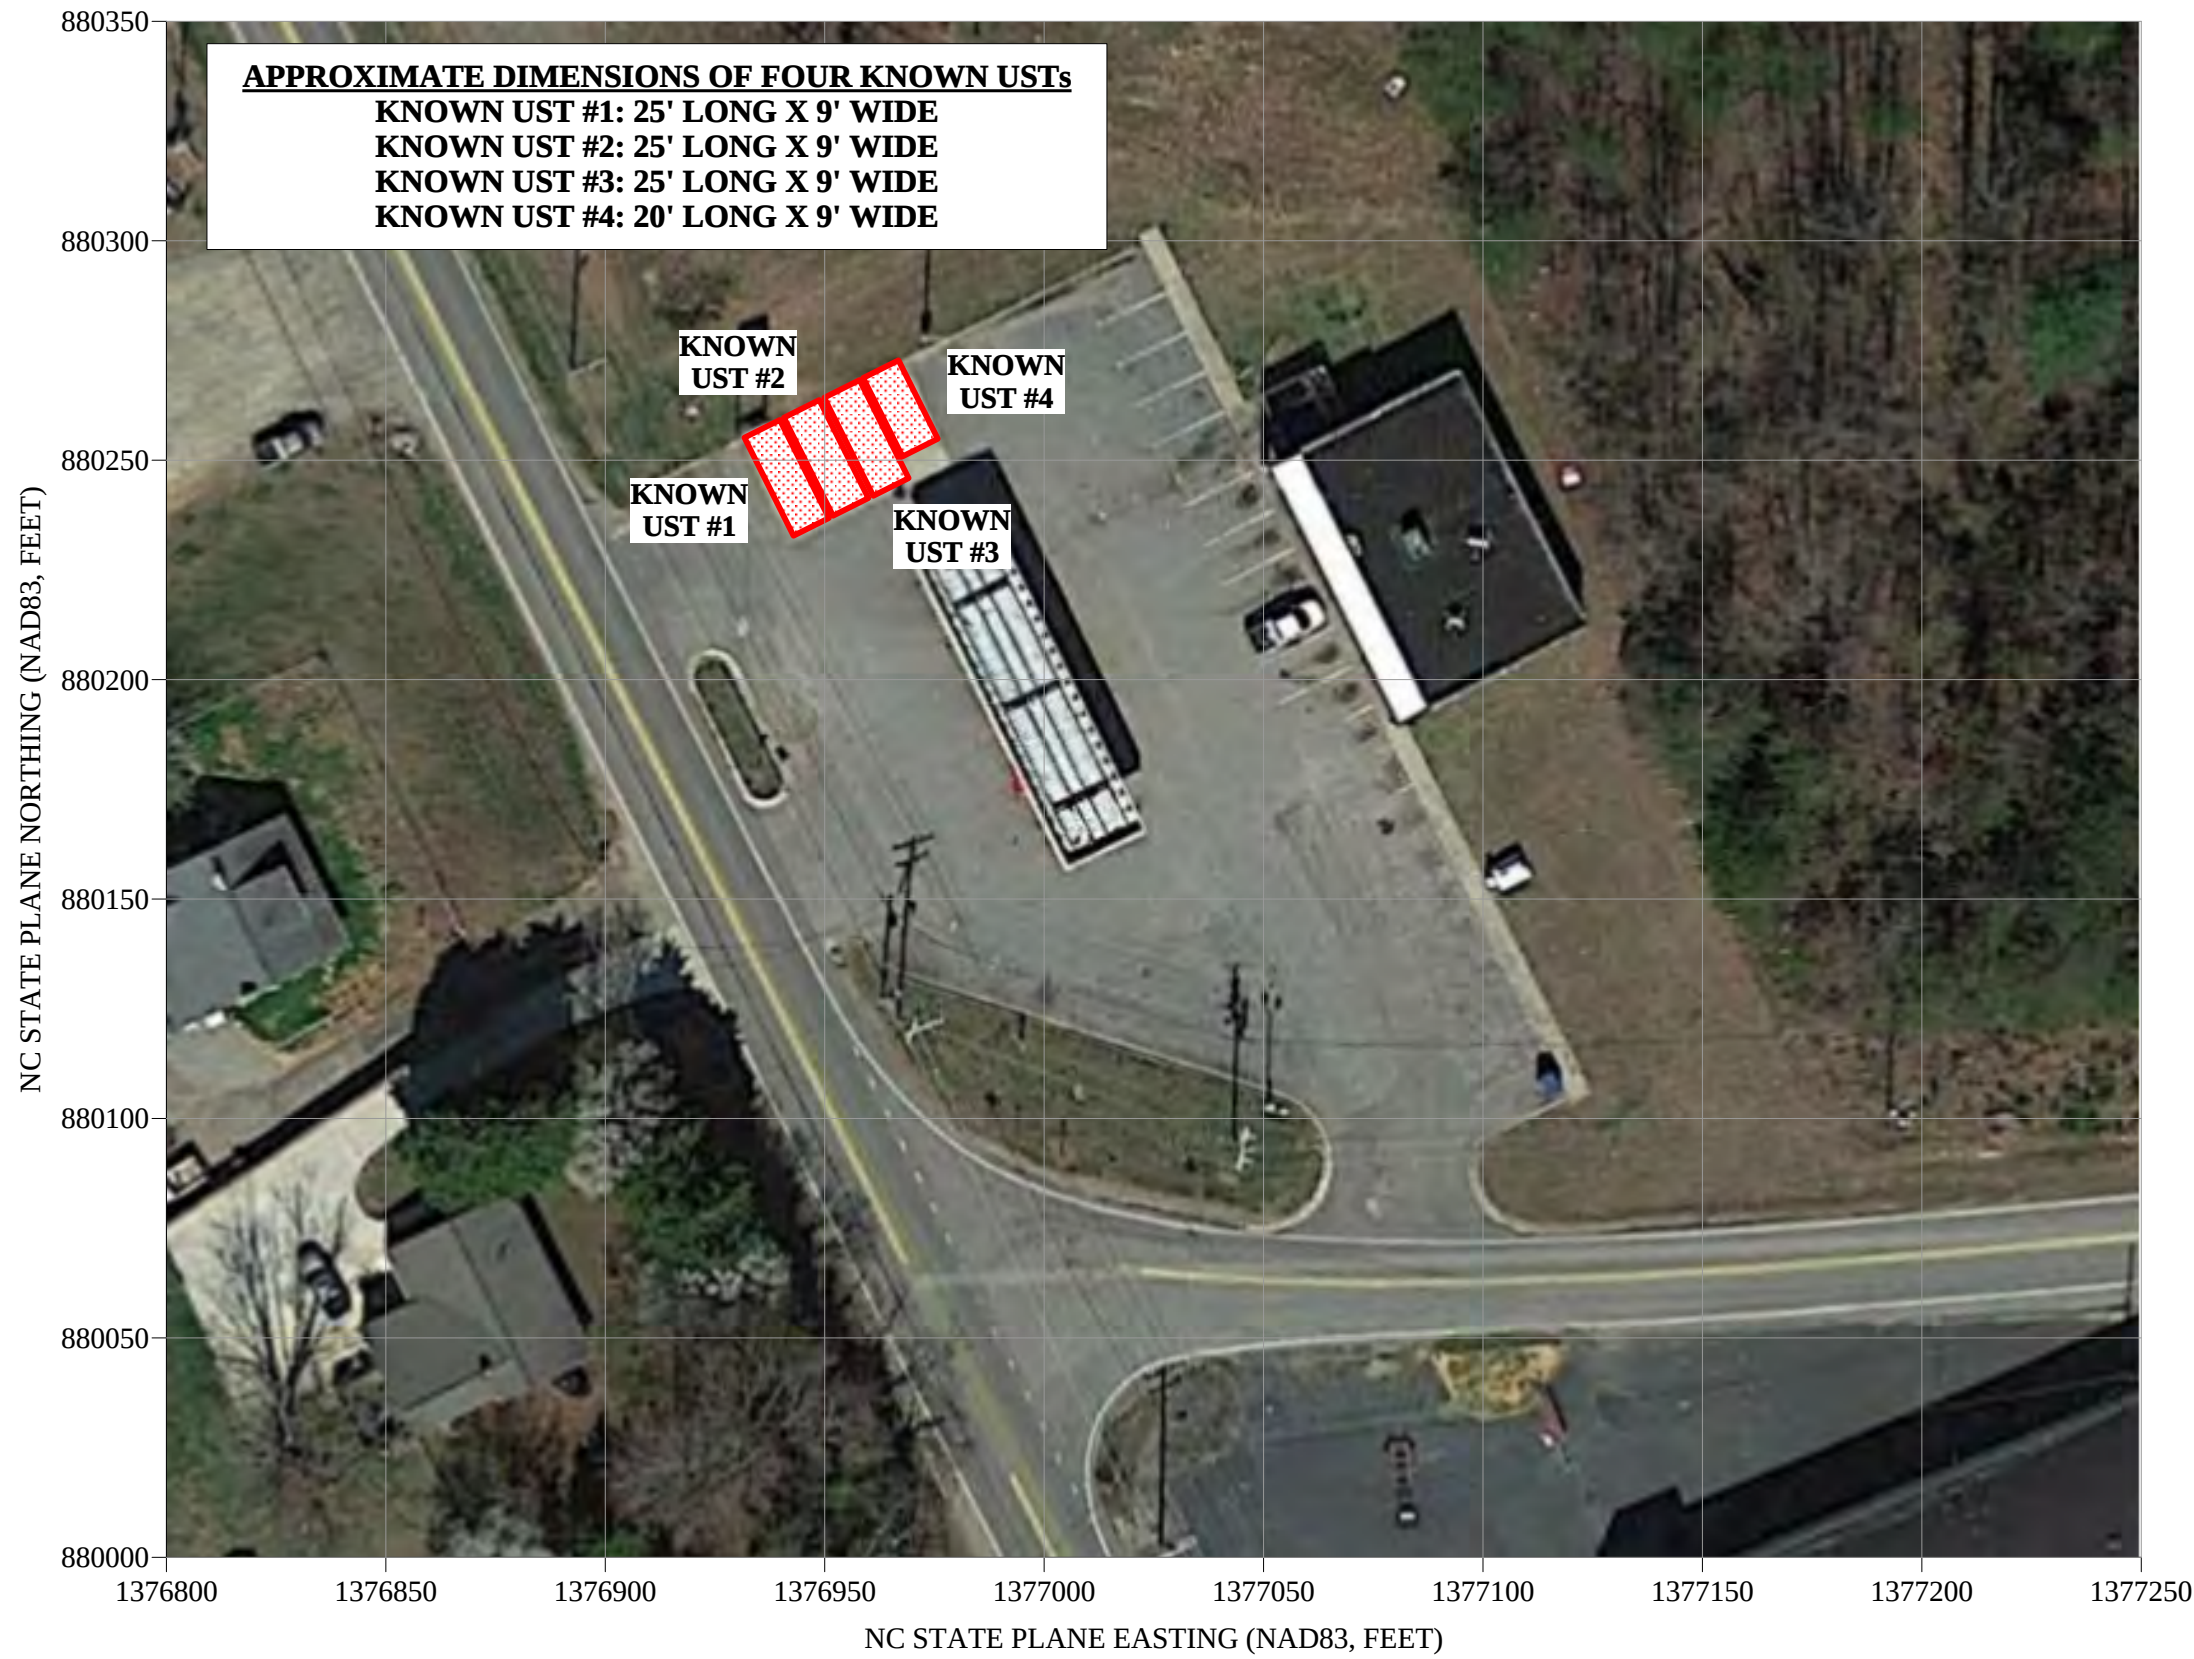
LOCATIONS OF FOUR KNOWN USTs

Four known USTs were observed in the northern portion of the parking lot. Known USTs #1-3 are all approximately 25 feet long by 9 feet wide. Known UST #4 is approximately 20 feet long by 9 feet wide. Collectively, the geophysical data recorded evidence of four known metallic USTs at Parcel 63. No evidence of any unknown USTs was observed.

View of Four Known USTs  
(Facing Approximately North)
