## **Phase II Site Assessment Report**

**August 16, 2021**  
**WBS Element: 44691.1.1**  
**State Project: R-5759**  
**Wilkes County**

**Parcel #060**  
**James D. & Shirley A. Johnson Et Al. Property**  
**2065 Statesville Road, North Wilkesboro, NC 28659**  
**PIN #: 3877-79-6463**  
**Facility ID No.: N/A**  
**Groundwater Incident No.: N/A**

**NCDOT WBS ELEMENT 44691.1.1  
STATE PROJECT R-5759  
PROPOSED WIDENING OF NC 115 FROM US 421 TO 2<sup>ND</sup>  
STREET IN WILKESBORO AND NORTH WILKESBORO**

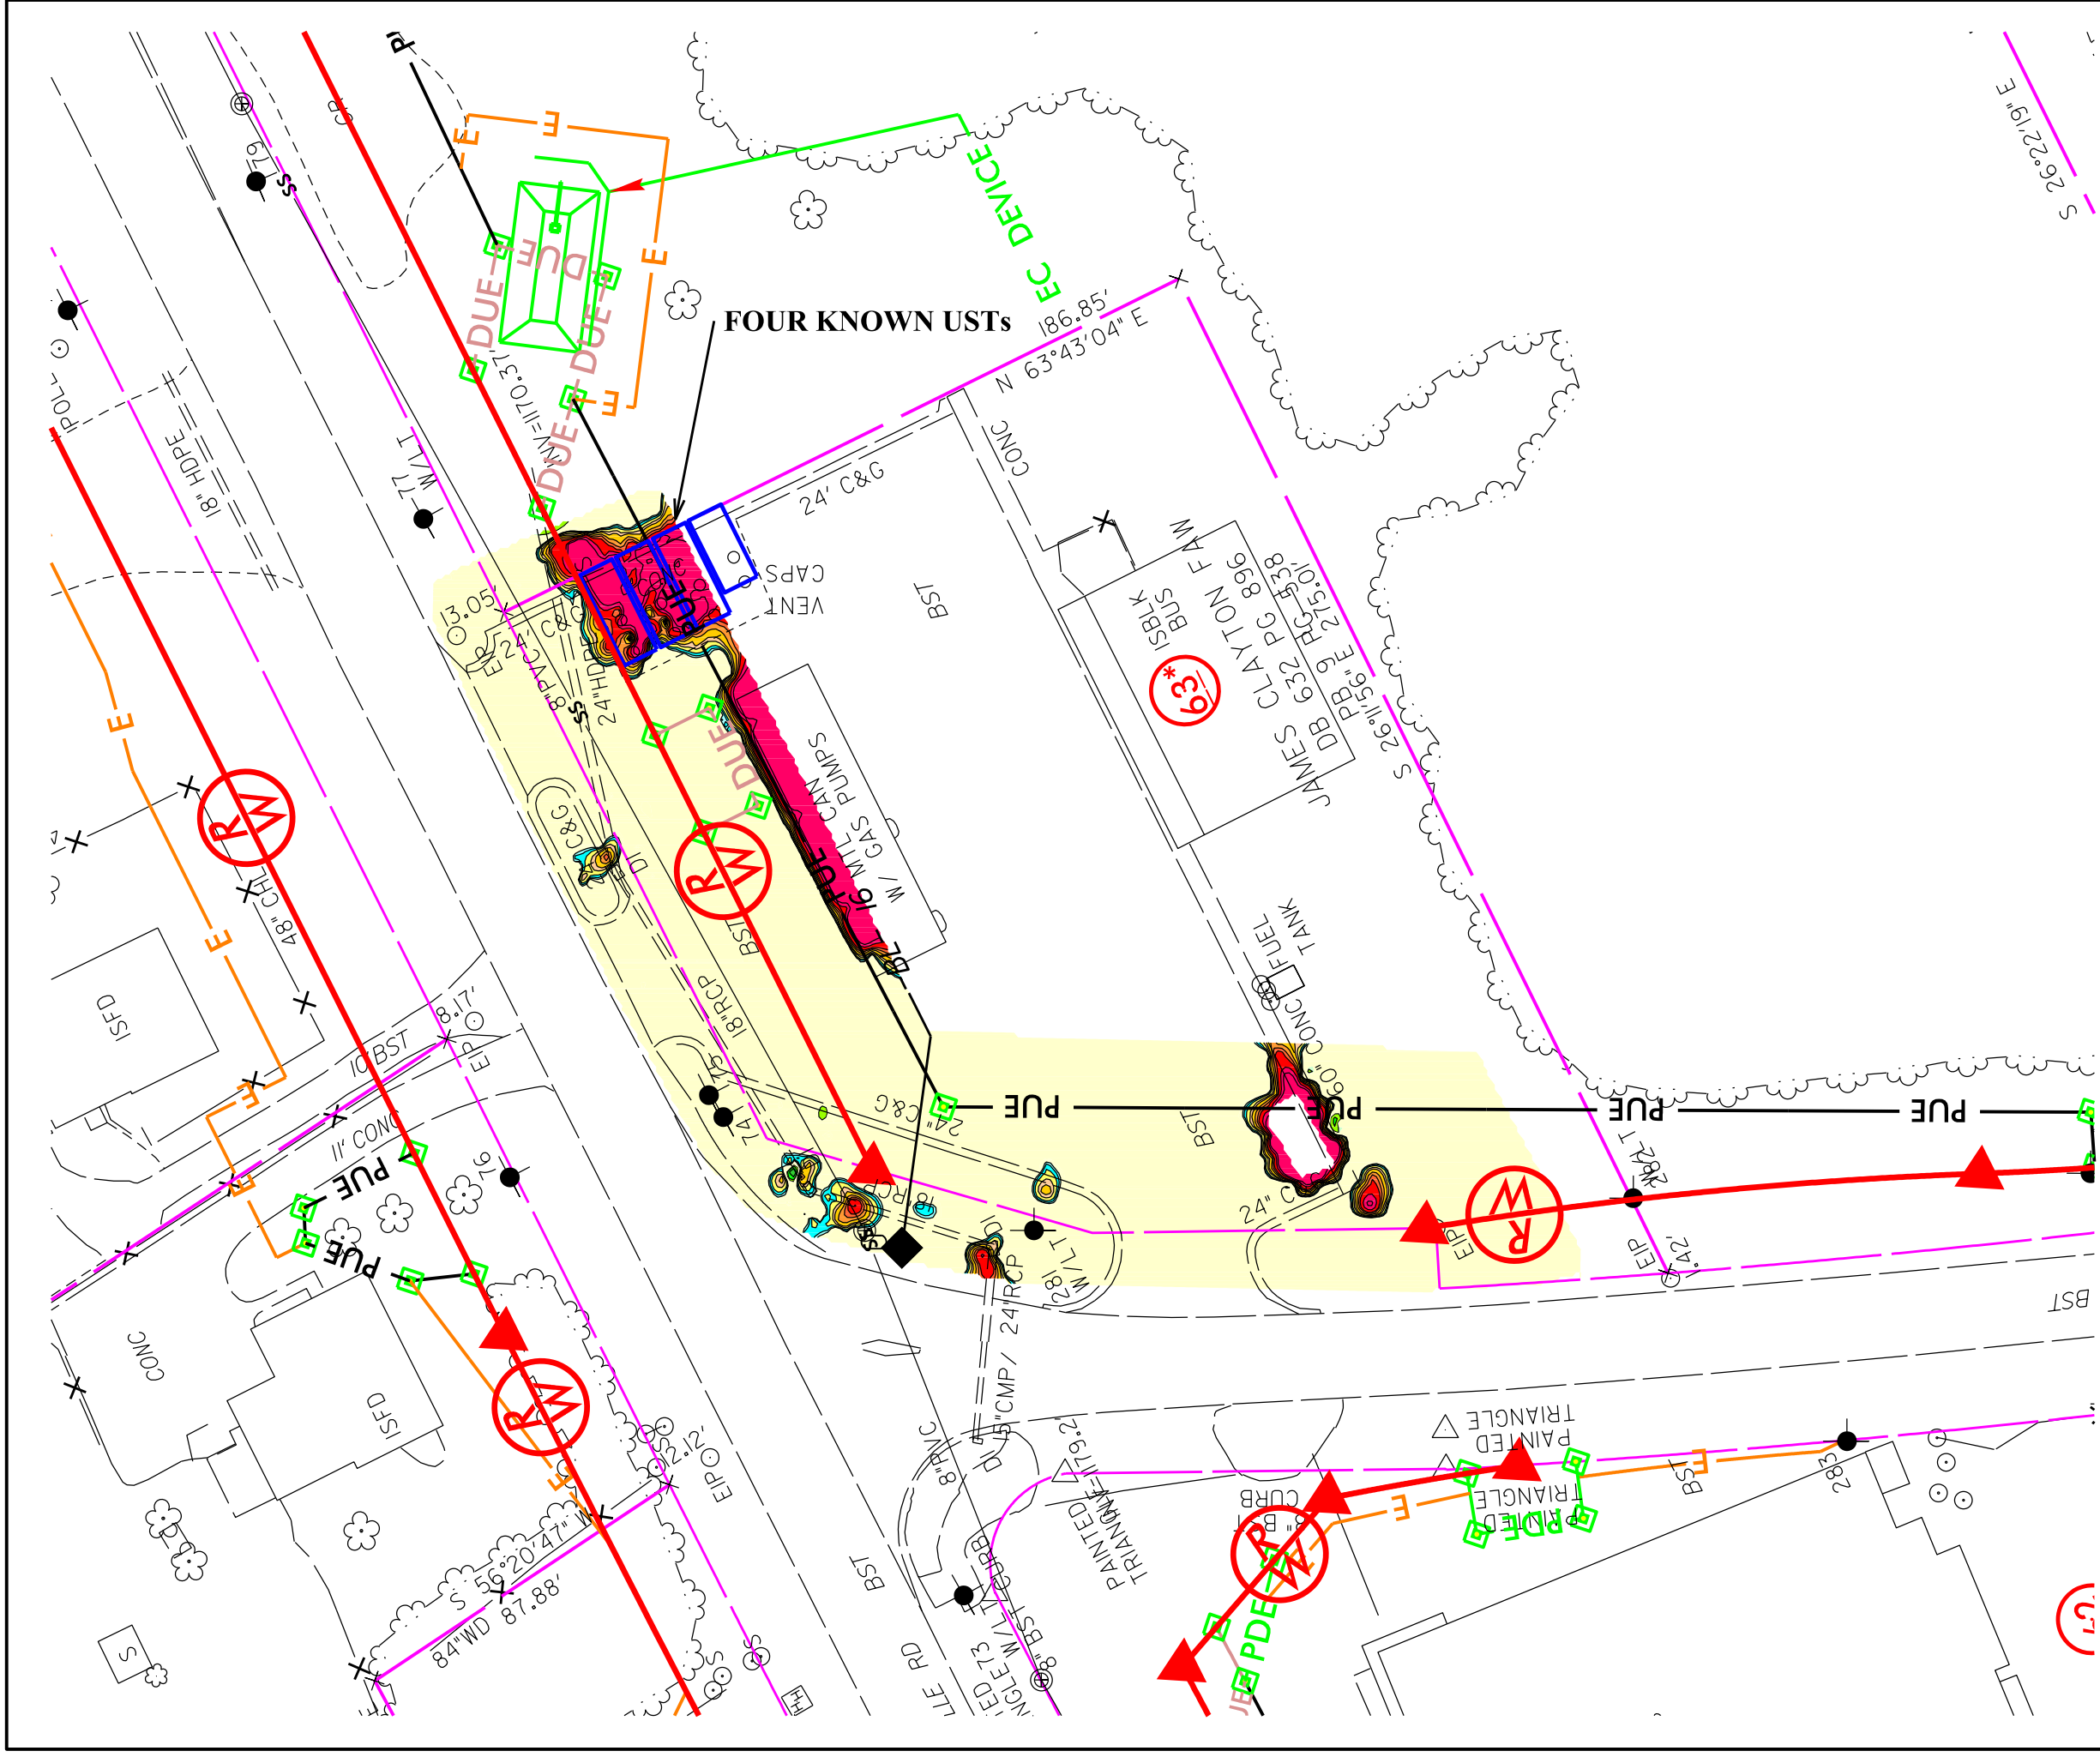
Collectively, the geophysical data recorded no evidence of unknown metallic USTs at Parcel 63. Four known USTs were observed in the northern portion of the parking lot. **Figure 5** provides an overlay of the metal detection results and four known USTs on the NCDOT engineering plans for reference.

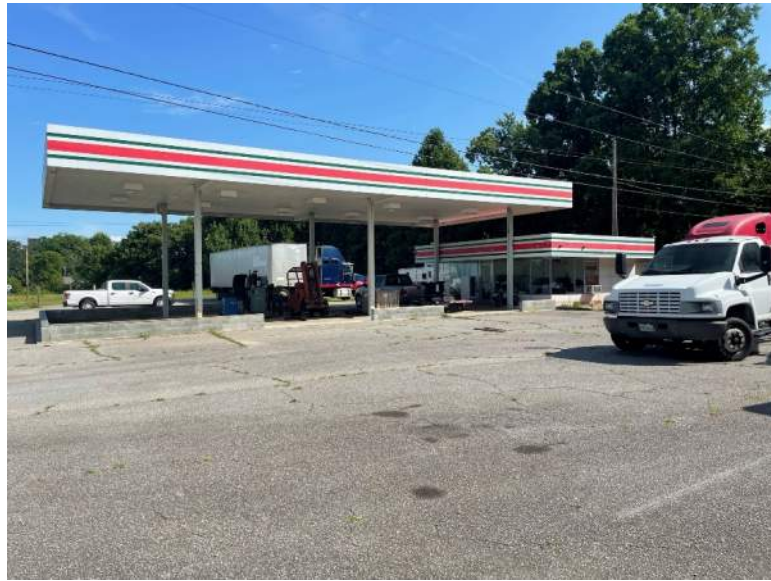
View facing north from the southwestern corner of the Project Study Area displaying inactive fuel islands and an inactive convenience store.

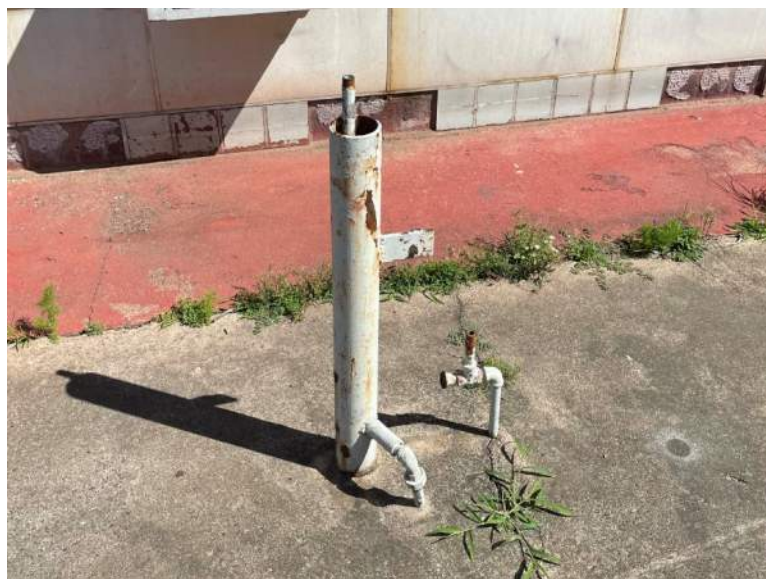
Inactive product pipe located along the southern side of the convenience store structure.

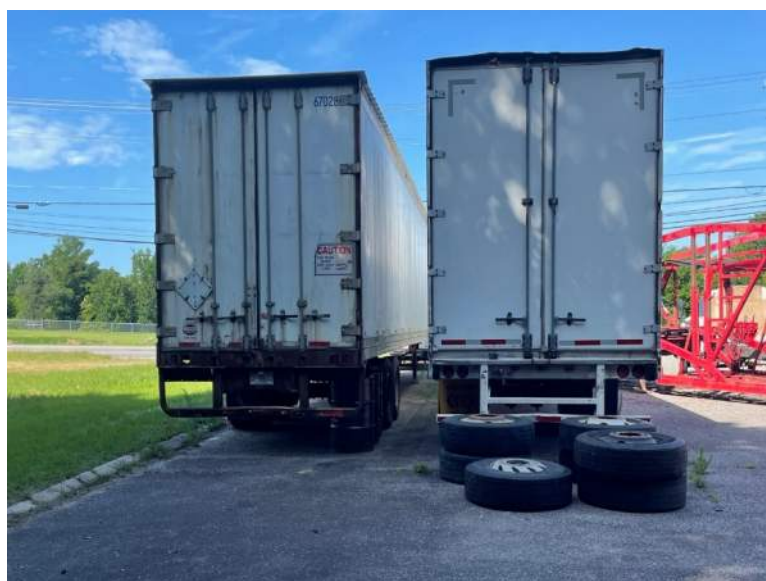
View facing west from the eastern boundary of the Project Study Area displaying parked commercial vehicles which prevented geophysical analysis within the area.

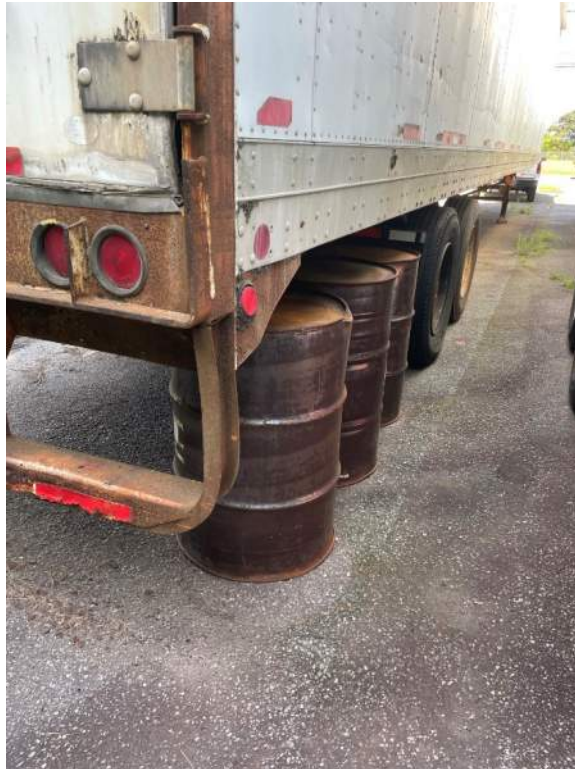
Three large steel drums with unknown contents stored underneath a parked commercial vehicle in the southern portion of the Project Study Area.

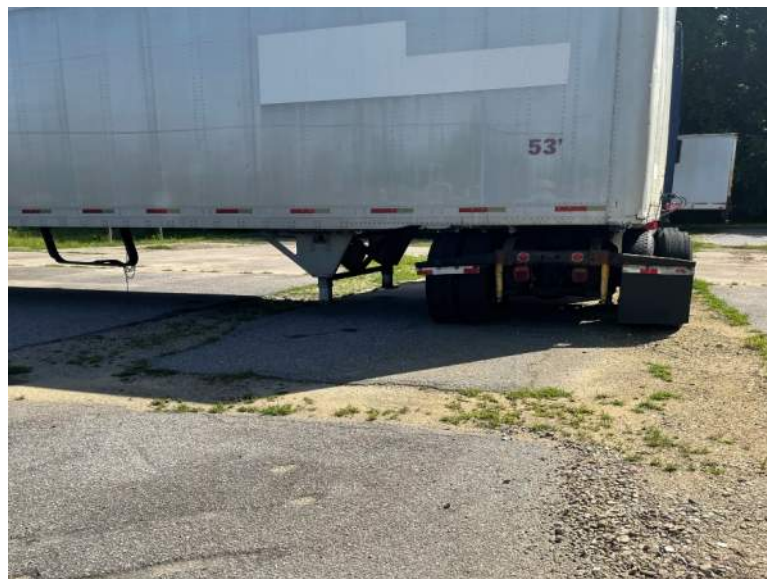
View facing southeast from the southern end of the fuel canopy displaying parked commercial vehicles which prevented geophysical analysis within the area.

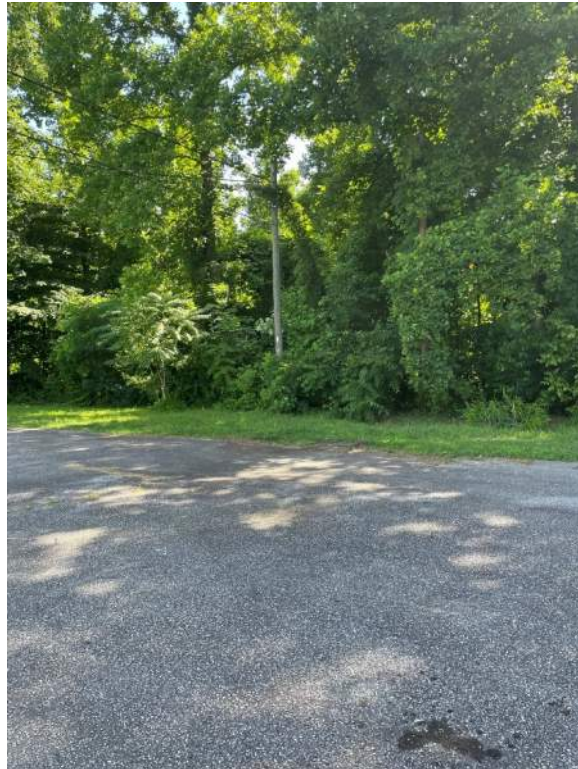
View facing east towards the eastern boundary of the Project Study Area, with some petroleum surface staining on the asphalt.

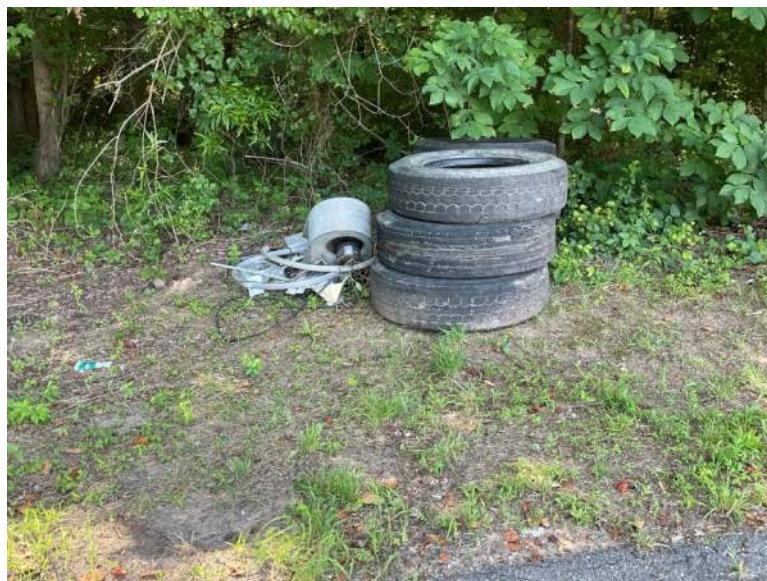
Discarded tires and automotive debris located in the eastern portion of the Project Study Area.

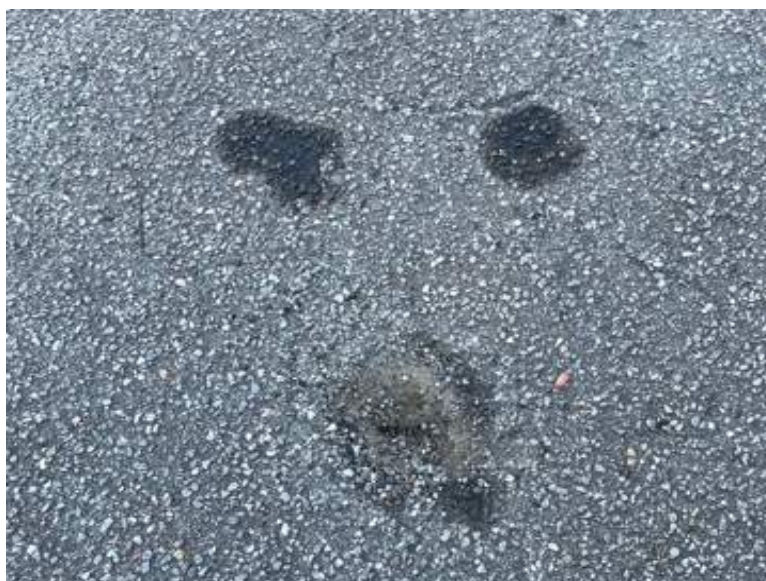
Petroleum surface staining in the eastern portion of the Project Study Area.

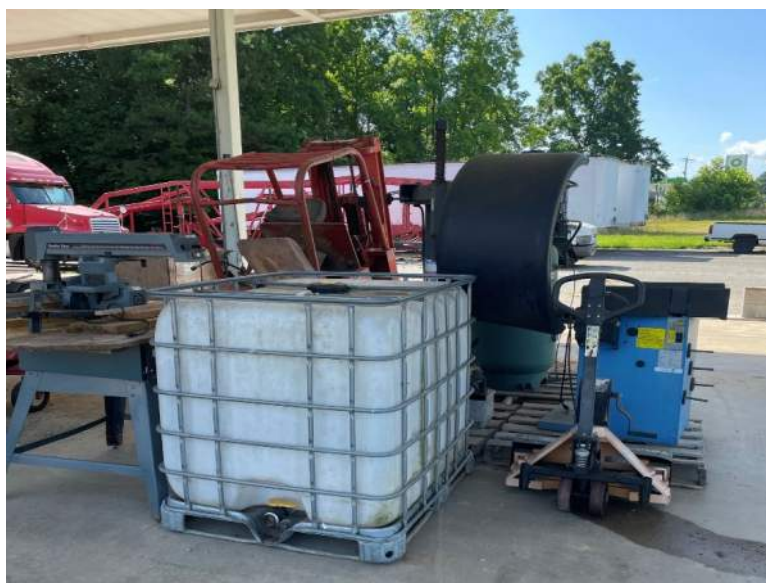
Stored equipment underneath the former fuel canopy with petroleum surface contamination.

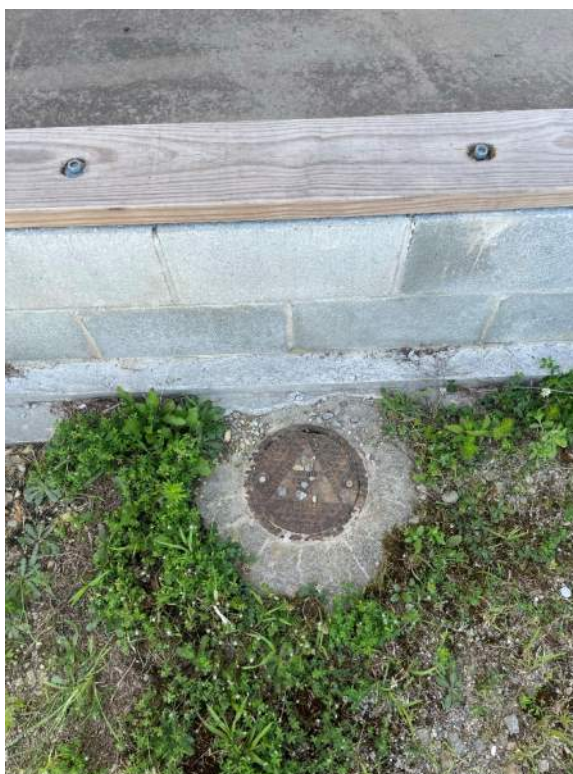
A groundwater monitoring well located outside of the northern edge of the concrete wall that bounds the area under the former fuel canopy, in the northern portion of the Project Study Area. *Original in Color*

One (1) active groundwater monitoring well was observed on Parcel 65 at the time of site exploration on Monday, August 2 and Tuesday, August 3, 2021. The groundwater monitoring well was located outside of the northern edge of the concrete wall that bounds the area underneath the former fuel canopy, in the northern portion of the Project Study Area, and is depicted on Figure 2.

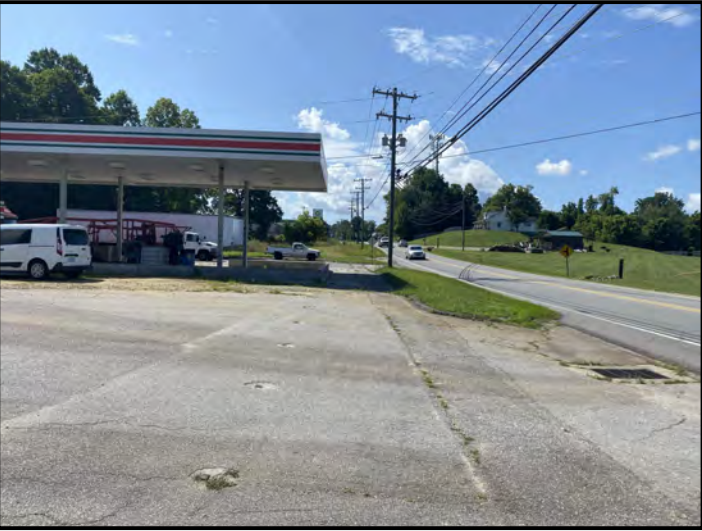
View of Survey Area (Facing Approximately South)

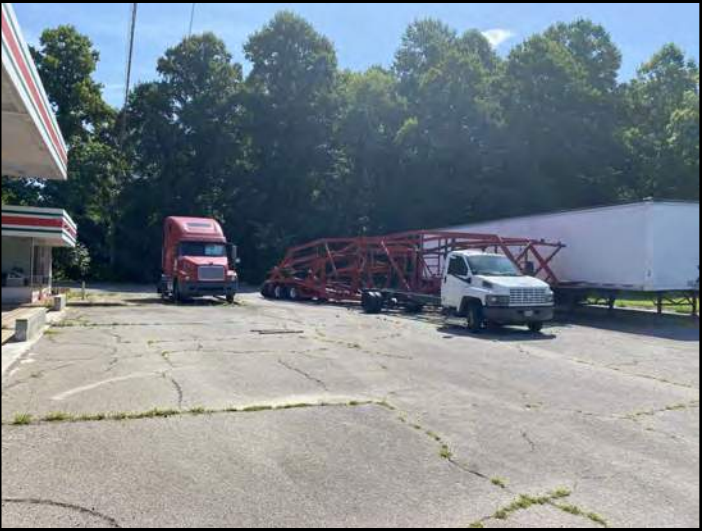
View of Survey Area (Facing Approximately East)

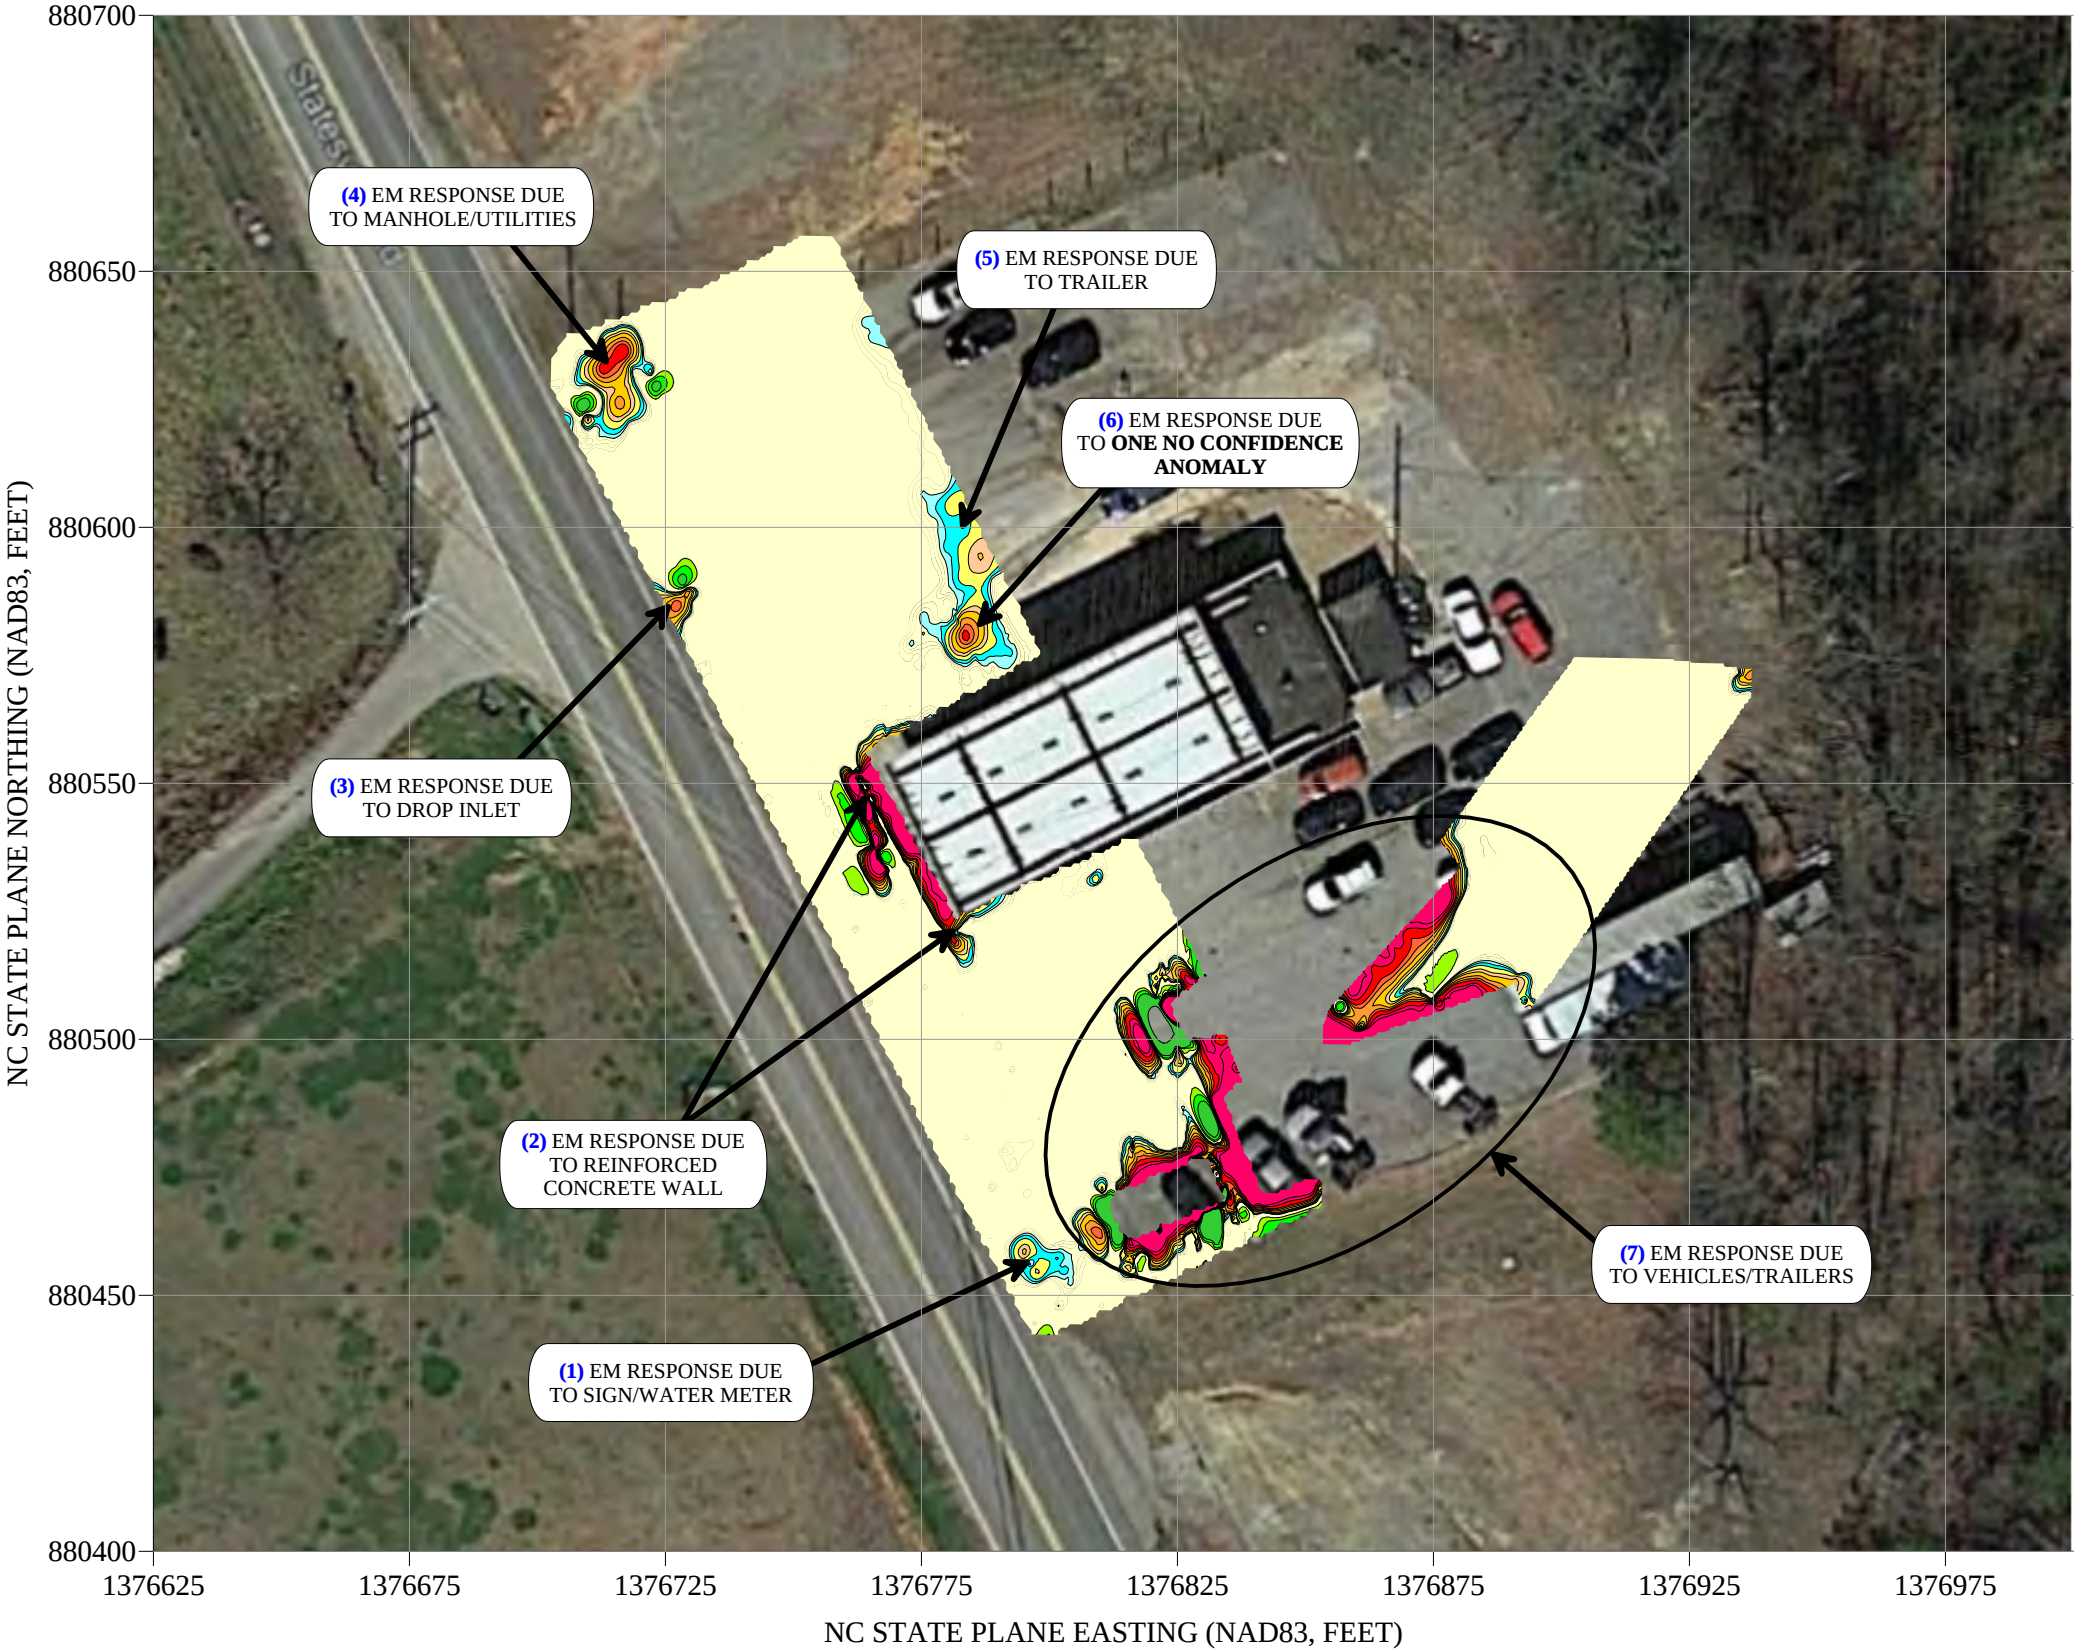
EM61 METAL DETECTION RESULTS

EVIDENCE OF ONE NO CONFIDENCE ANOMALY WAS OBSERVED.

The contour plot shows the differential results of the EM61 instrument in millivolts (mV). The differential results focus on larger metallic objects such as USTs and drums. The EM data were collected on July 14-15, 2021, using a Geonics EM61-MK2 instrument. Verification GPR data were collected using a GSSI SIR 4000 instrument with a 350 MHz HS antenna on July 16, 2021.

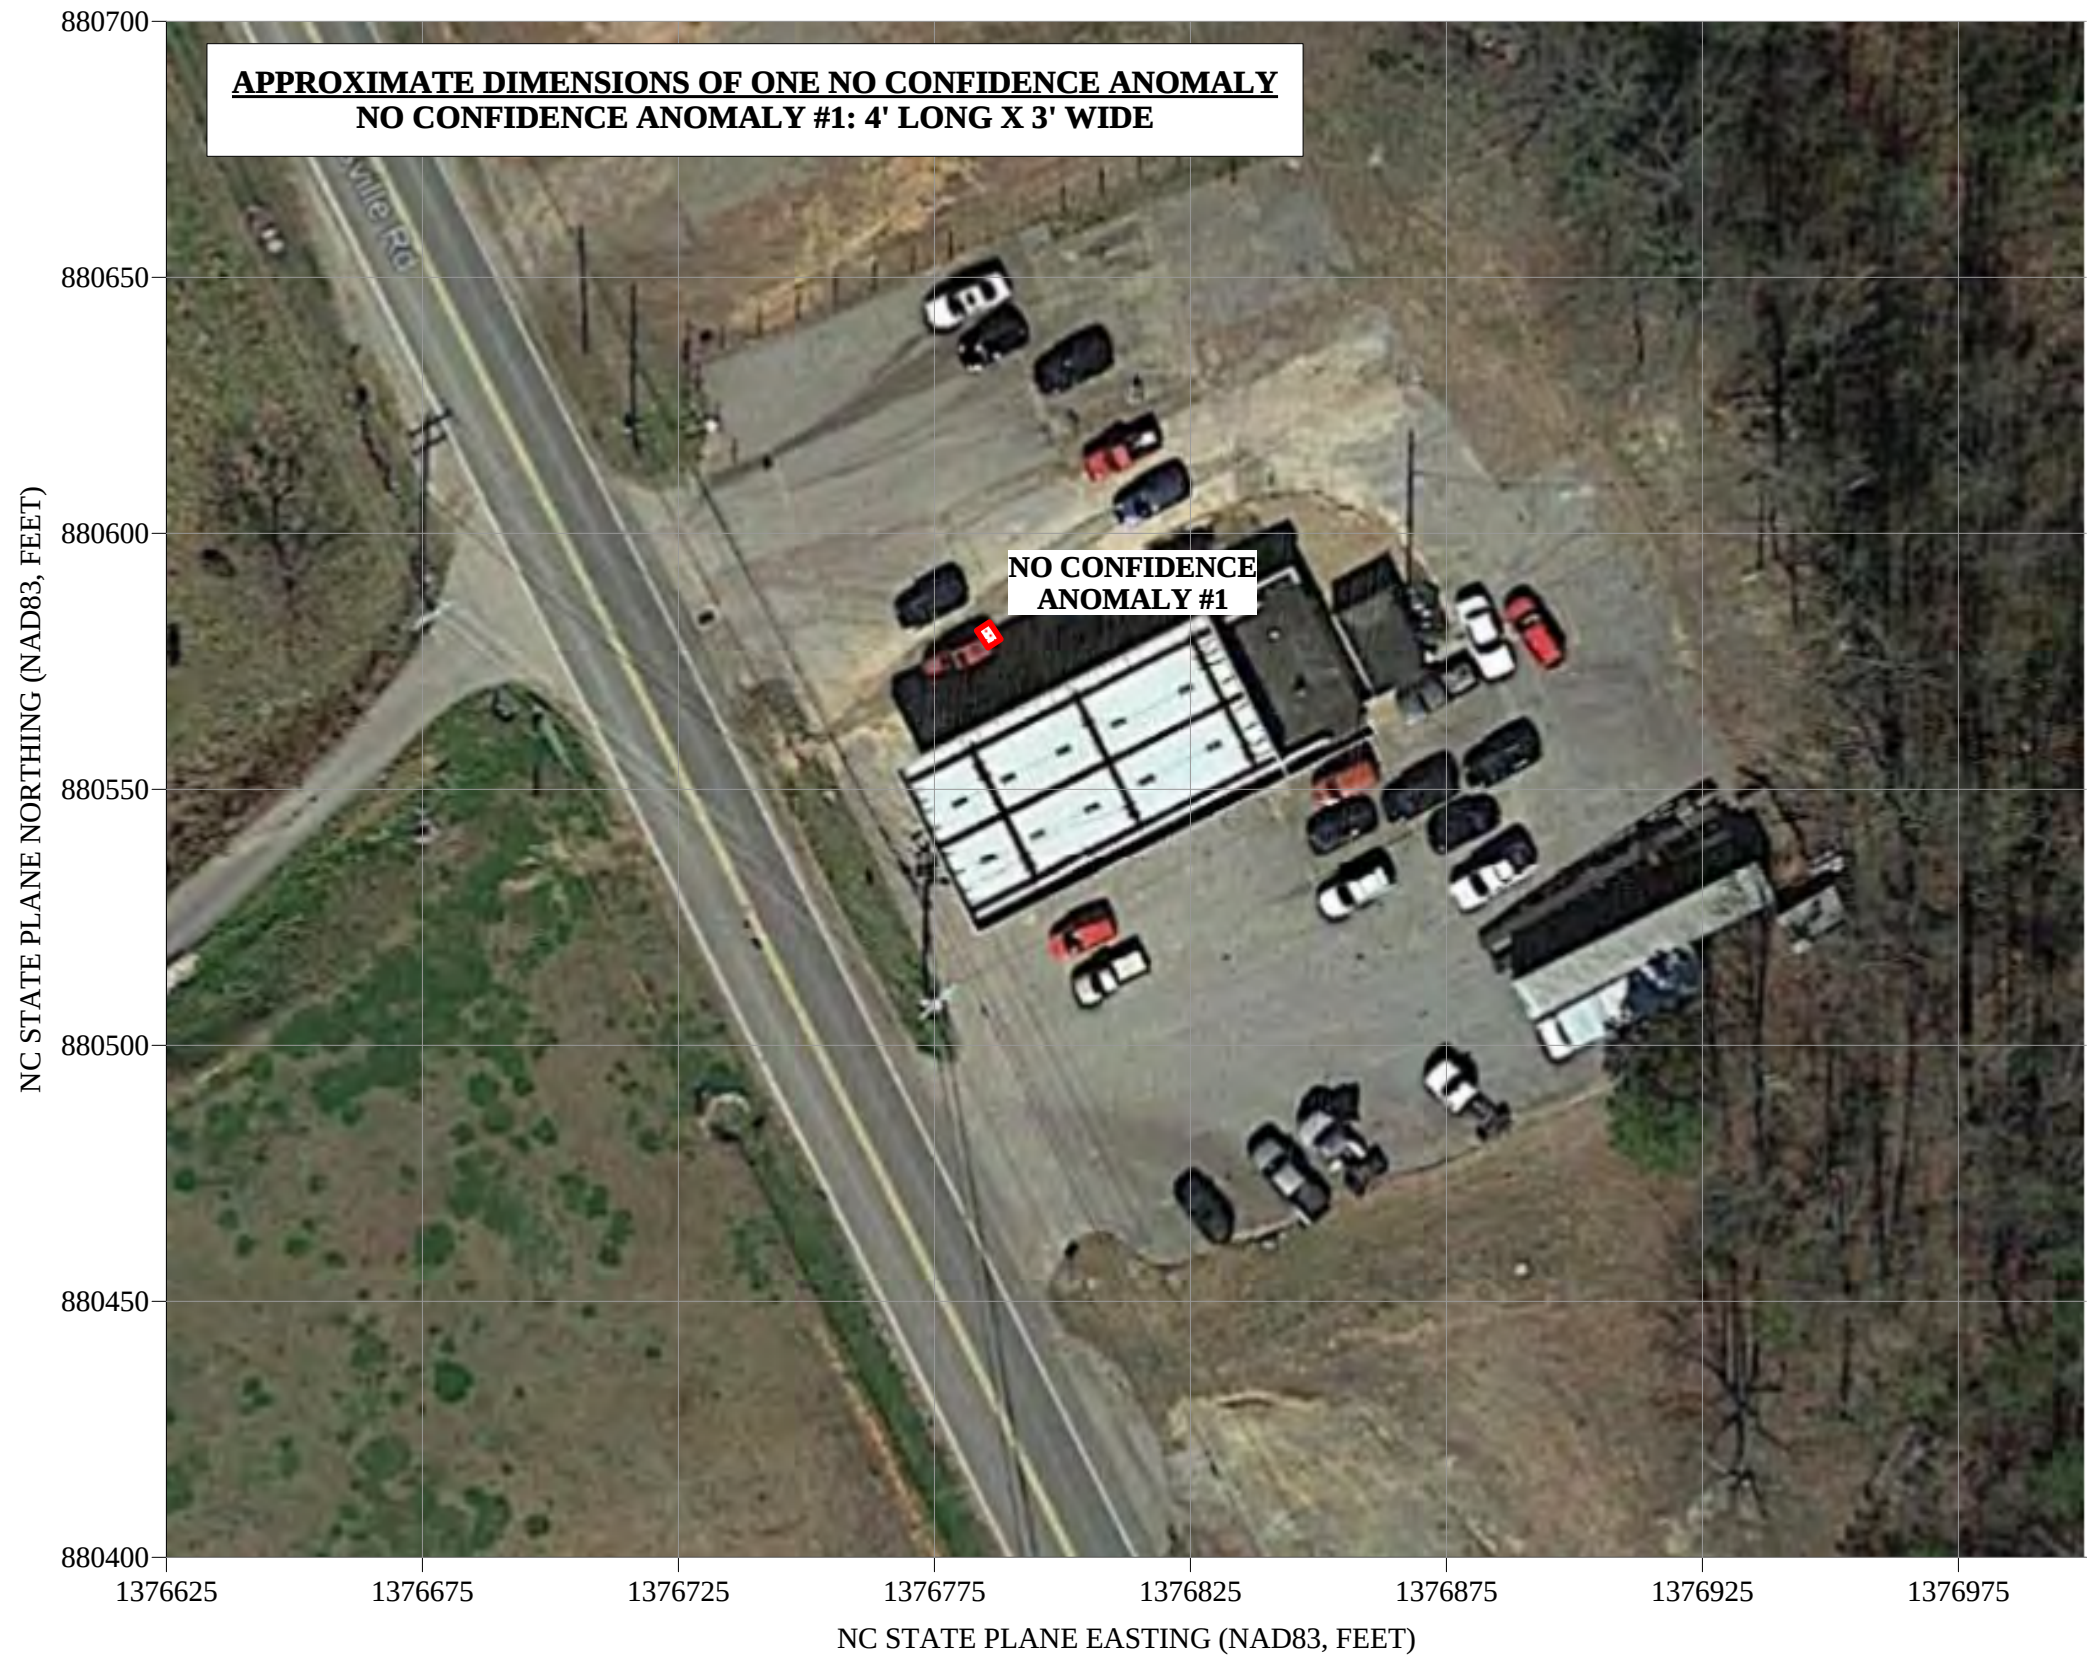
LOCATION OF ONE NO CONFIDENCE ANOMALY

View of One No Confidence Anomaly  
(Facing Approximately South)

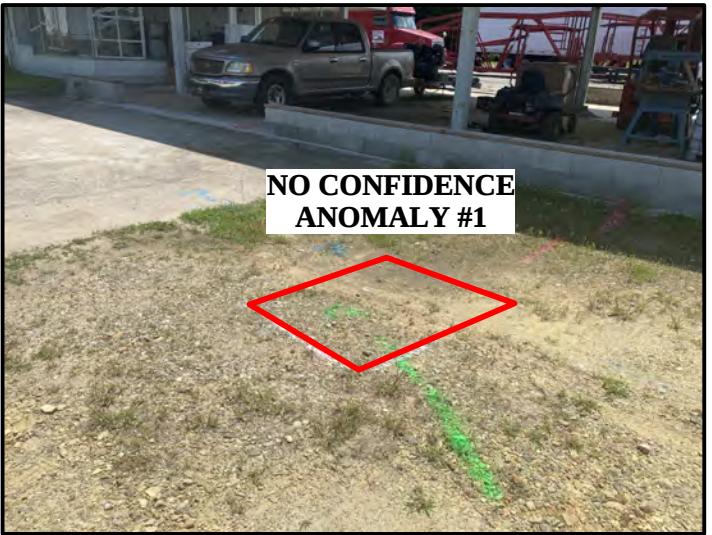
View of One No Confidence Anomaly  
(Facing Approximately Southeast)

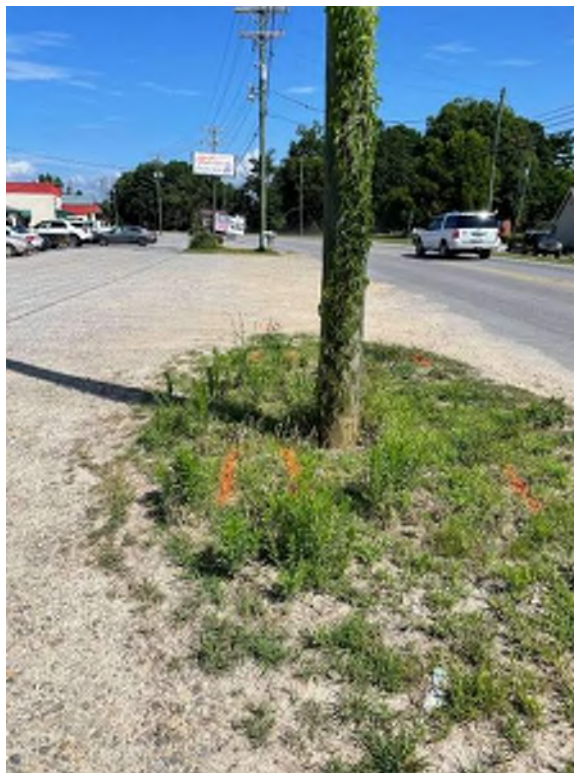
View facing north from the eastern portion of the Project Study Area, in the vicinity of the “no confidence anomaly,” depicting Parcel 72 proceeding into Parcel 73 along NC 115 southbound.

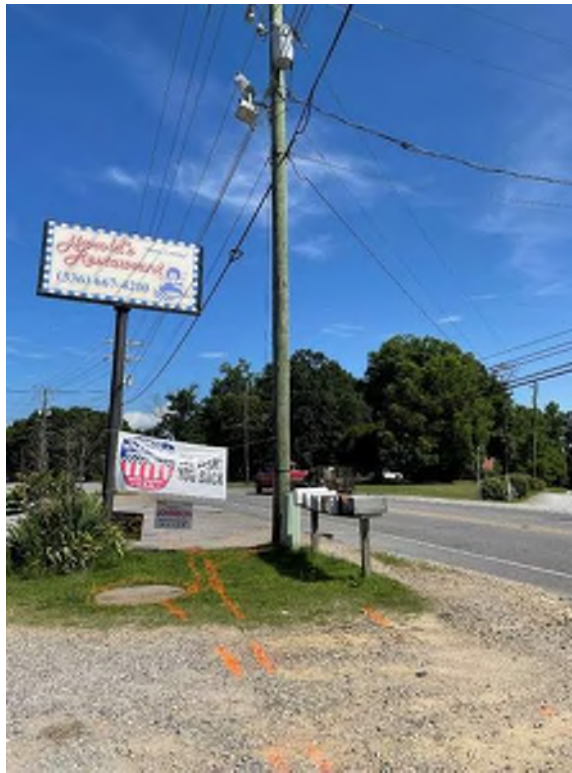
View facing north from the eastern portion of Parcel 73 along NC 115 southbound across the road from Eagle Lane, depicting overhead electric and sewer utilities.

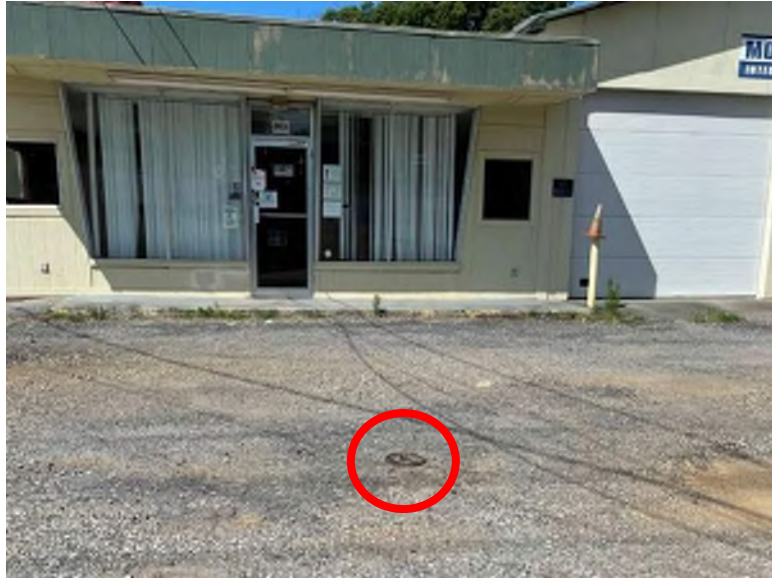
View facing west from the northeastern portion of Parcel 73 depicting an automotive store and groundwater monitoring well.

One (1) active groundwater monitoring well (P73-MW1) was observed on Parcel 73 at the time of site exploration, Tuesday, August 3, 2021. The groundwater monitoring well was located in the asphalt parking lot area east of the automotive storefront and approximately 20-ft south of the garage bay doors. The location of the well is indicated on Figure 2.

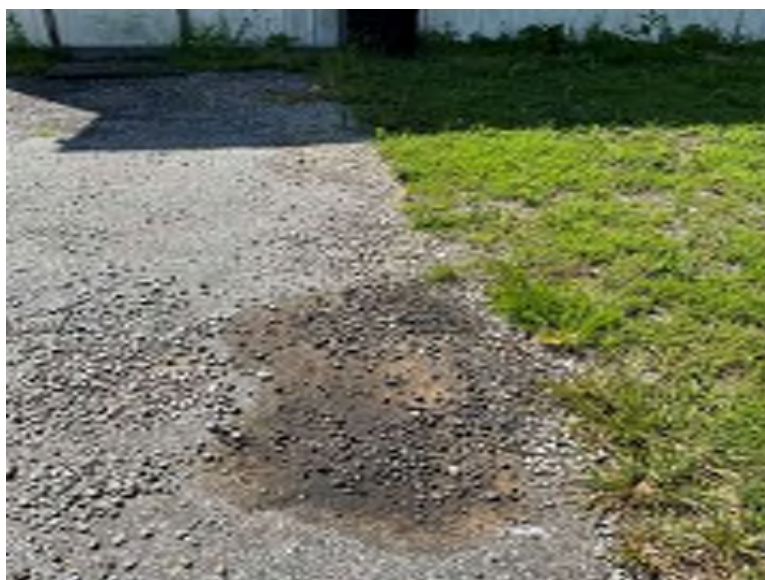
Surface staining in the northwestern portion of Parcel 73 west of the Project Study Area.

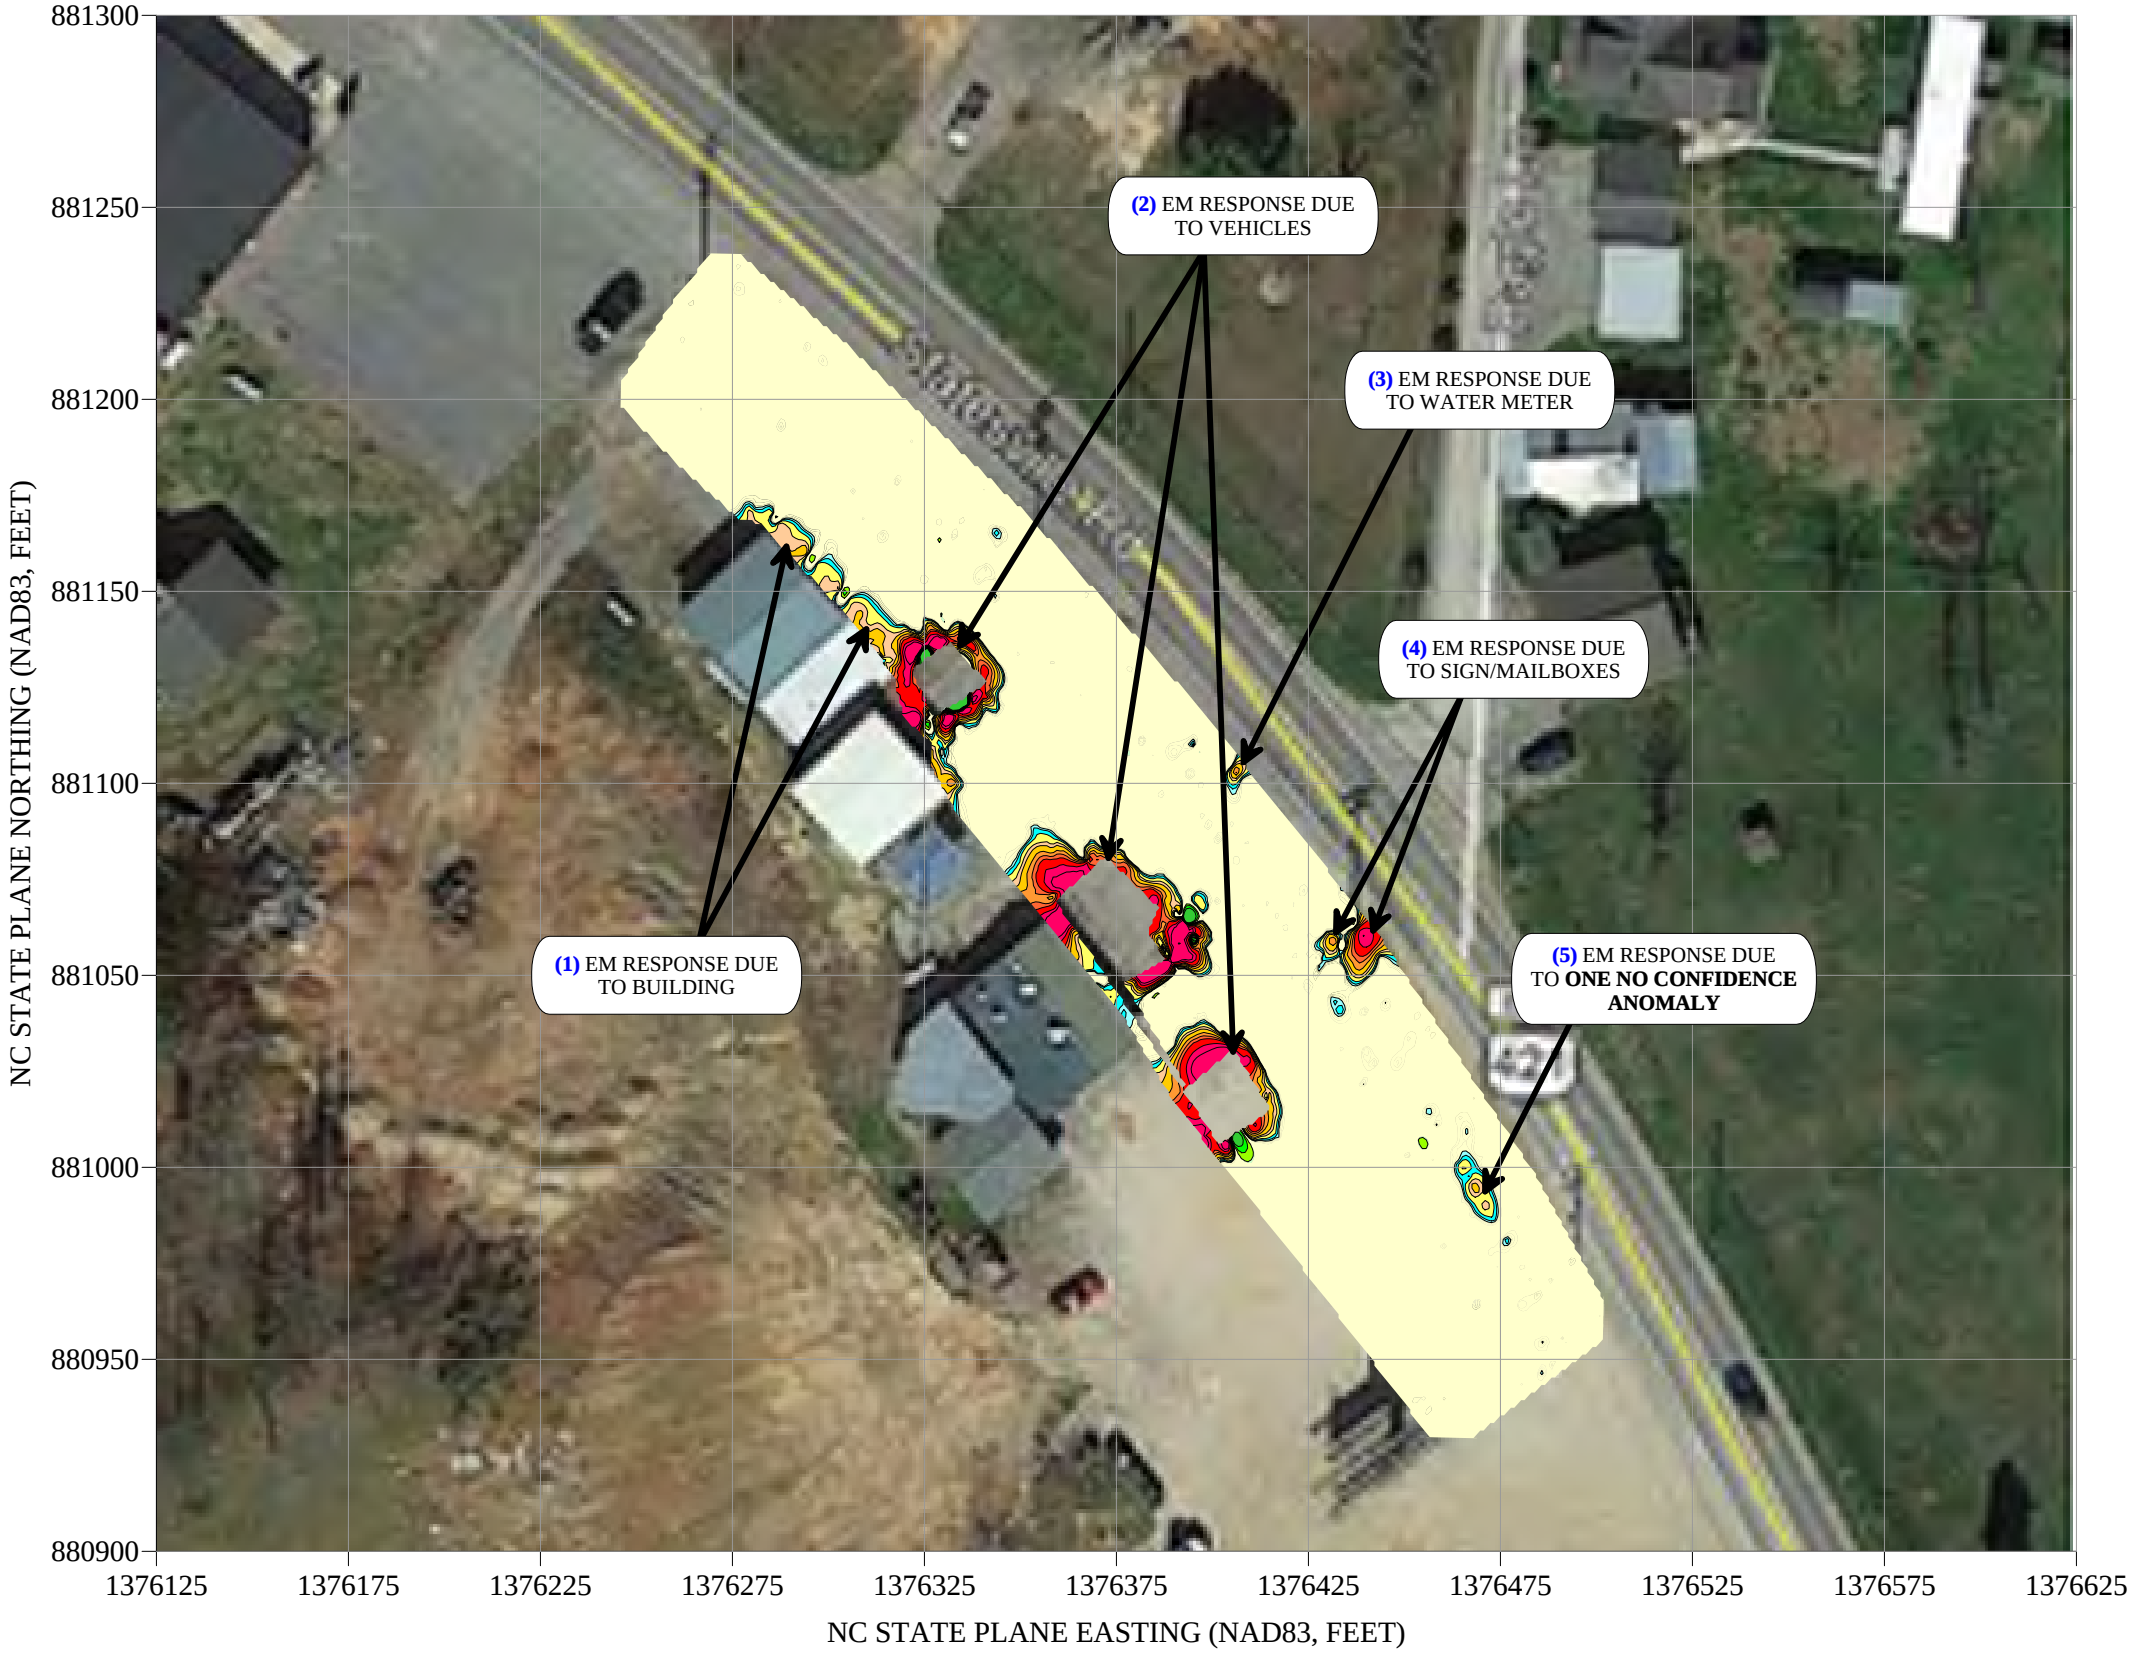
EM61 METAL DETECTION RESULTS

EVIDENCE OF ONE NO CONFIDENCE ANOMALY WAS OBSERVED.

The contour plot shows the differential results of the EM61 instrument in millivolts (mV). The differential results focus on larger metallic objects such as USTs and drums. The EM data were collected on July 15, 2021, using a Geonics EM61-MK2 instrument. Verification GPR data were collected using a GSSI SIR 4000 instrument with a 350 MHz HS antenna on July 16, 2021.
