## **Phase II Site Assessment Report**

**August 16, 2021**  
**WBS Element: 44691.1.1**  
**State Project: R-5759**  
**Wilkes County**

**Parcel #060**  
**James D. & Shirley A. Johnson Et Al. Property**  
**2065 Statesville Road, North Wilkesboro, NC 28659**  
**PIN #: 3877-79-6463**  
**Facility ID No.: N/A**  
**Groundwater Incident No.: N/A**

**NCDOT WBS ELEMENT 44691.1.1  
STATE PROJECT R-5759  
PROPOSED WIDENING OF NC 115 FROM US 421 TO 2<sup>ND</sup>  
STREET IN WILKESBORO AND NORTH WILKESBORO**

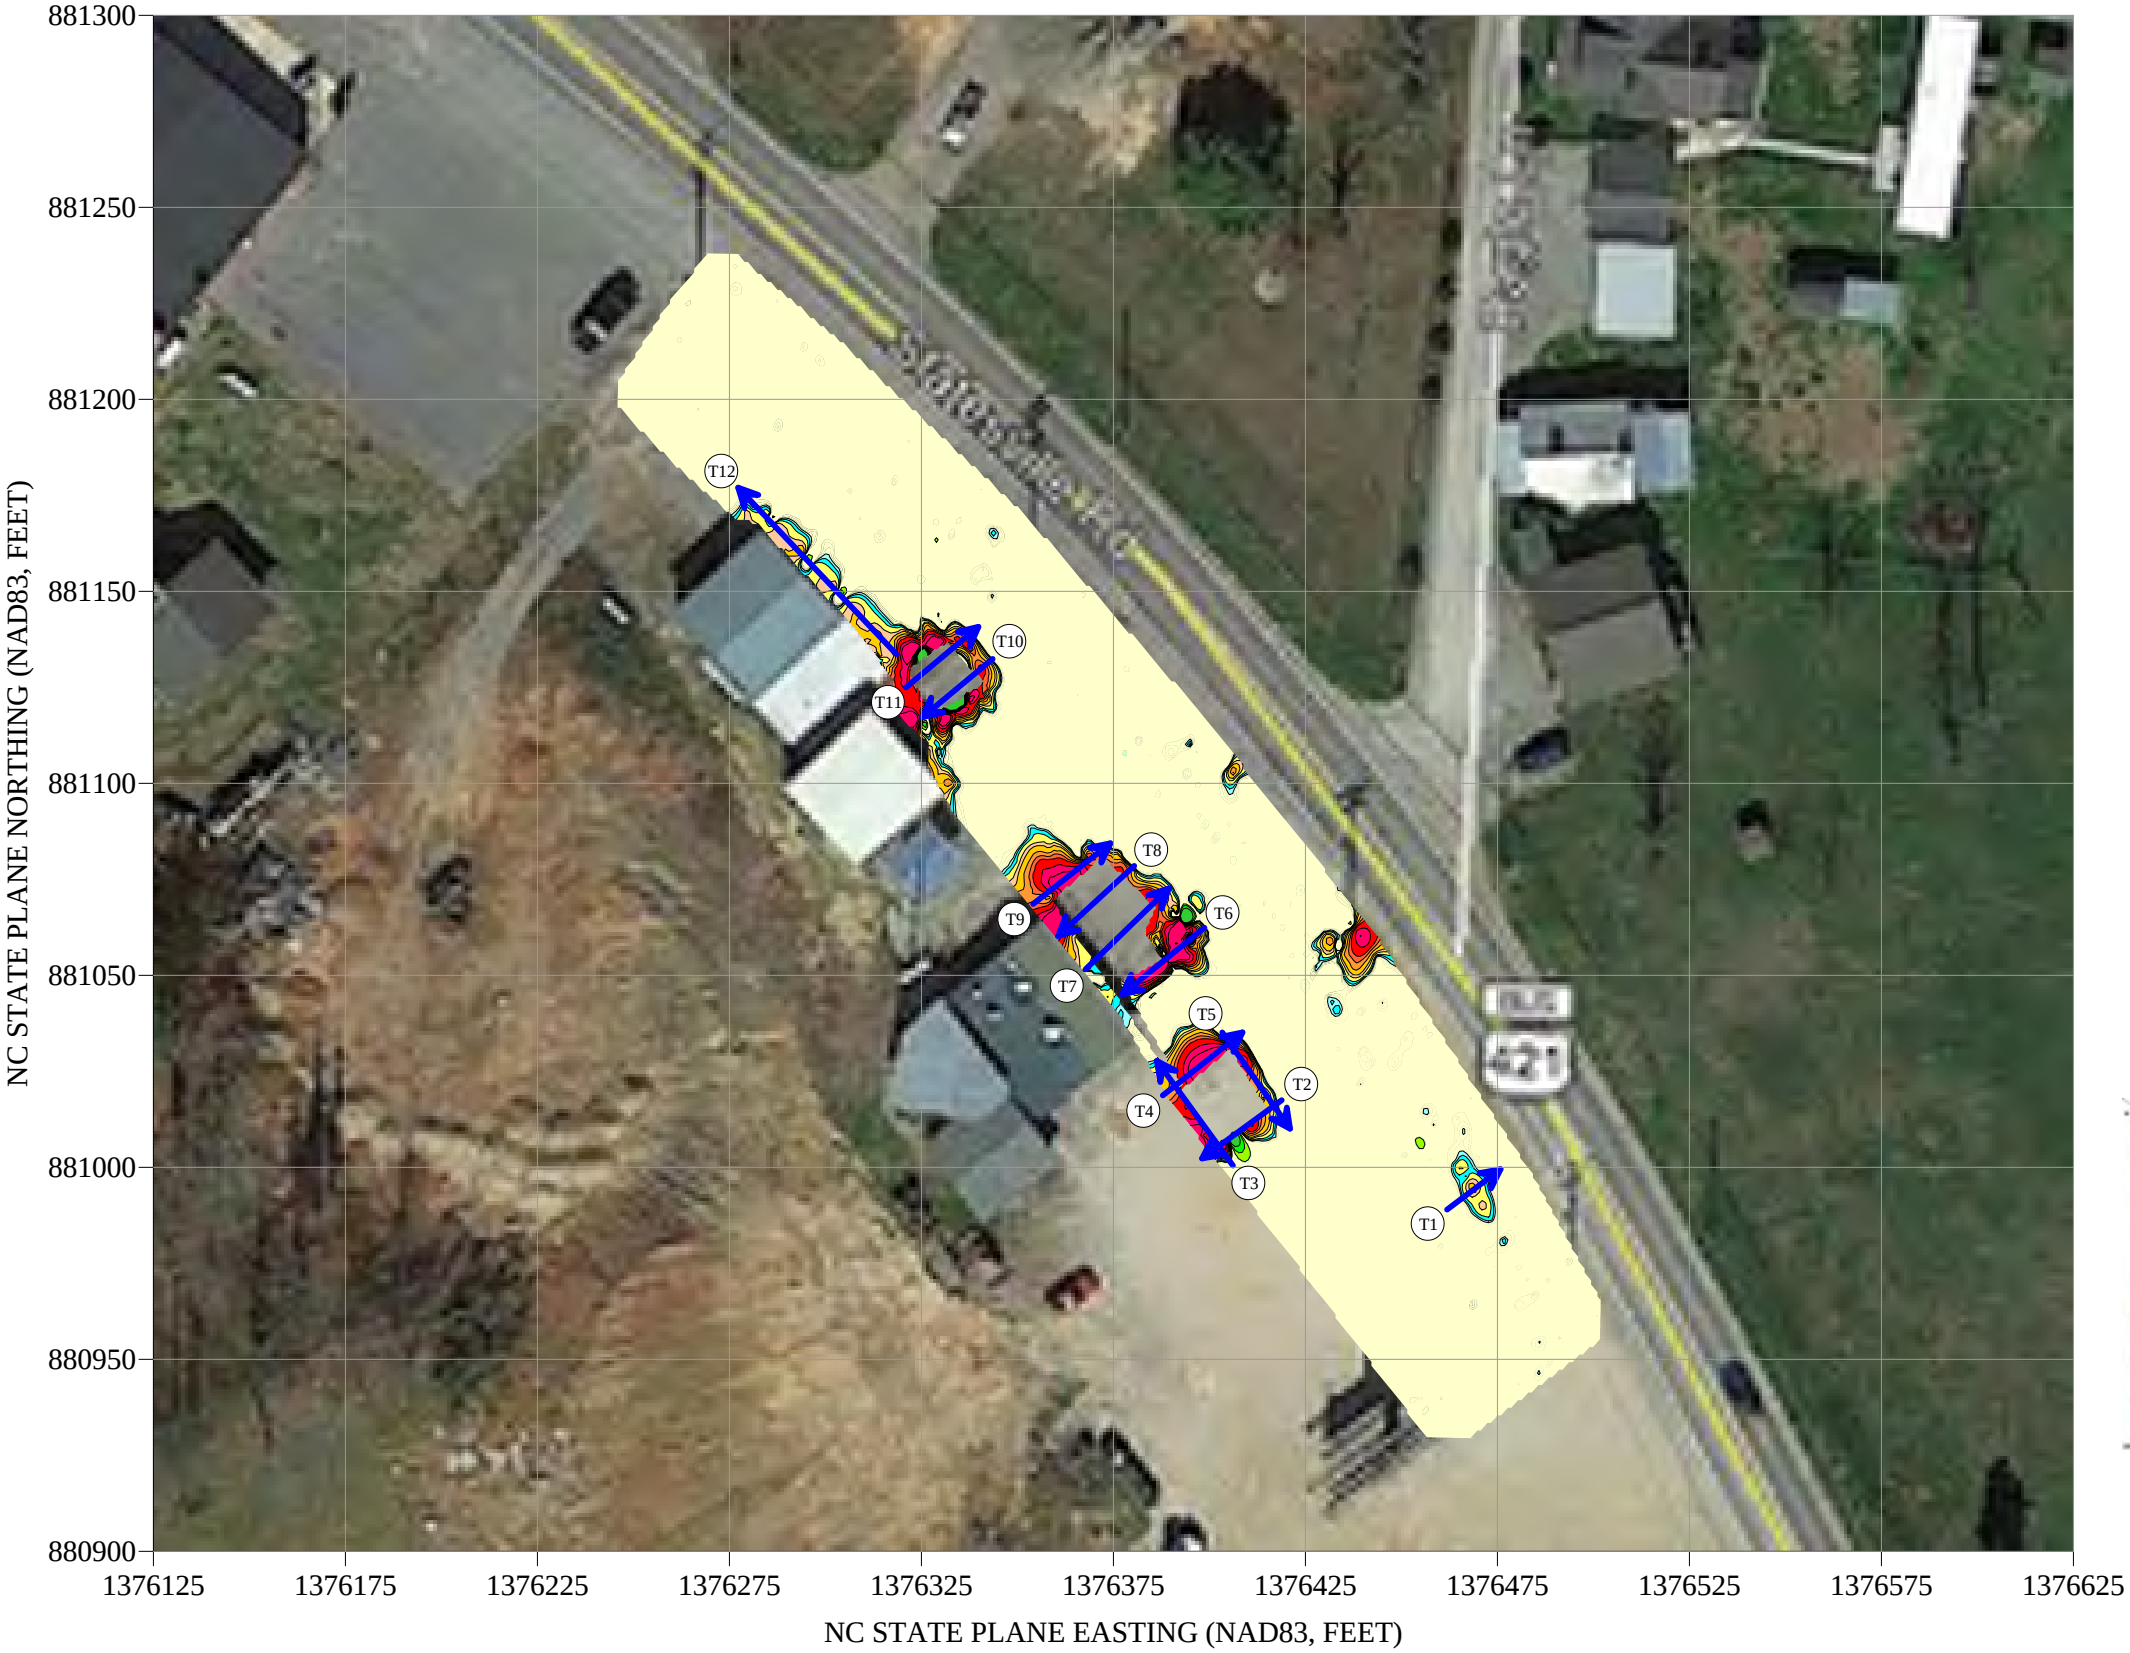
GPR TRANSECT LOCATIONS

NO SIGNIFICANT  
STRUCTURES  
OBSERVED

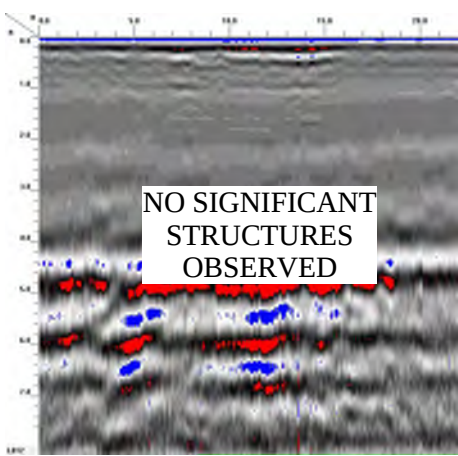
GPR TRANSECT 2 (T2)

NO SIGNIFICANT  
STRUCTURES  
OBSERVED

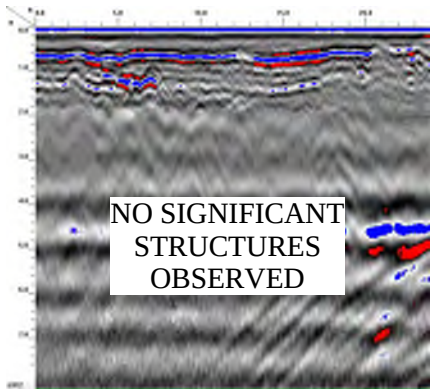
GPR TRANSECT 6 (T6)

NO SIGNIFICANT  
STRUCTURES  
OBSERVED
