**SUBJECT: Preliminary Site Assessment Report  
Parcel 121, Randy V. and Sandra J. Bell AKA Parker, James L  
WBS Element No. 44691.1.1, TIP No. R-5759  
Proposed widening of NC 115 from US 421 to 2<sup>nd</sup> Street in Wilkesboro and  
North Wilkesboro, Wilkes County, NC  
Kleinfelder Project No. 20221238.001A**

**PRELIMINARY SITE ASSESSMENT REPORT  
PARCEL 121, RANDY V. AND SANDRA J. BELL AKA PARKER,  
JAMES L  
PIN 1402990  
909 STATESVILLE ROAD  
NORTH WILKESBORO, WILKES COUNTY, NORTH CAROLINA**

**NCDOT WBS ELEMENT 44691.1.1  
STATE PROJECT R-5759  
PROPOSED WIDENING OF NC 115 FROM US 421 TO 2<sup>ND</sup>  
STREET IN WILKESBORO AND NORTH WILKESBORO**

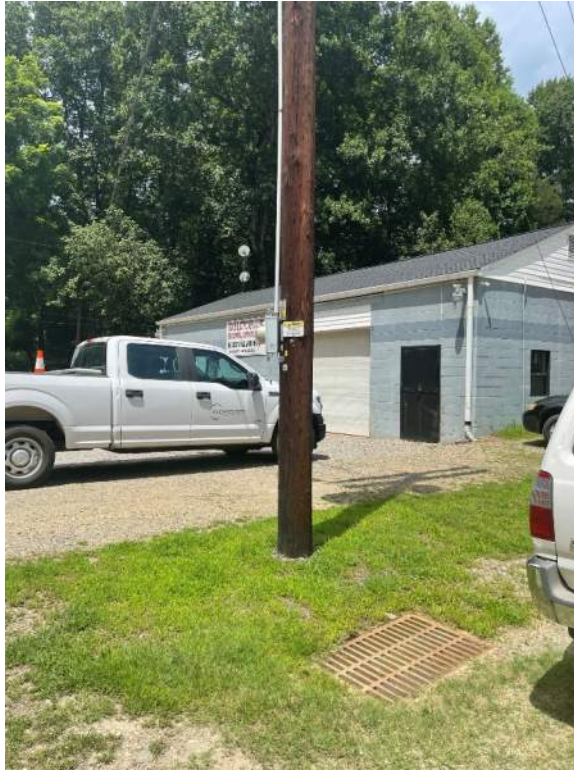
View facing northeast from the southwestern corner of the Project Study Area along NC 115.

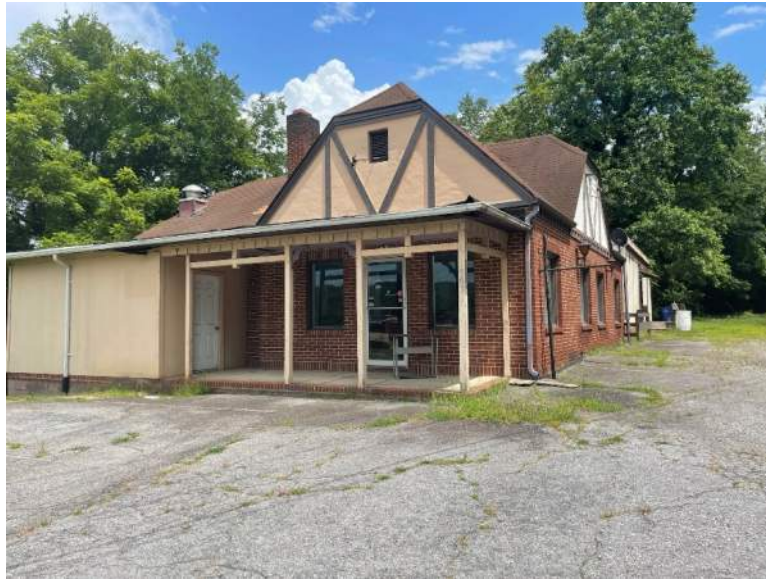
View facing east from the central portion of the Project Study Area, depicting the apparent storefront.

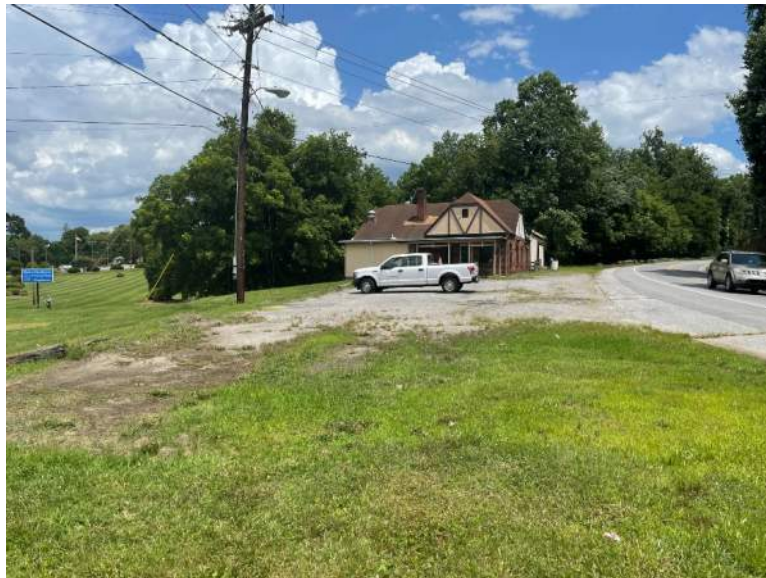
View facing southeast from the northwestern portion of the Project Study Area at the intersection of NC 115 and Armory Road.

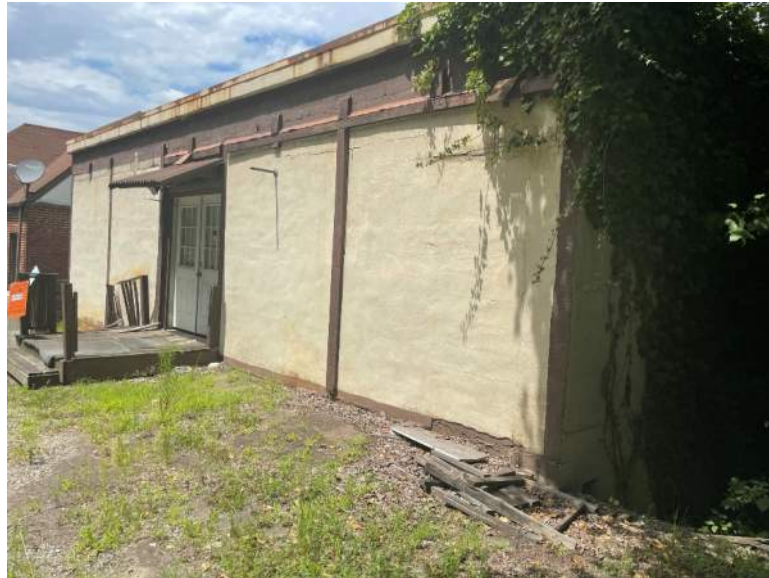
View facing east from the western portion of the Project Study Area along NC 115, depicting the eastern adjacent building of the apparent storefront.

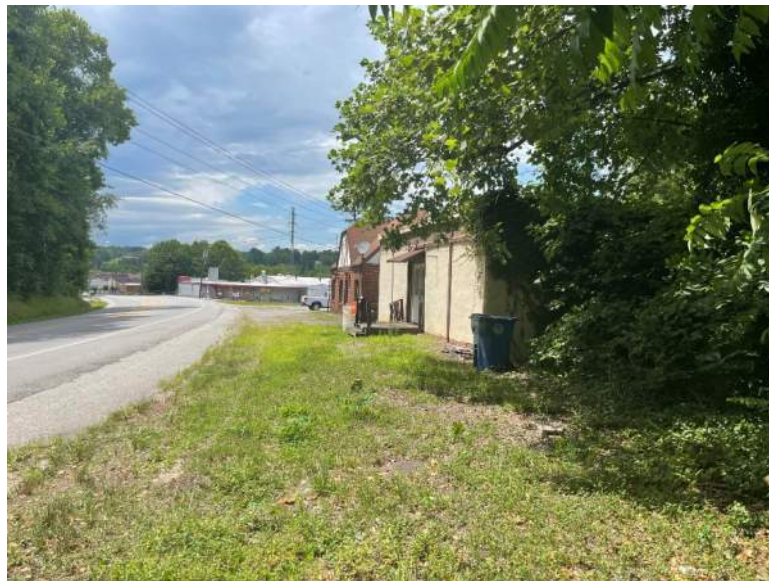
View facing northwest from the southern portion of the Project Study Area along NC 115.

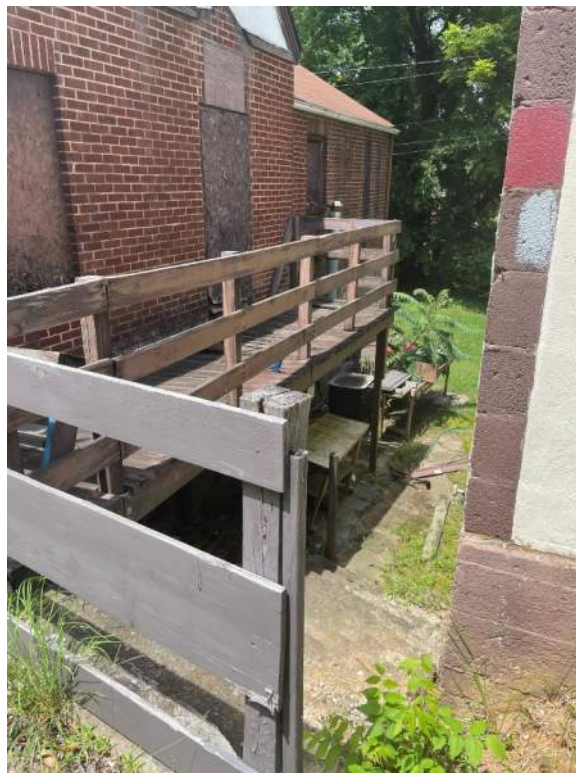
- An approximately 275-gallon heating oil AST was observed in the southern portion of the parcel, outside of the Project Study Area, between the apparent storefront and the adjacent eastern building along NC 115.

View facing east from the southwestern portion of the Project Study Area along NC 115, depicting the area between the apparent storefront and the adjacent eastern building outside of the Project Study Area.

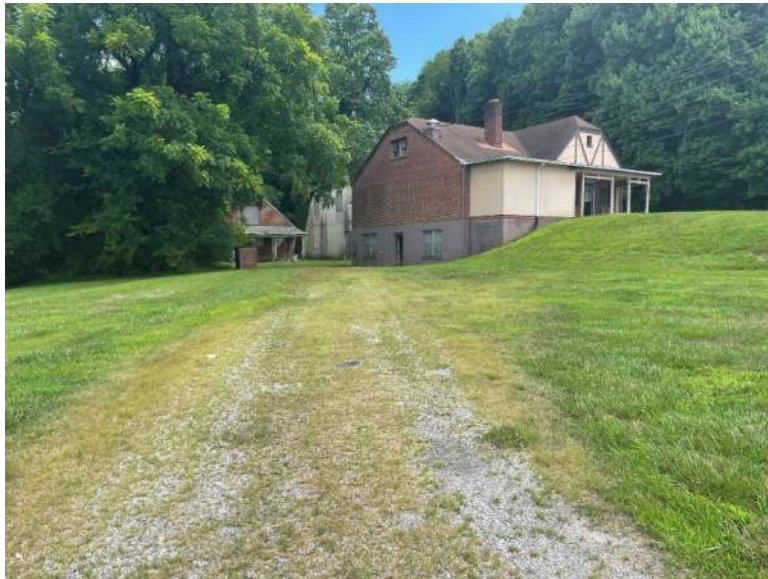
View facing south from the northern portion of the Project Study Area, depicting the northern sides of the apparent storefront and the adjacent eastern building, and a residential home in the eastern portion of the parcel.

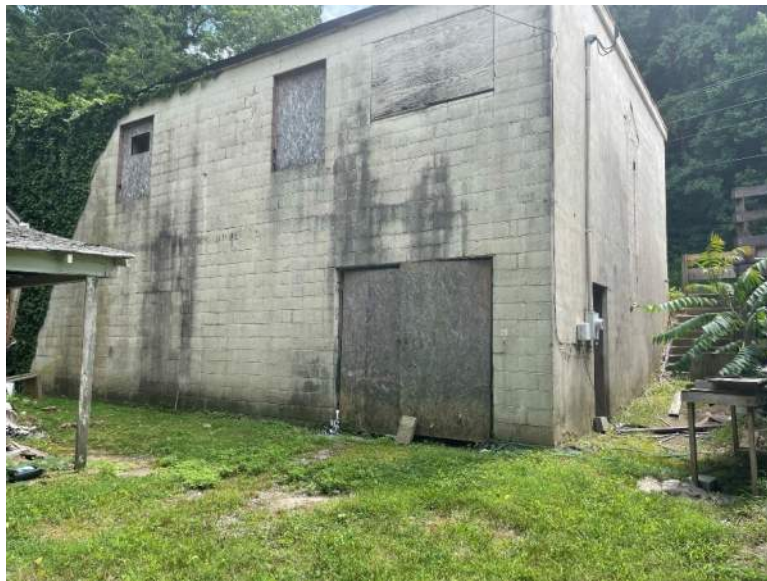
View depicting the northern side of the eastern adjacent building of the apparent storefront, outside of the Project Study Area.

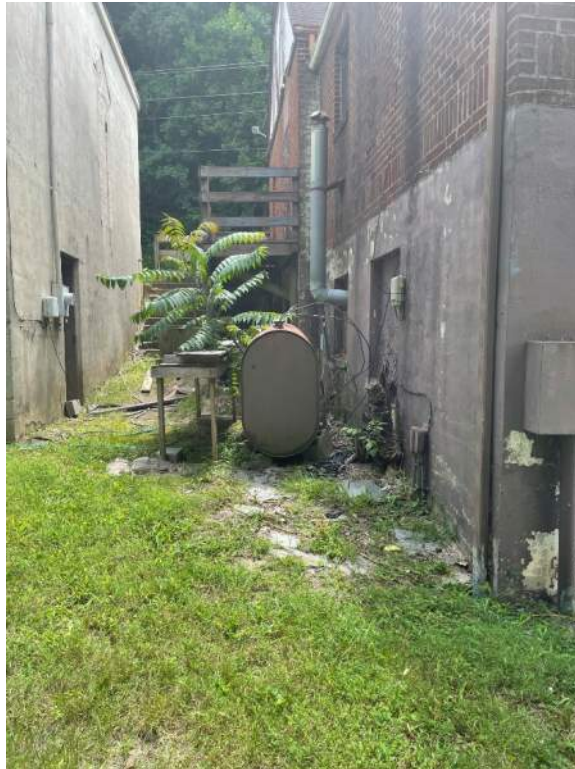
View facing southwest from the eastern portion of the parcel, depicting an approximately 275-gallon heating oil AST located outside of the Project Study Area between the apparent storefront and the eastern adjacent building.

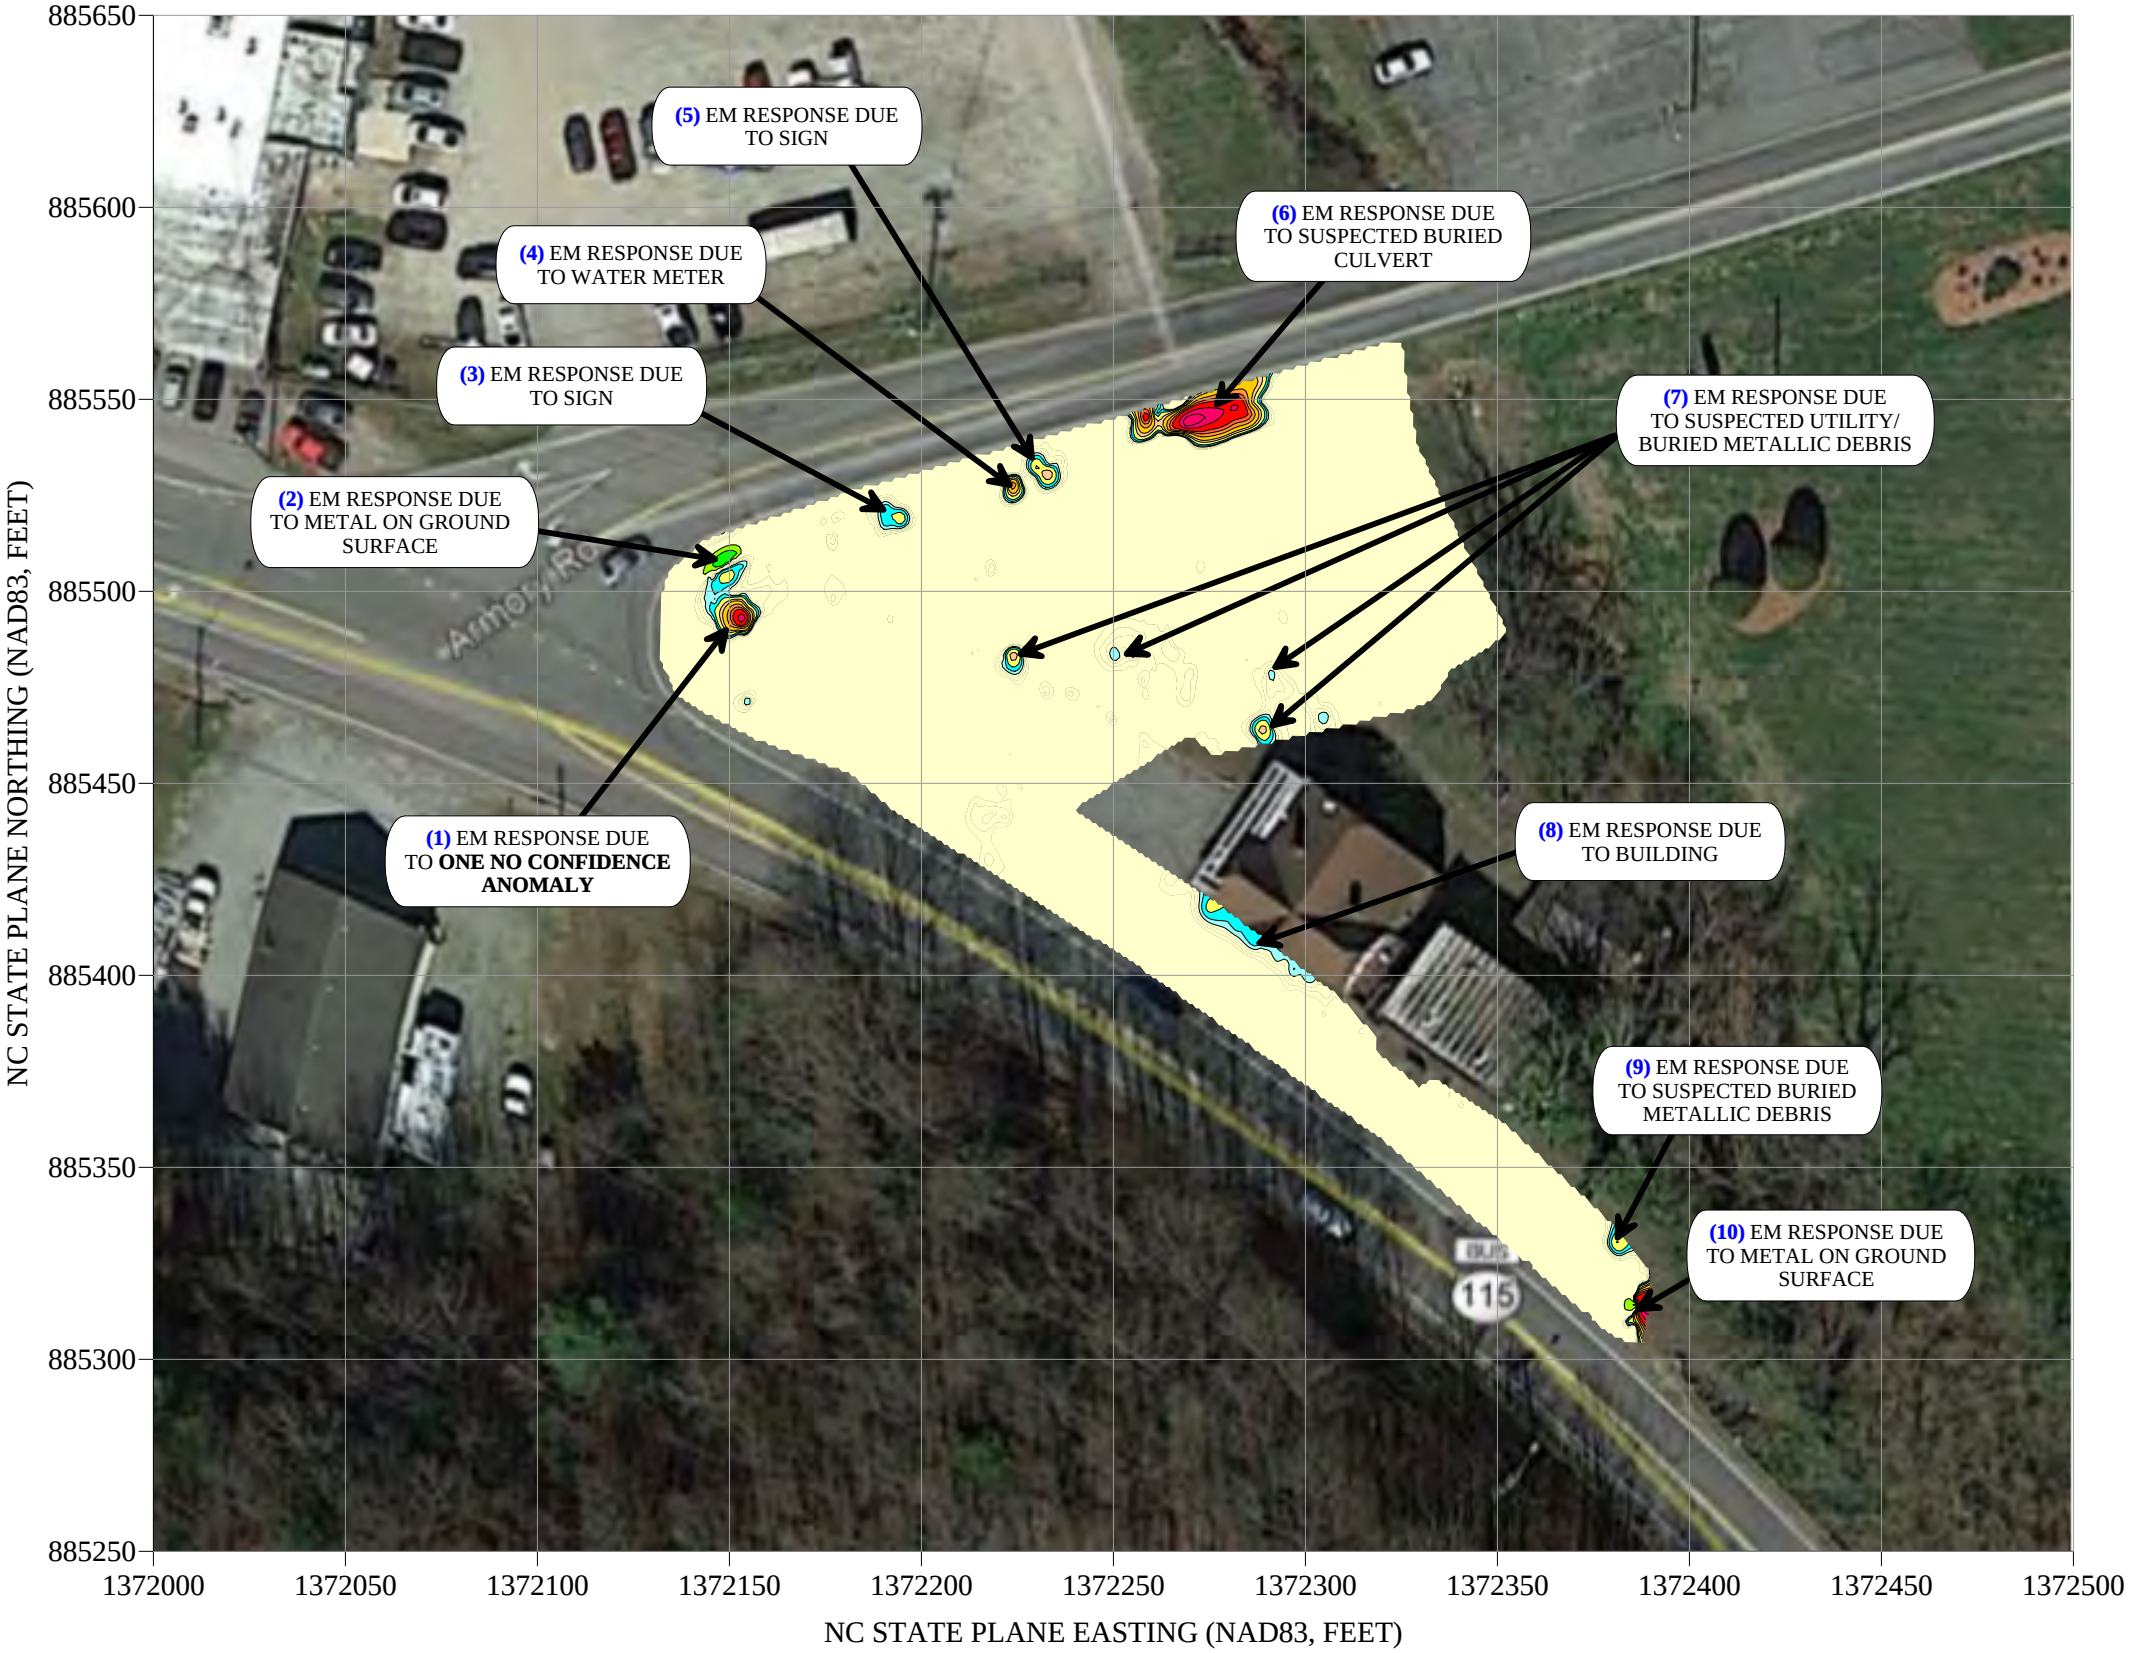
EM61 METAL DETECTION RESULTS

EVIDENCE OF ONE NO CONFIDENCE ANOMALY WAS OBSERVED.

The contour plot shows the differential results of the EM61 instrument in millivolts (mV). The differential results focus on larger metallic objects such as USTs and drums. The EM data were collected on July 14, 2021, using a Geonics EM61-MK2 instrument. Verification GPR data were collected using a GSSI SIR 4000 instrument with a 350 MHz HS antenna on July 20, 2021.

A contour plot of the EM61 results obtained across the survey area at the property is presented in **Figure 2**. Each EM anomaly is numbered for reference in the figure. The following table presents the list of EM anomalies and the cause of the metallic response, if known:

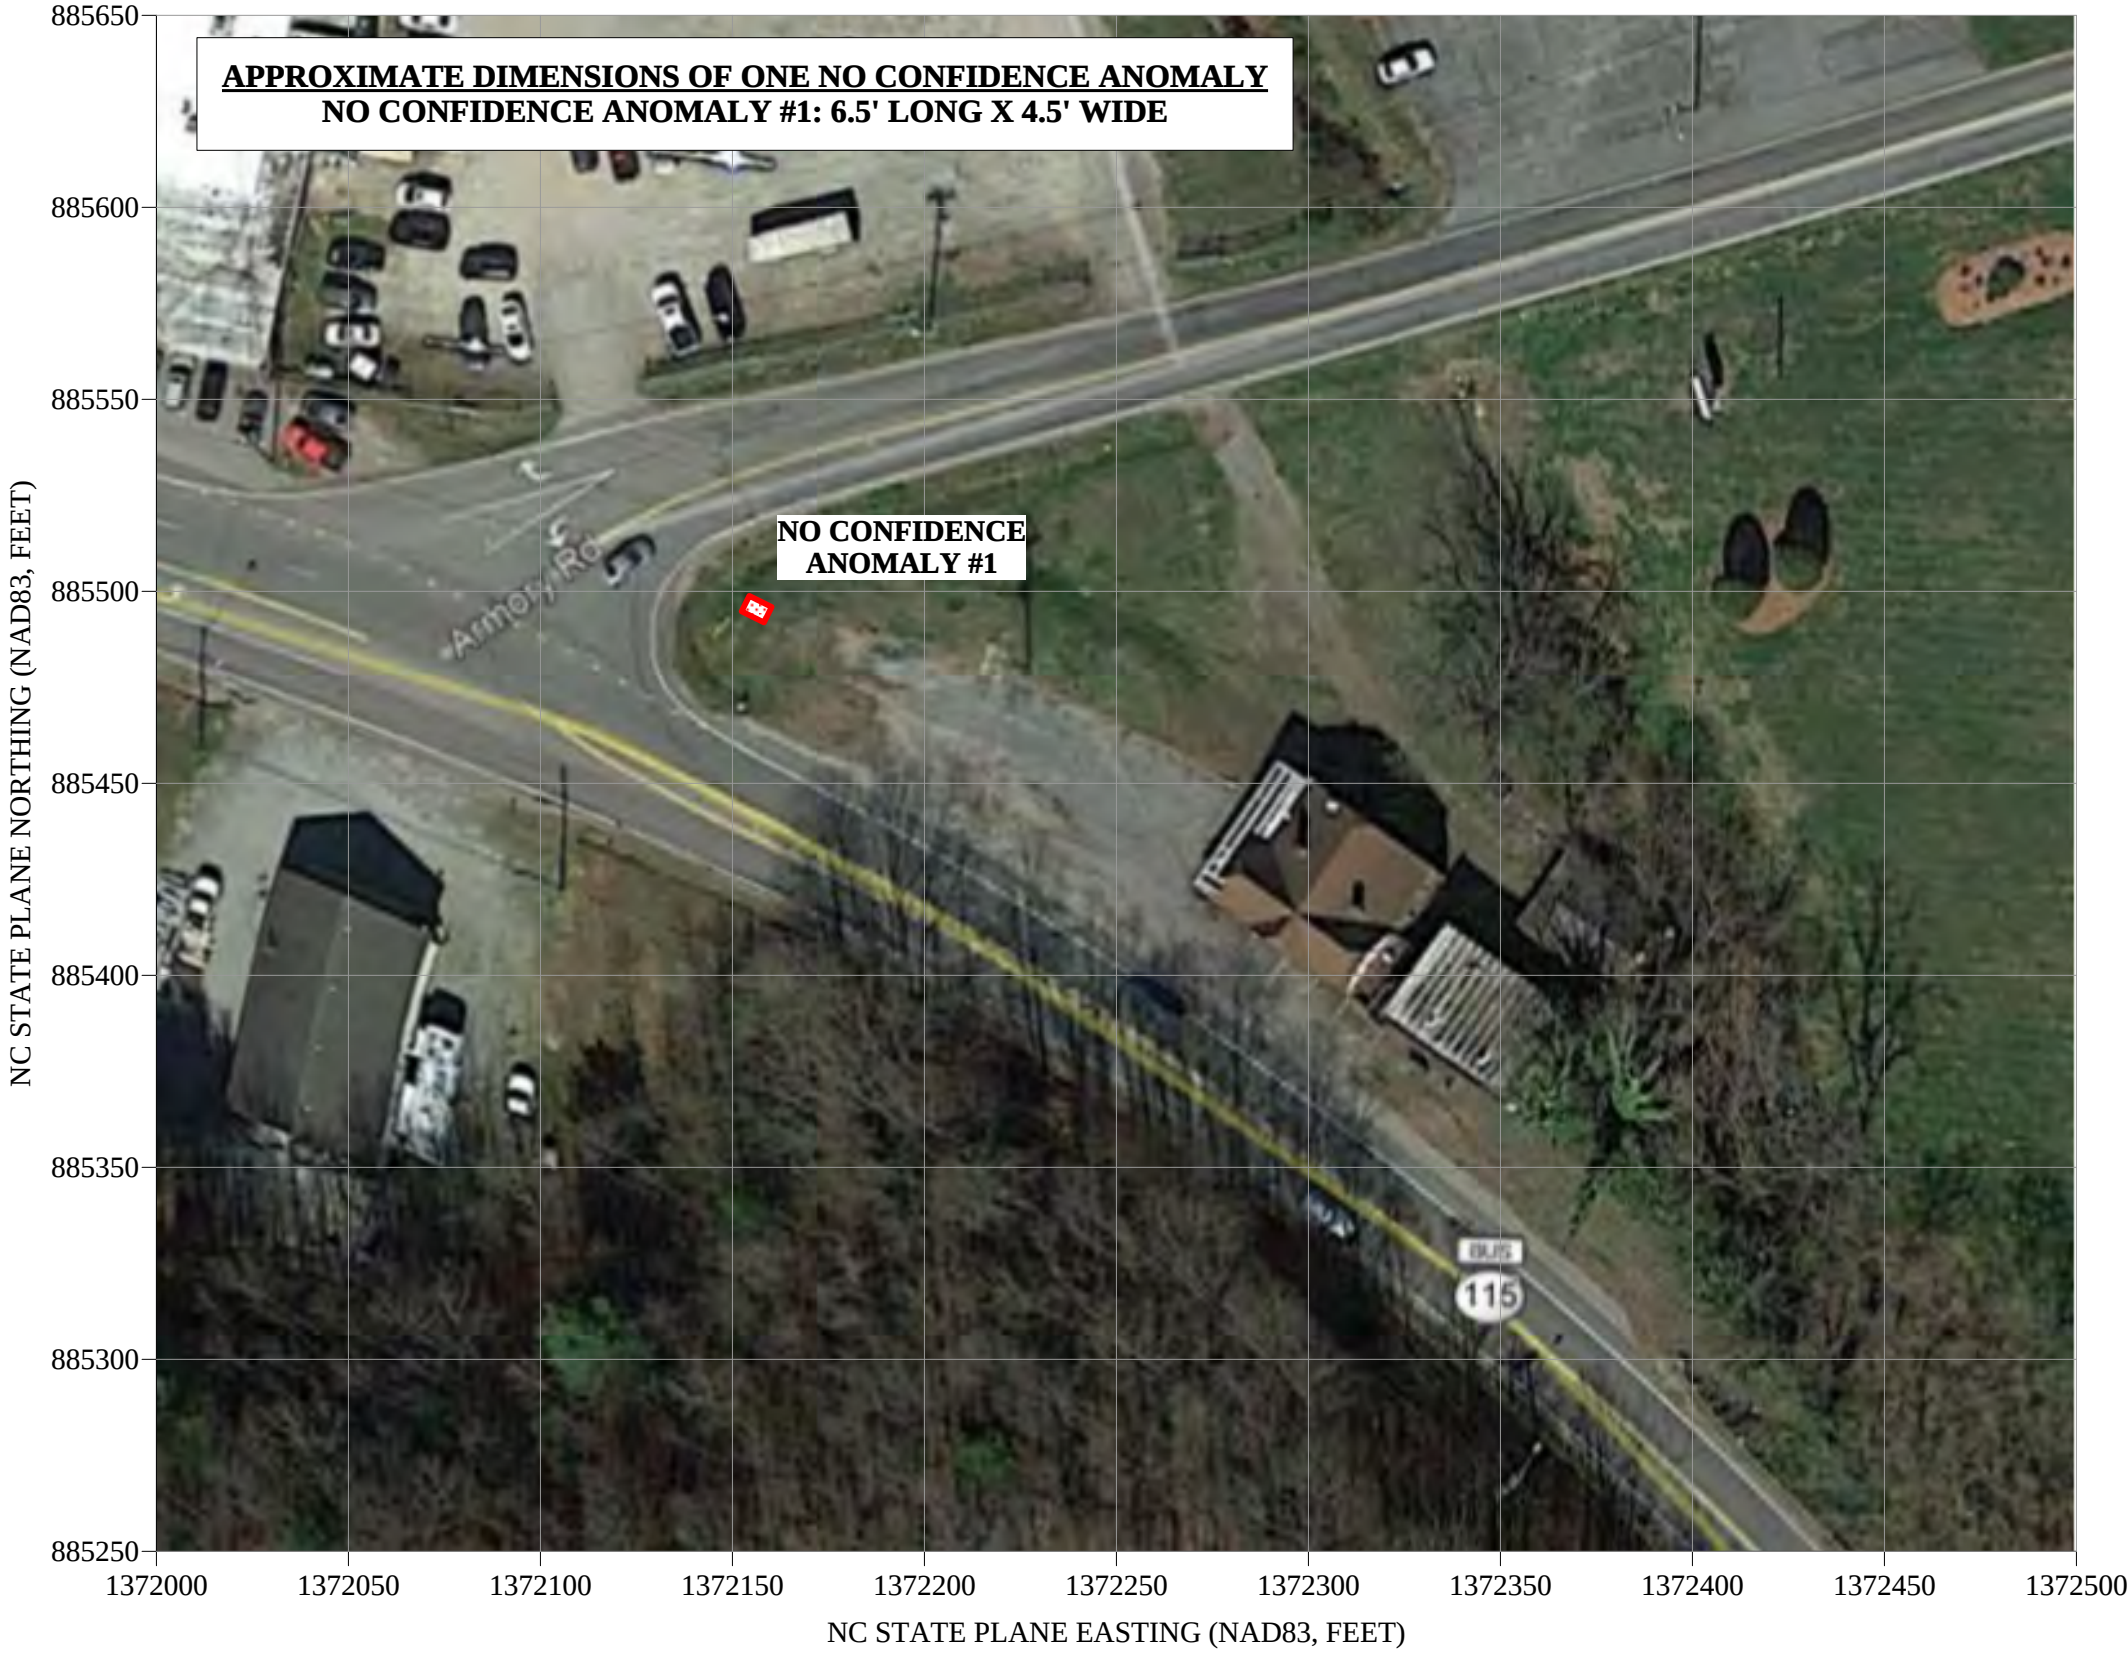
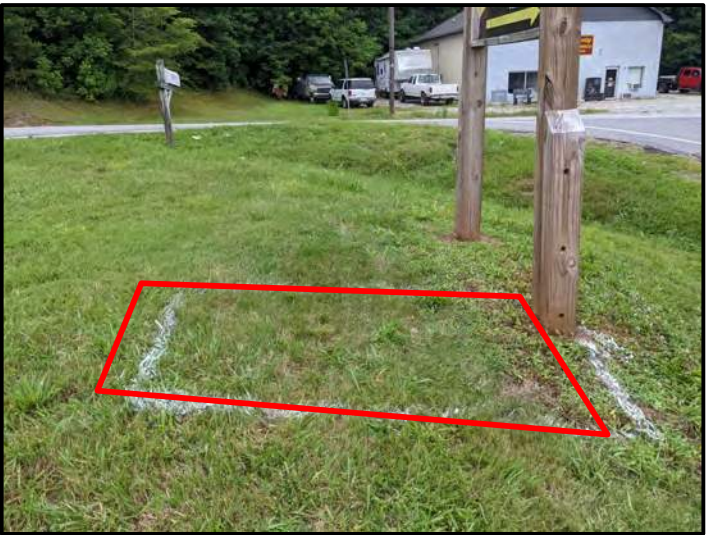
LOCATION OF ONE NO CONFIDENCE ANOMALY

A no confidence anomaly was identified on the northwest corner of the property, just under a sign. EM and GPR showed evidence of possible metal-reinforced infrastructure. These reflectors are not typical of a UST and this feature is classified as a no confidence anomaly. No Confidence Anomaly #1 is approximately 6.5 feet long by 4.5 feet wide. Collectively, the geophysical data recorded evidence of one no confidence anomaly at Parcel 140. No evidence of unknown metallic USTs was observed.

View of One No Confidence Anomaly  
(Facing Approximately Northwest)

View of One No Confidence Anomaly  
(Facing Approximately West)

Based on results of this Preliminary Site Assessment, Kleinfelder recommends that additional sampling or special handling of soils be performed in the vicinity of No Confidence Anomaly # 1, depicted on Figure 2, within the Project Study Area on Parcel 140 in North Wilkesboro, Wilkes County, North Carolina.

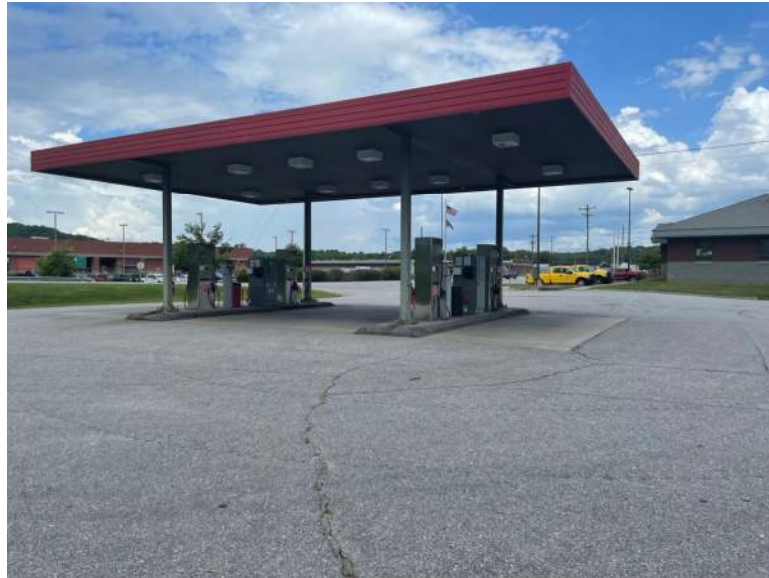
View facing southeast from the western corner of the Project Study Area, depicting the fuel islands, the fuel canopy, and the NCDOT office building.

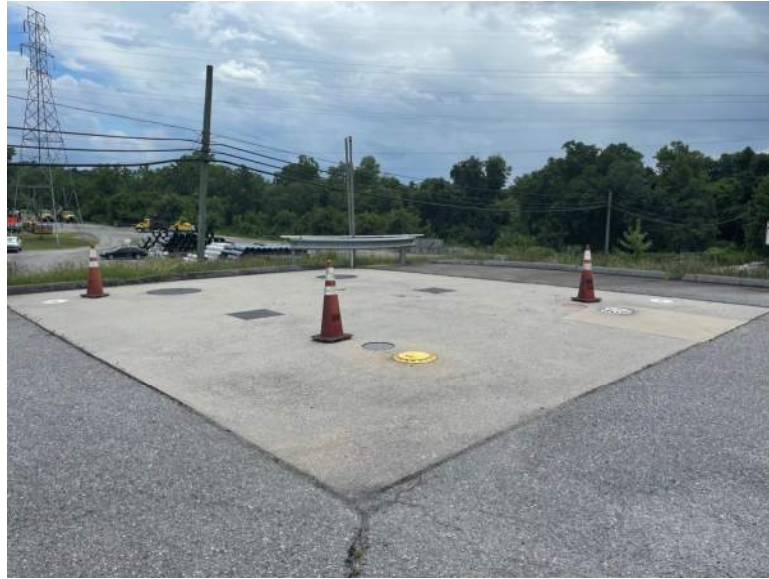
View facing southwest from the northwestern portion of the parcel, depicting an UST bed outside of the Project Study Area and to the southwest of the fuel pumps and canopy.

Based on review of the NCDEQ UST database, site visits and previous reports, there are six (6) active regulated USTs located on site. At the time of site exploration, Wednesday, July 14, 2021, no evidence of active USTs was observed within the Project Study Area.

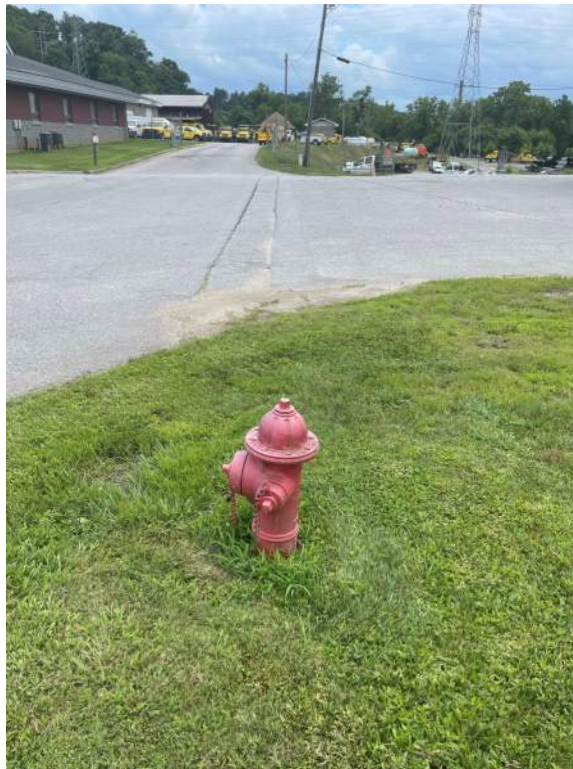
View facing south from the western portion of the Project Study Area, depicting the NCDOT office building and vehicle parking areas.

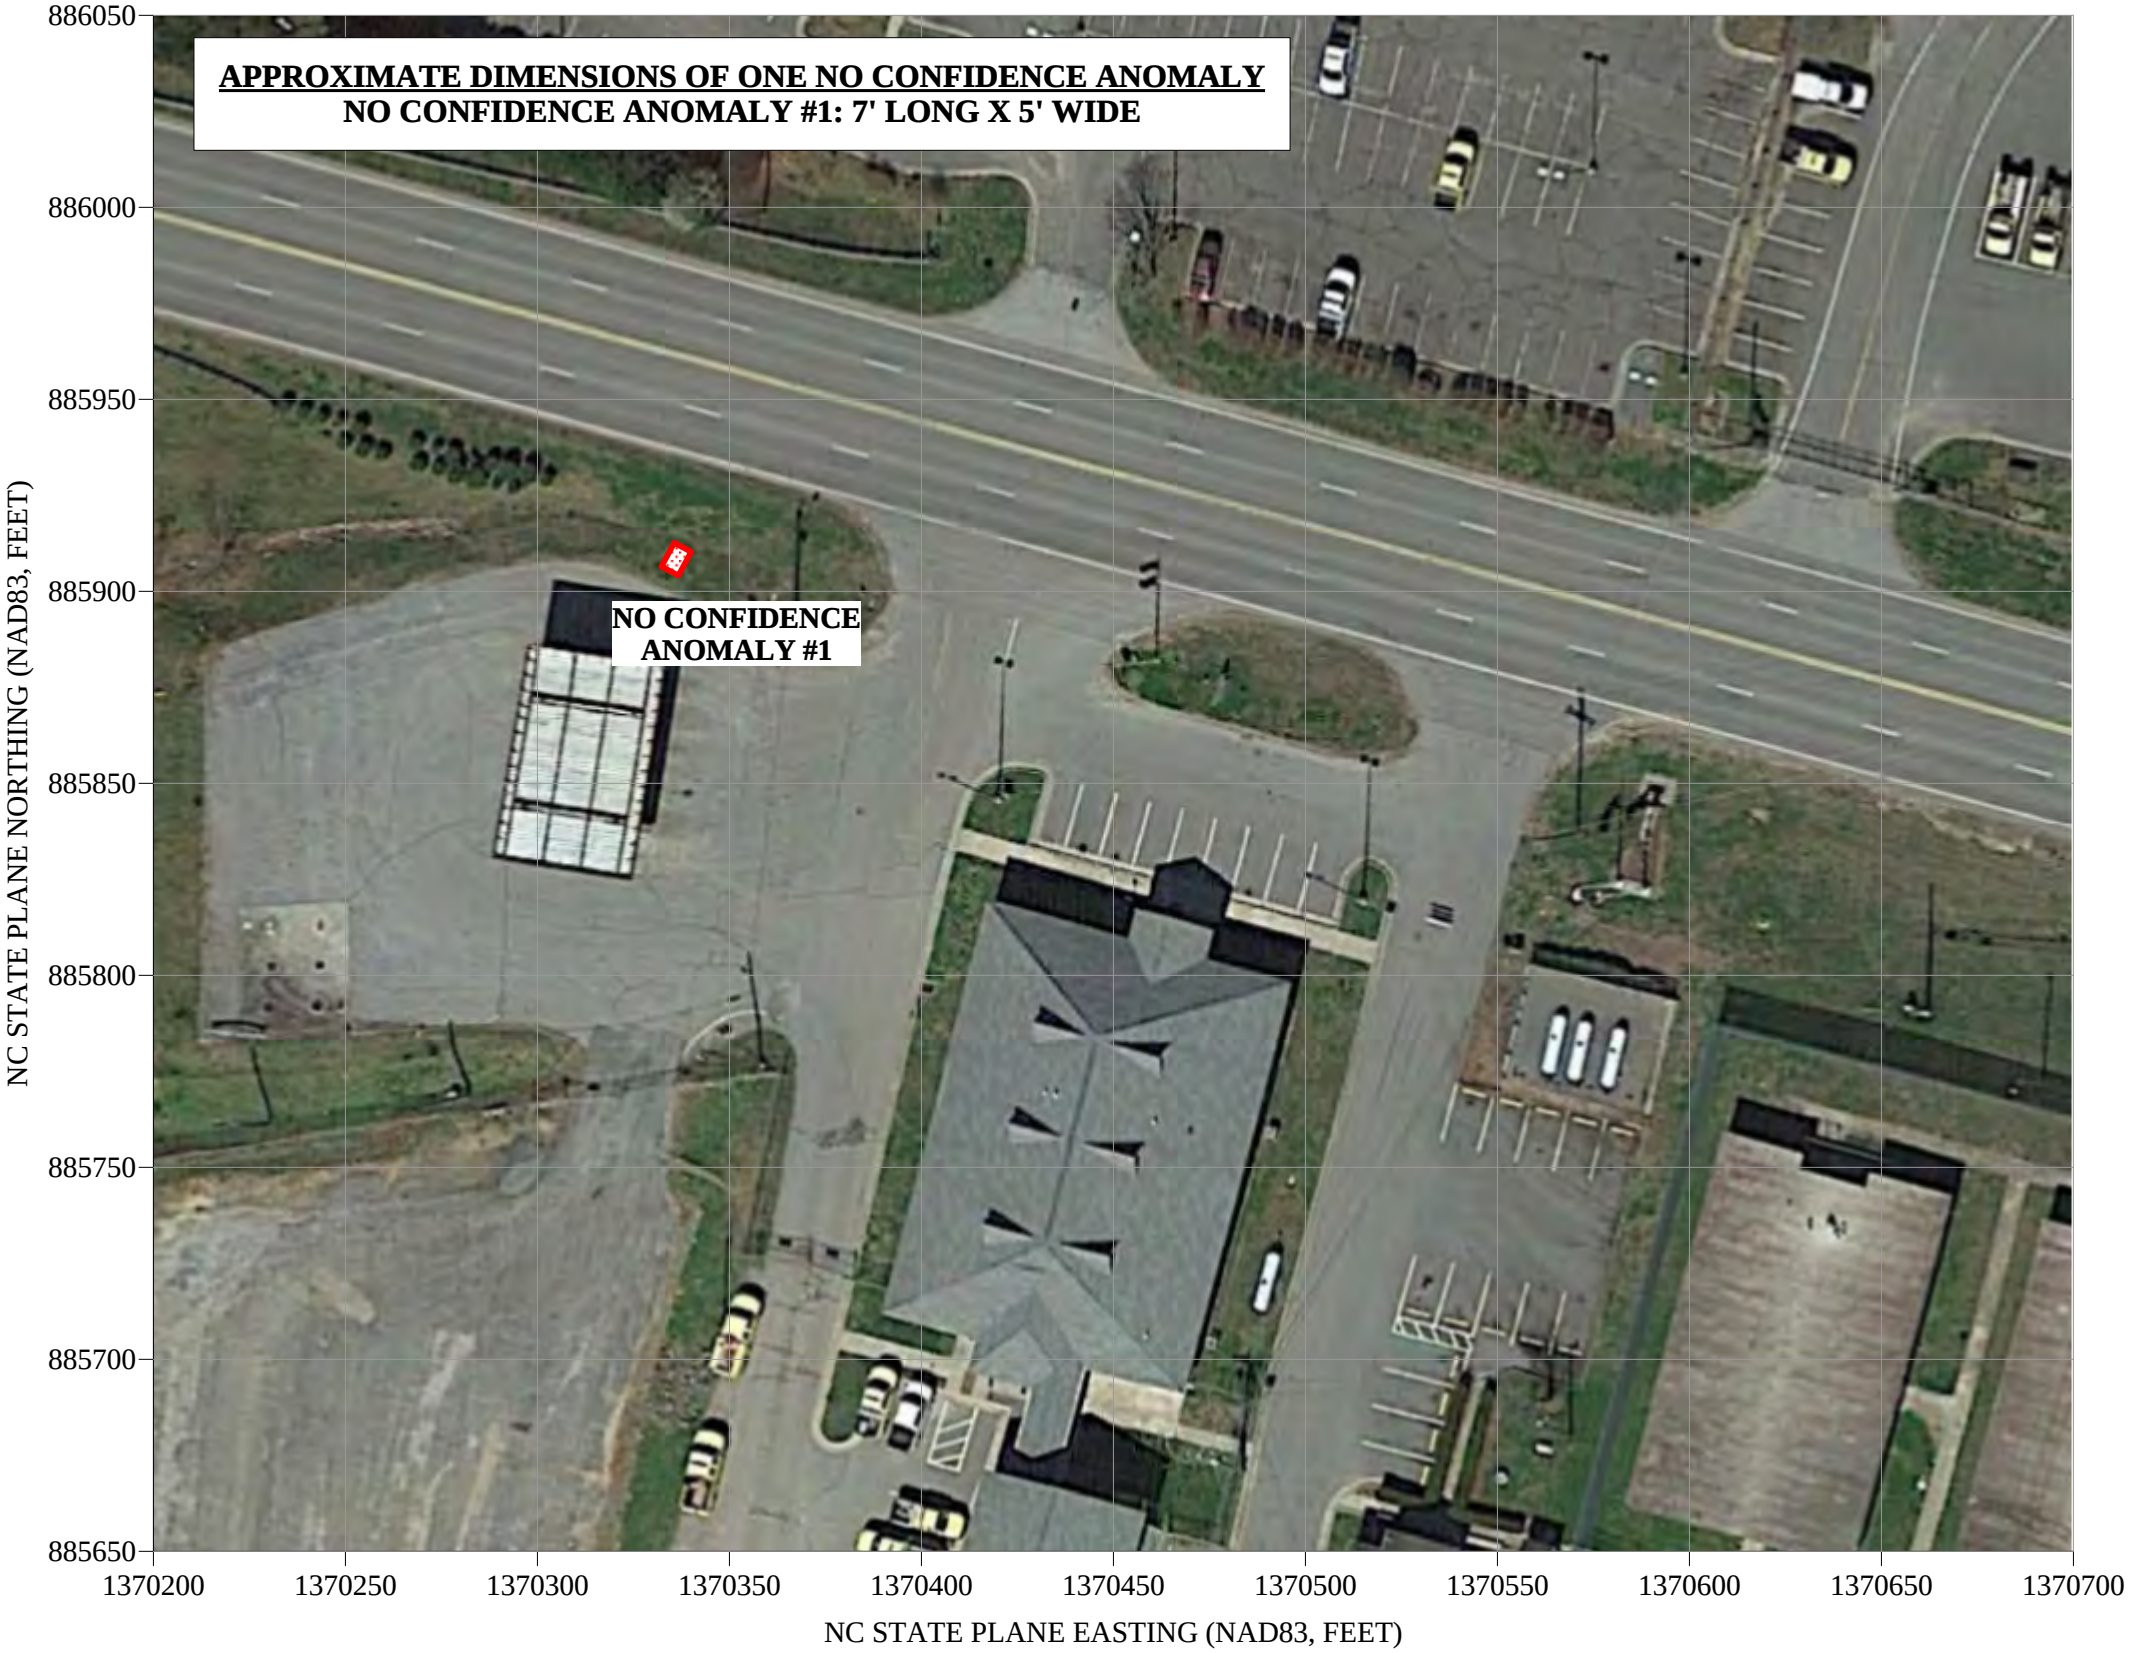
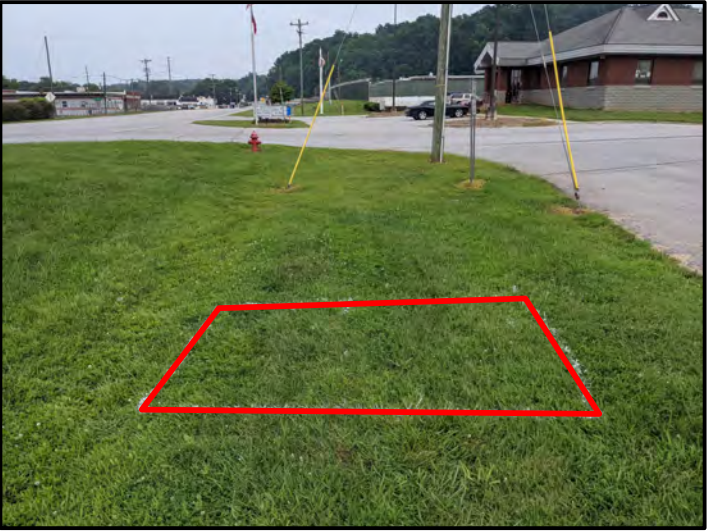
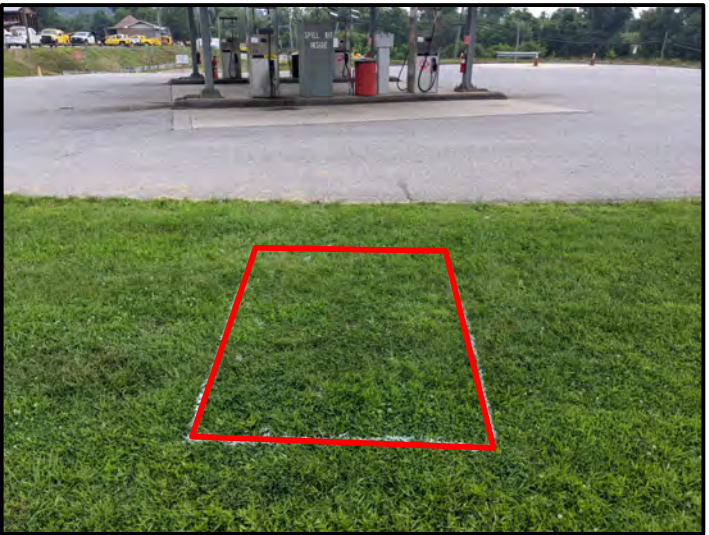
LOCATION OF ONE NO CONFIDENCE ANOMALY

View of One No Confidence Anomaly  
(Facing Approximately East)

View of One No Confidence Anomaly  
(Facing Approximately South)
