**SUBJECT: Preliminary Site Assessment Report  
Parcel 149, Absher, Terry Lee  
WBS Element No. 44691.1.1, TIP No. R-5759  
Proposed widening of NC 115 from US 421 to 2<sup>nd</sup> Street in Wilkesboro and  
North Wilkesboro, Wilkes County, NC  
Kleinfelder Project No. 20221238.001A**

**PRELIMINARY SITE ASSESSMENT REPORT  
PARCEL 149, ABSHER, TERRY LEE  
PIN 1405818  
700 STATESVILLE ROAD  
NORTH WILKESBORO, WILKES COUNTY, NORTH CAROLINA**

**NCDOT WBS ELEMENT 44691.1.1  
STATE PROJECT R-5759  
PROPOSED WIDENING OF NC 115 FROM US 421 TO 2<sup>ND</sup>  
STREET IN WILKESBORO AND NORTH WILKESBORO**

## PRELIMINARY SITE ASSESSMENT REPORT

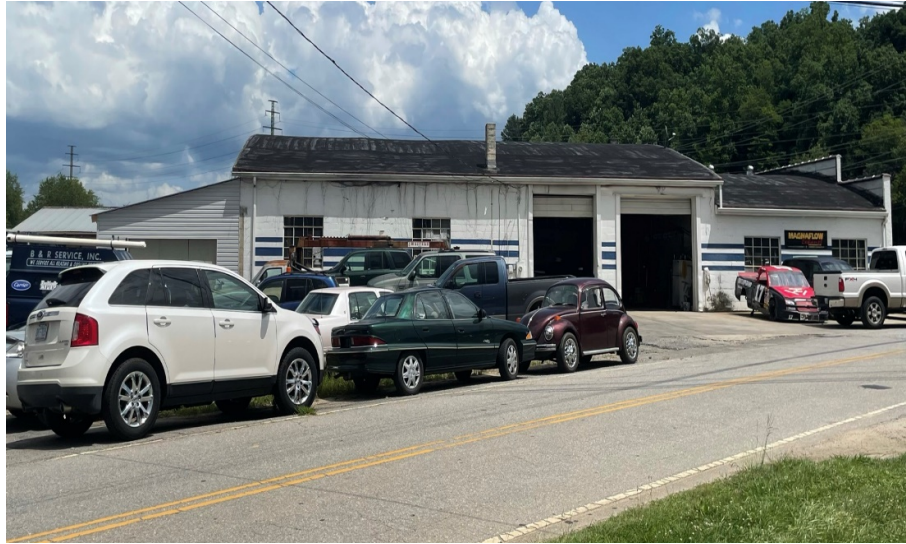
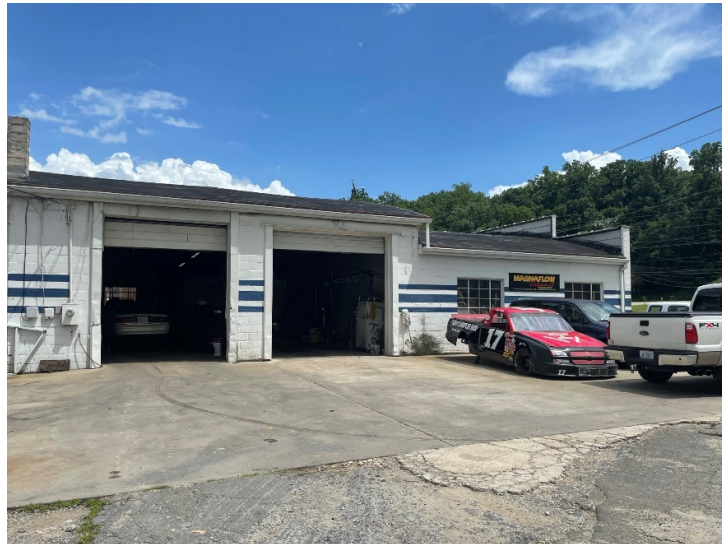
**A-1**

View facing east from the northern portion of the Project Study Area along Veterans Drive, depicting two bay doors of the automotive exhaust service station.

The September 20, 2018 Pre-Scoping Comments letter did not list a Facility ID Number associated with the property, but did identify two bay doors along the western side of the building that may contain in-ground hydraulic lifts. The letter listed anticipated impacts as the possible presence of USTs and petroleum impacted soil and/or groundwater. The proposed NCDOT easement passes through a portion of the parcel that encompasses a portion of the building and suggests that the building may be demolished by the NCDOT.

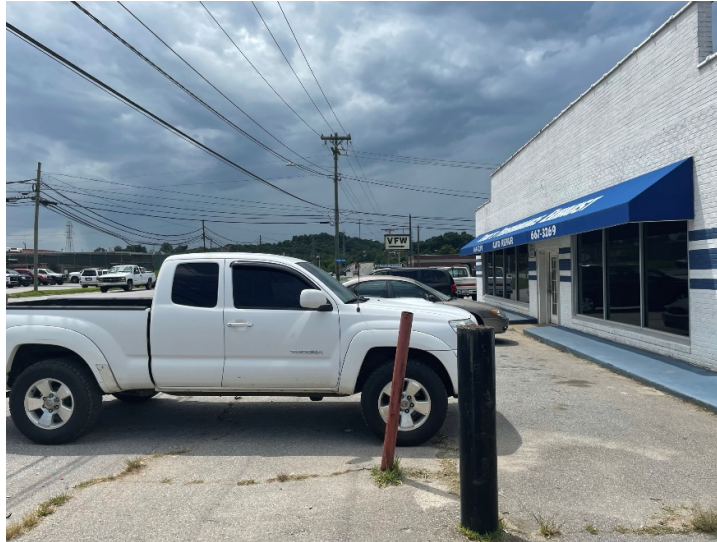
**A-2**

View facing west from the southeastern corner of the Project Study Area along NC 115.

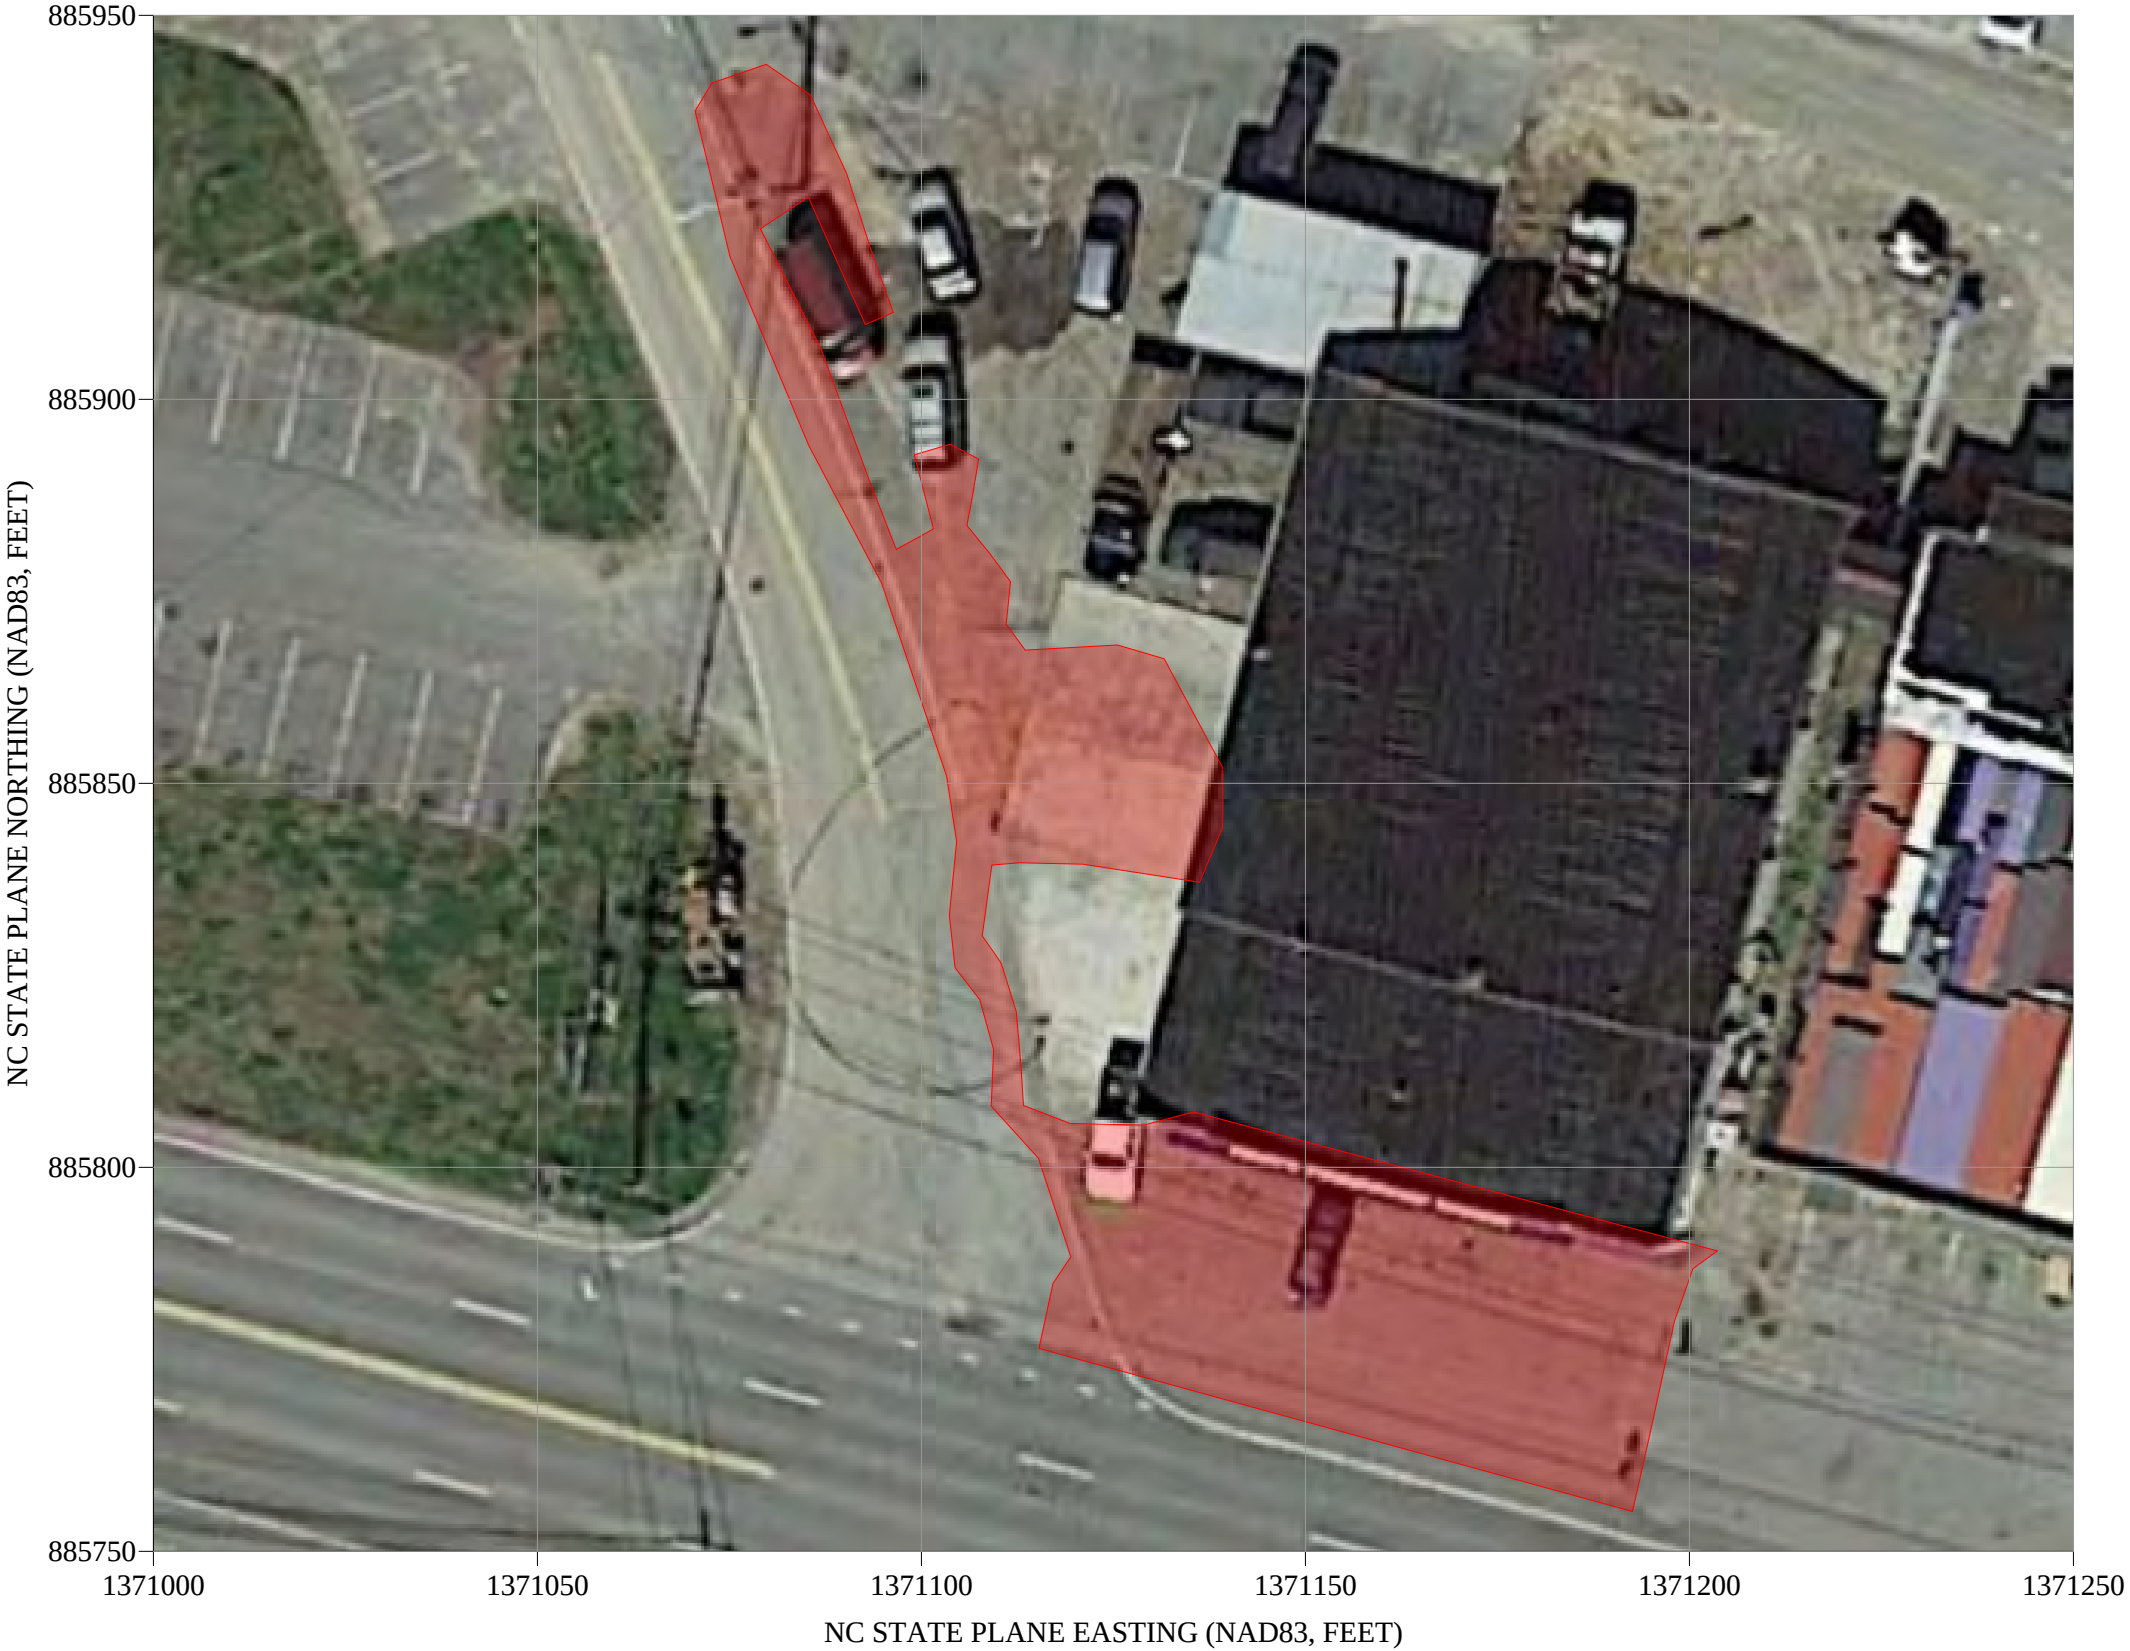
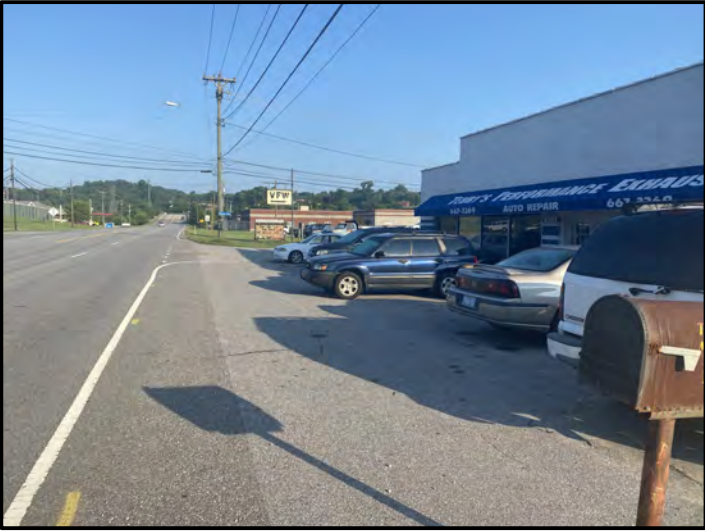
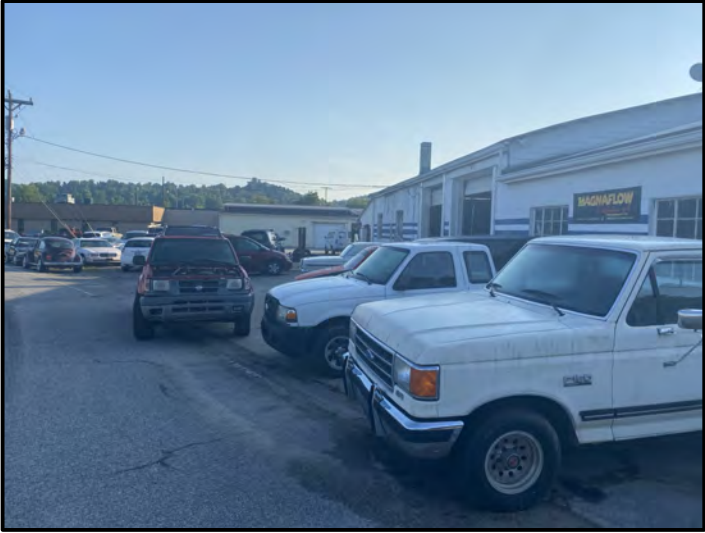
**FIGURE 1**

The site consisted of an automotive repair facility surrounded by asphalt, concrete, and grass surfaces. Most of the site is occupied by vehicles. These areas were not able to be effectively investigated with GPR. These areas could be revisited in a supplemental geophysical investigation should they be cleared of these objects. An aerial photograph showing the survey area boundaries and ground-level photographs are shown in **Figure 1**.

APPROXIMATE BOUNDARIES OF GEOPHYSICAL SURVEY AREA

View of Survey Area (Facing Approximately West)

View of Survey Area (Facing Approximately North)

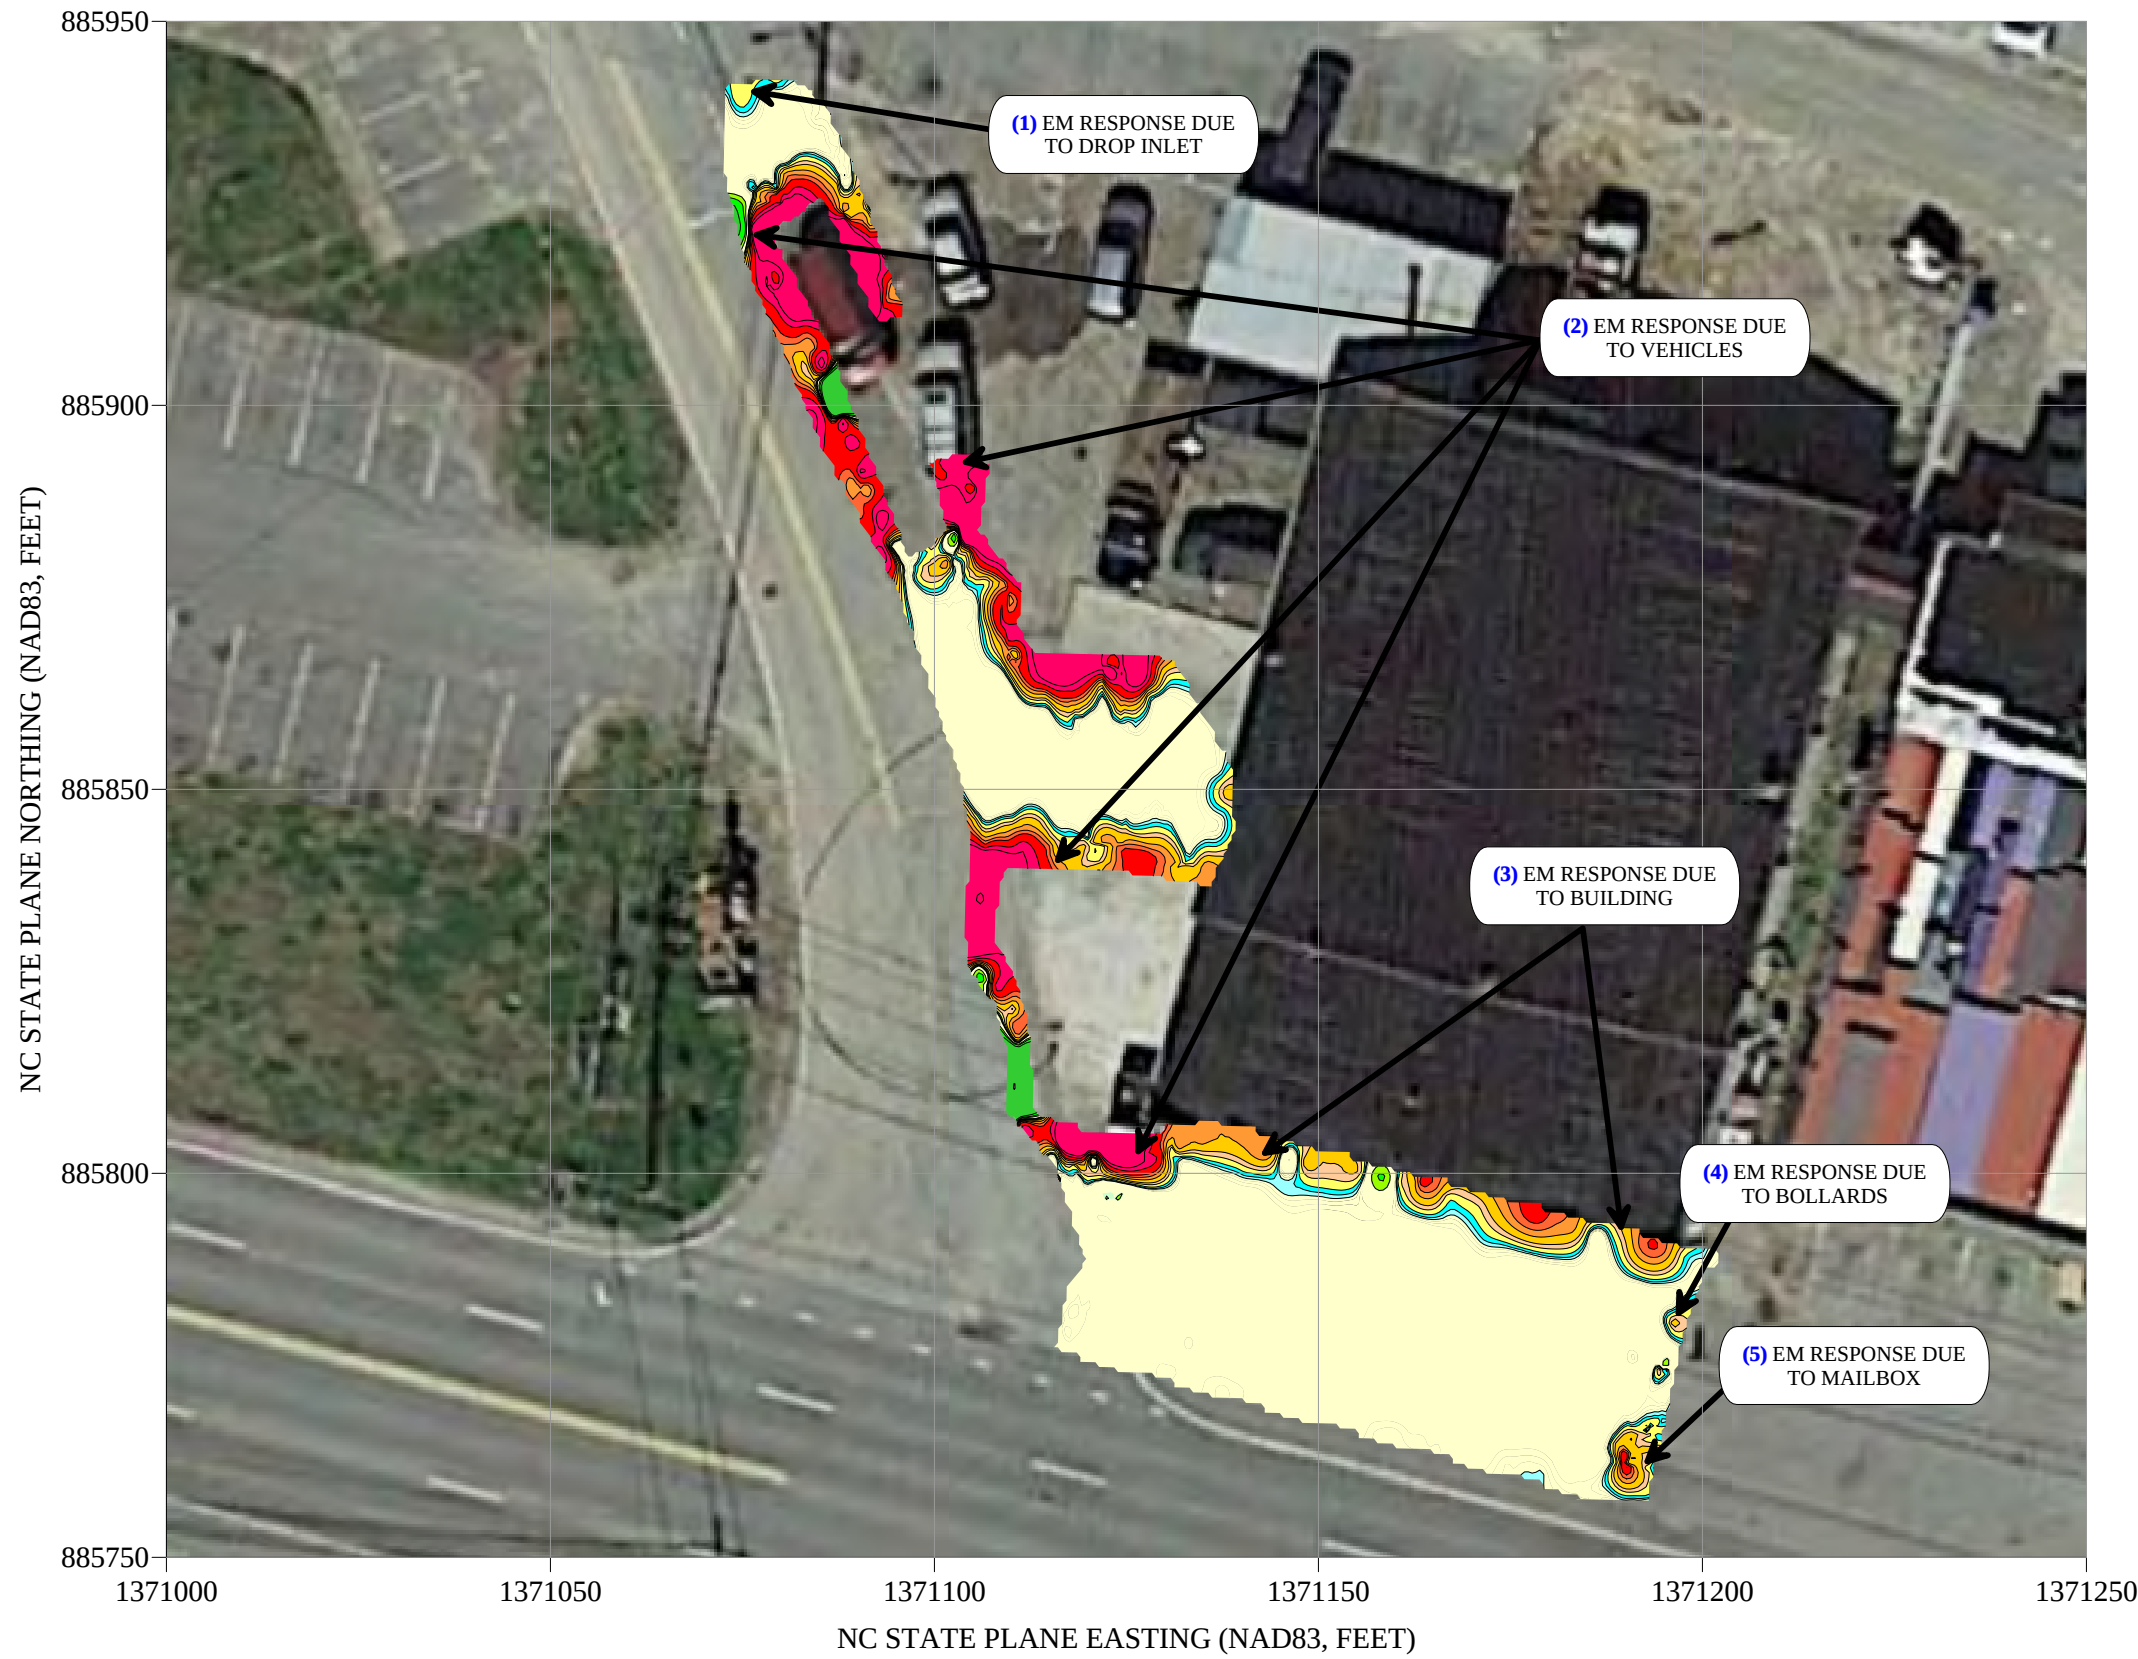
EM61 METAL DETECTION RESULTS

A contour plot of the EM61 results obtained across the survey area at the property is presented in **Figure 2**. Each EM anomaly is numbered for reference in the figure. The following table presents the list of EM anomalies and the cause of the metallic response, if known:

NO EVIDENCE OF METALLIC USTs WAS OBSERVED.

The contour plot shows the differential results of the EM61 instrument in millivolts (mV). The differential results focus on larger metallic objects such as USTs and drums. The EM data were collected on July 16, 2021, using a Geonics EM61-MK2 instrument. Verification GPR data were not collected due to the vehicles at the site. These areas were not able to be effectively investigated with GPR. These areas can be revisited for GPR investigation should they be cleared of these objects.
