Mid-Currituck Bridge

Submerged Aquatic Vegetation Mitigation Plan

May 2020

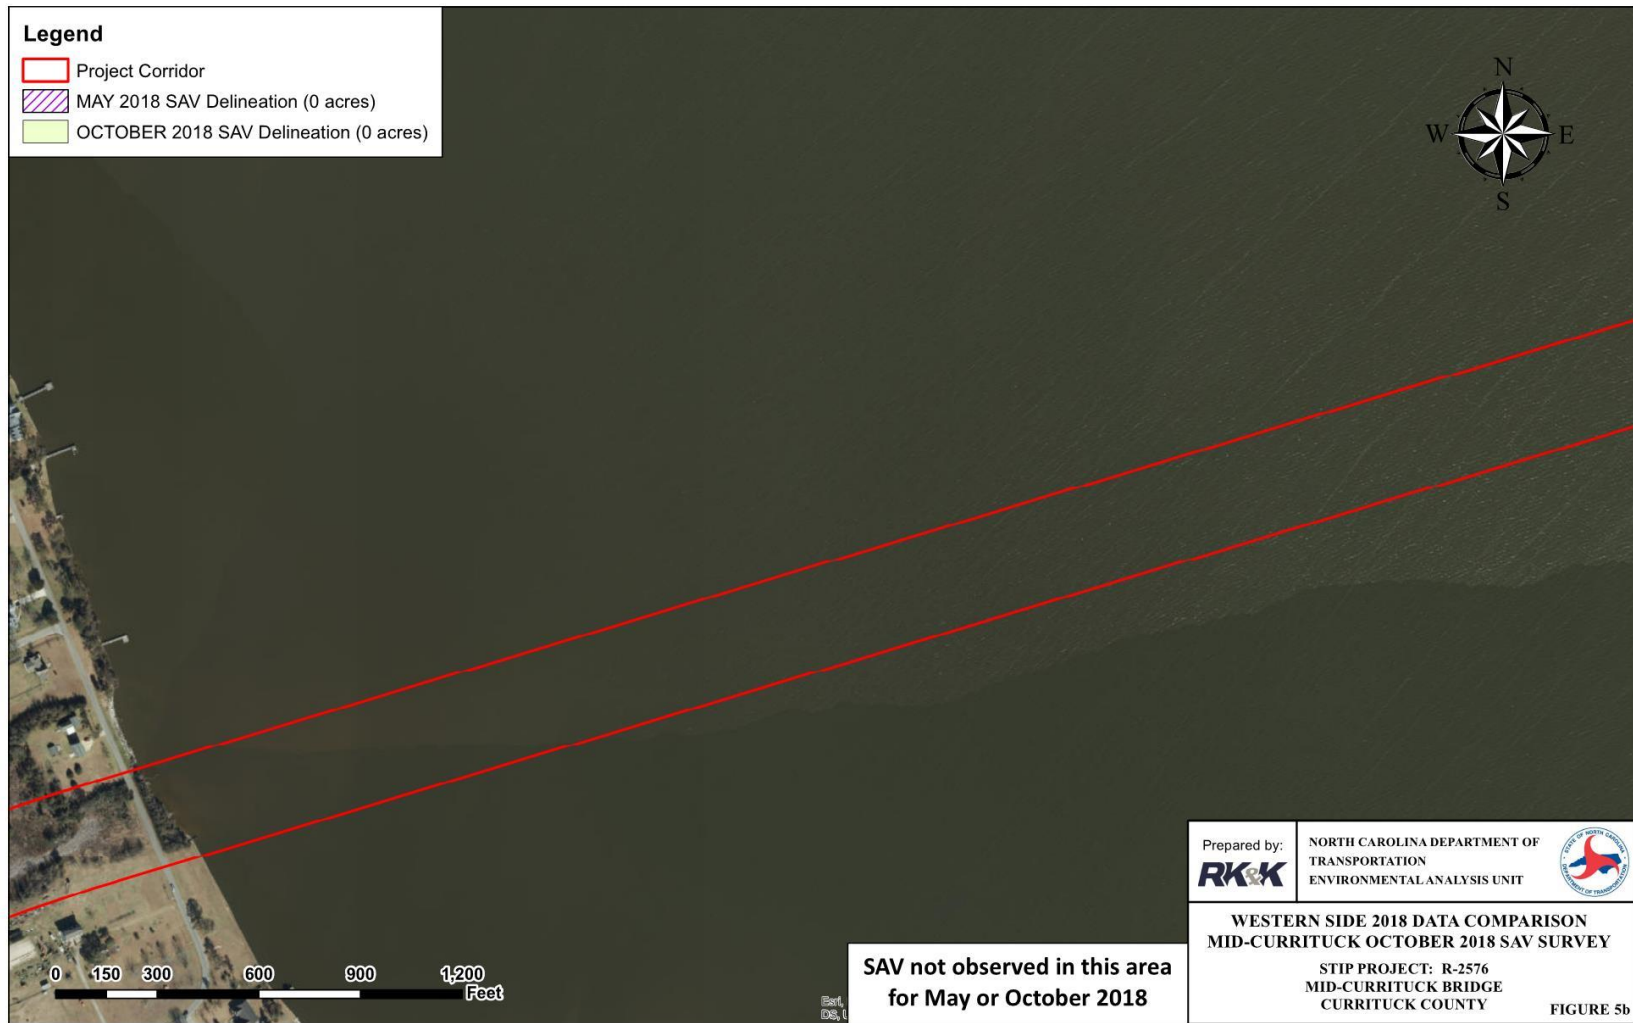
Figure 5b. Mainland (west) end of the proposed Mid-Currituck Bridge alignment showing lack of SAV cover in May and October 2018.

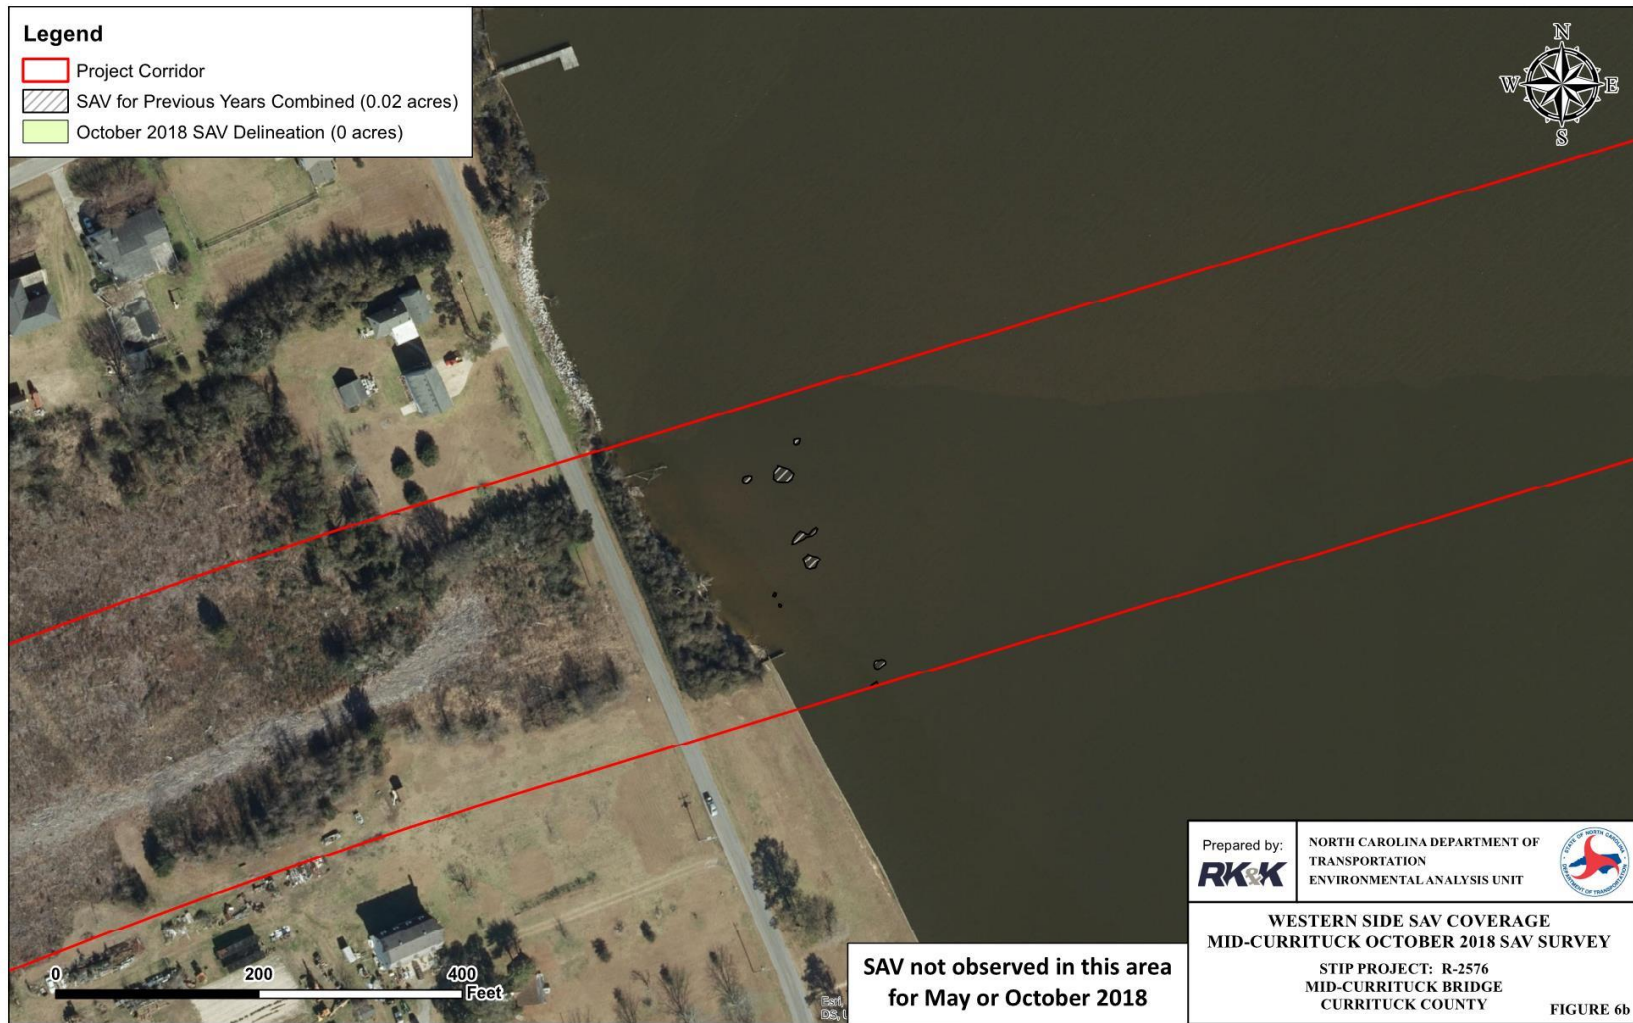
Figure 6b. Mainland (west) end of the proposed Mid-Currituck Bridge alignment showing SAV cover in October 2018 and previous years.
