**Revised Mid-Currituck Bridge  
Submerged Aquatic  
Vegetation Mitigation Plan,  
December 1, 2023 (Final)**

# Revised Mid-Currituck Bridge Submerged Aquatic Vegetation Monitoring and Mitigation Plan

December 1, 2023

DOCUMENT NO. CSA-RKANDK-FL-20-81045-3418-05-REP-01-FIN

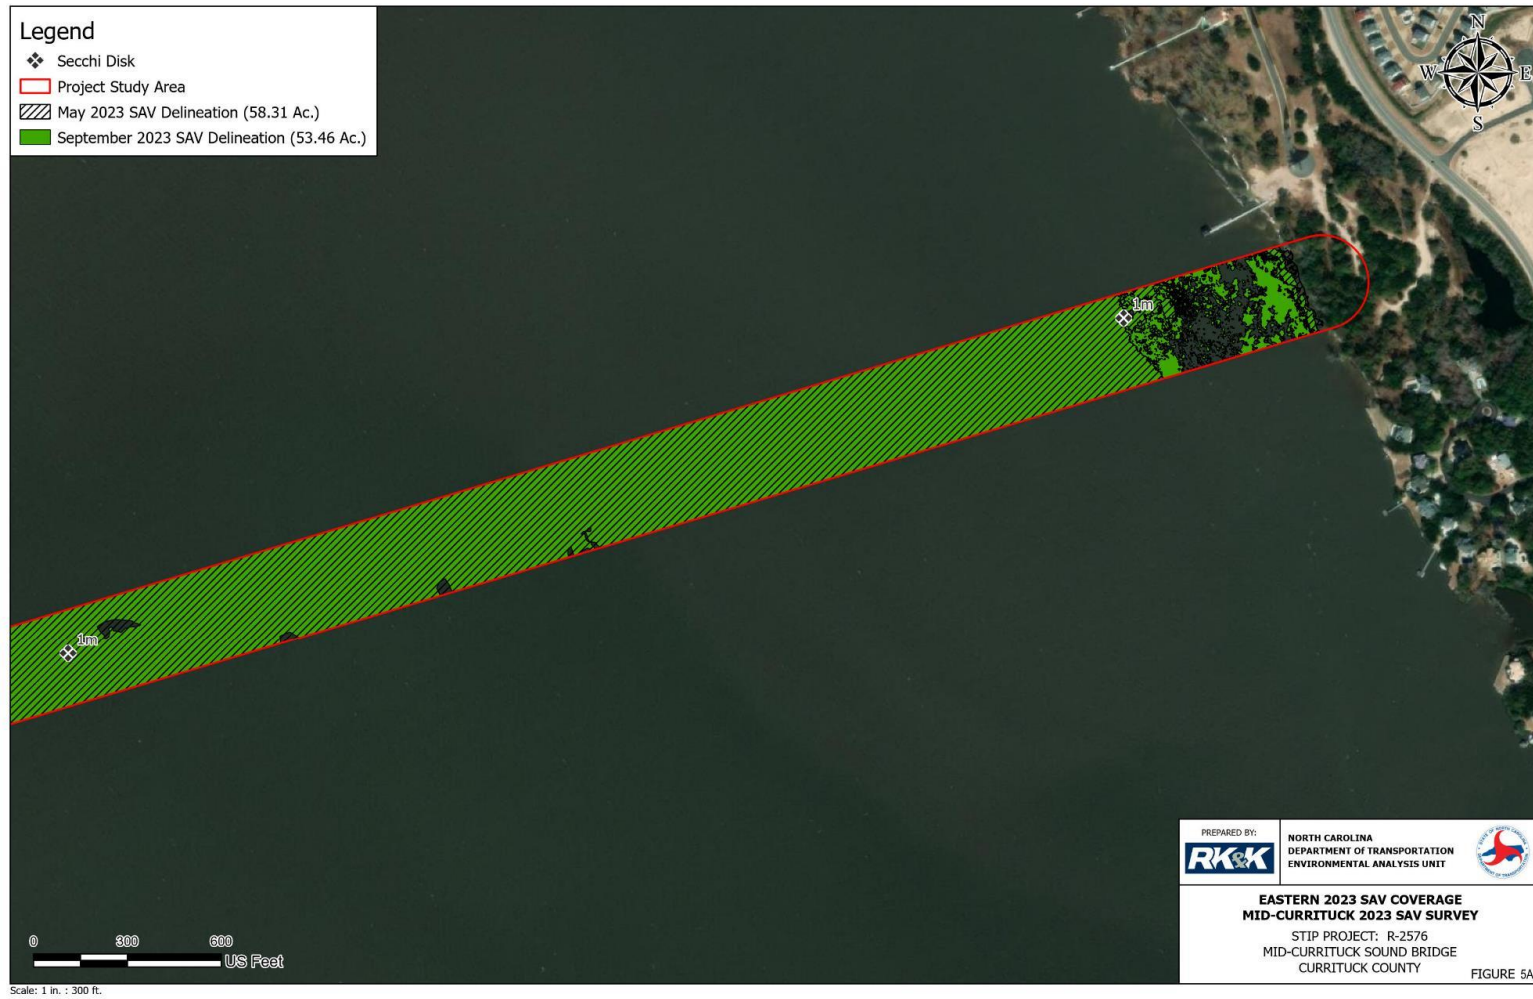
Figure 5a. East end of the proposed Mid-Currituck Bridge alignment showing SAV cover in May and October 2023.

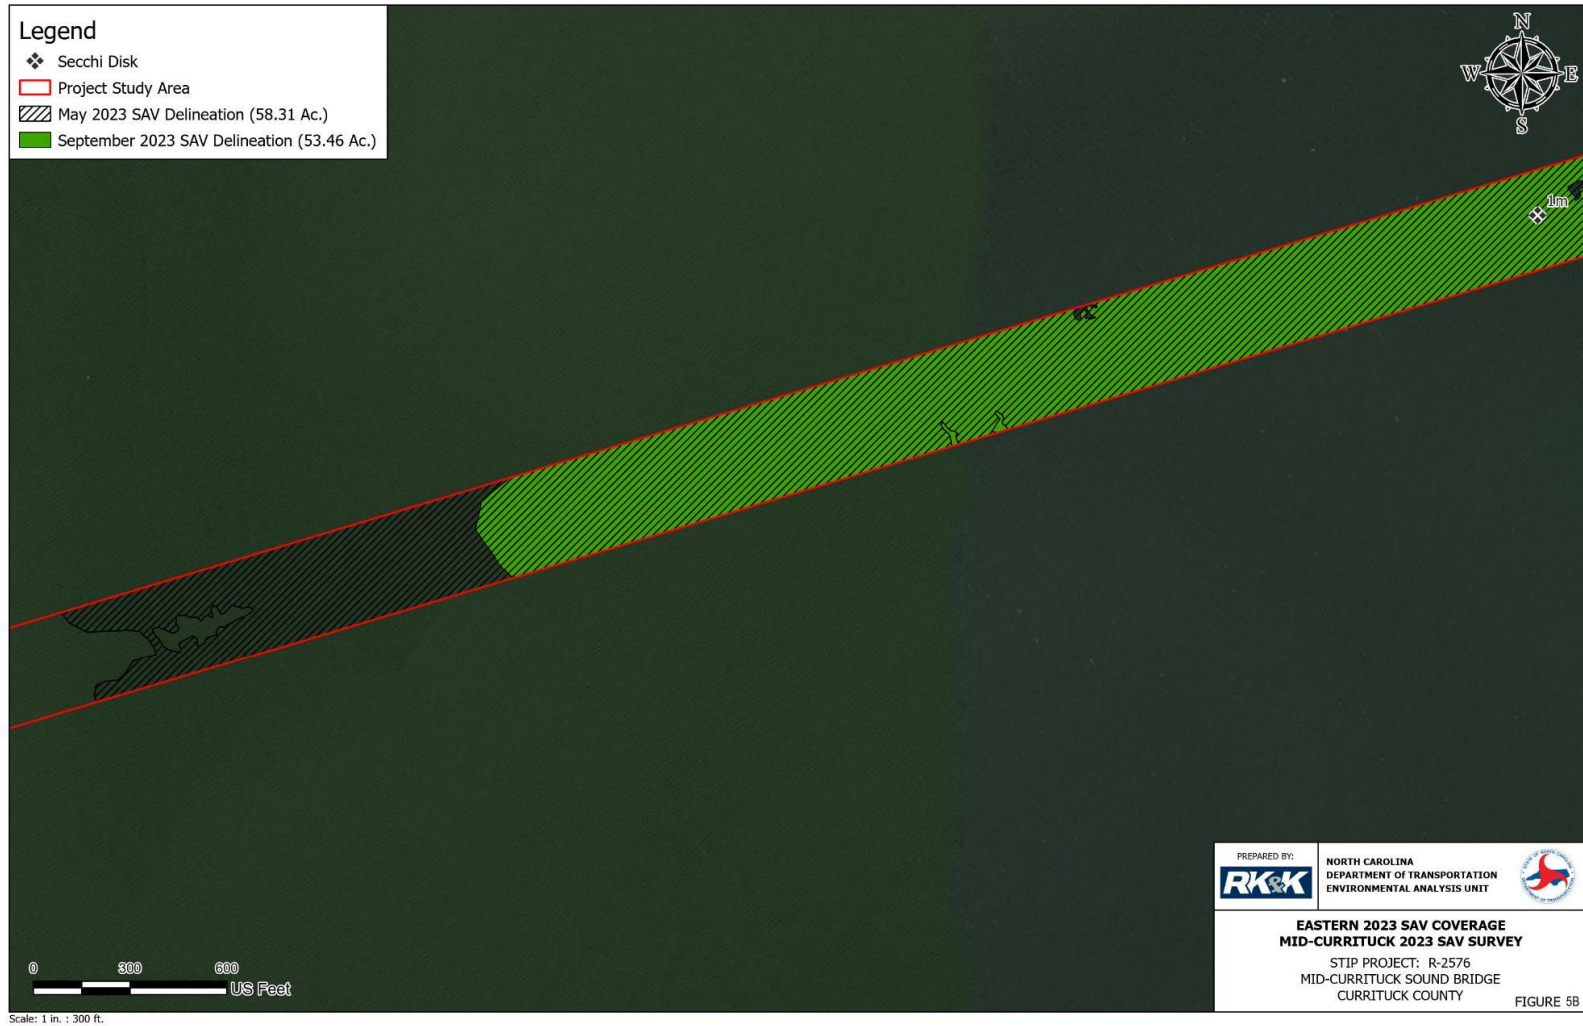
Figure 5b. Middle of the proposed Mid-Currituck Bridge alignment showing SAV cover in May and October 2023.

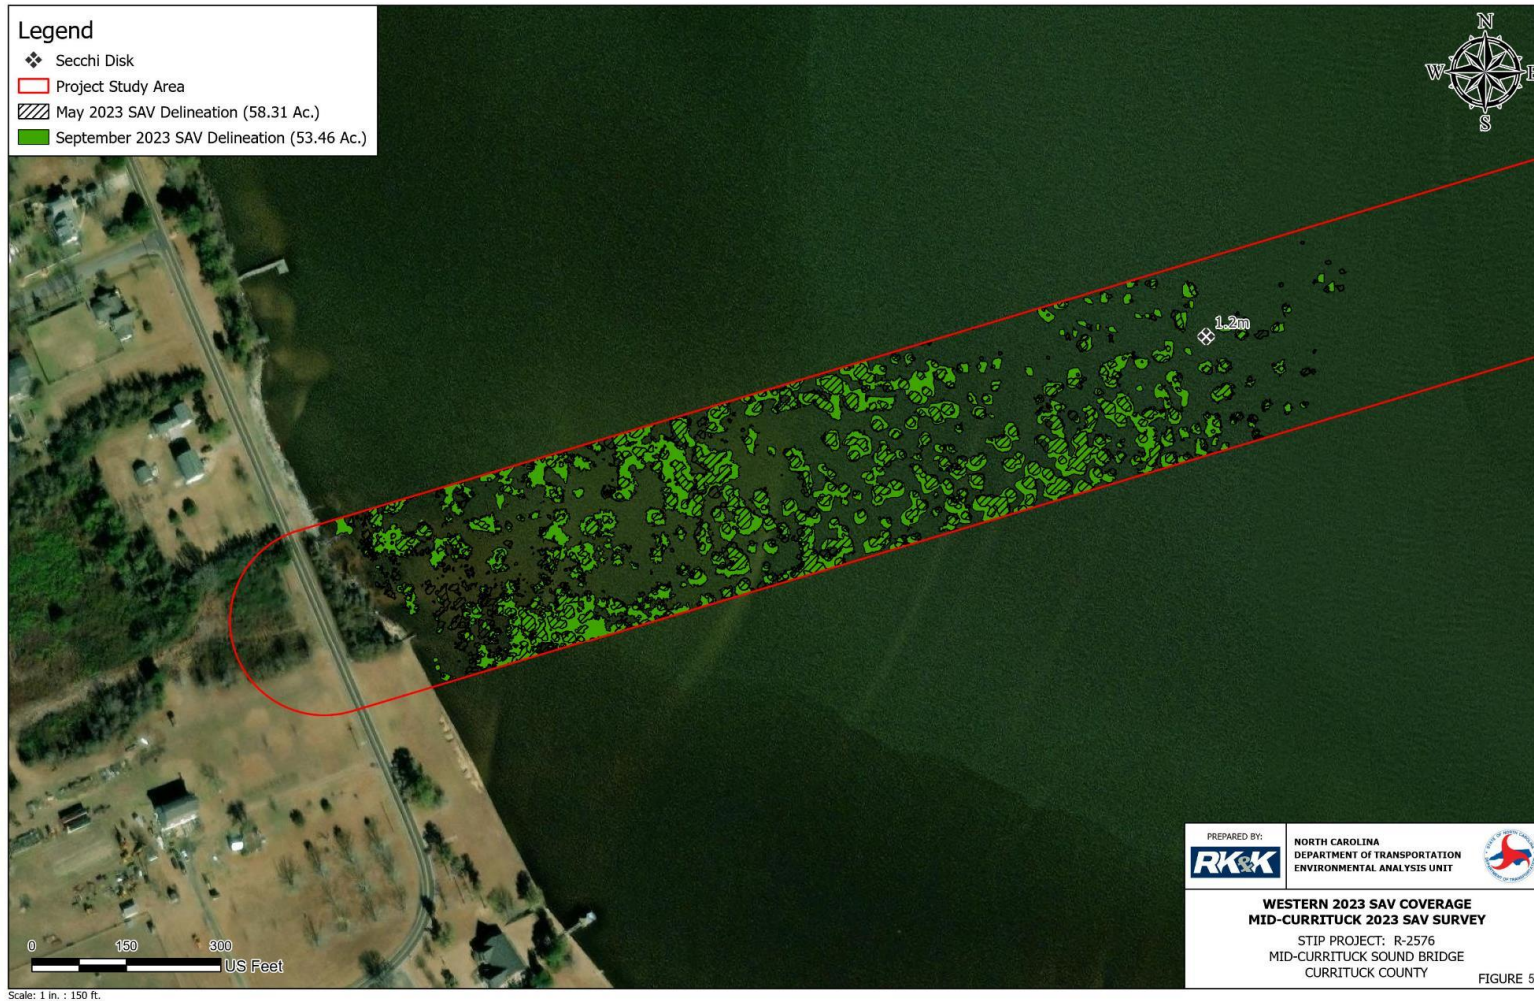
Figure 5c. Mainland (west) end of the proposed Mid-Currituck Bridge alignment showing SAV cover in May and October 2023.

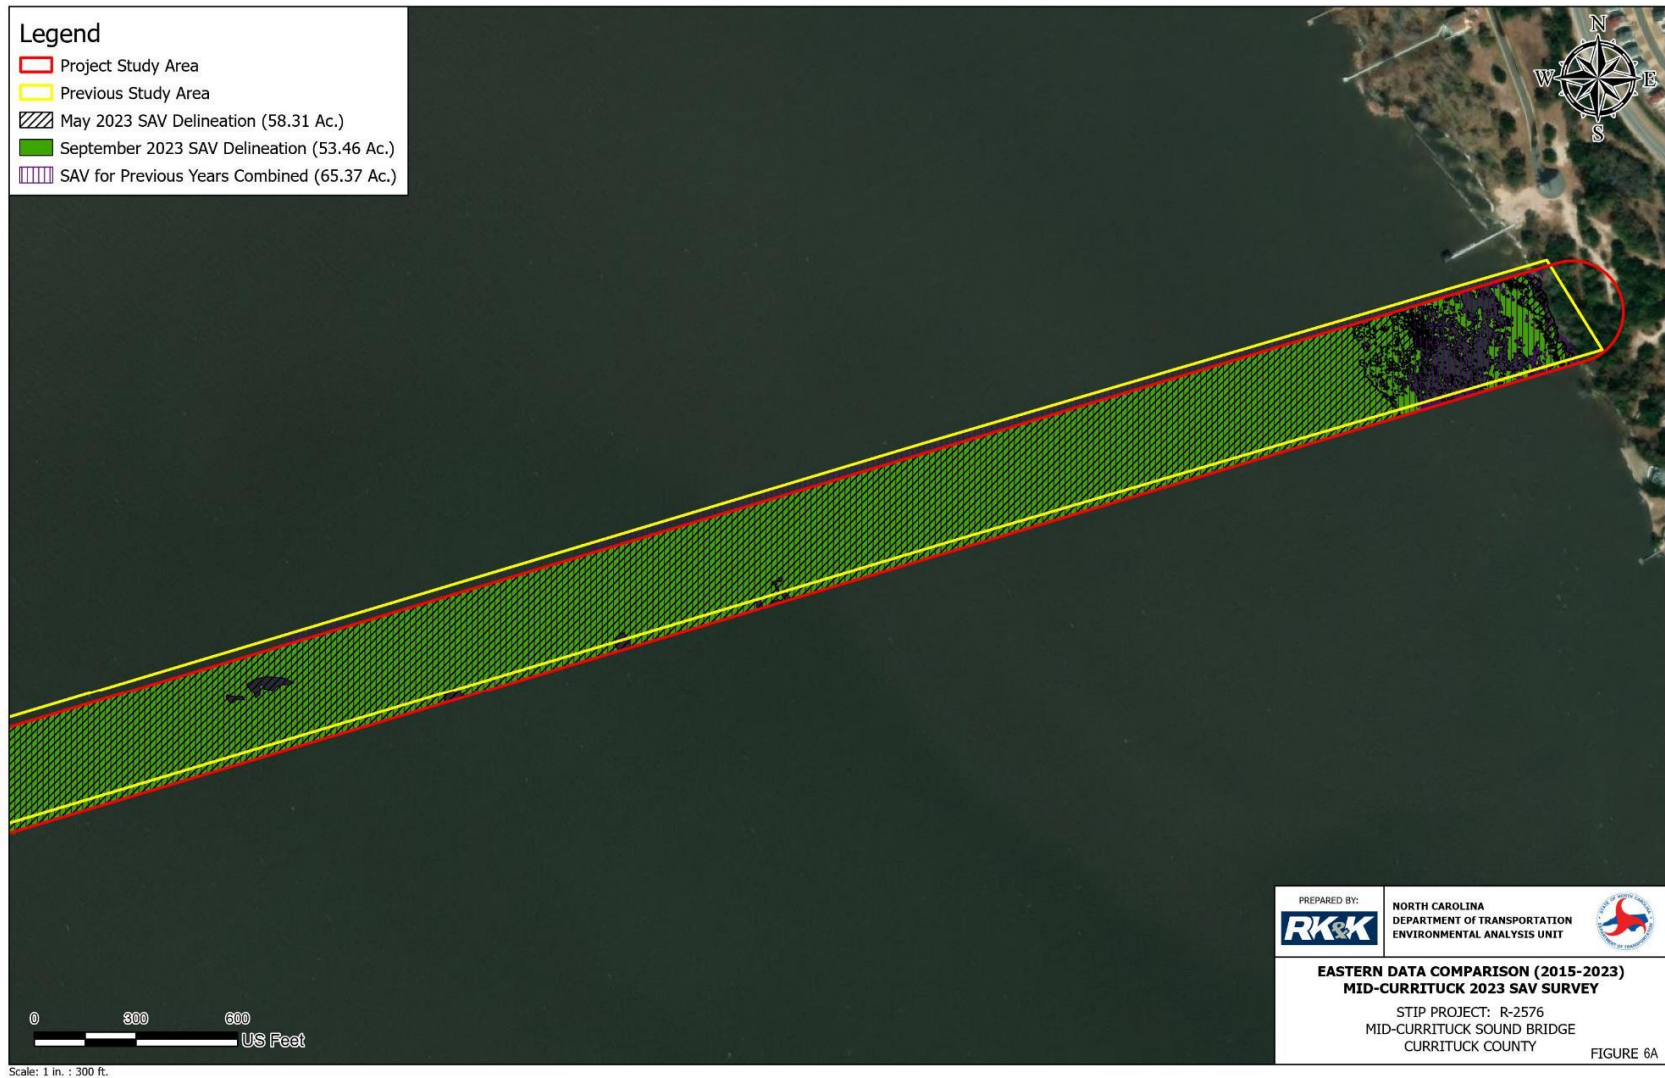
6a. East end of the proposed Mid-Currituck Bridge alignment showing submerged aquatic vegetation (SAV) cover in 2023 and previous years.

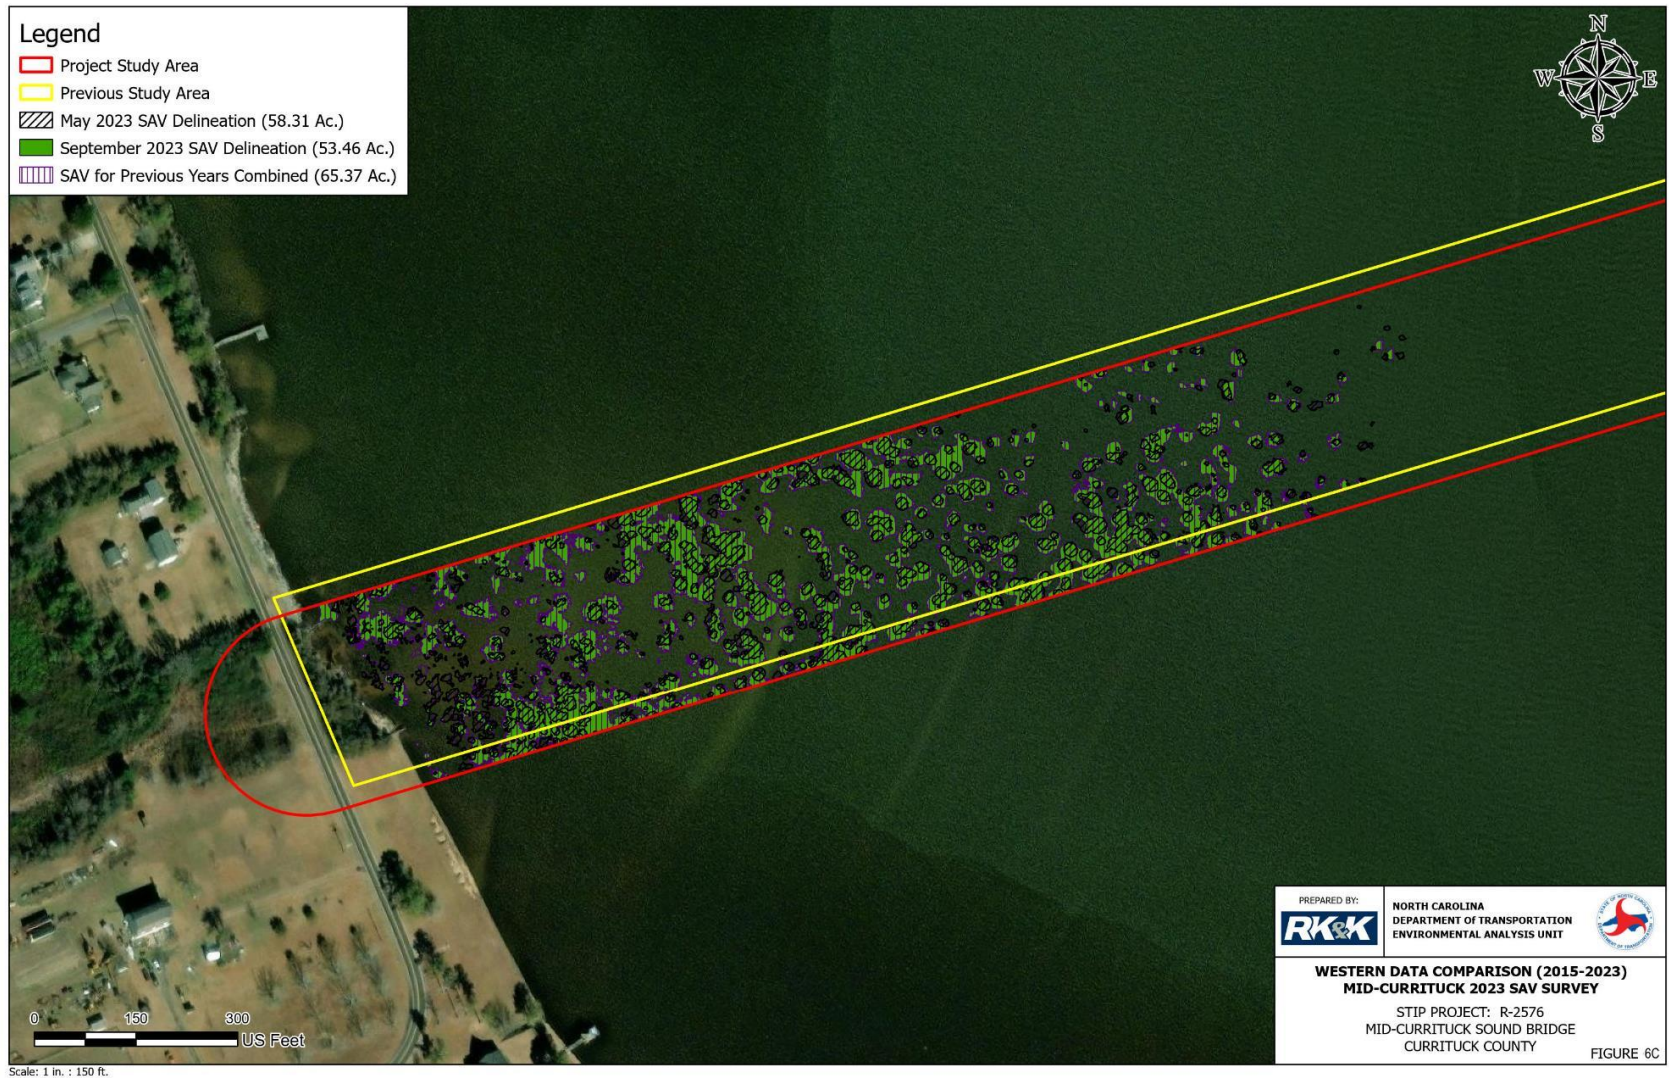
6c. West end of the proposed Mid-Currituck Bridge alignment showing submerged aquatic vegetation (SAV) cover in 2023 and previous years.

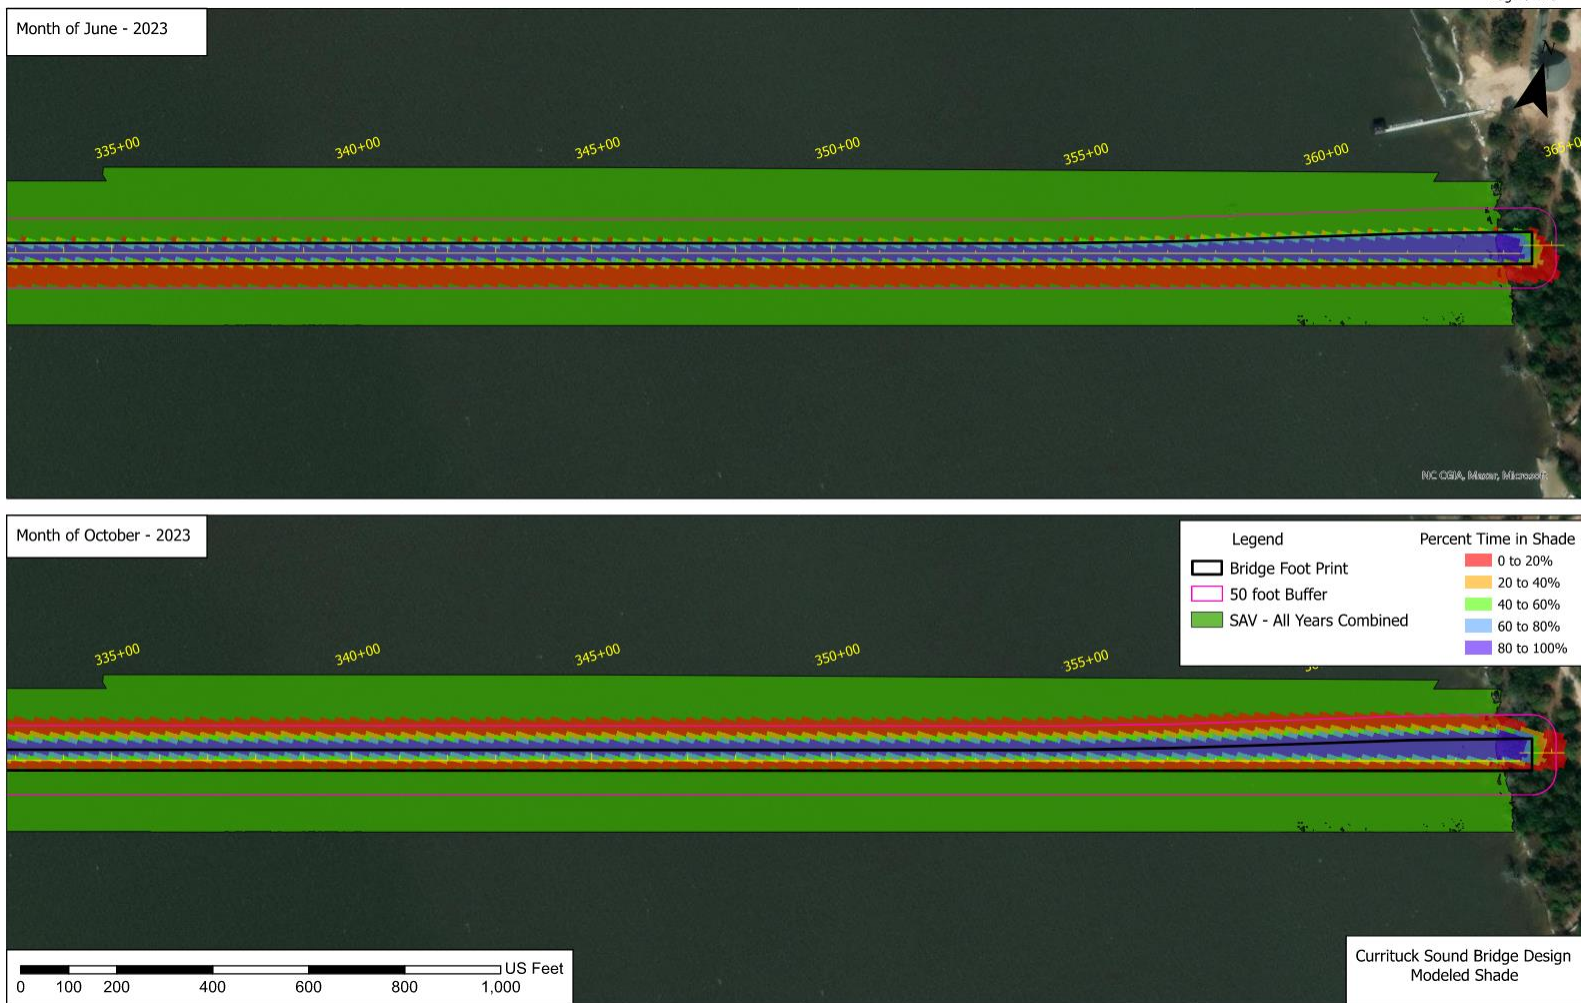
Figure 7d. East end of the proposed Mid-Currituck Bridge alignment showing SAV cover, and various gradations of shading predicted by the shading tool for June and October 2023. *Please zoom in on electronic version to better view legend.*

Estimations of acreage of SAV within the alignment corridor affected by varying percent time in shade was calculated by the shading tool for the alignment in June (**Table 3**) and October 2023 (**Table 4**). Results from the shading tool will be verified with field-based monitoring, which will include photosynthetic active radiation (PAR) measurements at the water’s surface and SAV abundance and density estimations for each of the five shading strata.
