# Re: R-2576 - Proposed Mid-Currituck Sound Bridge - Submerged Aquatic Vegetation Survey 2023 Monitoring Report

RK&K is pleased to provide you with the 2023 submerged aquatic vegetation (SAV) monitoring report for R-2576 (Mid-Currituck Sound Bridge).

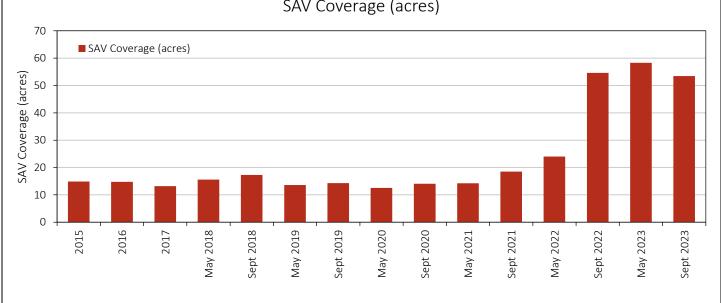
Year	SAV Coverage (acres)
2015	14.90
2016	14.78
2017	13.17
May 2018	15.59
September 2018	17.26
May 2019	13.59
September 2019	14.32
May 2020	12.57
September 2020	14.06
May 2021	14.22
September 2021	18.50
May 2022	24.01
September 2022	54.59
May 2023	58.31
September 2023*	53.46

#### Table 1. Submerged Aquatic Vegetation (SAV) coverage by year for R-2576 (Mid-Currituck Sound Bridge)

\*Tropical Storm Ophelia landfall occurred on September 21, 2023. This storm event may have impacted SAV in the area.

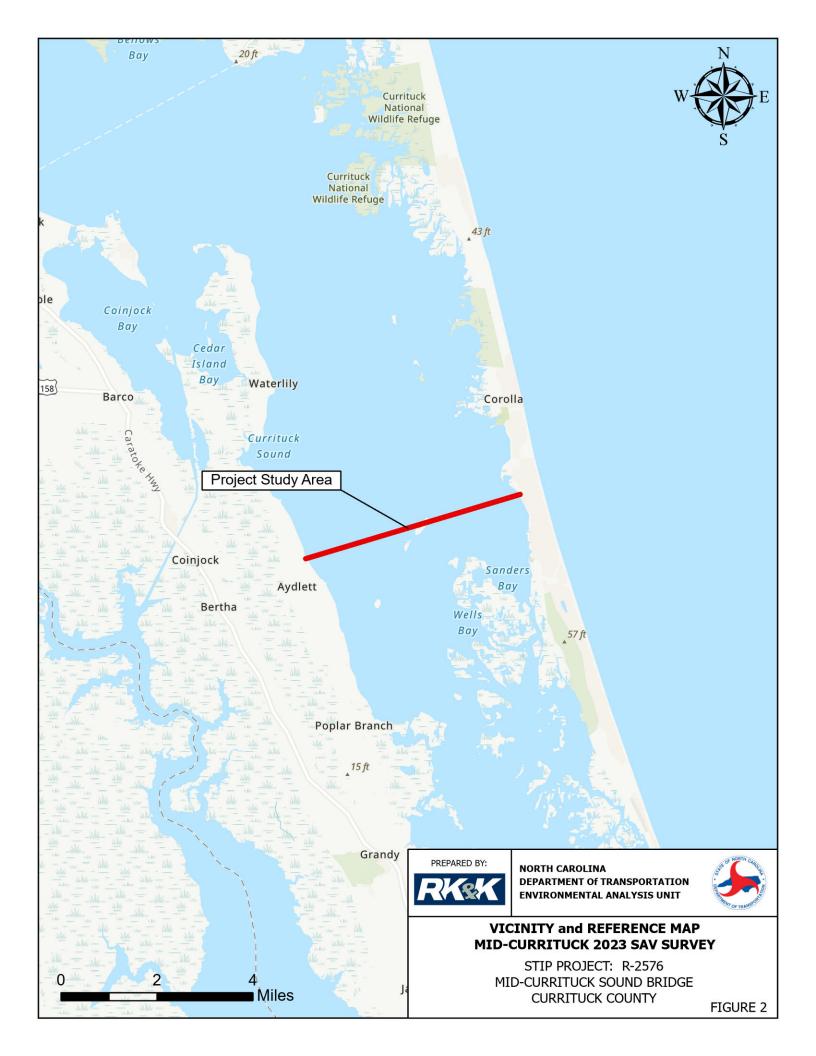
FIGURE 3A

- Secchi Disk
- Project Study Area
- May 2023 SAV Delineation (58.31 Ac.)
- September 2023 SAV Delineation (53.46 Ac.)

Delineated SAV within the project study area was 58.31 acres in May 2023 and 53.46 acres in September 2023 (Figures 3A-3C). The western terminus of the project area was previously void of SAV. However, since May of 2022, this area has experienced substantial growth (Figure 3C). Across the study area, SAV was observed in water depths down to -7.4 feet, not accounting for daily wind or tide variations. Deeper open waters (> -7.4 feet) were assessed and no SAV was located. Water clarity was measured with a Secchi disk and ranged from 1m to 1.2m in May and 0.4m to 1m in September (Figure 3A-3C). From 2015 to May 2021, SAV coverage has remained relatively constant throughout the study area; however, since the September 2021 survey, a steady increase in SAV coverage has been observed with a substantial increase starting in 2022 (Table 1 and Figure 1). There are likely multiple factors contributing to the increase in SAV. Favorable climate conditions have been observed in recent years, including the absence of large storm events and warmer water temperatures during the winter. These climate influences can create stable conditions and reduce turbidity. When turbidity is reduced, photosynthetically active radiation (PAR) can enhance SAV growth.

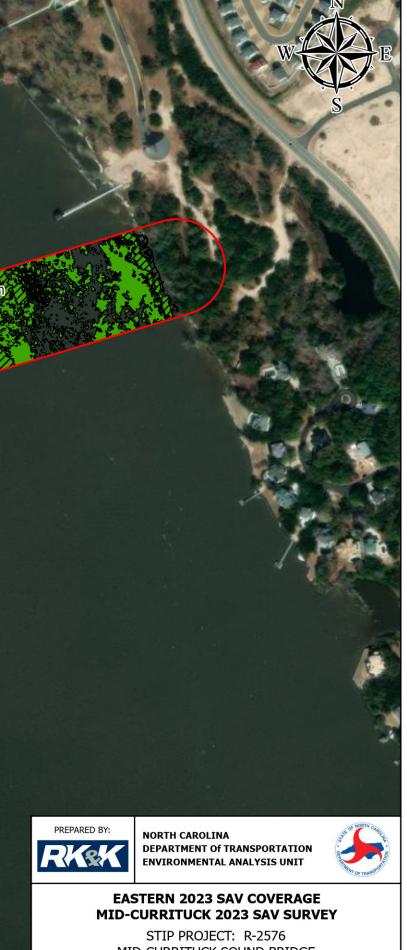
- Secchi Disk
- Project Study Area
- May 2023 SAV Delineation (58.31 Ac.)
- September 2023 SAV Delineation (53.46 Ac.)

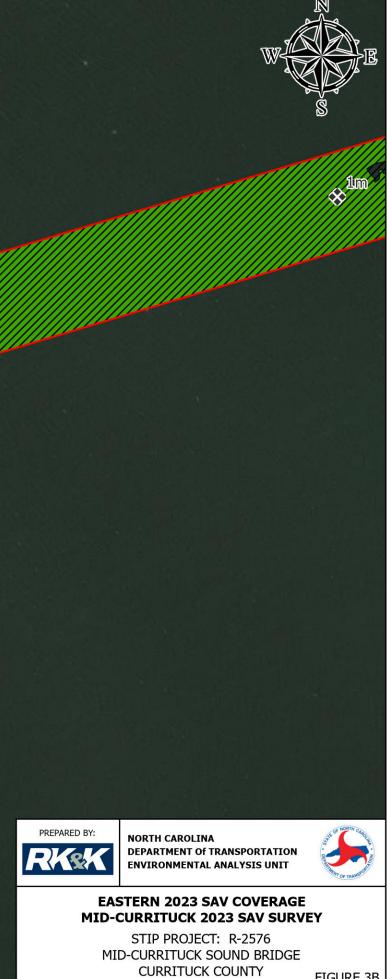
FIGURE 3B

- Secchi Disk
- Project Study Area
- May 2023 SAV Delineation (58.31 Ac.)
  - September 2023 SAV Delineation (53.46 Ac.)

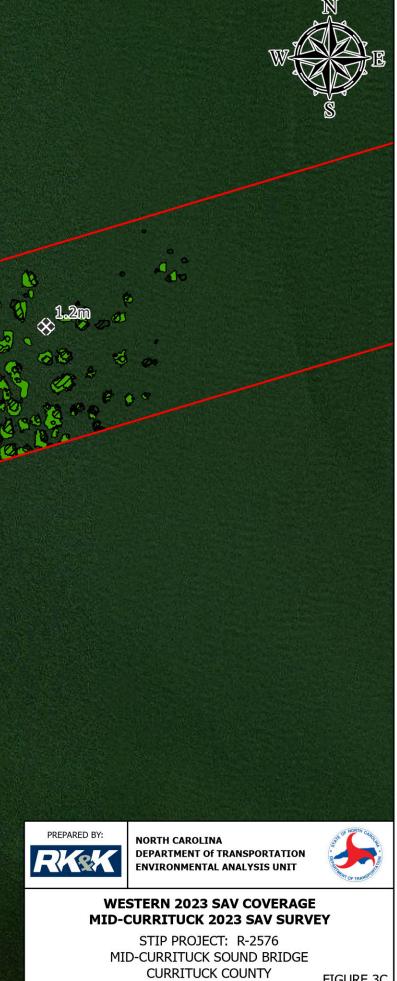
FIGURE 3C

- Project Study Area
- Previous Study Area
- May 2023 SAV Delineation (58.31 Ac.)
- September 2023 SAV Delineation (53.46 Ac.)
- SAV for Previous Years Combined (65.37 Ac.)

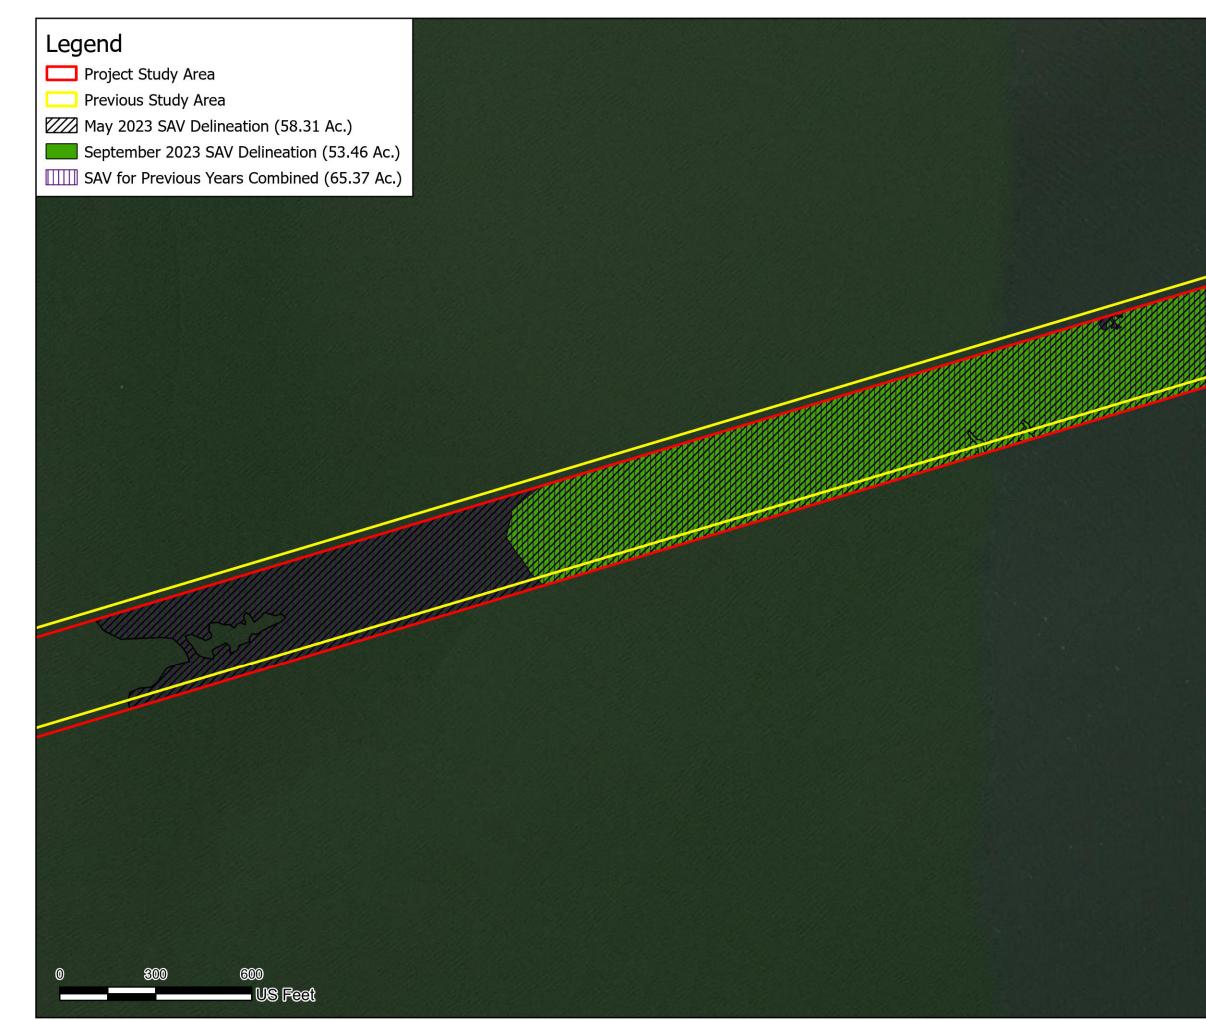
FIGURE 4B

EASTERN DATA COMPARISON (2015-2023) MID-CURRITUCK 2023 SAV SURVEY

- Project Study Area
- Previous Study Area
- May 2023 SAV Delineation (58.31 Ac.)
- September 2023 SAV Delineation (53.46 Ac.)
- SAV for Previous Years Combined (65.37 Ac.)

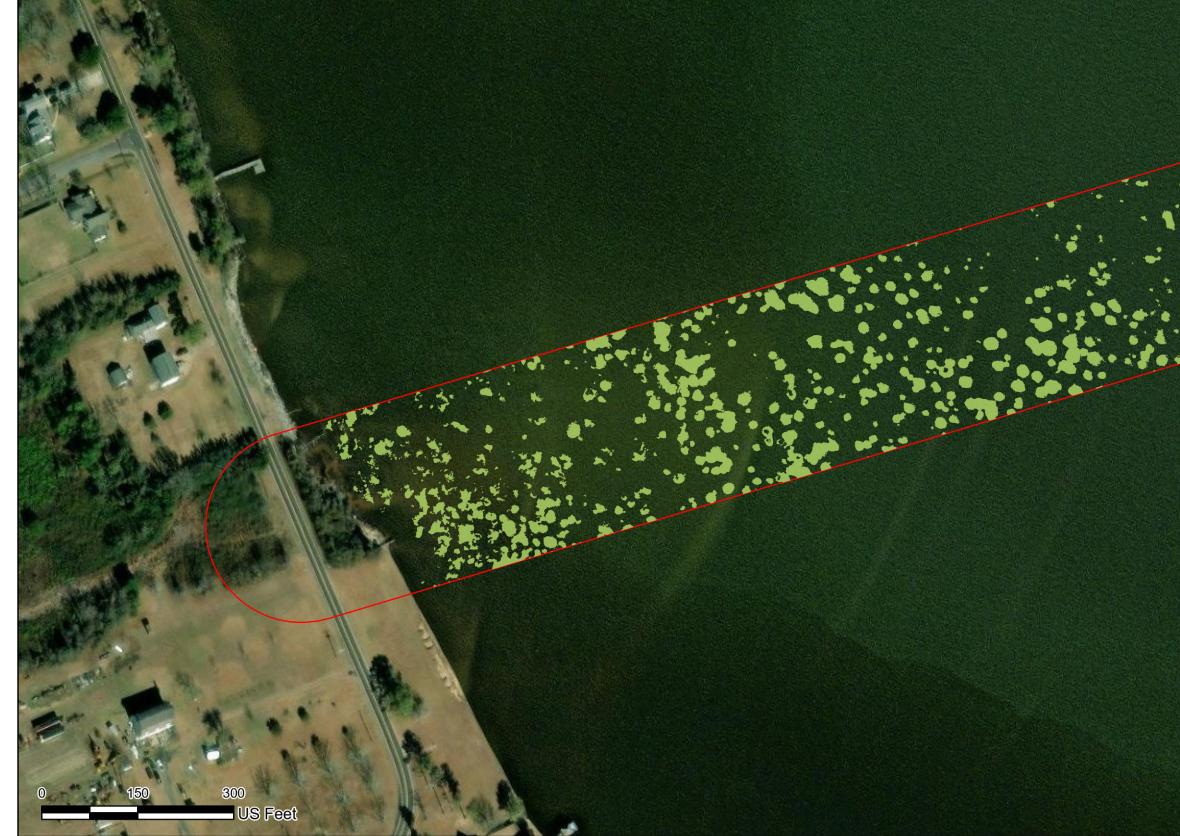
FIGURE 5A

EASTERN SPECIES COMPOSITION MID-CURRITUCK MAY 2023 SAV SURVEY

Vallisneria americana (VA), Myriophyllum spicatum (MS), and Ruppia maritima (RM)

Six species of SAV were identified during the May 2023 assessment: widgeon grass (*Ruppia maritima*), Eurasian watermilfoil (*Myriophyllum spicatum*), tapegrass (*Vallisneria americana*), southern waternymph (*Najas guadalupensis*), perfoliate pondweed (*Potamogeton perfoliatus*), and muskgrass (*Chara spp.*) (Figure 5A). Five species of SAV were identified during the September 2023 assessment: widgeon grass (*Ruppia maritima*), Eurasian watermilfoil (*Myriophyllum spicatum*), tapegrass (*Vallisneria americana*), southern waternymph (*Najas guadalupensis*) and perfoliate pondweed (*Potamogeton perfoliatus*), southern waternymph (*Najas guadalupensis*) and perfoliate pondweed (*Potamogeton perfoliatus*) (Figure 6). Distribution and percent cover of these species is illustrated in Figures 5 - 8. Due to the scarcity (and random distribution) of perfoliate pondweed (*Potamogeton perfoliatus*) and muckgrass (*Chara spp.*) these species are not illustrated in the figures.

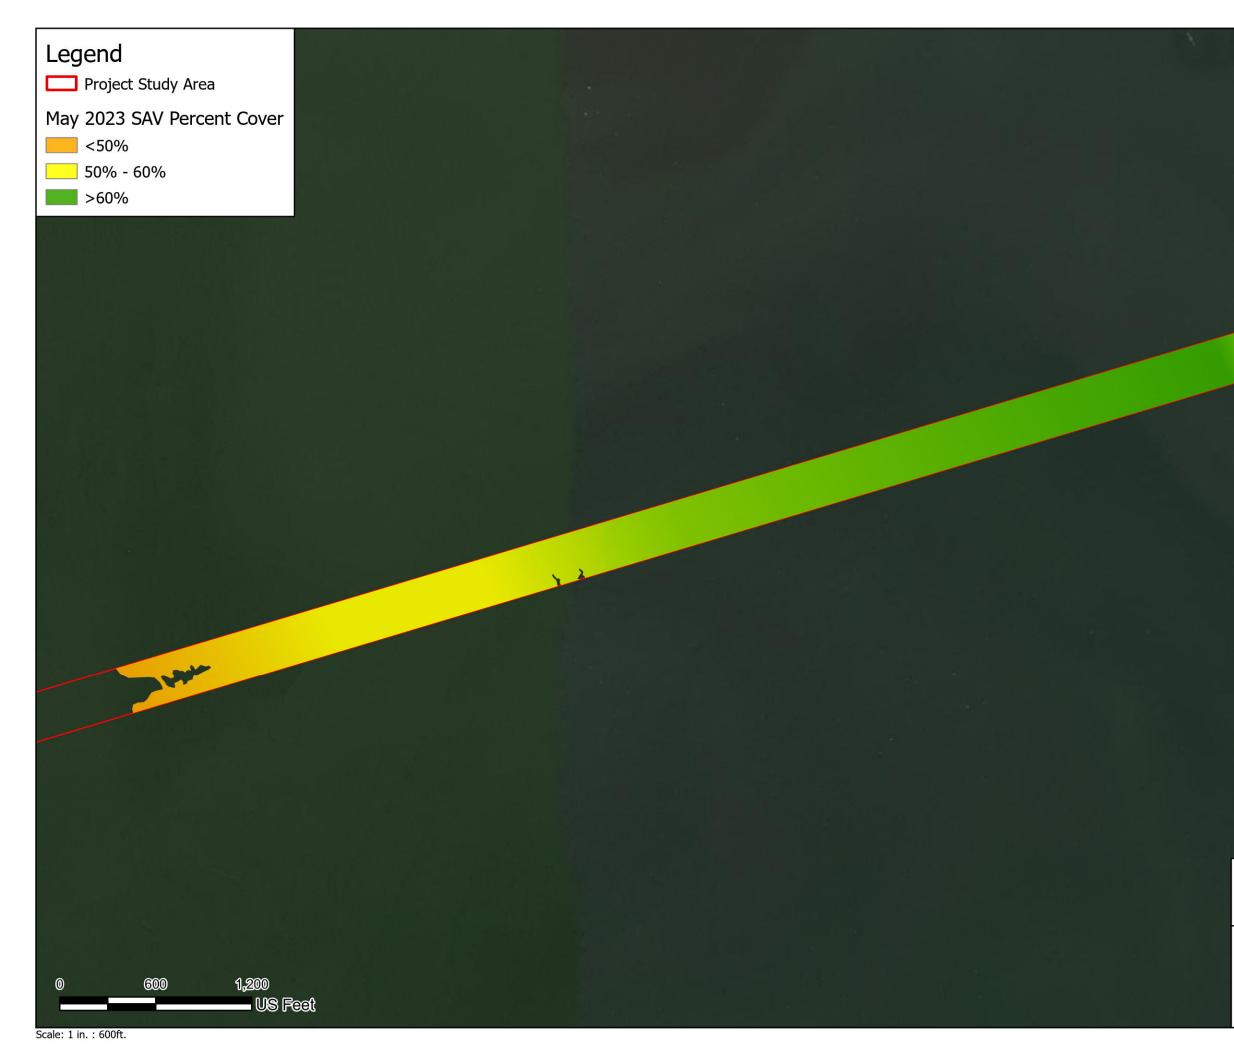
FIGURE 7A

MID-CURRITUCK MAY 2023 SAV SURVEY STIP PROJECT: R-2576 MID-CURRITUCK SOUND BRIDGE CURRITUCK COUNTY

EASTERN ESTIMATED PERCENT COVER

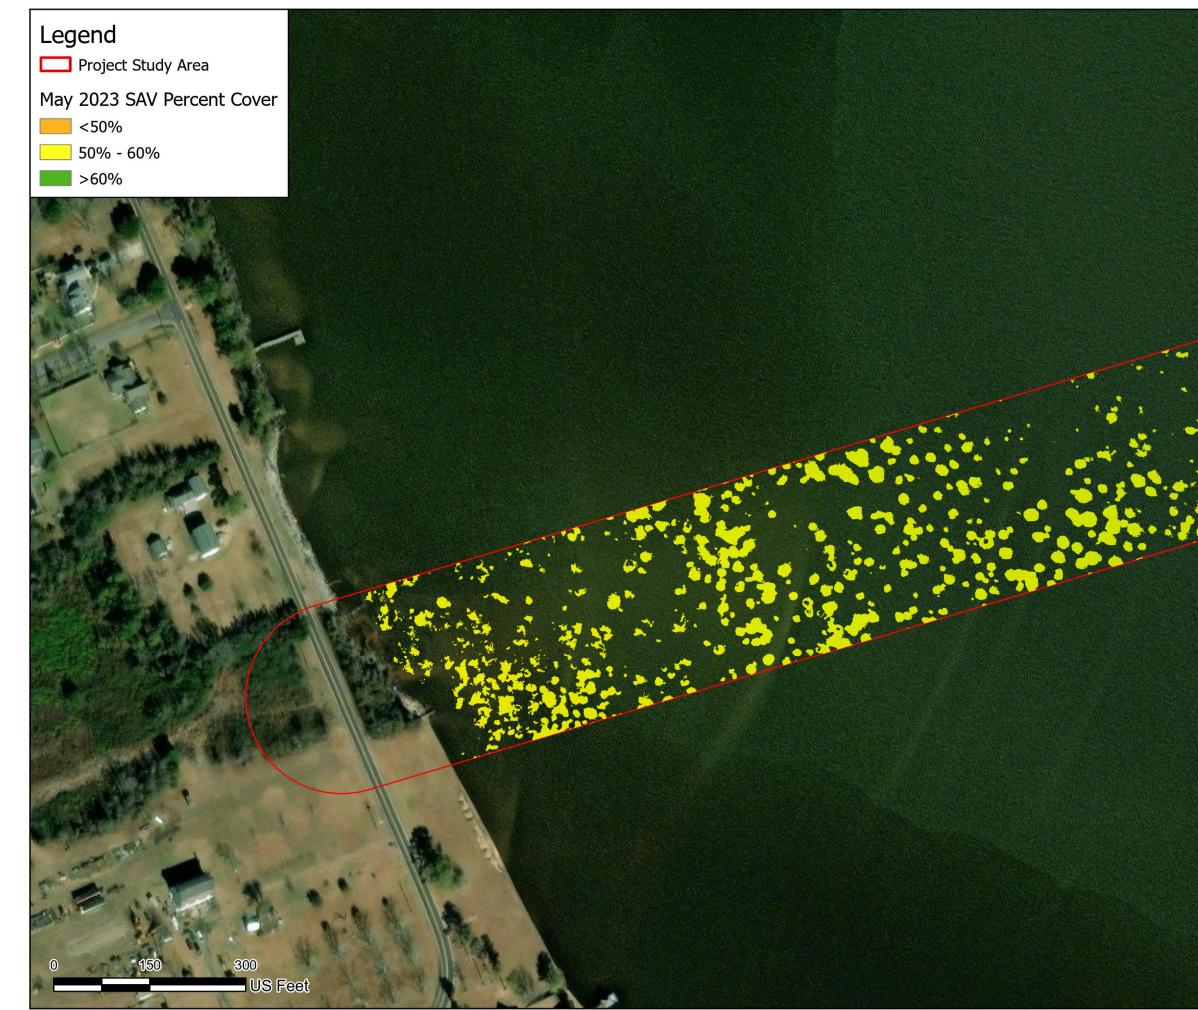
FIGURE 7B

WESTERN ESTIMATED PERCENT COVER MID-CURRITUCK MAY 2023 SAV SURVEY

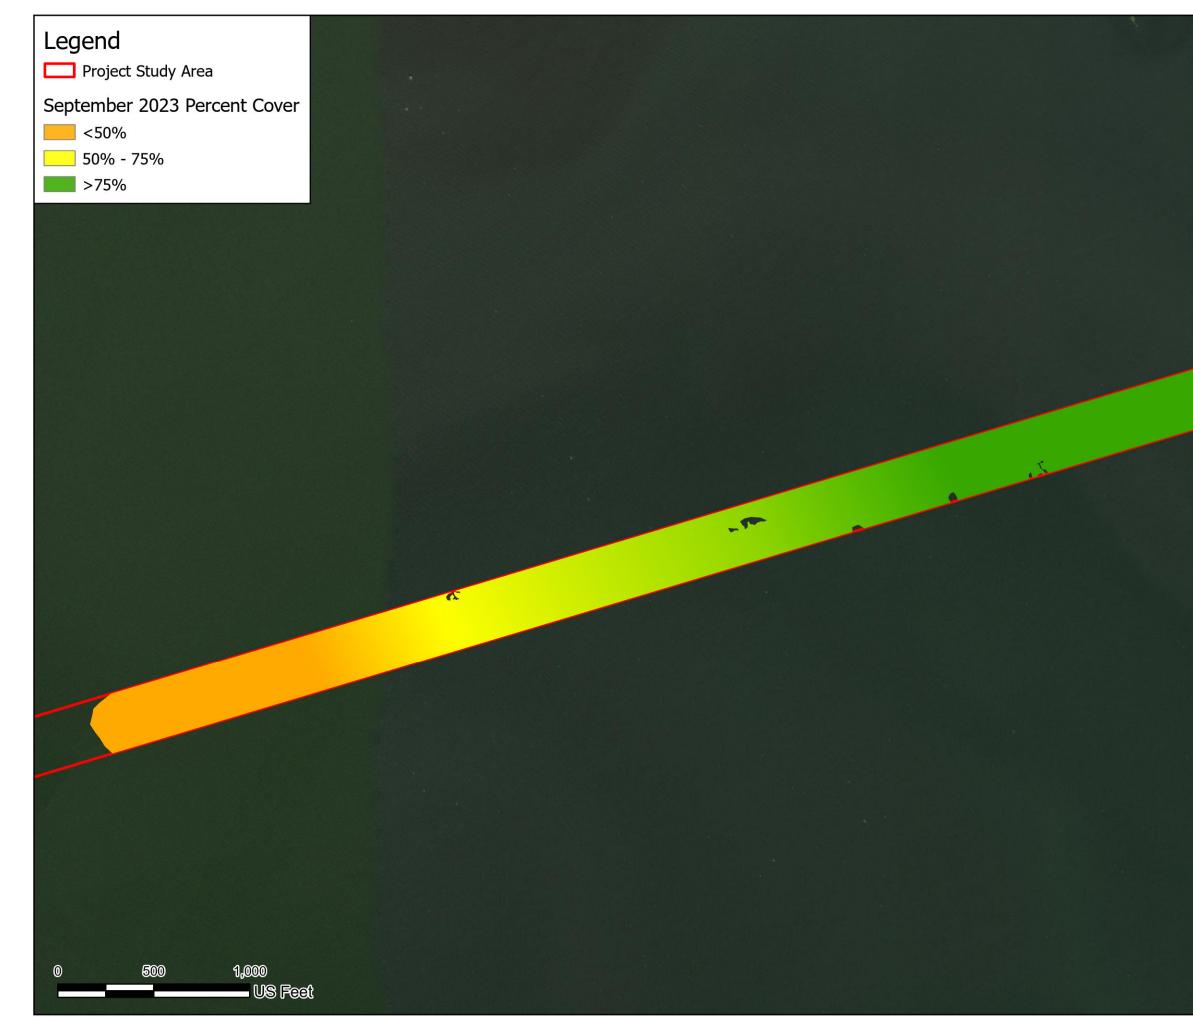
FIGURE 8A

PREPARED BY: NORTH CAROLINA DEPARTMENT OF TRANSPORTATION ENVIRONMENTAL ANALYSIS UNIT RKsK EASTERN ESTIMATED PERCENT COVER MID-CURRITUCK SEPTEMBER 2023 SAV SURVEY

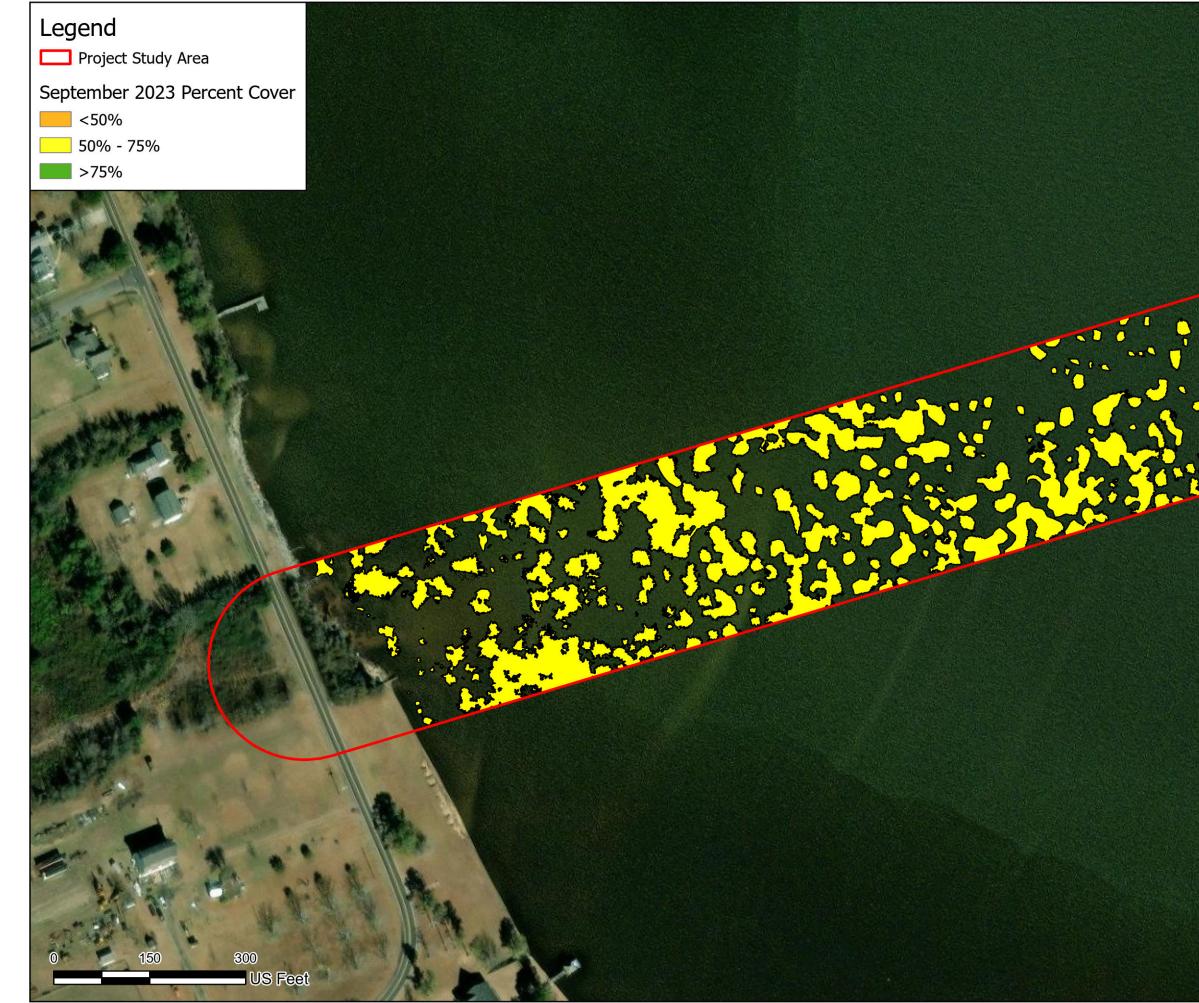
FIGURE 8B

WESTERN ESTIMATED PERCENT COVER MID-CURRITUCK SEPTEMBER 2023 SAV SURVEY

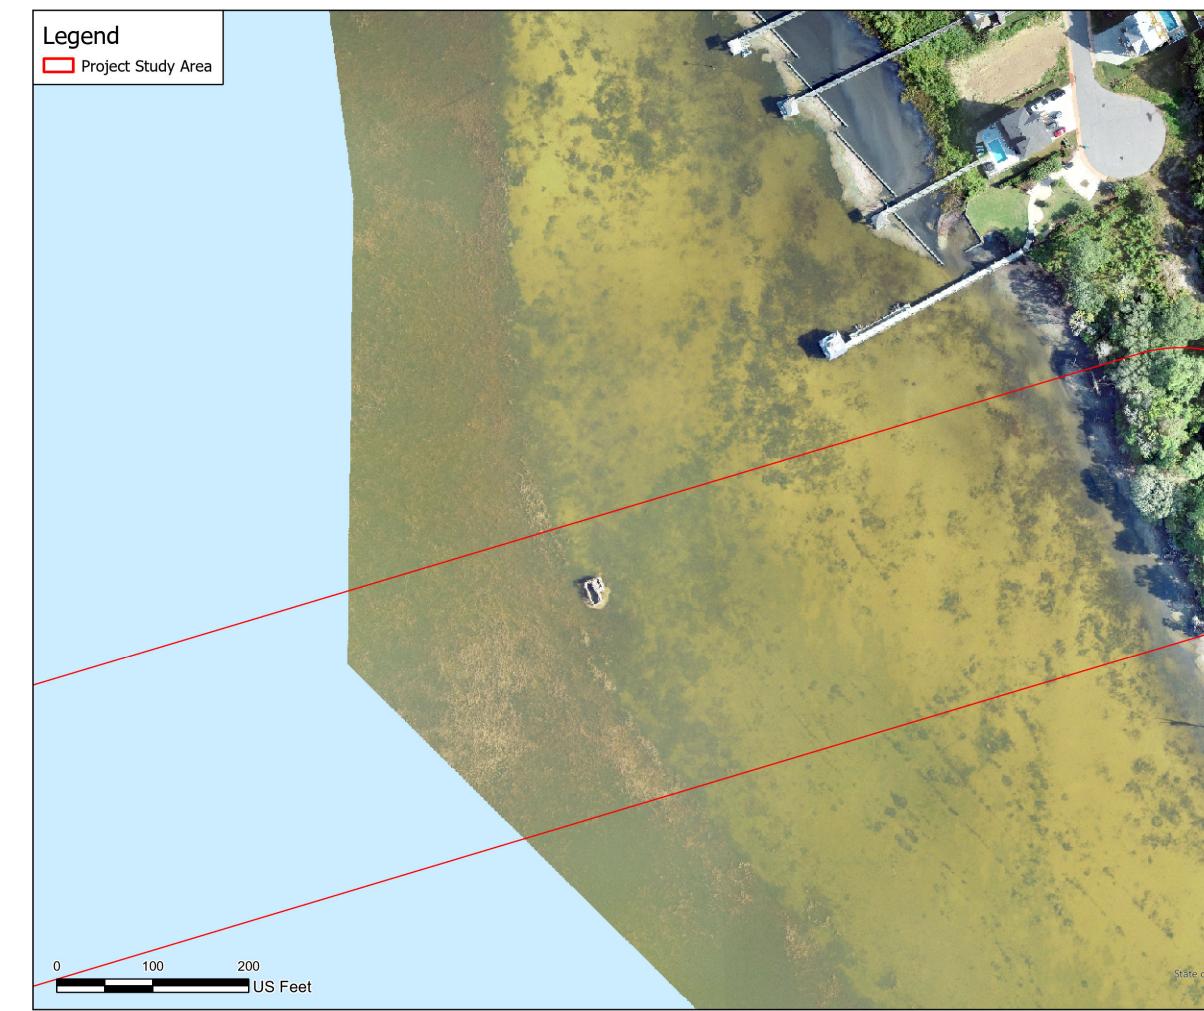
FIGURE 10A

EASTERN UAS IMAGERY MID-CURRITUCK SEPTEMBER 2023 SAV SURVEY

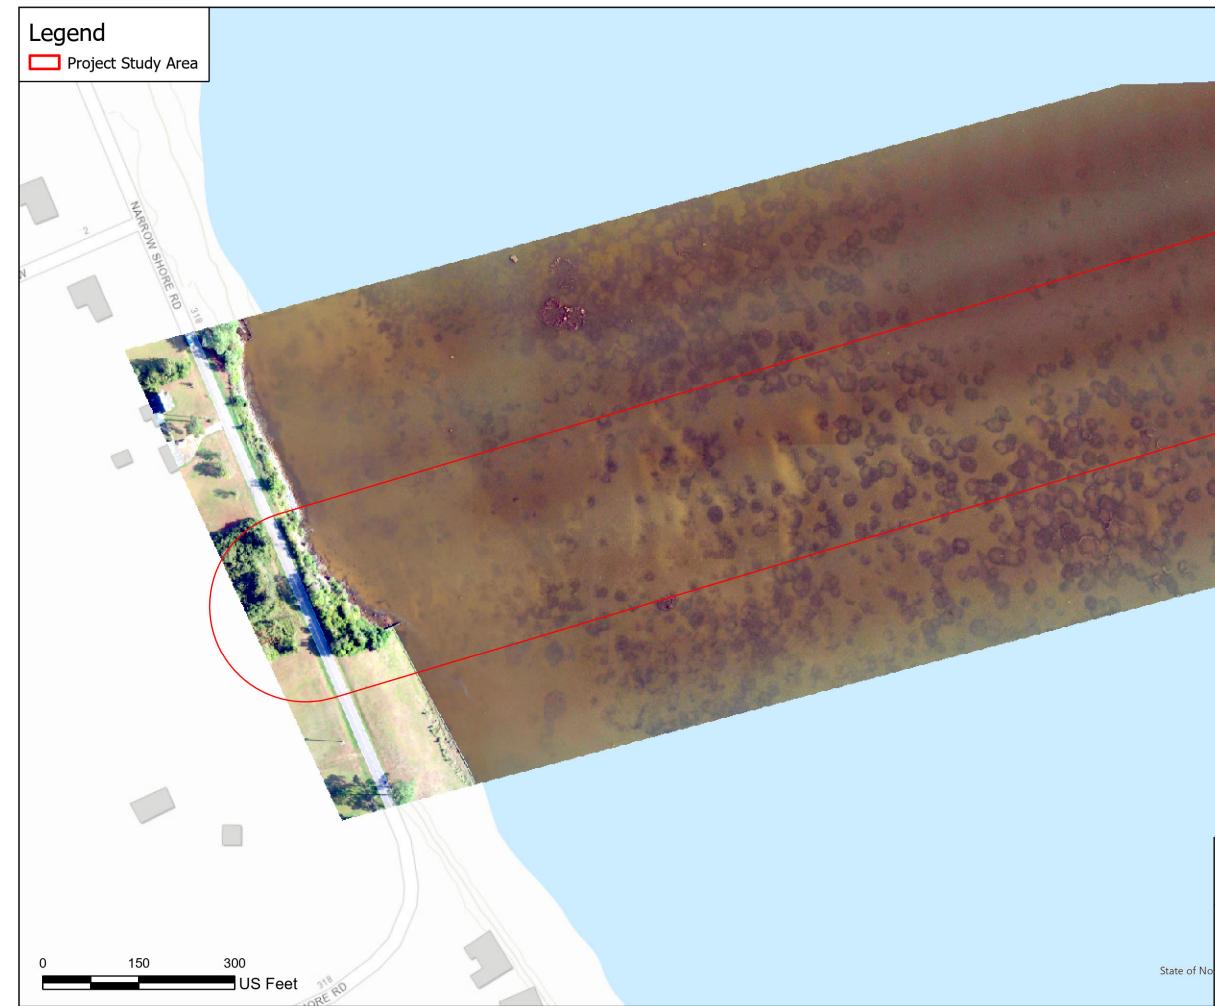
FIGURE 10B

WESTERN UAS IMAGERY MID-CURRITUCK SEPTEMBER 2023 SAV SURVEY
