Type I and II Ground Disturbing Categorical Exclusion Action Classification Form

STIP Project No.	B-5389
WBS Element	46104.1.1
Federal Project No.	N/A

Yadkin County
Bridge No. 105 on US 421 over Yadkin River Overflow Channel
WBS No. 46104.1.1
TIP No. B-5389.

**NO NATIONAL REGISTER OF HISTORIC PLACES
ELIGIBLE OR LISTED ARCHAEOLOGICAL SITES
AFFECTED FORM**

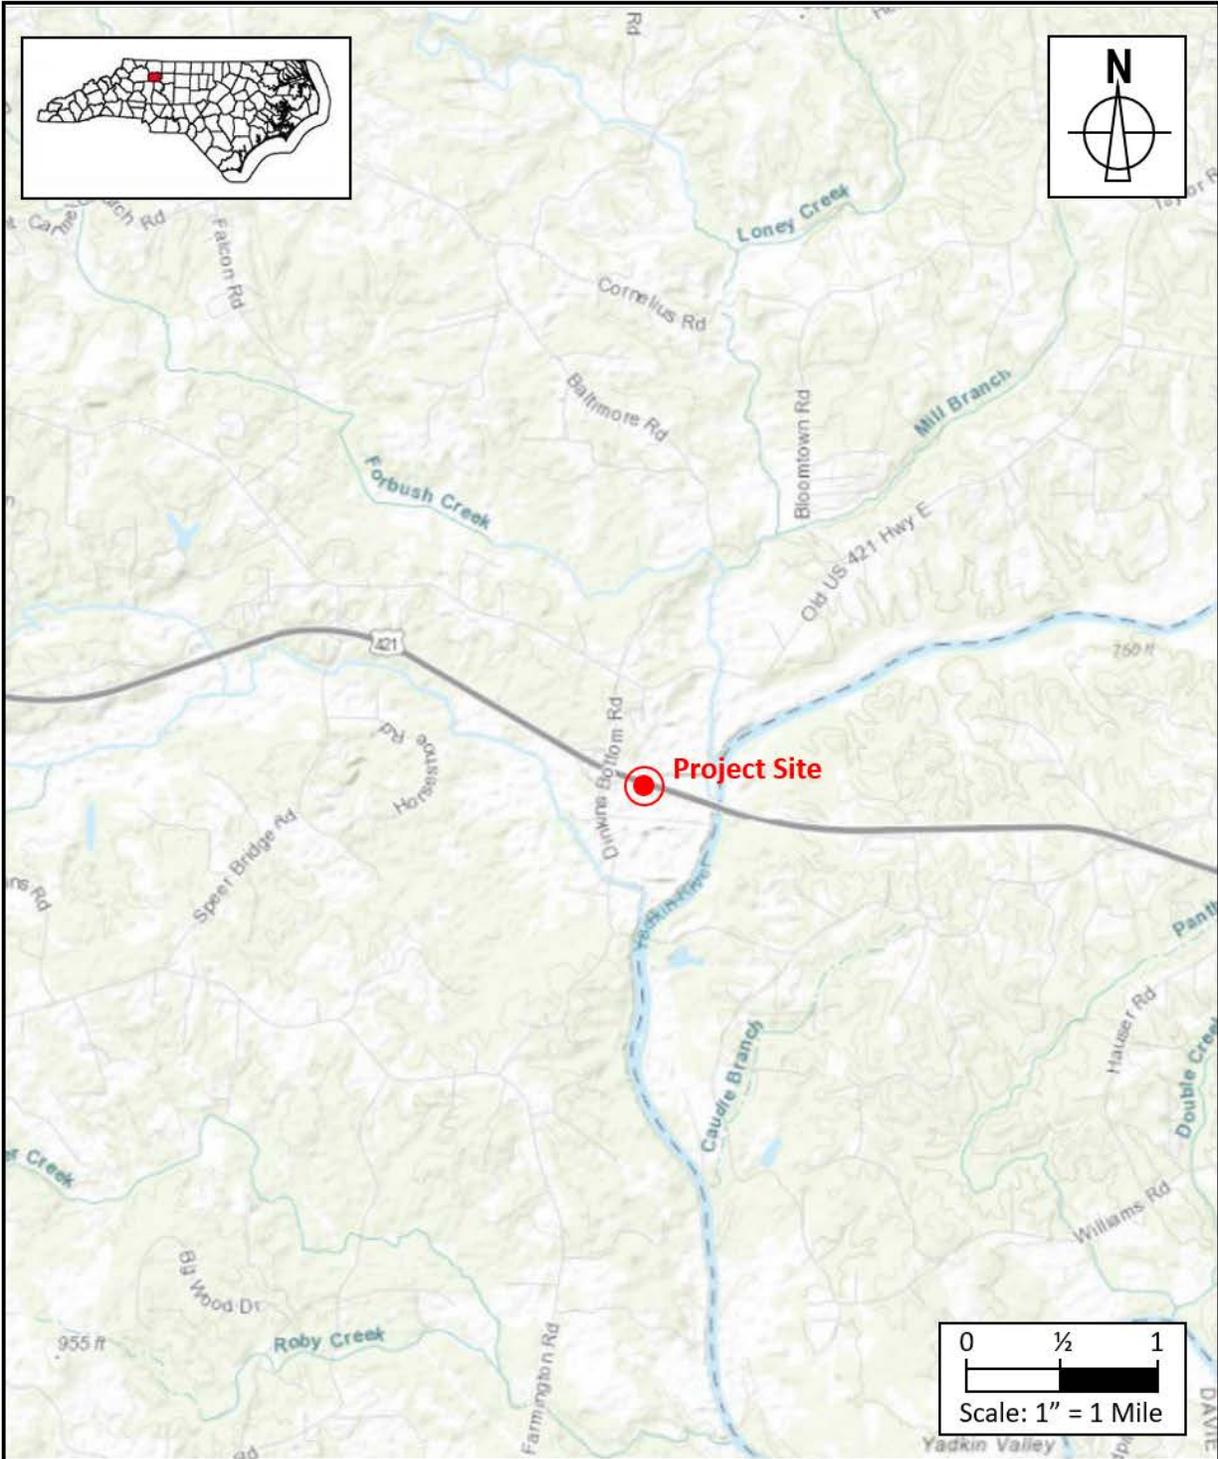
VICINITY MAP
Bridge No. 105 over Yadkin River Overflow
On US 421 Northbound Lanes

- A. **Project Description:** The proposed project will replace the existing two-lane bridge (Bridge No. 105) that carries the U.S. 421 northbound lanes over the Yadkin River overflow, with another two-lane bridge in the same location. The proposed replacement structure will be a multi-span structure that is approximately 0.087 mile (455 feet) in length, with a 38-foot wide clear deck width. The project's total length is 0.343 mile (1,812 feet). The existing northbound lane bridge will be replaced with a new structure at the existing location. Traffic on the northbound lanes will be maintained during construction with an on-site detour located north of the existing bridge location. The project is not included in the 2018-2027 North Carolina Department of Transportation (NCDOT) State Transportation Improvement Program (STIP). However, the project is in the NCDOT Structures Management Unit Bridge Program. Refer to Figure 1 (Vicinity Map) and project plan sheets at the end of this form.

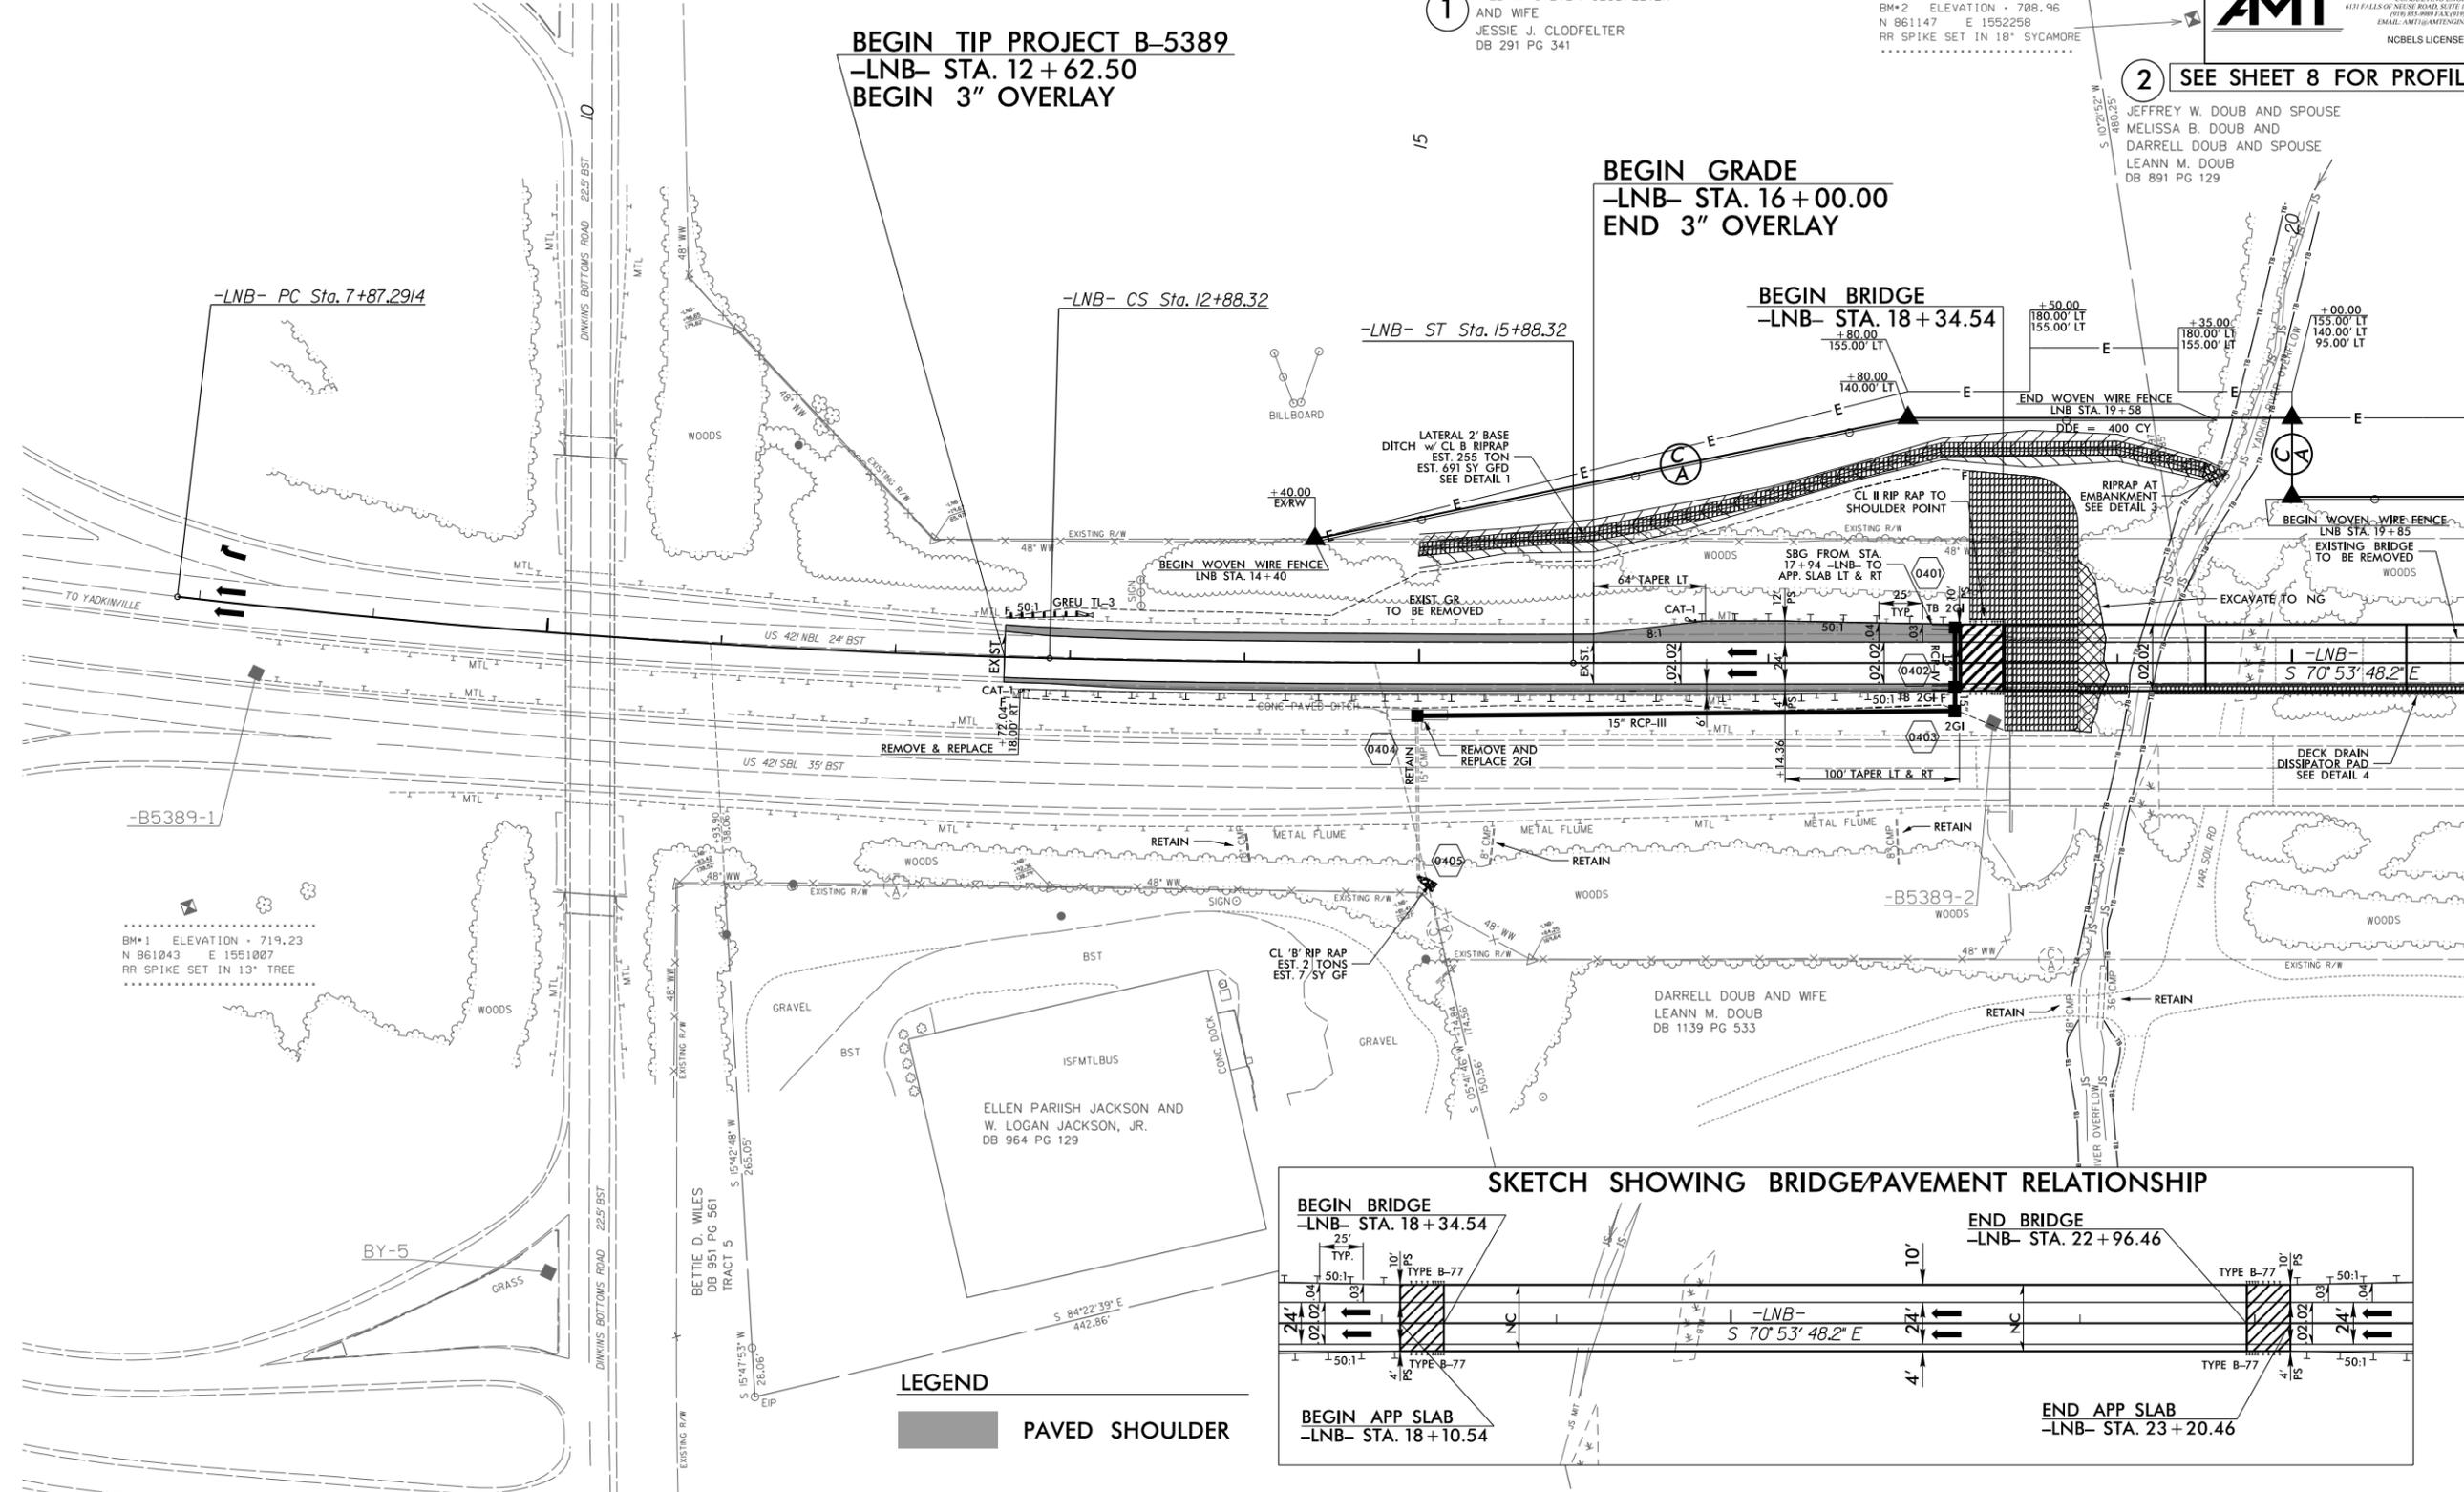
PROJECT REFERENCE NO. B-5389	SHEET NO. 4
ROADWAY DESIGN ENGINEER NORTH CAROLINA PROFESSIONAL SEAL 40655 WICK RAMIREZ	HYDRAULICS ENGINEER NORTH CAROLINA PROFESSIONAL SEAL 2697 JOSHUA G. DALON
DOCUMENT NOT CONSIDERED FINAL UNLESS ALL SIGNATURES COMPLETED

-LNB-
 PI Sta 10+37.97 PIs Sta 13+88.33
 $\Delta = 5'02'' 10.8'' (LT)$ $\Theta_s = 1'30'' 28.0''$
 $D = 1'00'' 18.7''$ $Ls = 300.00'$
 $L = 501.03'$ $LT = 200.01'$
 $T = 250.68'$ $ST = 100.01'$
 $R = 5,700.00'$
 SE = SEE PLANS

SEE SHEETS S-1 THRU S-37
 FOR STRUCTURE PLANS

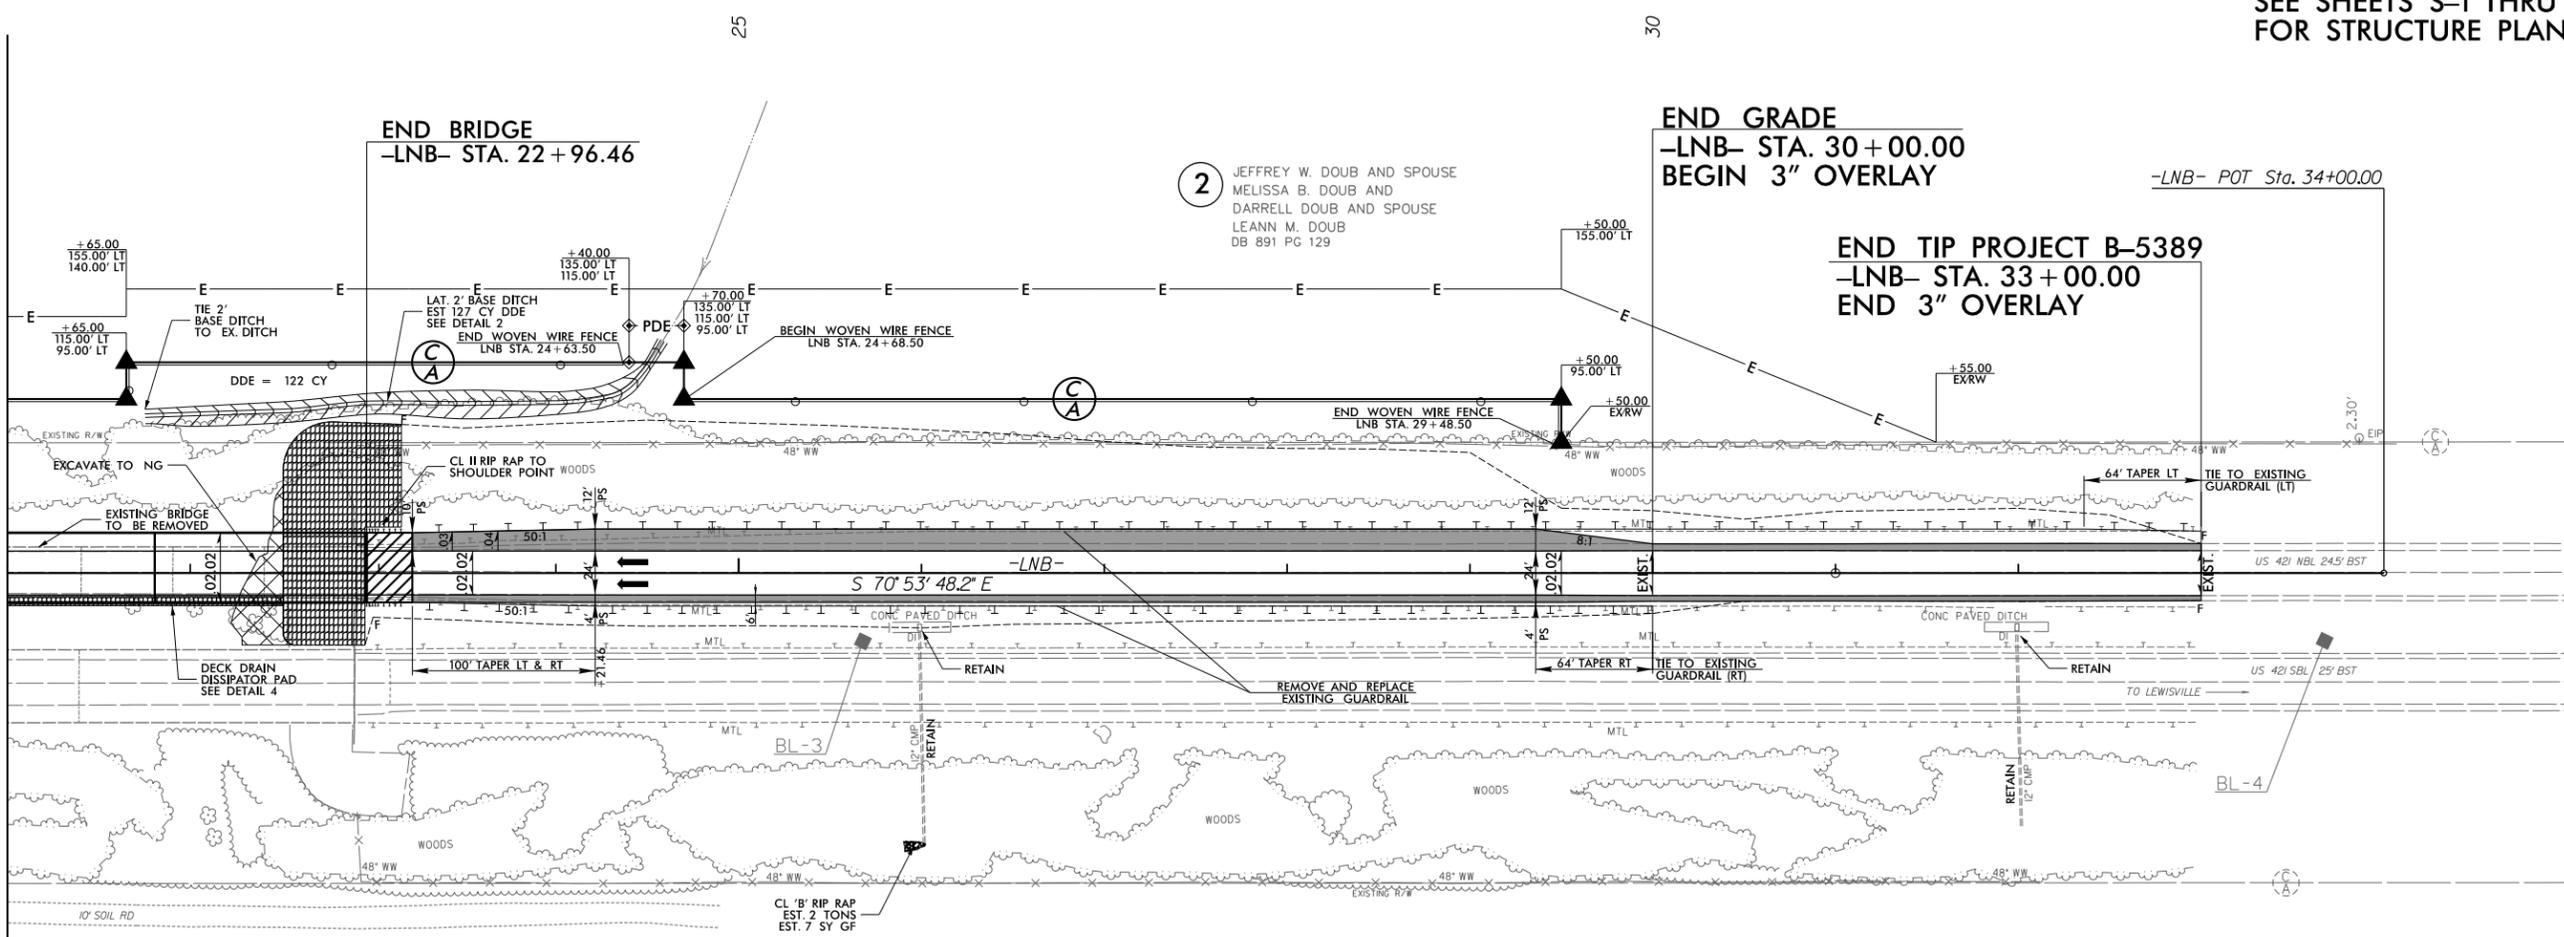
PROJECT REFERENCE NO. B-5389	SHEET NO. 5
RW SHEET NO.	
ROADWAY DESIGN ENGINEER NORTH CAROLINA PROFESSIONAL SEAL 40655 JACK RAMMEL	HYDRAULICS ENGINEER NORTH CAROLINA PROFESSIONAL SEAL 26971 JOSHUA G. DALTON
DOCUMENT NOT CONSIDERED FINAL UNLESS ALL SIGNATURES COMPLETED

SEE SHEET 8 FOR PROFILE VIEW
SEE SHEETS S-1 THRU S-37 FOR STRUCTURE PLANS

MATCHLINE SEE SHEET 4 -LNB- 21+00.00

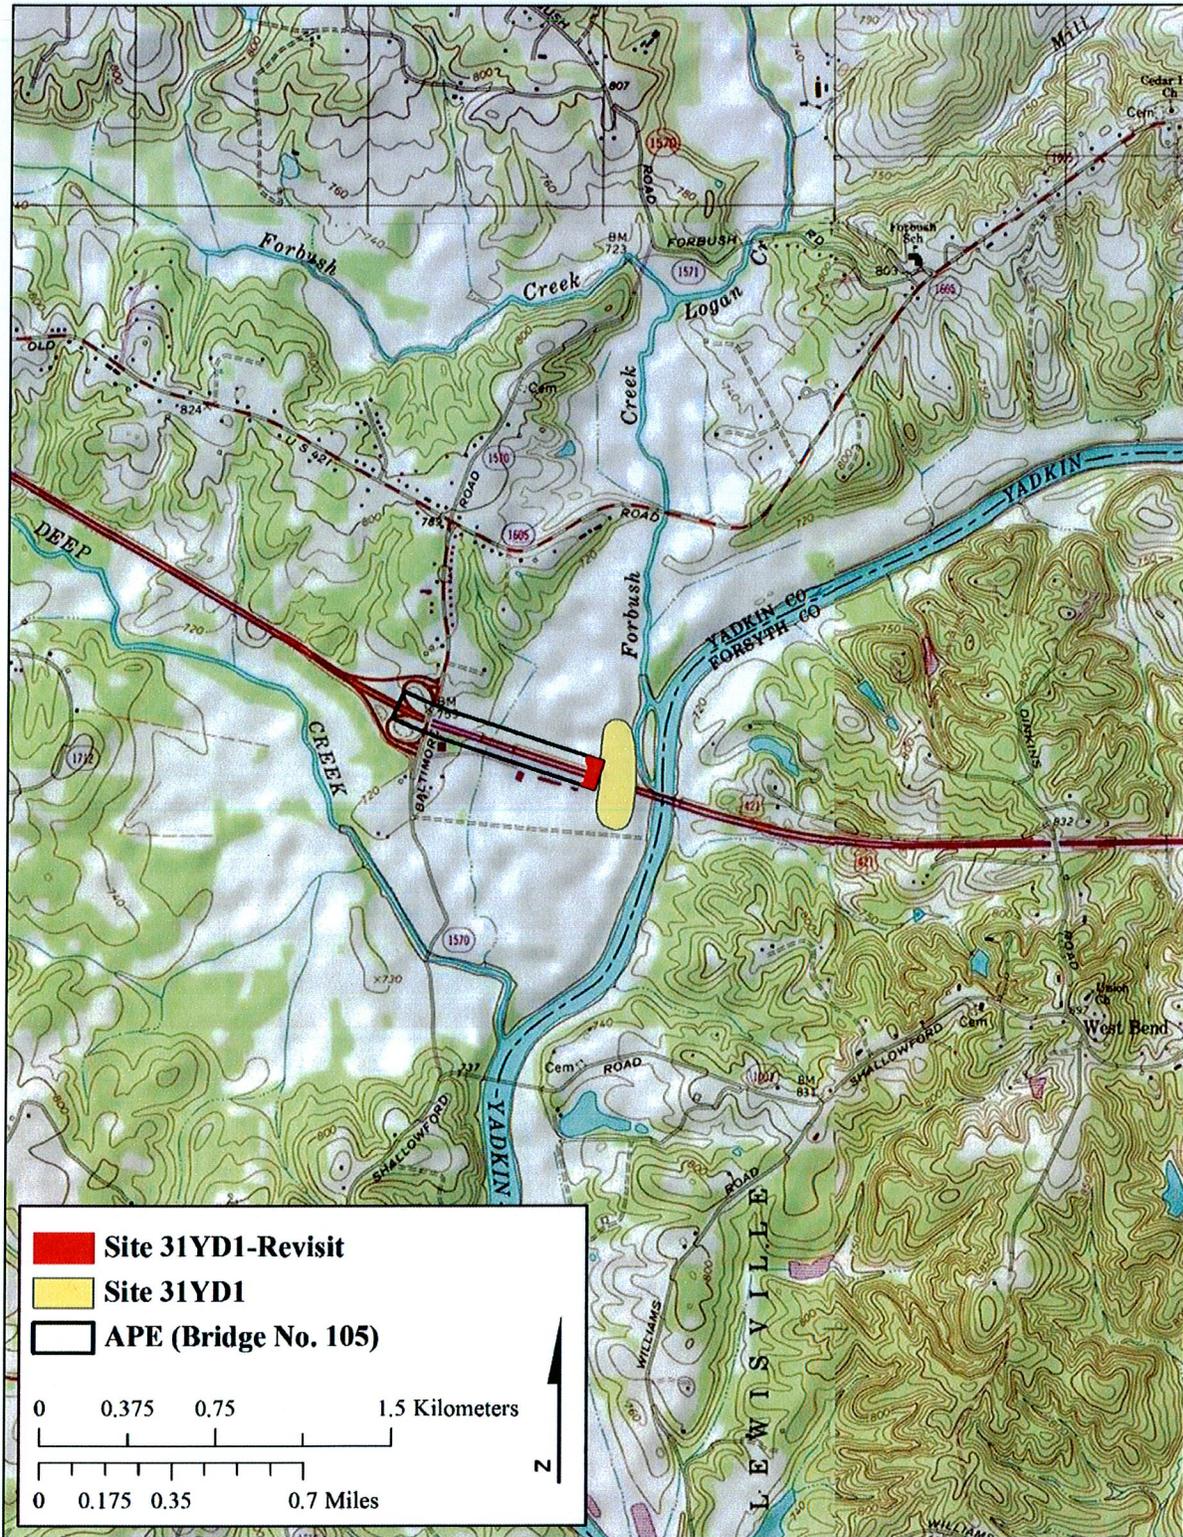
FIGURE 1. TOPOGRAPHIC MAP SHOWING THE PROJECT APE AND THE ORIGINAL SITE 31YD1 BOUNDARY

The project's APE along Bridge No. 105 on the northbound lane of U.S. 421 over the Yadkin River Overflow in Yadkin County was subjected to an intensive archaeological survey (Figure 1). In August 2015, New South Associates, Inc. completed shovel testing within the project APE at 30-meter intervals to survey for potential archaeological resources. The purpose of the fieldwork was to investigate the possibility of unknown archaeological resources that might be impacted by the proposed undertaking. The APE for this study measured approximately 2,500 feet (762 m) long running 1,250 feet (381 m) from each bridge end point. The corridor is 400 feet (121.92 m) wide and extends 200 feet (60.96 m) on either side of the U.S. 52 north bound centerline. The project area covers 109,935 square meters or 27 acres in size and is characterized by agricultural fields, pasture, and heavily disturbed areas associated with the highway, exit ramps, and overpass construction. Figures 2-4 show the general landscape within the project area.

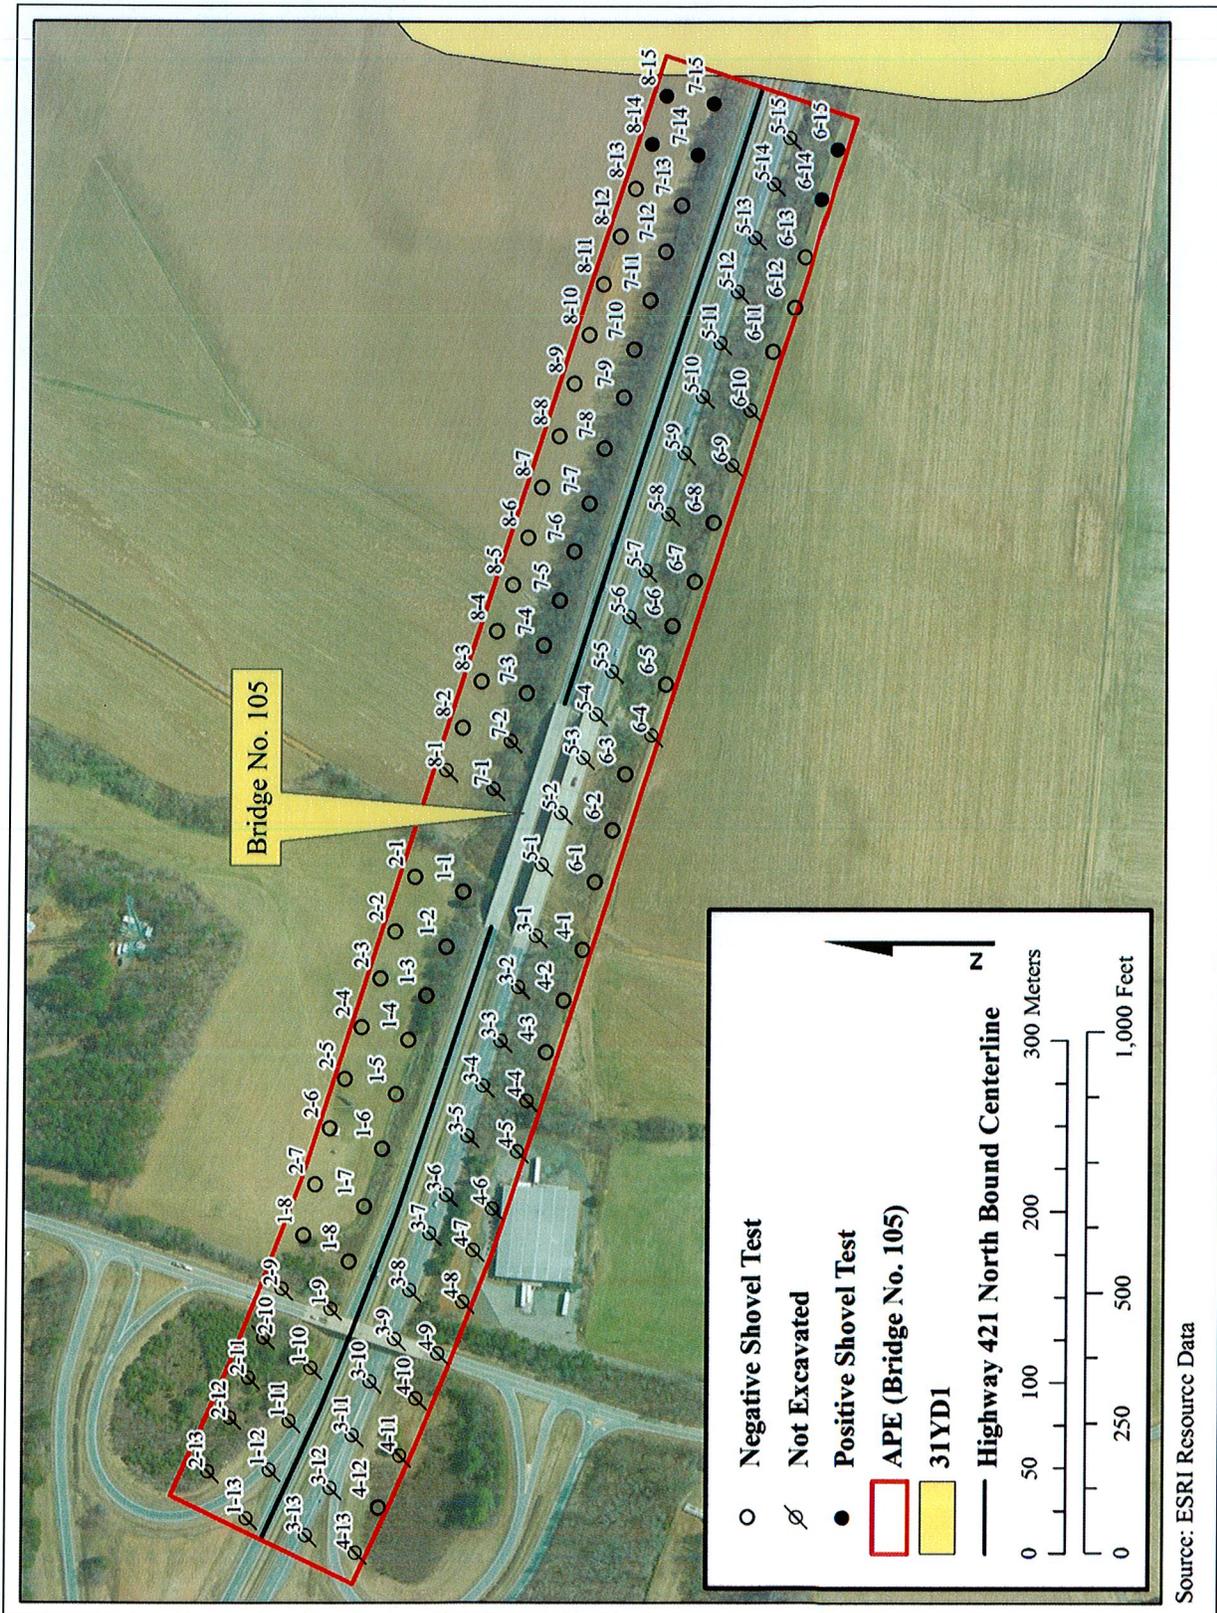
FIGURE 5. AERIAL VIEW OF THE PROJECT AREA SHOWING SHOVEL TEST RESULTS.

Transects 1 and 2 were placed in the northwestern quadrant of the APE. There were 26 shovel tests placed. Of those, 10 on the western end were not excavated because they were located in the disturbed exit ramp and U.S. 421 berms (see Figure 2a). Transects 3 and 4 were placed in the southwestern quadrant. Transect 3 was placed approximately 15-20 meters from the U.S. 421 northbound lane and was located within the southbound lane and berm for the whole transect. No shovel tests were excavated on Transect 3. Transect 4 was primarily located along the edge of an agricultural field. Of the 13 shovel tests that comprised Transect 4, nine were not excavated due to ground disturbance such as drainage ditches, a paved parking lot, and overpass and entrance ramp berms (see Figures 2b, 3a, 3b, and 4a). Transects 5 and 6 were excavated in the southeastern quadrant. Because of the length of the bridge from the actual bank, these transects were extended by three additional shovel tests to ensure adequate coverage of the floodplain. Transect 5 was unable to be excavated because of the U.S. 421 southbound lane and associated berm. Transect 6 was placed along the edge of an agricultural field. Of the 15 shovel tests for Transect 6, three were not excavated due to ground disturbance. Transects 7 and 8 were excavated in the northeast quadrant of the APE. Like those in the southeastern quadrant, transects were extended by three additional shovel tests to ensure adequate coverage between the bank and the edge of the bridge structure. Transects 7 and 8 were started approximately 35 meters from the bank edge due to hydric ground and an overburden of reed covering the ground surface (see Figure 4b). Thirty shovel tests were placed for Transects 7 and 8. Of those, three were not excavated due to ground disturbance (see Figure 4b). Figure 5 shows all of the survey shovel tests recorded during this investigation.

Two shovel tests (6-14 and 6-15) were found to contain prehistoric artifacts in Transect 6. During delineation this site was denoted as FS-1. On Transects 7 and 8, four shovel tests were found to contain prehistoric artifacts (7-14, 7-15, 8-14, and 8-15). During delineation, this artifact concentration was denoted as FS-2. Both field sites are part of previously recorded site 31YD1. They are discussed later in more detail.

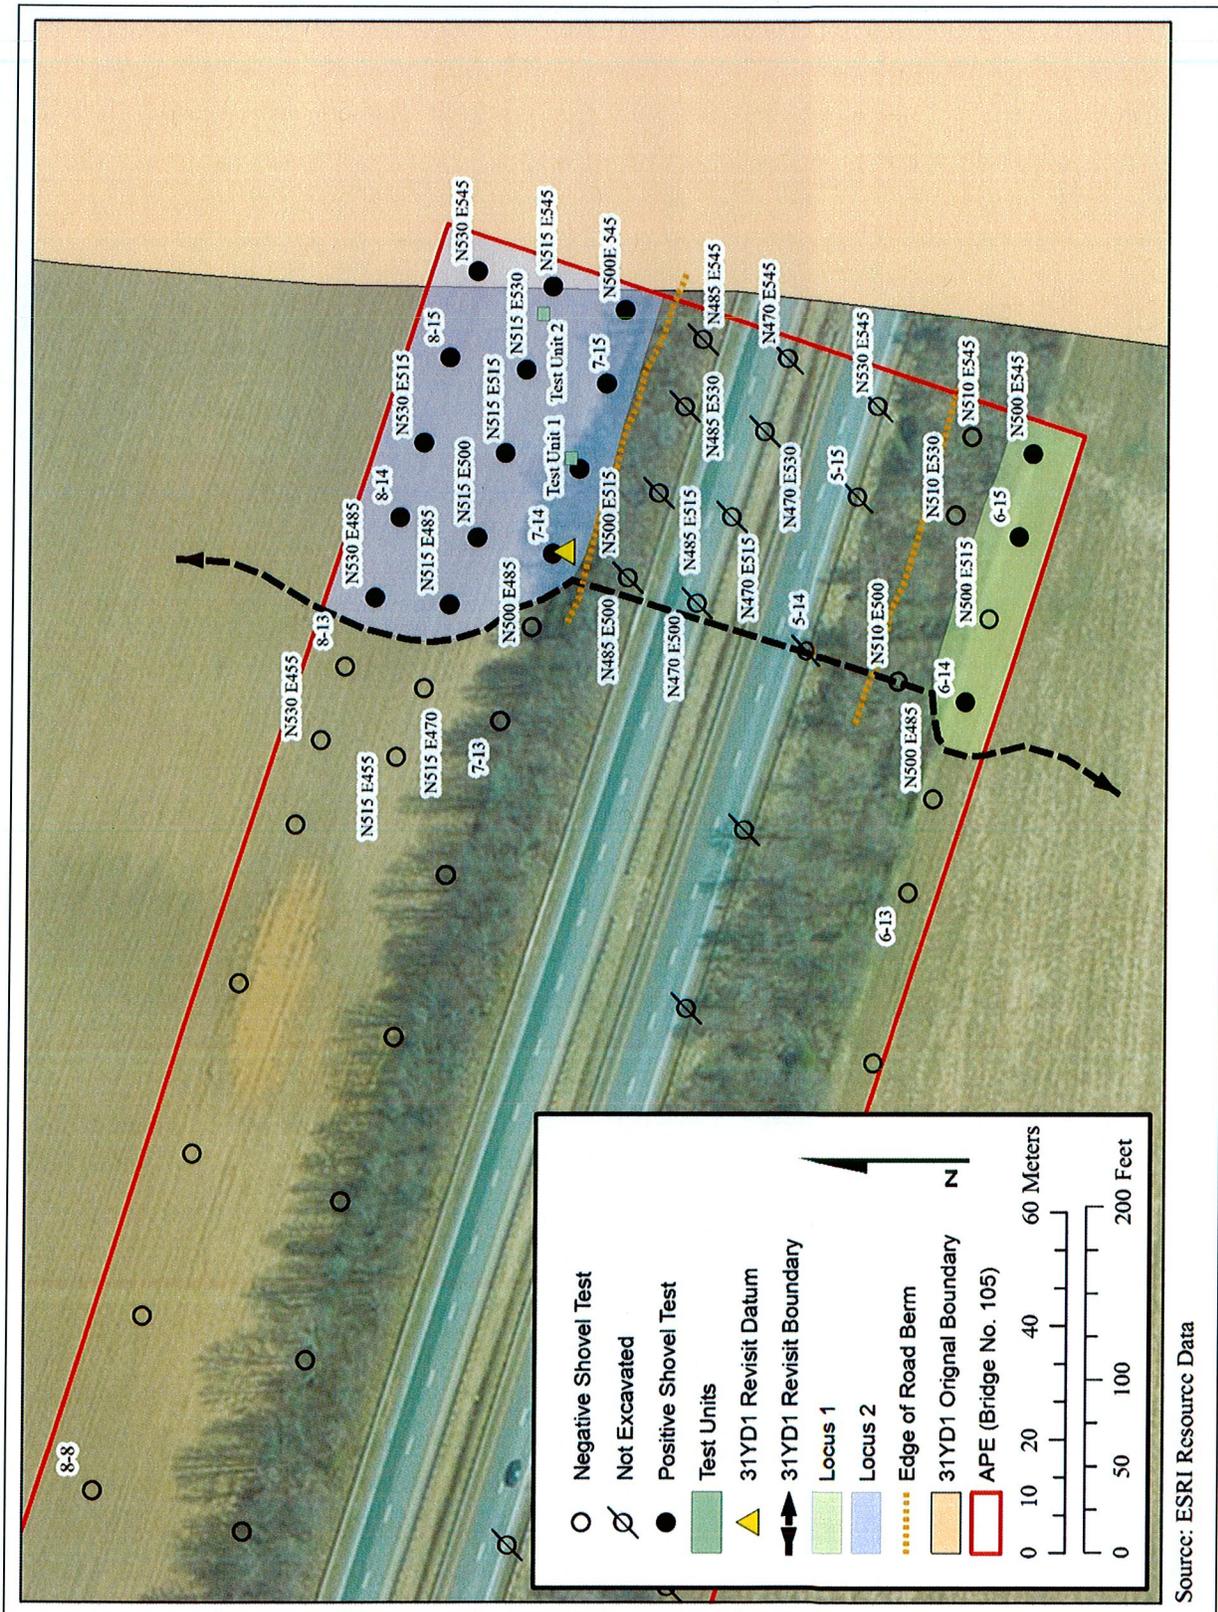
Figure 6. Site Map Showing Relocated 31YD1 Site Boundary.

The newly identified portions of 31YD1 were given the field names FS-1 and FS-2 (Figure 6), which for the purposes of this report, are referred to as Locus 1 and Locus 2, respectively. The first to be identified was Locus 1, which is located just south of the southbound lane of U.S. 421 in a tobacco field (Figure 7a). Two shovel tests along Transect 6 (6-14 and 6-15) were positive for prehistoric artifacts. This shovel test was delineated to the east and west on a 15-meter grid. The northern delineations were shortened to 10-meters because the road berm was in the way. Further delineation was prohibited because of the edge of the project APE. One additional shovel test (500N/545E) was found to contain prehistoric artifacts. The soils at FS-1 were deep and consisted of brown (10YR 5/3) to dark brown (10YR 3/3) silty loam up to 50 cmbs followed by yellowish-brown (10YR 6/3) to brown (10YR 5/3) silt to at least 100 cmbs. An auger was used on Shovel Test 6-14, which showed a continuation of yellowish-brown (10YR 6/3) to at least 200 cmbs.

Two test units were excavated within Locus 2 (see Figure 6). Test Unit 1 was excavated just northeast of Shovel Test N500/E515 because of the presence of deeply buried faunal remains from that shovel test. Test Unit 1 measured 1x1-meter in size. The southwestern corner served as datum, which was set at 10 centimeters above ground surface (cmags). Ten (10) levels were excavated within this test unit, which reached a depth of 100 cmbs in the southwestern corner. Each level was approximately 10 centimeters in thickness. Excavation ceased at one sterile level and one meter below surface, for safety reasons.

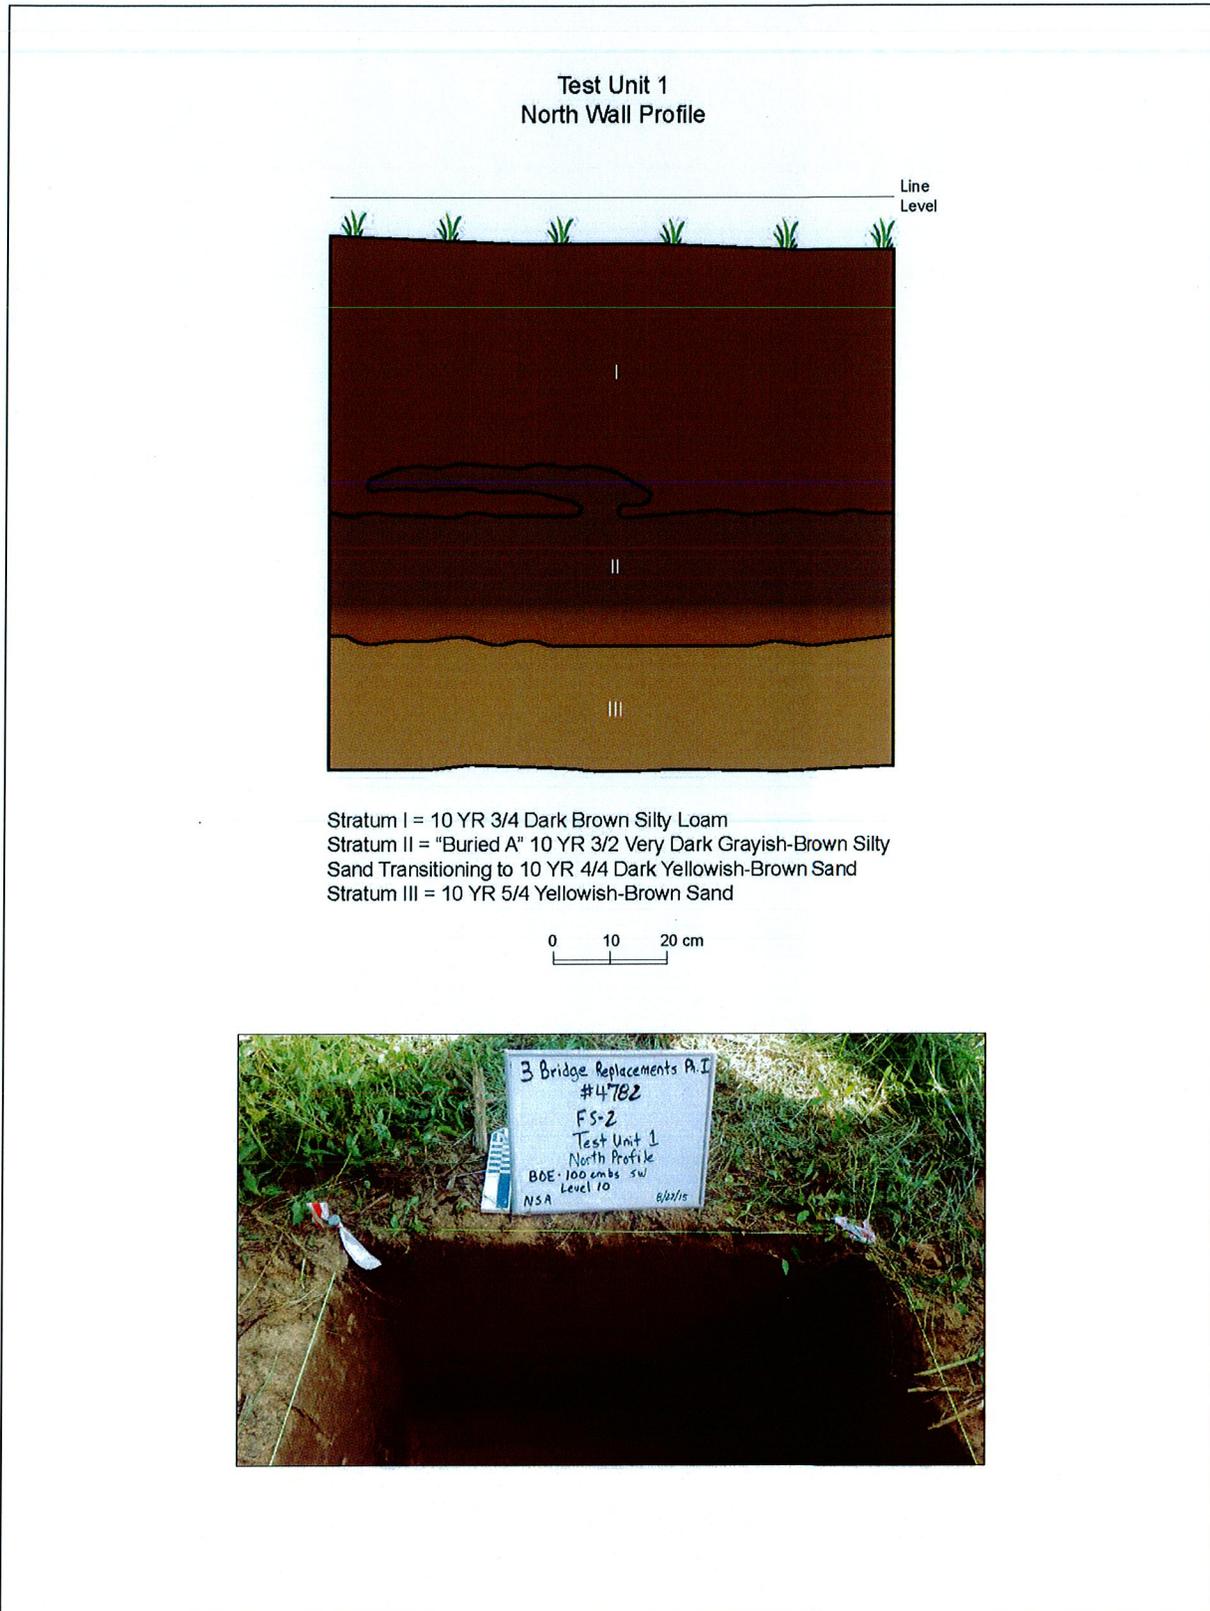
Figure 10. Test Unit 1, North Wall Profile and Drawing.

Three strata were present in the soil profile for Test Unit 1 (Figure 10). Stratum I was dark brown (10YR 3/4) silty loam extending to a depth of up to 50 cmbs. This was followed by a second stratum of very dark grayish-brown (10YR 3/2) silty sand, which has been interpreted as a possible buried A soil horizon due to it having a high artifact density. This layer was approximately 20 centimeters in thickness and may also represent a dense midden deposit. Following that was a transitional zone of mottled dark grayish-brown (10YR 3/2) and dark yellowish-brown (10YR 4/4) sand extending to approximately 80 cmbs. This transitional zone was about 10 centimeters in thickness and was in between the potential buried A horizon and Stratum III, which was yellowish-brown (10YR 5/4) sand extending to at least 100 cmbs. After completion of this test unit, an auger was used to investigate the underlying soils. Soils were consistent with the final stratum of yellowish-brown (10YR 5/4) to about 190 cmbs. At this point, their consistency became slightly clayey but with the same color. The only noted disturbance to the test unit was in Level 5, Stratum I, and consisted of plow scars. The plow scars were running east to west and were the same color as the potential buried A horizon that lay below Stratum I.

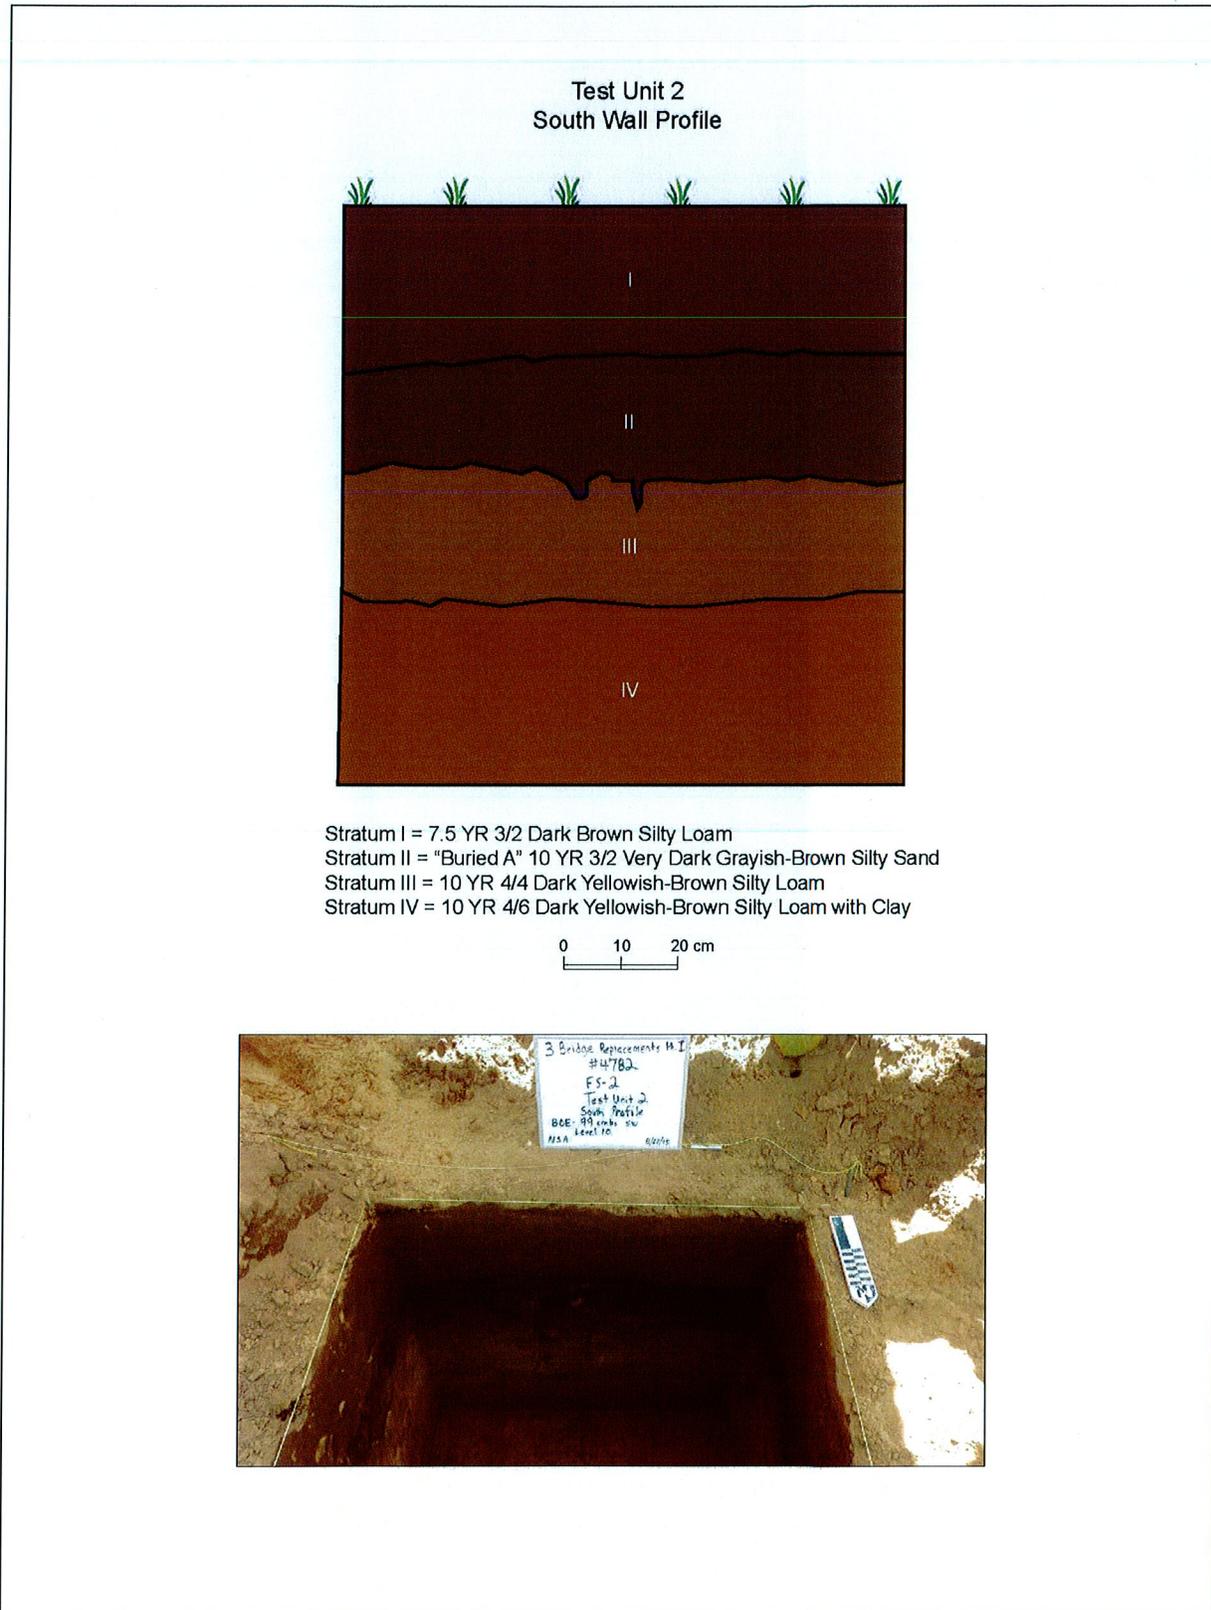
Figure 11. Test Unit 2, South Wall Profile and Drawing.

Four strata were present in the soil profile for Test Unit 2 (Figure 11). Stratum I was dark brown (7.5 YR 3/2) silty loam extending to a depth of up to 29 cmbs. This was followed by a second stratum of very dark grayish-brown (10YR 3/2) silty sand, which is consistent with the possible buried A soil horizon found in Test Unit 1. This layer was approximately 10-15 centimeters in thickness. The third stratum consisted of dark yellowish-brown (10YR 4/4) silty loam extending up to 70 cmbs. The first level in this stratum was a mottled transitional soil layer between the above potential buried A horizon and the dark yellowish-brown. Stratum IV was dark yellowish-brown (10YR 4/6) slightly clayey silty loam with thin lamella of dark brown (10YR 4/4) silt. After completion of this test unit, an auger was used to investigate the underlying soils. Soils were consistent with the final stratum of dark yellowish-brown (10YR 4/6) to about 200 cmbs. The only noted disturbance to the test unit was in Stratum I, Level 3, and consisted of plow scars. The plow scars were running east to west and were the same color as the potential buried A horizon that lay below Stratum I.
