MINIMUM CRITERIA DETERMINATION CHECKLIST

TIP Project No.: B-5703

Project Location: Bridge No. 60 on US 401 over Lower Little River in Cumberland and Harnett Counties.

Archaeological Survey for the Proposed Replacement of Bridge No. 60 on US 401 over the Lower Little River, Cumberland County, North Carolina (NCDOT TIP B-5703; PA 16-01-0036)

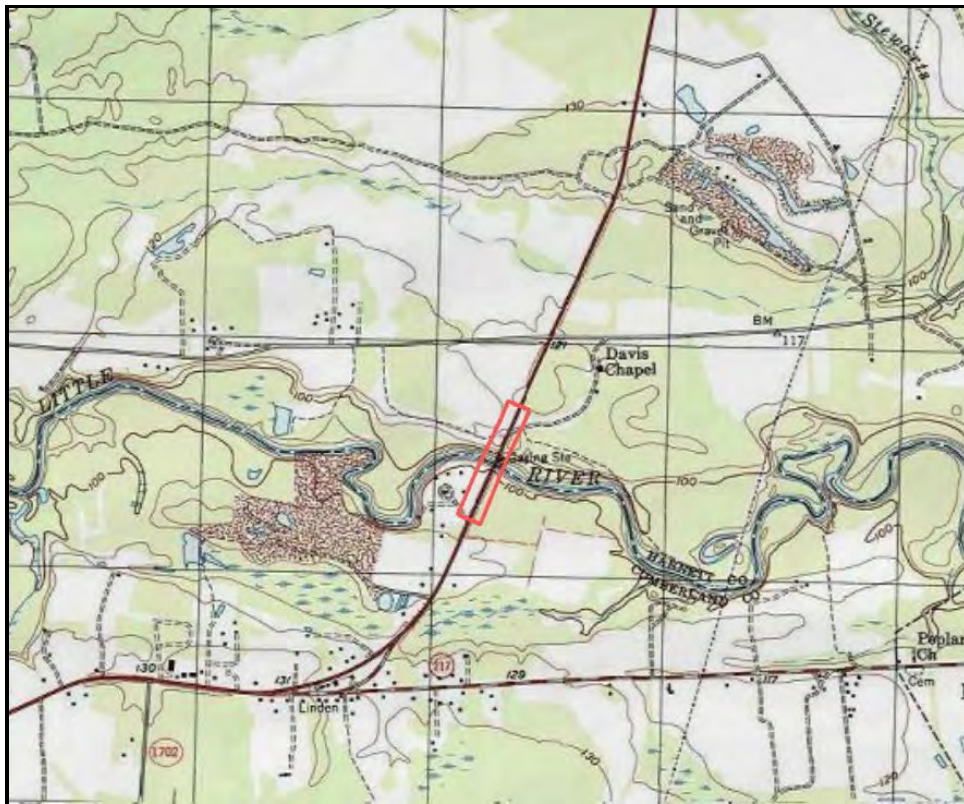
Figure 2: Bridge 60 APE (Bunn Level, N.C. Topographic Quadrangle).

Bridge No. 60 is located on US 401 over the Lower Little River in Cumberland and Harnett counties (**Figure 1**). The bridge's Area of Potential Effects (APE) is located in a narrow stream valley with level terraces and upland flats on each side (**Figure 2**). The bridge is oriented southwest-northeast but is described as north-south for this report. The archaeological APE for this project is approximately 300 feet (91.4 meters) wide (centered on the existing bridge) and extends 875 feet (266.7 meters) from each end of the existing bridge (**Figure 3**).

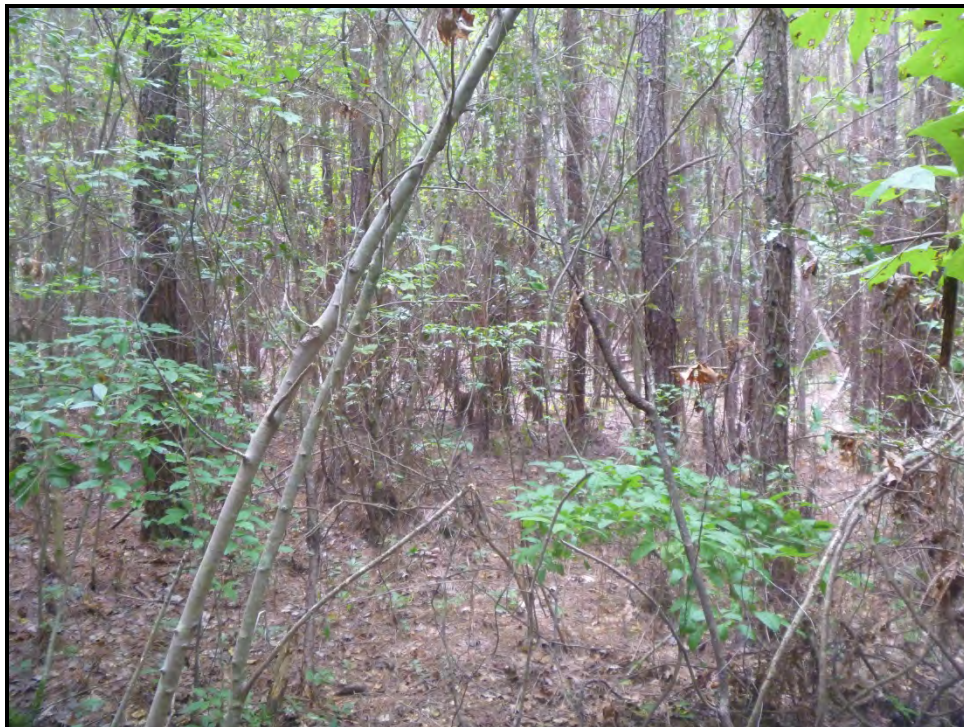
Figure 6: Pine Stand in Southern Portion of Southeast Quadrant of APE, facing Southwest.

The southeast quadrant of the APE was wooded. Young, moderately dense pine plantation covered the southern one-third of the APE; mixed hardwoods were present in the remaining two-thirds of the APE. Photographs of the southeast quadrant are shown on **Figures 6–8**. Surface visibility in this portion of the APE was poor due to groundcover; a general visual inspection of this portion of the APE revealed no surface artifacts or evidence of historic or prehistoric cultural activity. Seven shovel tests (see **Figure 3** for locations) were excavated in this portion of the APE.

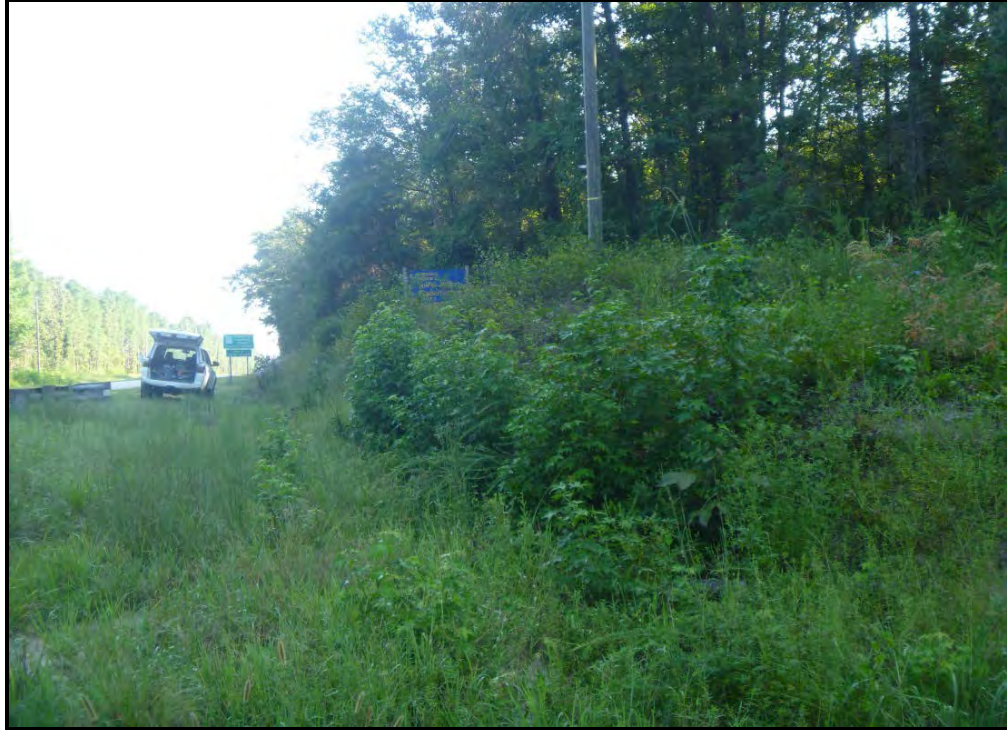
Figure 9: Northeast Quadrant of APE, facing North.

The northeast quadrant of the APE consisted of a mixed pine and hardwood forest with moderately dense understory vegetation (see **Figures 9–12**). Surface visibility in this quadrant was poor due to ground cover; however, a general visual inspection of this portion of the APE was undertaken to look for above ground structural remains, surface artifacts, or other evidence of past cultural activity. Several unpaved

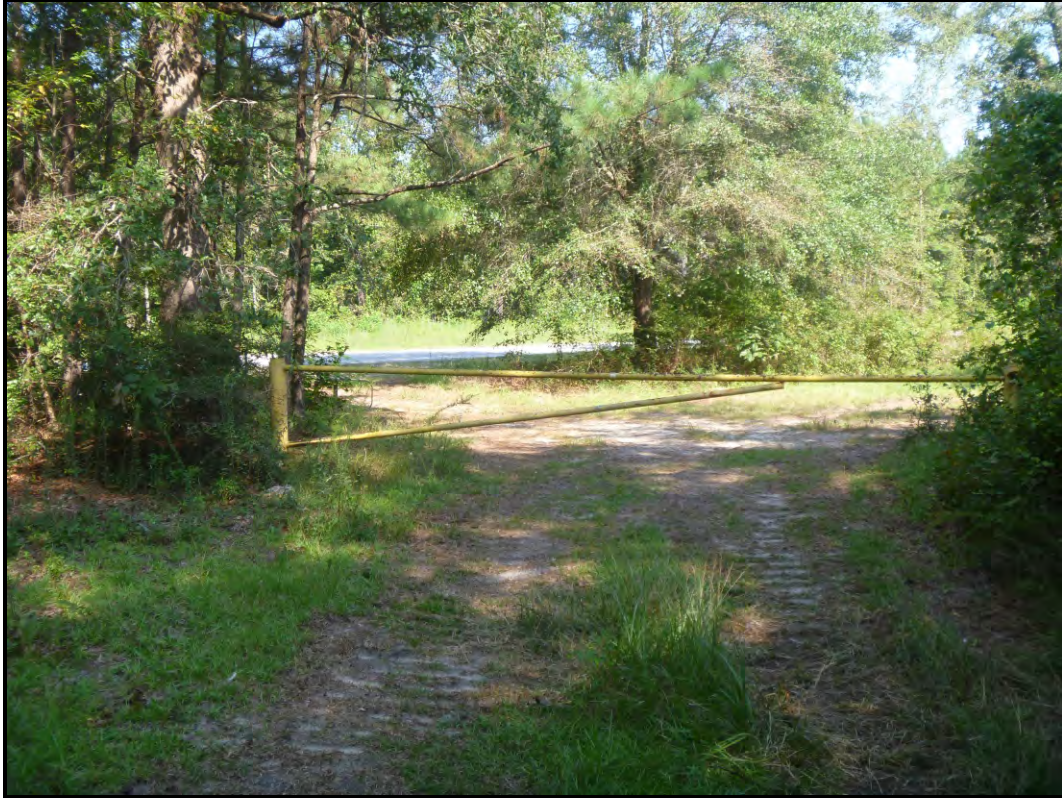
Figure 11: Unpaved Road in Northeast Quadrant of APE, facing Northwest.

roads and trails were observed within and west of the APE (see **Figure 11**). These roads appear to be maintained and may be used as access roads for hunting or logging.

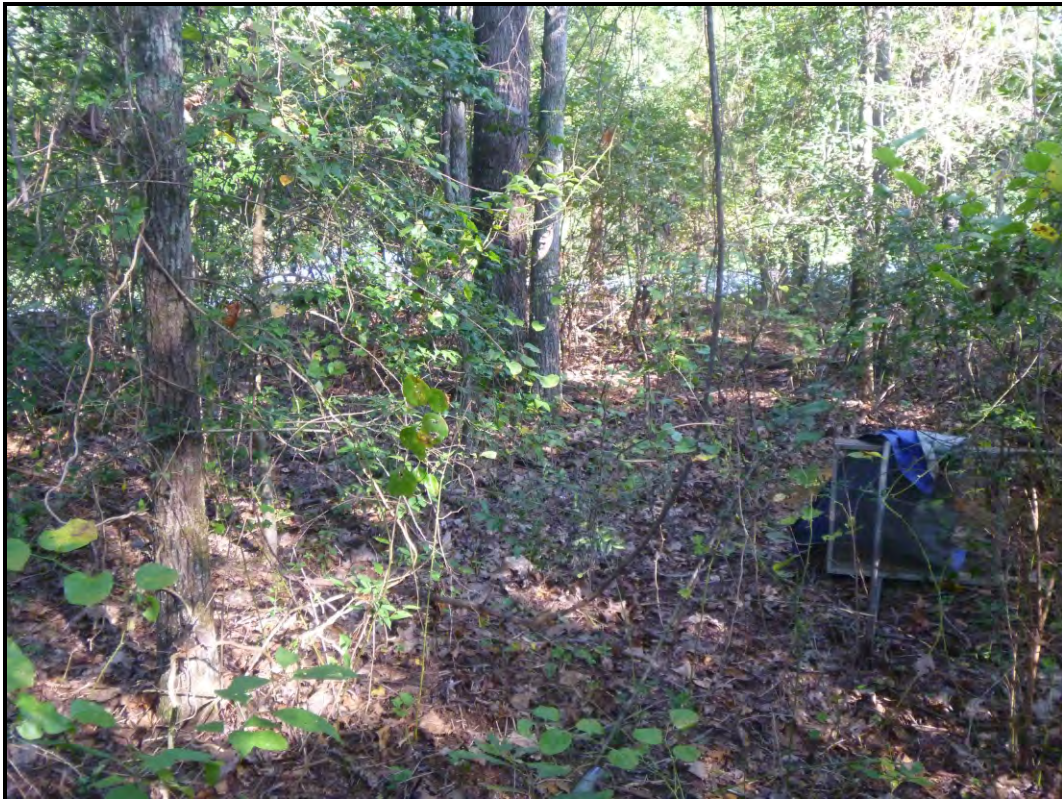
Figure 12: Site 31HT1240/1240, facing Northwest.**

Site Description: Excavation of Shovel Test (ST) 11 yielded three prehistoric artifacts and one historic artifact (see **Figure 12**). Delineation shovel testing at 15-meter intervals within the APE yielded no additional cultural materials (see **Figure 3** for shovel test locations). Soils in ST 11 consisted of 25 centimeters of grayish brown loamy sand and gravel over yellowish brown sand. Prehistoric and historic artifacts were comingled in the top 25 centimeters of excavated soil (Stratum I).

Summary and Recommendations: This site consists of a comingled prehistoric artifact scatter and historic isolate. The isolated historic artifact does not have the potential to yield significant information pertaining to the history of the area. The prehistoric component is represented by a lithic scatter with no temporally diagnostic materials or evidence of cultural features. This site is recommended *Not Eligible* for the National Register of Historic Places (NRHP).

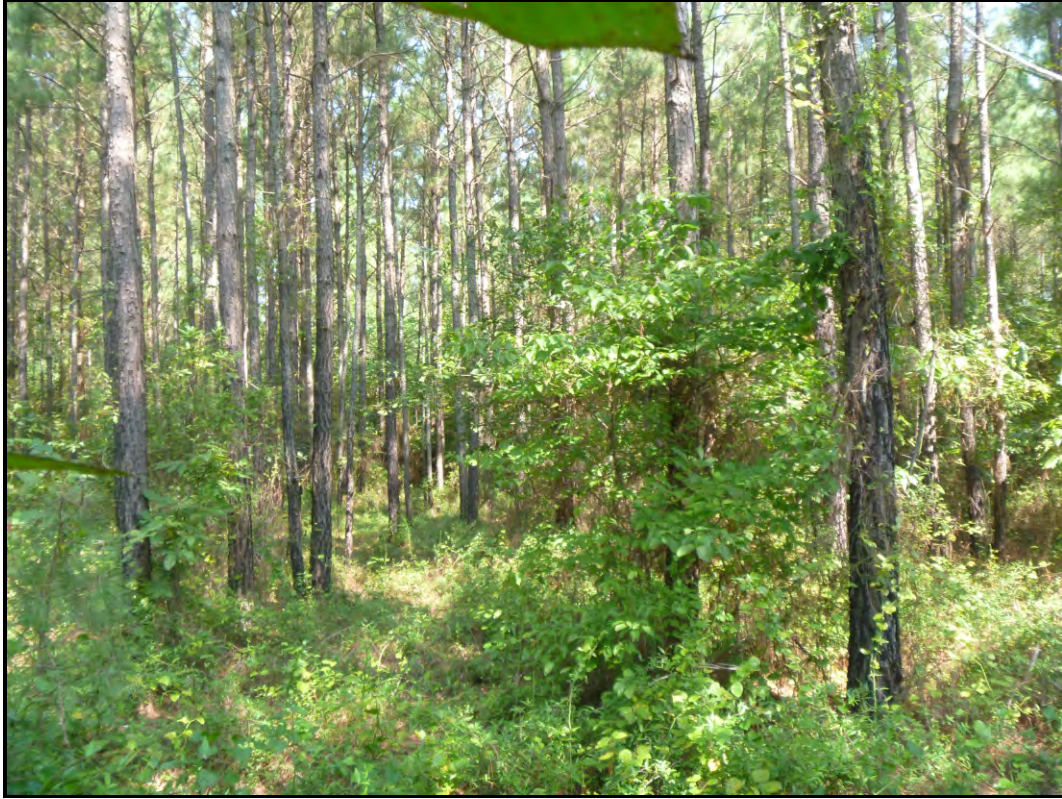
Figure 13: Pine Plantation in Northernmost Portion of Northwest Quadrant of APE, facing West.

The majority of the northwest quadrant of the APE consisted of a mixed pine and young hardwood stand with very dense understory vegetation (see **Figures 13–14**). The northernmost portion of this quadrant consisted of young pine plantation. Surface visibility in this quadrant was poor due to ground cover and vegetation.

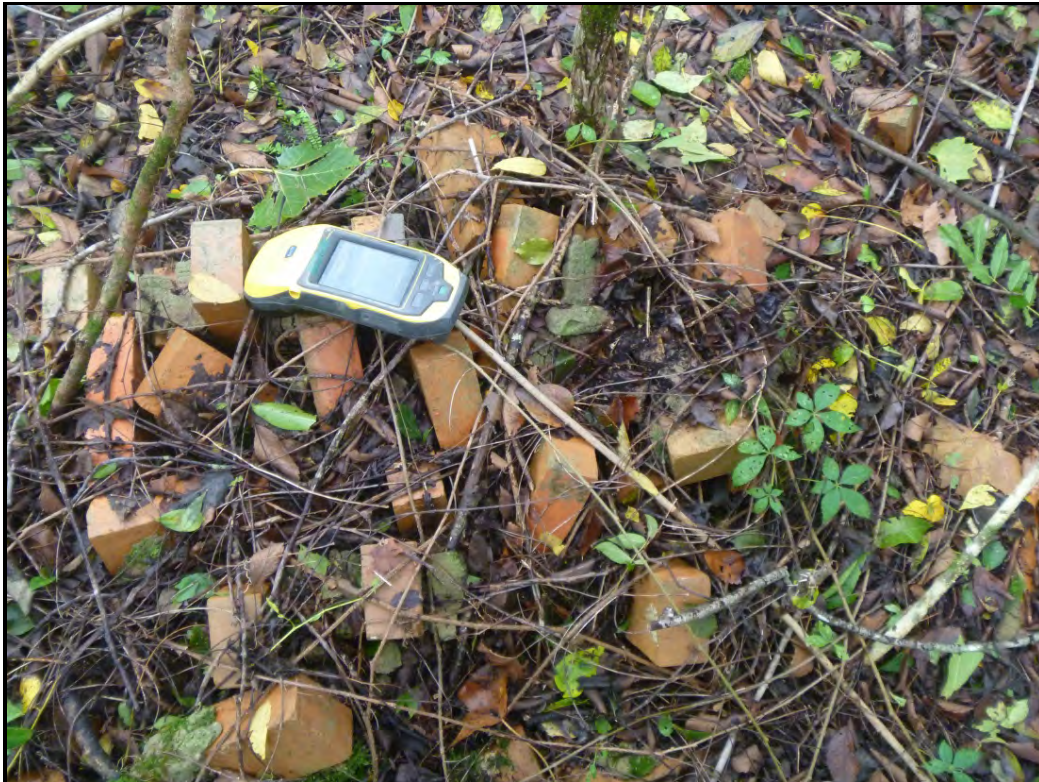
Figure 17: Brick Pile at 31HT1241**.

Site Description: Shovel testing within the northwest quadrant of the APE yielded several small brick fragments from ST 24 (**Figure 16**). A visual inspection of the vicinity noted several areas of mid-twentieth century trash and brick piles (**Figures 17–18**). The bricks were concentrated along the western edge of the APE and do not appear to represent intact structural remains; instead, the bricks appeared to have been bulldozed into linear piles along the western edge of the APE. No mature tree growth was noted in this area, suggesting the pushpiles of brick may have resulted from previous land clearing or timbering activities. Additionally, several ruts and trails were observed throughout the APE, likely the result of clearcutting or logging activities.

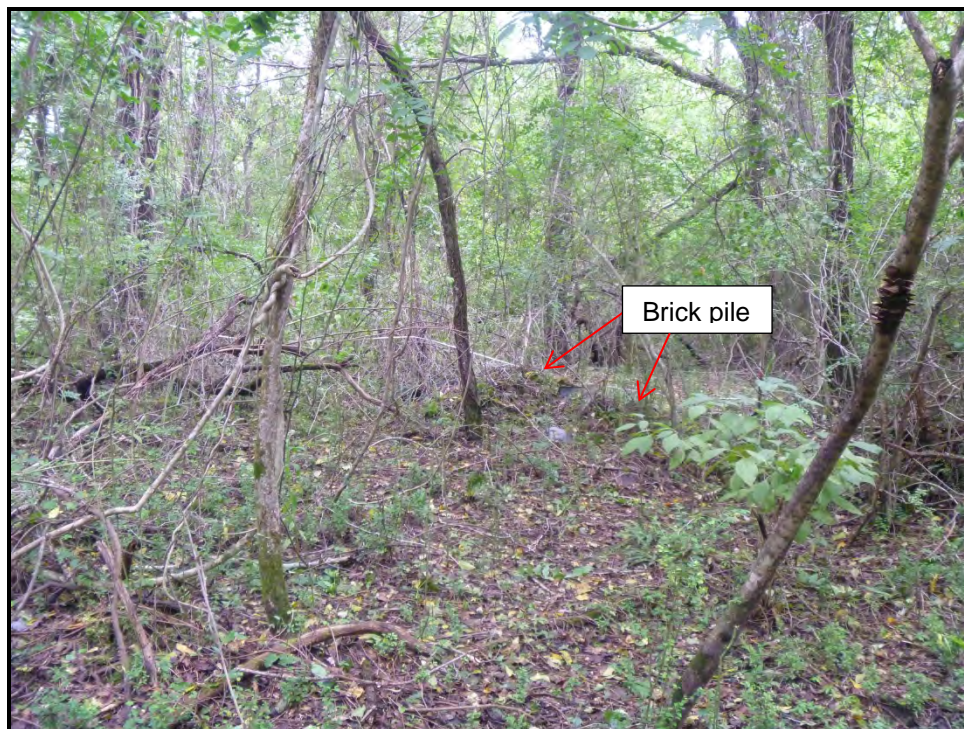
Figure 18: 31HT1241**, facing east towards ST d5.

Delineation shovel testing at 15-meter intervals yielded additional cultural materials from three adjacent shovel tests (STs d1, d2, and d5). Materials recovered included brick fragments, cement mortar, undecorated whiteware and porcelain sherds, glass shards (canning jar, beer bottle, and window glass), nails (galvanized and wire nails), and plastic (**Table 3**).

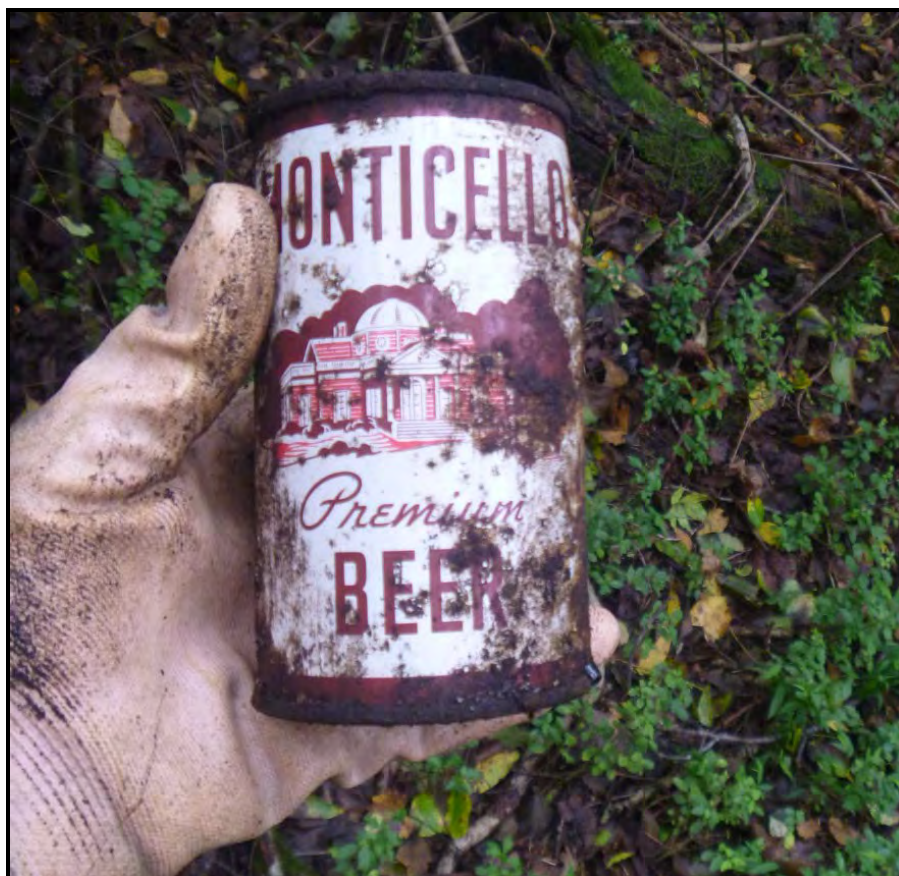
Figure 19: c. 1956 Beer Can from Site 31HT1241** (Outside of APE).

A scatter of mid-twentieth century trash (primarily glass bottles and metal cans) was noted both within and outside of the APE. Dateable materials noted but not collected included a 1956 beer can (**Figure 19**) as well as several broken Sun Crest and Pepsi-Cola bottles (mid to late-1950s).

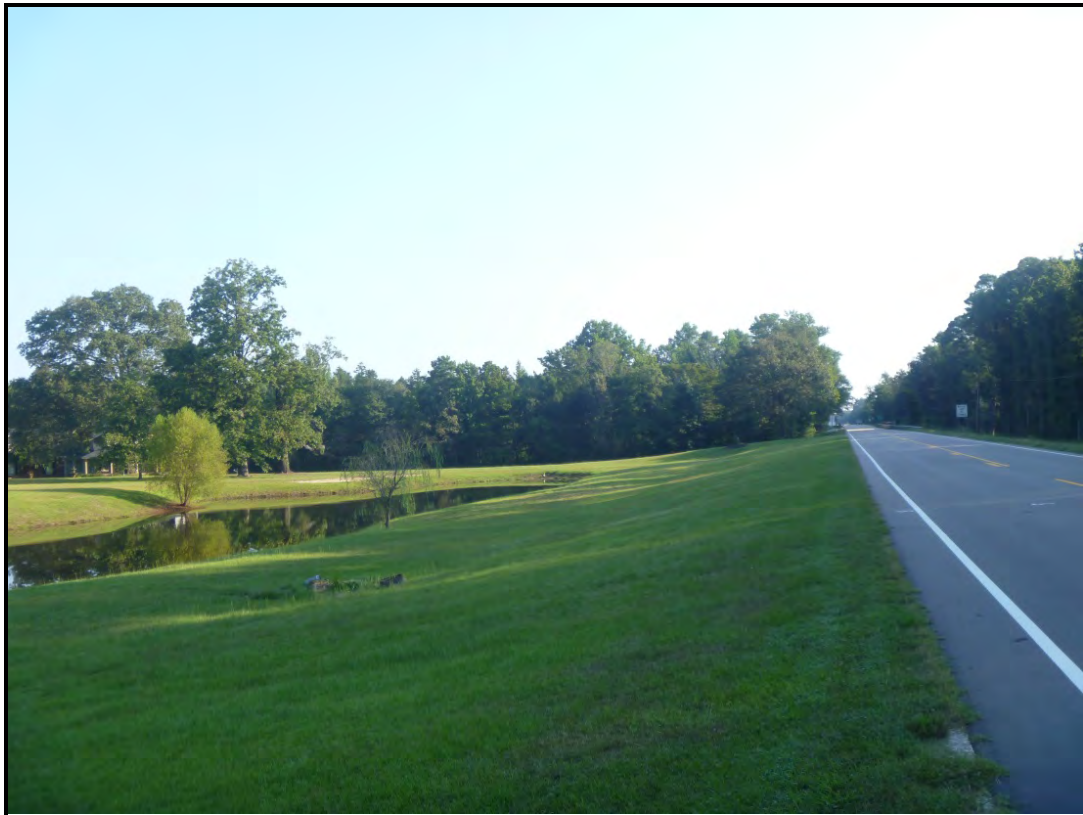
Figure 22: Southwest Quadrant of APE, facing Northeast.

The southwest quadrant of the APE consists entirely of a residential yard and has been disturbed by the construction of ponds and landscaping (see **Figures 22–23**). Surface visibility in this portion of the APE was poor due to a maintained lawn and other groundcover; a general visual inspection of this portion of the APE revealed no surface artifacts. No shovel tests were excavated in this quadrant.

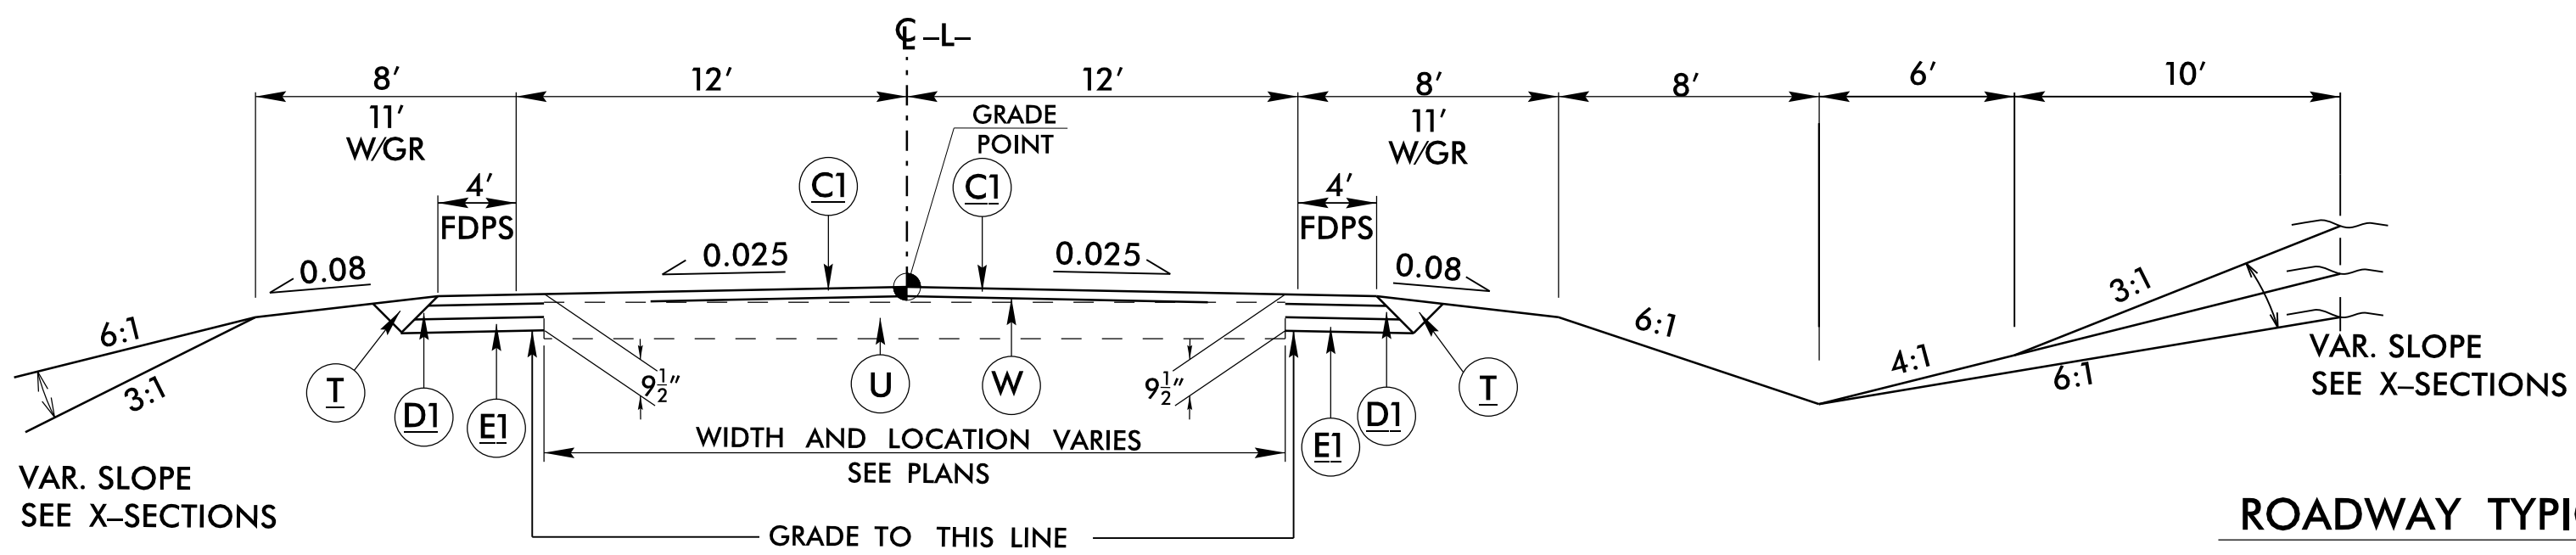
ROADWAY TYPICAL SECTION NO. 1
 -L- STA. 12+26.00 TO STA. 15+45.20
 -L- STA. 18+40.20 TO STA. 21+57.00

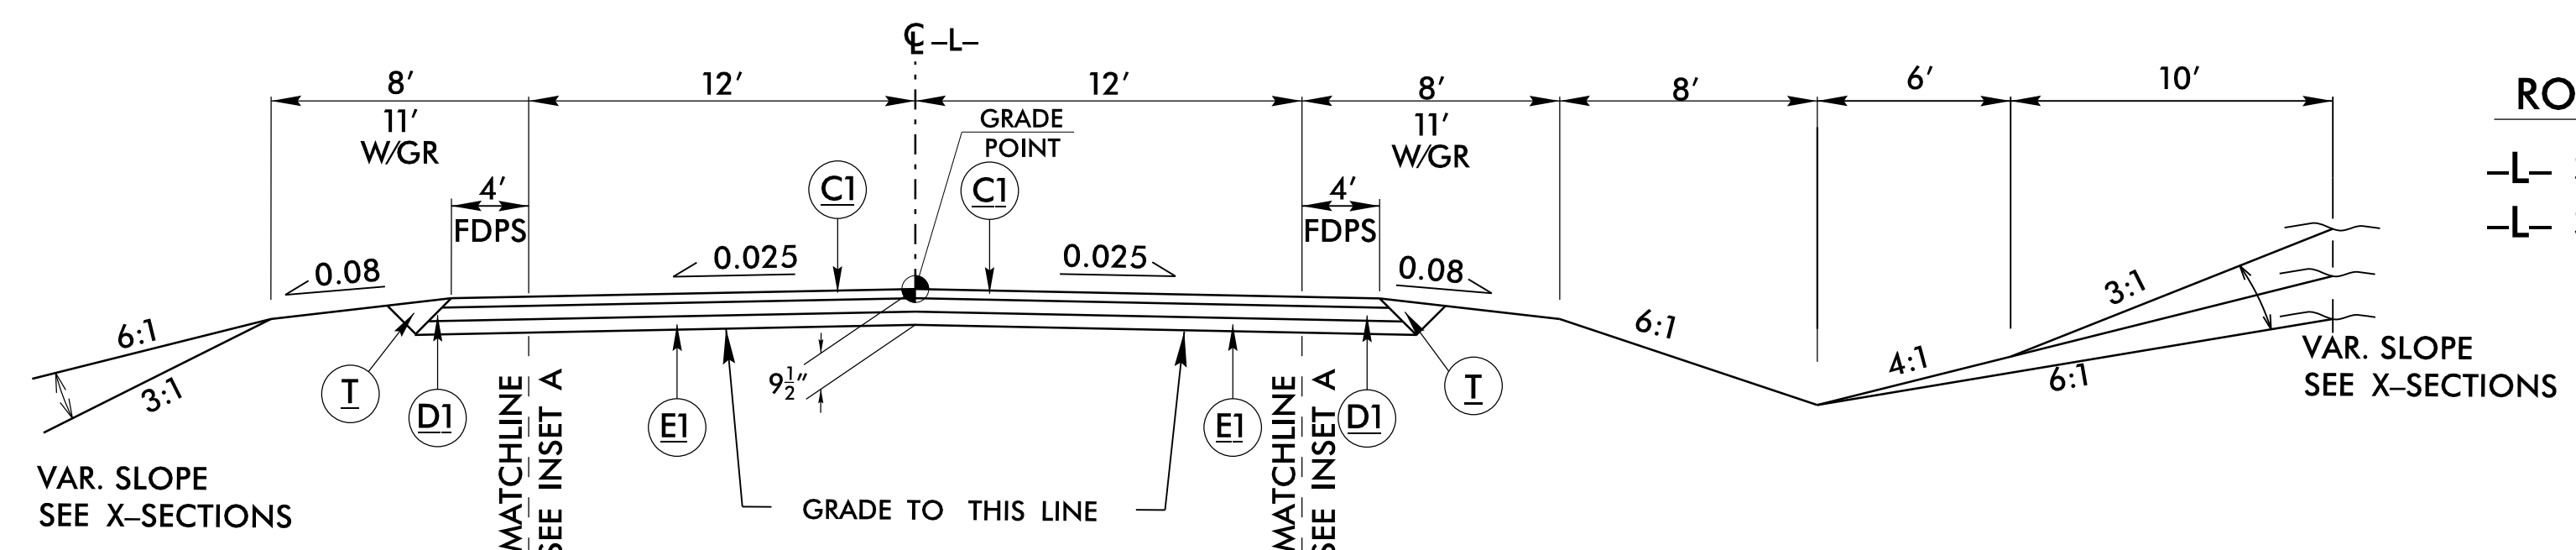
ROADWAY TYPICAL SECTION NO. 2
 -L- STA. 15+45.20 TO STA. 15+94.20
 -L- STA. 17+91.20 TO STA. 18+40.20

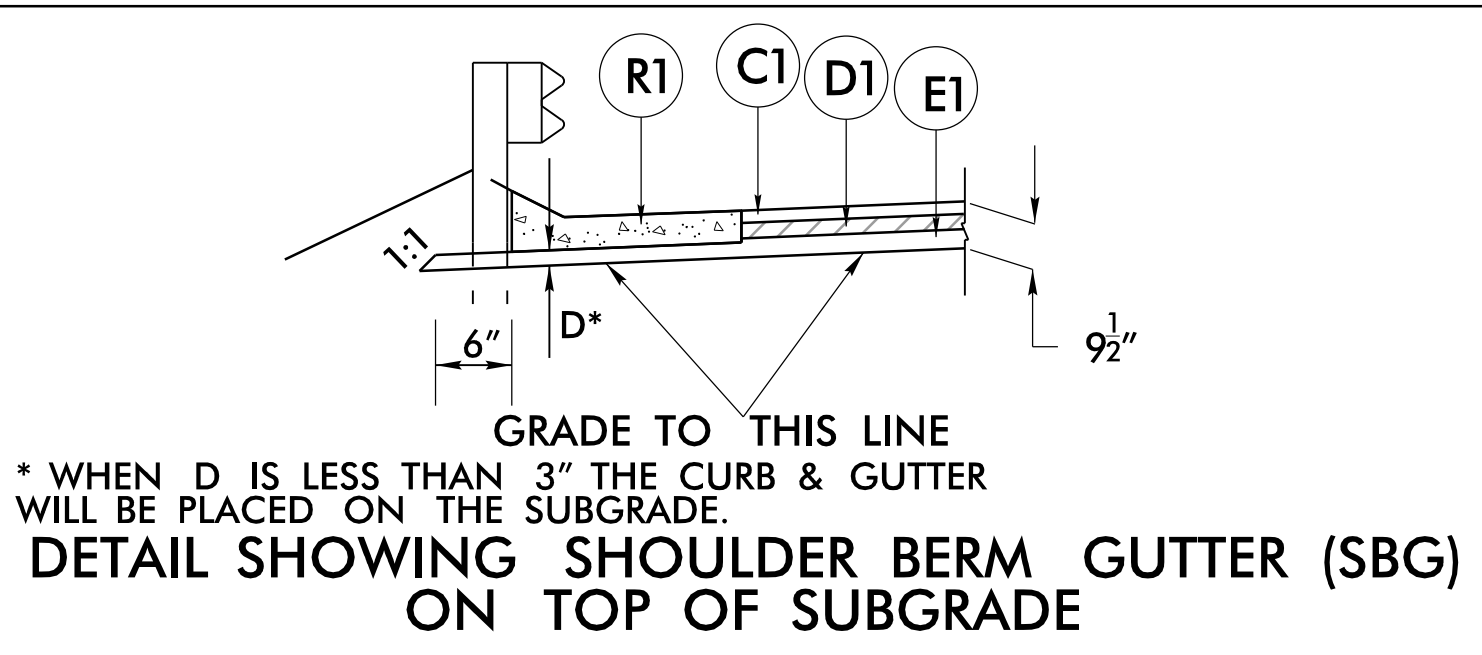
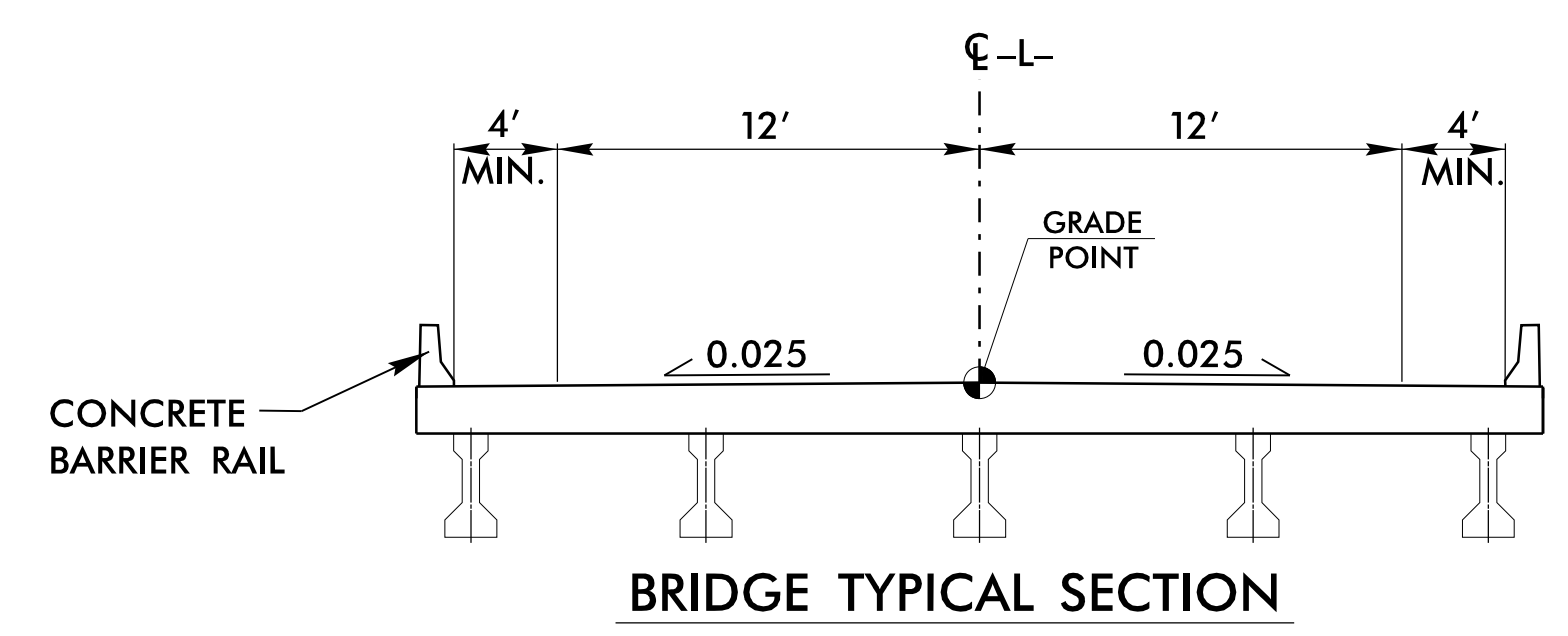
-L- BRIDGE TYPICAL SECTION
 -L- STA. 15+94.20 TO STA. 17+91.20

Bridge No. 60 will be replaced on the existing alignment. The approximate project length is 900 feet. The replacement structure will be approximately 190 feet long with a minimum clear roadway width of 33 feet. The bridge will include two twelve-foot lanes and 4.5-foot offsets on each side. The bridge length is based on preliminary design information and is set by hydraulic requirements. The roadway grade of the new structure will be approximately the same as the existing structure.
