MINIMUM CRITERIA DETERMINATION CHECKLIST

TIP Project No.: B-5893

Project Location: Bridge No. 19 on NC 226 over Cub Creek in Mitchell County.

Project Description: The proposed project involves replacing Bridge No. 19 on NC 226 over Cub Creek in Mitchell County (see Figure 1). The replacement structure will be a bridge approximately 40 feet long (see Figure 2). The bridge will have a minimum 39 feet roadway width, with two 11-foot lanes and 4-foot paved shoulders with a minimum of 42-inch-high bicycle safe railing on each side. Six foot shoulders (9 feet with guardrail) will be included on the roadway approaches. The bridge length is based on preliminary design information and is set by hydraulic requirements. The roadway grade of the new structure will account for the low chord of the existing structure. Construction will be staged using a signalized one-lane two-way detour with traffic being maintained on the existing bridge in Phase 1.

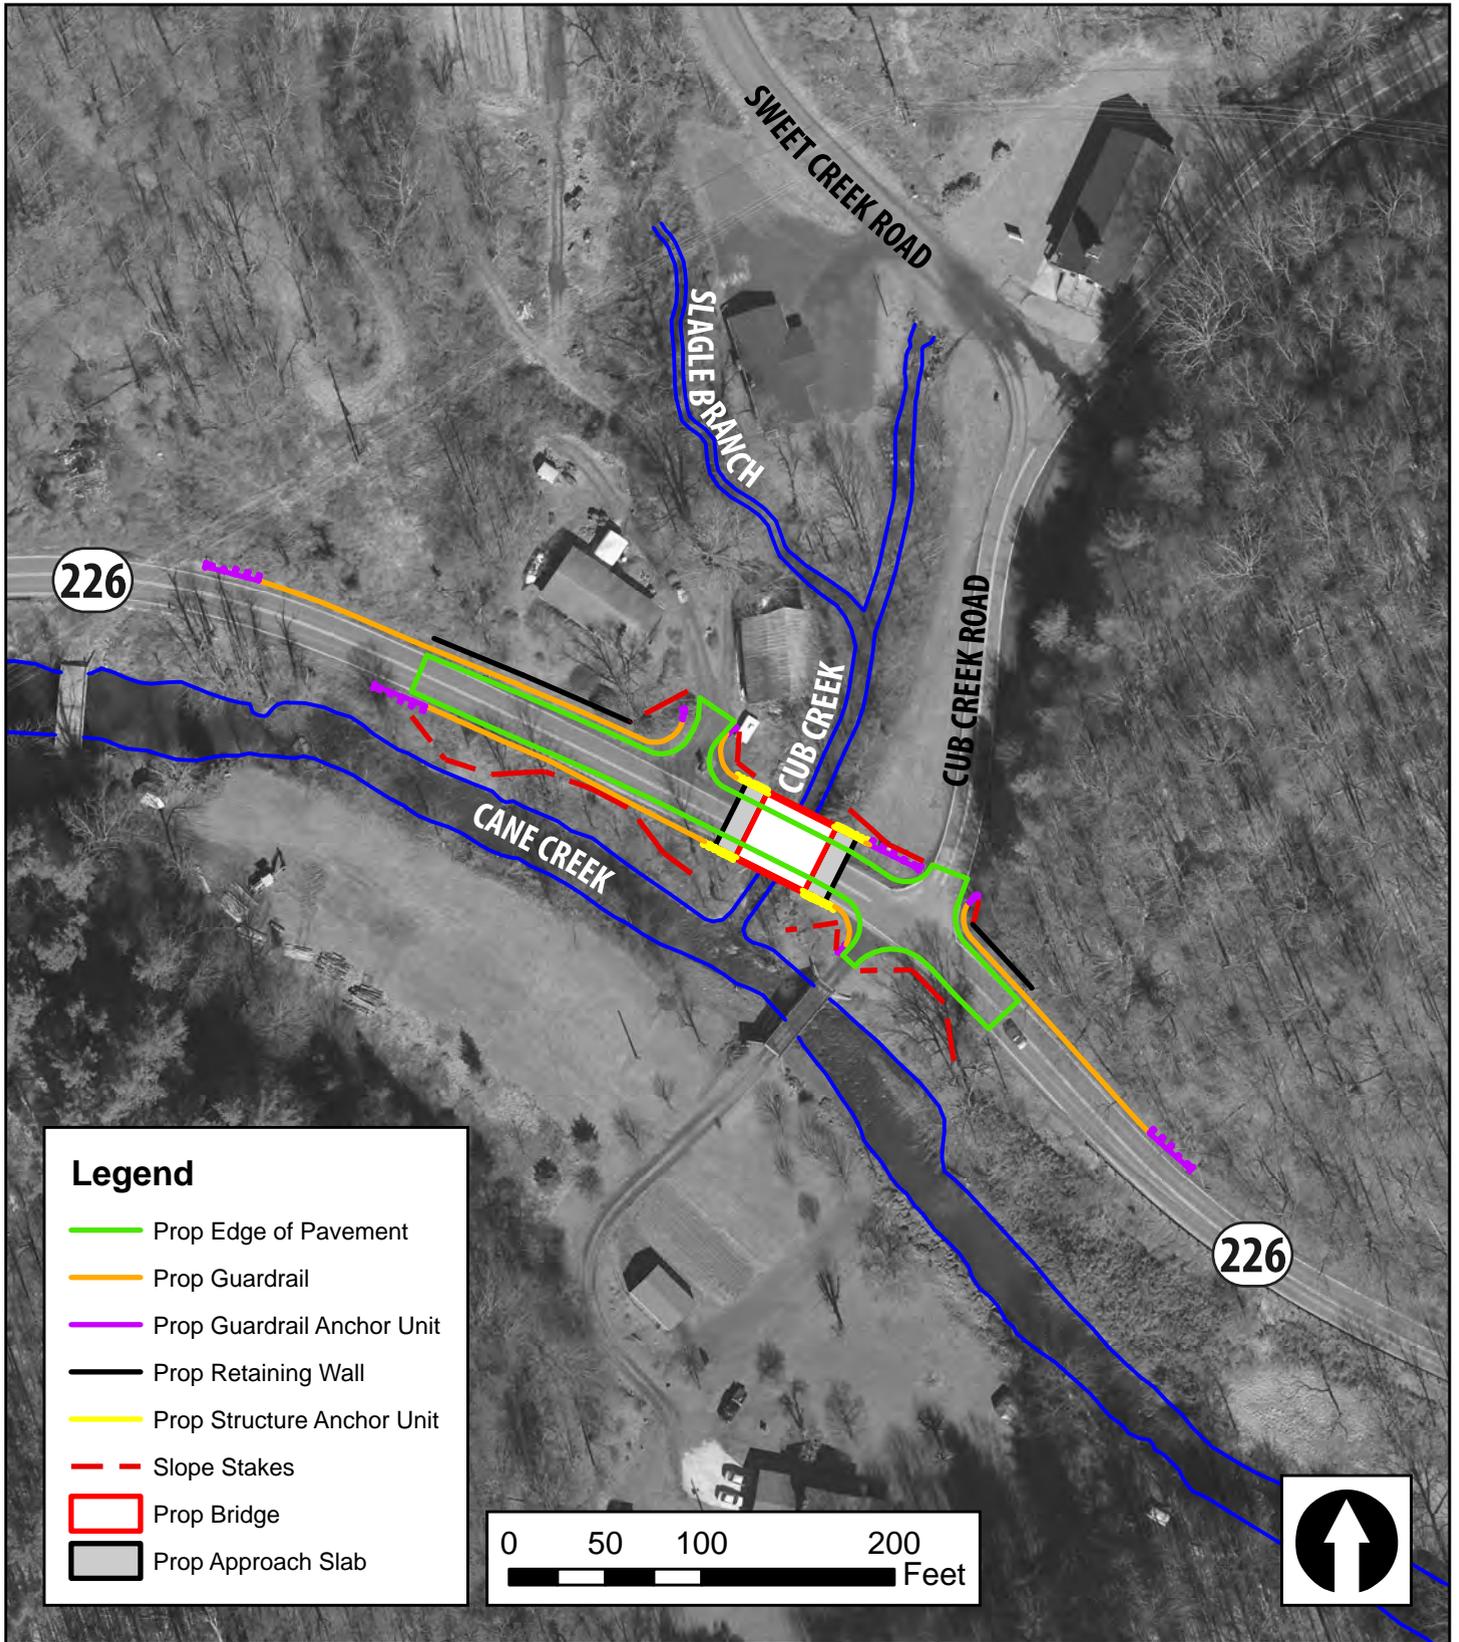
Figure 2

Proposed Improvements
 Replace Bridge No. 19 on NC 226
 over Cub Creek with Staged Construction
Mitchell County
 B-5893

Staged Construction - Bridge No. 19 will be staged by using a signalized one-lane two-way detour with traffic being maintained on the existing bridge in Phase 1, while a new bridge is constructed. The proposed bridge would be 40 feet long. Staged construction would allow for minimal impacts to local school traffic, residents, and EMS operations. NCDOT concurs that this is the preferred alternative.

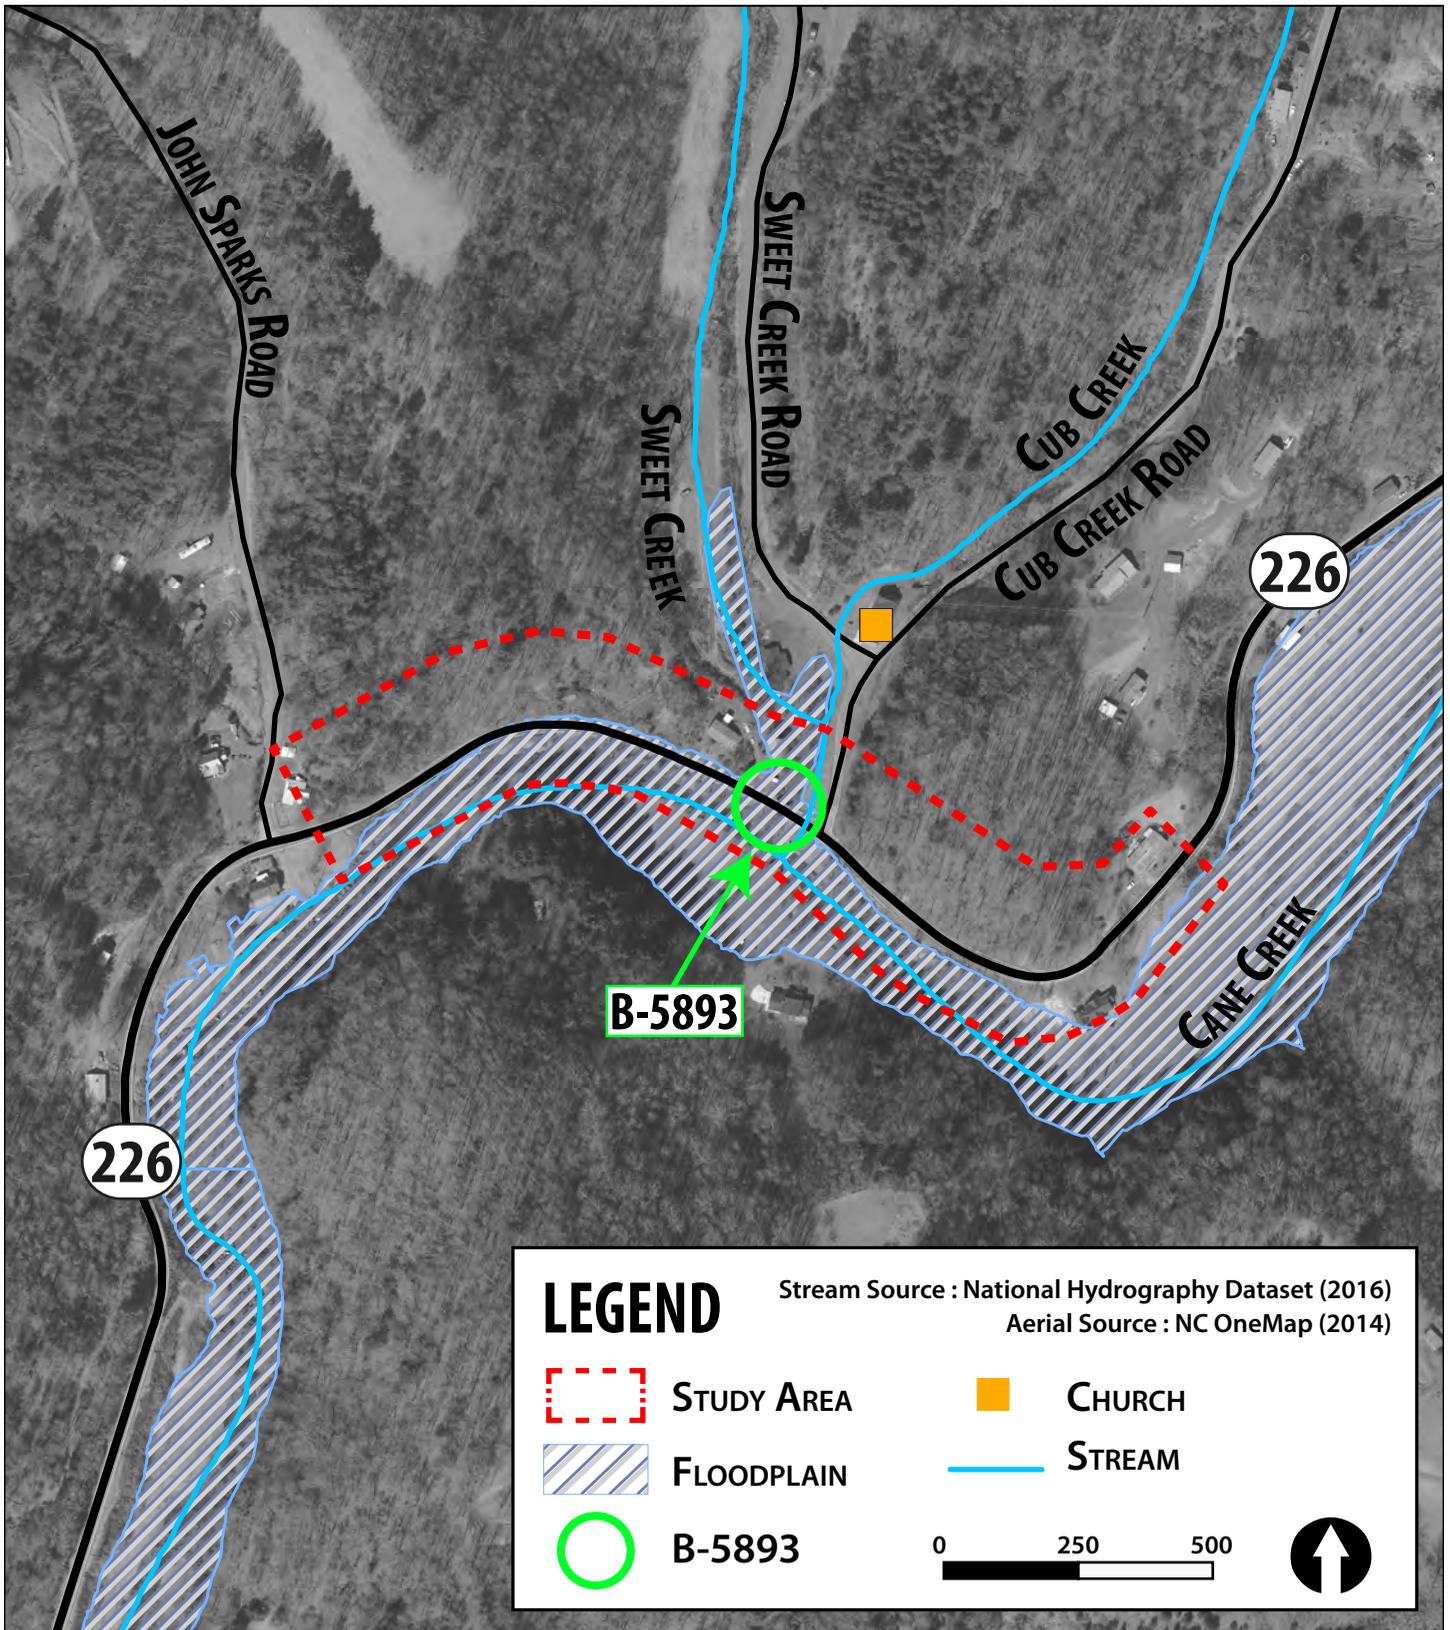
Figure 3

Environmental Constraints Map
 Replace Bridge No. 19 on NC 226
 over Cub Creek with Staged Construction
Mitchell County
 B-5893

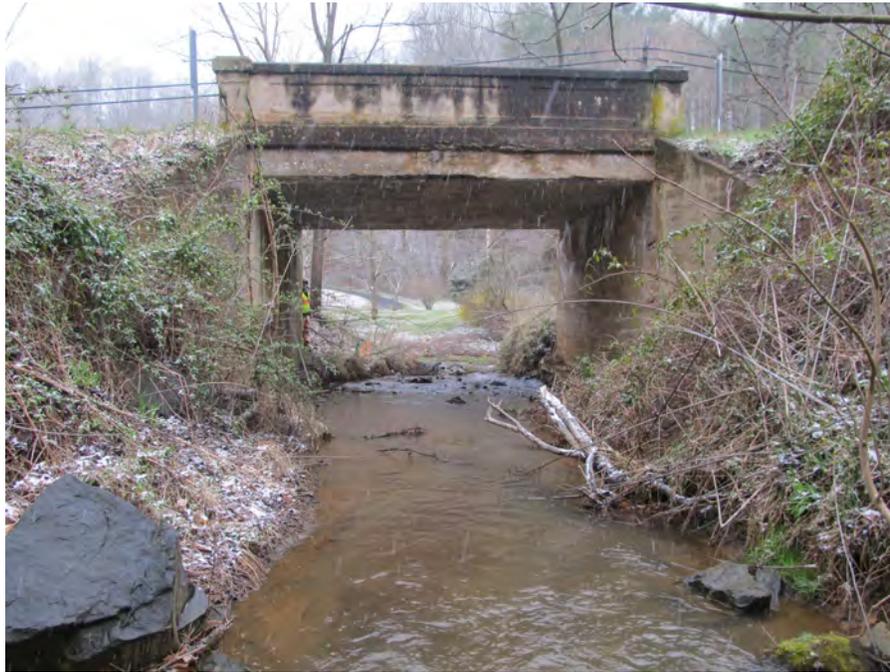
Figure 4

Bridge No. 19 Upstream Bridge Face

Purpose and Need: The purpose of this project is to replace a structurally deficient bridge. Bridge No. 19 was built in 1935. The bridge is 22 feet long with approximately 19 feet and 2 inches of clear roadway width. The superstructure of the bridge is reinforced concrete slab. The substructure of the bridge consists of reinforced concrete abutments.

Components of the deck have experienced an increasing degree of section loss, deterioration, spalling or scour that can no longer be addressed by maintenance activities. Bridge No. 19 has an Average Annual Daily Traffic (AADT) volume of 2,000 vehicles

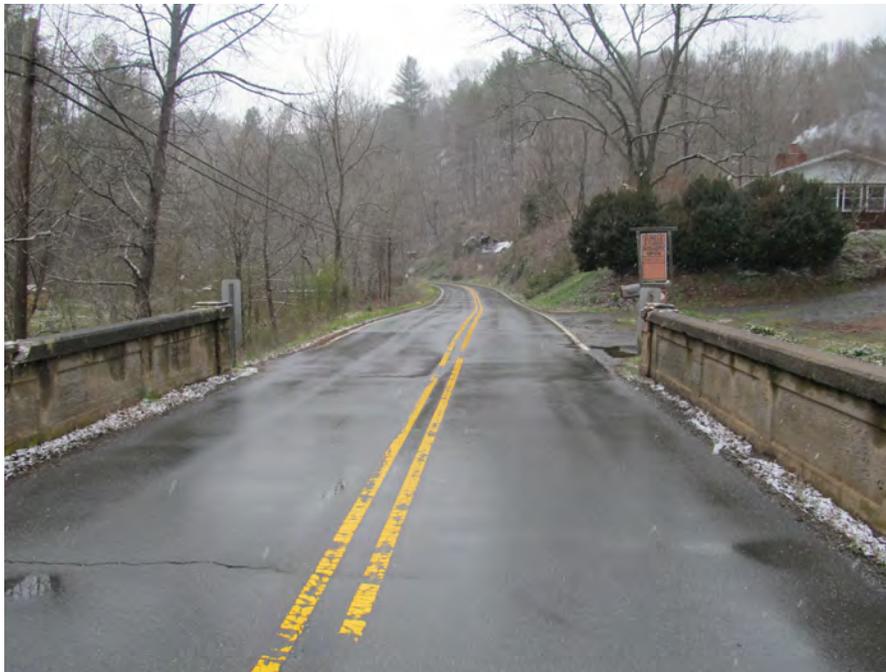
Bridge No. 19 West Approach

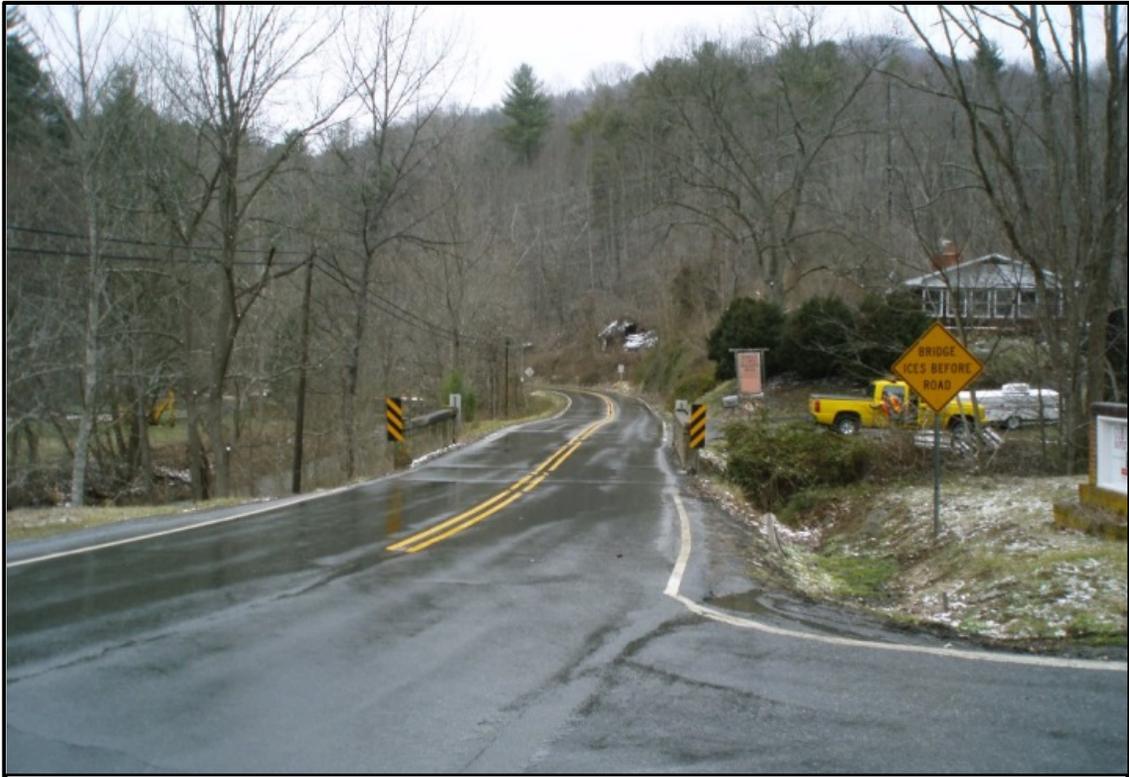
Figure 1: West view of Bridge 19.

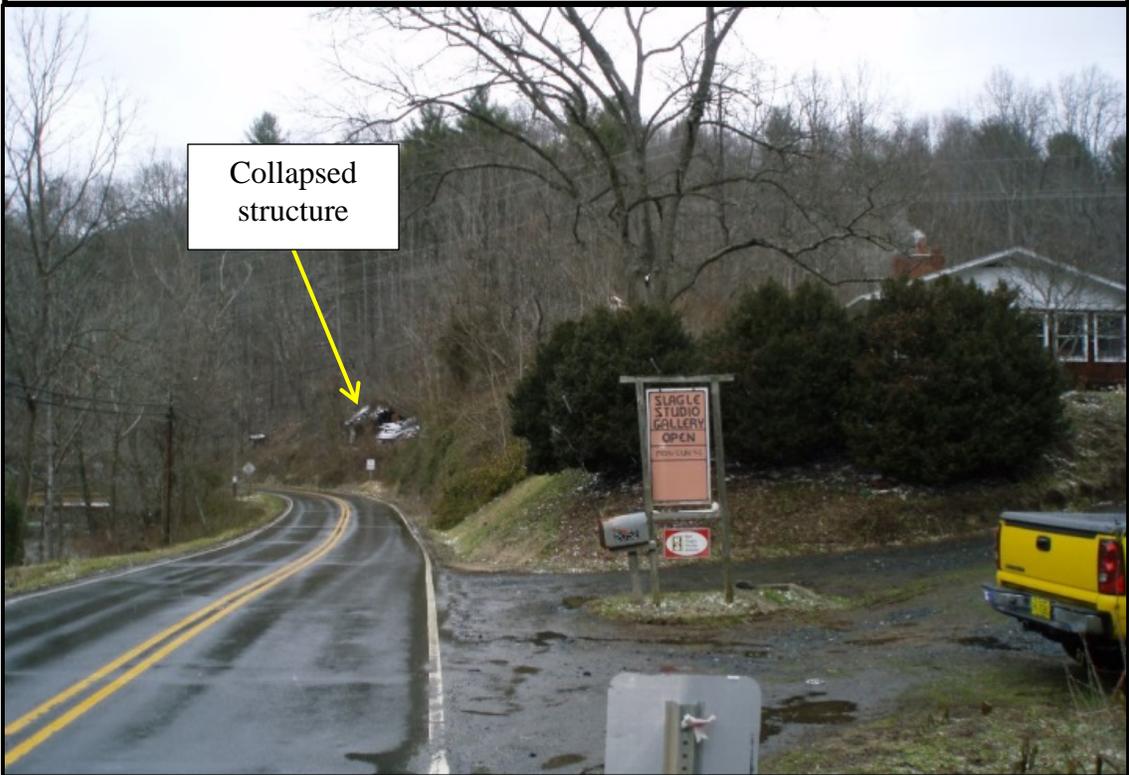
Figure 2: West view of the northwest quadrant.

A visual reconnaissance of the project area was conducted by NCDOT archaeologists Scott Halvorsen and Caleb Smith on 2/25/2016. The reconnaissance found that the landforms within the A.P.E. have a low potential for archaeological sites. The A.P.E. in the northwest quadrant is occupied by a parking area, a residential yard, and then a sloped hillside. There is a collapsed structure on the north side of NC 226 approximately 120 meters (394 ft.) west of the bridge. The southwest quadrant is a narrow strip of land between NC 226 and Cane Creek. The

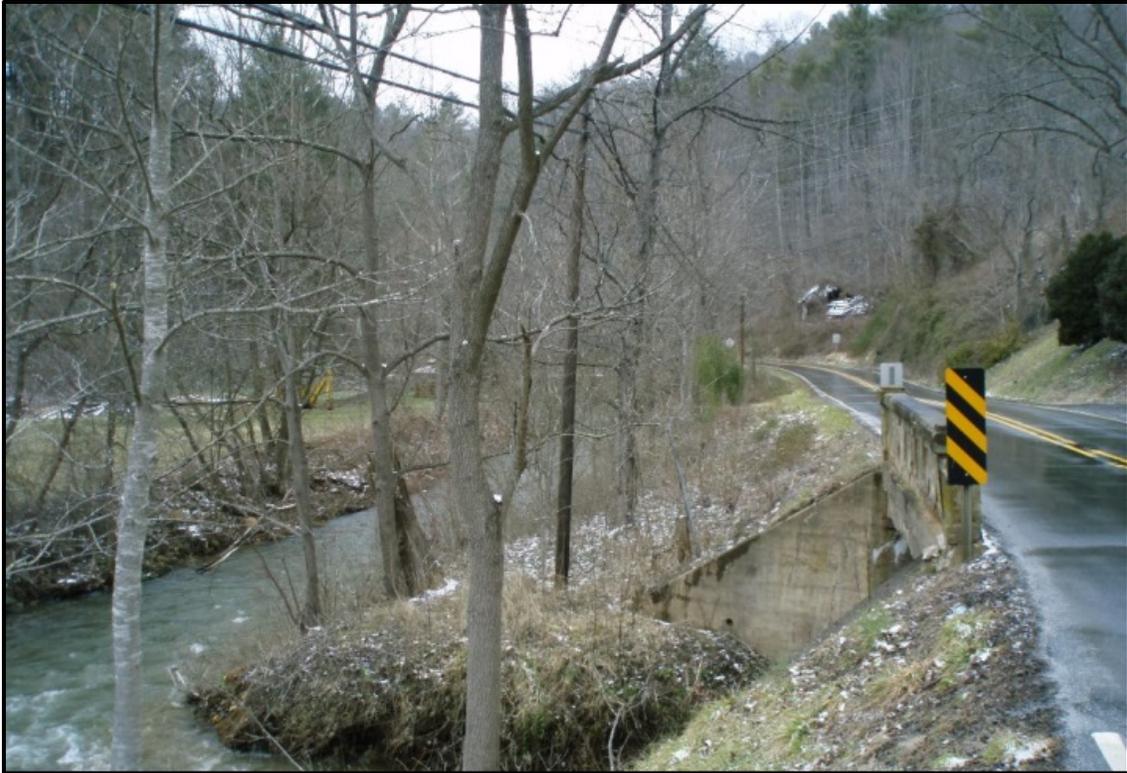
Figure 3: West view of the southwest quadrant.

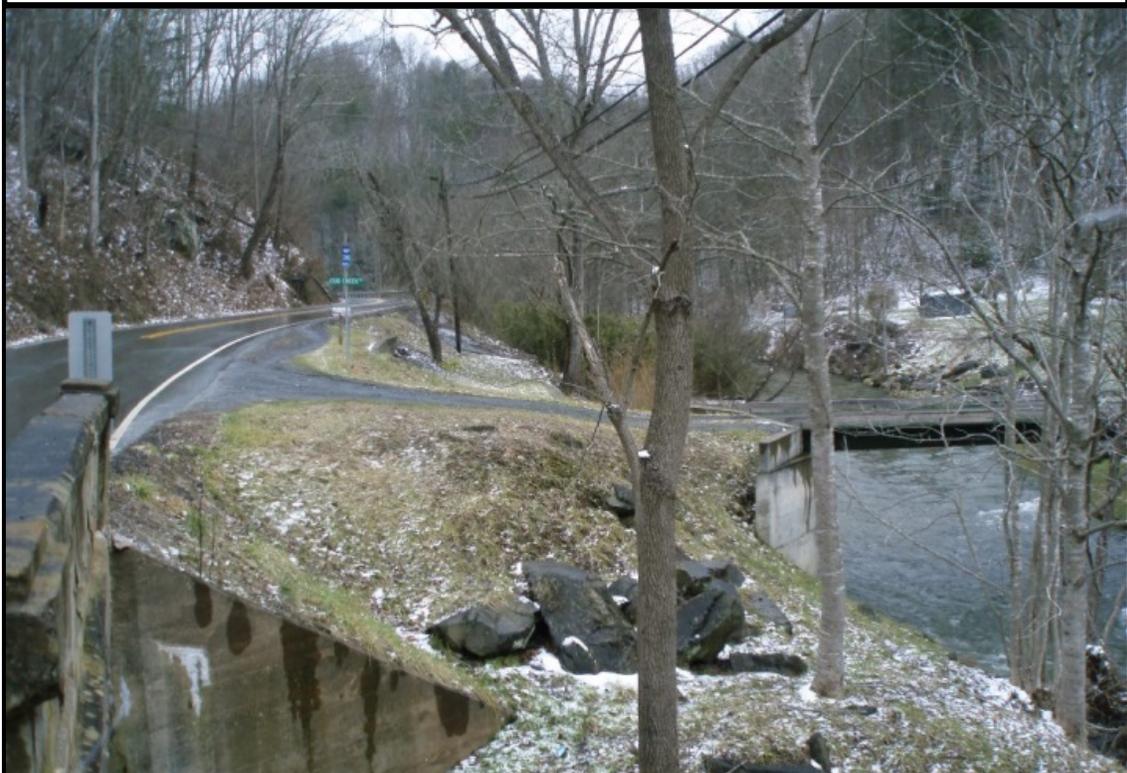
Figure 4: Southeast view of the southeast quadrant.

southeast quadrant is a driveway next to the bridge, and then a narrow strip between NC 226 and Cane Creek. The northeast quadrant is a level, elevated terrace from the creek east for approximately 20 meters (66 ft.), then Cub Creek Rd. (SR 1300), and then a steep hillside. The level terrace is too narrow to have much archaeological potential, and may be disturbed by roadside uses. There is a sign for the Cub Creek Baptist Church there now.

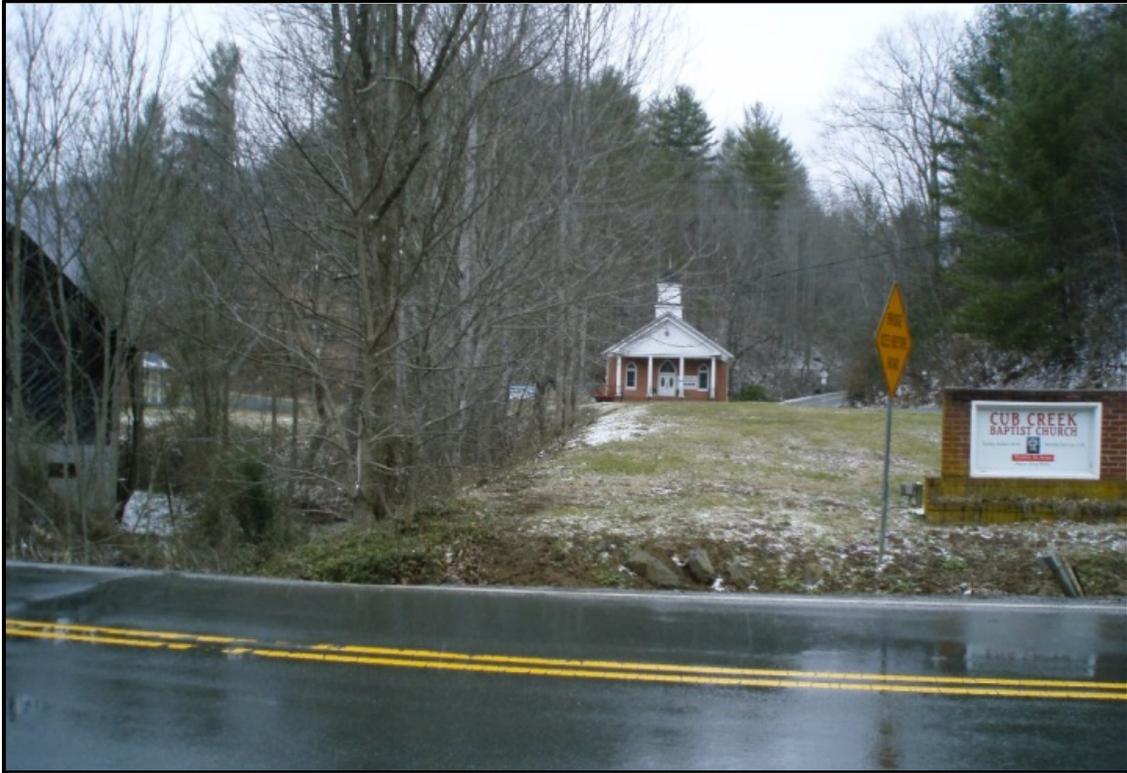
Figure 5: North view of the level terrace in the northeast quadrant.

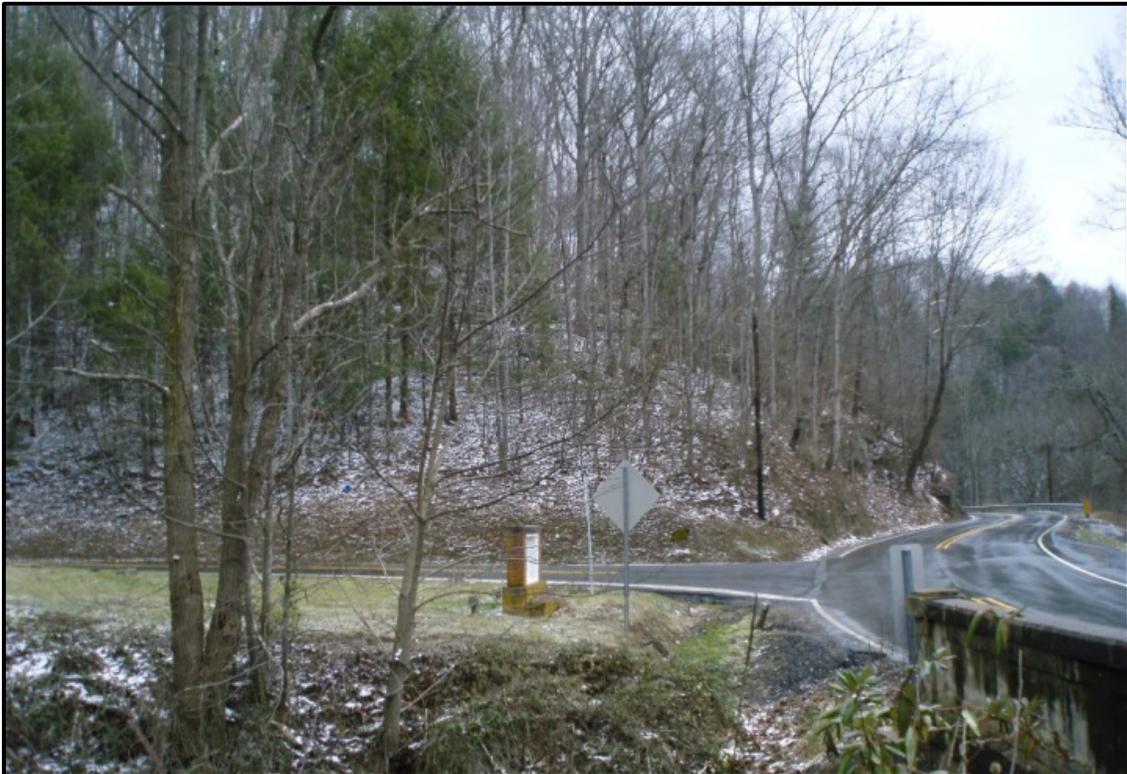
Figure 6: Southeast view of the northeast quadrant.
