MINIMUM CRITERIA DETERMINATION CHECKLIST

TIP Project No.: BR-0009

Project Description: The North Carolina Department of Transportation (NCDOT) plans to replace Bridge #100079 on NC 9 over the Broad River (TIP # BR-0009) in Buncombe County (Division 13).

**NO NATIONAL REGISTER OF HISTORIC PLACES
ELIGIBLE OR LISTED ARCHAEOLOGICAL SITES
AFFECTED FORM**

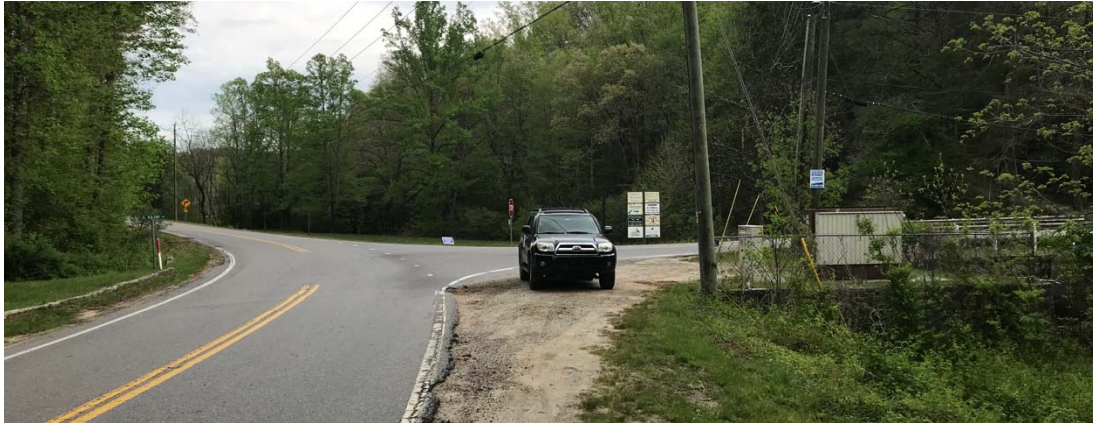
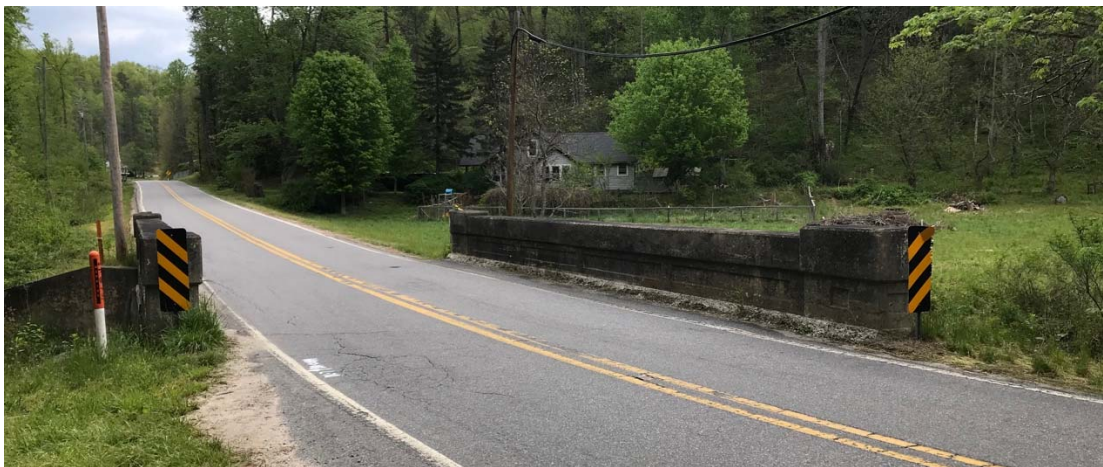
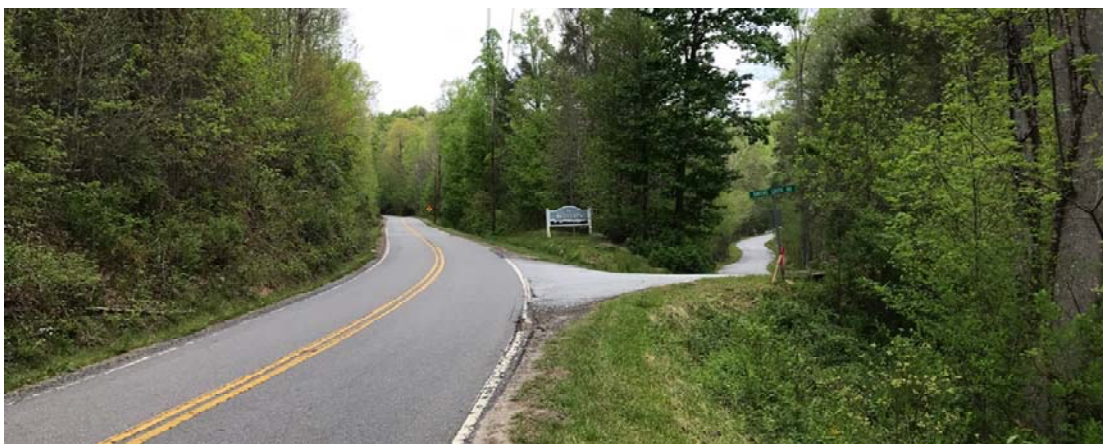
Figure 2. Current Conditions in the Bridge 79 APE

A) The Intersection of NC 9 and Old Fort Road, Facing West

B) Bridge 79 Over the Broad River, Facing North

C) The NC 9 and Havens Creek Road Intersection

The NCDOT preliminary background investigation recommended an archaeological survey. The project area is minimally disturbed with level terrain and dry soils (Figure 2). These areas are suitable for prehistoric occupations. Subsurface testing was needed to identify any significant archaeological resources that might be impacted by the proposed replacement of Bridge No. 79 in Buncombe County.

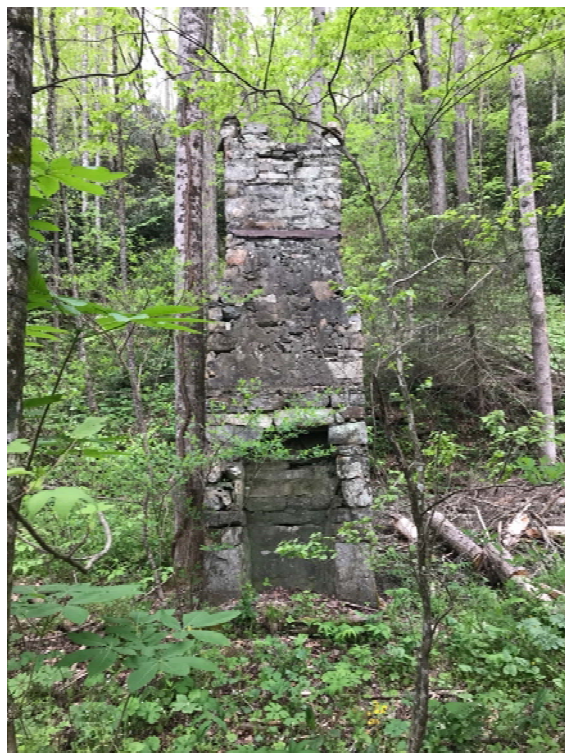
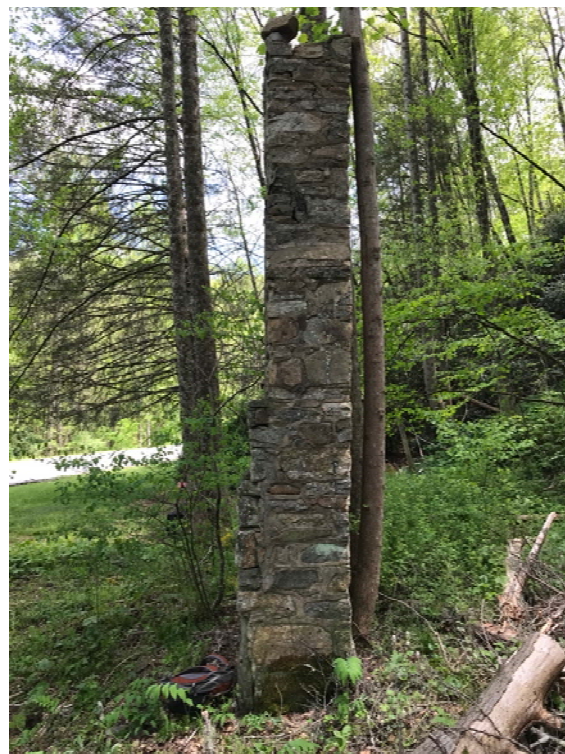
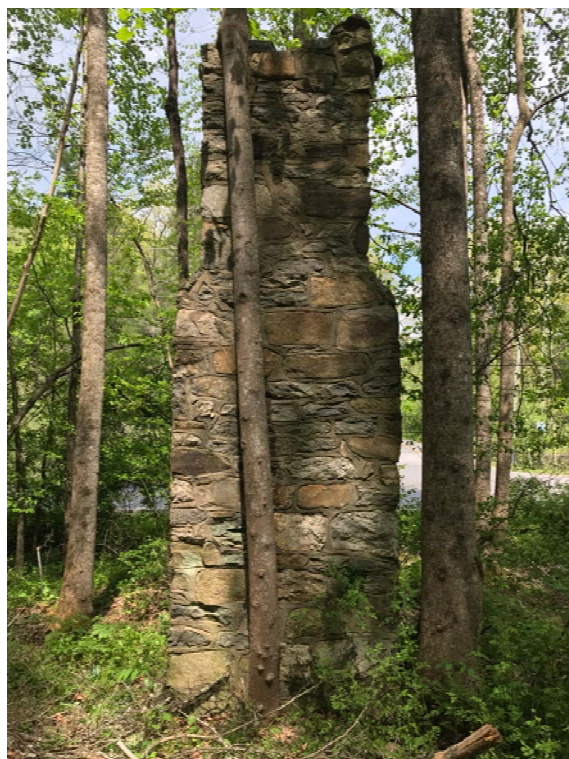
Figure 9. Chimney at Site 31BN1035

C. Facing West

B. Facing South

A. Facing East

The chimney measured 80x160 centimeters in plan and was constructed of stone and mortar (Figure 9). The east-facing fireplace included an elevated stone hearth. A horizontal piece of standing seam metal roofing was embedded in the upper chimney, and mortar present on the interior (eastern) chimney face. No foundation or pier supports were located during the site evaluation. The position of the chimney suggests the house extended into the NC 9 right of way, and it is highly probable that standing structural elements in the area were demolished during road construction. Though survey testing did not locate any artifacts near the chimney, five 7.5-meter interval shovel tests were excavated during the site evaluation (Figures 10 and 11). These tests revealed 30 centimeters of brown (7.5YR 3/4) silty clayey loam overlying reddish yellow (7.5YR 7/8) silty clay subsoil. One test, at N507.5 E500, produced seven historic artifacts from a depth of 0-30 centimeters below the ground surface. This test location and the chimney location indicate the site measures 15 meters in diameter.
