## Type I and II Ground Disturbing Categorical Exclusion Action Classification Form

Project No.	BR-0114
WBS Element	48823.1.1
Federal Project No.

The North Carolina Department of Transportation (NCDOT) proposes to replace Bridge No. 480165 on SR 1601 (Branton Road) over Rocky Creek in Iredell County (Refer to Figure 1).

**TIP PROJECT: BR-0114**

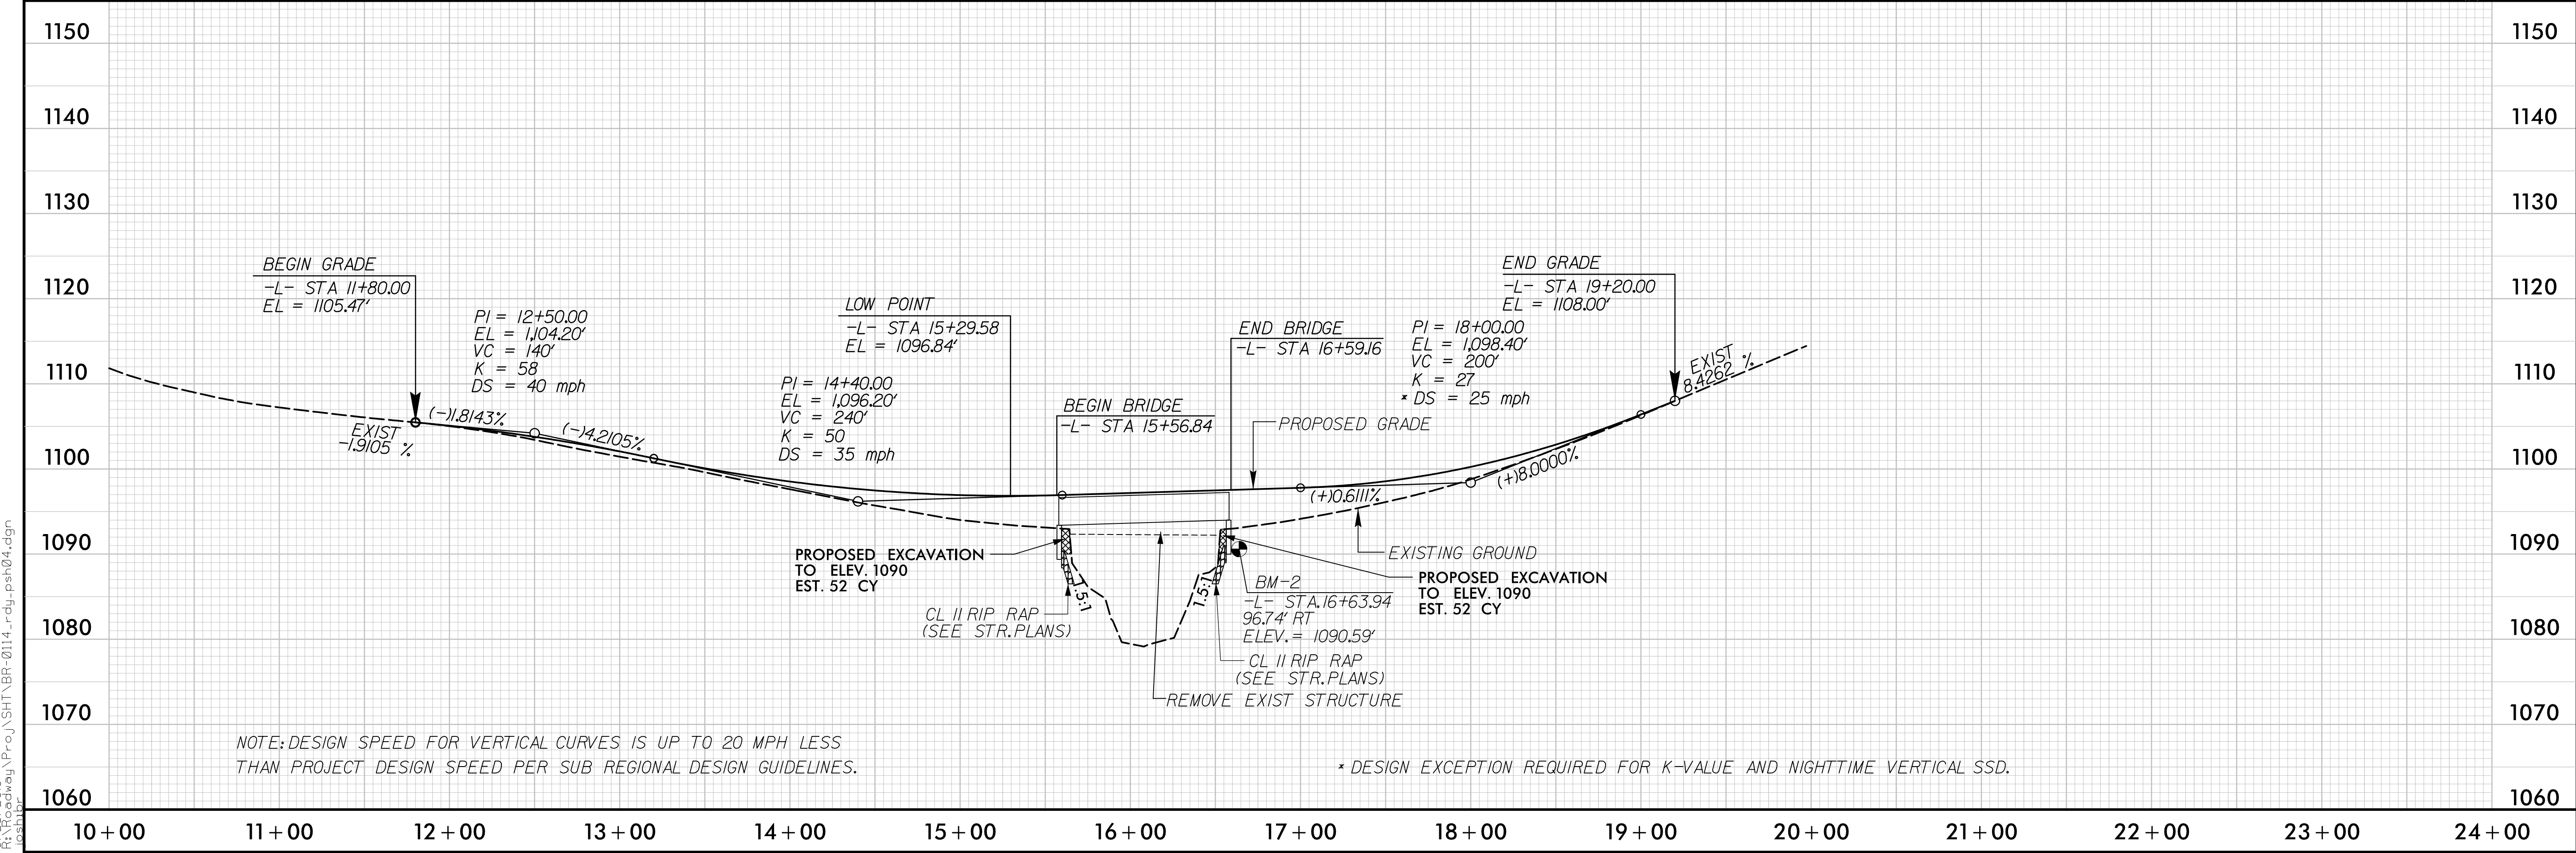
NOTE: DESIGN SPEED FOR VERTICAL CURVES IS UP TO 20 MPH LESS THAN PROJECT DESIGN SPEED PER SUB REGIONAL DESIGN GUIDELINES.

**Design Exceptions:** A design exception is required for the sag vertical curve (K value) due to the existing sag at the bridge and the steepness of the roadway between the bridge and Linney's Mill Road. This will result in a speed limit reduction in the area of the bridge.

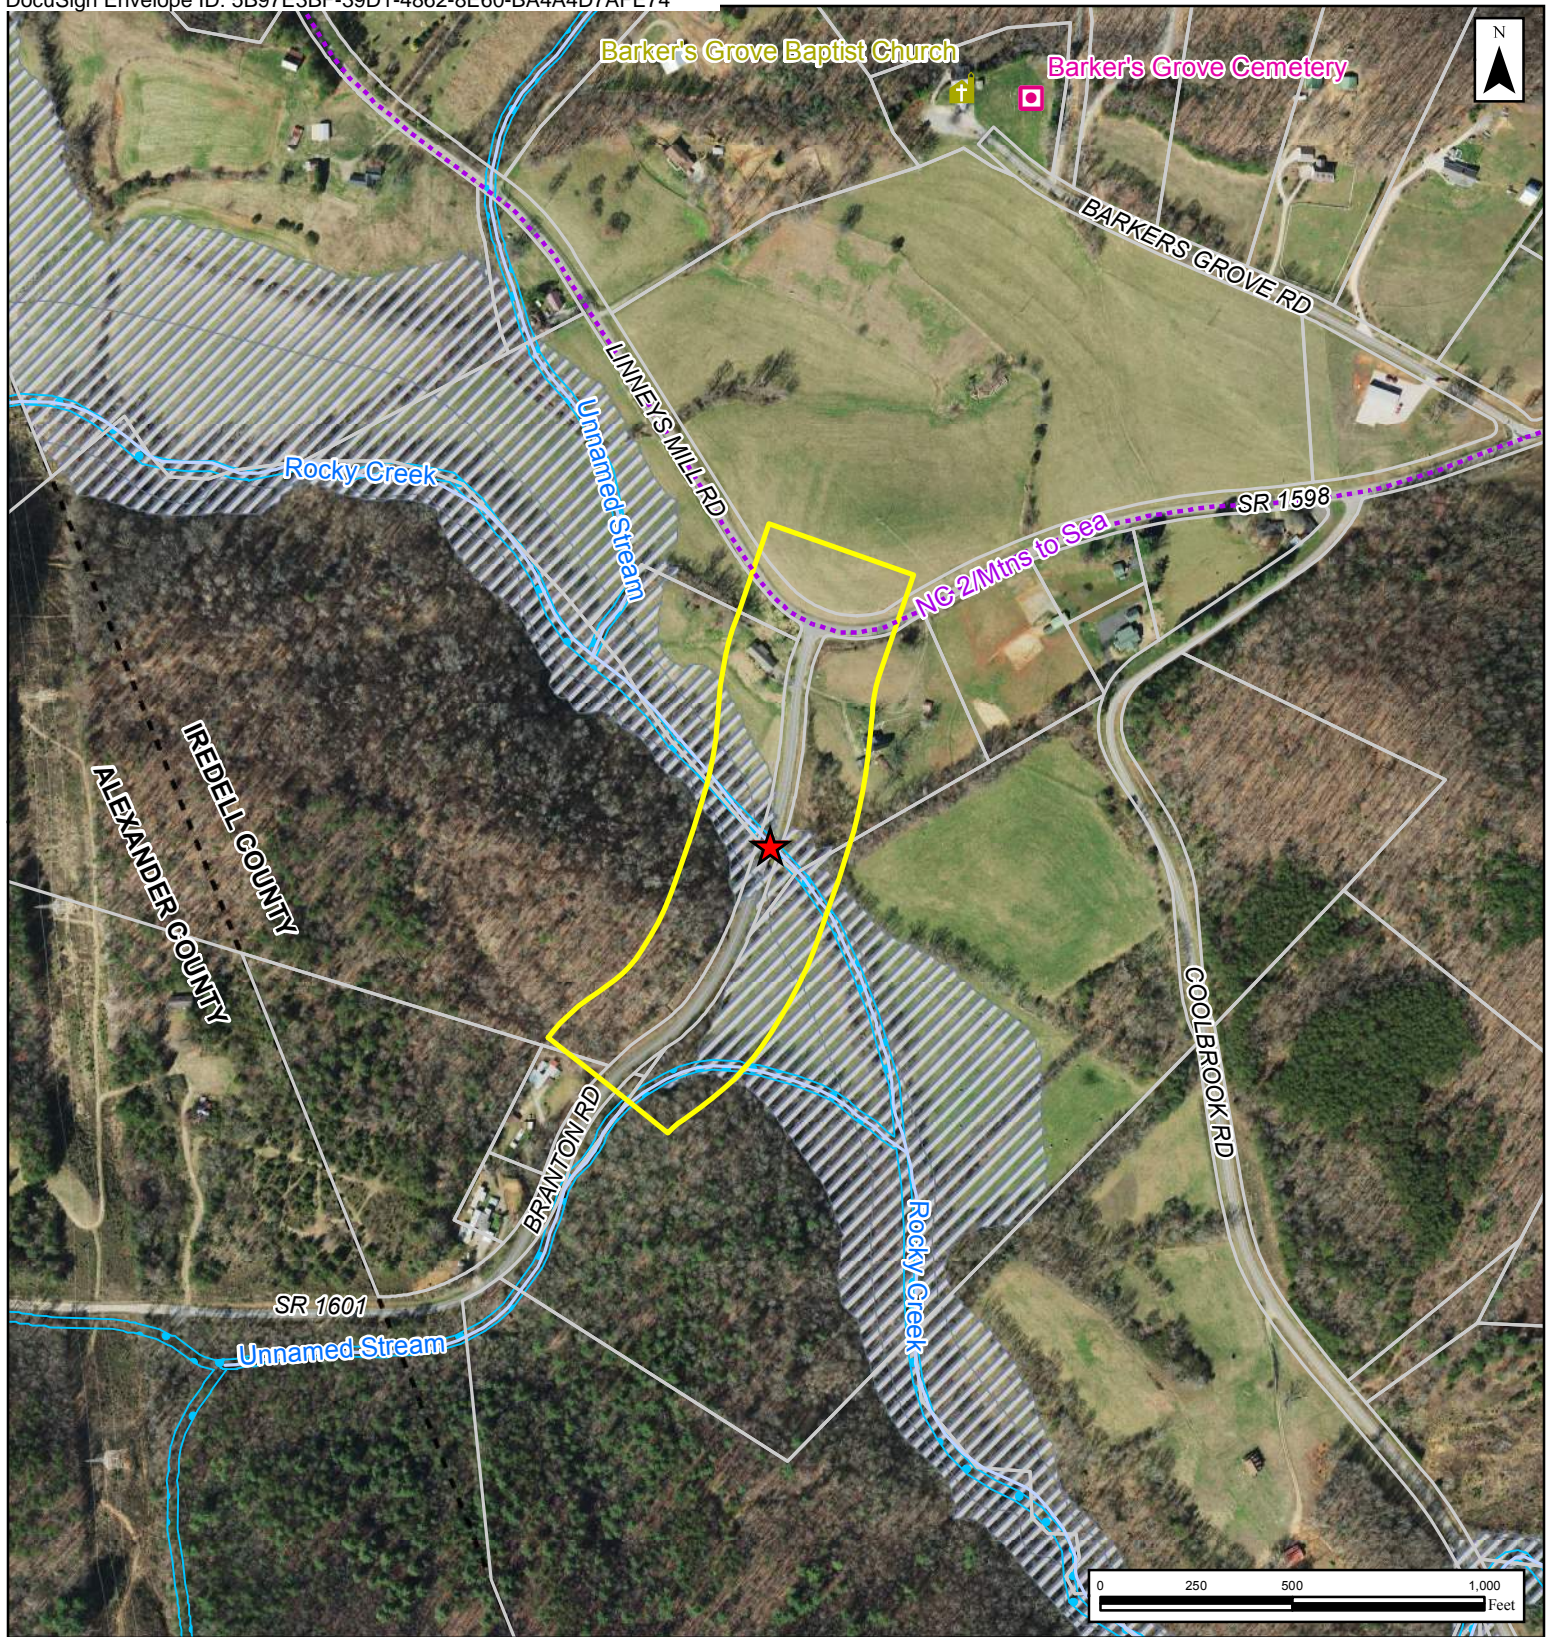
**Figure 1**

**BR-0114**  
**Bridge No. 165**  
**Replacement Project**  
**over Rocky Creek**  
**Iredell County**  
**NCDOT Division 12**
