STATE OF NORTH CAROLINA  
DEPARTMENT OF TRANSPORTATION

Subject: *Updated information for the Application Requesting Modification of Section 404 Individual Permit and Section 401 Water Quality Certification for the U-2579B Section of the Winston-Salem Northern Beltway, from US 158 to I-40 Business/US 421, Forsyth County, Division 9, WBS 34839.2.10*

*This letter and permit drawings dated January 14, 2020, are an update (shown in italics) to the previous letter and permit drawings submitted with the October 21, 2019 application for the Smith Creek relocation permit modification.*

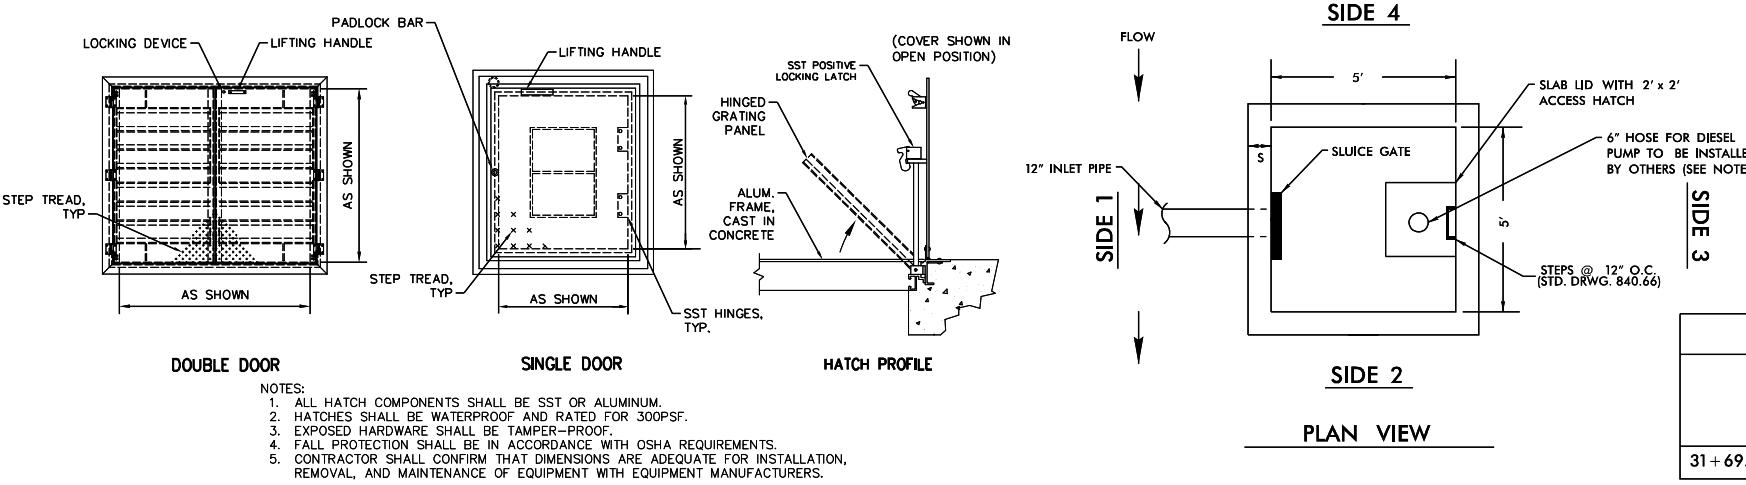
1. SLUICE GATE IS FOR INTAKE VAULT AND SHOULD REMAIN CLOSED DURING NORMAL OPERATION.
2. SLUICE GATE SHALL PROVIDE WATERPROOF SEAL. PROVIDE ADEQUATE CLEARANCE FOR INTAKE VAULT OPERATION.
3. SELECT BOX STANDARD AS REQUIRED TO ACCOMMODATE SLUICE GATE AND SLAB LID WITH ACCESS HATCH.
4. ENSURE ACCESS HATCH OPENS FREELY AND WITHOUT INTERFERENCE WITH SLUICE GATE.
5. ADJUST FOOTER DIMENSIONS AS NEEDED FOR ANTI-FLOTATION. FOOTER DIMENSIONS CAN BE 5' x 5' x 9' DEEP OR 8' x 8' x 4' DEEP. ANTI-FLOTATION MATERIAL IS REQUIRED AND SHALL BE CONCRETE.
6. NOT IN CONTRACT. SEE SPECIAL PROVISIONS.

MINIMUM DIMENSIONS FOR STREAM INTAKE VAULT							
STATION	S (INCHES) 6" MIN.	B (INCHES) 6" MIN.	BASIN BOTTOM MINIMUM ELEV.	TOP ELEVATION CONTROL STRUCTURE	INV. ELEVATION	ANTI-FLOTATION MATERIAL (F) THICKNESS FEET <sup>5</sup>	CTL. STR. DIMENSIONS (W x L x H)
31+69.64 -SMITH CREEK-	6	6	825.00'	835.82'	827.88'	9.0'	5' X 5' X 10.82'

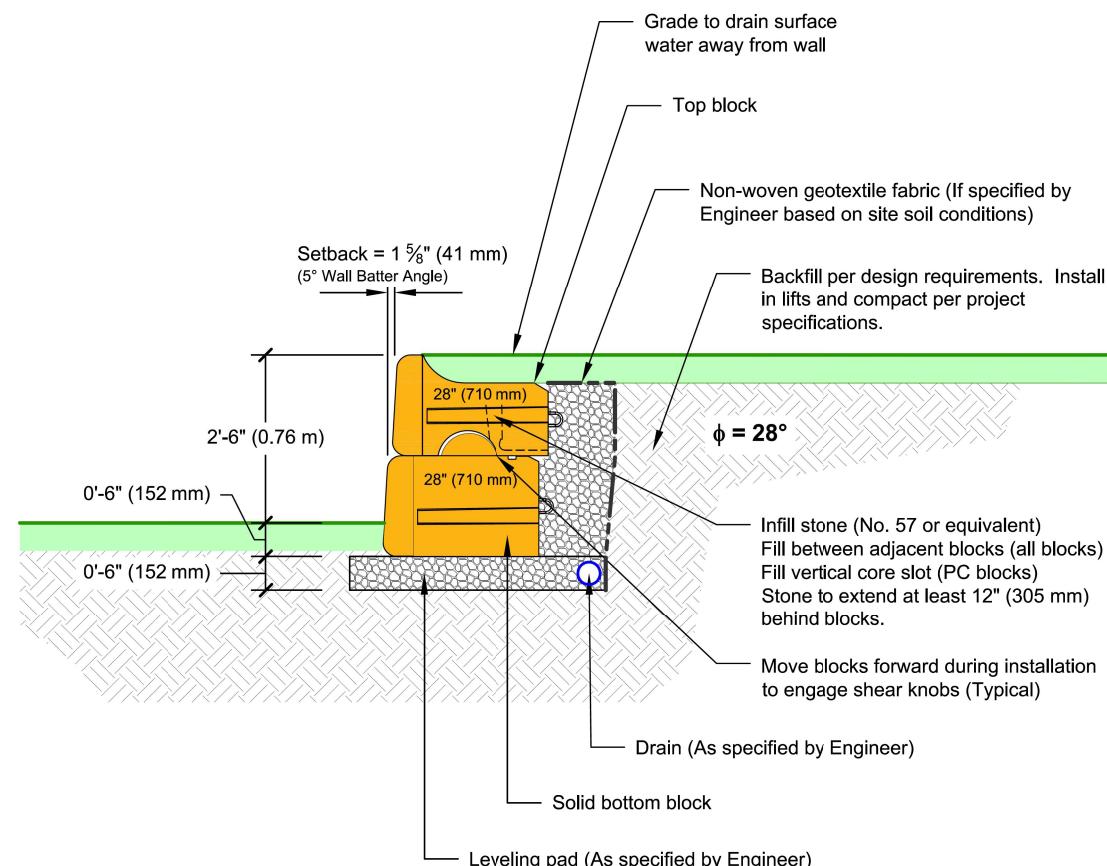
DRAWN BY:	TITLE: <b>Preliminary Wall Section</b>
APPROVED BY:	Silty Sand or Clayeey Sand, $\phi = 28^\circ$
DATE:	No Live Load Surcharge, No Back Slope, No Toe Slope
SHEET:	FILE: A_28_B_28_36_cad.dwg

**LOAD CONDITION A** | NO LIVE LOAD SURCHARGE, NO BACK SLOPE, NO TOE SLOPE

(2) 28" (710 mm) Blocks

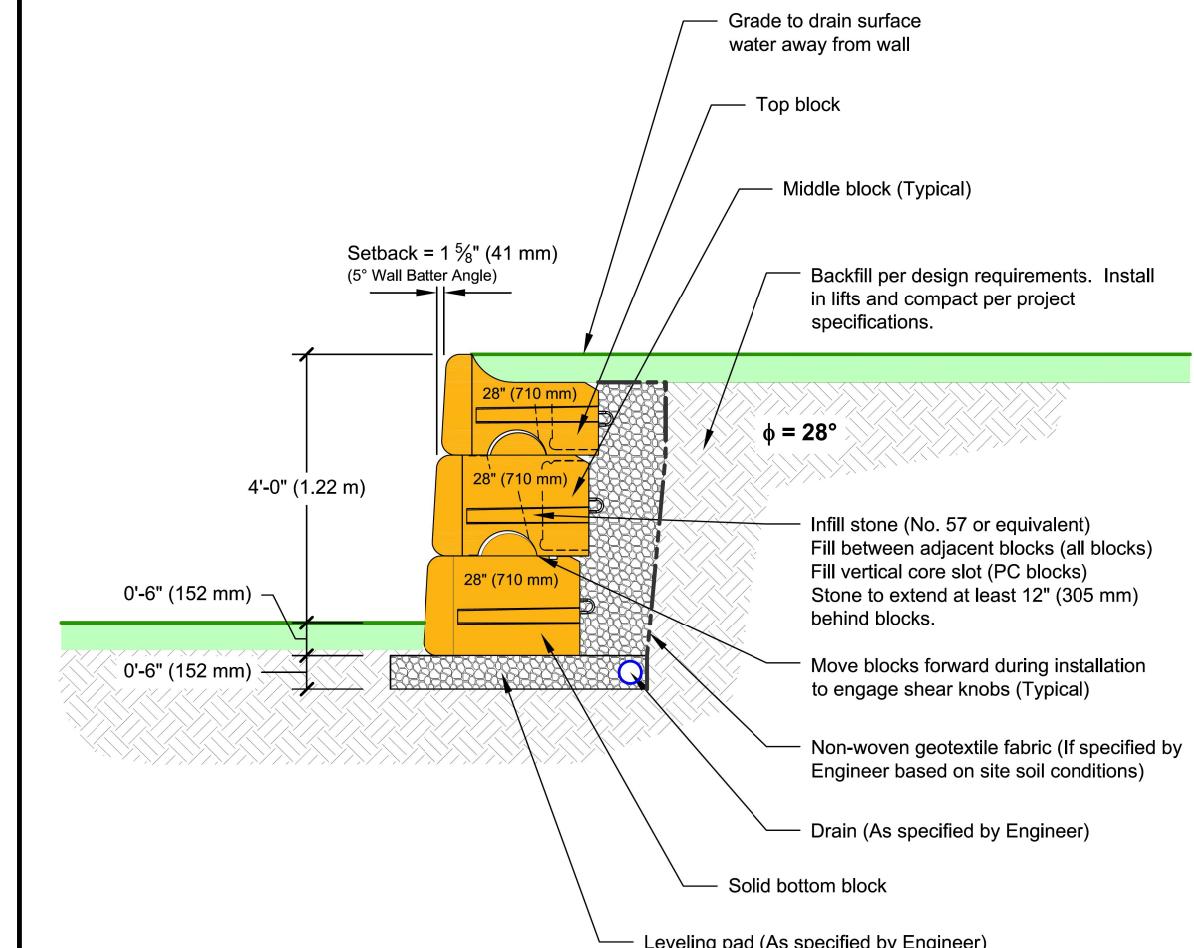
DRAWN BY:	TITLE: <b>Preliminary Wall Section</b>
APPROVED BY:	Silty Sand or Clayeey Sand, $\phi = 28^\circ$
DATE:	No Live Load Surcharge, No Back Slope, No Toe Slope
SHEET:	FILE: A_30_B_28_54_cad.dwg

**LOAD CONDITION A** | NO LIVE LOAD SURCHARGE, NO BACK SLOPE, NO TOE SLOPE

(3) 28" (710 mm) Blocks

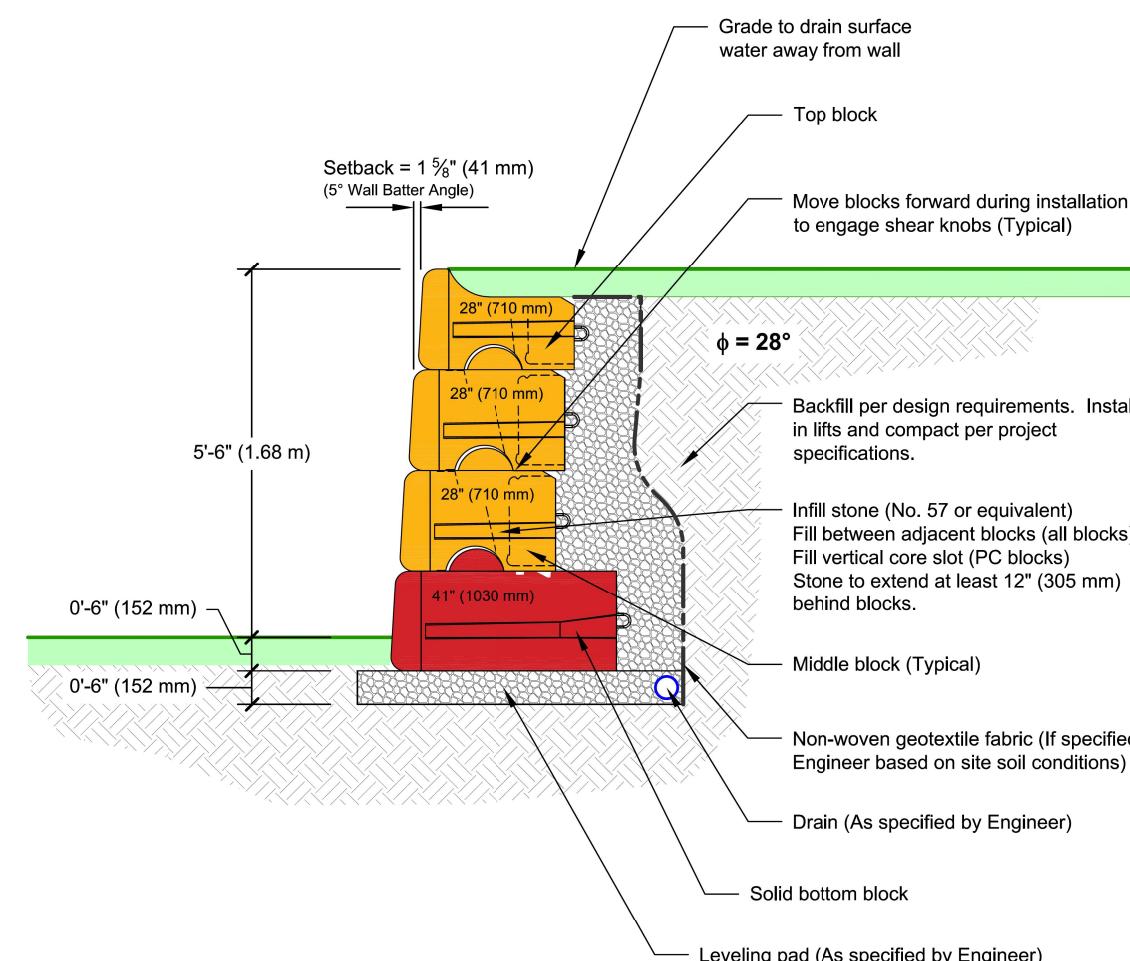
DRAWN BY:	TITLE: <b>Preliminary Wall Section</b>	
APPROVED BY:	Silty Sand or Clayey Sand, $\phi = 28^\circ$	
DATE:	No Live Load Surcharge, No Back Slope, No Toe Slope	
SHEET:	FILE: A_28_B_41_72_cad.dwg

**LOAD CONDITION A** | NO LIVE LOAD SURCHARGE, NO BACK SLOPE, NO TOE SLOPE

(3) 28" (710 mm) Blocks  
(1) 41" (1030 mm) Block

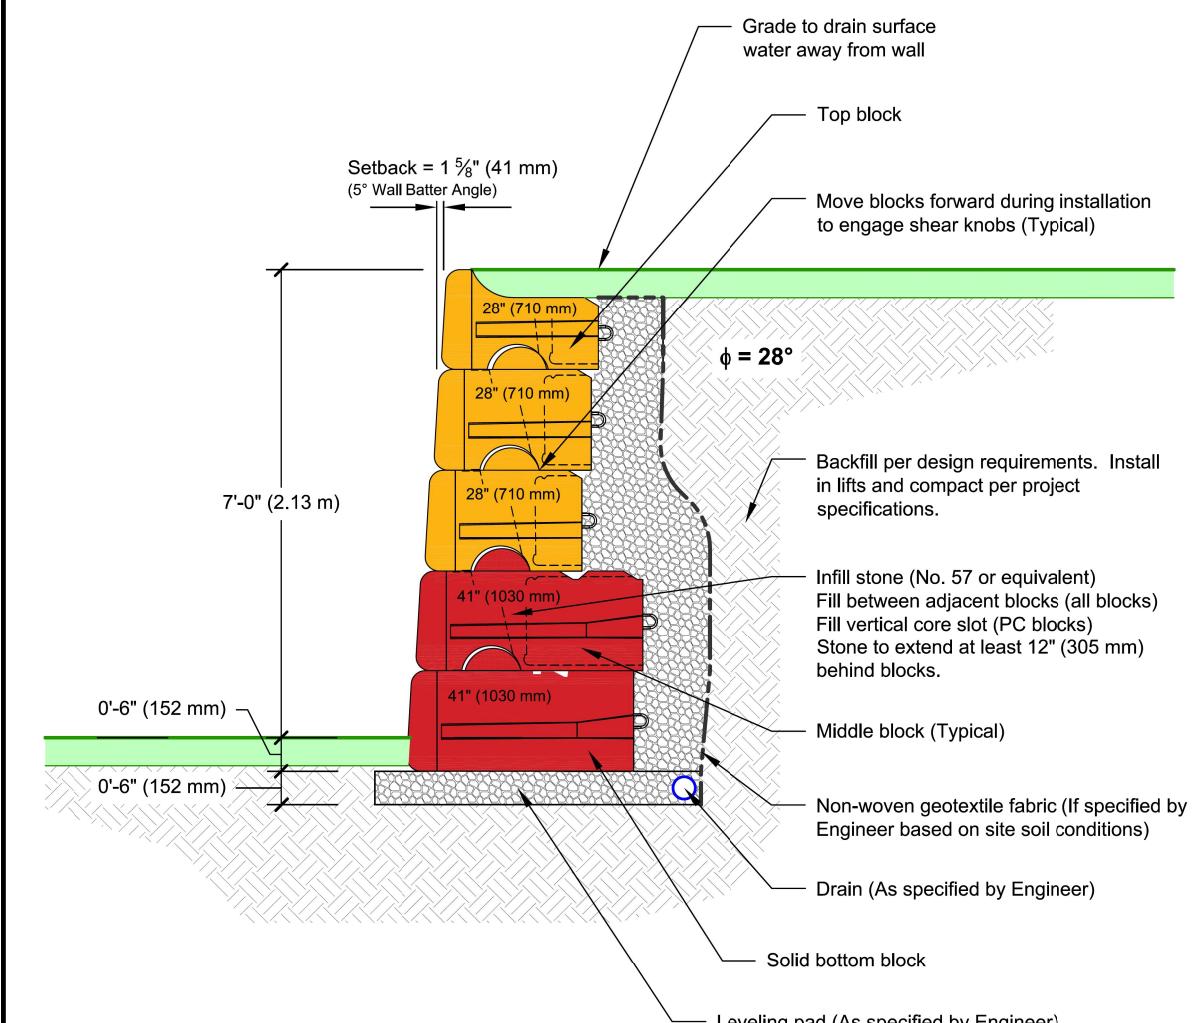
DRAWN BY:	TITLE: <b>Preliminary Wall Section</b>	
APPROVED BY:	Silty Sand or Clayey Sand, $\phi = 28^\circ$	
DATE:	No Live Load Surcharge, No Back Slope, No Toe Slope	
SHEET:	FILE: A_28_B_41_90_cad.dwg

**LOAD CONDITION A** | NO LIVE LOAD SURCHARGE, NO BACK SLOPE, NO TOE SLOPE

**5 BLOCK HIGH SECTION**

(3) 28" (710 mm) Blocks  
(2) 41" (1030 mm) Blocks

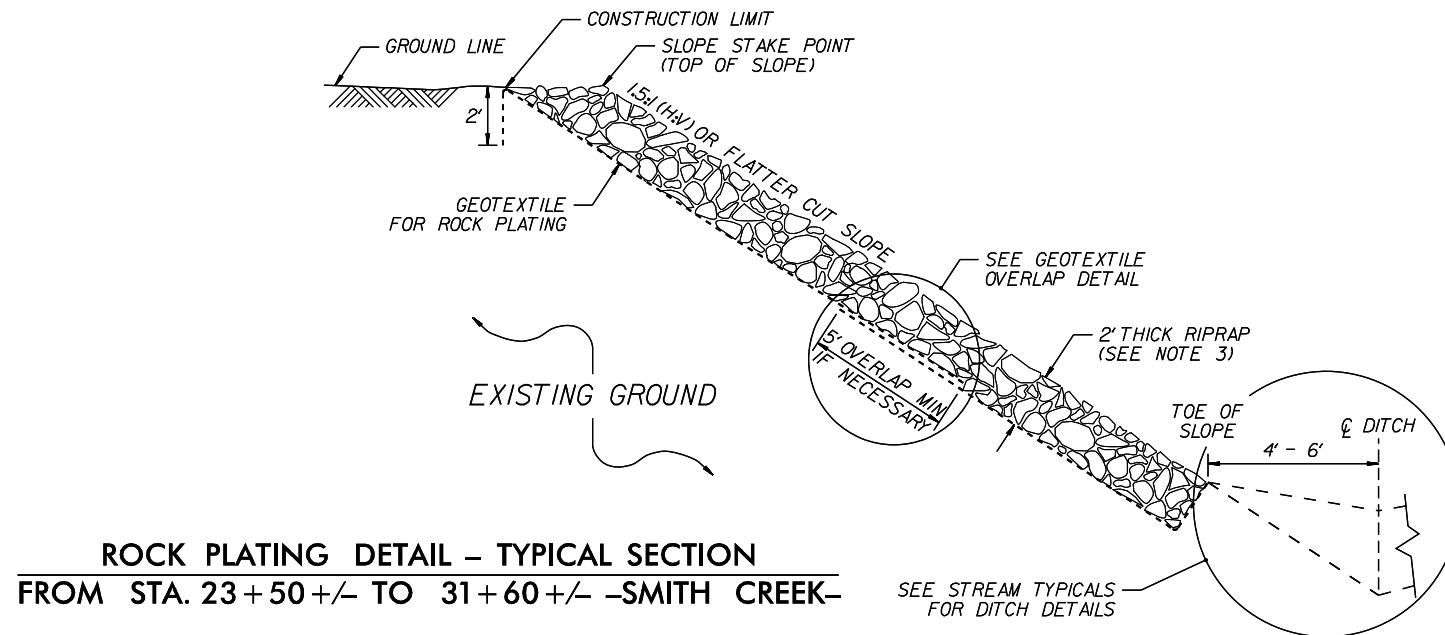
ROCK PLATING DETAIL - TYPICAL SECTION  
FROM STA. 23+50+/- TO 31+60+/- -SMITH CREEK-

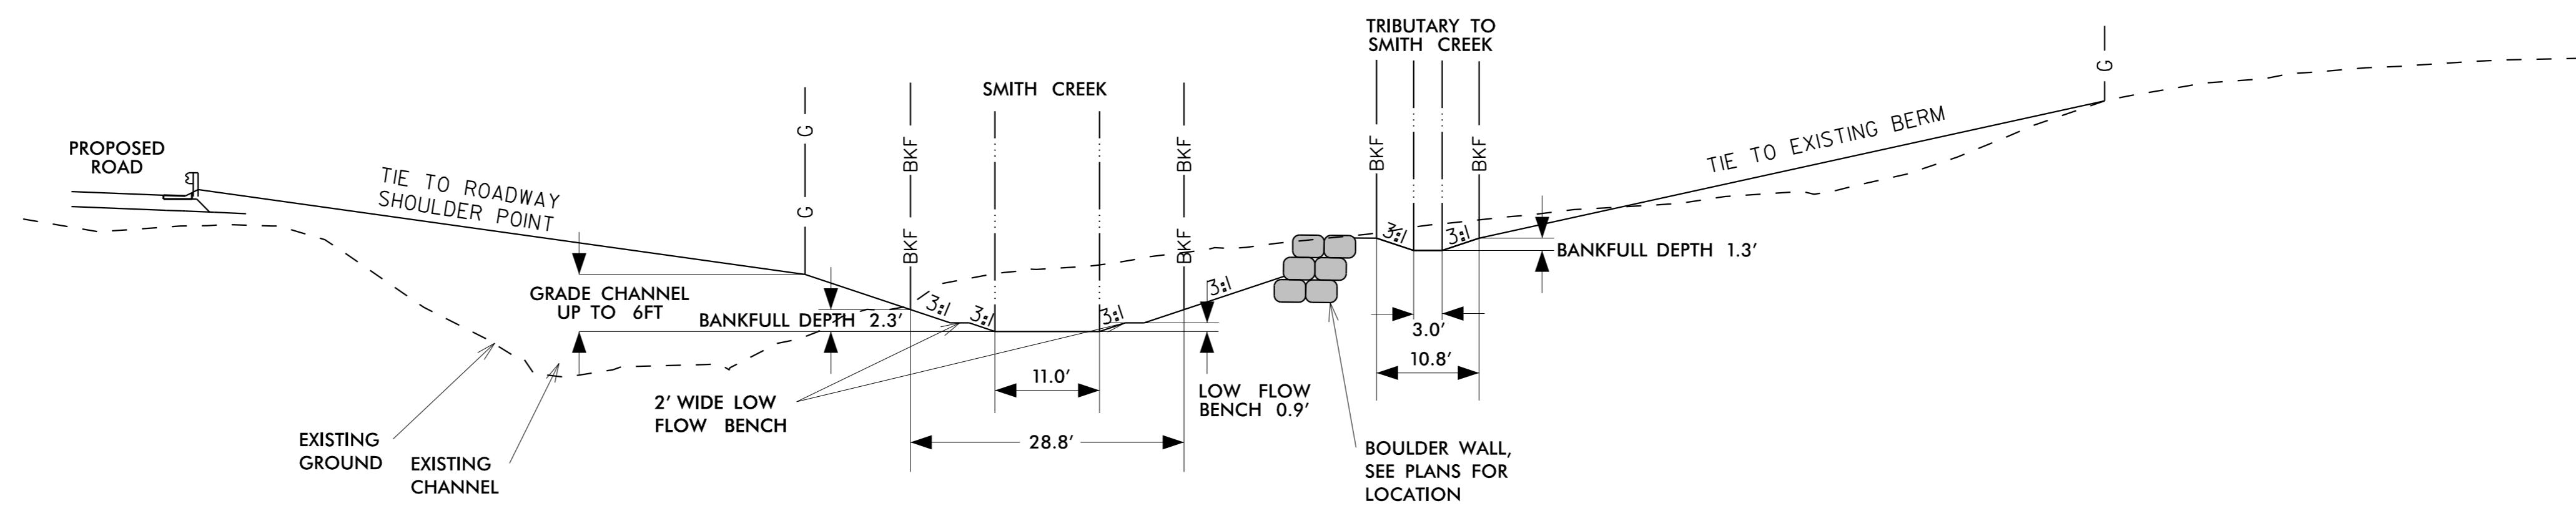
### RIFFLE

SEE PROFILE FOR RIFFLE AND POOL LOCATIONS

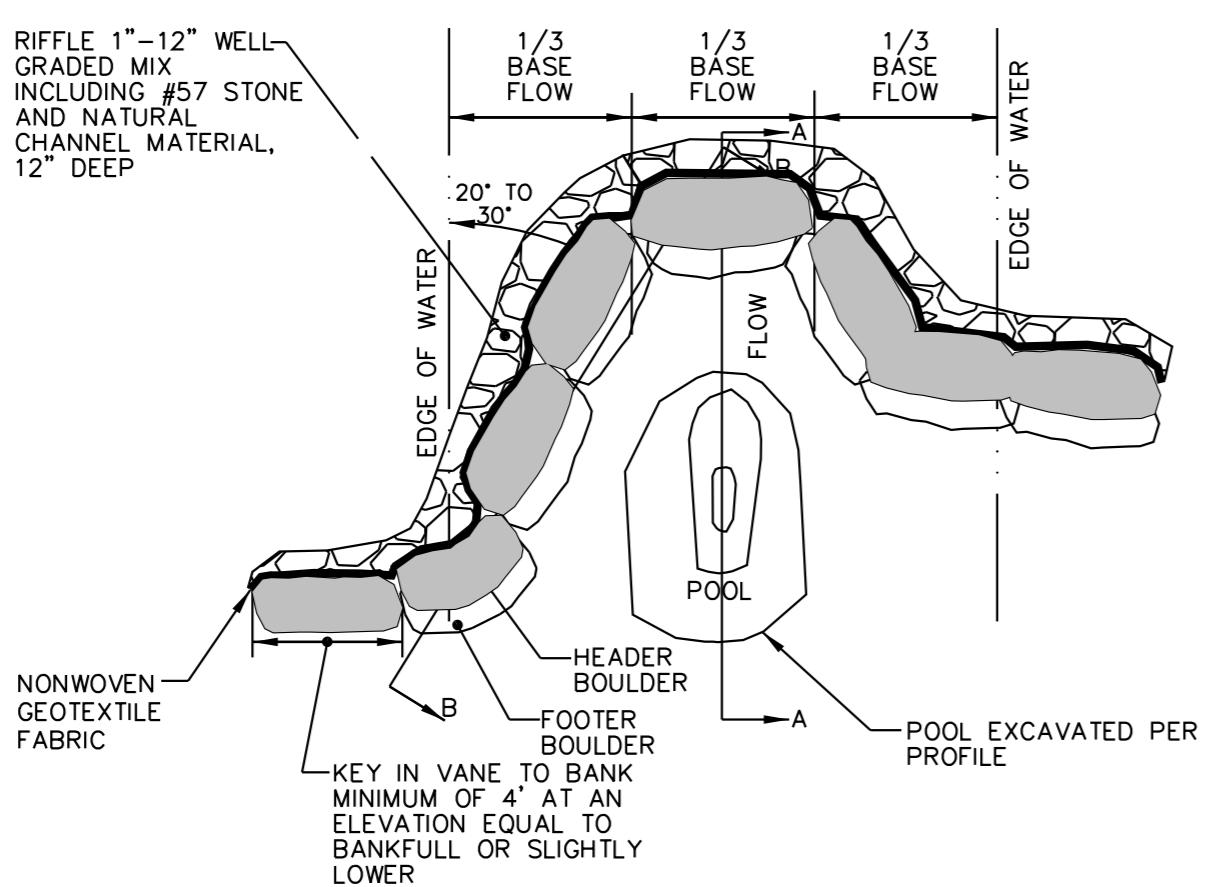
## J-HOOK VANE DETAIL

NOTES:  
1. DEEPEST PART OF POOL TO BE IN LINE WITH WHERE  
VANE ARM TIES INTO THE BANK.  
2. POOL DEPTH SHOULD BE ACCORDING PROFILE.  
3. BOULDERS SHALL HAVE A MEAN DIAMETER OF 30"

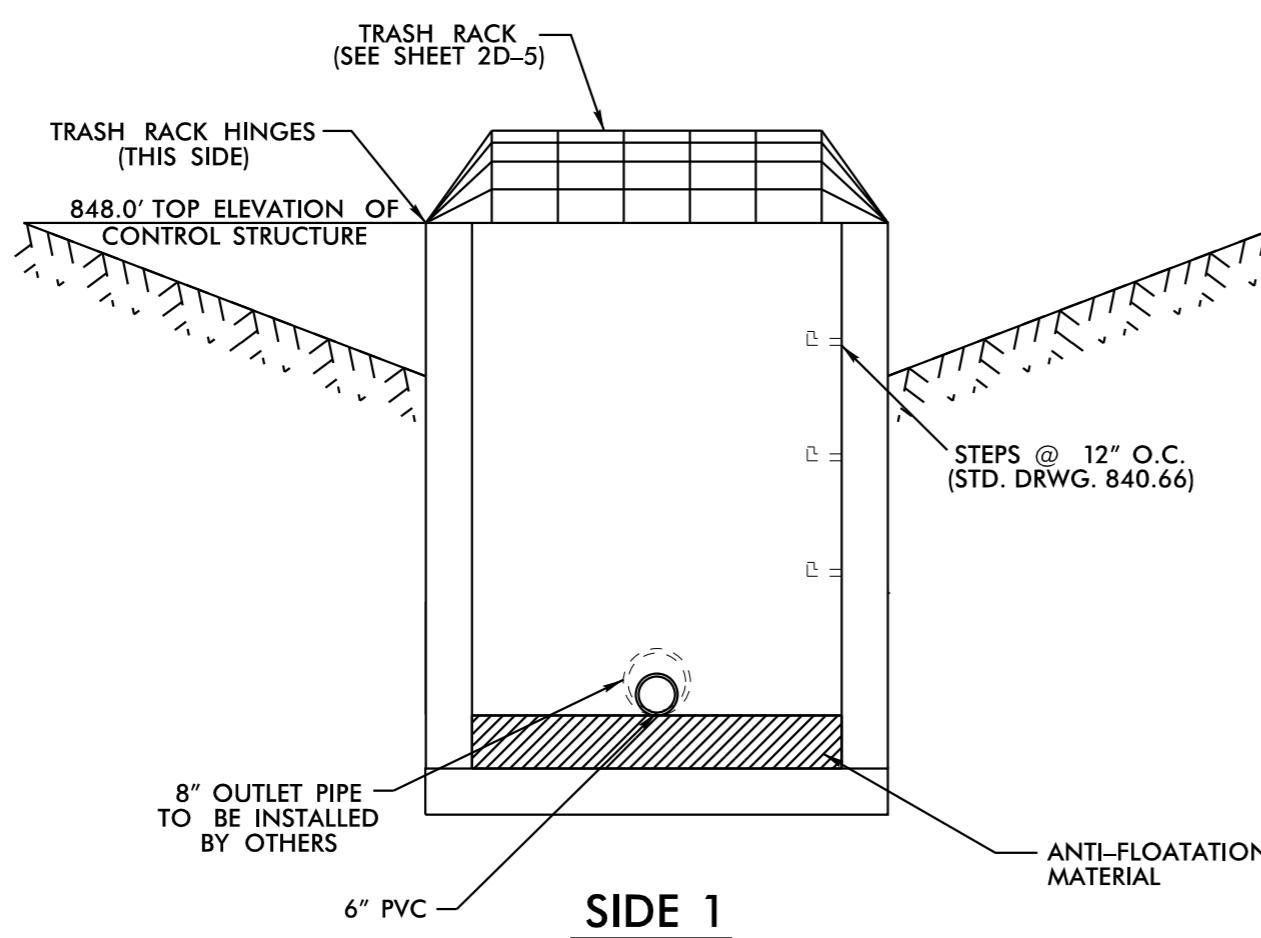
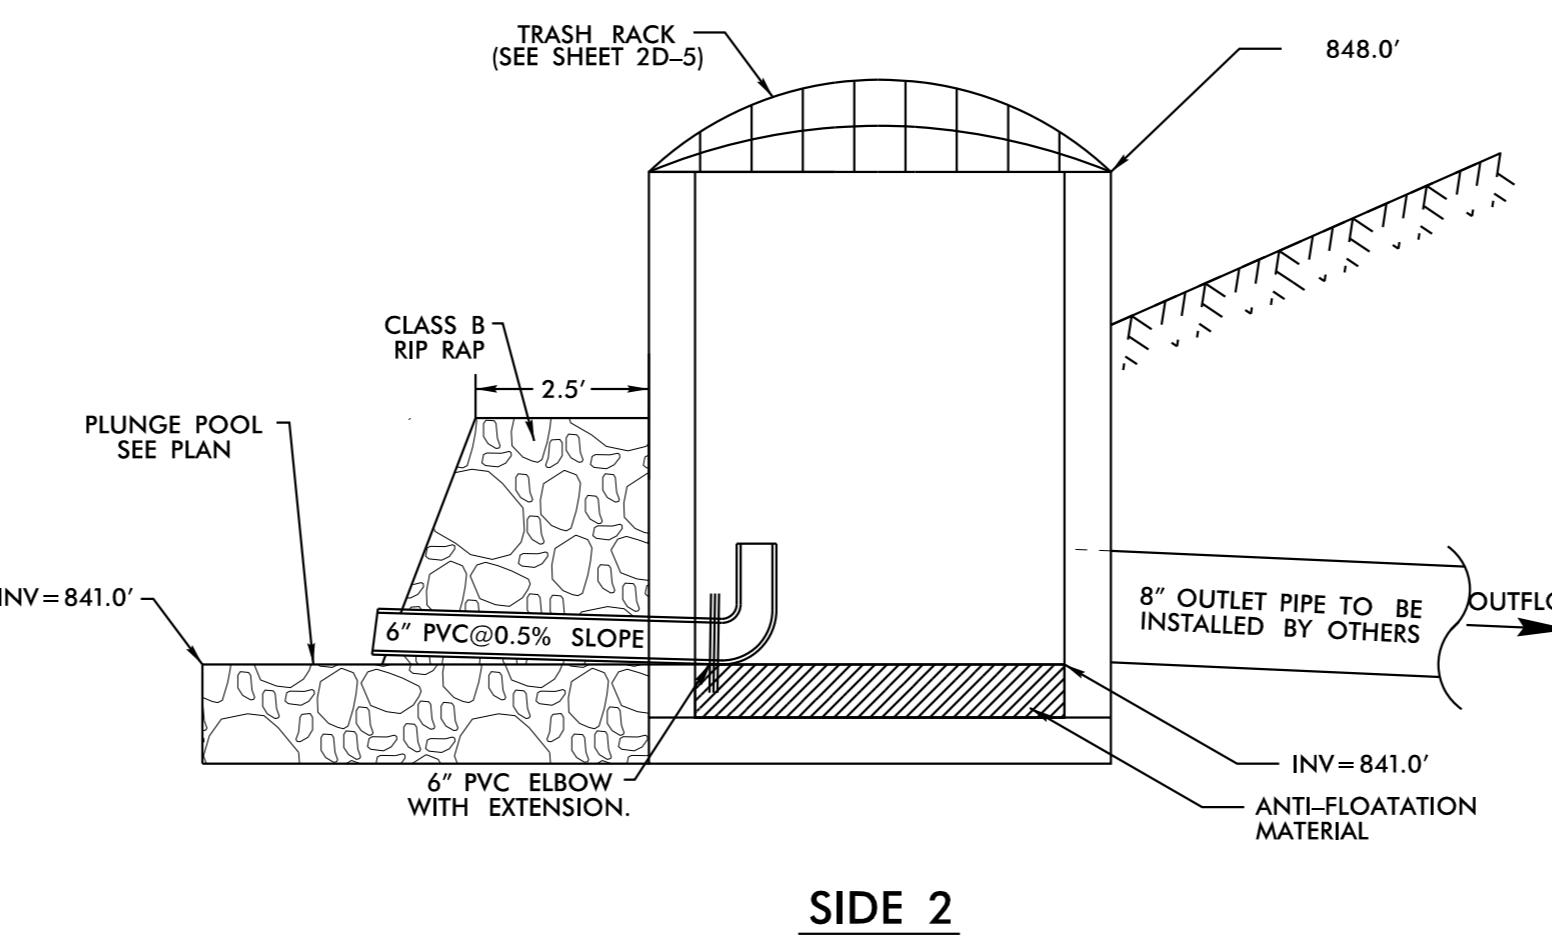
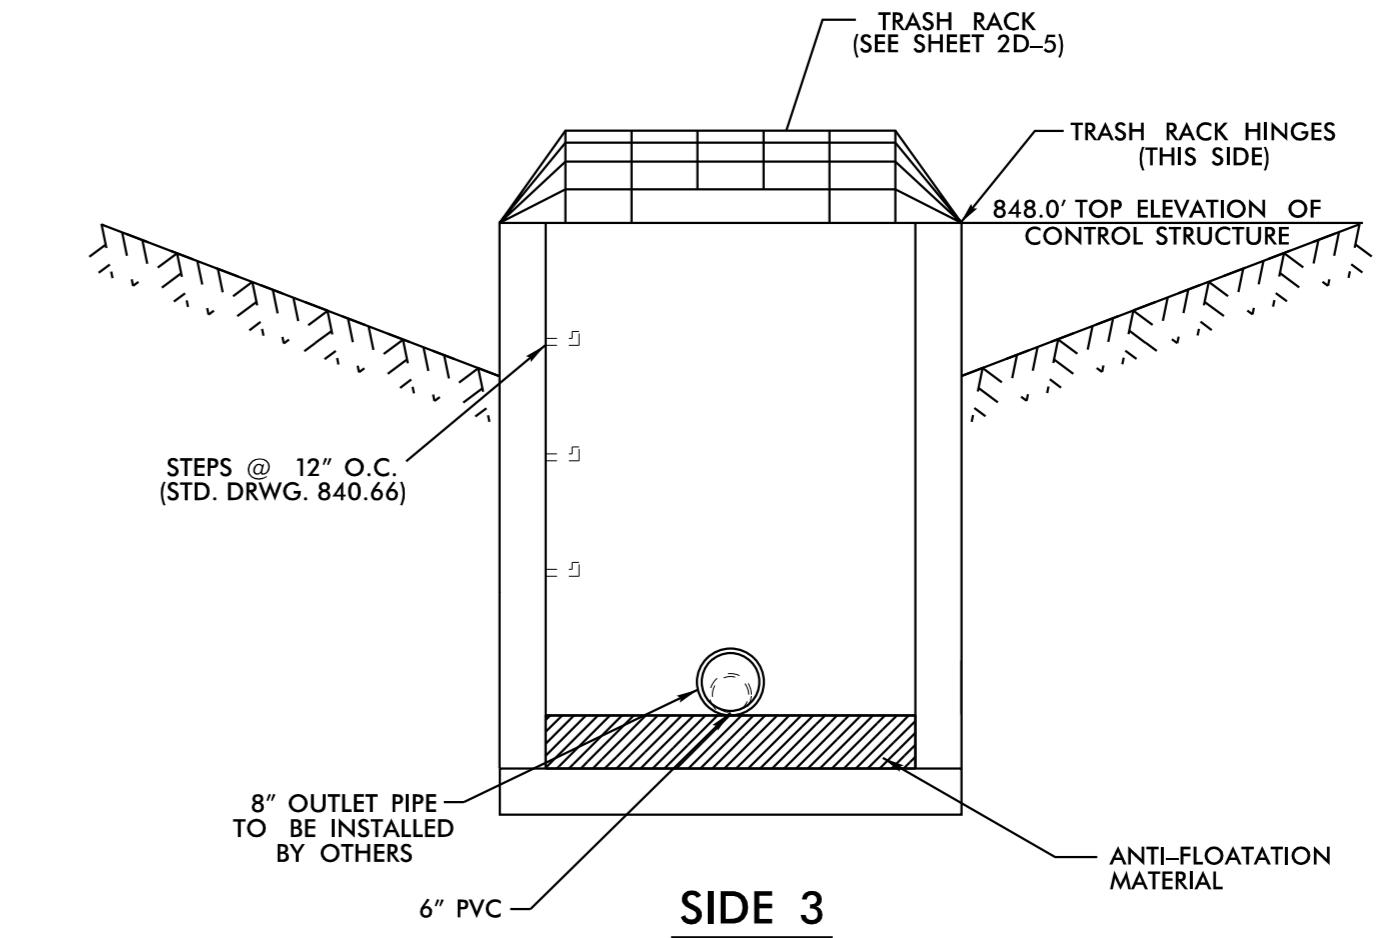
**DETAIL**  
**STREAM BYPASS STRUCTURE**

**PLAN VIEW**

TRASH RACK NOT SHOWN FOR CLARITY

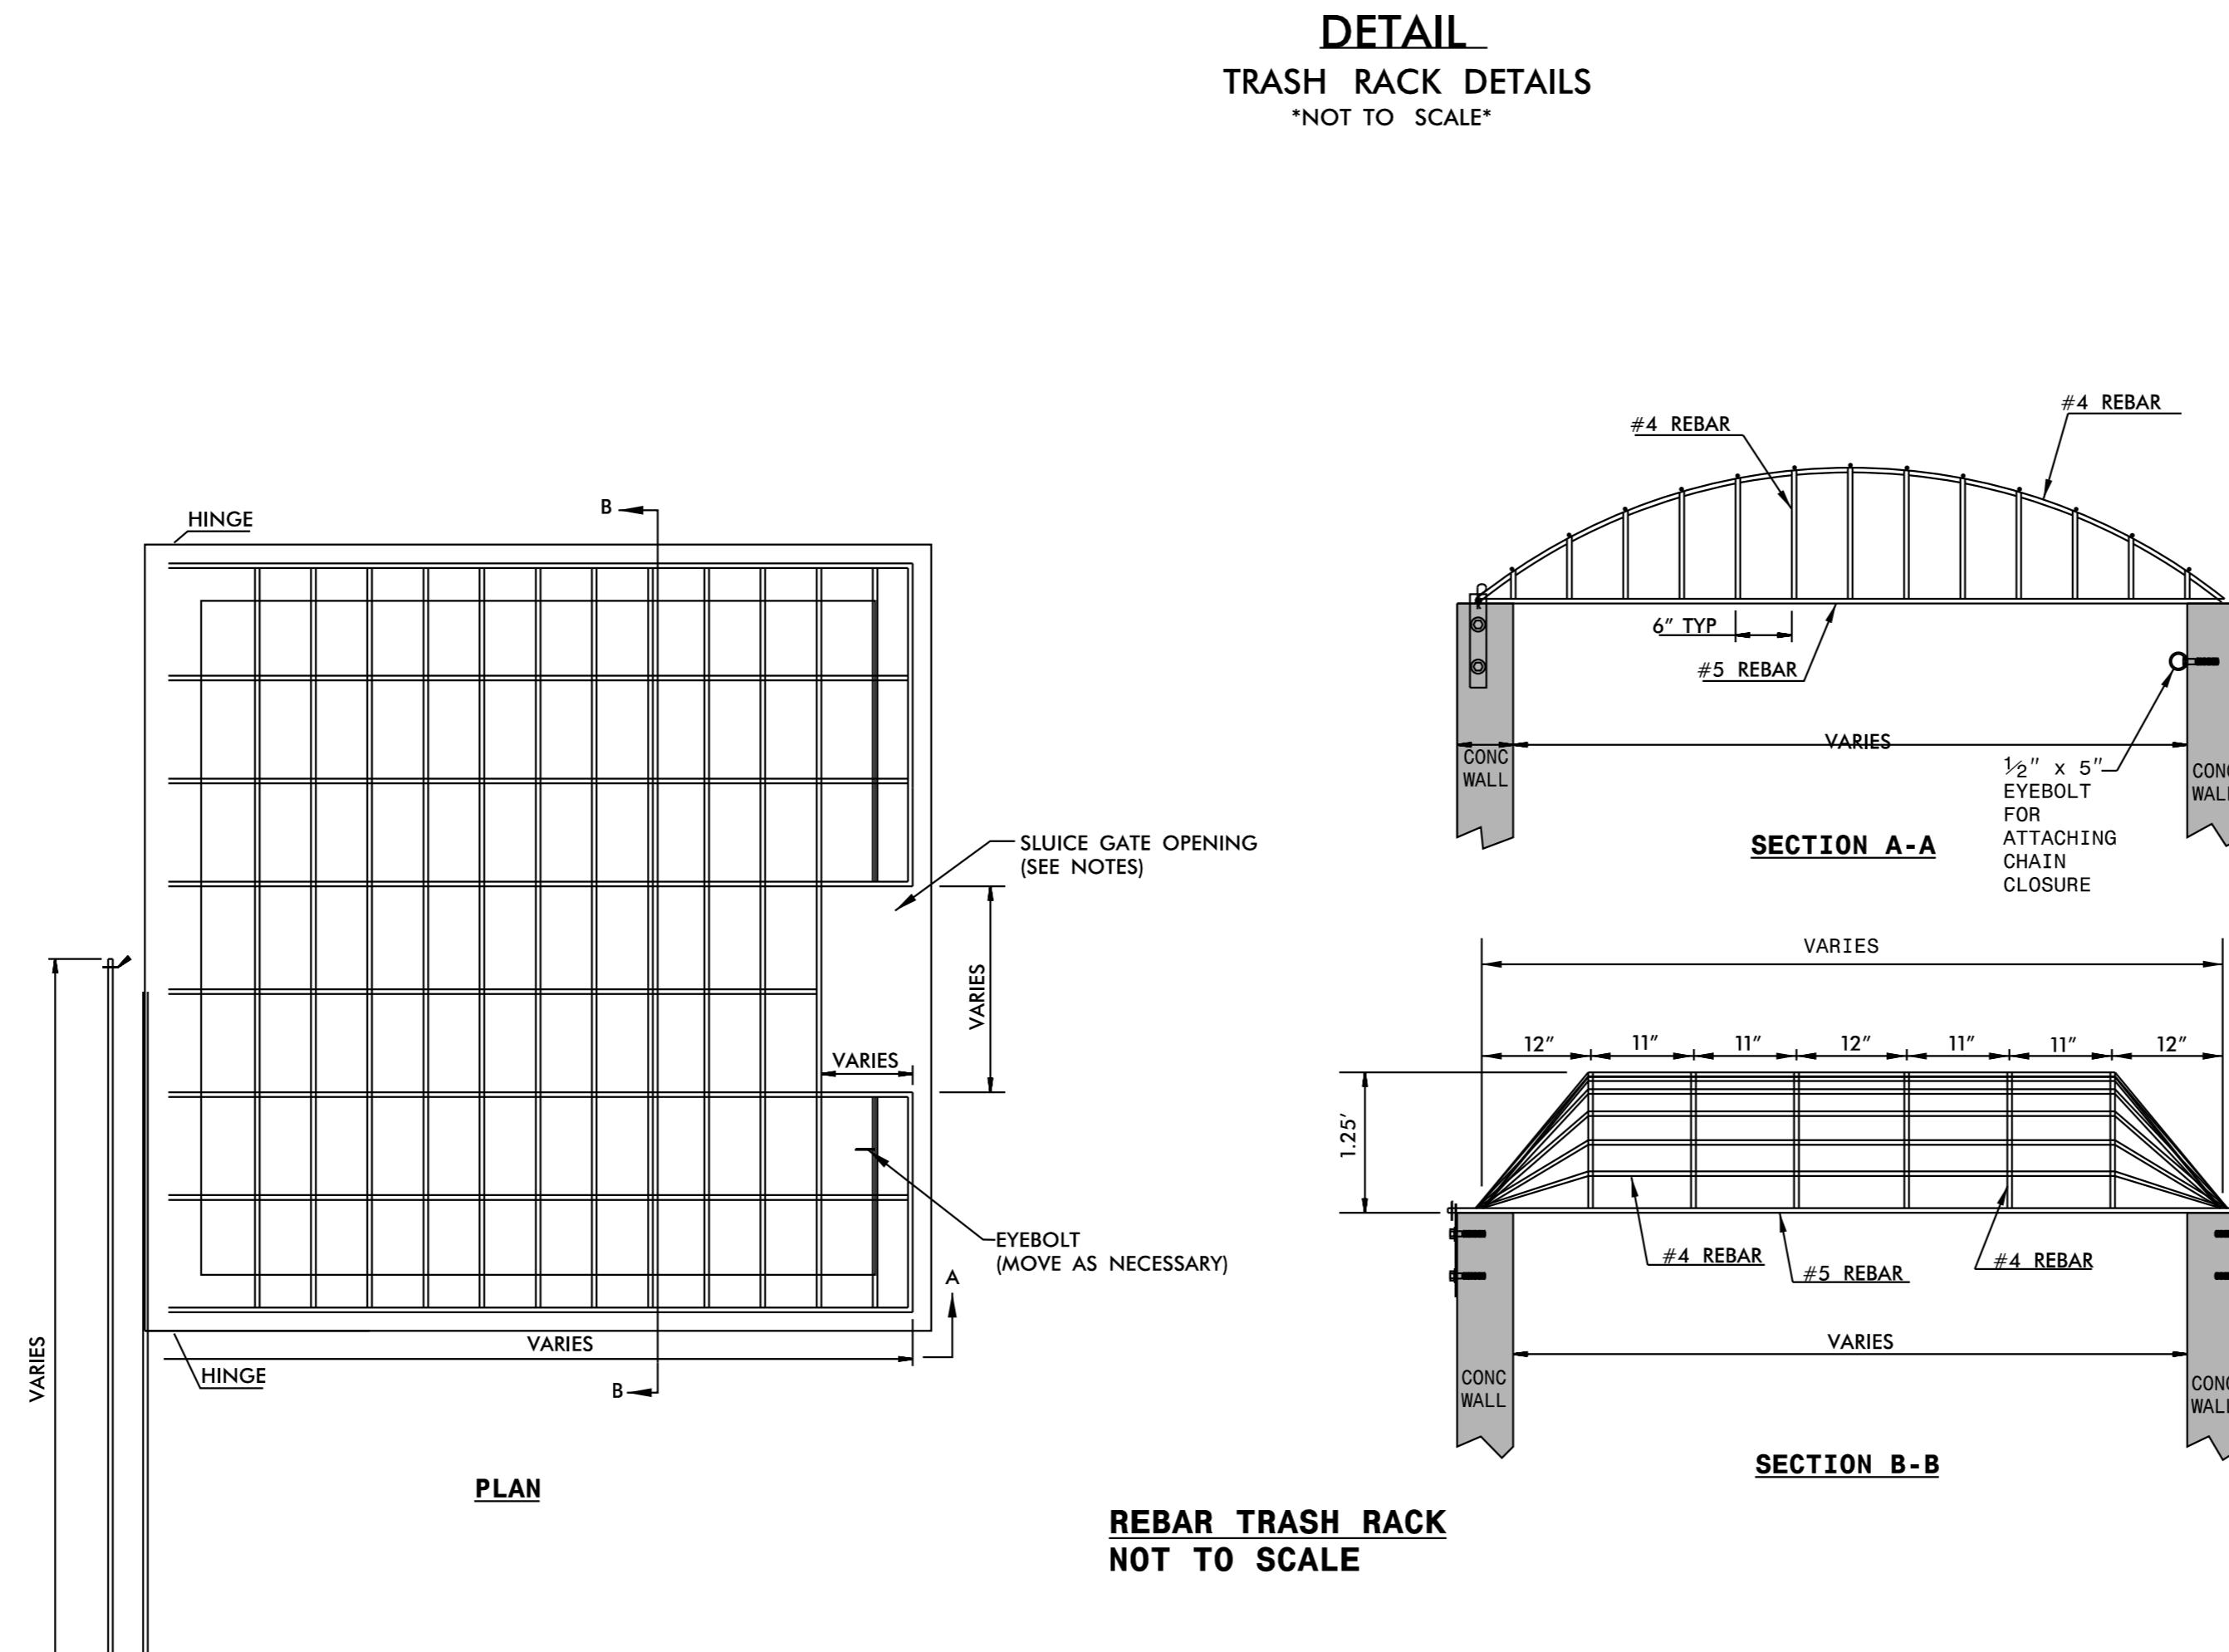
**RISER TRASH RACK NOTES:**

1. ALL JOINTS SHALL BE FULLY WELDED AROUND JOINT WITH A MINIMUM OF A 1/4" BEAD.
2. IF BOLTS ARE ANCHORED IN CONCRETE, FOLLOW STD. DWG. 862.03 AND 862.04 FOR ANCHORING PROCEDURE.
3. EYEBOLT FOR CHAIN CLOSURE SHALL BE INSTALLED BY THE SAME METHOD AS THE HINGE PLATE BOLTS.
4. RACK AND HARDWARE SHALL BE ALUMINUM OR REBAR AND GALVANIZED IN ACCORDANCE WITH ASTM A-153.
5. PROVIDE OPENING IN TRASH RACK TO ACCOMODATE SLUICE GATE ON THE OUTLET PIPE. ENSURE TRASH RACK OPENS FREELY AND WITHOUT INTERFERENCE WITH SLUICE GATES.
