STATE OF NORTH CAROLINA  
DEPARTMENT OF TRANSPORTATION

Subject: **Application for Section 404 Nationwide Permit 33/3 & 401 Water Quality Certification under the Expedited Processing Provisions for Hurricane Helene Response** for the Proposed Repair of NC 9 from US 74A (Bat Cave) to Buncombe County Line in Henderson County, Division 14, WBS 18314.1045061.

Repair of NC 9 from US 74A (Bat Cave) to Buncombe County Line in Henderson County, NC.

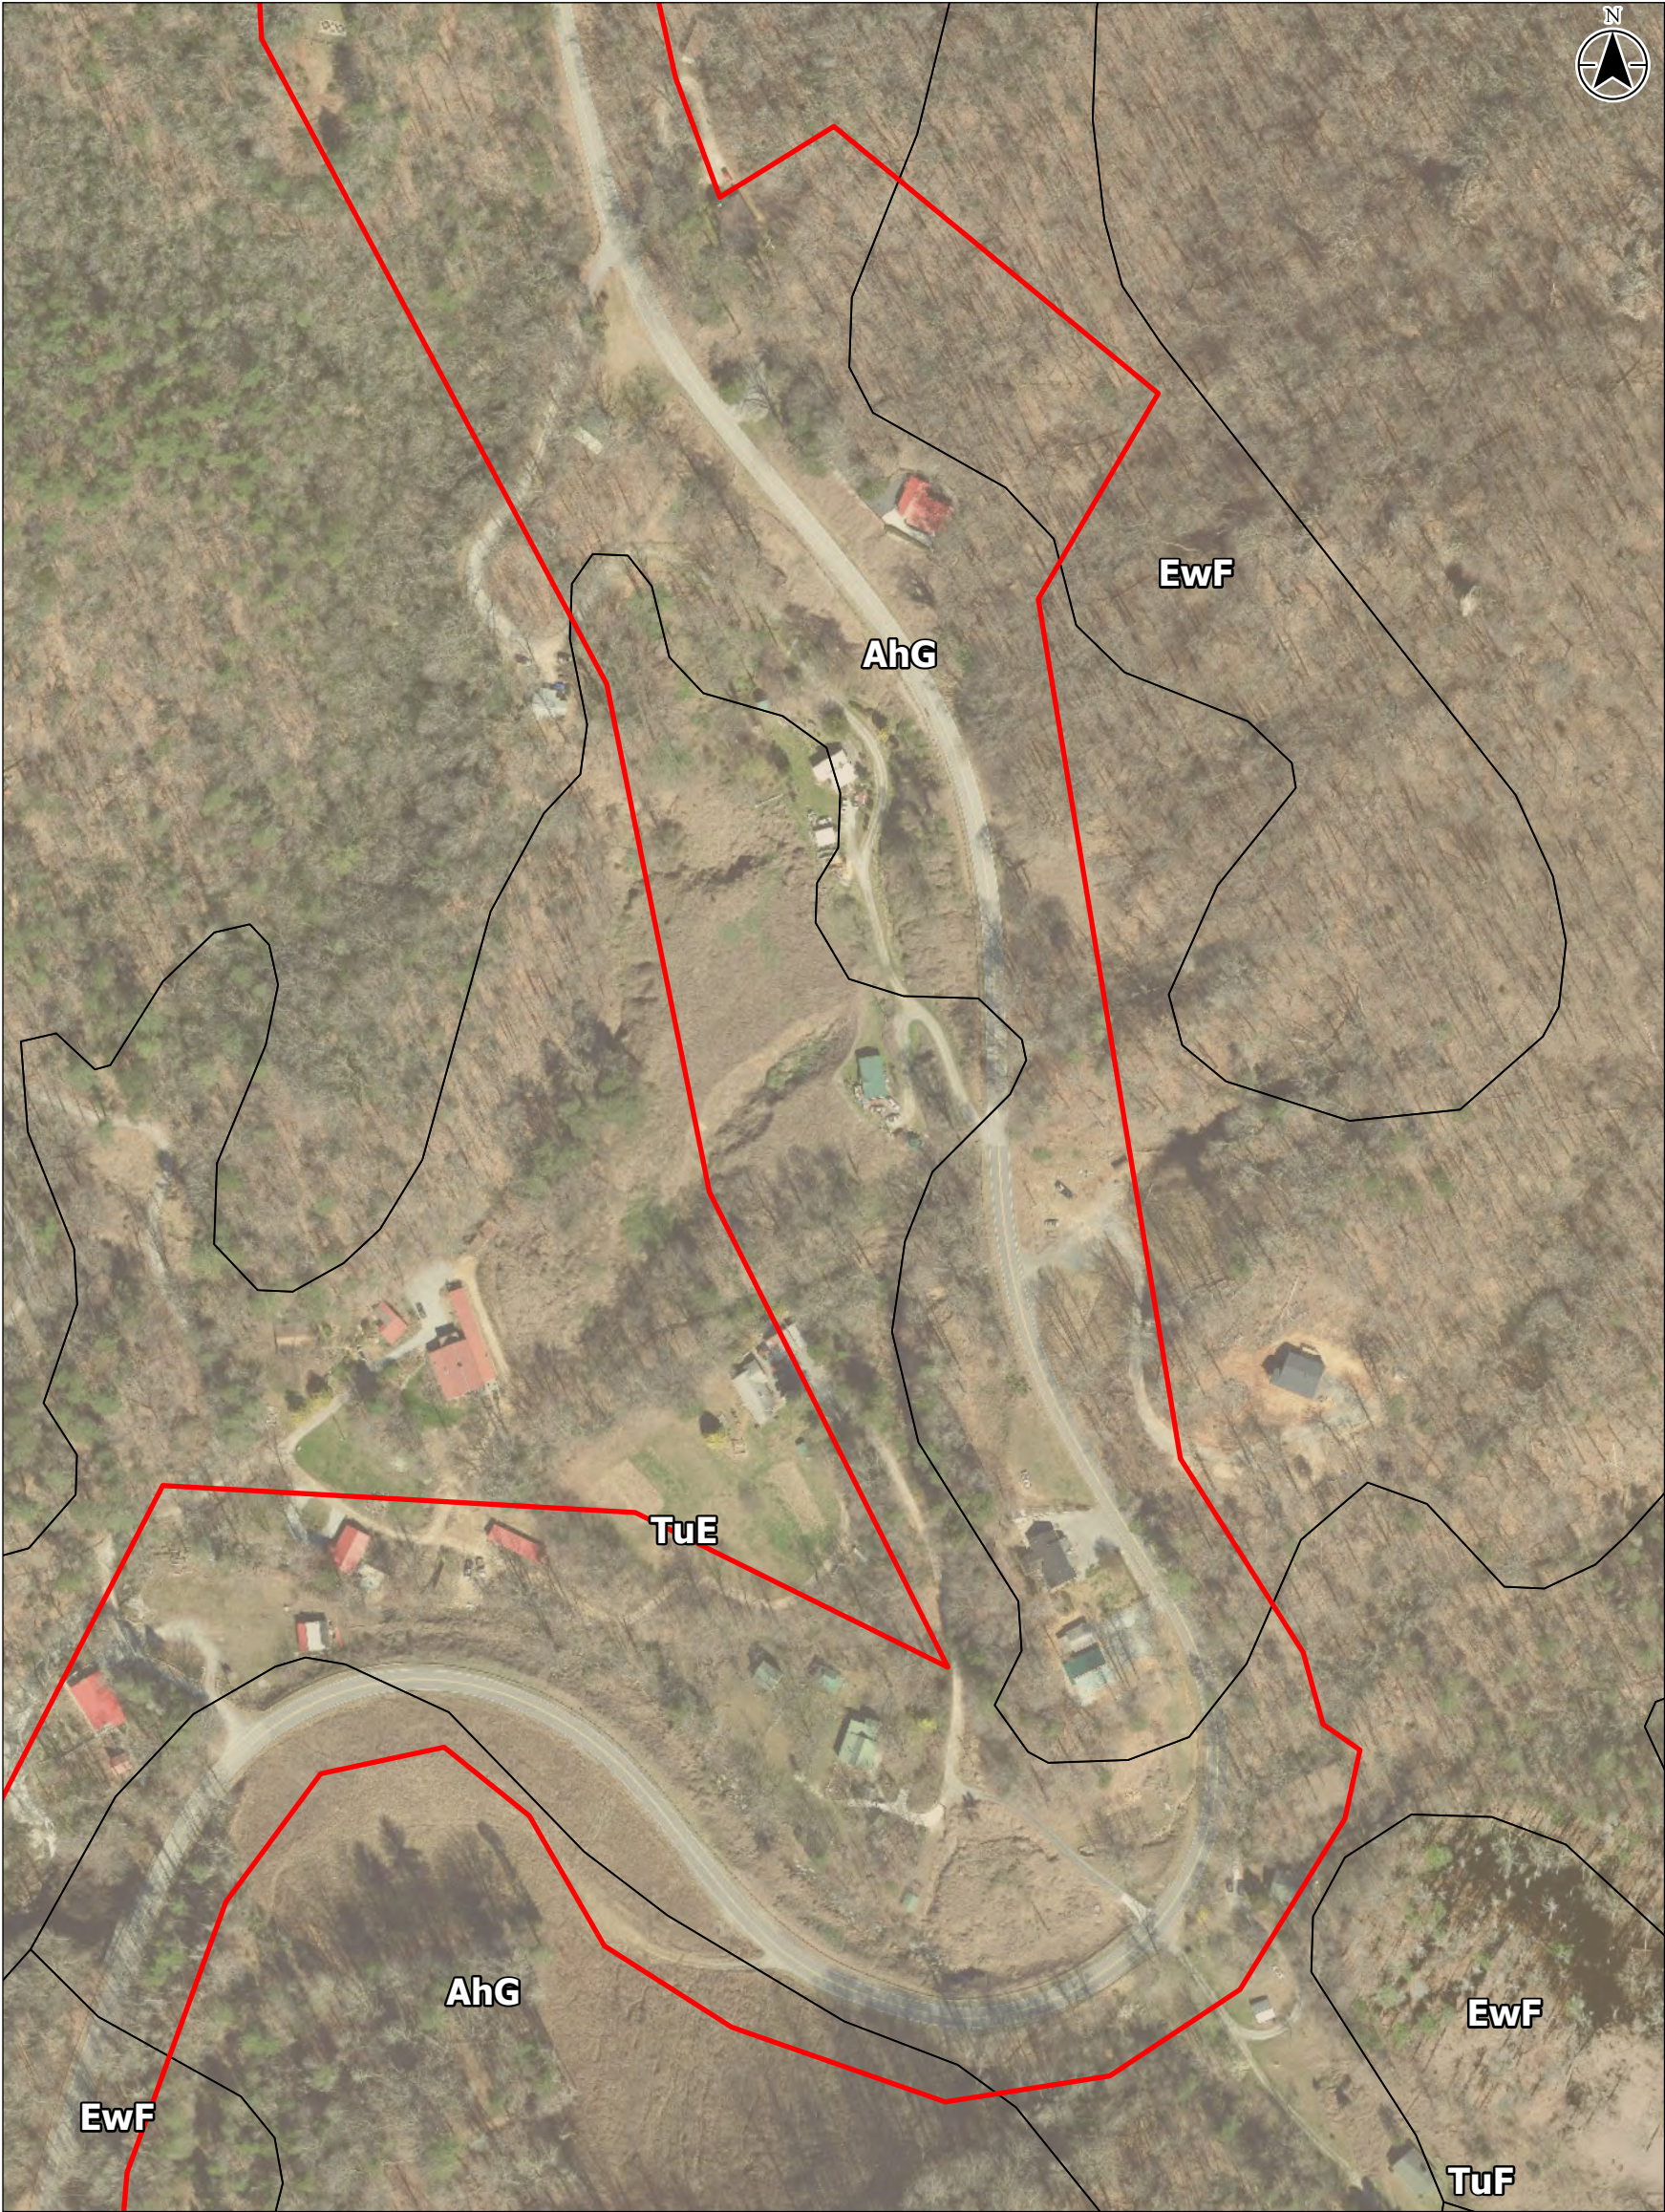
Figure No.  
4-2

Title  
**Soils Map**

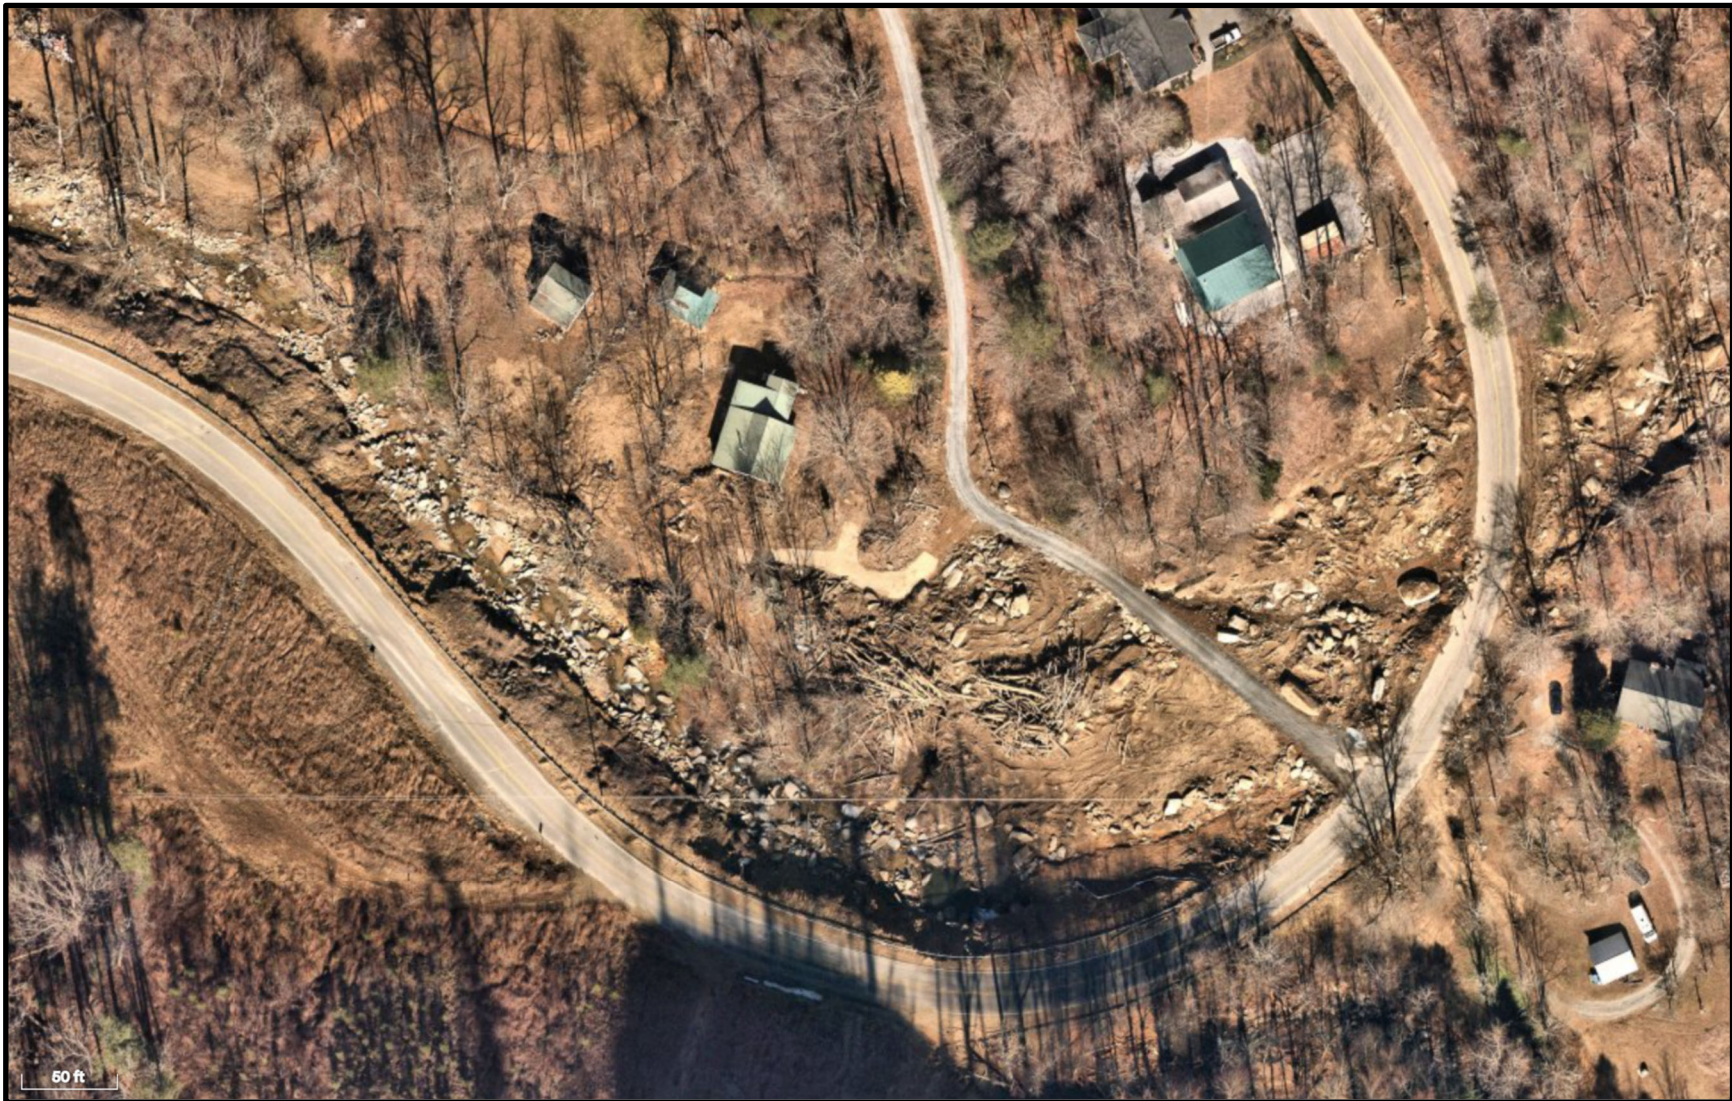
**Figure 3. Detail from aerial imagery showing the nature and scale of the altered landscape after the Helene floods along a bend on NC 9 at the crossing of Grassy Creek (image extracted from Nearmap, image date January 25, 2025). Note the heavy erosion, shift of the creek banks, and alluvium deposits which swept and redeposited massive amounts of soil, large boulders, and other debris.**

The NC Office of State Archaeology reviewed an area inside of the current APE for a (rock) slide waste site at the bend of NC 9 over Grassy Creek (18-1276) which did not require a survey. Another series of recent, small environmental reviews (ER 25-0621, DR-4827-NC) are associated with the Helene flooding along the Broad River as close as 500 feet (0.1 miles), though, too, none were recommended for survey. A very recent survey has occurred on the north side of the Broad River about a mile to the southeast for the "Chimney Rock Borrow Site." No sites were identified on the 45-acre, mostly sloped mountainside (ER 24-2608). Also, there are a few, small NCDOT reviews in the general area (ex., PA 12-08-0082 and PA 13-08-0050) that did not receive recommendations for survey. PA 24-11-0012 and PA 25-01-01, the previously mentioned emergency repairs to US 64/US 74A at the south end of the current project, are all strongly associated in nature and scale. Neither of those two projects to restore the highways after flood damage were recommended for archeological survey.
