Section 404/NEPA Merger Project Team Meeting Concurrence Point No. 2 and Concurrence Point No. 2A June 6, 2018

Widen Sweeten Creek Road (US 25A) to a multilane roadway from Hendersonville Road (US 25) to Rock Hill Road (SR 3081) in Asheville, Buncombe County, North Carolina, State Transportation Improvement Project (STIP) No. U-2801A, Federal-Aid No. STP-025A(5), WBS No. 34859.1.FR3.

Information for Concurrence Point 2 – Detailed Study Alternatives Carried Forward

Information for Concurrence Point 2A – Bridging Decisions and Alignment Review

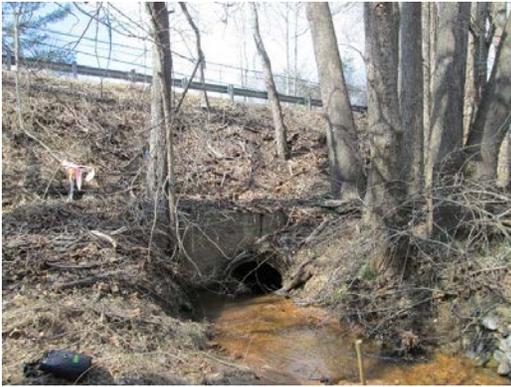
Site 3 – Upstream Face

This stream crossing has a drainage area of 0.42 square miles. The current land use is primarily residential. The existing structure is a 42" corrugated metal pipe (CMP) with a concrete headwall skewed 135 degrees to the roadway. It ties into an existing system with Dingle Creek (Site 4) after passing under Sweeten Creek Road and outfalls to the West of the railroad through a 72" CMP approximately 110 feet downstream. Existing structure is in fair condition. The upstream banks are vegetated and stable, but the downstream left bank at the outfall has been undercut and is actively eroding. The centerline of the roadway is approximately 17 feet above the creek bed. Normal depth of flow is approximately 0.3 feet, and ordinary high water is about 2.5 feet above the streambed. Preliminary calculations suggest that the 100-year storm does not overtop the road.

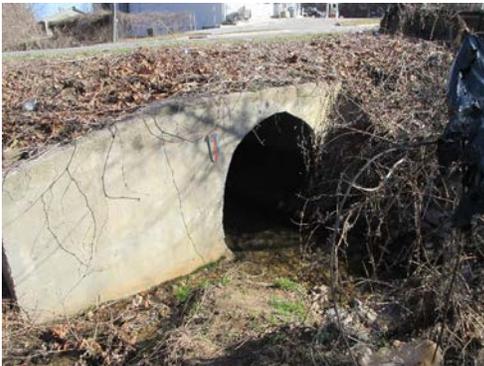
Site 6 – Upstream Face

This stream crossing has a drainage area of 0.72 square miles. The current land use is primarily residential, with some commercial development along the roadway. The existing structure is an 84" corrugated metal pipe (CMP) with a concrete headwall at a 90-degree skew to the roadway. The structure is in fair condition. The centerline of the road is approximately 10 feet above the creek bed. The normal water depth is 0.5 feet. Upstream and downstream banks are vegetated and stabilized with rip rap. There is an 8-inch sewer line across the channel upstream, as well as a 24-inch RCP outfall. The pipe is buried 6 inches at the outlet, and there are two additional CMP outfalls downstream that have been damaged. According to residents in the area and bridge maintenance staff, the roadway has not overtopped. The FEMA model shows overtopping at the 100-year discharge. There is a structure in the 100-year floodplain upstream in the southwest quadrant of the crossing. There are also multiple structures downstream on both sides of the creek, 200 feet downstream of the culvert. This structure is the downstream structure for site 5.

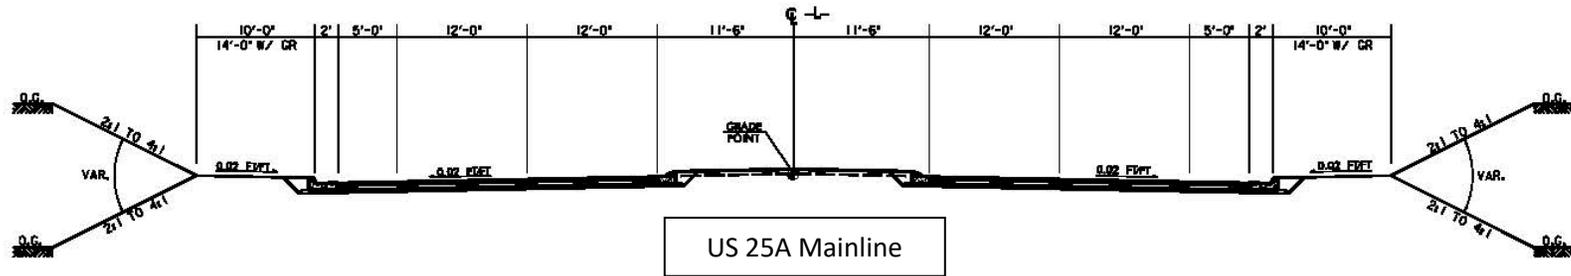
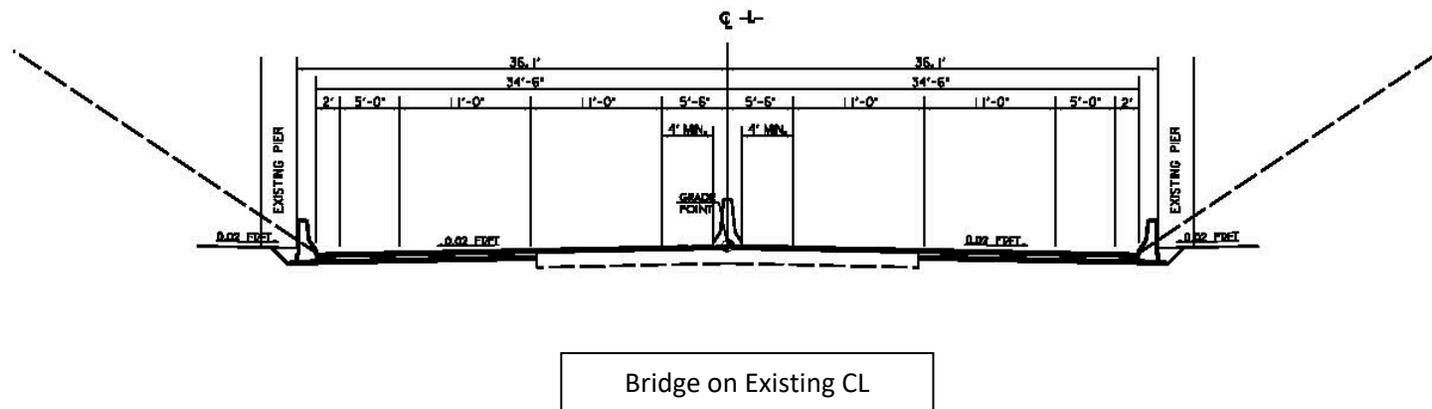
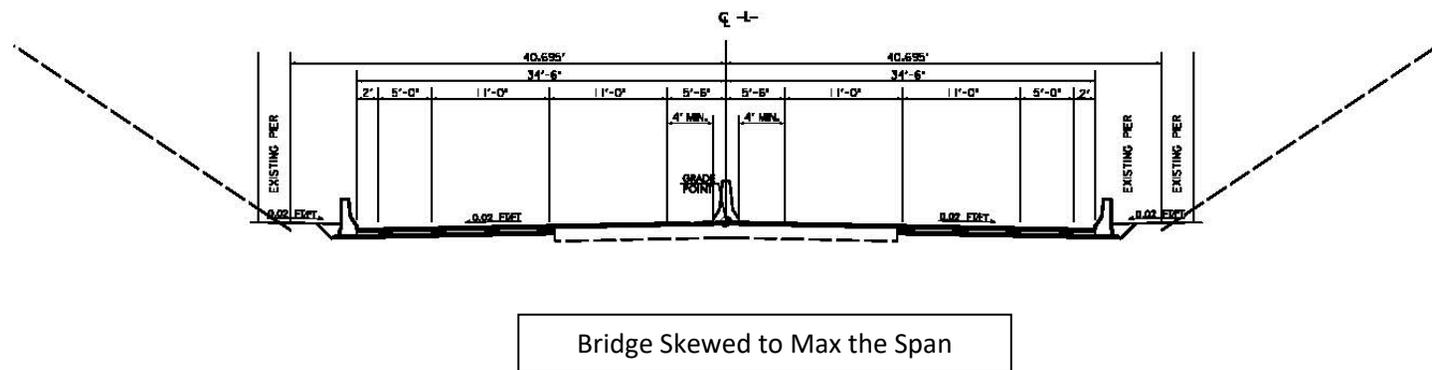
Figure 1 - U-2801A Typical Sections

The project team has developed two typical sections for use in this project. The base typical section, Typical Section No. 1, is a four-lane divided section with a 23-foot raised grass median with 1'-6" mountable curb and gutter along the inside lanes and 2'-6" standard curb and gutter along the outside lanes. The travel lanes consist of two 12-foot lanes in each direction, with 5-foot bike lanes and 10-foot planting strips behind the outside curb and gutter on each side that can accommodate sidewalk.

A variation of the base typical section, Typical Section No. 2, includes a 3-foot concrete jersey median barrier, two 11-foot travel lanes with 5-foot bike lanes in each direction, and 2-foot paved shoulders with jersey barrier along the outside to allow narrowing of the right-of-way in the area of the Blue Ridge Parkway Bridge to avoid widening and rebuilding the bridge. Sidewalks will be redirected to the space behind the existing bridge piers, and will be "benched" into the existing slope protection so that they are elevated to reduce the amount of material to be removed behind the bridge piers.

Figure 1 illustrates the typical sections; additionally, the design assumptions outlining the parameters for each typical section are shown in Table 1.

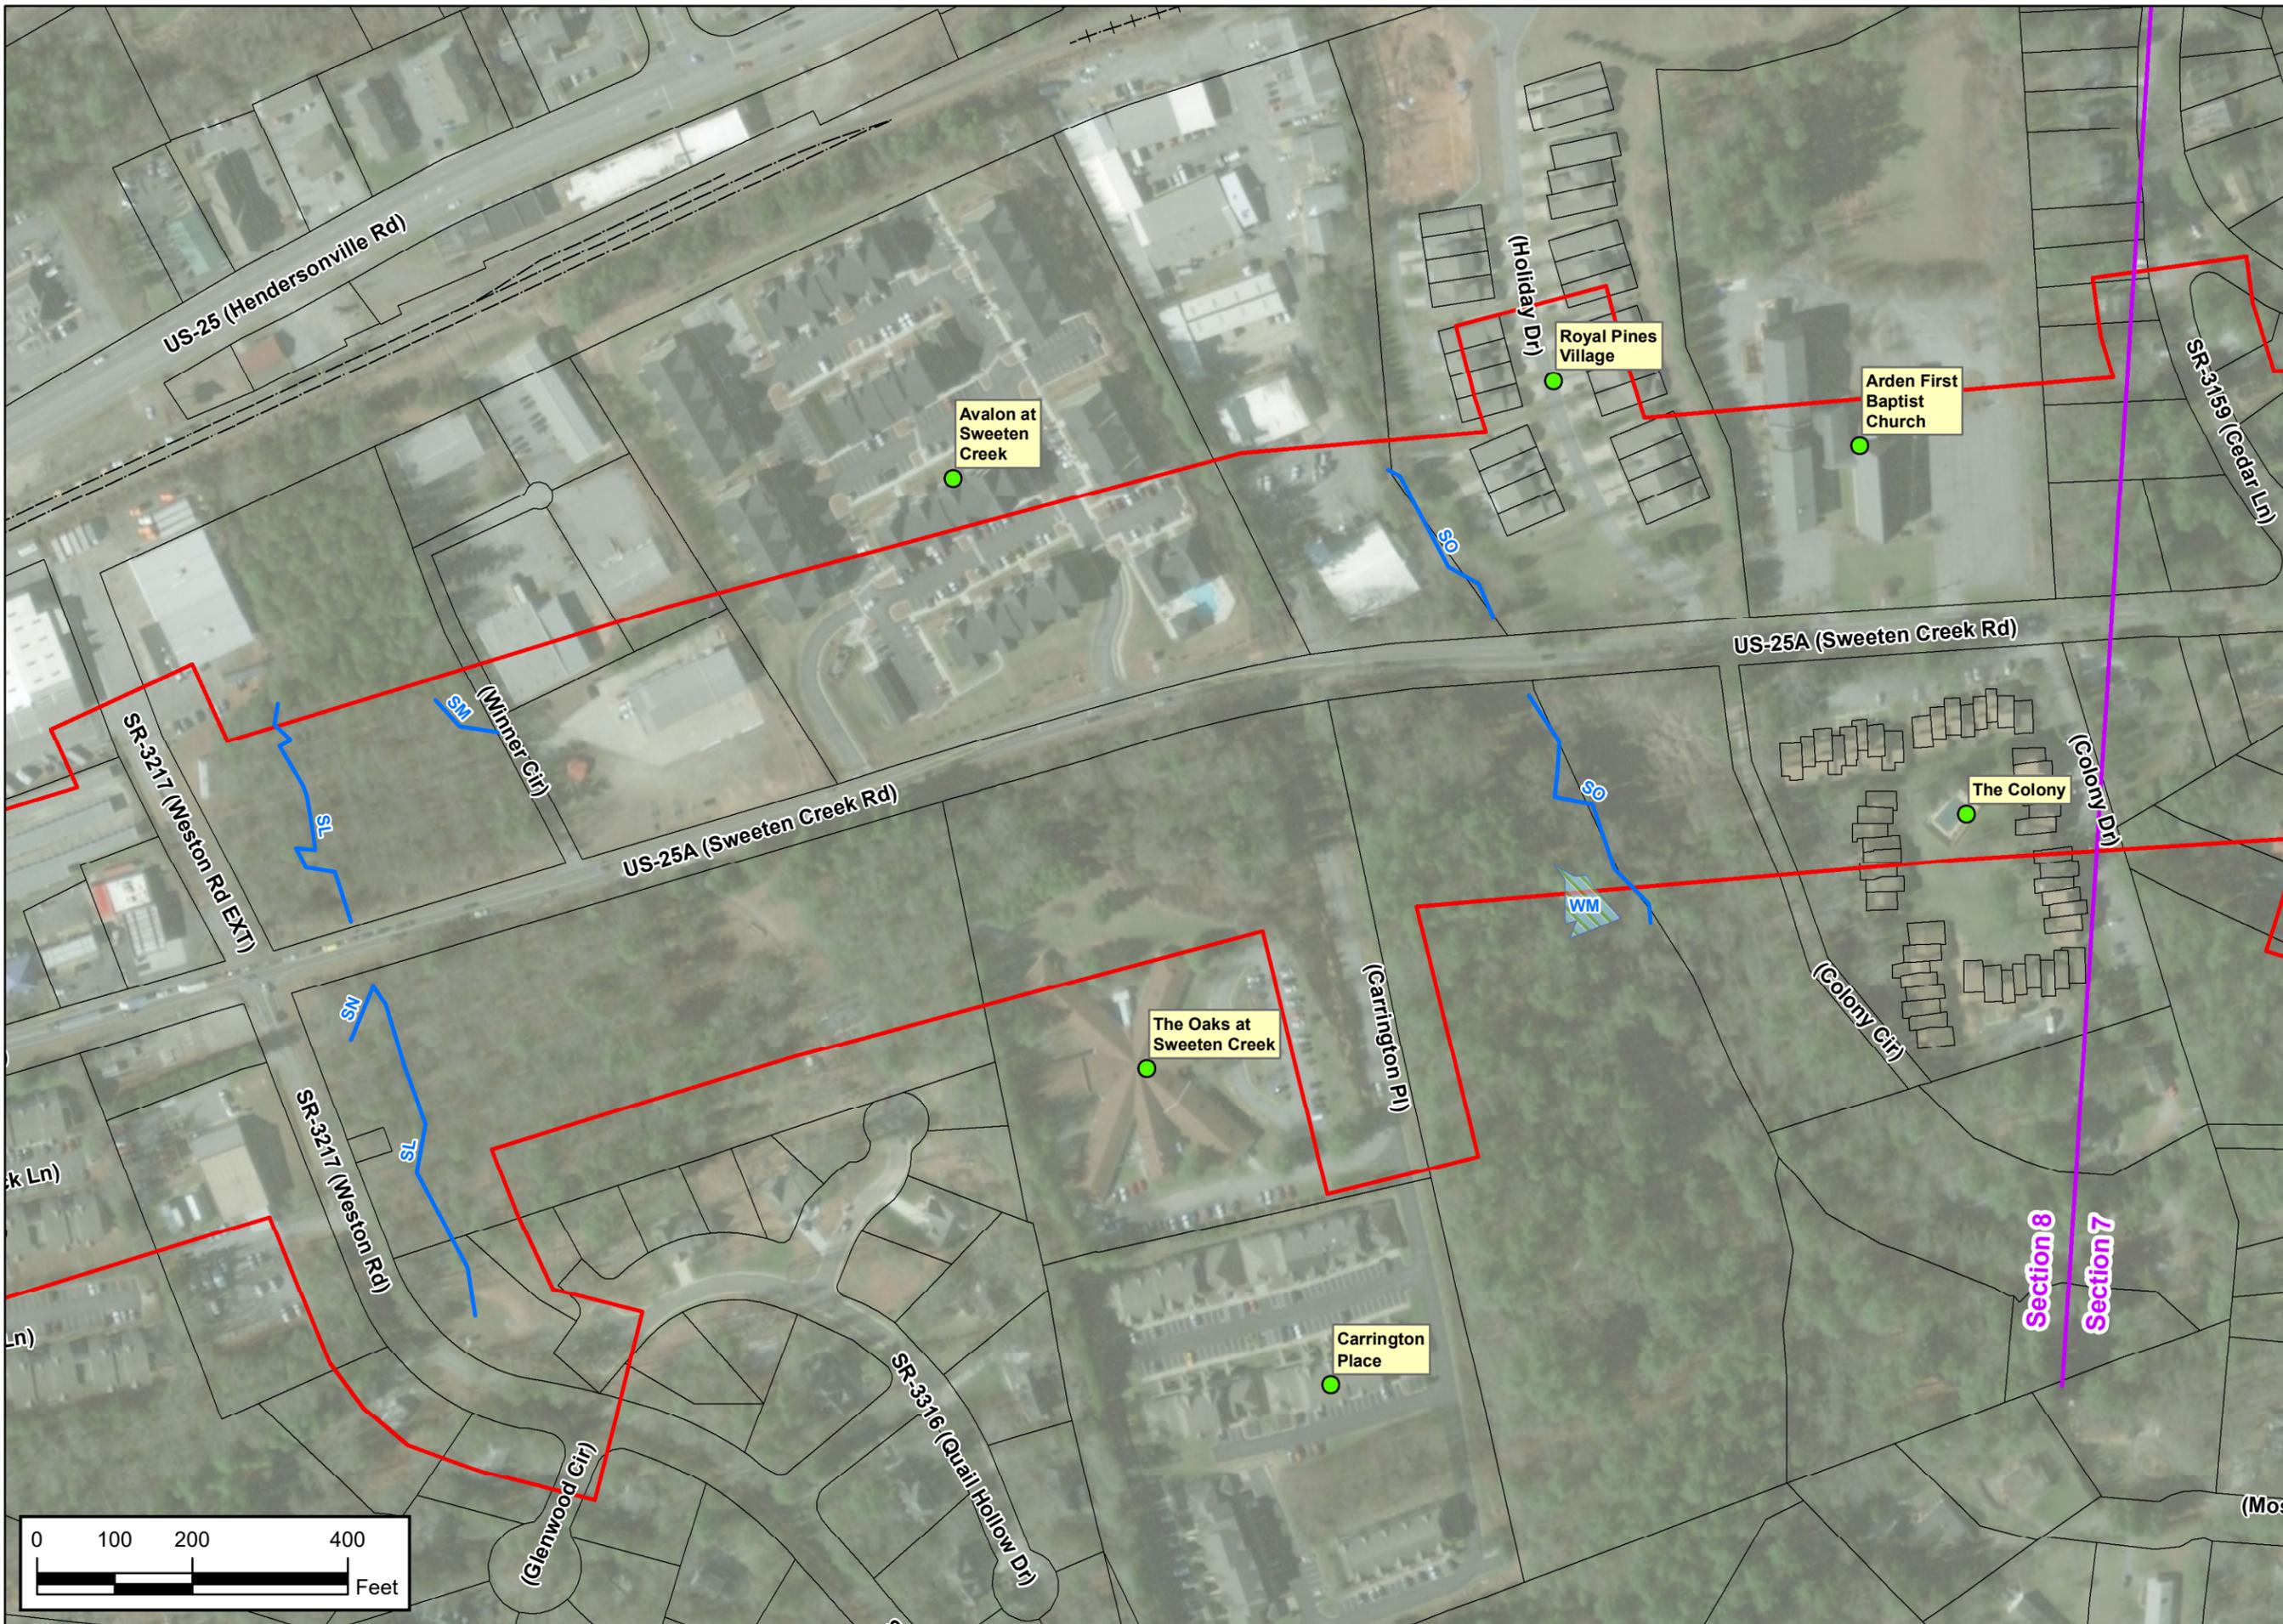
Figure
2-1

ENVIRONMENTAL FEATURES MAP
WIDEN SWEETEN CREEK RD
FROM HENDERSONVILLE RD (US 25)
TO SR 3801 (ROCK HILL HD)
BUNCOMBE COUNTY
STIP PROJECT U-2801A

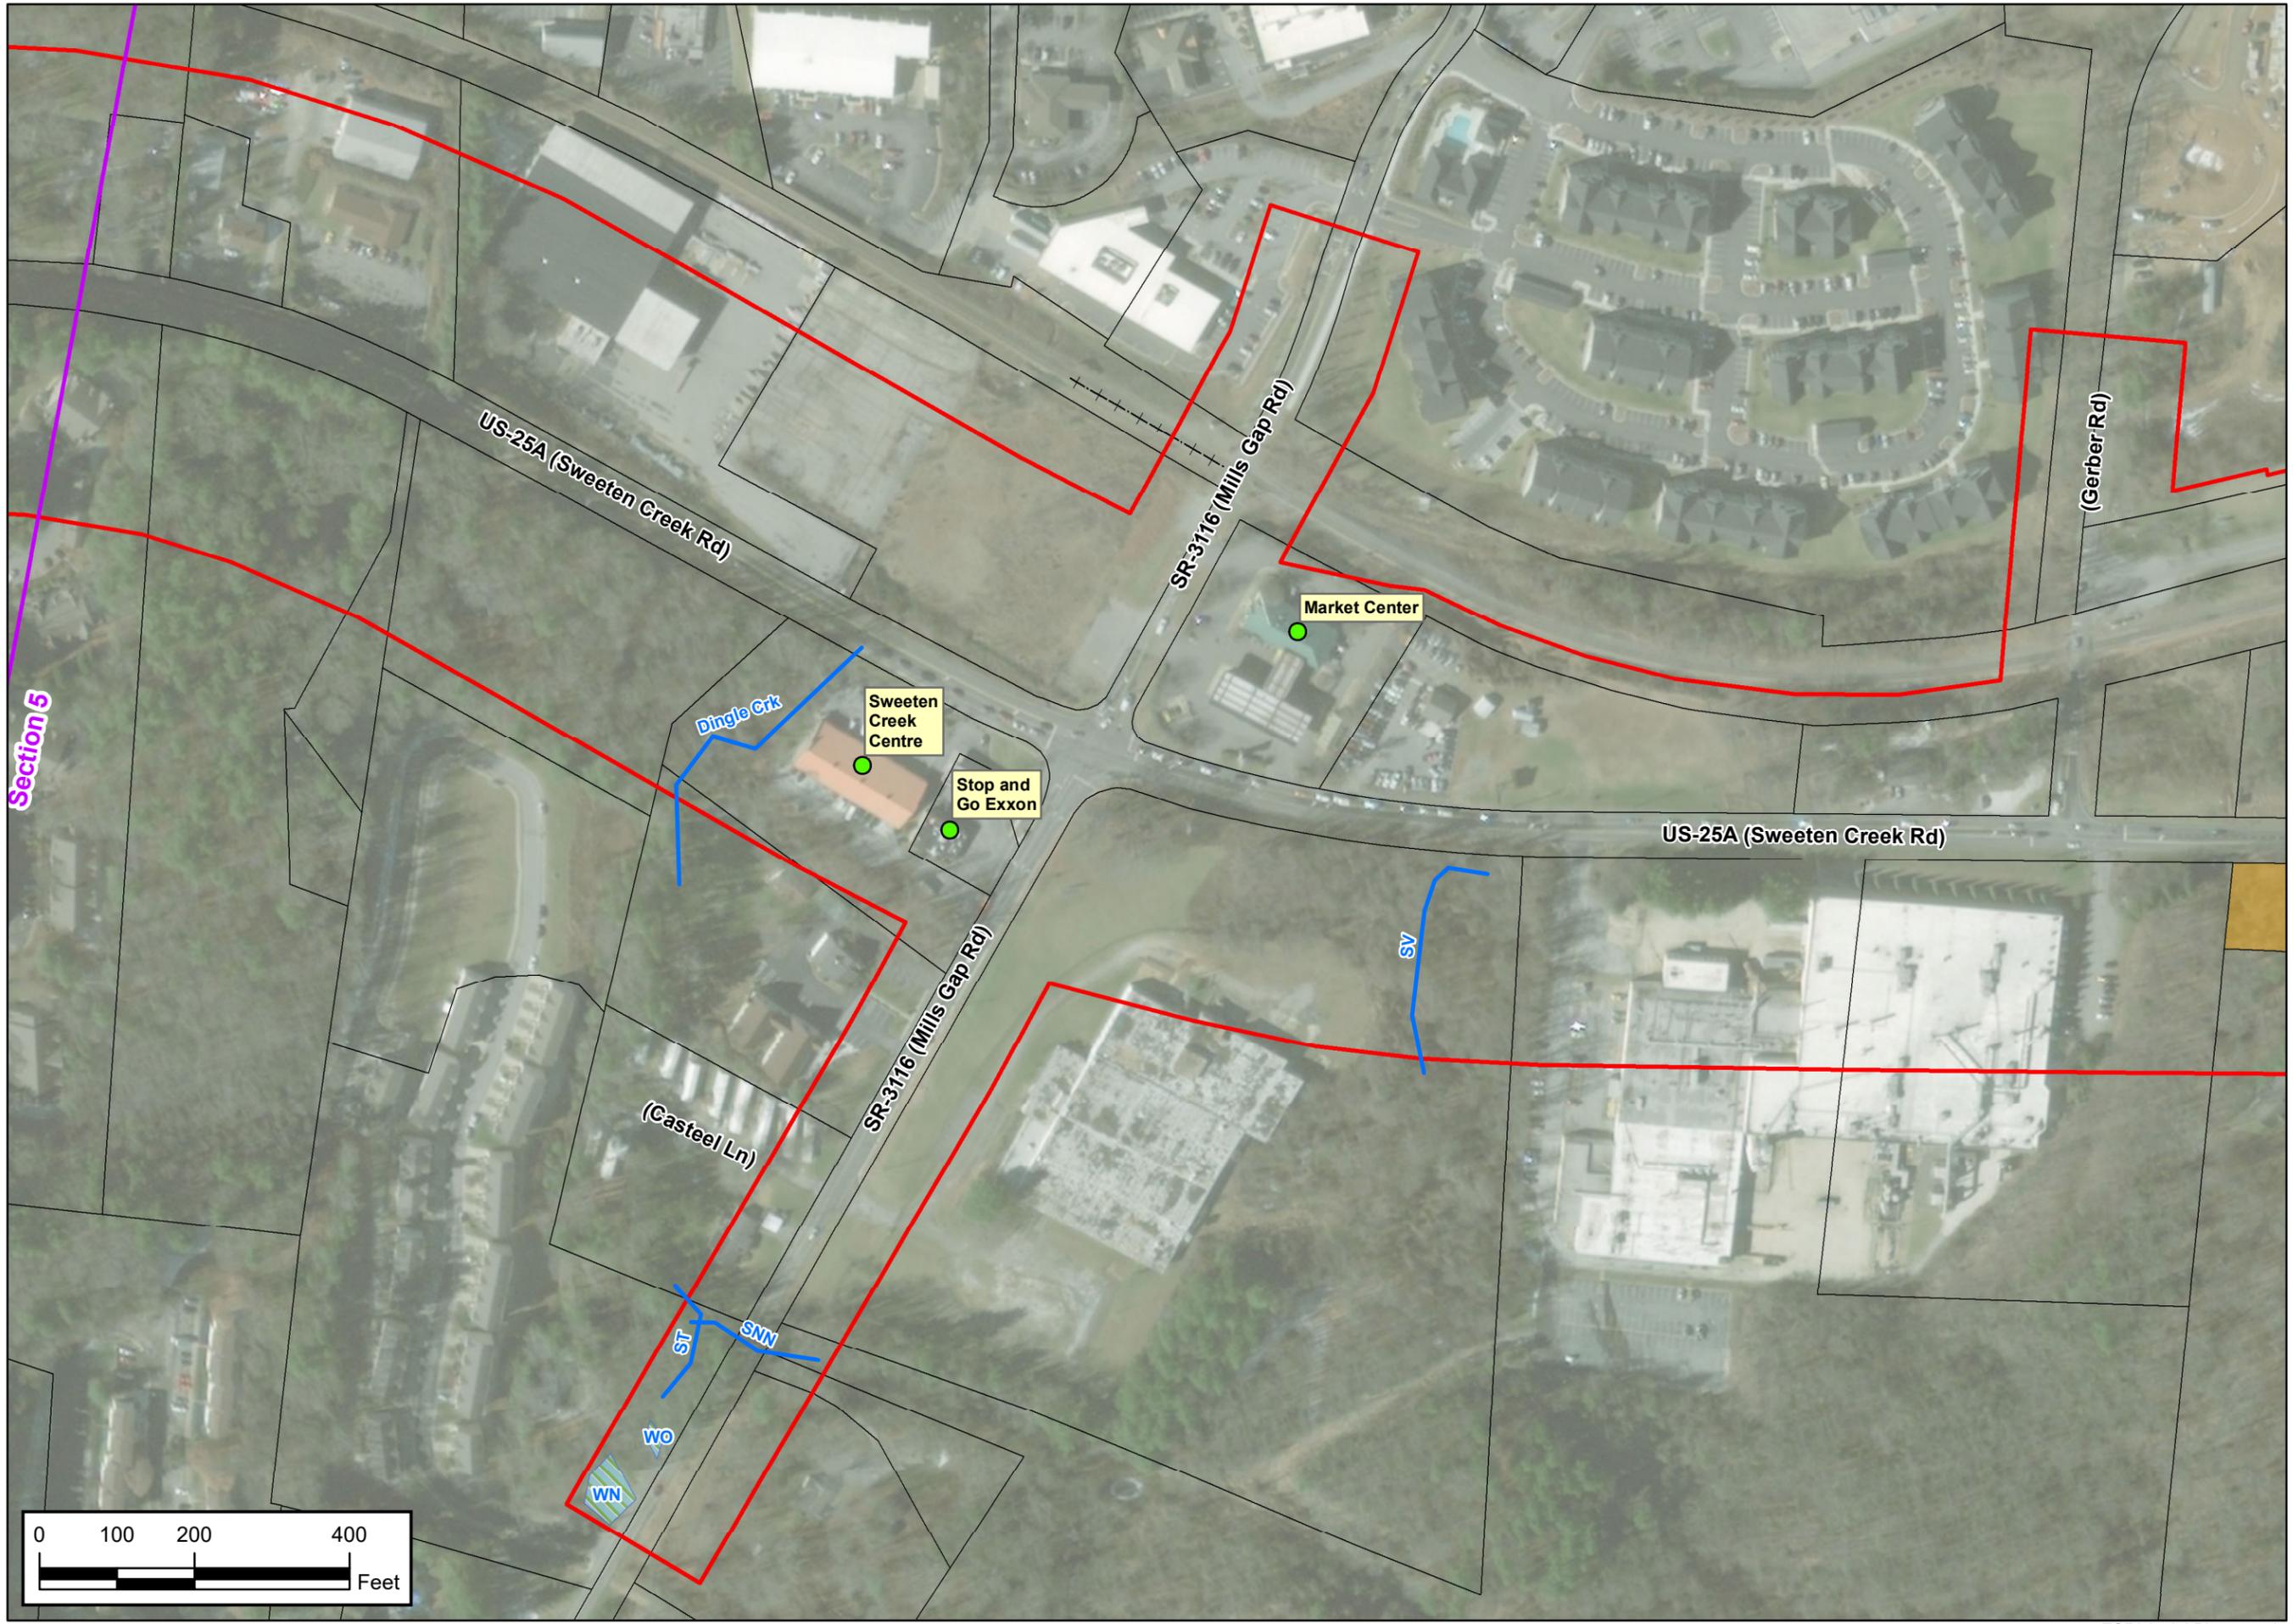
Figure
2-5

ENVIRONMENTAL FEATURES MAP
WIDEN SWEETEN CREEK RD
FROM HENDERSONVILLE RD (US 25)
TO SR 3801 (ROCK HILL HD)
BUNCOMBE COUNTY
STIP PROJECT U-2801A

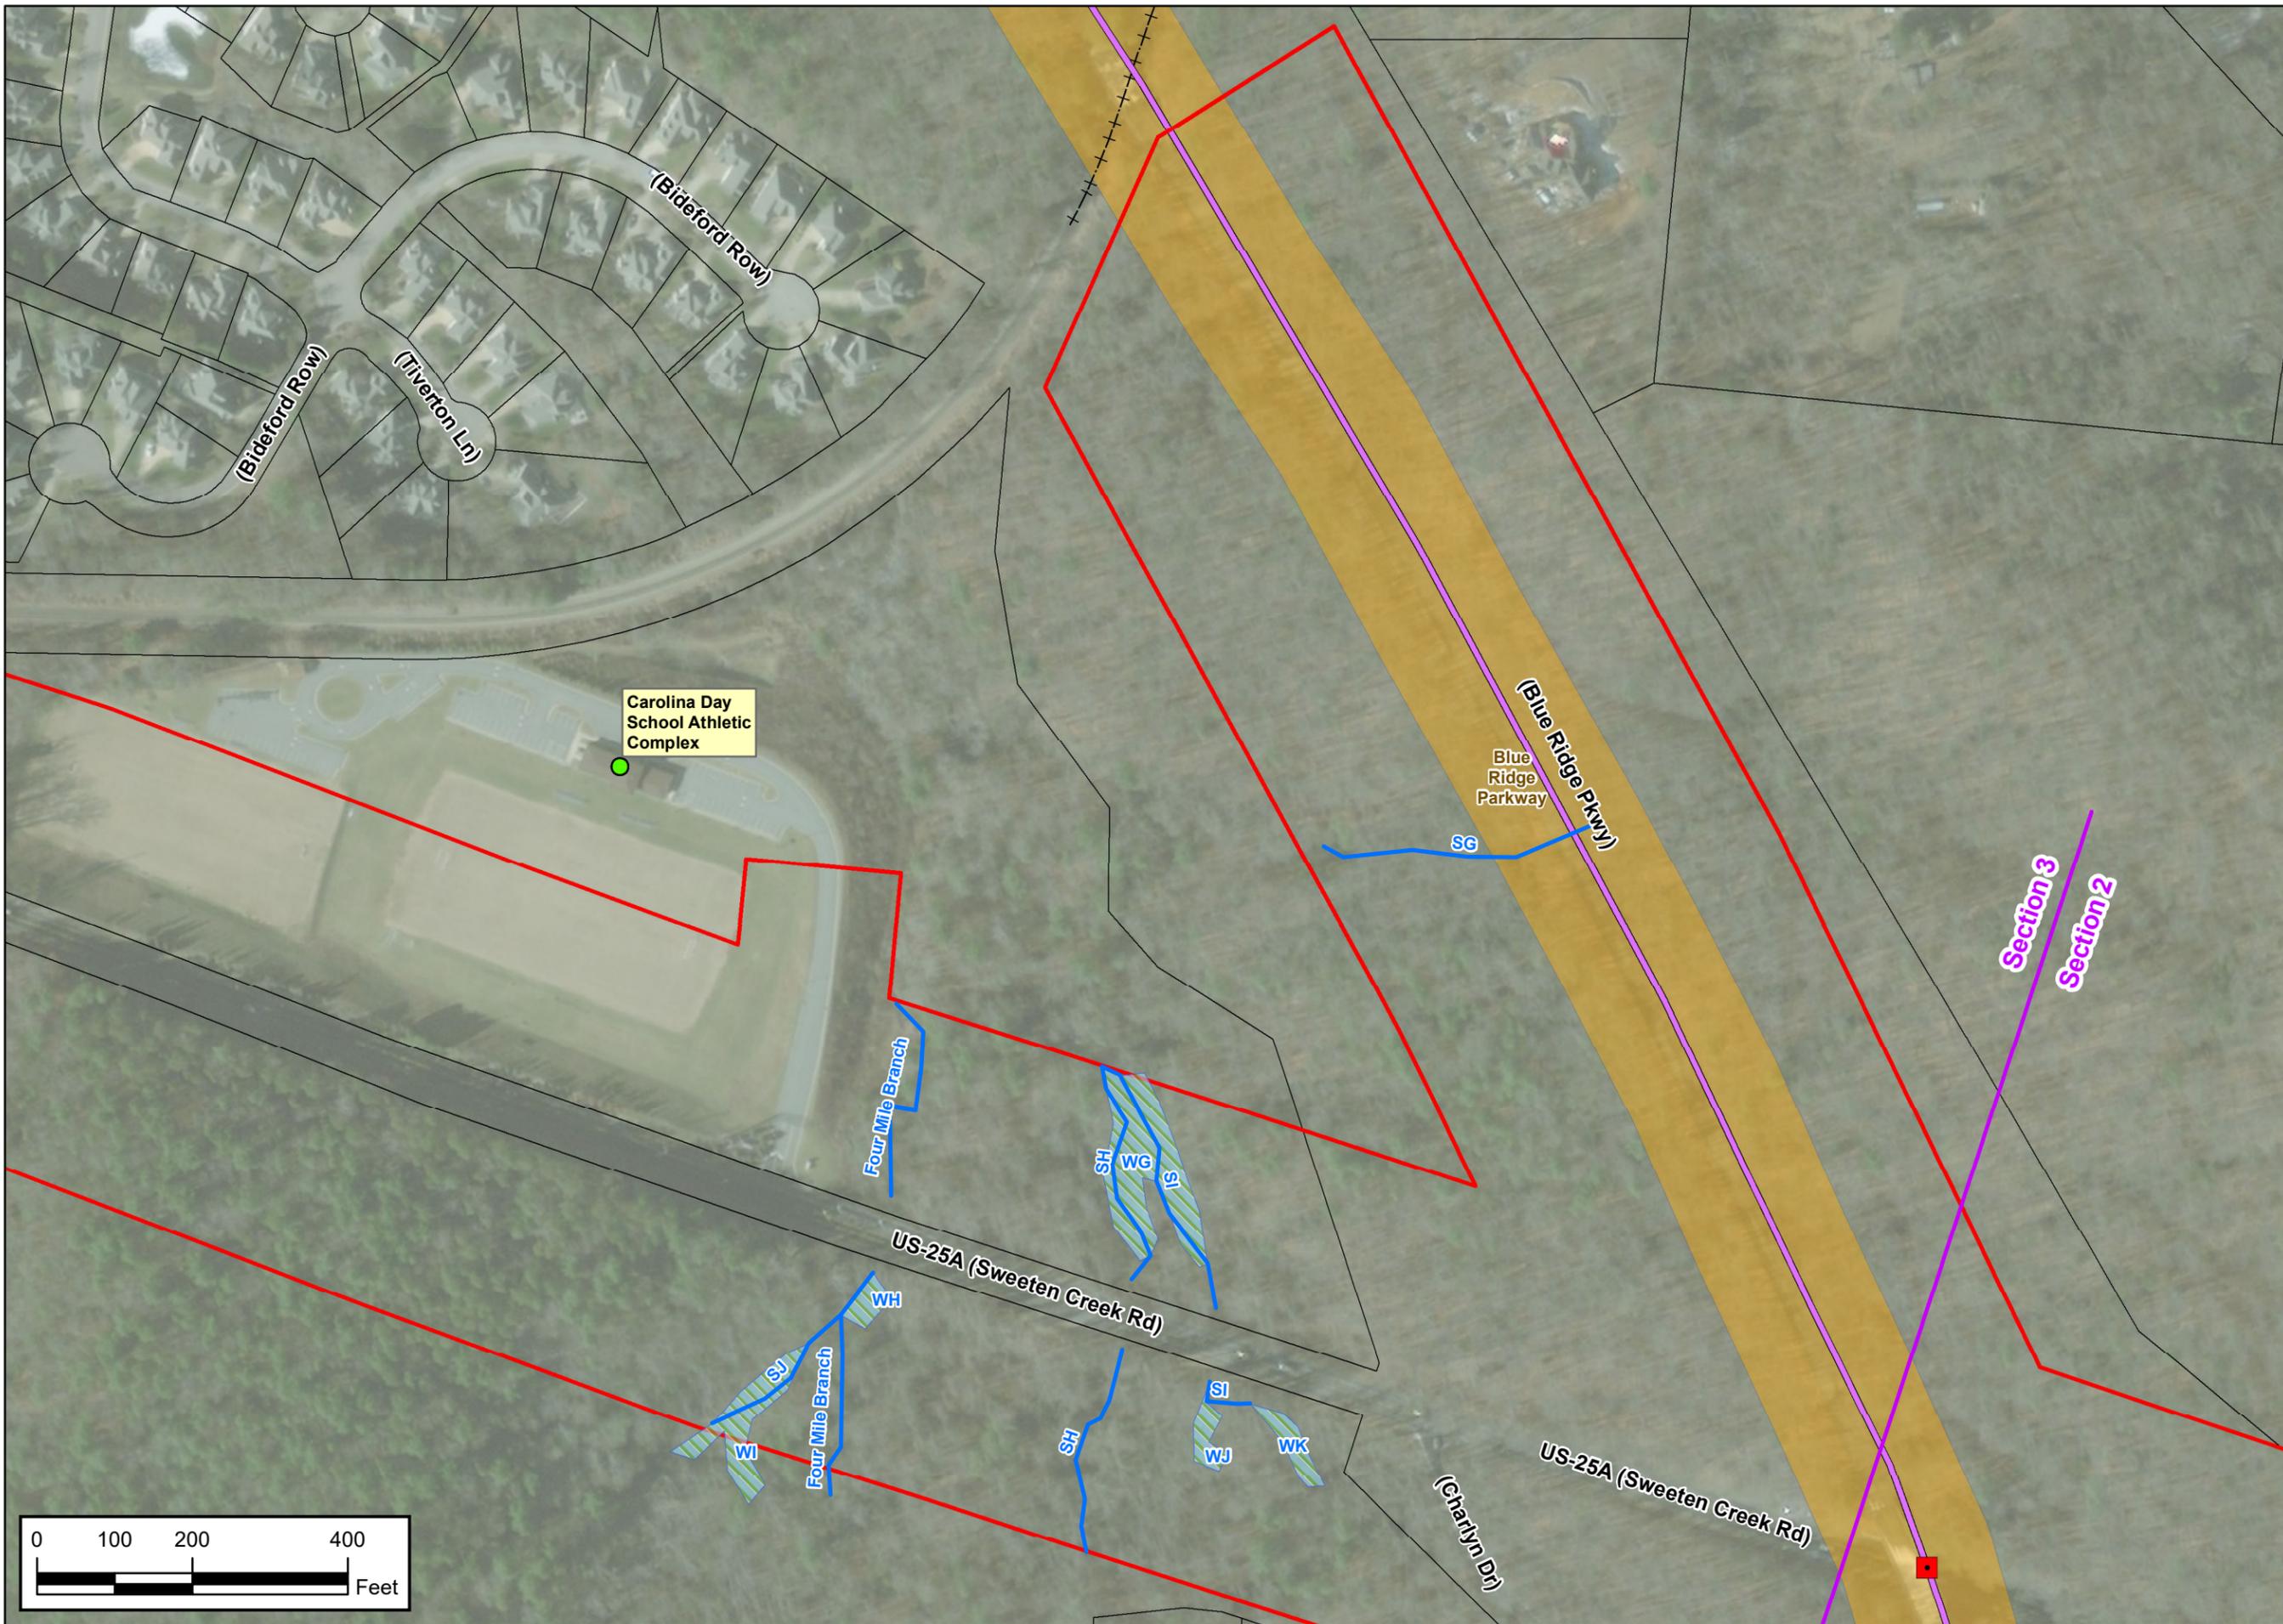
Figure
2-8

ENVIRONMENTAL FEATURES MAP
WIDEN SWEETEN CREEK RD
FROM HENDERSONVILLE RD (US 25)
TO SR 3801 (ROCK HILL HD)
BUNCOMBE COUNTY
STIP PROJECT U-2801A

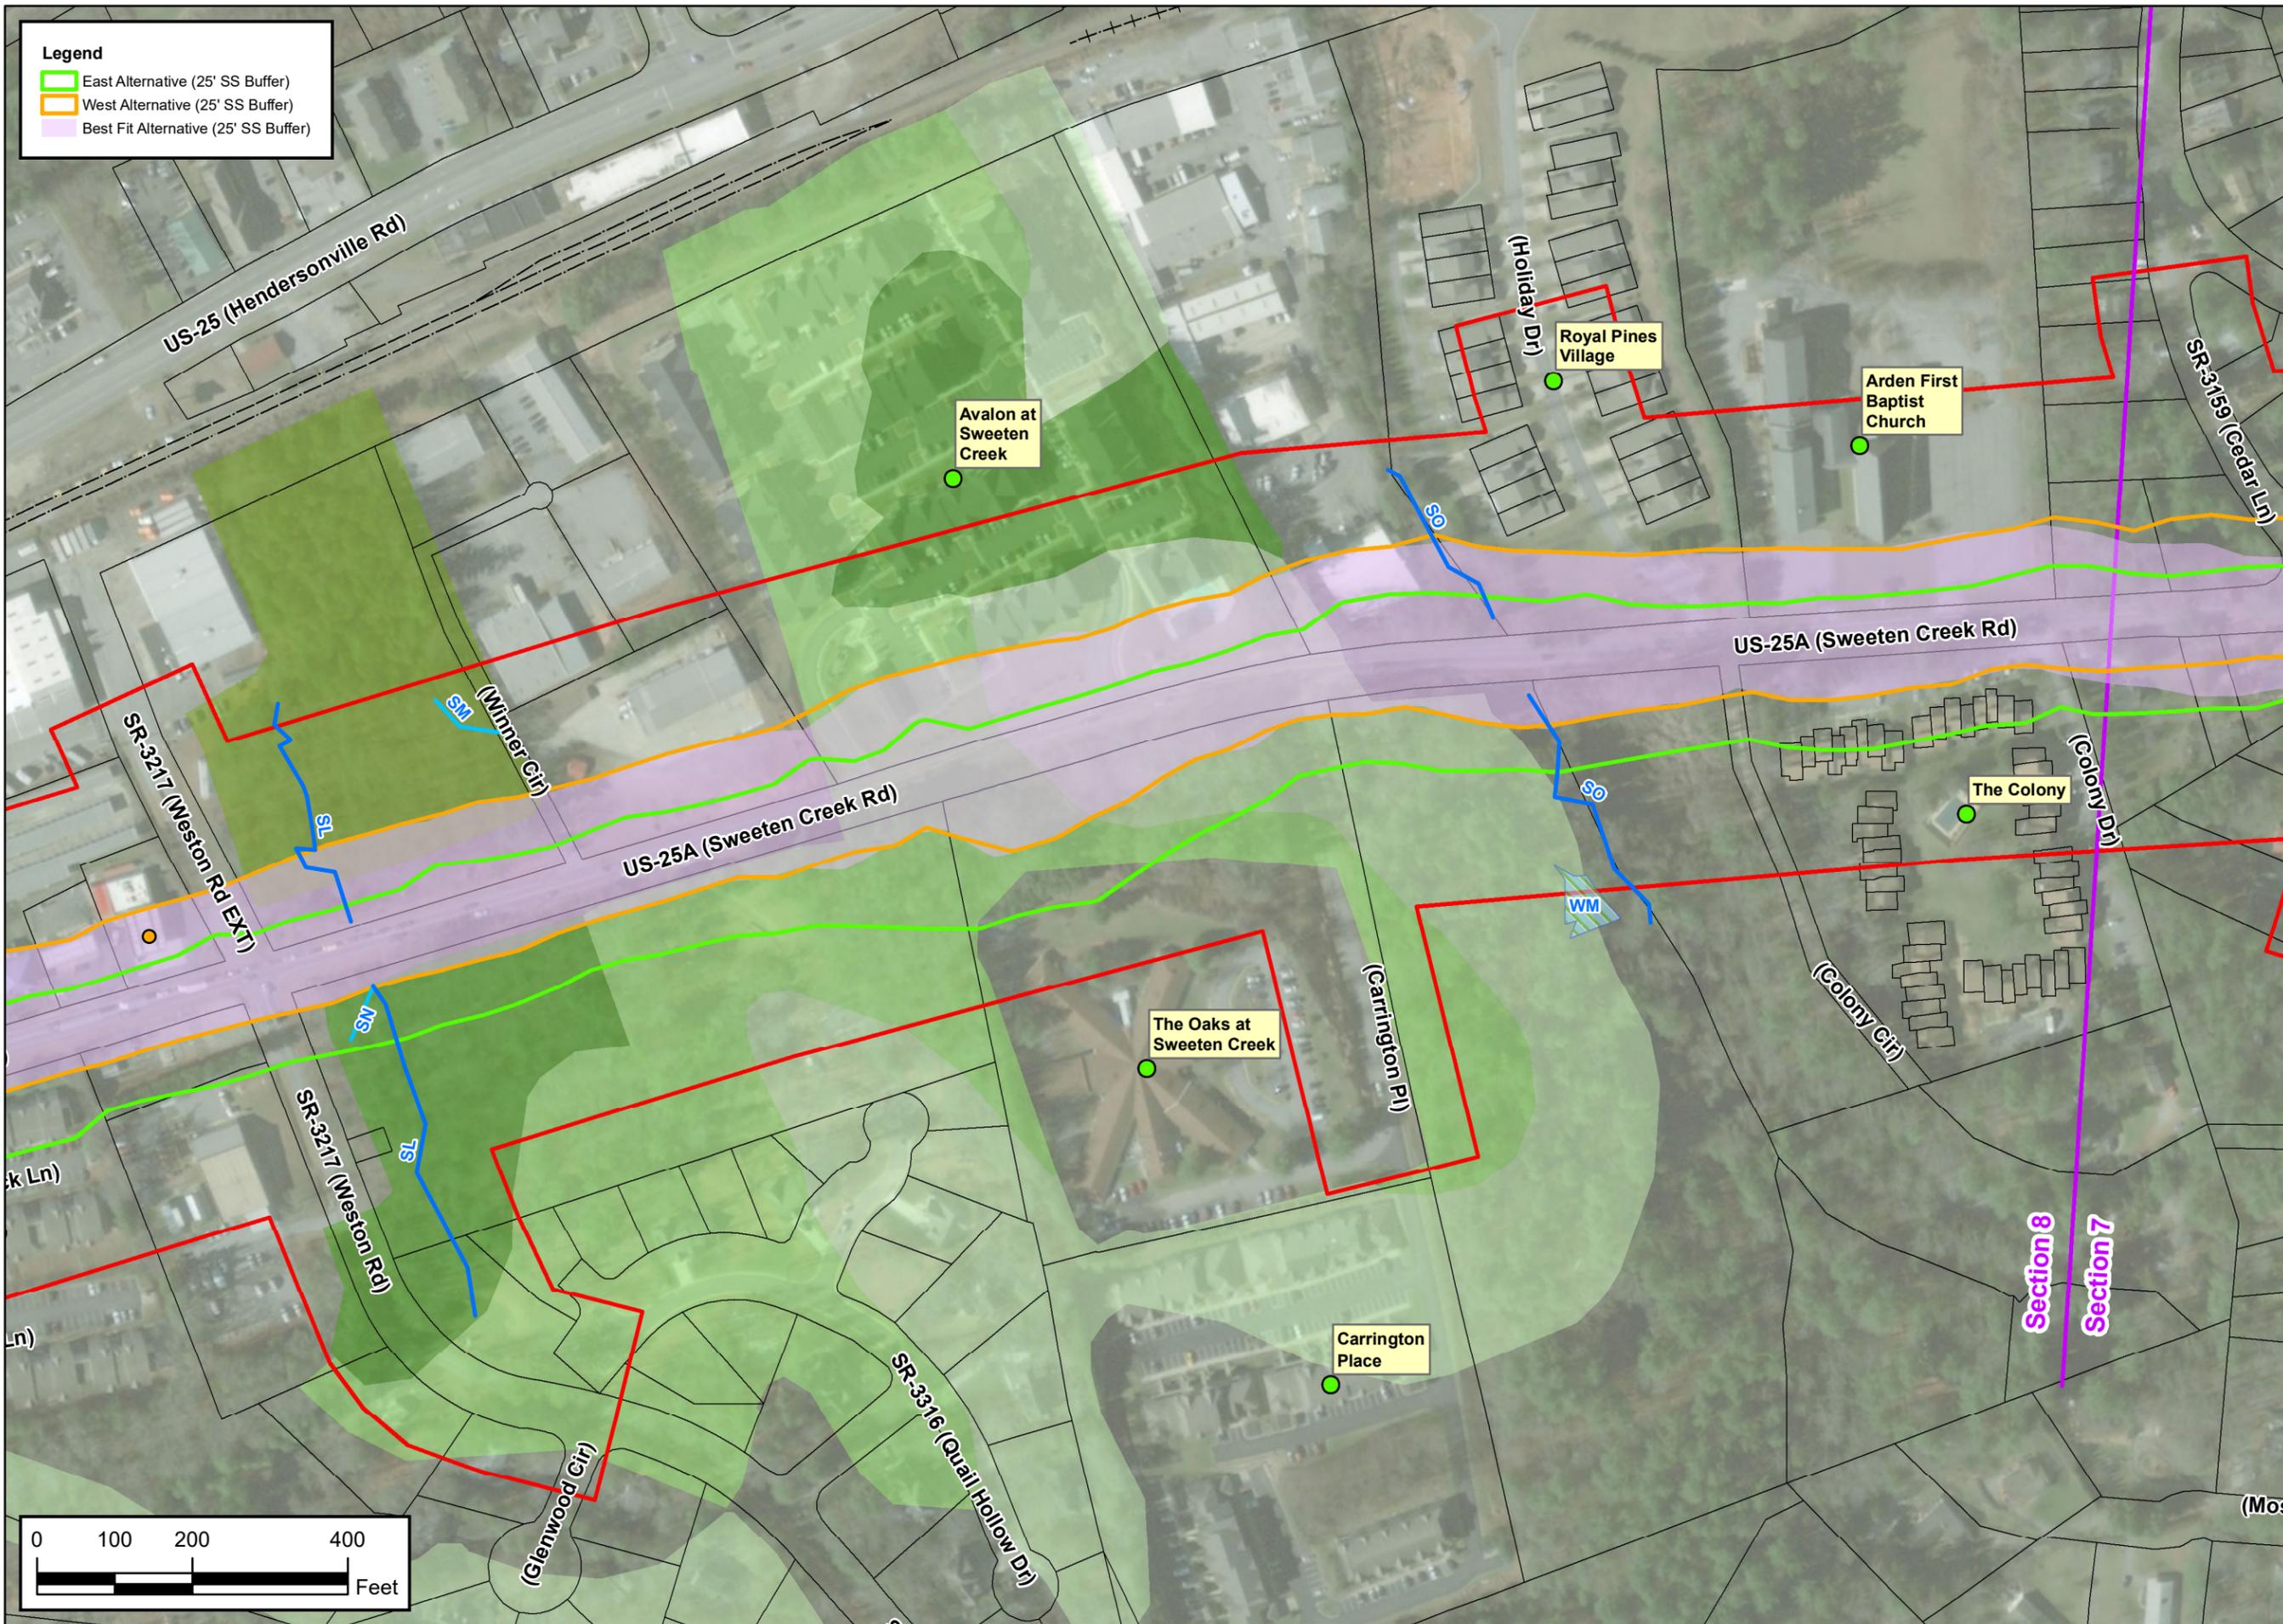
ALTERNATIVES IMPACT MAP
WIDEN SWEETEN CREEK RD
FROM HENDERSONVILLE RD (US 25)
TO SR 3801 (ROCK HILL HD)
BUNCOMBE COUNTY
STIP PROJECT U-2801A

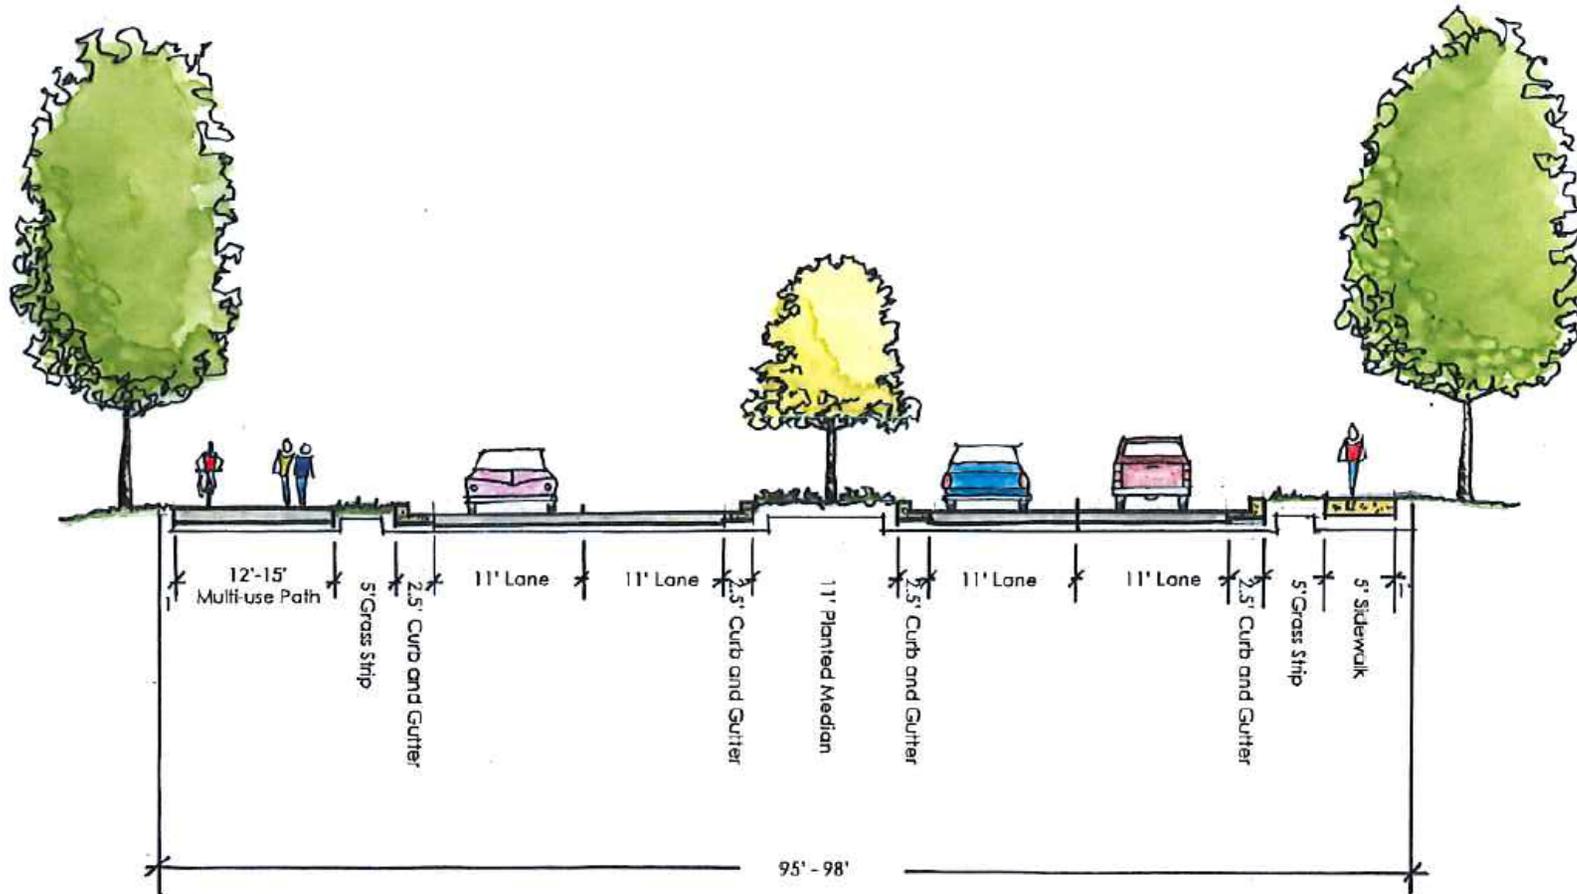
Figure 4

City of Asheville – Resolution 18-79
Recommended Typical Section – Sweeten Creek Road

SWEETEN CREEK ROAD
CONCEPT A SCALE 1"=10'

On April 10, 2018, the City of Asheville City Council passed a resolution stating that the city is revising the Asheville in Motion (AIM) Multimodal Transportation Plan to reflect a typical cross section for Sweeten Creek Road that includes a physically-separated multi-use path along one side of Sweeten Creek Road with sidewalks along the other side, and incorporates a planted median and 11-foot travel lanes (see Figure 4).
