Section 404/NEPA Merger Project Team Meeting
Concurrence Point No. 2A
August 9, 2018

Widen Sweeten Creek Road (US 25A) to a multilane roadway from Hendersonville Road (US 25) to Rock Hill Road (SR 3081) in Asheville, Buncombe County, North Carolina, State Transportation Improvement Project (STIP) No. U-2801A, Federal-Aid No. STP-025A(5), WBS No. 34859.1.FR3.

Information for Concurrence Point 2A – Bridging Decisions and Alignment Review

Preliminary Hydraulic Study for Environmental Impact Conclusions:

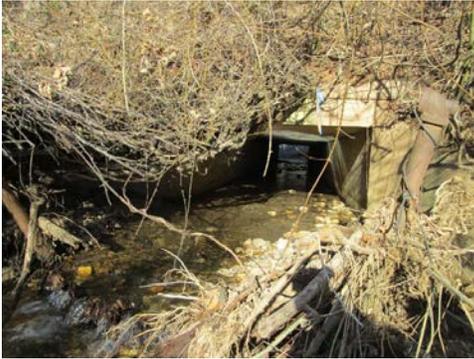
Site 1 - Downstream Face

This stream crossing has a drainage area of 0.45 square miles. The current land use is primarily residential and wooded. The existing structure is an 8-foot span, bottomless reinforced concrete box culvert (RCBC) skewed 75 degrees to the roadway. The upstream opening is 8 feet by 5 feet, and the downstream opening is 8 feet by 4.5 feet. The structure is in fair condition, with some cracking and spalling of the concrete. The centerline of the roadway is approximately 18 feet above the creek bed, and the normal depth of flow is approximately 0.5 feet, with ordinary high water at approximately 2 feet above the stream bed. The stream has migrated to the right, causing a scour hole approximately 10 feet wide by 6 feet deep behind the upstream wing wall. Preliminary calculations suggest that the 100-year storm does not overtop the road.

This stream crossing has a drainage area of 0.45 square miles. The current land use is primarily residential and wooded. The existing structure is an 8-foot span, bottomless reinforced concrete box culvert (RCBC) skewed 75 degrees to the roadway. The upstream opening is 8 feet by 5 feet, and the downstream opening is 8 feet by 4.5 feet. The structure is in fair condition, with some cracking and spalling of the concrete. The centerline of the roadway is approximately 18 feet above the creek bed, and the normal depth of flow is approximately 0.5 feet, with ordinary high water at approximately 2 feet above the stream bed. The stream has migrated to the right, causing a scour hole approximately 10 feet wide by 6 feet deep behind the upstream wing wall. Preliminary calculations suggest that the 100 year storm does not overtop the road.

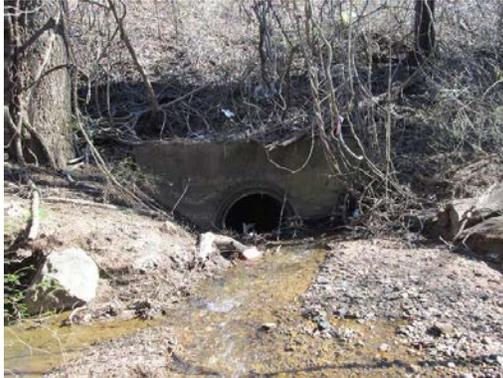
Site 2 - Upstream Face

This stream crossing has a drainage area of 0.32 square miles. The current land use is primarily residential, with some commercial development along the roadway. The existing structure is a 42" corrugated metal pipe (CMP) with a concrete headwall. The structure is in fair condition. It ties to a system behind Goodwill off of Hendersonville Road and outfalls through a 42" CMP approximately 850 feet from US-25 Alt. The pipe is buried 6 inches at the outlet. Aggradation on the inlet side has caused the bed to rise 1.5

feet above the pipe invert. The centerline of the roadway is approximately 20 feet above the elevation of the creek bed. Normal water depth is 0.5 feet, and ordinary high water is 2.5 feet above the streambed. There is a 24" CMP outfall upstream of the crossing which has caused some scour; however, no scour was observed downstream. Banks are stable and vegetated up and downstream. Preliminary calculations suggest that the 100-year storm does not overtop the road.

Site 2 hydraulically requires a box culvert; however, an existing 42" corrugated metal pipe (CMP) is attached to the existing roadway pipe at the outlet end. This pipe extends an additional 850 feet downstream under parking lots and eventually discharges into Dingle Creek. This existing CMP controls the hydraulic capacity through the roadway embankment; therefore, we are recommending upgrading the roadway pipe to a Concrete Pipe as a culvert would not create a more efficient crossing.

This stream crossing has a drainage area of 0.32 square miles. The current land use is primarily residential, with some commercial development along the roadway. The existing structure is a 42" corrugated metal pipe (CMP) with a concrete headwall. The structure is in fair condition. It ties to a system behind Goodwill off of Hendersonville Road and outfalls through a 42" CMP approximately 850

feet from US-25 Alt. The pipe is buried 6 inches at the outlet. Aggradation on the inlet side has caused the bed to rise 1.5 feet above the pipe invert. The centerline of the roadway is approximately 20 feet above the elevation of the creek bed. Normal water depth is 0.5 feet, and ordinary high water is 2.5 feet above the streambed. There is a 24" CMP outfall upstream of the crossing which has caused some scour; however, no scour was observed downstream. Banks are stable and vegetated up and downstream. Preliminary calculations suggest that the 100 year storm does not overtop the road.

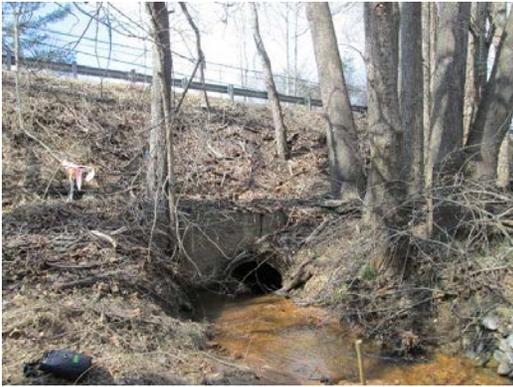
Site 3 – Upstream Face

This stream crossing has a drainage area of 0.42 square miles. The current land use is primarily residential. The existing structure is a 42" corrugated metal pipe (CMP) with a concrete headwall skewed 135 degrees to the roadway. It ties into an existing system with Dingle Creek (Site 4) after passing under Sweeten Creek Road and outfalls to the West of the railroad through a 72" CMP approximately 110 feet downstream. Existing structure is in fair condition. The upstream banks are vegetated and stable, but the downstream left bank at the outfall has been undercut and is actively eroding. The centerline of the roadway is approximately 17 feet above the creek bed. Normal depth of flow is approximately 0.3 feet, and ordinary high water is about 2.5 feet above the streambed. Preliminary calculations suggest that the 100-year storm does not overtop the road.

This stream crossing has a drainage area of 0.42 square miles. The current land use is primarily residential. The existing structure is a 42" corrugated metal pipe (CMP) with a concrete headwall skewed 135 degrees to the roadway. It ties into an existing system with Dingle Creek (Site 4) after passing under Sweeten Creek Road and outfalls to the West of the railroad through a 72" CMP approximately 110 feet downstream. Existing structure is in fair condition. The upstream banks are vegetated and stable, but the downstream left bank at the outfall has been undercut and is actively eroding. The centerline of the roadway is approximately 17 feet above the creek bed. Normal depth of flow is approximately 0.3 feet, and ordinary high water is about 2.5 feet above the streambed. Preliminary calculations suggest that the 100 year storm does not overtop the road.

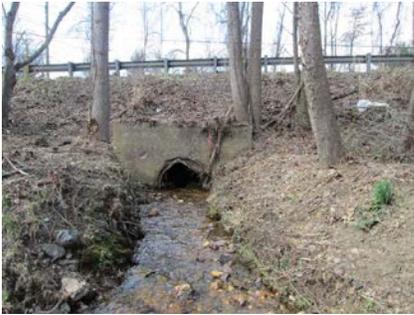
Site 4 – Upstream Face

This stream crossing has a drainage area of 0.38 square miles. The current land use is primarily residential. The existing structure is a concrete pipe slip lined with a 42" corrugated metal pipe (CMP). The structure is in poor condition: there is a crack in the headwall downstream, the pipe is corroded, and the upstream pipe entrance is damaged. The centerline of the road is approximately 14 feet above the creek bed. The normal depth of flow is approximately 0.4 feet, and the ordinary high water is 1.5 feet above the streambed. The pipe is buried 6 inches. No scour was observed downstream. Banks on both the upstream and downstream side are vegetated and stable, and there are no structures in the floodplain. Downstream of this crossing the stream runs parallel to the roadway for approximately 200 feet. According to residents in the area and bridge maintenance staff, the roadway has not overtopped. The FEMA model shows overtopping at the 100-year discharge. There are multiple structures in the 100-year floodplain from 300-700 feet upstream of the culvert.

This stream crossing has a drainage area of 0.38 square miles. The current land use is primarily residential. The existing structure is a concrete pipe slip lined with a 42" corrugated metal pipe (CMP). The structure is in poor condition: there is a crack in the headwall downstream, the pipe is corroded, and the upstream pipe entrance is damaged. The centerline of the road is approximately 14 feet above the creek bed. The normal depth of flow is approximately 0.4 feet, and the ordinary high water is 1.5 feet above the streambed. The pipe is buried 6 inches. No scour was observed downstream. Banks on both the upstream and downstream side are vegetated and stable, and there are no structures in the floodplain. Downstream of this crossing the stream runs parallel to the roadway for approximately 200 feet. According to residents in the area and bridge maintenance staff, the roadway has not overtopped. The FEMA model shows overtopping at the 100-year discharge. There are multiple structures in the 100-year floodplain from 300-700 feet upstream of the culvert.

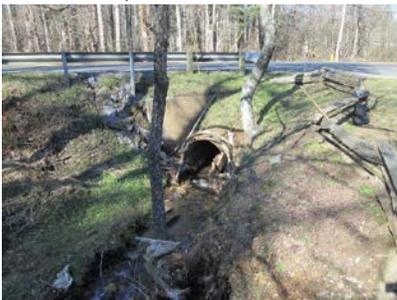
Site 5 – Upstream Face

This stream crossing has a drainage area of 0.28 square miles. The current land use is primarily residential. The existing structure is a 48" reinforced concrete pipe (RCP) that has been partially slip lined upstream with a 42" corrugated metal pipe (CMP), skewed 135 degrees to the roadway. The structure is deteriorated and in poor condition. The centerline of the road is approximately 8 feet above the creek bed. The normal water depth is approximately 0.5 feet, with ordinary high water approximately 4 feet above the streambed. According to residents in the area and bridge maintenance staff, the roadway has not overtopped. The FEMA model shows overtopping at the 100-year discharge. There is a structure in the 100-year floodplain just upstream in the Northeast quadrant of the culvert crossing. This structure is the upstream structure for site 6.

Sites 5 and 6 have embankment heights of 8 feet and 9 feet above the stream bed, respectively. The height of the proposed replacement box culverts will require the roadway profile to be raised in order to have the required minimum fill height over the culvert and freeboard for the 100-year flood. In addition, if wildlife passage is an issue taller culverts may be required which would lead to a greater increase in the roadway profile at sites 5 and 6. Prior to commitment to the taller structures, a more detailed hydraulic analysis is recommended as there are structures within the floodplain of Sweeten Creek and Rock Hill Road currently overtops in the 100-year storm event.

This stream crossing has a drainage area of 0.28 square miles. The current land use is primarily residential. The existing structure is a 48" reinforced concrete pipe (RCP) that has been partially slip lined upstream with a 42" corrugated metal pipe (CMP), skewed 135 degrees to the roadway. The structure is deteriorated and in poor condition. The centerline of the road is approximately 8 feet above the creek bed. The normal water depth is approximately 0.5 feet, with ordinary high water approximately 4 feet above the streambed. According to residents in the area and bridge maintenance staff, the roadway has not overtopped. The FEMA model shows overtopping at the 100-year discharge. There is a structure in the 100-year floodplain just upstream in the Northeast quadrant of the culvert crossing. This structure is the upstream structure for site 6.

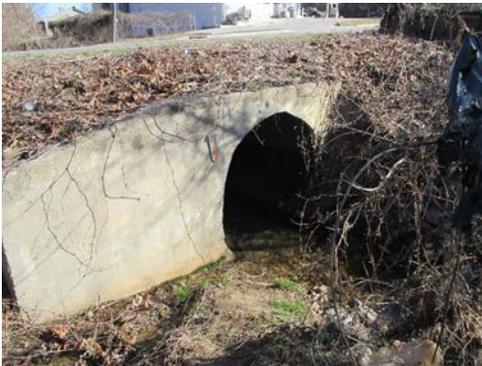
Site 6 – Upstream Face

This stream crossing has a drainage area of 0.72 square miles. The current land use is primarily residential, with some commercial development along the roadway. The existing structure is an 84" corrugated metal pipe (CMP) with a concrete headwall at a 90-degree skew to the roadway. The structure is in fair condition. The centerline of the road is approximately 10 feet above the creek bed. The normal water depth is 0.5 feet. Upstream and downstream banks are vegetated and stabilized with rip rap. There is an 8-inch sewer line across the channel upstream, as well as a 24-inch RCP outfall. The pipe is buried 6 inches at the outlet, and there are two additional CMP outfalls downstream that have been damaged. According to residents in the area and bridge maintenance staff, the roadway has not overtopped. The FEMA model shows overtopping at the 100-year discharge. There is a structure in the 100-year floodplain upstream in the Southwest quadrant of the crossing. There are also multiple structures downstream on both sides of the creek 200 feet downstream of the culvert. This structure is the downstream structure for site 5.

This stream crossing has a drainage area of 0.72 square miles. The current land use is primarily residential, with some commercial development along the roadway. The existing structure is an 84" corrugated metal pipe (CMP) with a concrete headwall at a 90 degree skew to the roadway. The structure is in fair condition. The centerline of the road is approximately 10 feet above the creek bed. The normal water depth is 0.5 feet. Upstream and downstream banks are vegetated and stabilized with

rip rap. There is an 8-inch sewer line across the channel upstream, as well as a 24-inch RCP outfall. The pipe is buried 6 inches at the outlet, and there are two additional CMP outfalls downstream that have been damaged. According to residents in the area and bridge maintenance staff, the roadway has not overtopped. The FEMA model shows overtopping at the 100-year discharge. There is a structure in the 100-year floodplain upstream in the Southwest quadrant of the crossing. There are also multiple structures downstream on both sides of the creek 200 feet downstream of the culvert. This structure is the downstream structure for site 5.

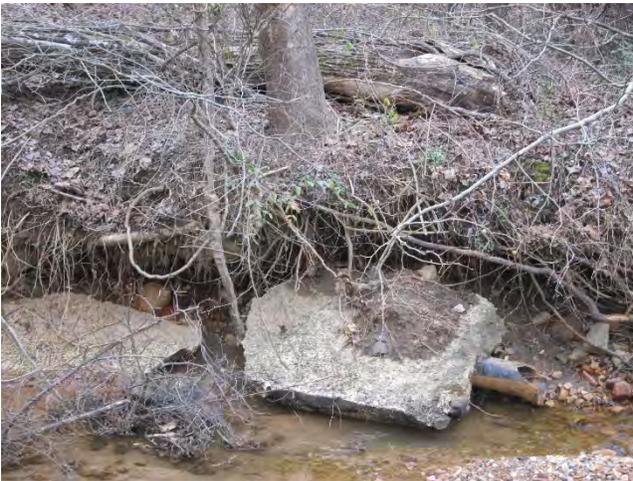
Downstream Left Bank Undercut

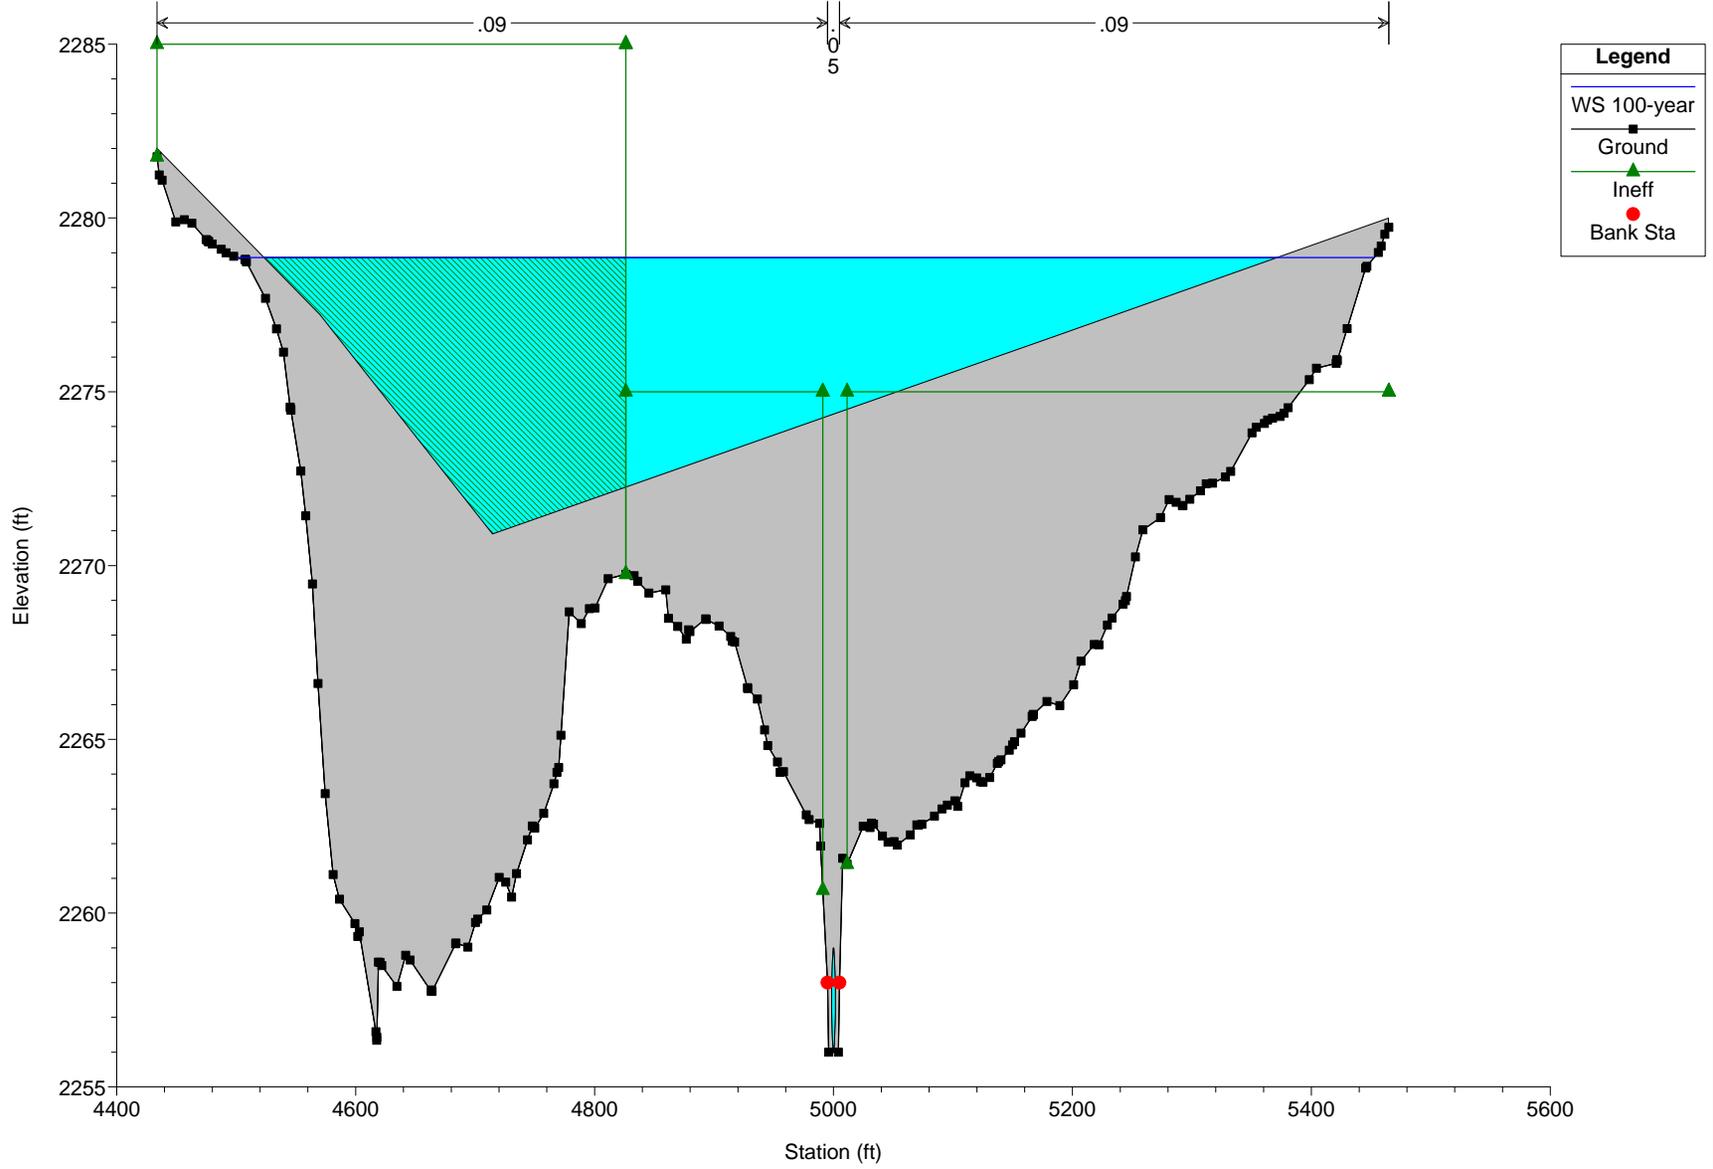
Dingle Creek Limited Detail Study Plan: Floodway Run 2/22/2016

Dingle_Crk_XS47Structure ID: Sweeten Creek US 25Approximate Su

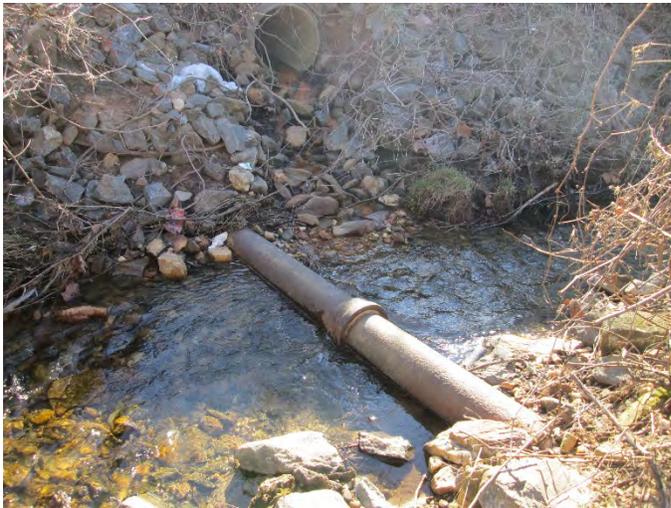
Sewer Line and 24-inch Outfall Upstream

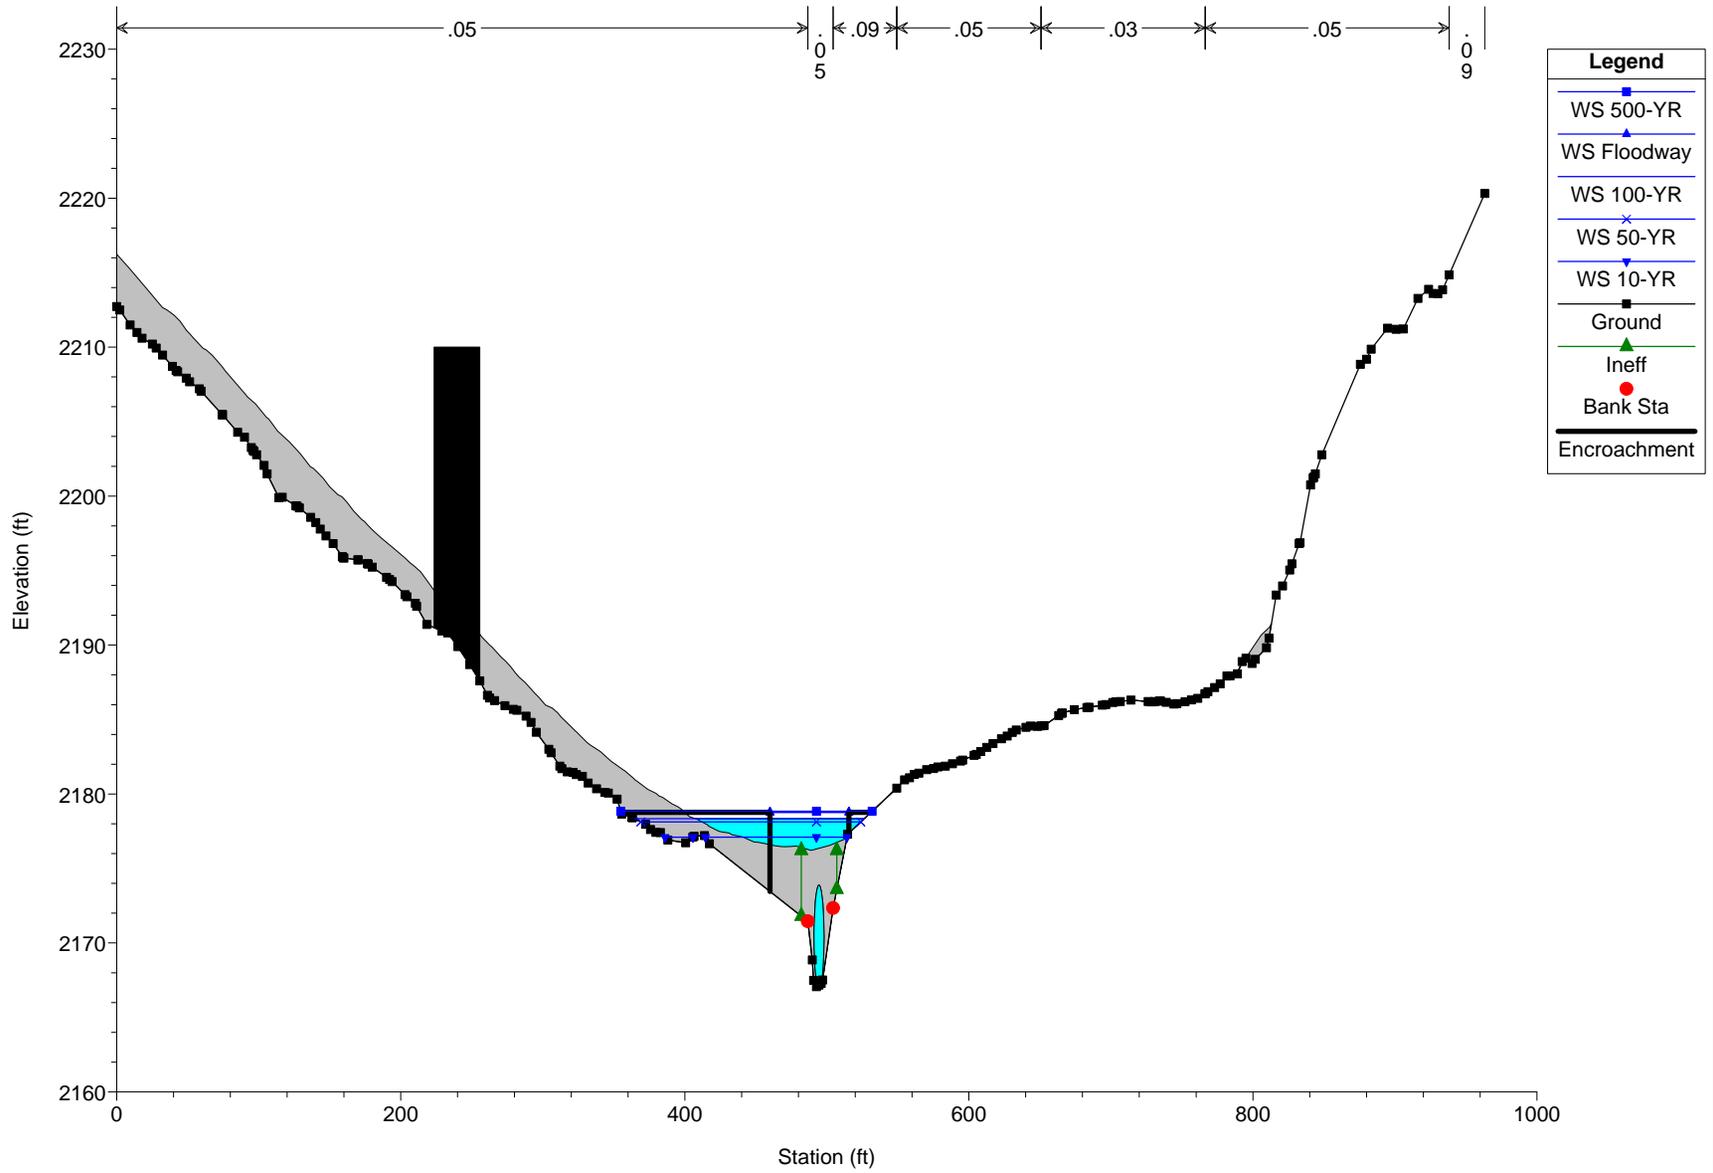
Sweeten Creek - Detailed Study Plan: Detailed 2/23/2016

Rock Hill Road - FBSTR474
