Buncombe County  
Bridge No. 220 on SR 2098 over Reems Creek  
Federal-Aid Project No. BRZ-2098(1)  
State Project 8.2844601  
WBS # 33402.1.1  
TIP Project No. B-4036

CATEGORICAL EXCLUSION  
UNITED STATES DEPARTMENT OF TRANSPORTATION  
FEDERAL HIGHWAY ADMINISTRATION  
AND  
NORTH CAROLINA DEPARTMENT OF TRANSPORTATION  
DIVISION OF HIGHWAYS

Subject: **Clean Water Act Nationwide Permit 13 application** for replacement of Bridge No. 220 on SR 2098 (Herron Cove Road) over Reems Creek, Federal Aid No. BRZ-2098(1), State Project No. 8.2844601, Buncombe County, Division 13, TIP No. B-4036. WBS Element No. 33402.1.1.

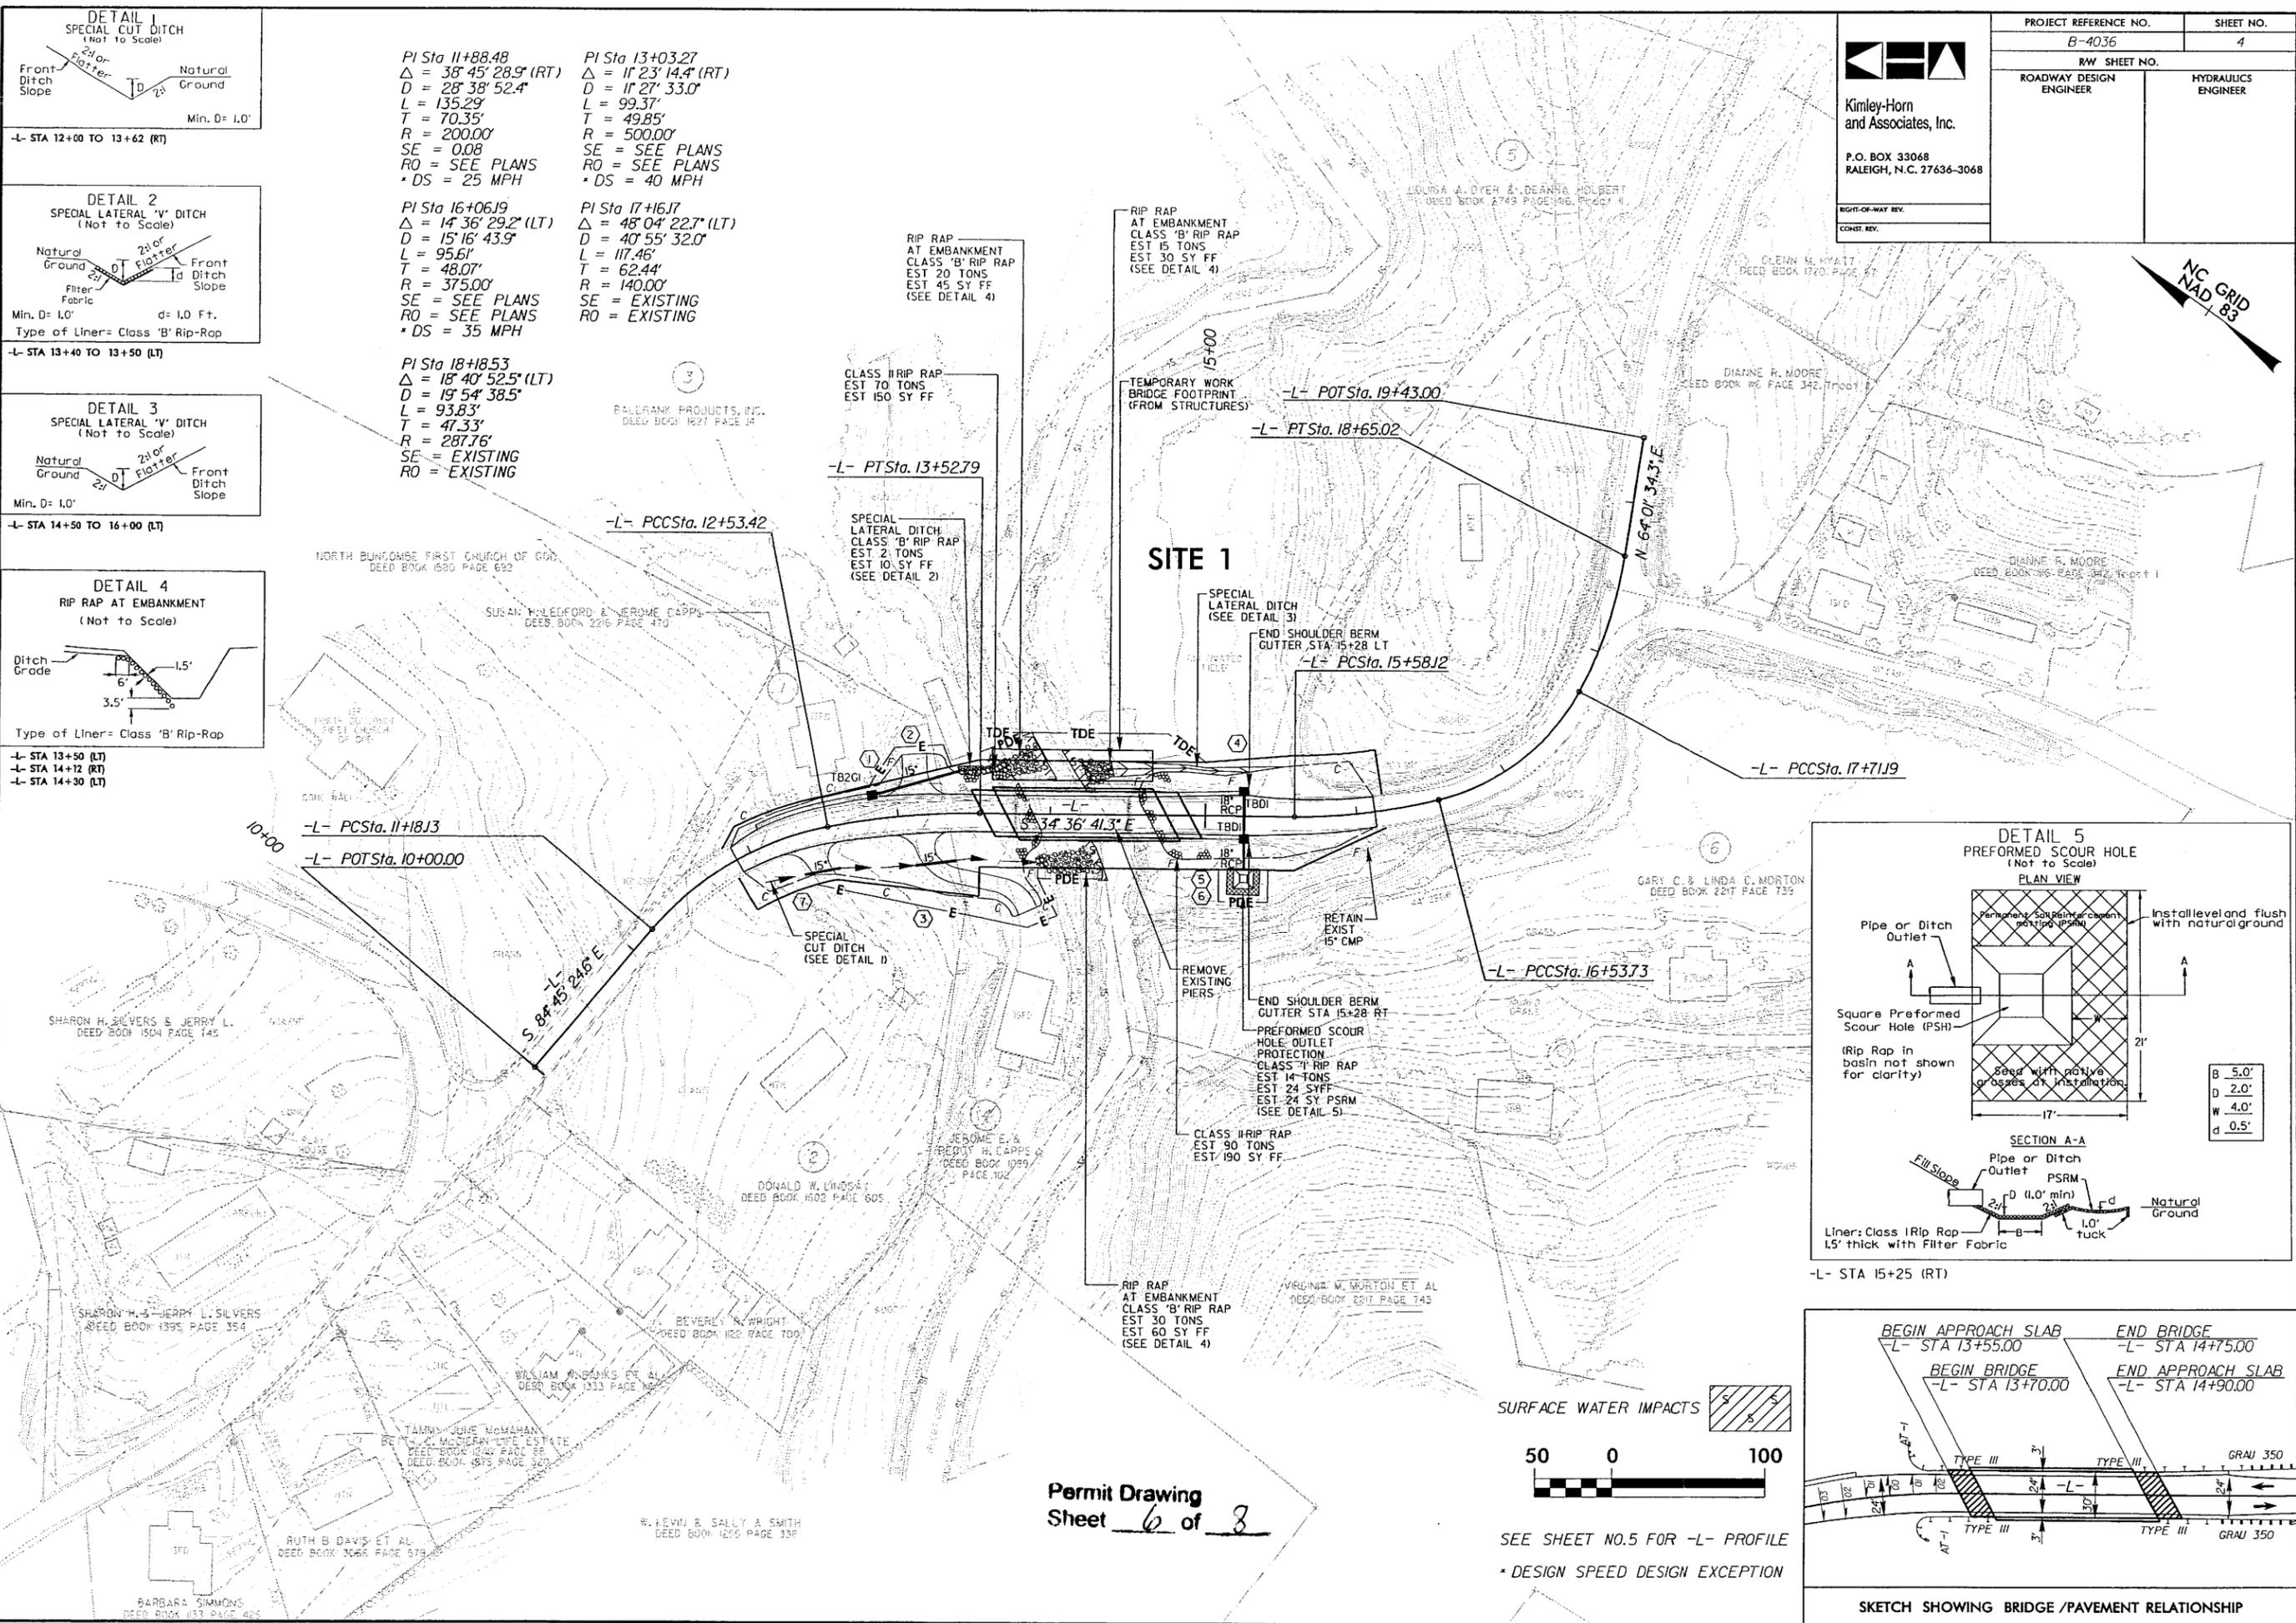
Permit Drawing  
Sheet 6 of 8

PI Sta 17+16.17  
 $\Delta = 48' 04" 22.7" (LT)$   
 $D = 40' 55" 32.0"$   
 $L = 117.46'$   
 $T = 62.44'$   
 $R = 140.00'$   
 $SE = \text{EXISTING}$   
 $RO = \text{EXISTING}$

PI Sta 18+18.53  
 $\Delta = 18' 40" 52.5" (LT)$   
 $D = 19' 54" 38.5"$   
 $L = 93.83'$   
 $T = 47.33'$   
 $R = 287.76'$   
 $SE = \text{EXISTING}$   
 $RO = \text{EXISTING}$

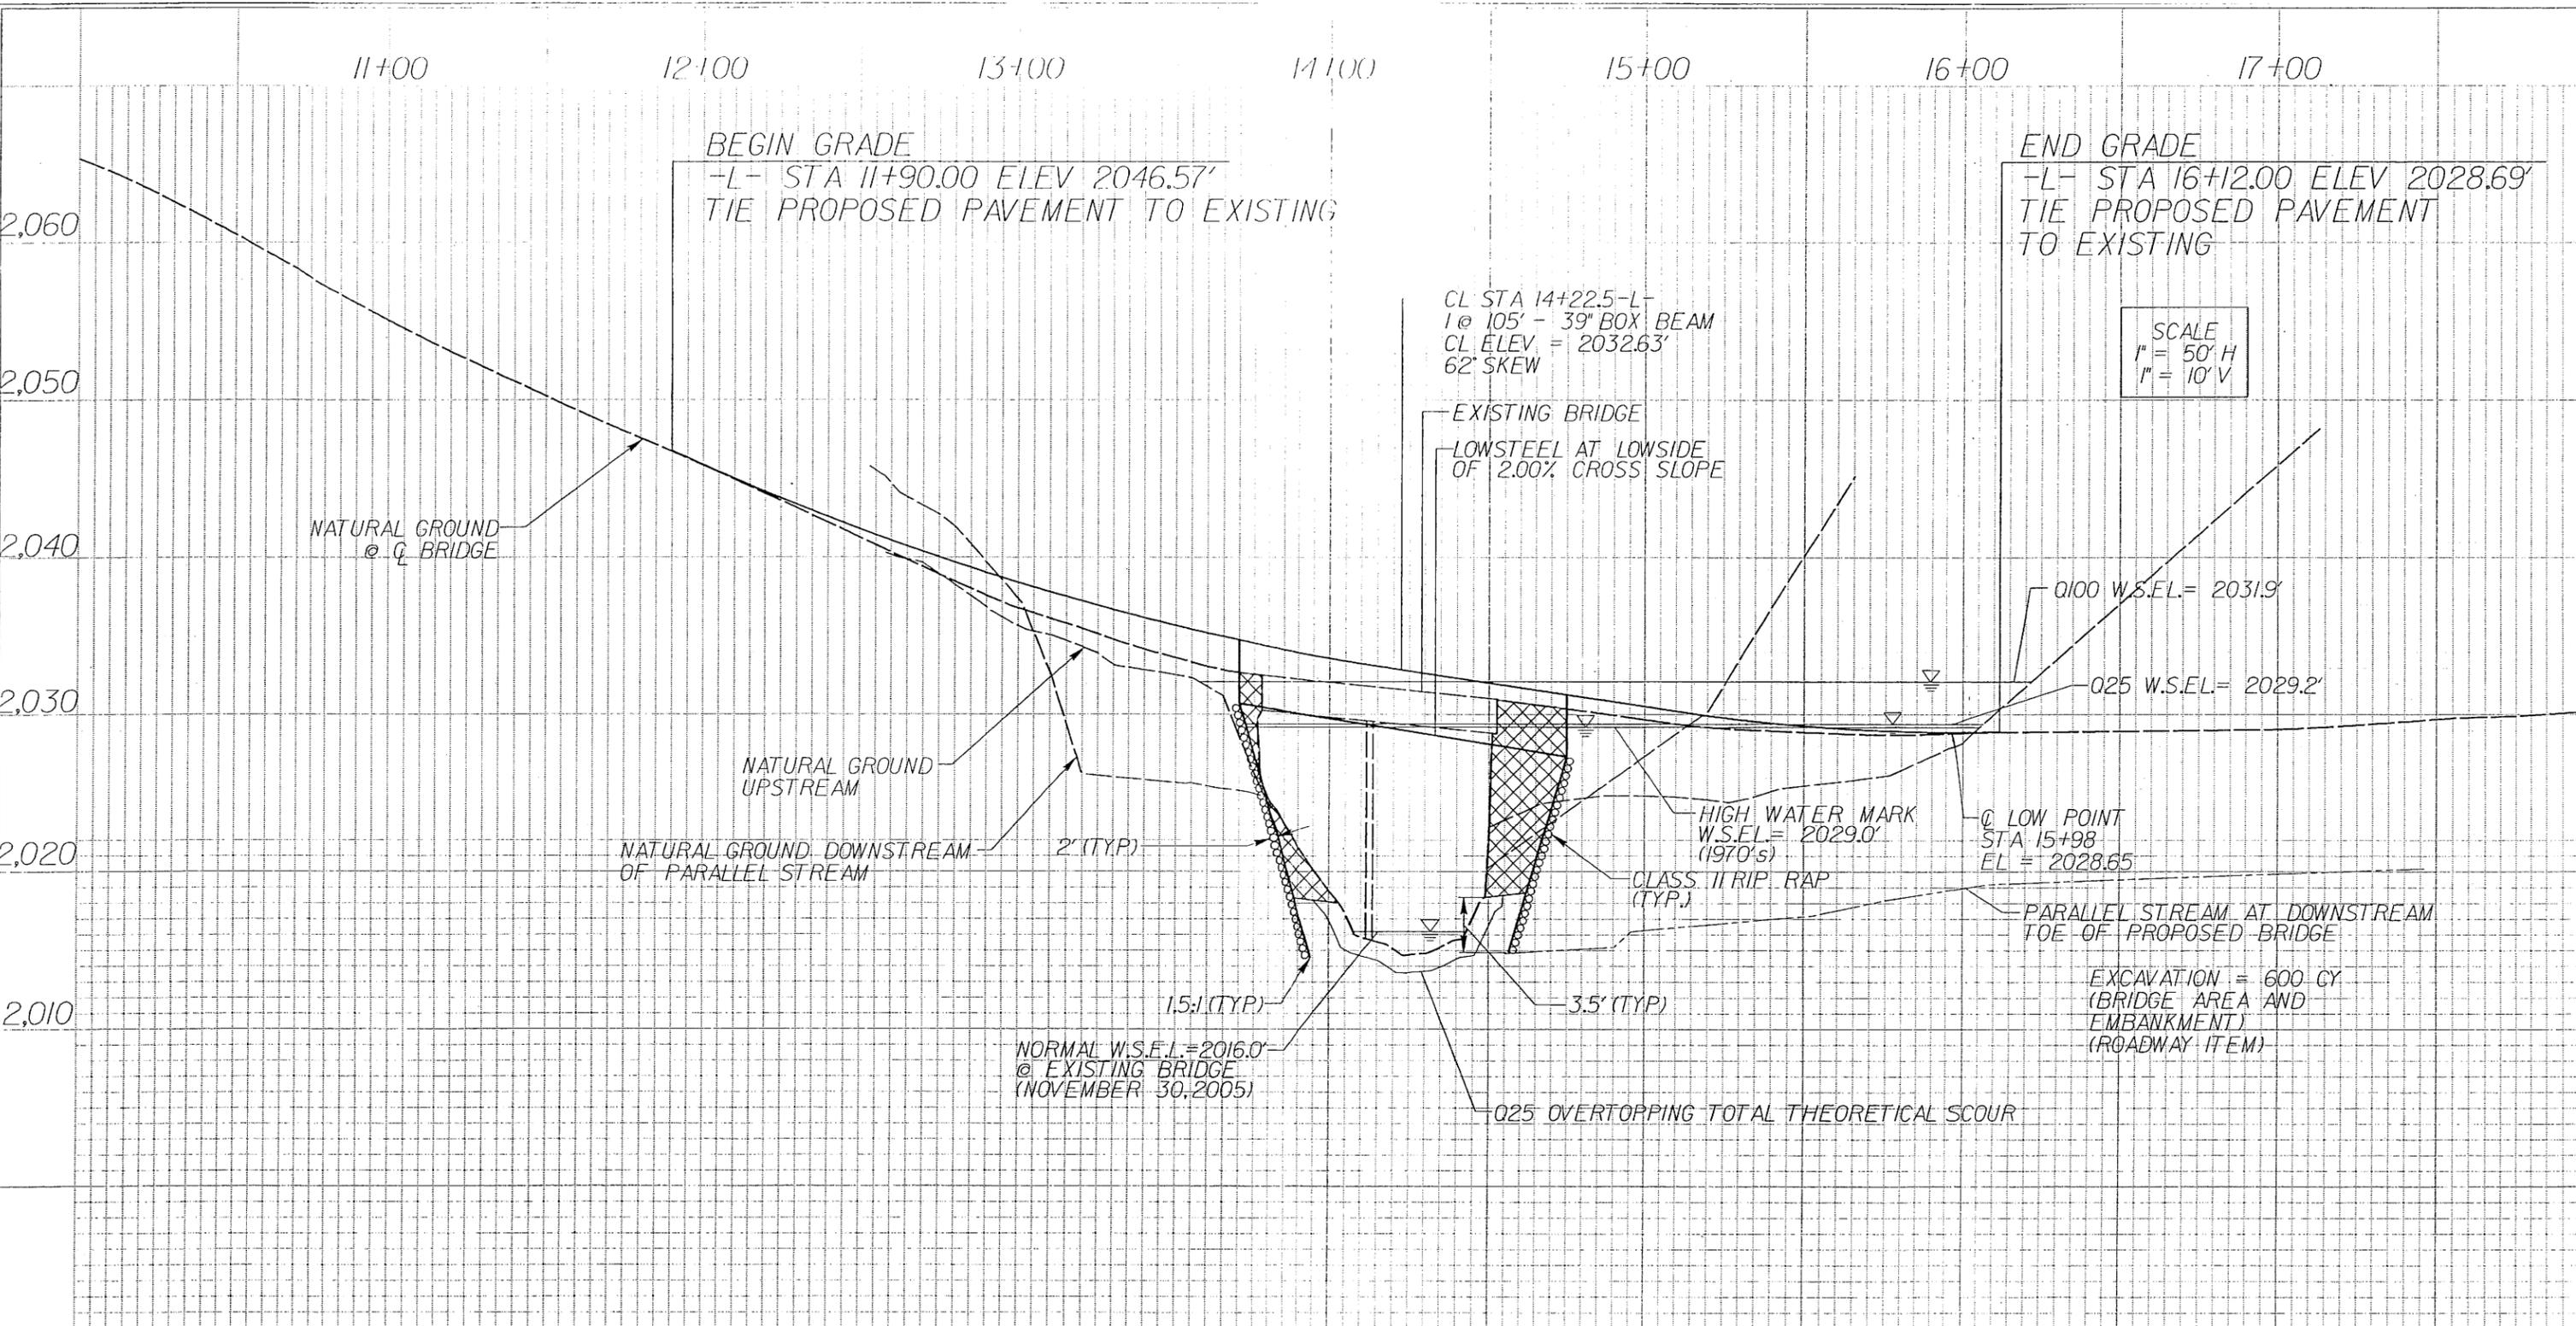
Permit Drawing  
 Sheet 7 of 8

**WETLAND PERMIT DRAWING**  
**BSR PROFILE**  
**B-4036**

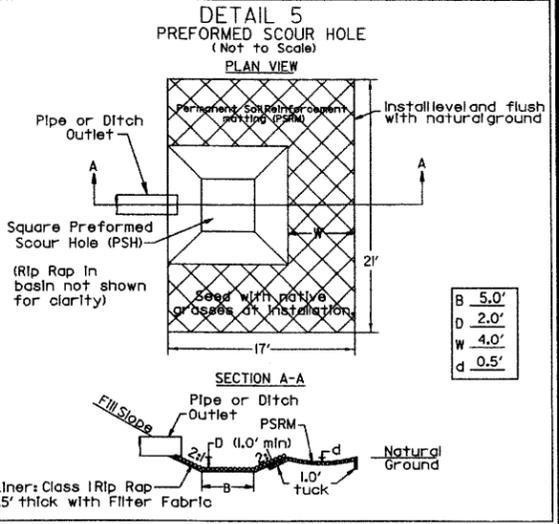
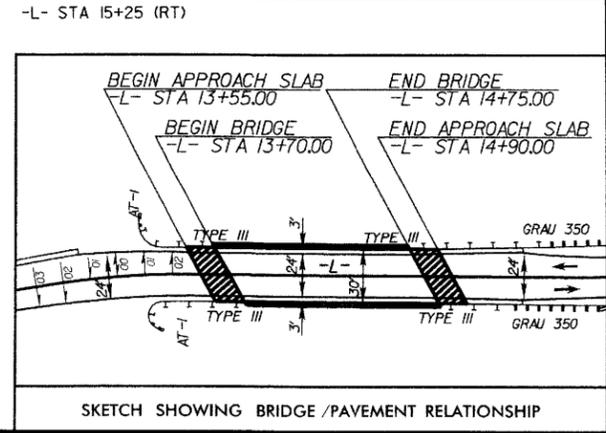
PREFORMED SCOUR HOLE OUTLET PROTECTION CLASS 'A' RIP RAP EST 14 TONS EST 24 SY PSRM (SEE DETAIL 5)

SKETCH SHOWING BRIDGE / PAVEMENT RELATIONSHIP

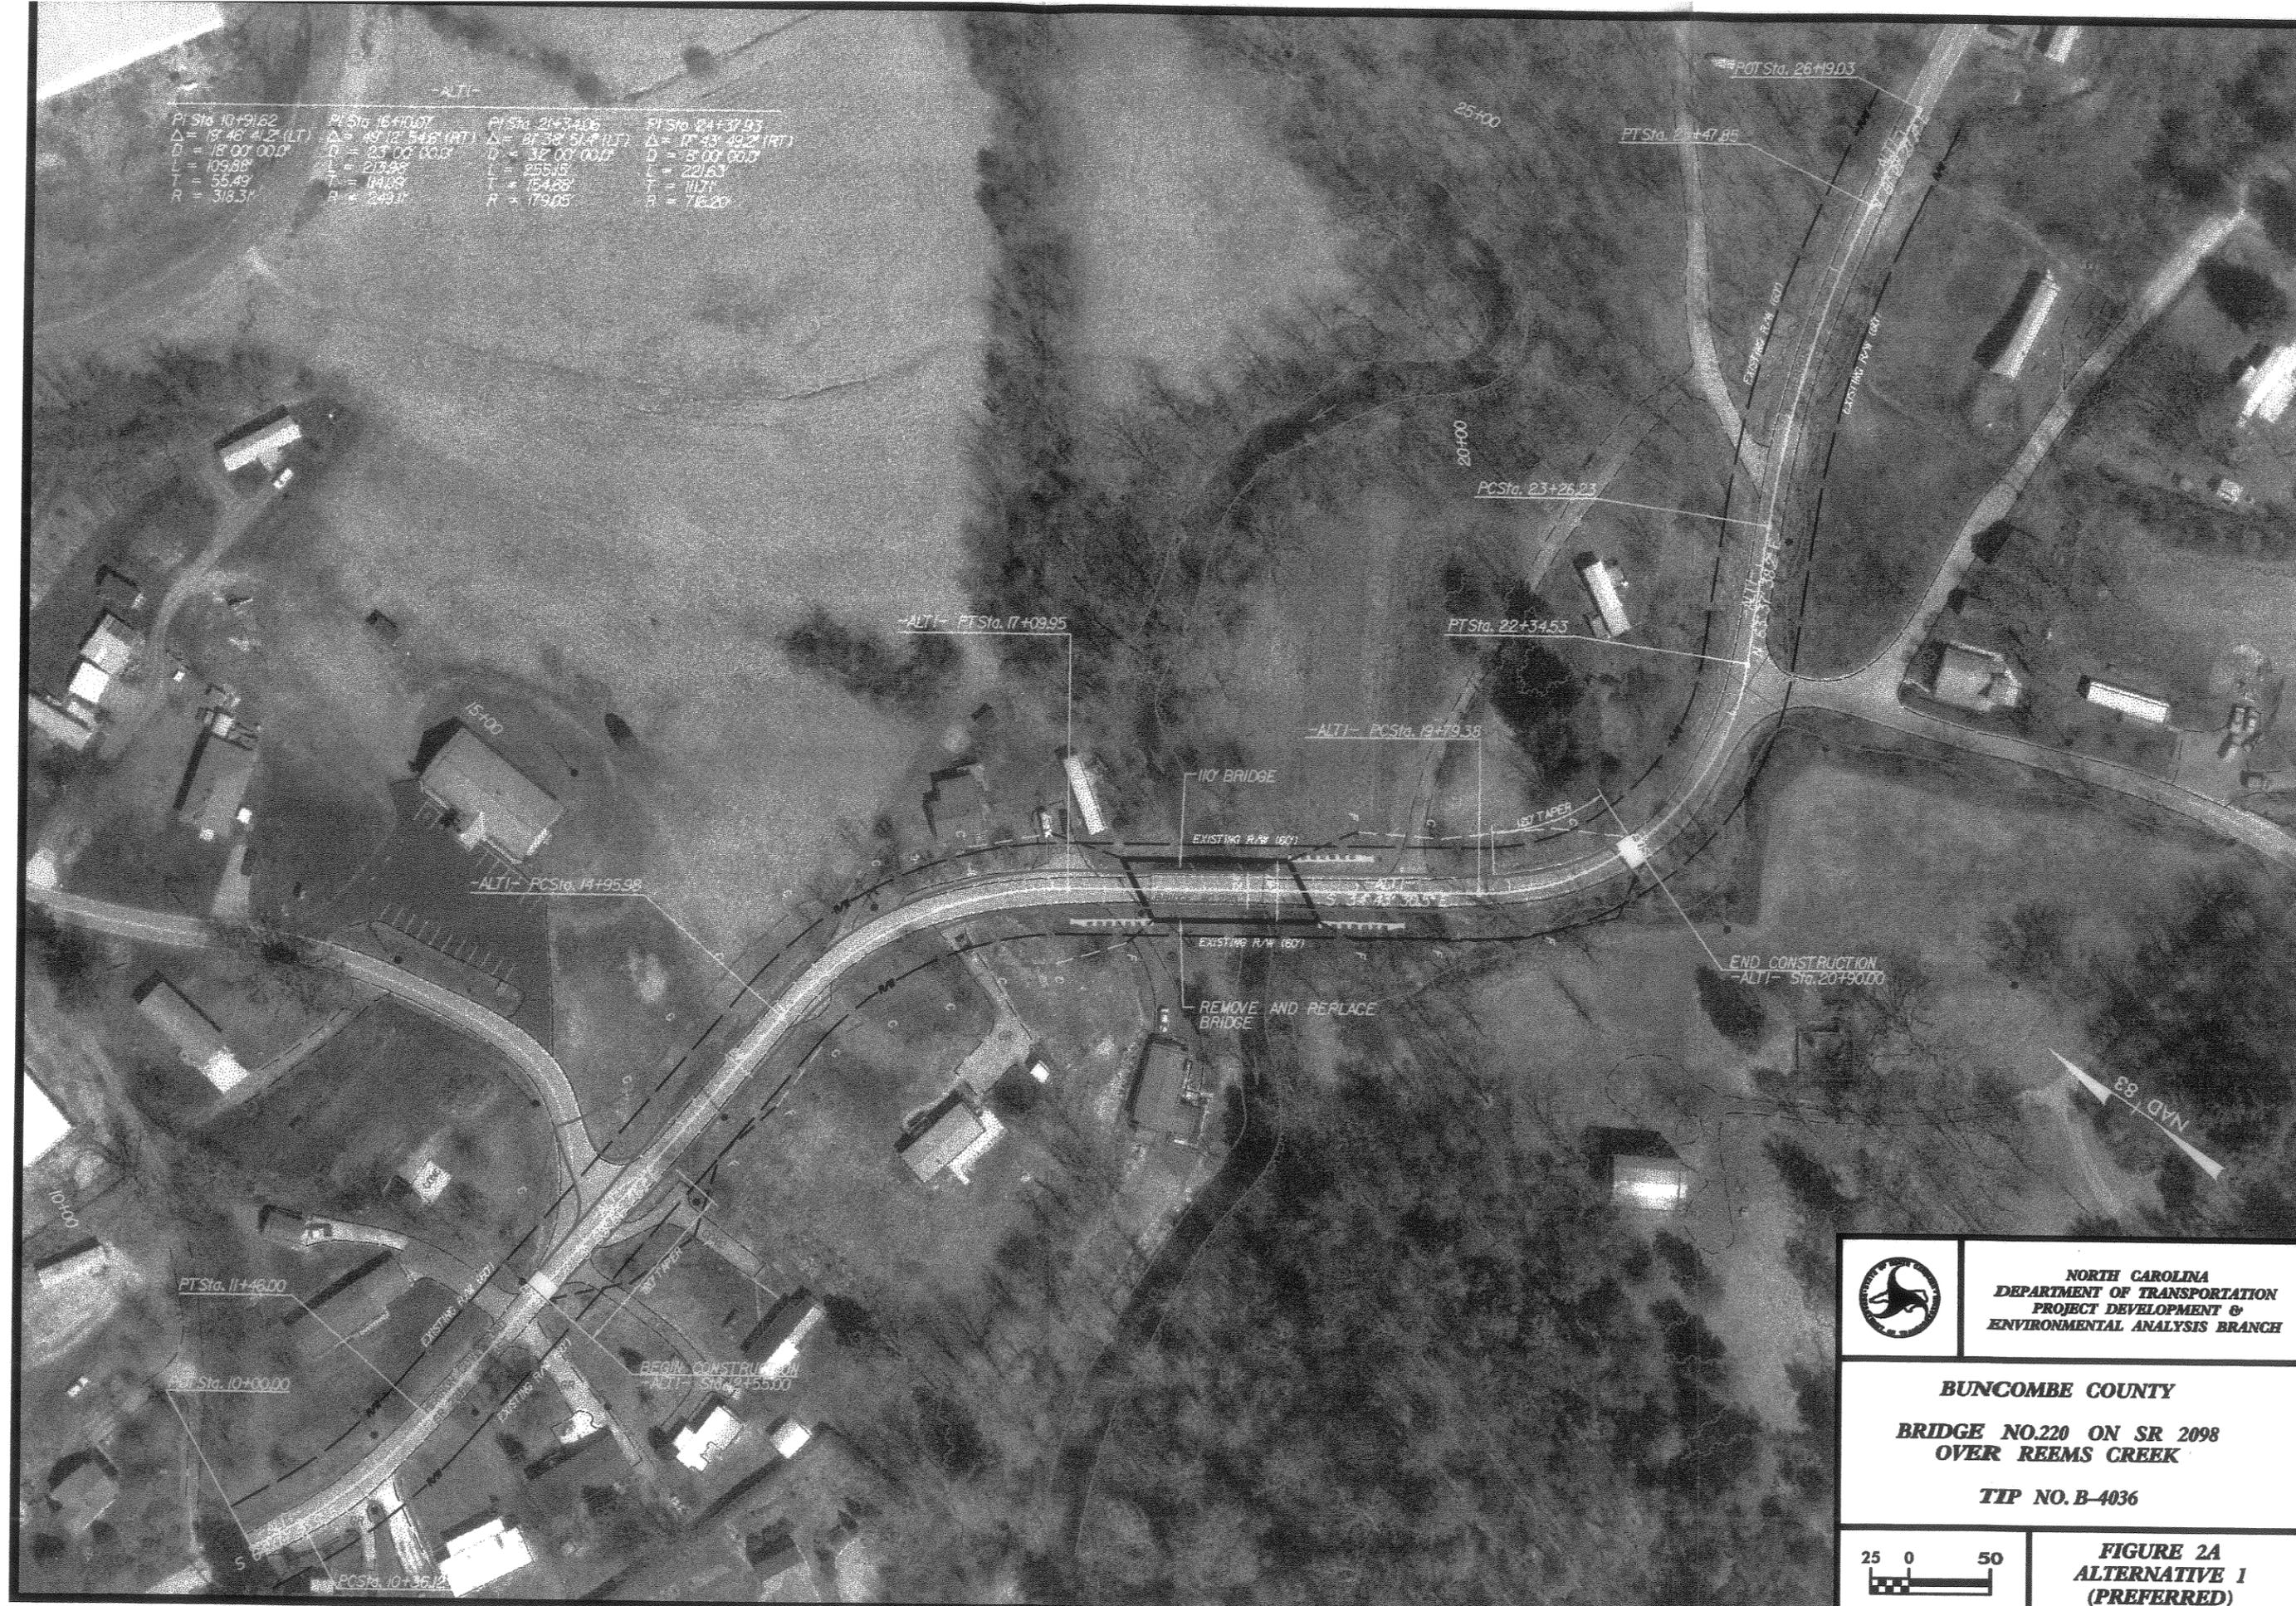
<p>NORTH CAROLINA DEPARTMENT OF TRANSPORTATION PROJECT DEVELOPMENT &amp; ENVIRONMENTAL ANALYSIS BRANCH</p>
<p>BUNCOMBE COUNTY BRIDGE NO.220 ON SR 2098 OVER REEMS CREEK TIP NO. B-4036</p>	
	<p>FIGURE 2A ALTERNATIVE 1 (PREFERRED)</p>

-ALTI-			
PI Sta 10+91.62	PI Sta 15+10.07	PI Sta 21+34.06	PI Sta 24+37.93
$\Delta = 18' 46" 41.2$ (LT)	$\Delta = 45' 12" 54.8$ (RT)	$\Delta = 87' 38" 51.2$ (LT)	$\Delta = 0' 43" 42.2$ (RT)
$D = 18' 00" 00.0$	$D = 23' 00" 00.0$	$D = 32' 00" 00.0$	$D = 18' 00" 00.0$
$L = 109.88'$	$L = 27.88'$	$L = 255.15'$	$L = 20.63'$
$T = 55.43'$	$T = 14.09'$	$T = 154.88'$	$T = 11.71'$
$R = 318.31'$	$R = 24.91'$	$R = 179.03'$	$R = 76.20'$

**Alternative 1** (Preferred – Figure 2A) replaces the existing bridge in-place while maintaining traffic with an off-site detour. In Alternative 1, the bridge is replaced with roadway improvements at the existing location. The detour route includes SR 2094 (Stoney Knob Road) to the south and SR 1003 (Reems Creek Road) to

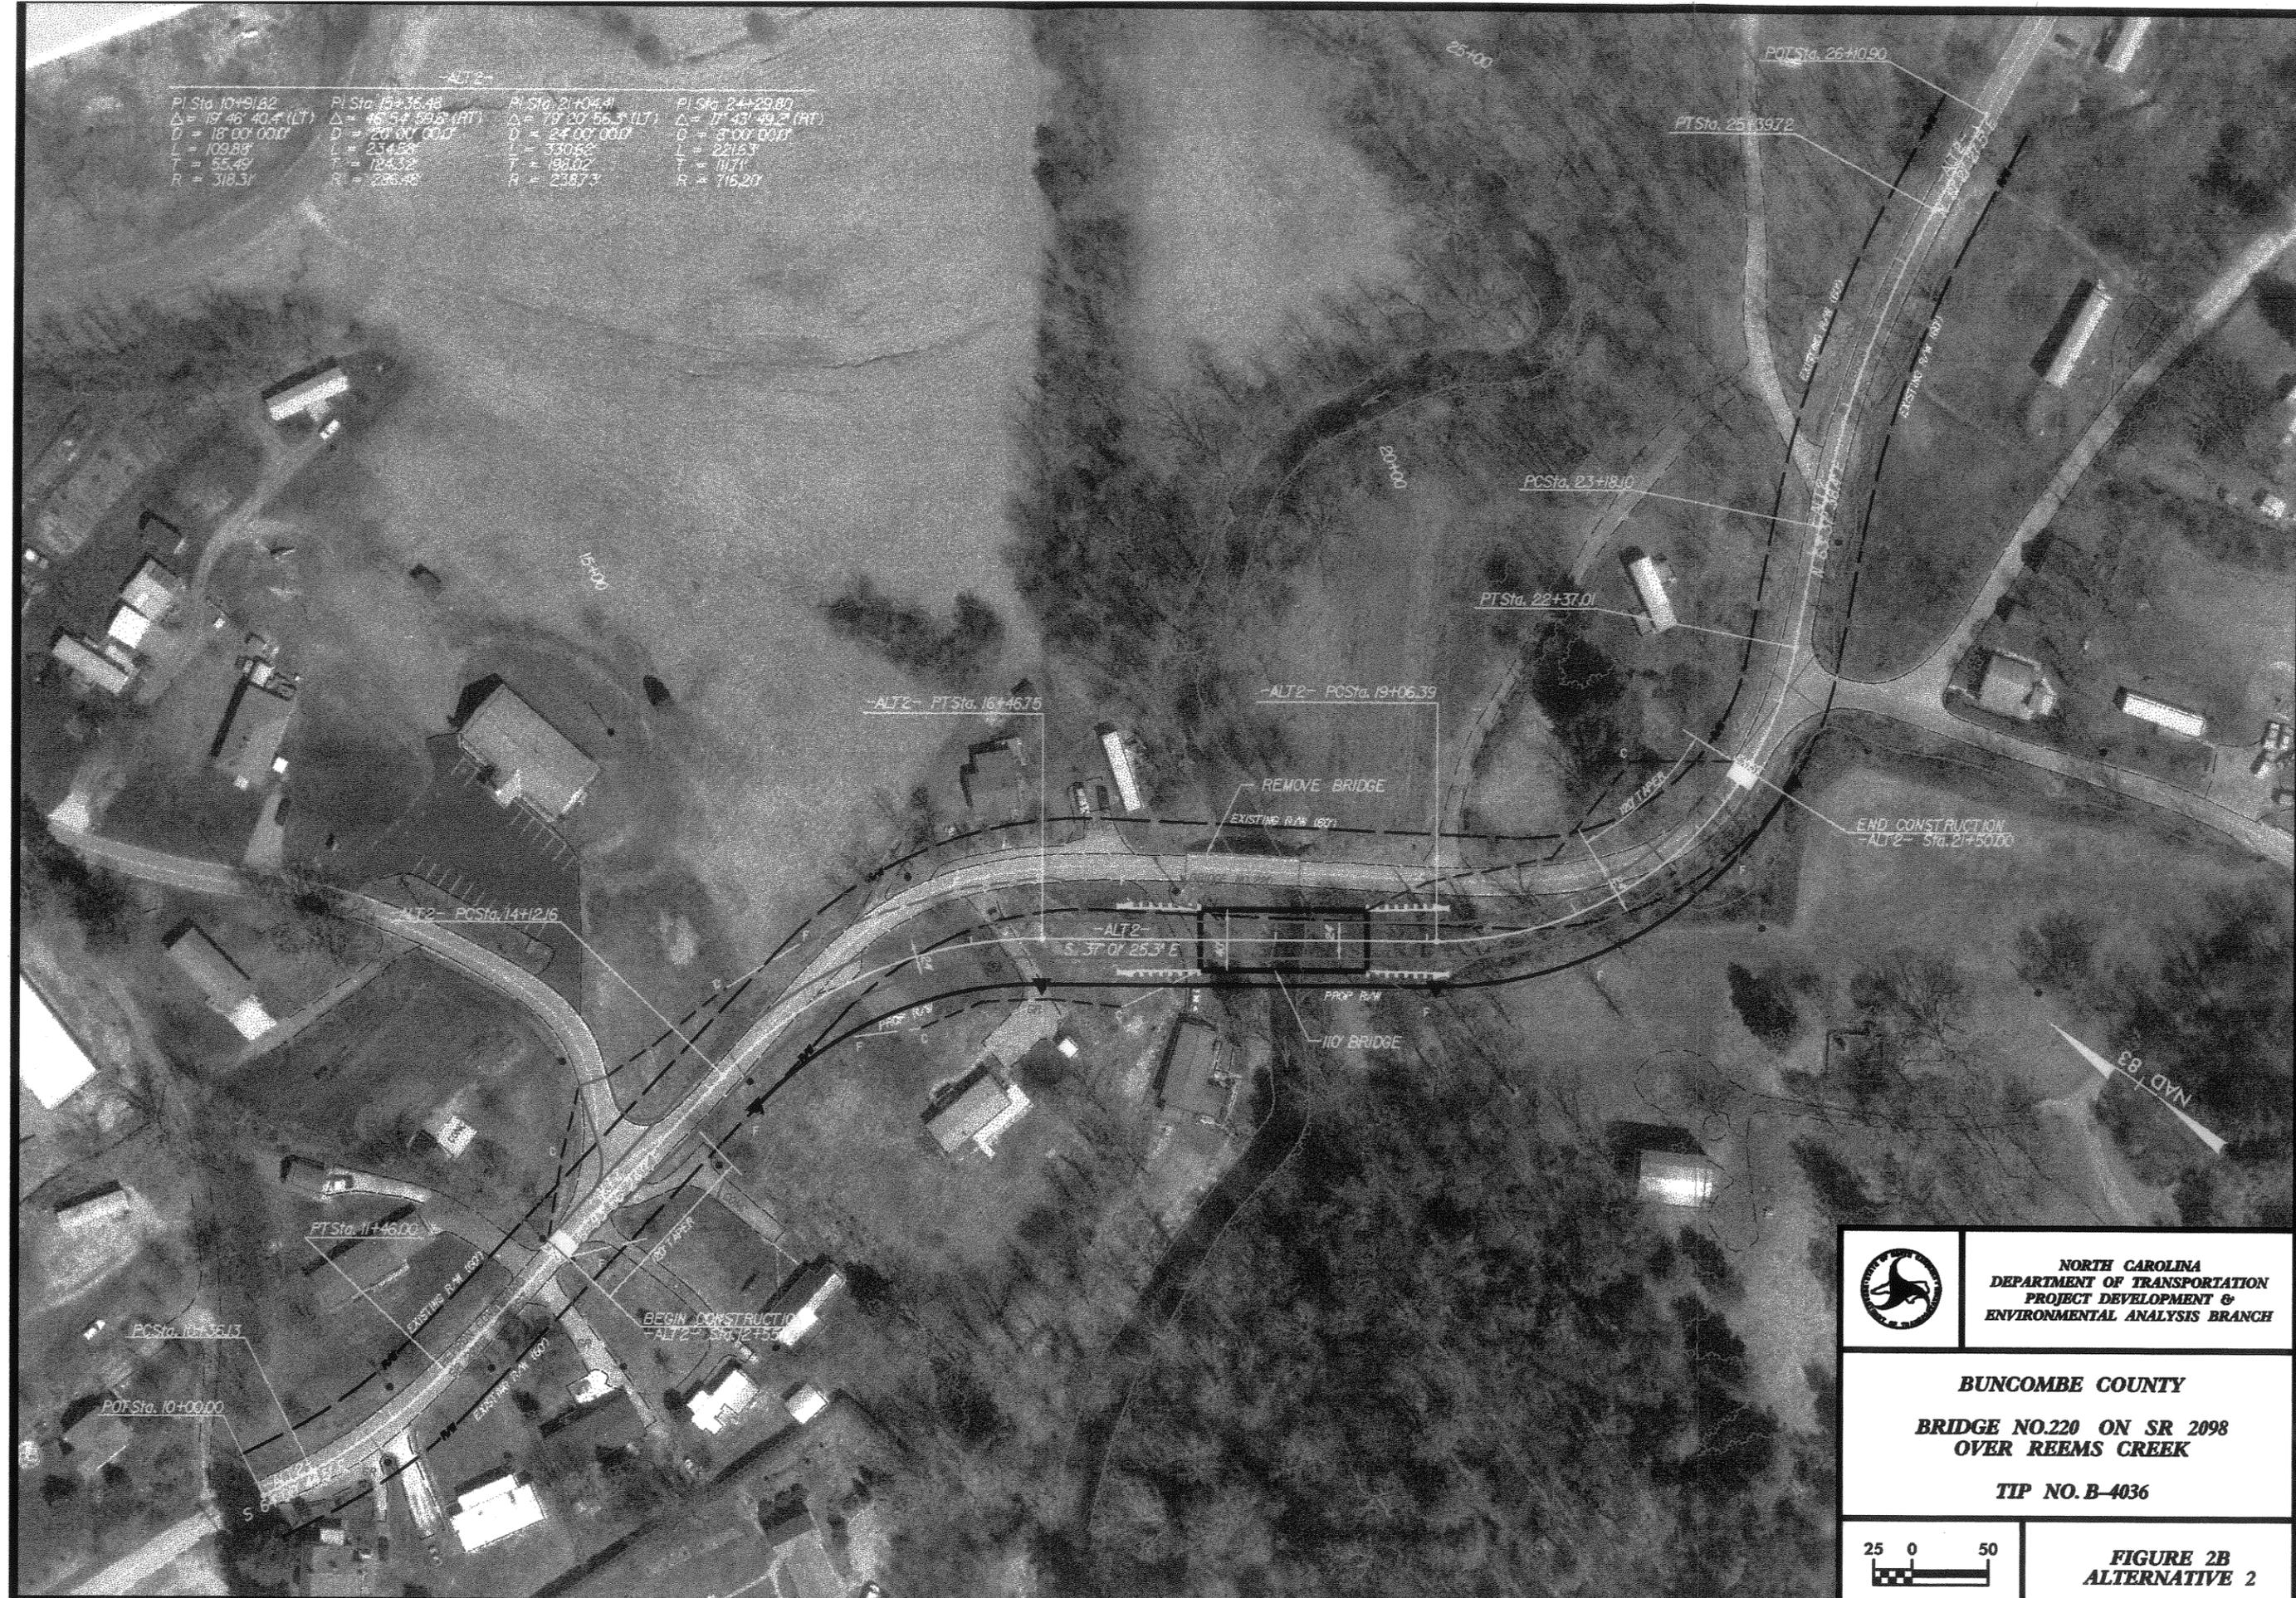
**FIGURE 2B**  
**ALTERNATIVE 2**

-ALT 2-			
PI Sta. 10+91.82	PI Sta. 15+36.48	PI Sta. 21+04.41	PI Sta. 24+29.80
$\Delta = 19^{\circ} 46' 40.4" (LT)$	$\Delta = 46^{\circ} 34' 59.2" (RT)$	$\Delta = 79^{\circ} 20' 56.3" (LT)$	$\Delta = 17^{\circ} 43' 49.2" (RT)$
$D = 18^{\circ} 00' 00.0"$	$D = 20^{\circ} 00' 00.0"$	$D = 24^{\circ} 00' 00.0"$	$D = 3^{\circ} 00' 00.0"$
$L = 109.83'$	$L = 234.58'$	$L = 330.62'$	$L = 221.63'$
$T = 55.43'$	$T = 124.32'$	$T = 193.02'$	$T = 11.71'$
$R = 318.31'$	$R = 286.46'$	$R = 238.73'$	$R = 716.20'$

**Alternative 2** (Figure 2B) replaces the existing bridge on new alignment 45 feet downstream of the existing bridge while maintaining traffic on the existing bridge during construction. Alternative 2 was not selected as the preferred because it is not cost-effective and increases impacts to adjacent properties.

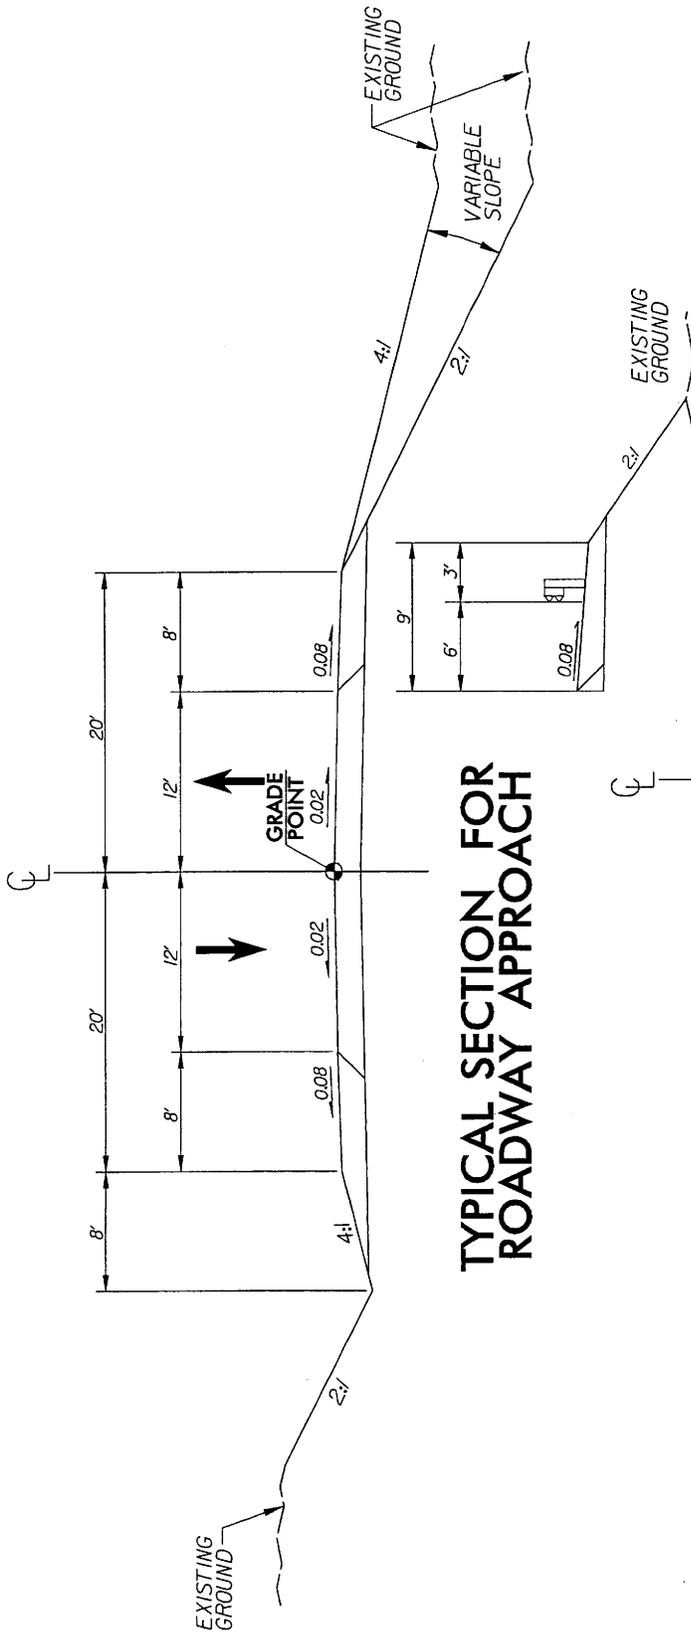
**FIGURE 3**

**TYPICAL SECTION FOR ROADWAY APPROACH**

The proposed replacement structure for Bridge No. 220 is a three-span sloping abutment bridge. It is anticipated that the bridge length will be approximately 110 feet. The final bridge length and type will be determined during final design. The proposed bridge will consist of two 12-foot travel lanes with eight-foot shoulders.

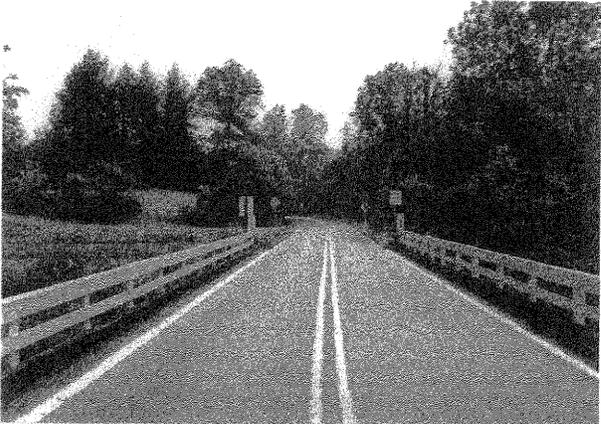
Looking Southeast on Bridge No. 220  
from the Northwest Side of SR 2098

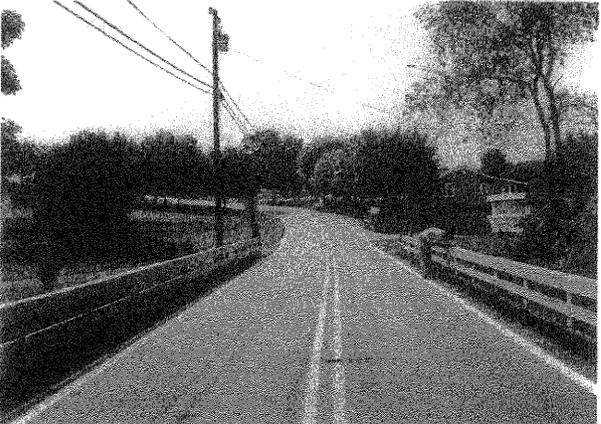
Looking Northwest on Bridge No. 220  
from the Southeast Side of SR 2098

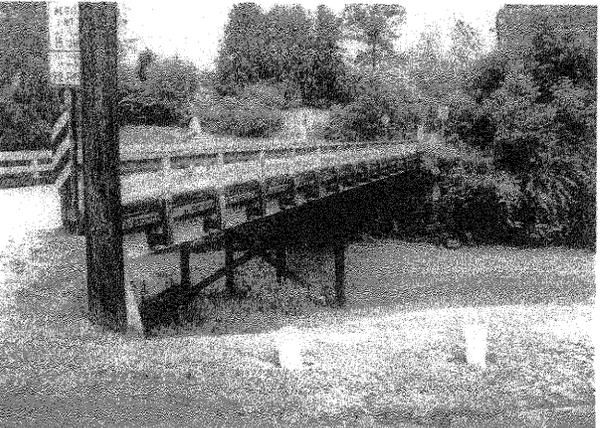
Looking East toward Bridge No. 220  
from the West Side
