Buncombe County
Bridge No. 262 on SR 4352 over South Hominy Creek
Federal-Aid Project No. BRZ-3452(1)
State Project 8.2844701
WBS # 33403.1.1
TIP Project No. B-4037

CATEGORICAL EXCLUSION

February 2005

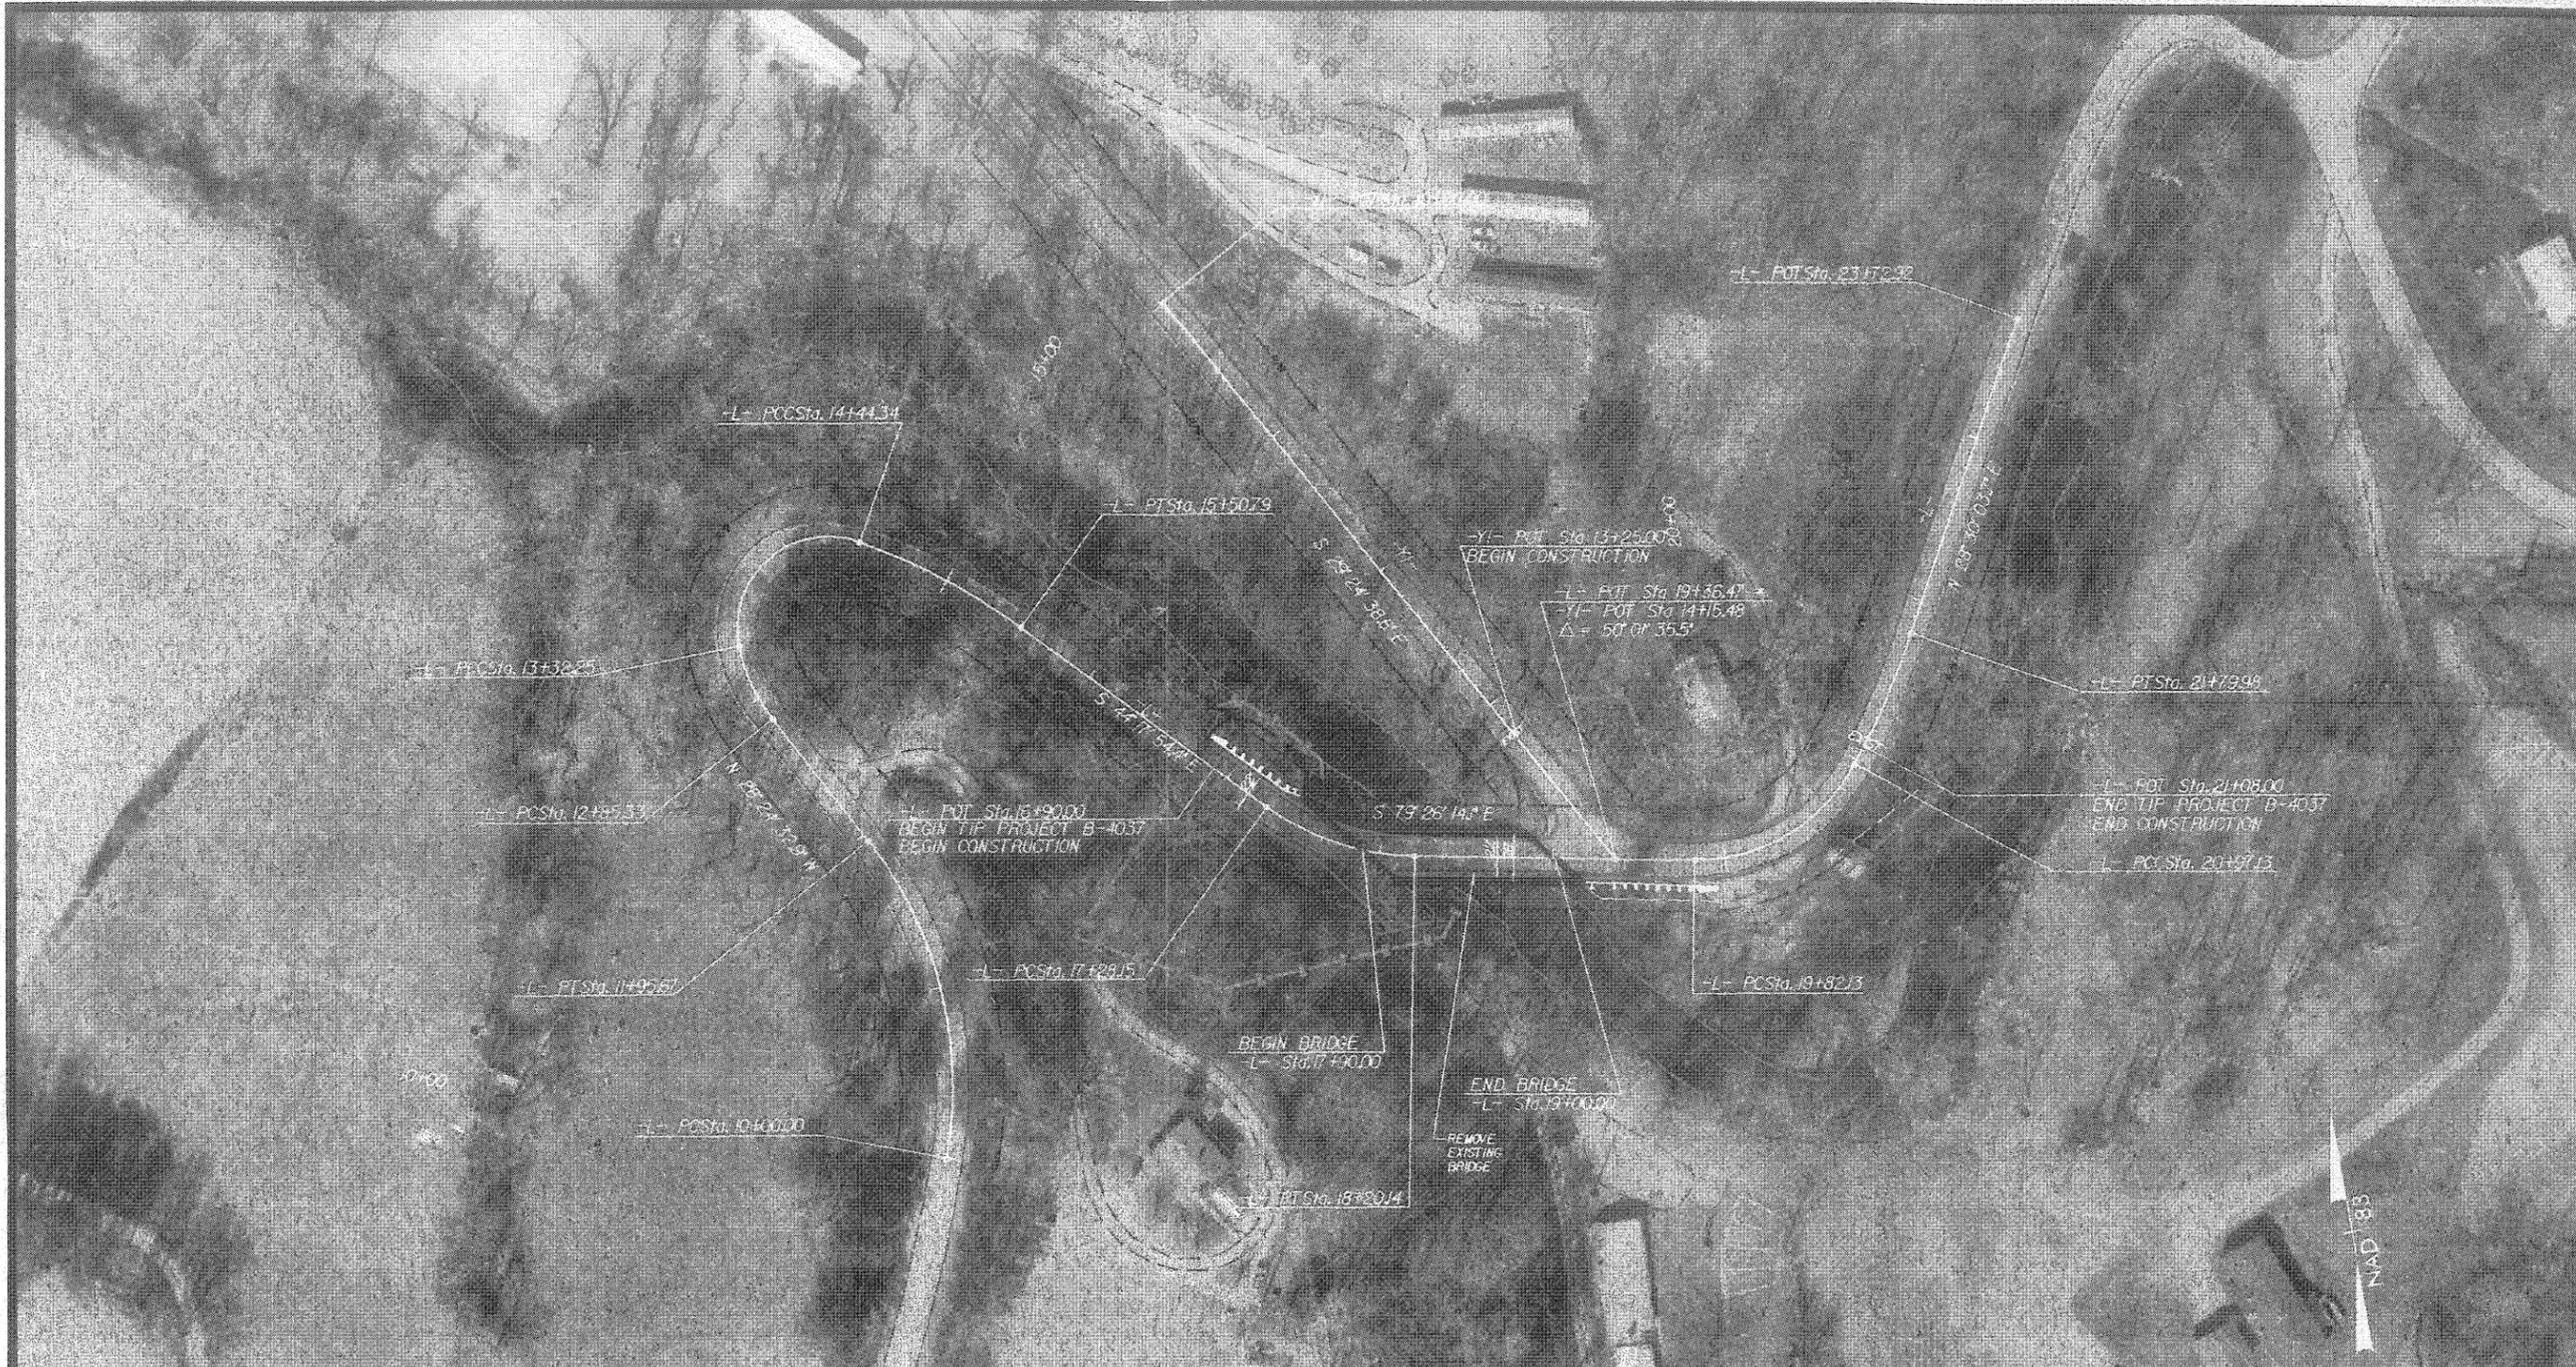
**FIGURE 2A
ALTERNATIVE 1**

Alternative 1 (Figure 2A) replaces the structure at its existing location. During construction, traffic will be re-routed to an off-site detour. The detour route includes SR 3454 (Lower Glady Fork Road) to the north and the south end of SR

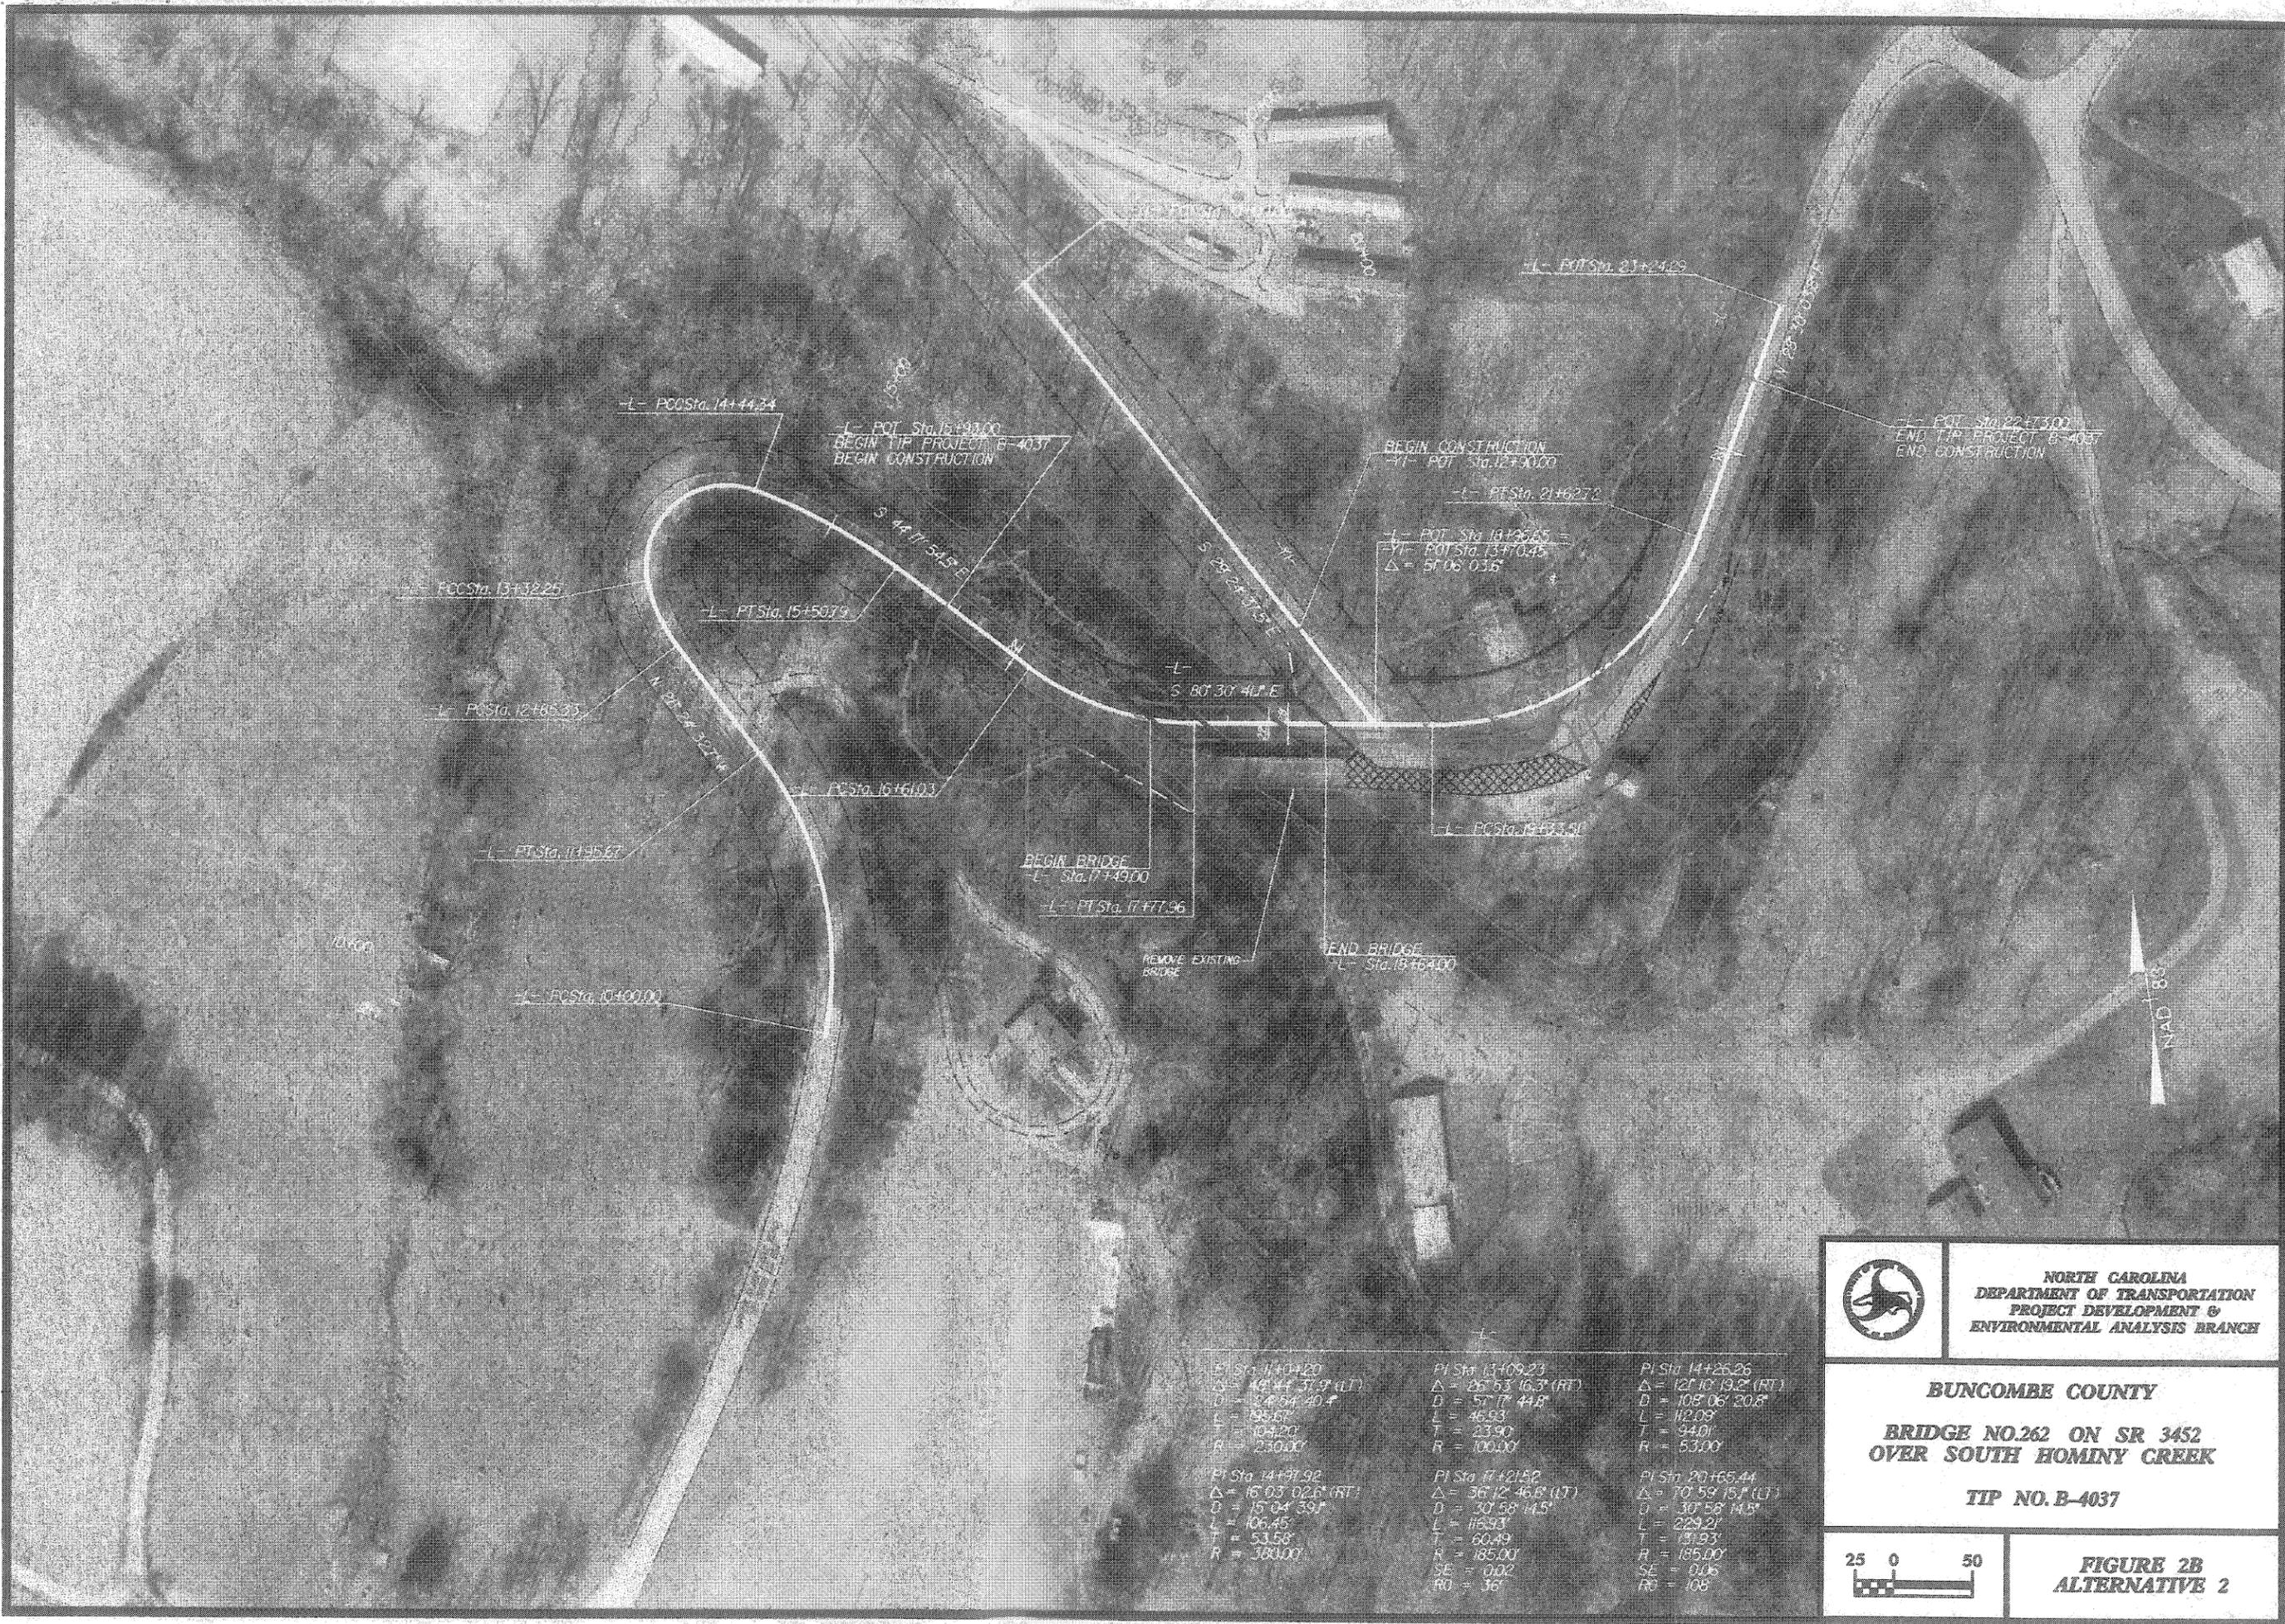
**FIGURE 2B
ALTERNATIVE 2**

Alternative 2 (Figure 2B) replaces the existing structure on new alignment 35 feet upstream of the existing bridge. During construction, traffic will be maintained on the existing structure. It is anticipated that the bridge length will be approximately 115 feet. The final bridge length will be determined during final design. Alternative 2 was not selected as the preferred because it is not cost-effective and does not address the safety concerns of the local residents.

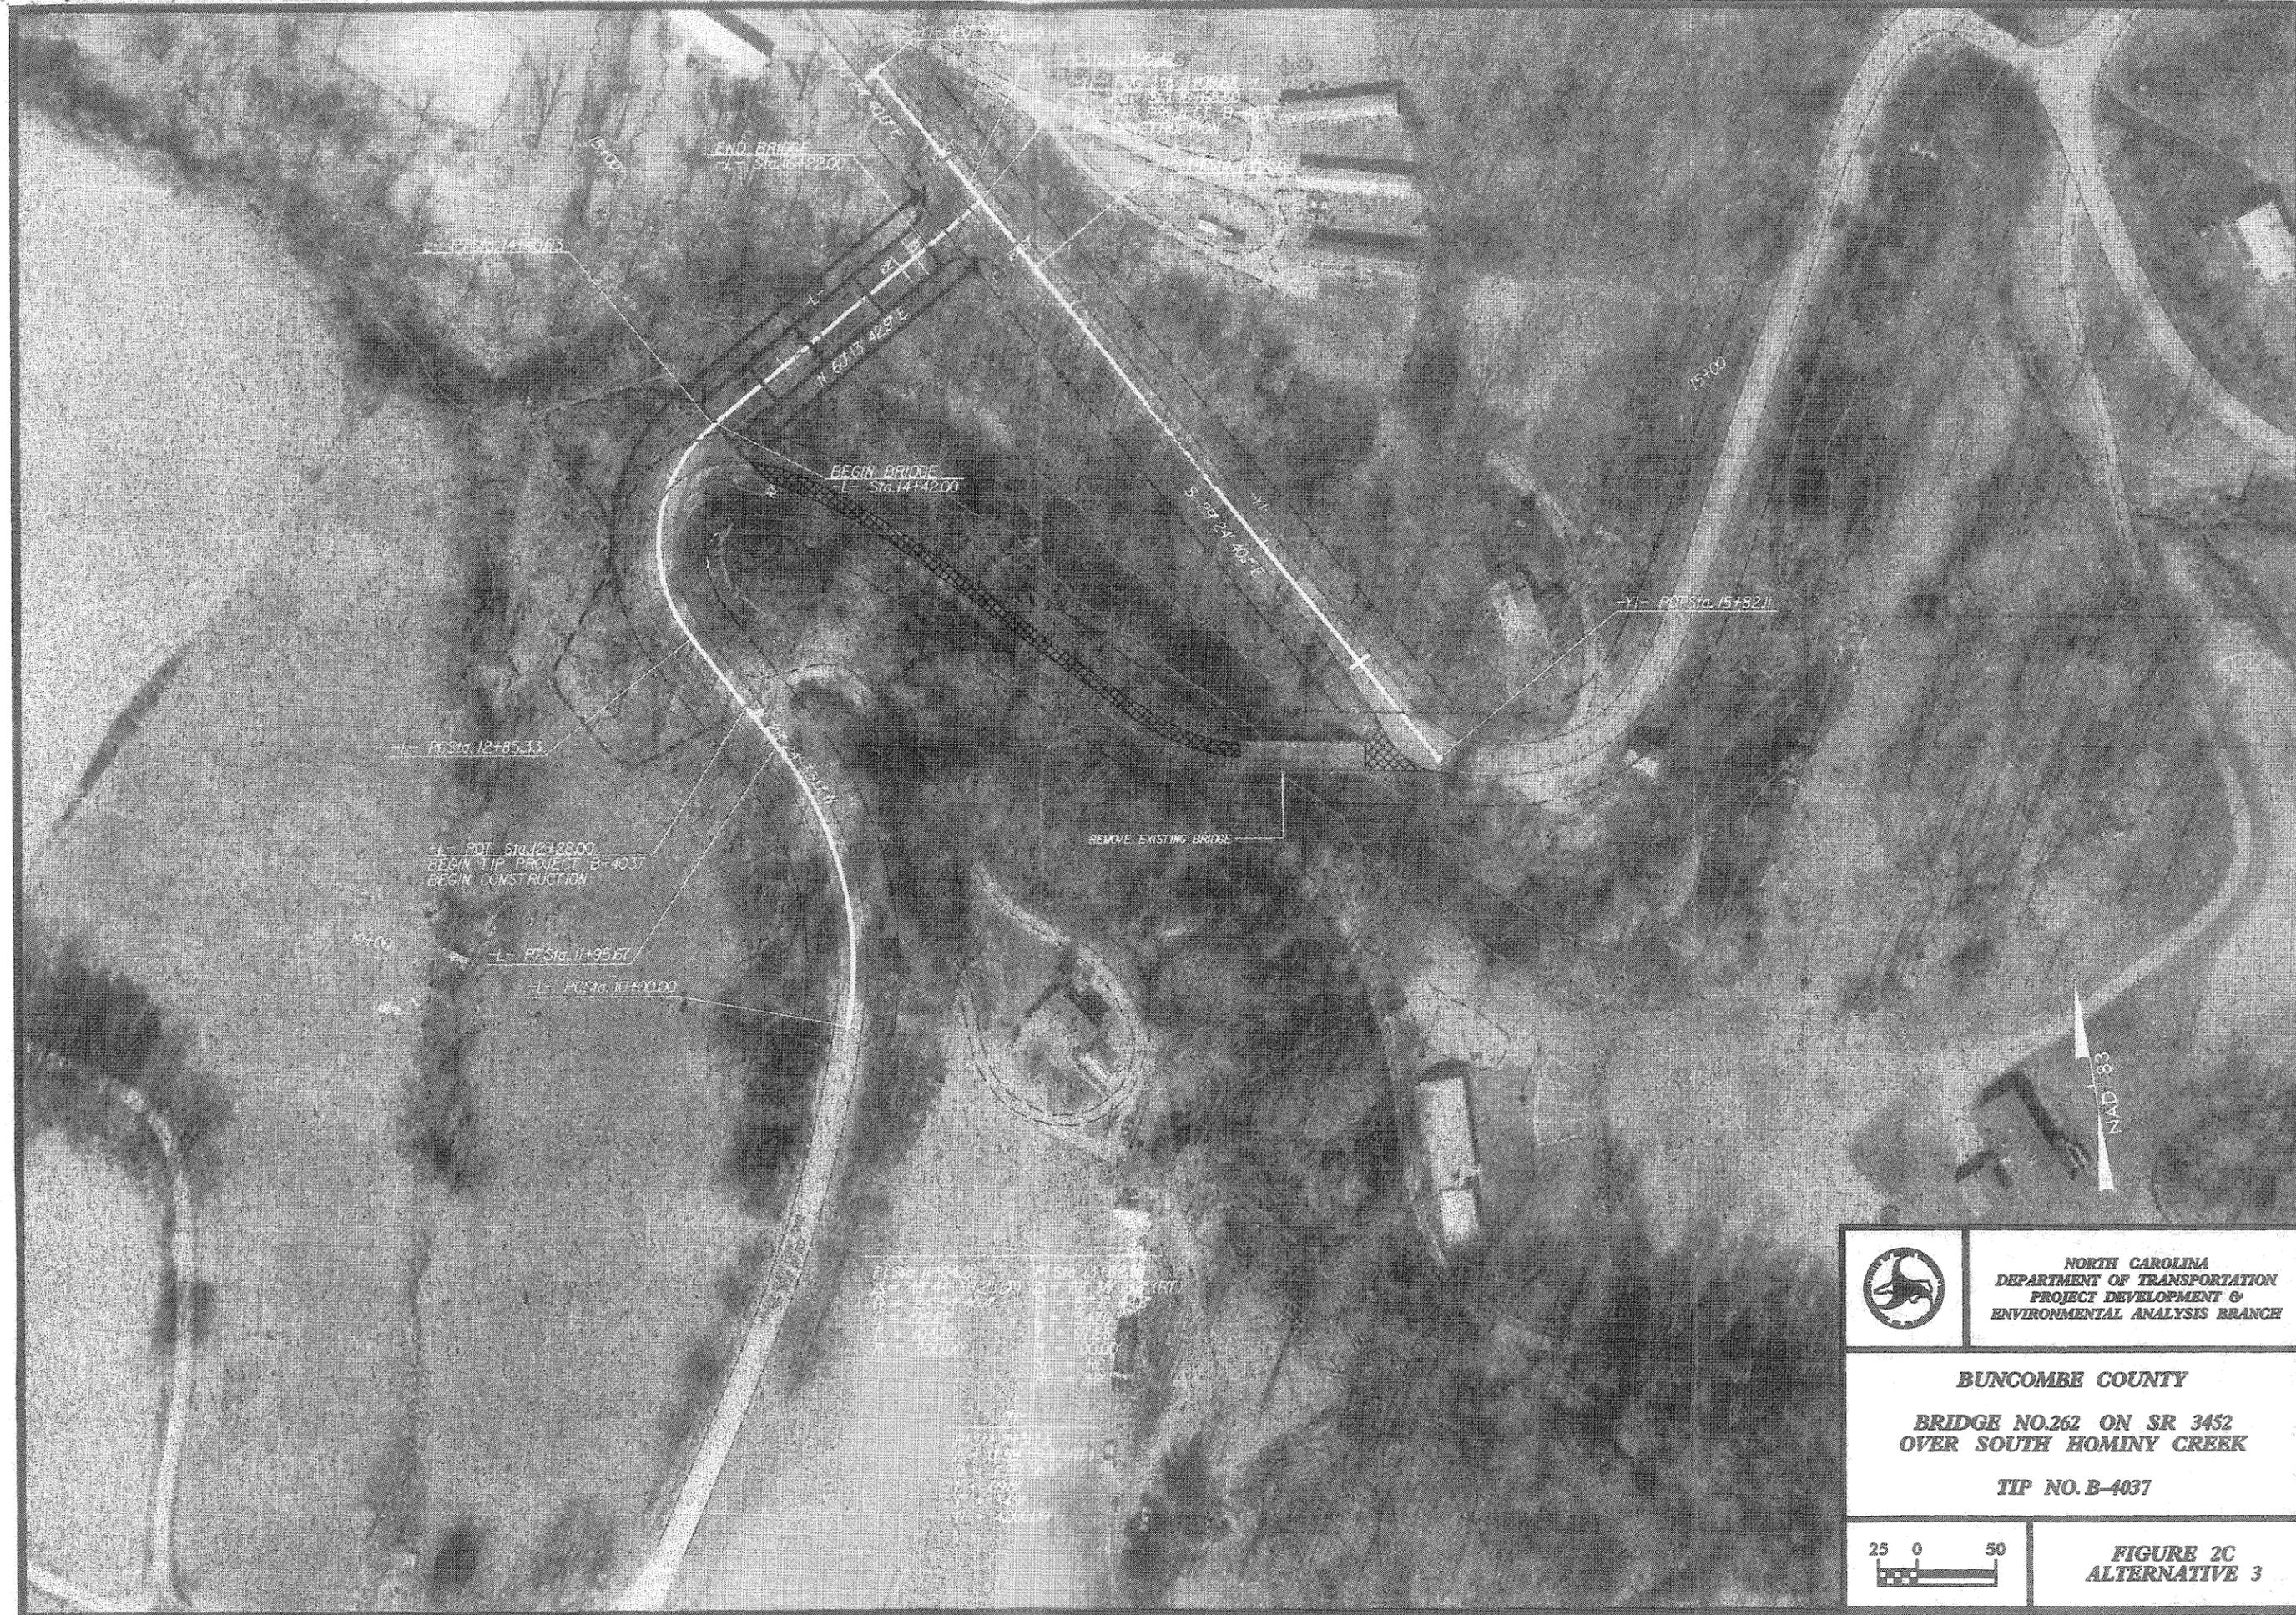
FIGURE 2C
ALTERNATIVE 3

Alternative 3 (Preferred – Figure 2C) replaces the existing structure on new alignment 400 feet upstream of the existing bridge. During construction, traffic will be maintained on the existing structure. It is anticipated that the bridge length will be approximately 180 feet. The final bridge length will be determined during final design. The new roadway approach from the east would form a new stop-controlled intersection with Lower Glady Fork Road while the roadway from the west would tie-in to an existing curve as the new Upper Glady Fork Road. The existing roadway section of Upper Glady Fork Road, from the existing structure to the west of the new structure, would be left as a local access driveway.

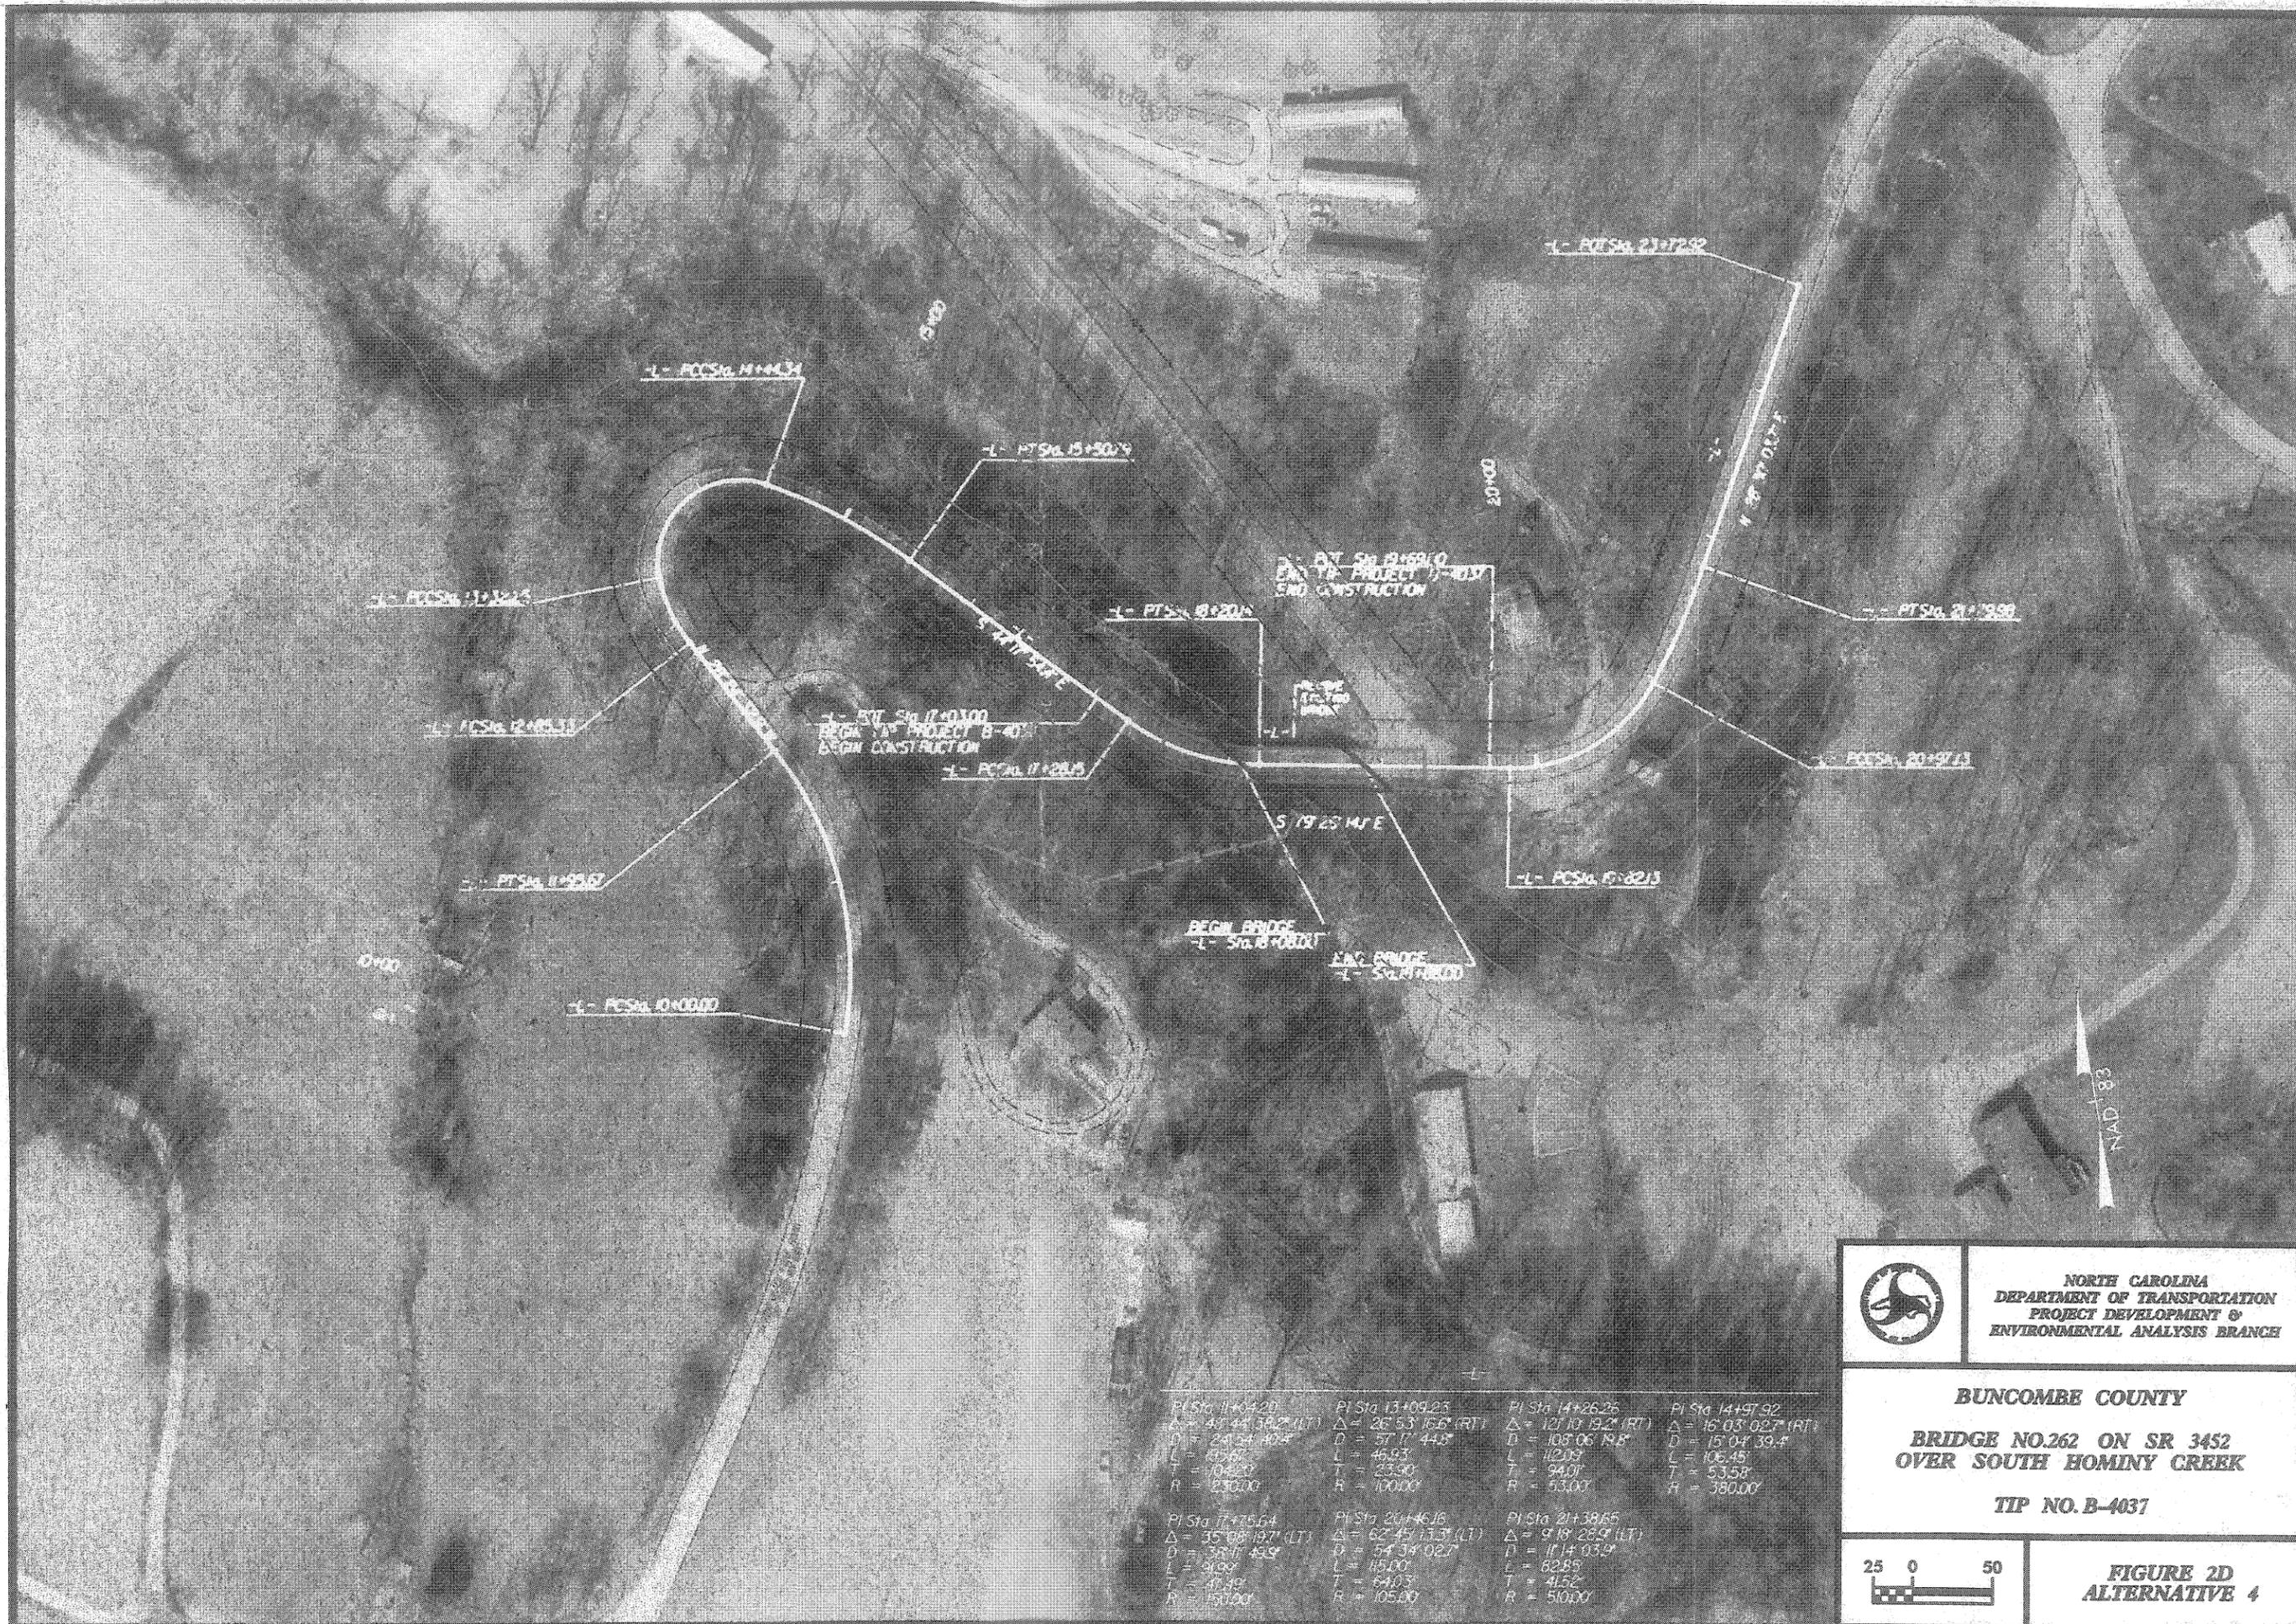
FIGURE 2D
ALTERNATIVE 4

Alternative 4 (Figure 2D) replaces the structure at its existing location with no roadway improvements. During construction, traffic will be re-routed to an off-site detour. It is anticipated that the bridge length will be approximately 80 feet. The final bridge length will be determined during final design. Alternative 4 was not selected as the preferred alternative because it requires an off-site detour and does not address the safety concerns of the local residents.

PI Sta 11+0420 Δ = 45° 44' 38.2" (LT) D = 241.24 40.4' L = 152.65' T = 104.23' R = 230.00'	PI Sta 13+0923 Δ = 26° 53' 16.6" (RT) D = 57' 1" 44.8' L = 46.93' T = 23.90' R = 100.00'	PI Sta 14+2626 Δ = 12' 10' 19.2" (RT) D = 108.06 18.8' L = 42.09' T = 94.01' R = 93.00'	PI Sta 14+97.92 Δ = 16° 03' 02.7" (RT) D = 15' 0.4' 39.4' L = 106.45' T = 53.58' R = 380.00'
PI Sta 17+75.64 Δ = 35° 08' 19.7" (LT) D = 38' 11' 49.9" L = 91.09' T = 41.49' R = 51.00'	PI Sta 20+46.16 Δ = 62° 45' 13.3" (LT) D = 54' 34' 02.7" L = 115.00' T = 64.03' R = 105.00'	PI Sta 21+39.65 Δ = 9° 18' 26.9" (LT) D = 11' 14' 03.9" L = 62.85' T = 41.52' R = 510.00'

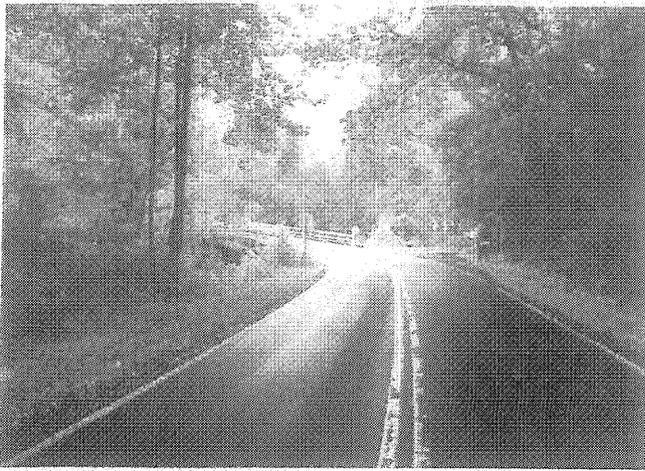
FIGURE 4 – COLOR PHOTOGRAPHS
B-4037 Buncombe County
Bridge No. 262 on SR 3452 over
South Hominy Creek

Looking Southeast Along SR 3452
Toward Bridge No. 262

Bridge No. 262 was constructed in 1961. The existing structure is 82.3 feet in length and consists of two spans of equal length. The clear roadway width is 19.1 feet, providing two travel lanes with no effective shoulder width. The existing right of way width is 60 feet. The superstructure of Bridge No. 262 consists of a timber floor on I-beams with an asphalt wearing surface and timber railing. The substructure of the bridge consists of reinforced concrete abutments, and one interior bent consisting of timber caps on timber piles with timber sills. The bed to crown height is approximately 17 feet. The normal depth of flow observed in the field is 1.3 feet. The posted weight limit is 16 tons for single vehicles (SV) and 19 tons for truck-tractor semi-trailers (TTST).

The superstructure of Bridge No. 262 consists of a timber floor on I-beams with an asphalt wearing surface and timber railing. The substructure of the bridge consists of reinforced concrete abutments, and one interior bent consisting of timber caps on timber piles with timber sills. The bridge has 2 equal spans that total 82 feet in length.

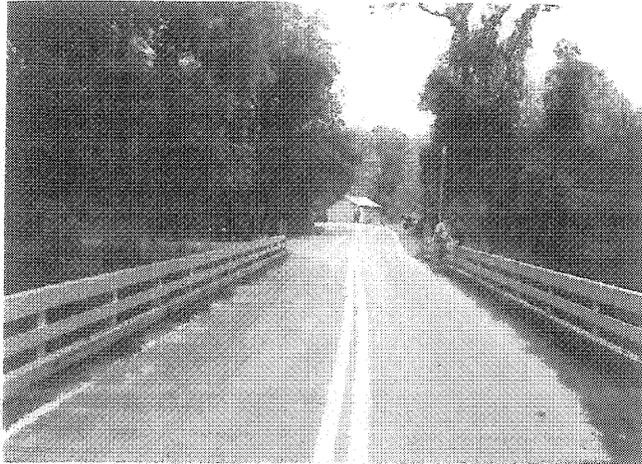
Looking East Along SR 3452 on Bridge
No. 262

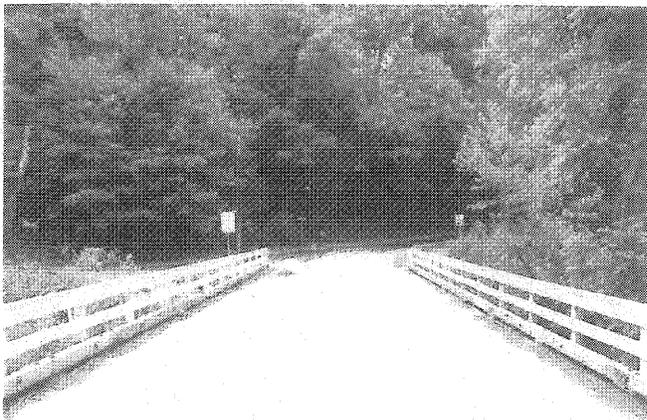
Looking West Along SR 3452 on Bridge
No. 262

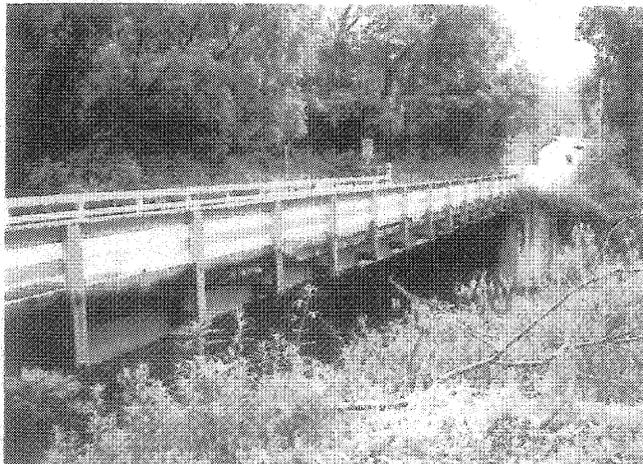
Looking East toward Bridge No. 262
from the West Side of SR 3452

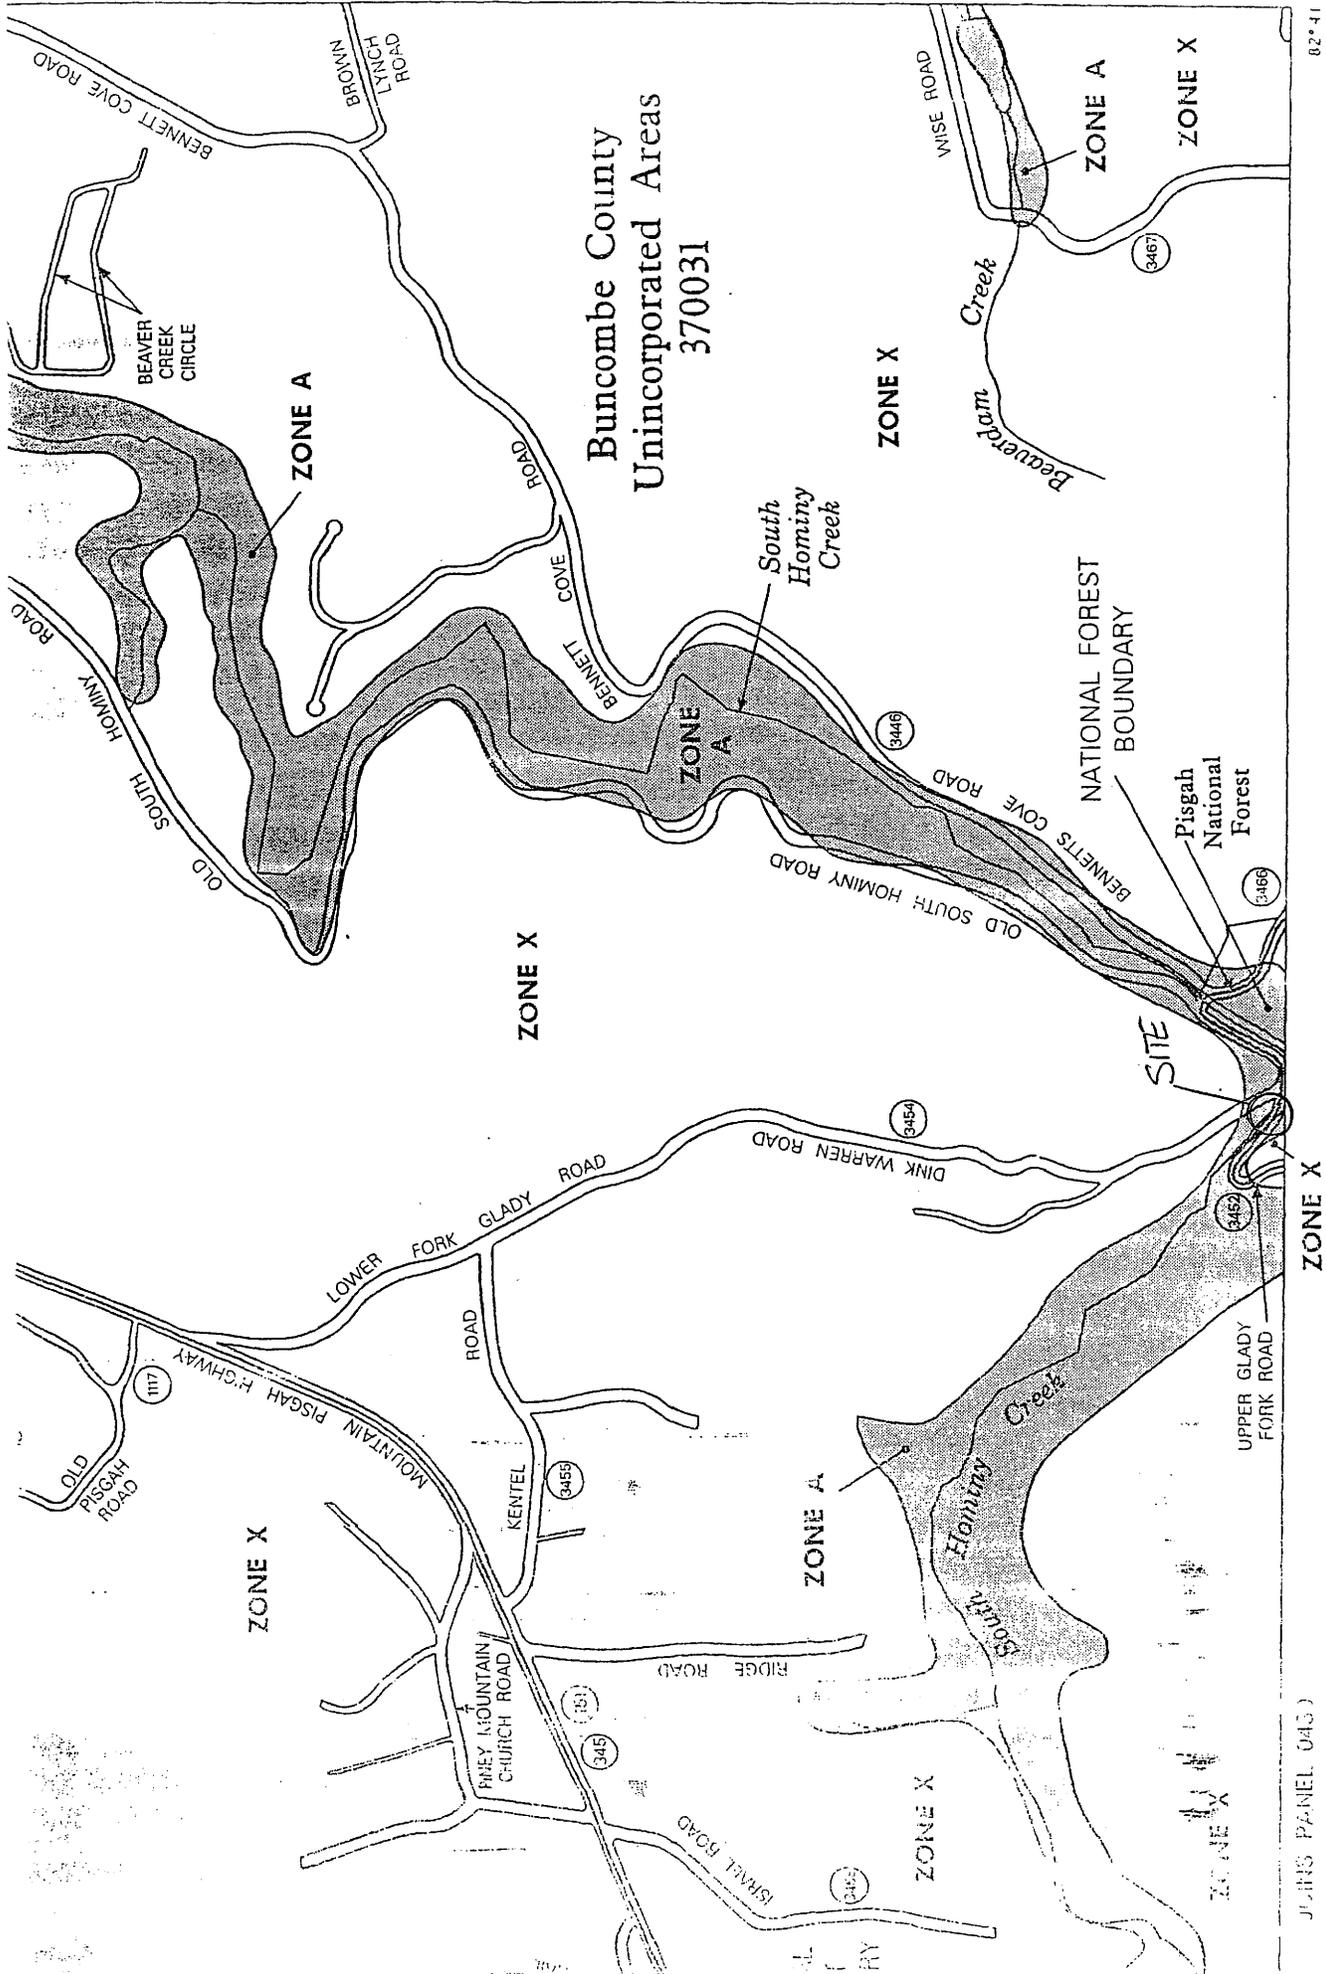
FIGURE 5
FLOODPLAIN MAP

Buncombe County is a participant in the National Flood Insurance Program. The project site on South Hominy Creek is not included in a Detailed FEMA Study area. A copy of the Flood Insurance Rate Map is shown in Figure 5. The project is not anticipated to increase the level or extent of the upstream flood hazard and no practical alternatives exist to crossing the flood plain.
