Subject: Application for Section 404 Nationwide Permits 23, 33, and 13, Section 401 Water Quality Certification, and Neuse Riparian Buffer Authorization for the replacement of Bridge No. 29 over Clarks Creek on SR 1007 (Poole Road), Wake County. Federal Aid Project Number BRSTP-1007(8), WBS No. 33637.1.1, State Project No. 8.2409201, Division 5, T.I.P No. B-4300.

1. Name of project: Replace Bridge No. 29 over Clarks Creek on SR 1007 with a culvert.
2. T.I.P. Project Number or State Project Number (NCDOT Only): B-4300

Wake County
Bridge No. 29 on SR 1007 (Poole Road)
Over Clarks Creek
Federal-Aid Project No. BRSTP-1007(8)
State Project No. 8.2409201
WBS No. 33637.1.1
T.I.P. No. B-4300

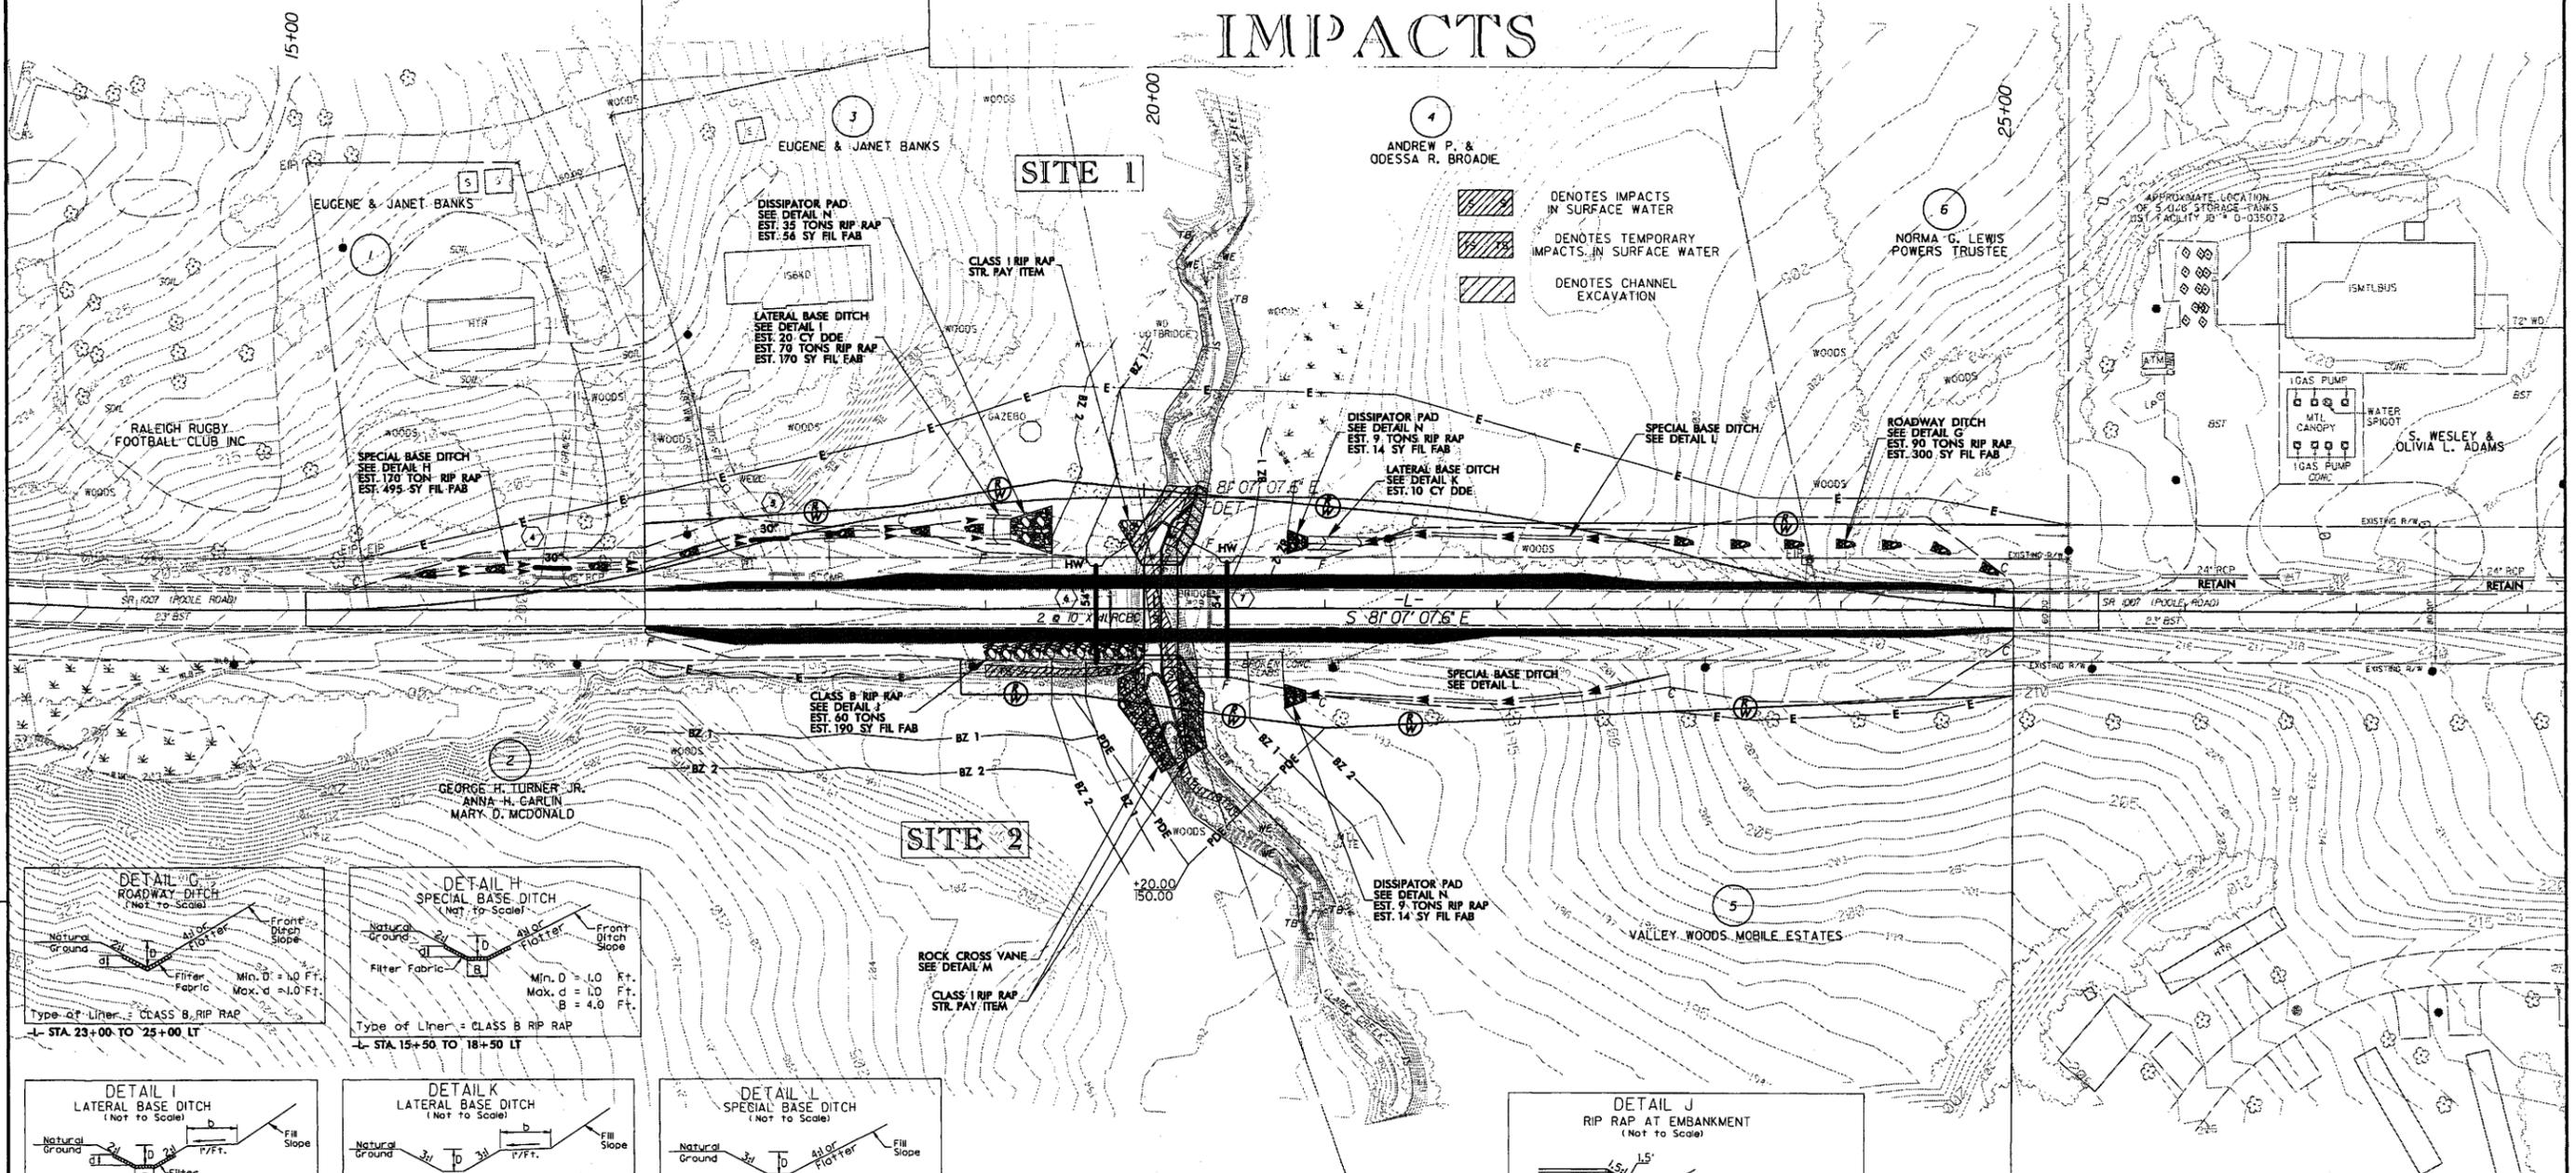
STREAM & WETLAND IMPACTS

PROJECT REFERENCE NO. B-4300	SHEET NO. 4
R/W SHEET NO.	HYDRAULICS ENGINEER
ROADWAY DESIGN ENGINEER

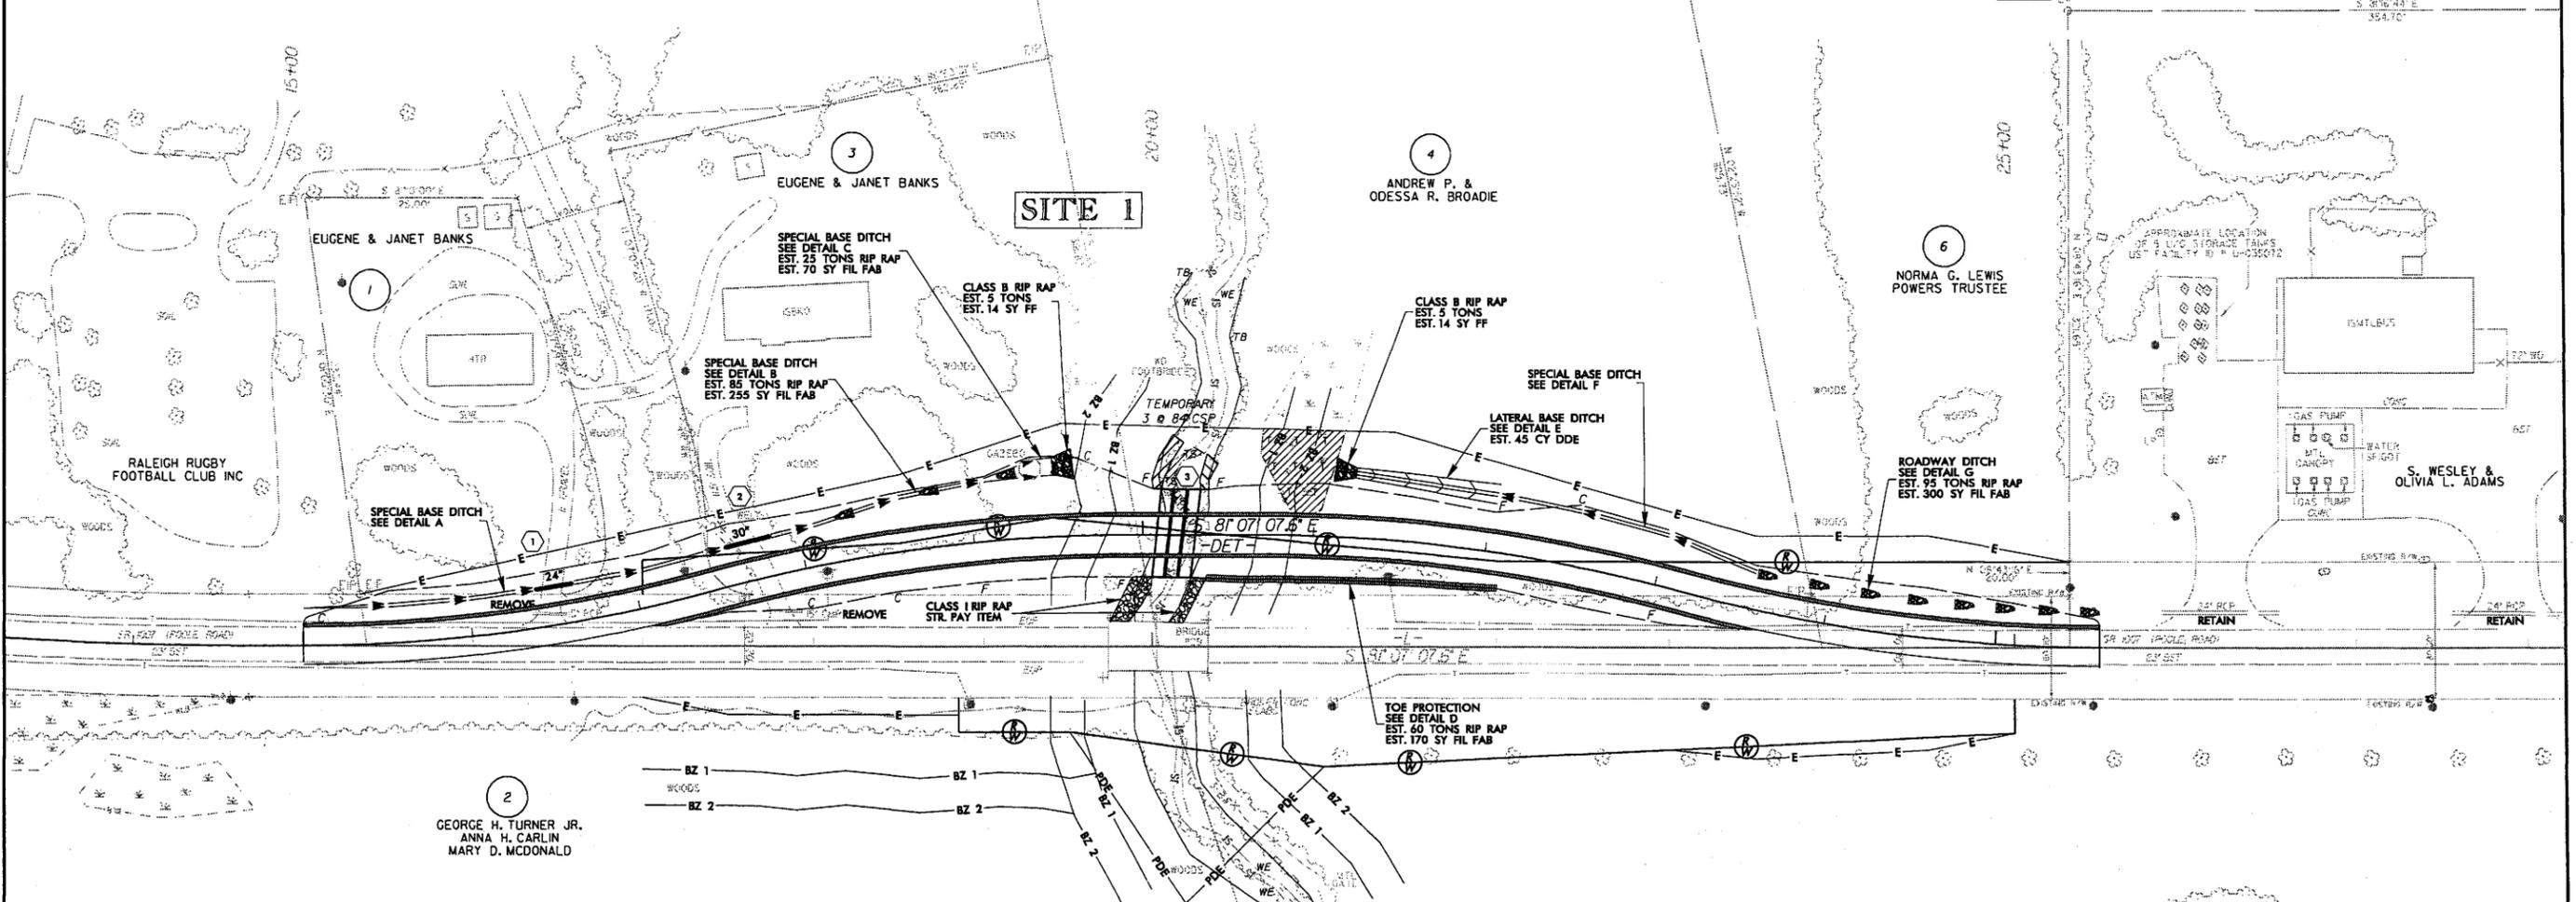
Permit Drawing
Sheet 9 of 10

- TEMPORARY IMPACTS IN SURFACE WATER
- DENOTES TEMPORARY FILL IN WETLAND
- DENOTES CHANNEL EXCAVATION

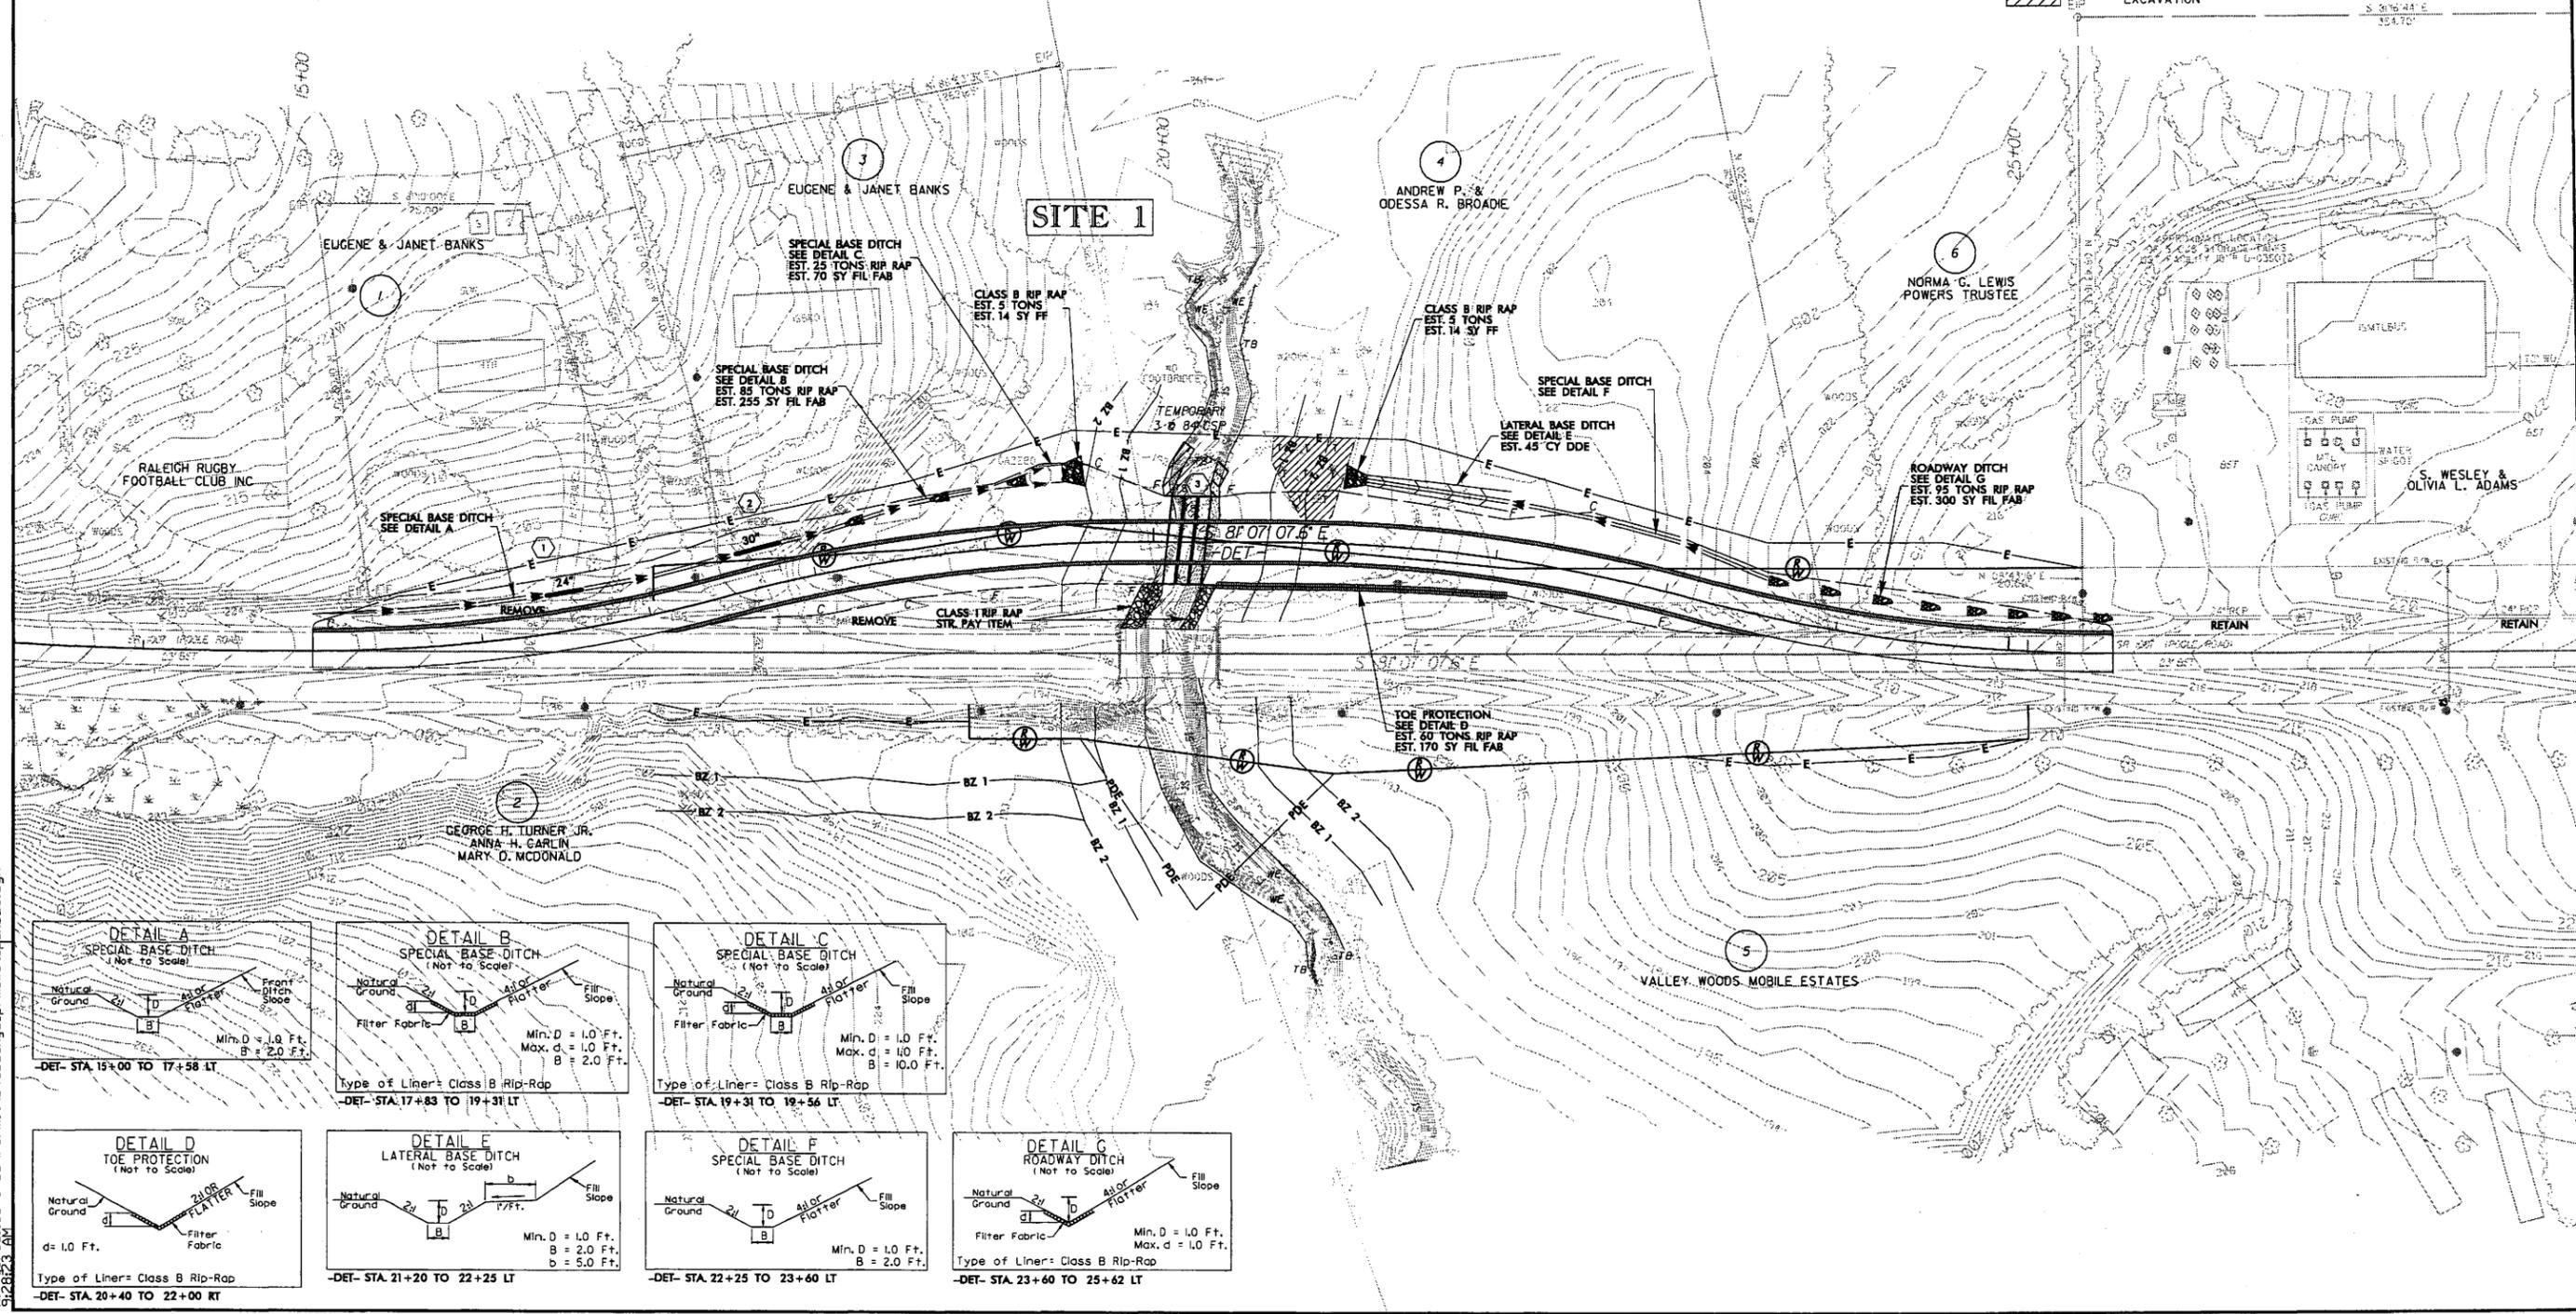
Permit Drawing
Sheet 10 of 10

- TEMPORARY IMPACTS IN SURFACE WATER
- DENOTES TEMPORARY FILL IN WETLAND
- DENOTES CHANNEL EXCAVATION

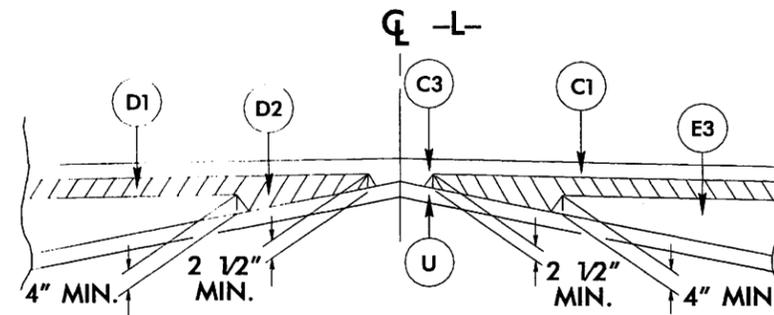
DETAIL SHOWING METHOD OF WEDGING

USE IN CONJUNCTION WITH TYPICAL SECTION NO. 1

NOTE: AFTER DETOUR REMOVAL, OVERLAY EXISTING PAVEMENT WITH C1 FROM

- L- STA. 15+00.00 TO STA. 17+50.00
- L- STA. 24+50.00 TO STA. 25+50.00

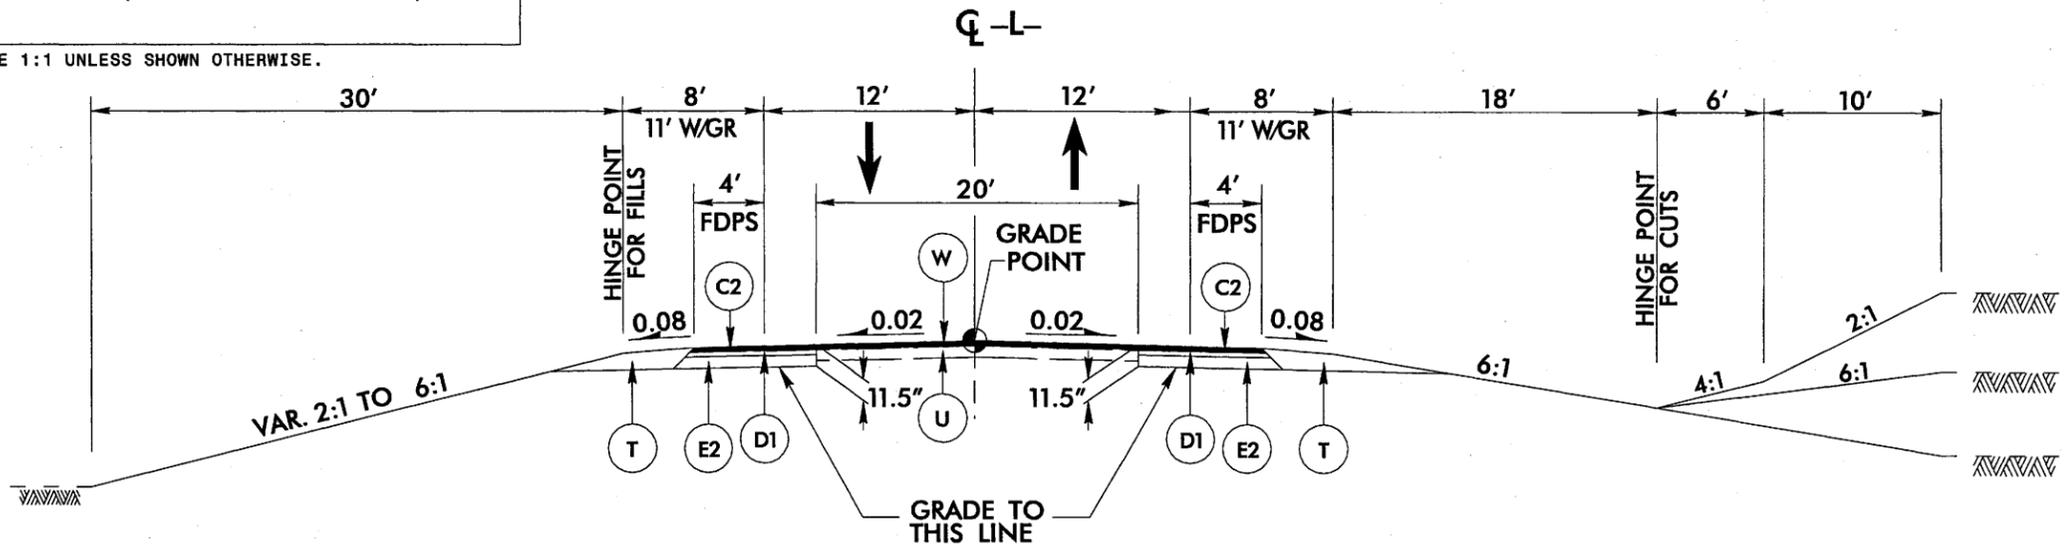
USE TYPICAL SECTION NO. 1 AT THE FOLLOWING LOCATIONS

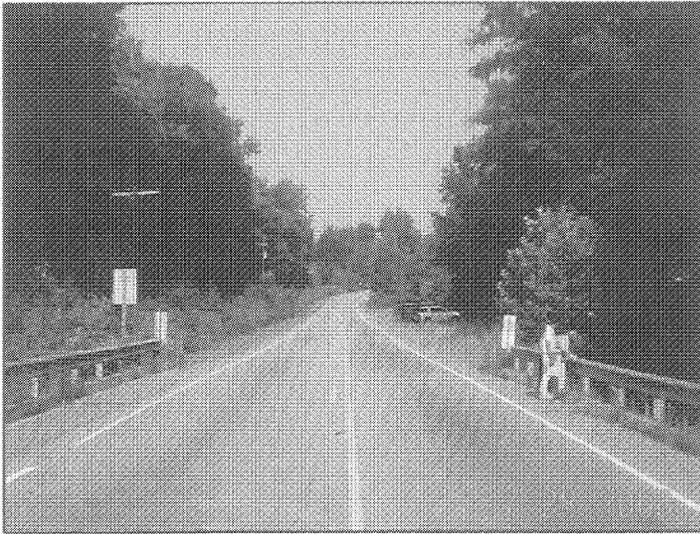
View of west approach from Bridge No. 29.

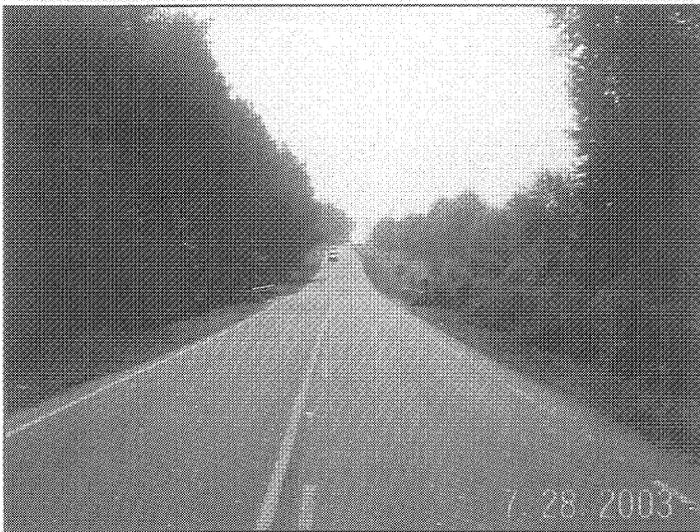
View of east approach from Bridge No. 29.

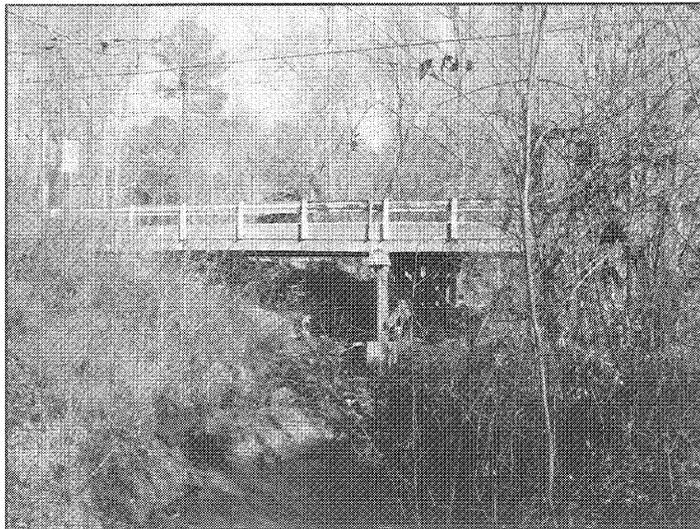
Bridge No. 29 side view.

Bridge Maintenance Unit records indicate that Bridge No. 29 has a sufficiency rating of 7.0 out of a possible 100 for a new structure. The bridge is considered functionally obsolete and structurally deficient. The replacement of this inadequate structure will result in safer, more efficient traffic operations.

Investigation of the existing structure by the NCDOT’s Bridge Maintenance Unit indicates that “rehabilitation” of this bridge is not feasible because of its age and deteriorated condition.

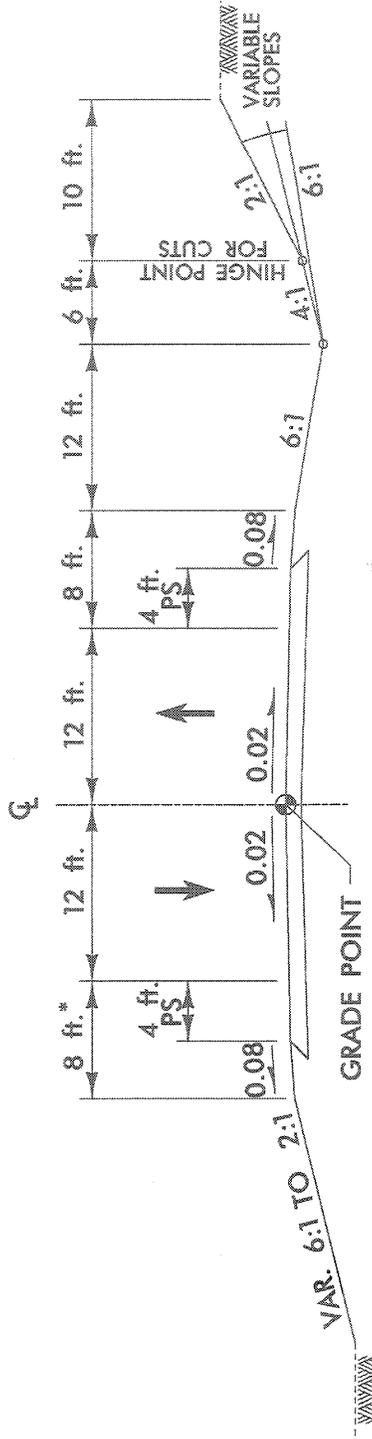
FIGURE 3A

TYPICAL APPROACH SECTION
(PROPOSED)

* 11 ft. WITH GUARDRAIL IS WARRANTED

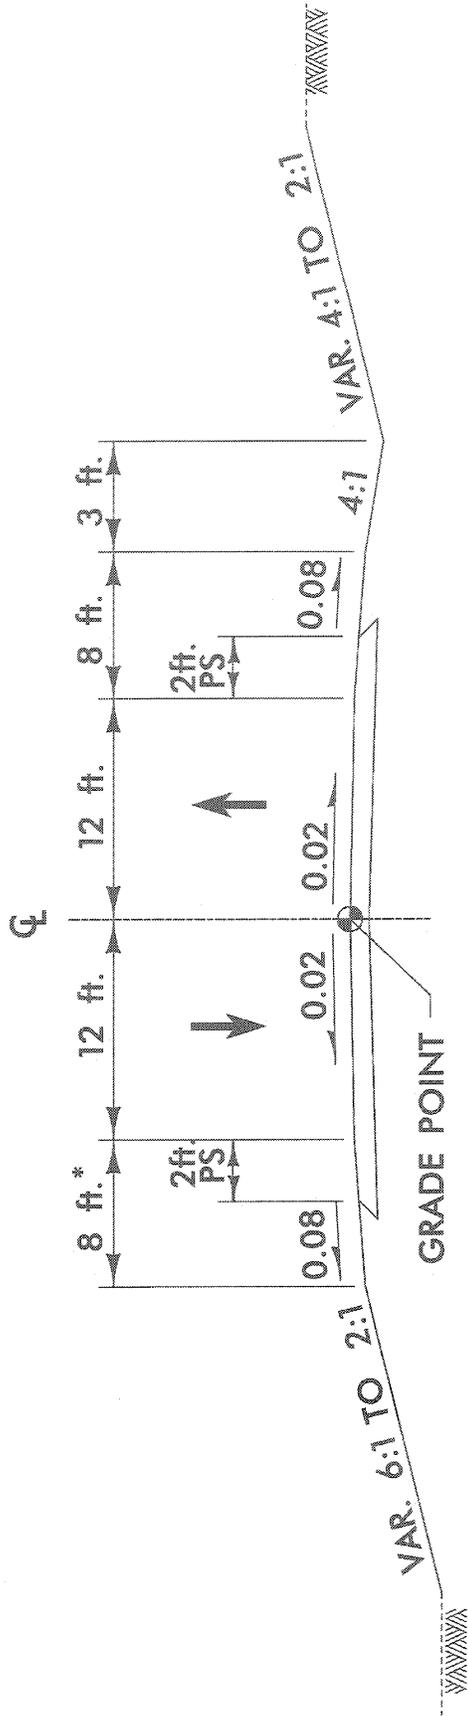
FIGURE 3B

TYPICAL APPROACH SECTION
(DETOUR)

* 10 ft. WHEN GUARDRAIL IS WARRANTED

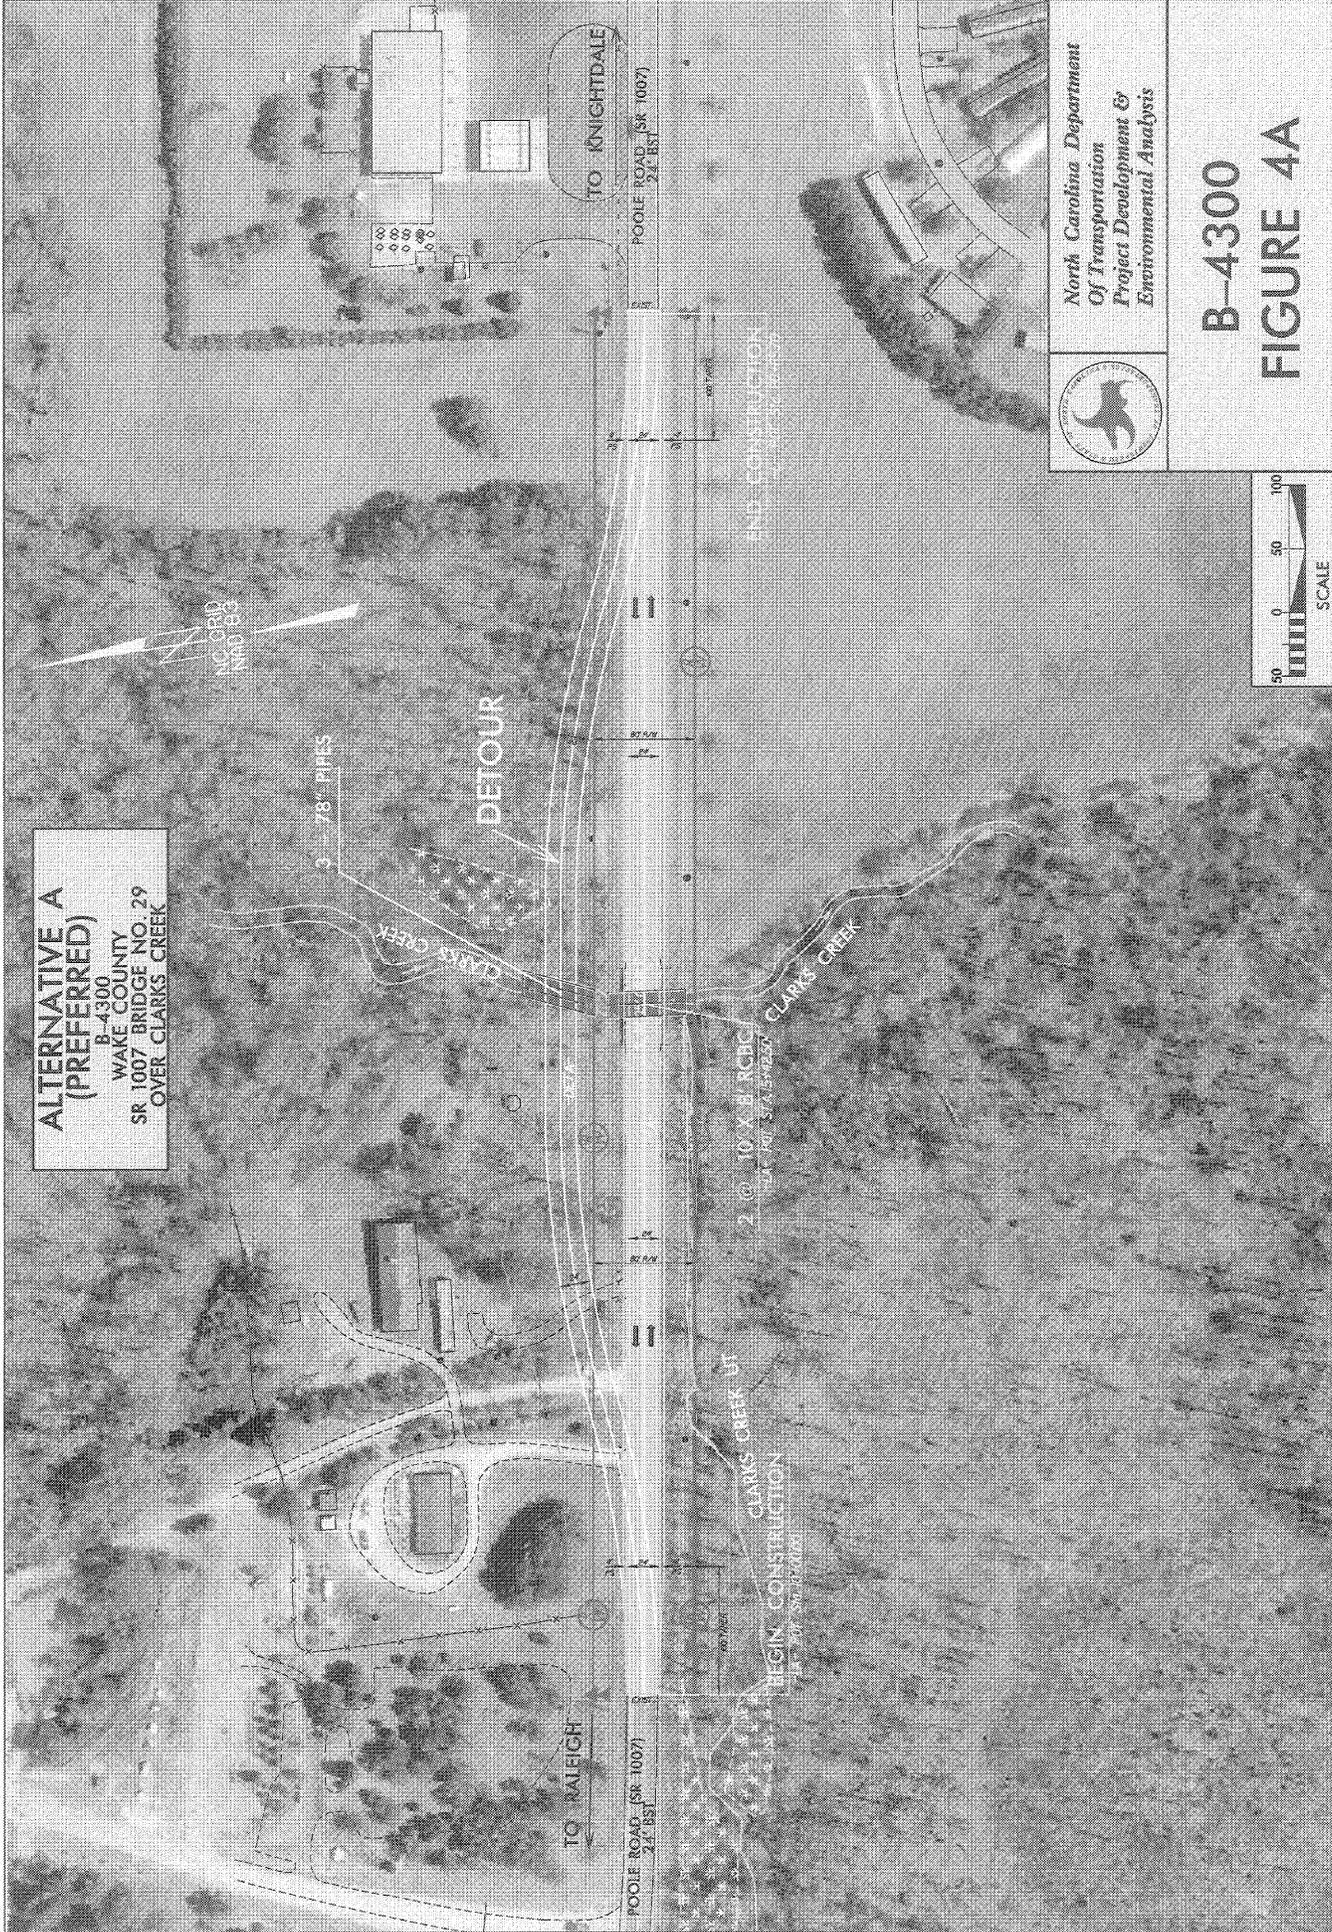
**B-4300
 FIGURE 4A**

**ALTERNATIVE A
(PREFERRED)**
 B-4300
 WAKE COUNTY
 SR 1007 BRIDGE NO. 29
 OVER CLARKS CREEK

Alternative A (preferred) replaces the bridge at the existing location. During construction, traffic will be maintained by an on-site detour north of the existing bridge.
