**CATEGORICAL EXCLUSION ACTION CLASSIFICATION FORM**

TIP Project No.	<u>B-4631</u>
WBS No.	<u>33805.1.1</u>
State Project No.	<u>8.2891801</u>
Federal Project No.	<u>BRZ-1347 (3)</u>

**REPLACEMENT OF BRIDGE NO. 526 ON SR 1347  
OVER WEST BRANCH MOUNTAIN CREEK  
RUTHERFORD COUNTY, NORTH CAROLINA**

**NATURAL RESOURCES TECHNICAL REPORT**

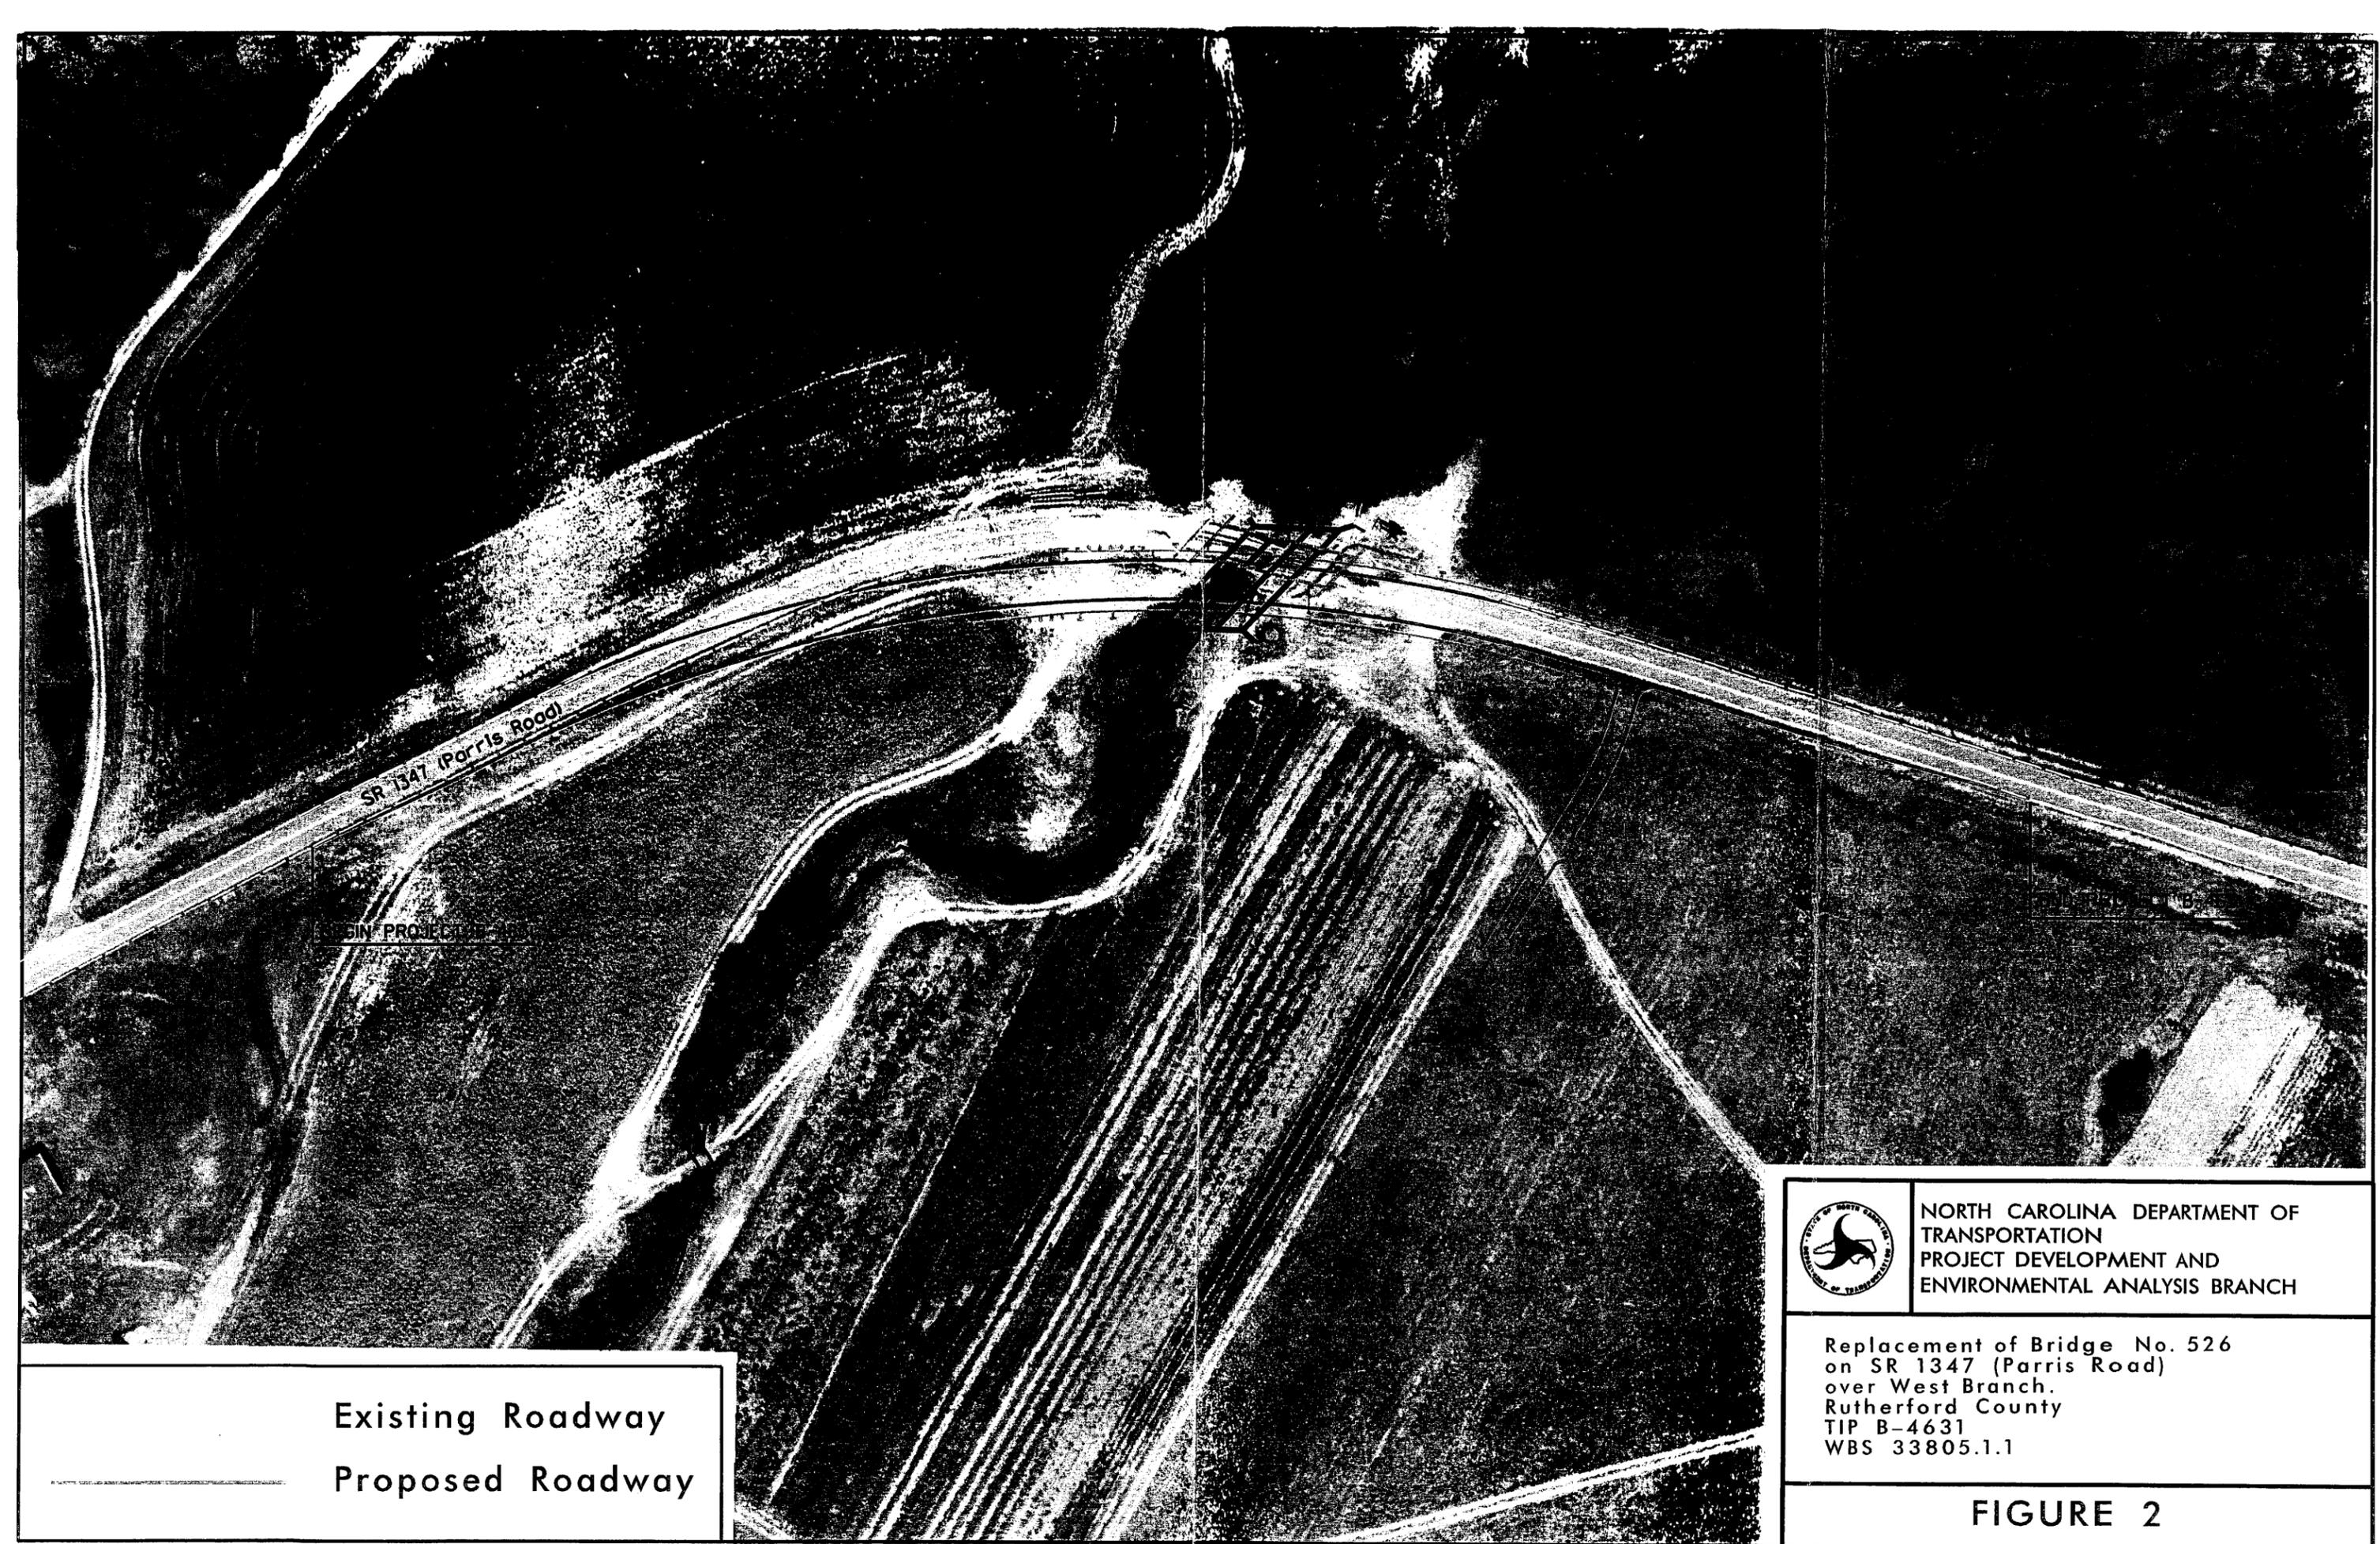
FIGURE 2

Existing Roadway  
Proposed Roadway

Replacement of Bridge No. 526  
 on SR 1347 (Parris Road)  
 over West Branch.  
 Rutherford County  
 TIP B-4631  
 WBS 33805.1.1

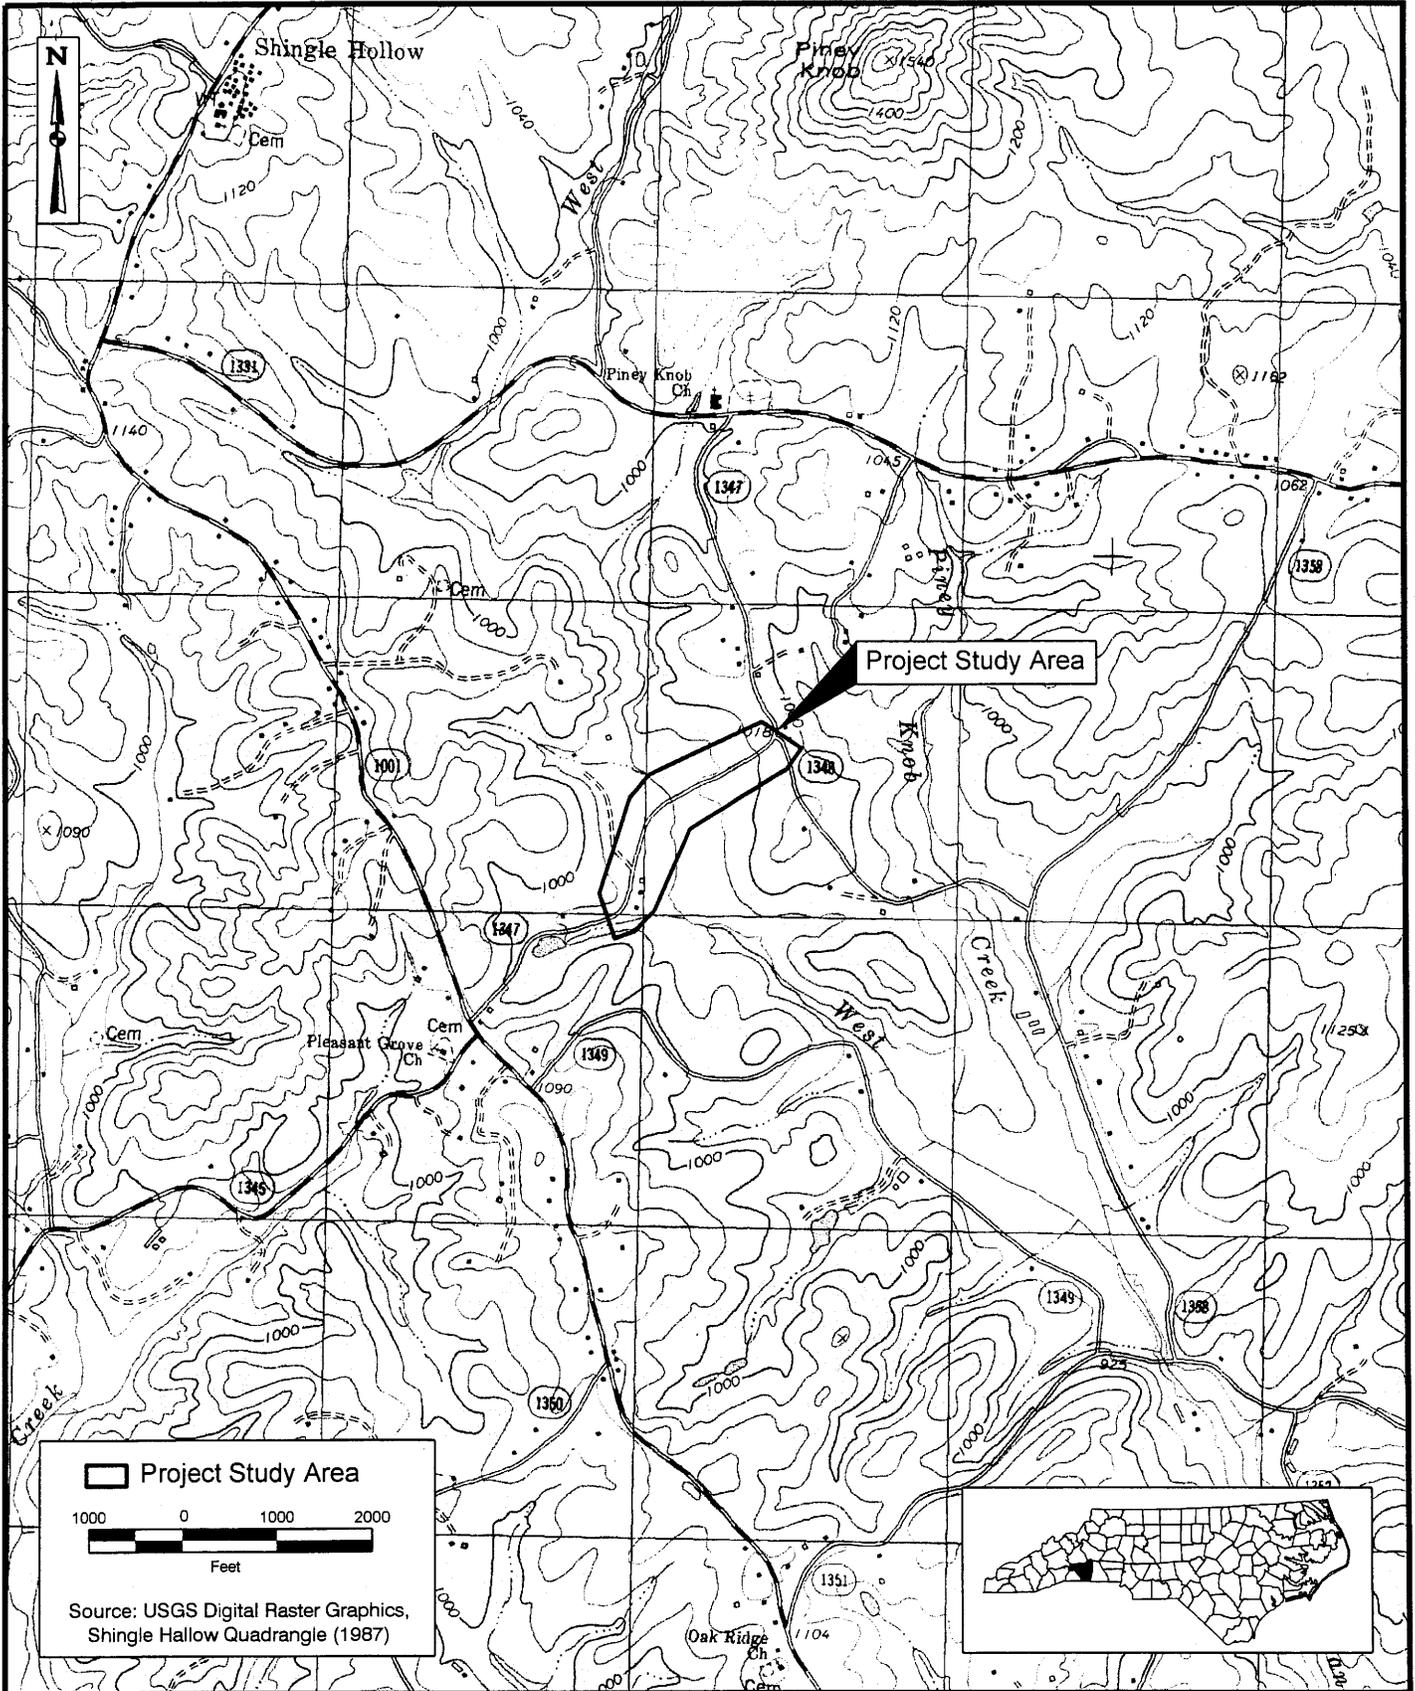
Project Study Area
