Subject: **Nationwide Permit 23 Application** for the proposed replacement of Bridge No. 265 on SR-1791 (Ballenger Road) over Dunn Creek in Henderson County. Federal Project No. BRZ-1791(1), State Project No. 8.2952001, T.I.P. No. B-3665.

NCDOT  
DIVISION OF HIGHWAYS  
HENDERSON COUNTY  
PROJECT: 33210.1.1 (B-3665)  
BRIDGE NO. 265 OVER  
DUNN CREEK AND  
APPROACHES ON SR 1791

B-3665  
**ALTERNATE B**

B-3665 Henderson County  
Bridge No 265 on SR 1791 over Dunn Creek

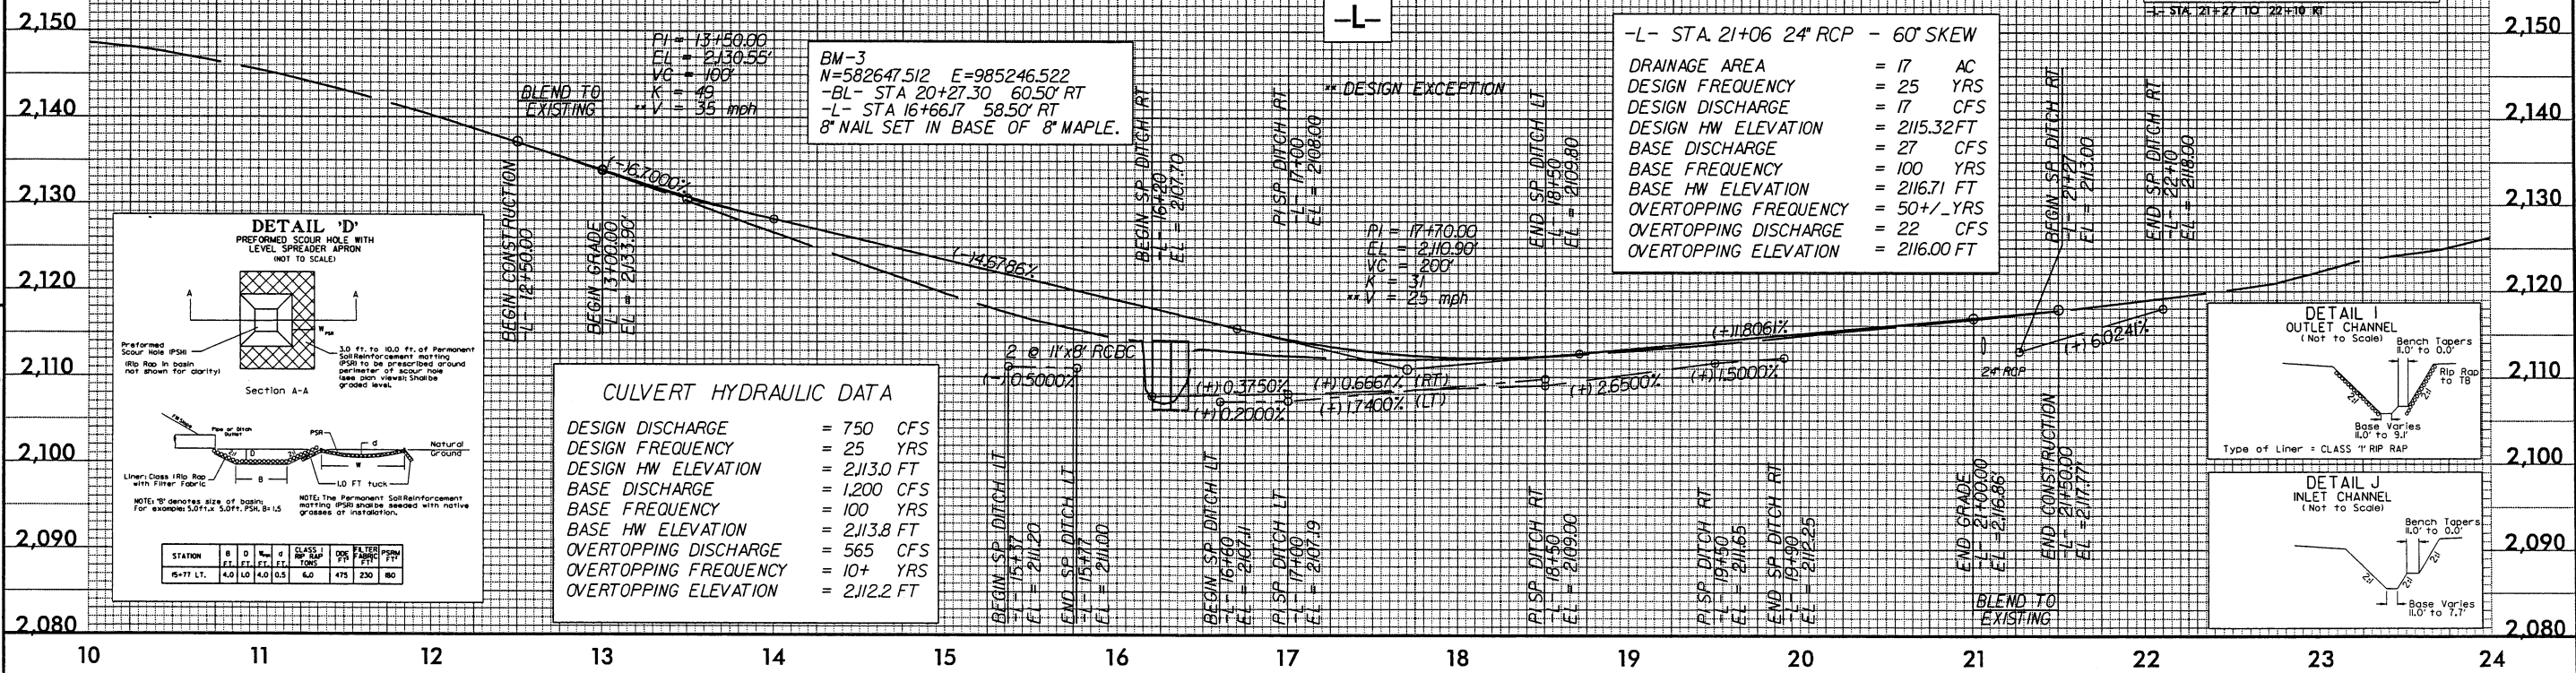
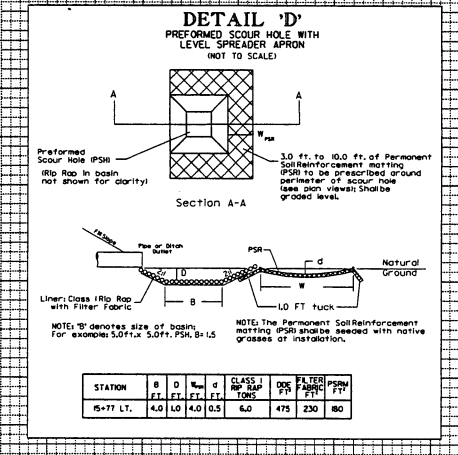
CULVERT HYDRAULIC DATA

DESIGN DISCHARGE = 750 CFS  
DESIGN FREQUENCY = 25 YRS  
DESIGN HW ELEVATION = 2113.0 FT  
BASE DISCHARGE = 1,200 CFS  
BASE FREQUENCY = 100 YRS  
BASE HW ELEVATION = 2113.8 FT  
OVERTOPPING DISCHARGE = 565 CFS  
OVERTOPPING FREQUENCY = 10+ YRS  
OVERTOPPING ELEVATION = 2112.2 FT

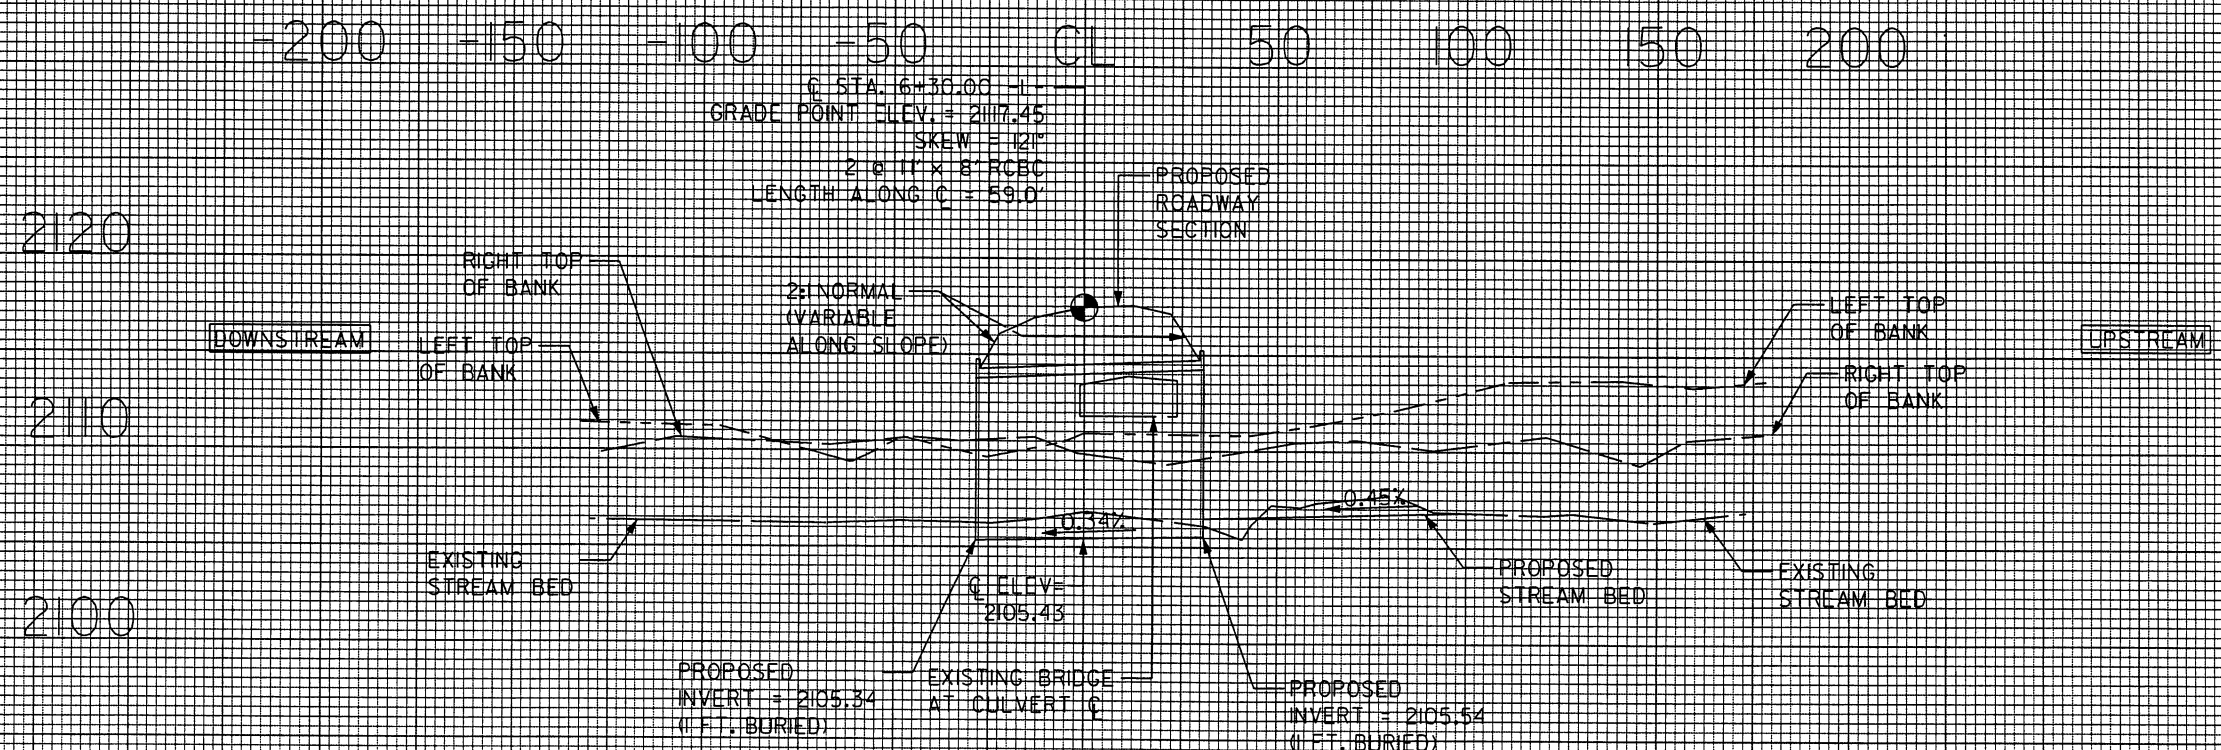
PROFILE ALONG STRUCTURE

SCALE  
HORIZONTAL: 1"=50'  
VERTICAL: 1"=10'

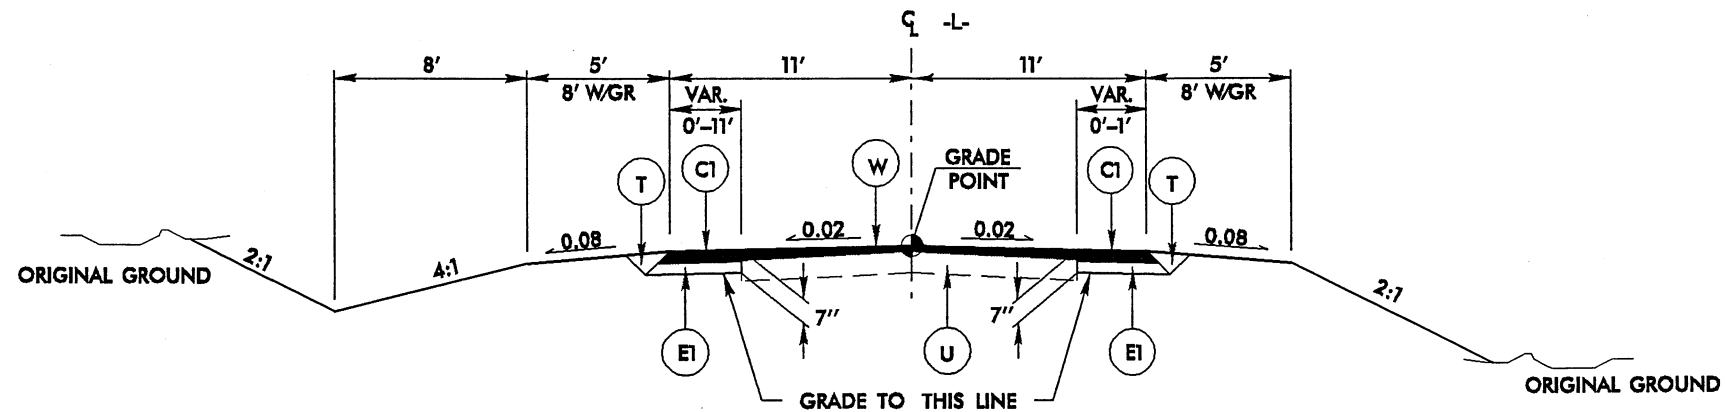
**TYPICAL SECTION NO. 1**

USE TYPICAL SECTION NO. 1 AT THE FOLLOWING LOCATIONS:

- L- STA 12+50.00 TO STA 13+75.00
- L- STA 17+50.00 TO STA 21+50.00

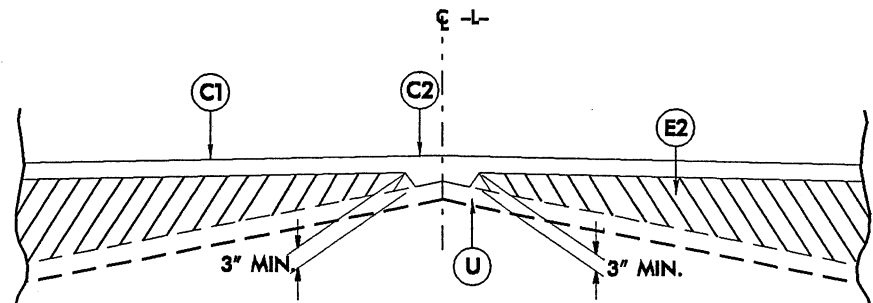
**DETAIL SHOWING METHOD OF WEDGING**

USE IN CONJUNCTION WITH TYPICAL SECTION NO. 1

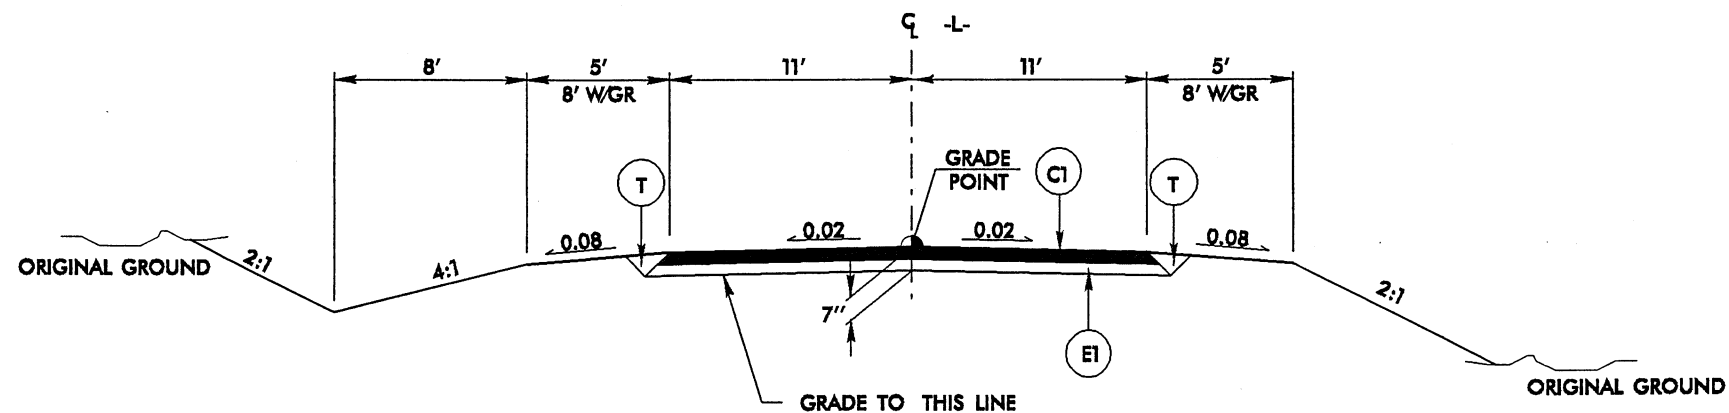
**TYPICAL SECTION NO. 2**

USE TYPICAL SECTION NO. 2 AT THE FOLLOWING LOCATIONS:

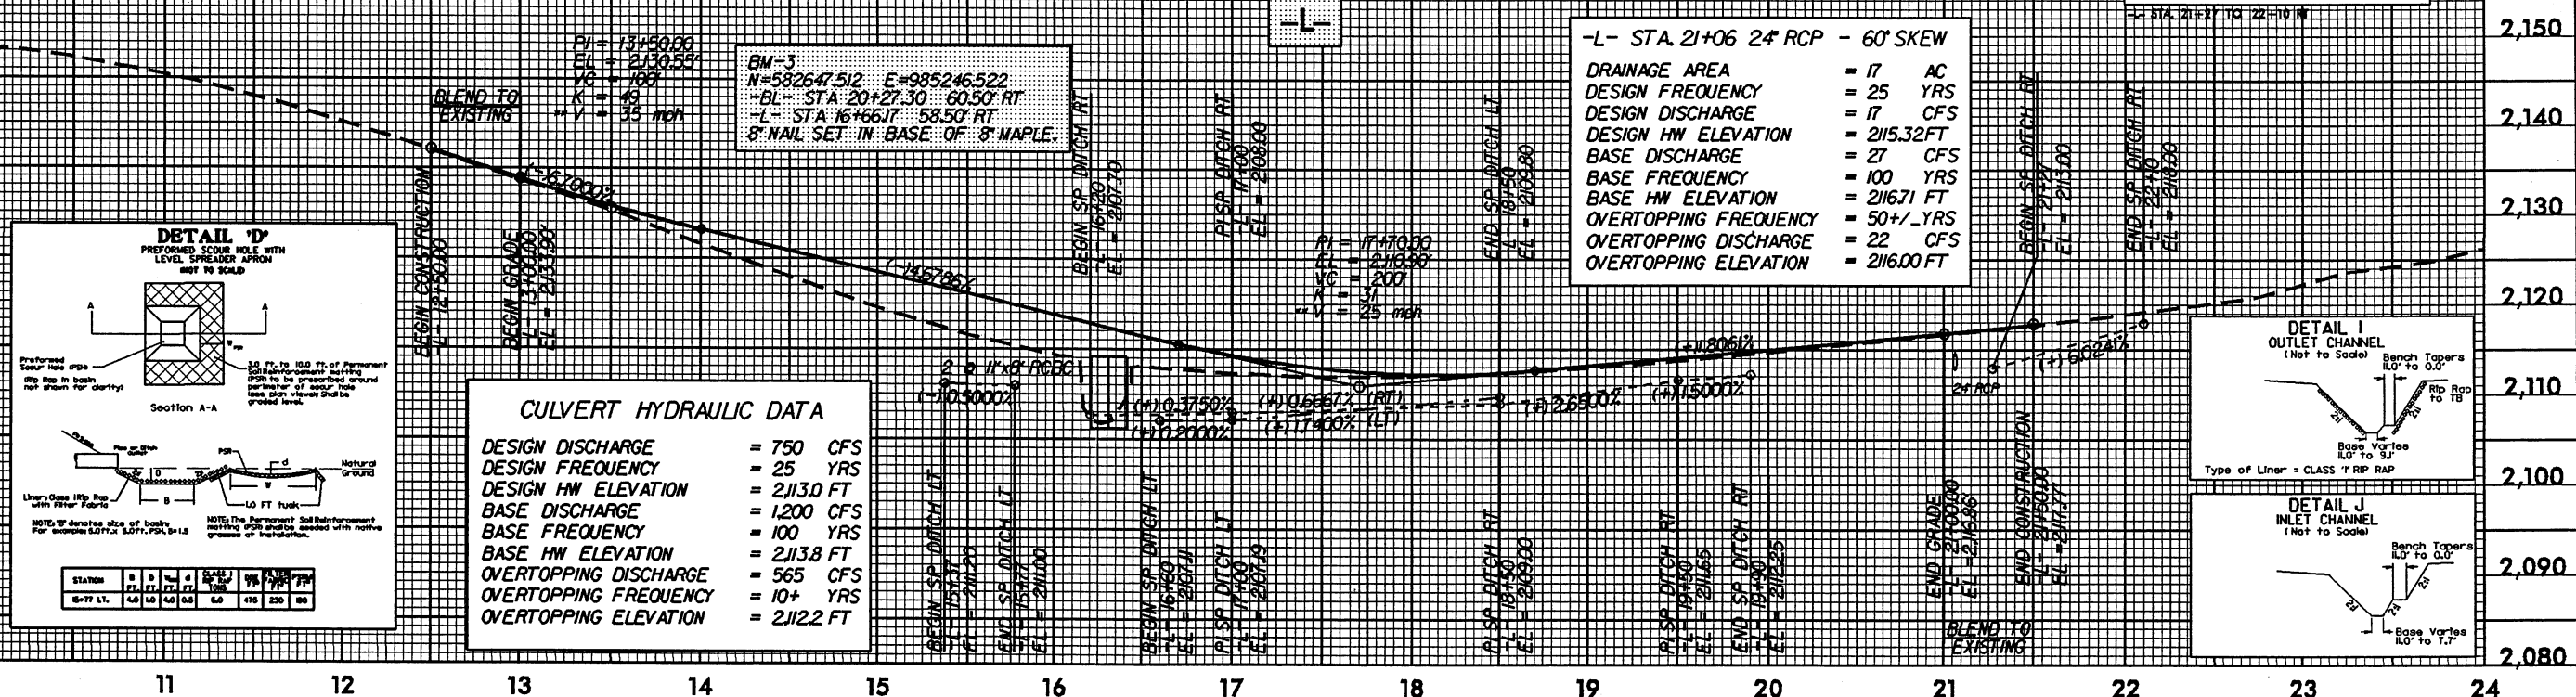
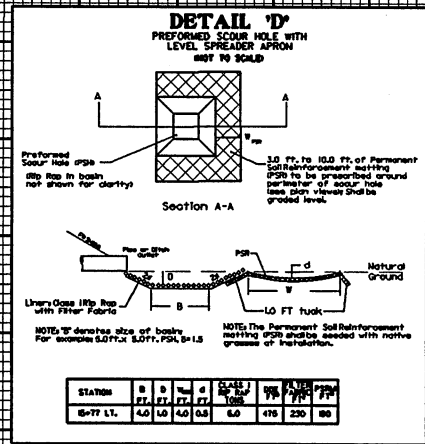
**CULVERT HYDRAULIC DATA**

DESIGN DISCHARGE = 750 CFS  
 DESIGN FREQUENCY = 25 YRS  
 DESIGN HW ELEVATION = 2113.0 FT  
 BASE DISCHARGE = 1200 CFS  
 BASE FREQUENCY = 100 YRS  
 BASE HW ELEVATION = 2113.8 FT  
 OVERTOPPING DISCHARGE = 565 CFS  
 OVERTOPPING FREQUENCY = 10+ YRS  
 OVERTOPPING ELEVATION = 2112.2 FT

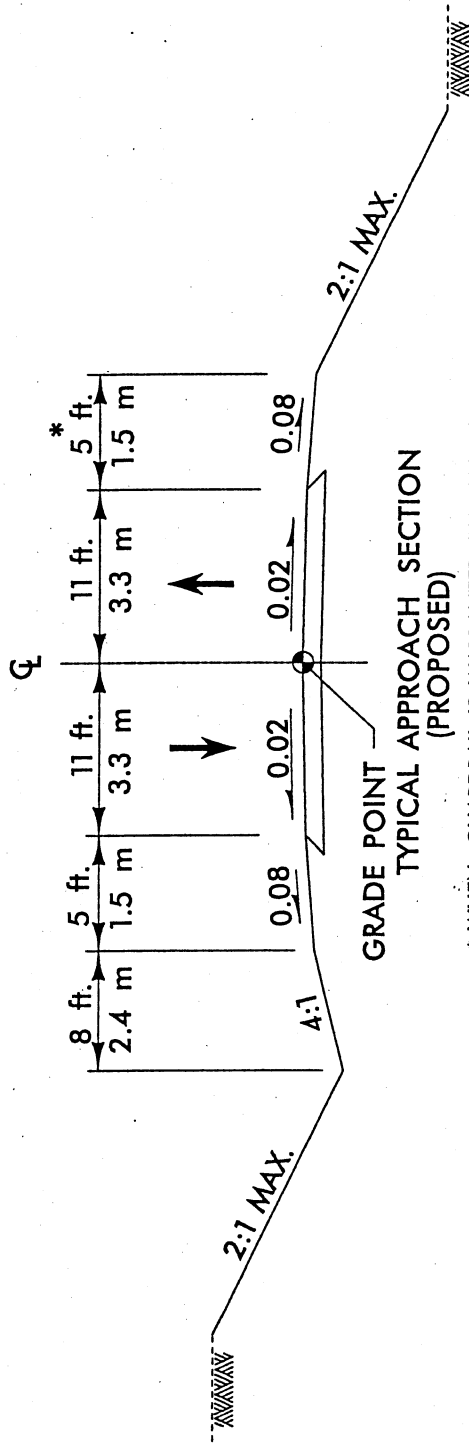
GRADE POINT  
TYPICAL APPROACH SECTION  
(PROPOSED)

\* WHEN GUARDRAIL IS WARRANTED, THE MINIMUM SHOULDER WIDTH IS INCREASED BY 3'-0" (1.0 m)  
REPLACE BRIDGE NO. 265 WITH A REINFORCED CONCRETE BOX CULVERT WITH 2 BARRELS @ 9' X 8' (2.7 m X 2.4 m)

Based on the preliminary hydraulics report the proposed replacement structure for Bridge No. 265 will be a reinforced concrete box culvert with two (2) barrels at 9 feet (2.7 meters) by 8 feet (2.4 meters) and approximately 60 feet (18 meters) in length.

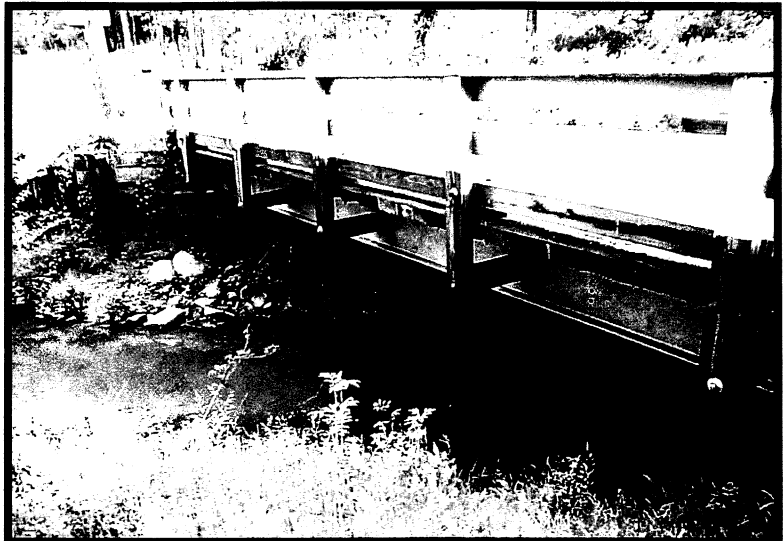
Side view of Bridge No. 265.

The superstructure of Bridge No. 265 is a single span structure consisting of a timber deck on steel I-beams supported by timber caps and piles, with an overall length of 31 feet and a clear roadway width of 20 feet. Bridge No. 265 can be removed without dropping components into Waters of the United States. Guidelines for bridge demolition and removal will be followed in addition to Best Management Practices for the Protection of Surface Waters and BMP's for Bridge Demolition and Removal.
