SUBJECT: Neuse Riparian Buffer Authorization Request for the proposed replacement of Bridge No. 9 on NC 55 over Jericho Run in Lenoir County. Federal Project No. BRSTP-55(21), State Project No. 8.1151401, WBS Element 33519.1.1, T.I.P. No. B-4172.

Lenoir County
Bridge No. 9 on NC 55 Over Jericho Run
Federal-Aid Project No. BRSTP-55(21)
State Project No. 33519.1.1
T.I.P. Project No. B-4172

CATEGORICAL EXCLUSION
UNITED STATES DEPARTMENT OF TRANSPORTATION
FEDERAL HIGHWAY ADMINISTRATION
AND
NORTH CAROLINA DEPARTMENT OF TRANSPORTATION

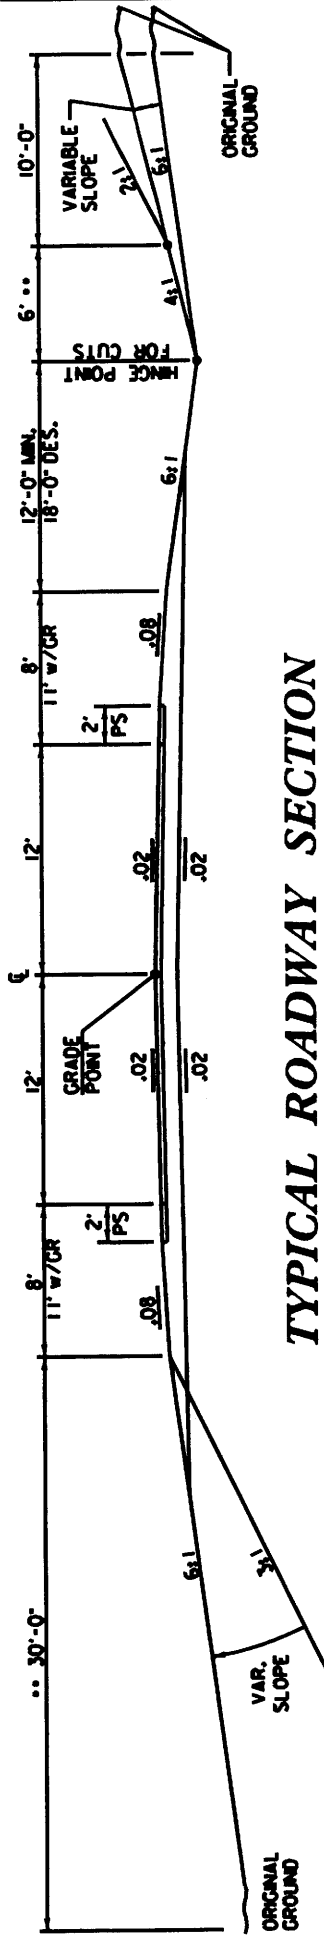
TYPICAL ROADWAY SECTION

.. WHEN THESE DISTANCES INDICATE SLOPES OUTSIDE THE LIMITS 6:1 TO 3:1, THE DISTANCE BECOMES VARIABLE AND THE MAX. OR MIN. SLOPE MAINTAINED.

**FUNCTIONAL CLASSIFICATION:
 RURAL MAJOR COLLECTOR**

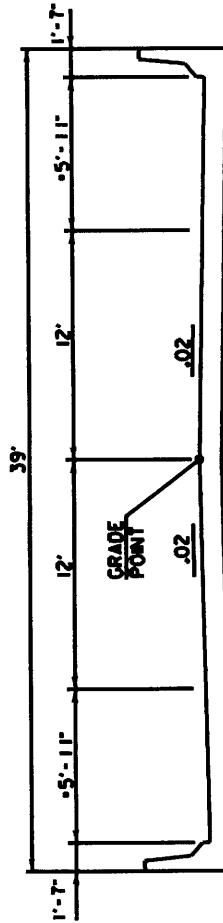
TYPICAL BRIDGE SECTION

EXISTING BRIDGE LENGTH IS 22 FT.

Based on a preliminary hydraulic analysis, Bridge No. 9 will be replaced with an approximate 110-foot long bridge. The grade of the roadway will match the elevation of the existing roadway since lowering the grade could cause the road to be flooded by Jericho Run. The minimum deck grade will be 0.3%. The length of the proposed bridge and the recommended roadway elevation may be adjusted (increased or decreased) to accommodate design floods as determined in the final hydrologic study and hydraulic design.
