Subject: **Application for Section 404 Nationwide Permit 14 and Section 401 Water Quality Certification under USACE Emergency Permitting Provisions for Hurricane Helene Response** for the Proposed Replacement of Bridge 125 on SR 1306 (Hicks Hollow Road) over the Elk River in Avery County, Division 11, TIP No. B-5835, Debit \$323 from WBS 45788.1.2.

The North Carolina Department of Transportation (NCDOT) proposes to replace bridge number 125 on SR 1306 (Hicks Hollow Road) over the Elk River with a new bridge to the immediate north of the previous location.

LOCATION: REPLACE BRIDGE NO. 125  
OVER ELK RIVER ON SR 1306

TIP PROJECT: B-5835

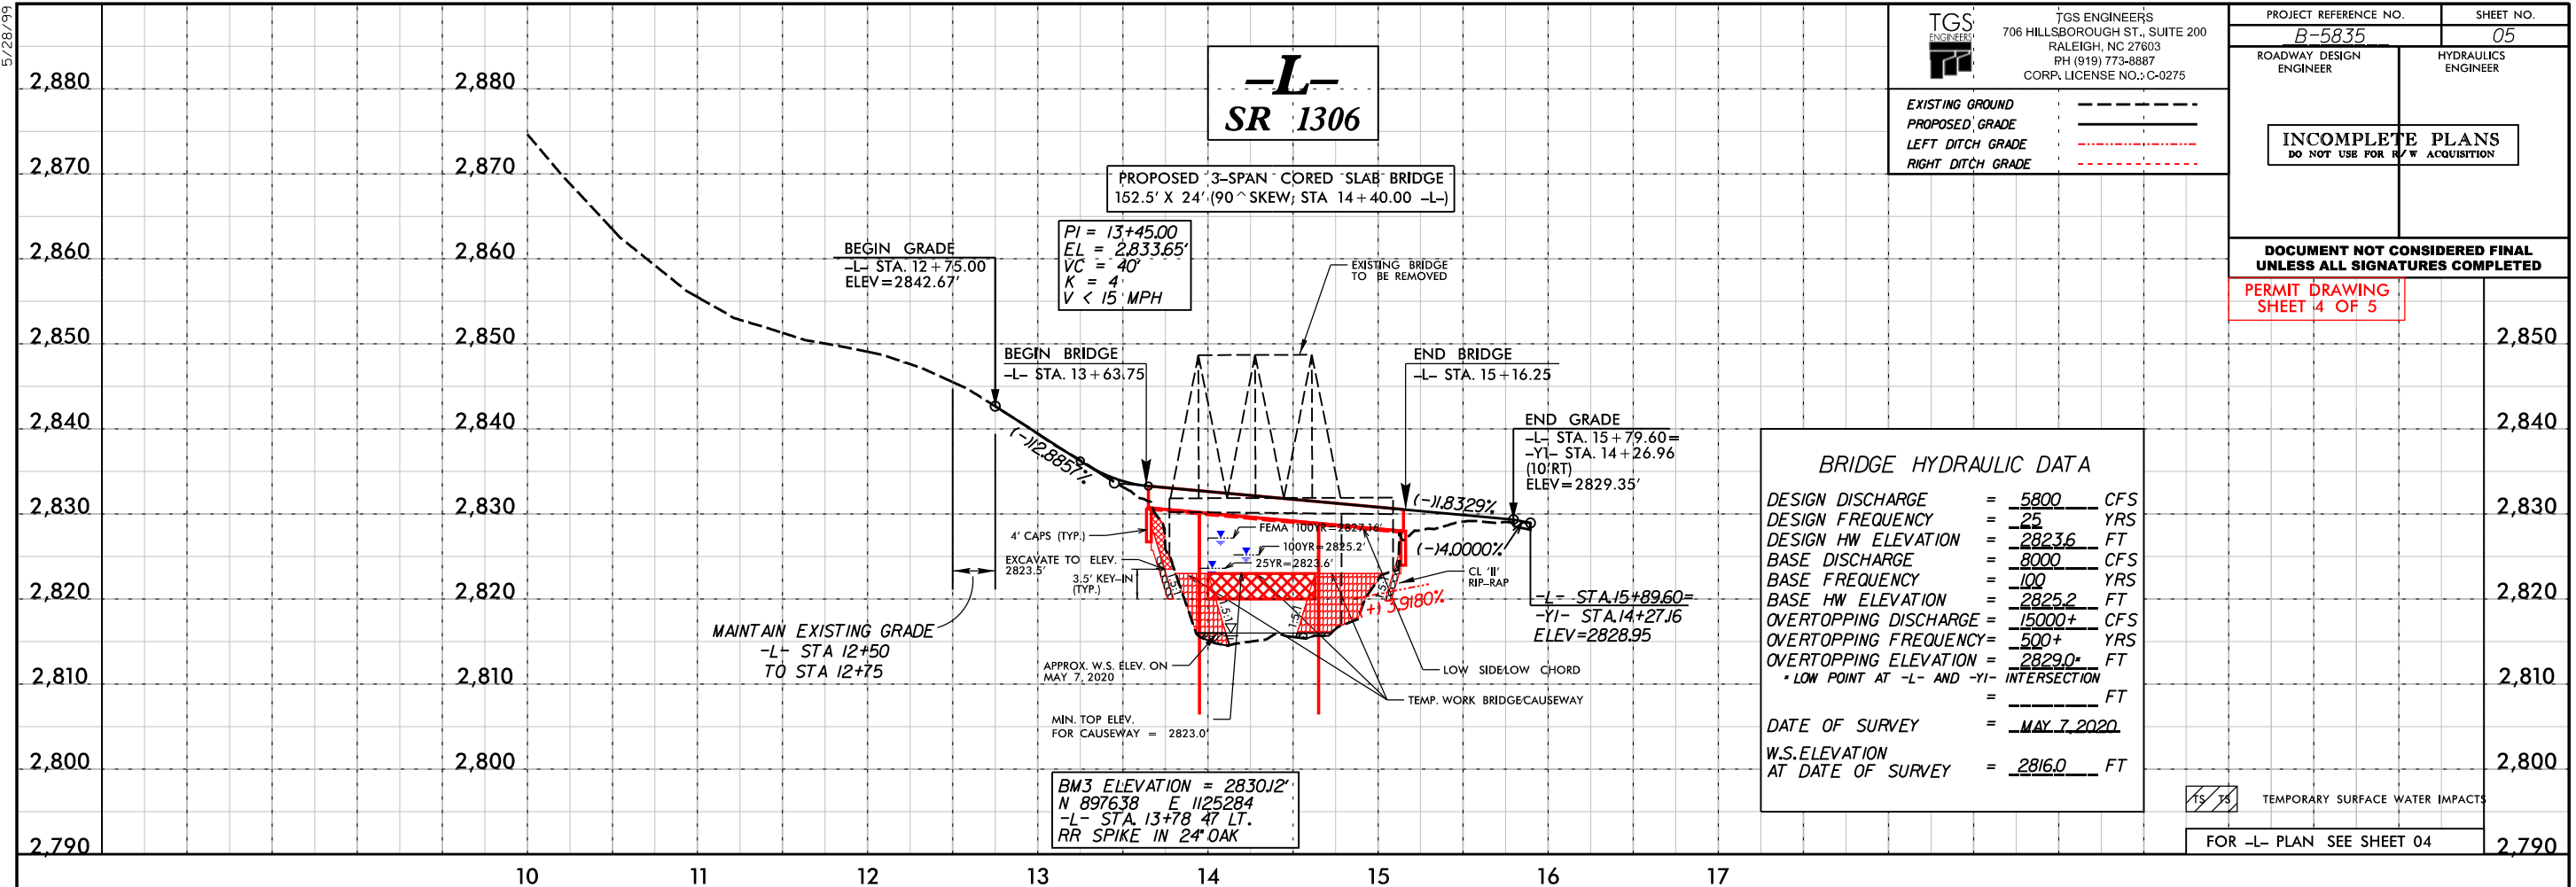
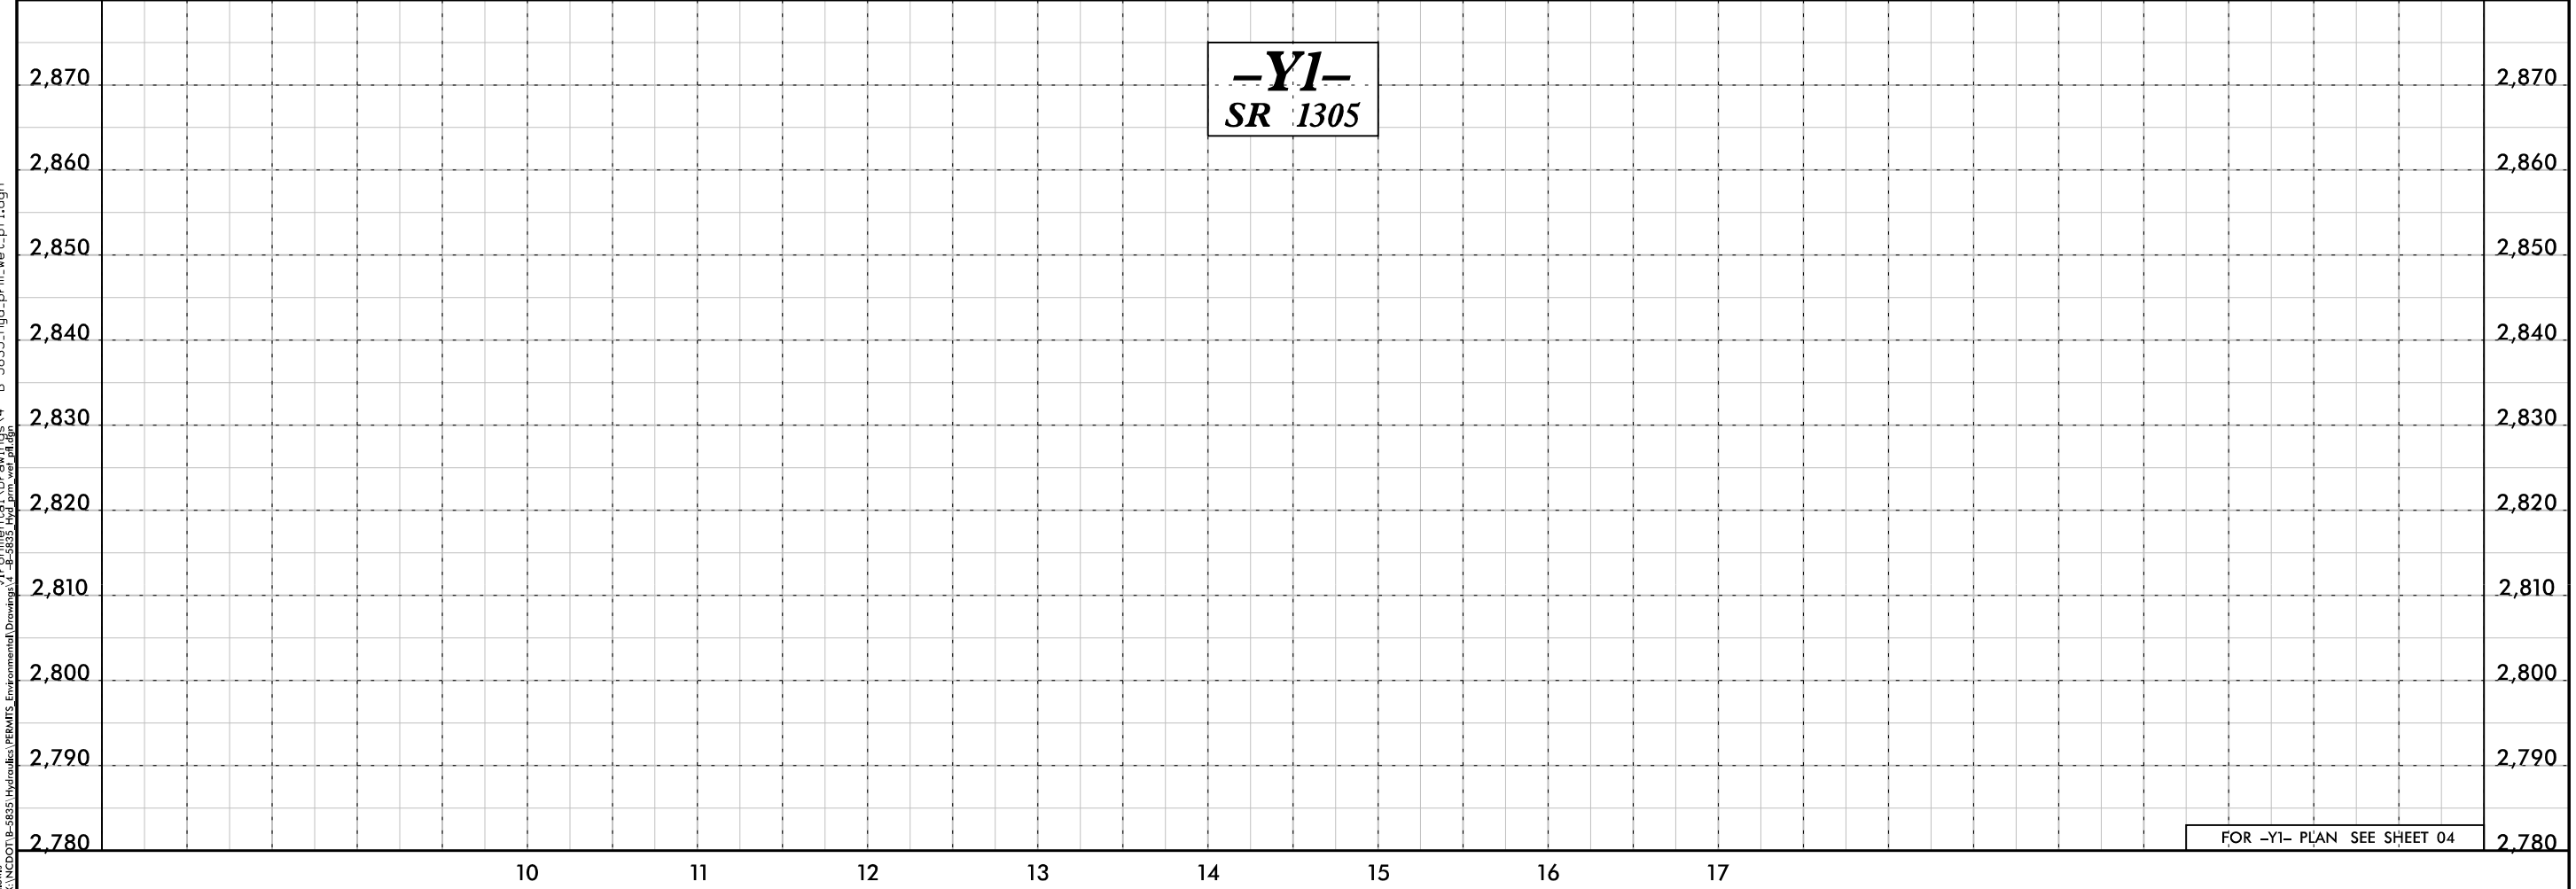
PERMIT DRAWING  
SHEET 4 OF 5

**WETLAND AND SURFACE WATER IMPACTS SUMMARY**

Site No.	Station (From/To)	Structure Size / Type	WETLAND IMPACTS					SURFACE WATER IMPACTS				
			Permanent Fill In Wetlands (ac)	Temp. Fill In Wetlands (ac)	Excavation in Wetlands (ac)	Mechanized Clearing in Wetlands (ac)	Hand Clearing in Wetlands (ac)	Permanent SW impacts (ac)	Temp. SW impacts (ac)	Existing Channel Impacts Permanent (ft)	Existing Channel Impacts Temp. (ft)	Natural Stream Design (ft)
1A	13+85 to 14+85	Causeway/Work Bridge						0.06		67		
1B	13+90	Bank Stabilization						< 0.01		6		
1C	14+78	Bank Stabilization						< 0.01		6		
<b>TOTALS*:</b>								< 0.01	0.06	12	67	0

3a. Reason for impact* (?)	3b. Impact type*	3c. Type of impact*	3d. S. name*	3e. Stream Type* (?)	3f. Type of Jurisdiction*	3g. S. width*	3h. Impact length*
S1	Site 1A - Causeway/Work Bridge	Temporary	Workpad/Causeway	Elk River	Perennial	Both	39 Average (feet)	67 (linear feet)
S2	Site 1B - Bank Stabilization	Permanent	Bank Stabilization	Elk River	Perennial	Both	39 Average (feet)	6 (linear feet)
S3	Site 1C - Bank Stabilization	Permanent	Bank Stabilization	Elk River	Perennial	Both	39 Average (feet)	6 (linear feet)

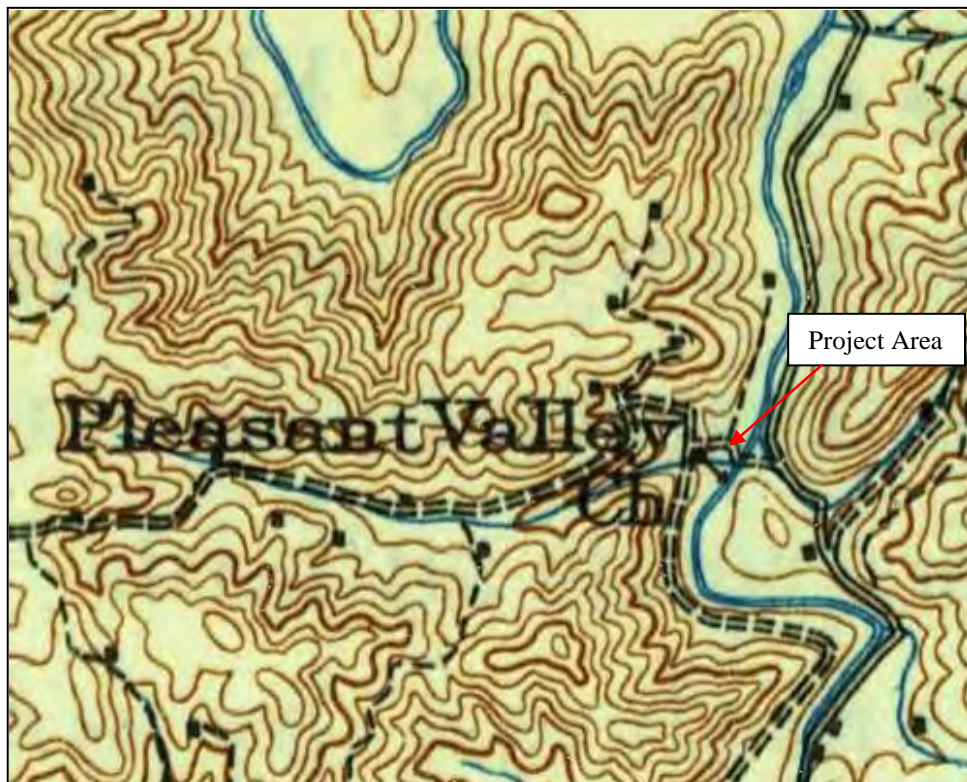
**Figure 3.** 1934 map showing project area (1934 USGS *Elk Park, NC*, 1:24,000 scale topographic map).

A review of the historic maps including the 1938 Avery County Highway map (NCSHPWC 1938) and USGS topographic maps dating from 1893 to 1960 (USGS 1893, 1895, 1899, 1902, 1934, 1944, 1953, 1955, 1960), depict the area as extremely remote and very sparsely populated. The 1934 USGS topographic map is the first to show SR 1306 and Pleasant Valley Church (Figure 3). The 1934 and 1940 USGS topographic maps show SR 1306 following a different course than the current road, suggest this road was rerouted before 1960. The 1960 USGS map shows the roads as they are currently and depicts three structures in the project vicinity (Figure 4). One of these is the Pleasant Valley Church located in the northwest quadrant, on the north side of SR 1306. This church is still in use. In general, the historic maps show little development in the area throughout the twentieth century.

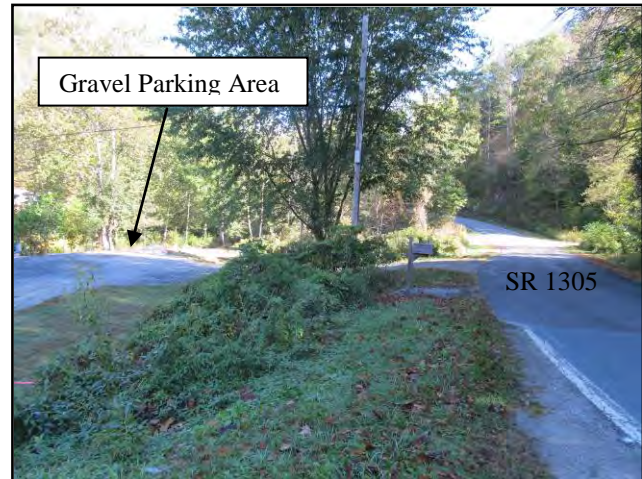
**Figure 8.** View of western portion of the northeast quadrant, looking north/northeast.

*Northeast Quadrant.* The APE in the northeast quadrant primarily encompasses a floodplain between the bridge and SR 1305 (Figure 7). A campground is located in this area. The campground is characterized by a gravel area in the southern portion of the quadrant and a grassy area for campfires in the central portion of the quadrant. A transmission line also extends across this portion of the quadrant. Two recreational vehicles were parked on the gravel area of campground and a permanent building utilized as a washhouse is located in this vicinity, just north of the bridge. The campground can be accessed by a gravel driveway that extends west from SR 1305. Skalley Creek joins the Elk River just north of the bridge on the western side of the SR 1305. Also, a small unnamed creek parallels the western side of SR 1305. This creek separates the campground area from a small linear segment of land on the western side of SR 1305. A dirt path runs north through this segment of the quadrant. The eastern side of SR 1305 is characterized by wooded steep slope (Figure 8). An old gravel road extends east from SR 1305, across from the campground.

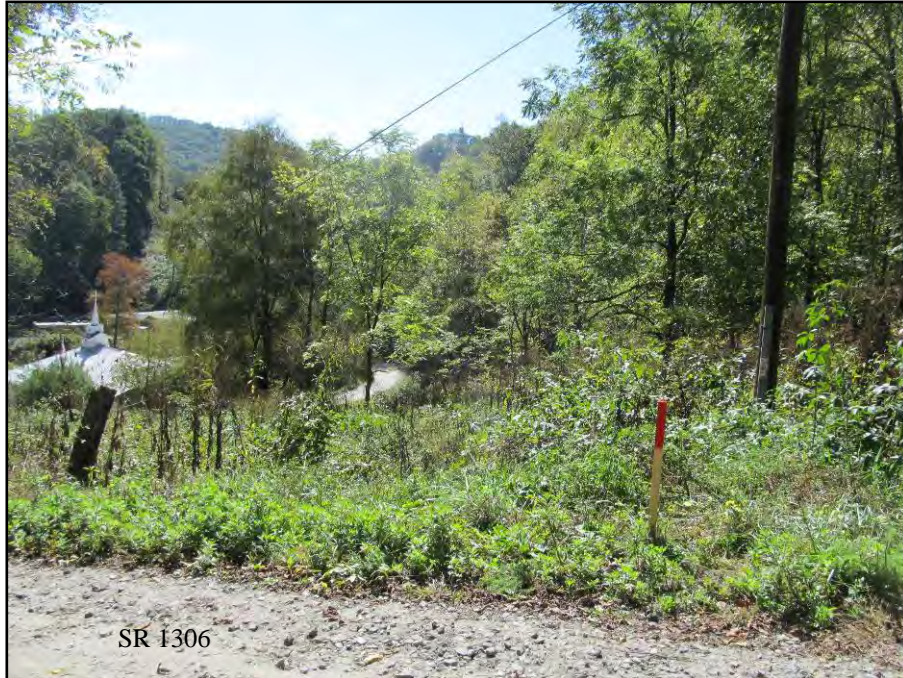
**Figure 9.** View of western portion of the northwest quadrant, looking south.

*Northwest Quadrant.* The northwest quadrant is characterized primarily by wooded ridge side slope in the northern and western portions of the quadrant (Figure 9) and by a strip of grassy floodplain adjacent to the river in the eastern portion of the quadrant (Figure 10). Pleasant Valley Church is situated on the eastern side of SR 1306 on a terrace overlooking Elk River (Figure 11). As mentioned above, this church is first mapped on the 1934 topographic map (USGS 1934; see Figure 3). A gravel parking lot is located east and north of the church and a gravel driveway leads from the church and intersects SR 1306 just west of Bridge No. 125. A second gravel driveway diverges from SR 1306 in the northern portion of the quadrant. This driveway leads to a currently occupied residence. A small outbuilding is located on the eastern side of the gravel drive (Figure 12).

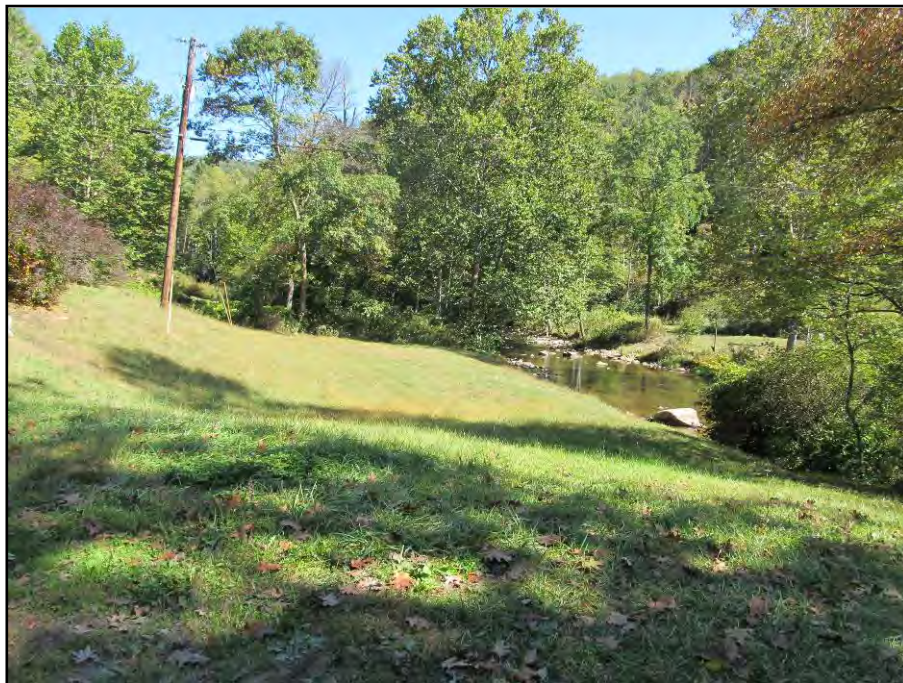
**Figure 10.** View of grassy floodplain in the northwest quadrant, looking northeast.

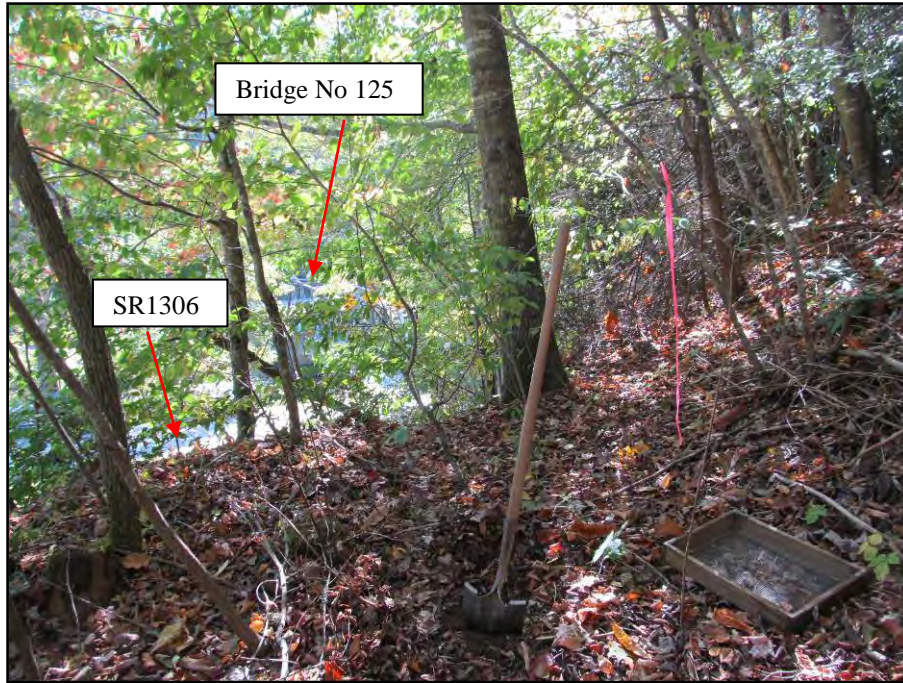
**Figure 13.** View of slope in southwest quadrant, looking southeast.

*Southwest Quadrant.* The southwest quadrant consists of steep ridge side slope characterized by hardwoods (Figure 13). A gravel drive intersects SR 1306 just west of the bridge and meanders up the slope (Figure 14).

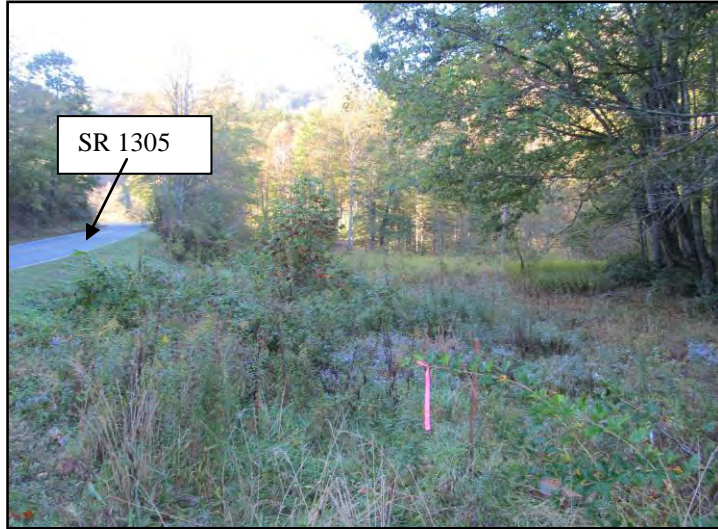
**Figure 15.** View of floodplain in southeast quadrant, looking south/southwest.

*Southeast Quadrant.* The southeast quadrant encompasses a segment of floodplain vegetated with tall brush and scattered hardwoods between Elk River and SR 1305 (Figure 15). Ridge toe slope encroaches into the southern portion of this segment of the quadrant. Also, an old road bed runs through the southwestern portion of the quadrant (see Figures 5 and 6). Ridge toe slope, characterized by mixed pines and hardwoods, is the dominant landform on the eastern side of SR 1305. A small grassy level area is located at the base of the ridge toe in the southern most portion of the quadrant on the eastern side of SR 1305.

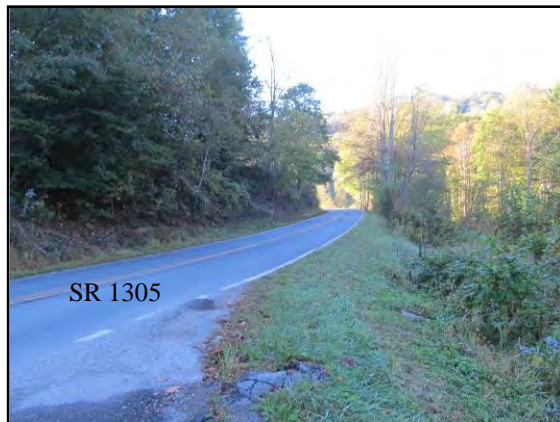
**Figure 16.** View of slope in eastern portion of the southeast quadrant, looking south.

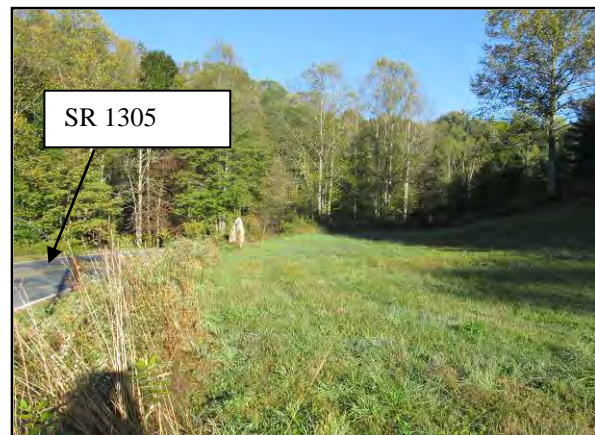
**Figure 17.** View of level area in eastern portion of the southeast quadrant, looking north.

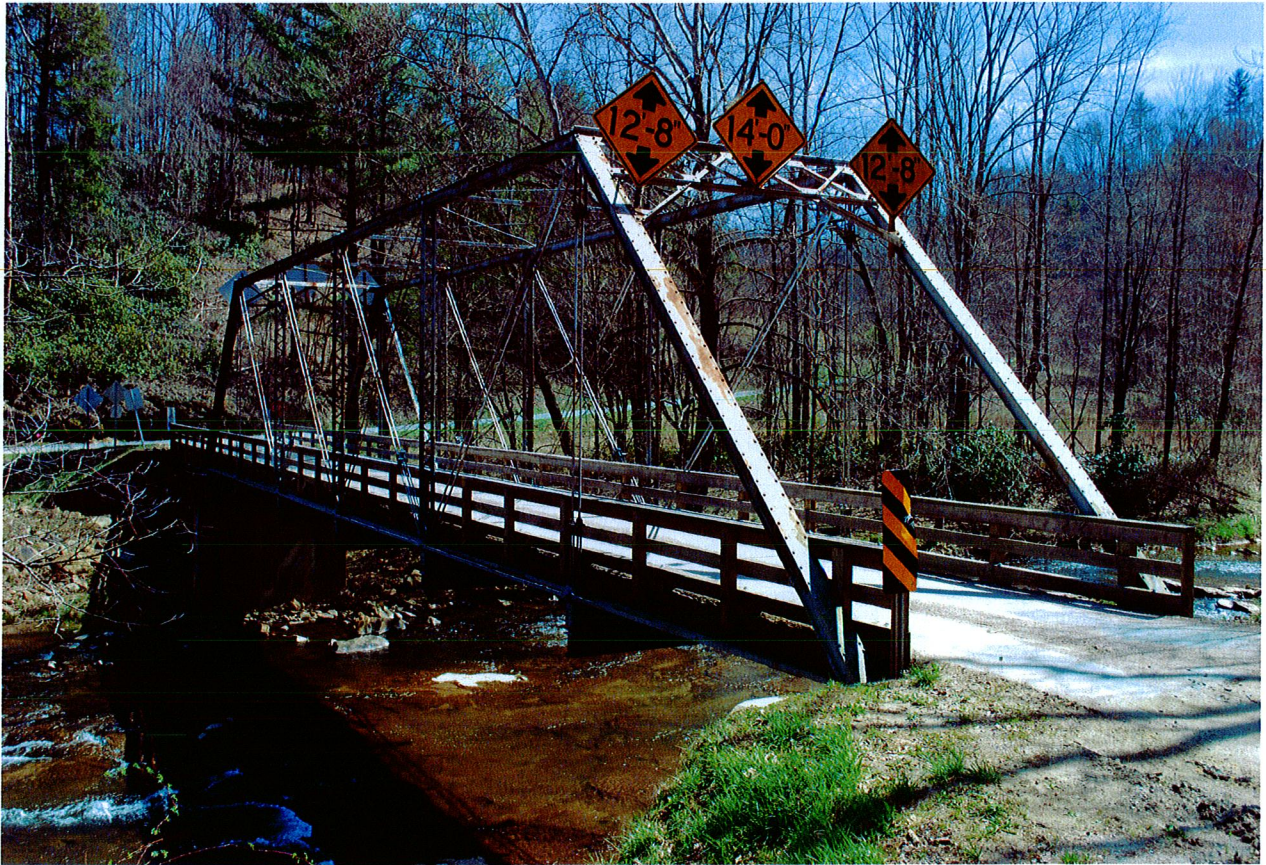
Avery County Bridge No. 125 (AV0125)

<b>Property Name:</b>	Avery County Bridge No. 125	<b>Status:</b>	DOE
<b>Survey Site No.:</b>	AV0125	<b>PIN:</b>	
<b>Effects</b> <input type="checkbox"/> No Effect <input type="checkbox"/> No Adverse Effect <input checked="" type="checkbox"/> Adverse Effect			
<b><u>Explanation of Effects Determination:</u></b> The bridge will be dismantled and removed from its location.

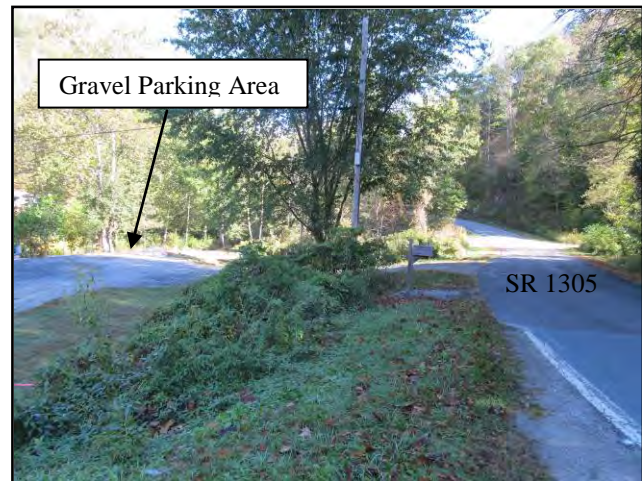
**Figure 8.** View of western portion of the northeast quadrant, looking north/northeast.

*Northeast Quadrant.* The APE in the northeast quadrant primarily encompasses a floodplain between the bridge and SR 1305 (Figure 7). A campground is located in this area. The campground is characterized by a gravel area in the southern portion of the quadrant and a grassy area for campfires in the central portion of the quadrant. A transmission line also extends across this portion of the quadrant. Two recreational vehicles were parked on the gravel area of campground and a permanent building utilized as a washhouse is located in this vicinity, just north of the bridge. The campground can be accessed by a gravel driveway that extends west from SR 1305. Skalley Creek joins the Elk River just north of the bridge on the western side of the SR 1305. Also, a small unnamed creek parallels the western side of SR 1305. This creek separates the campground area from a small linear segment of land on the western side of SR 1305. A dirt path runs north through this segment of the quadrant. The eastern side of SR 1305 is characterized by wooded steep slope (Figure 8). An old gravel road extends east from SR 1305, across from the campground.

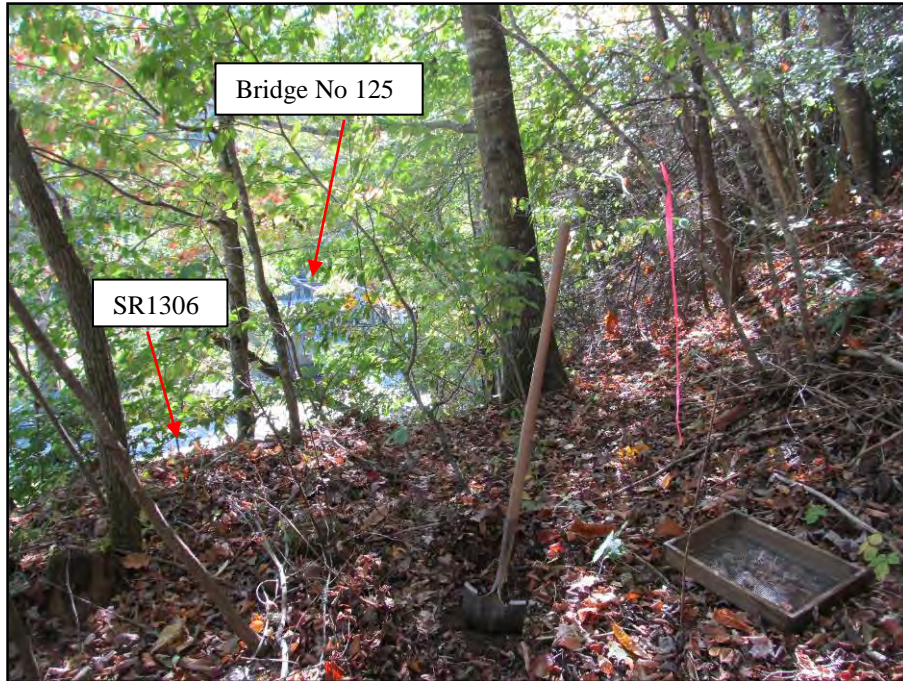
**Figure 13.** View of slope in southwest quadrant, looking southeast.

*Southwest Quadrant.* The southwest quadrant consists of steep ridge side slope characterized by hardwoods (Figure 13). A gravel drive intersects SR 1306 just west of the bridge and meanders up the slope (Figure 14).

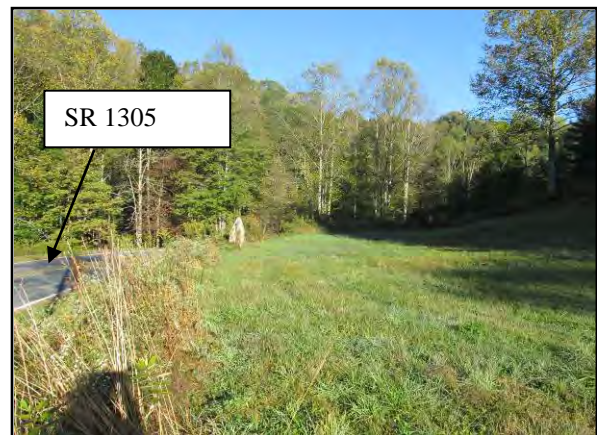
**Figure 17.** View of level area in eastern portion of the southeast quadrant, looking north.
