Subject: **Application for Section 404 Nationwide Permit 14 and 401 Water Quality Certification** for the proposed replacement of Bridge No. 190002 on NC 141 over Slow Creek in Cherokee County, Division 14, TIP No. BR-0011.
Debit \$240 from WBS 67011.1.1.

Replacement of Bridge 190002 on NC 141 over Slow Creek

**PERMIT DRAWING
SHEET 1 OF 7**

TIP PROJECT: BR-0011

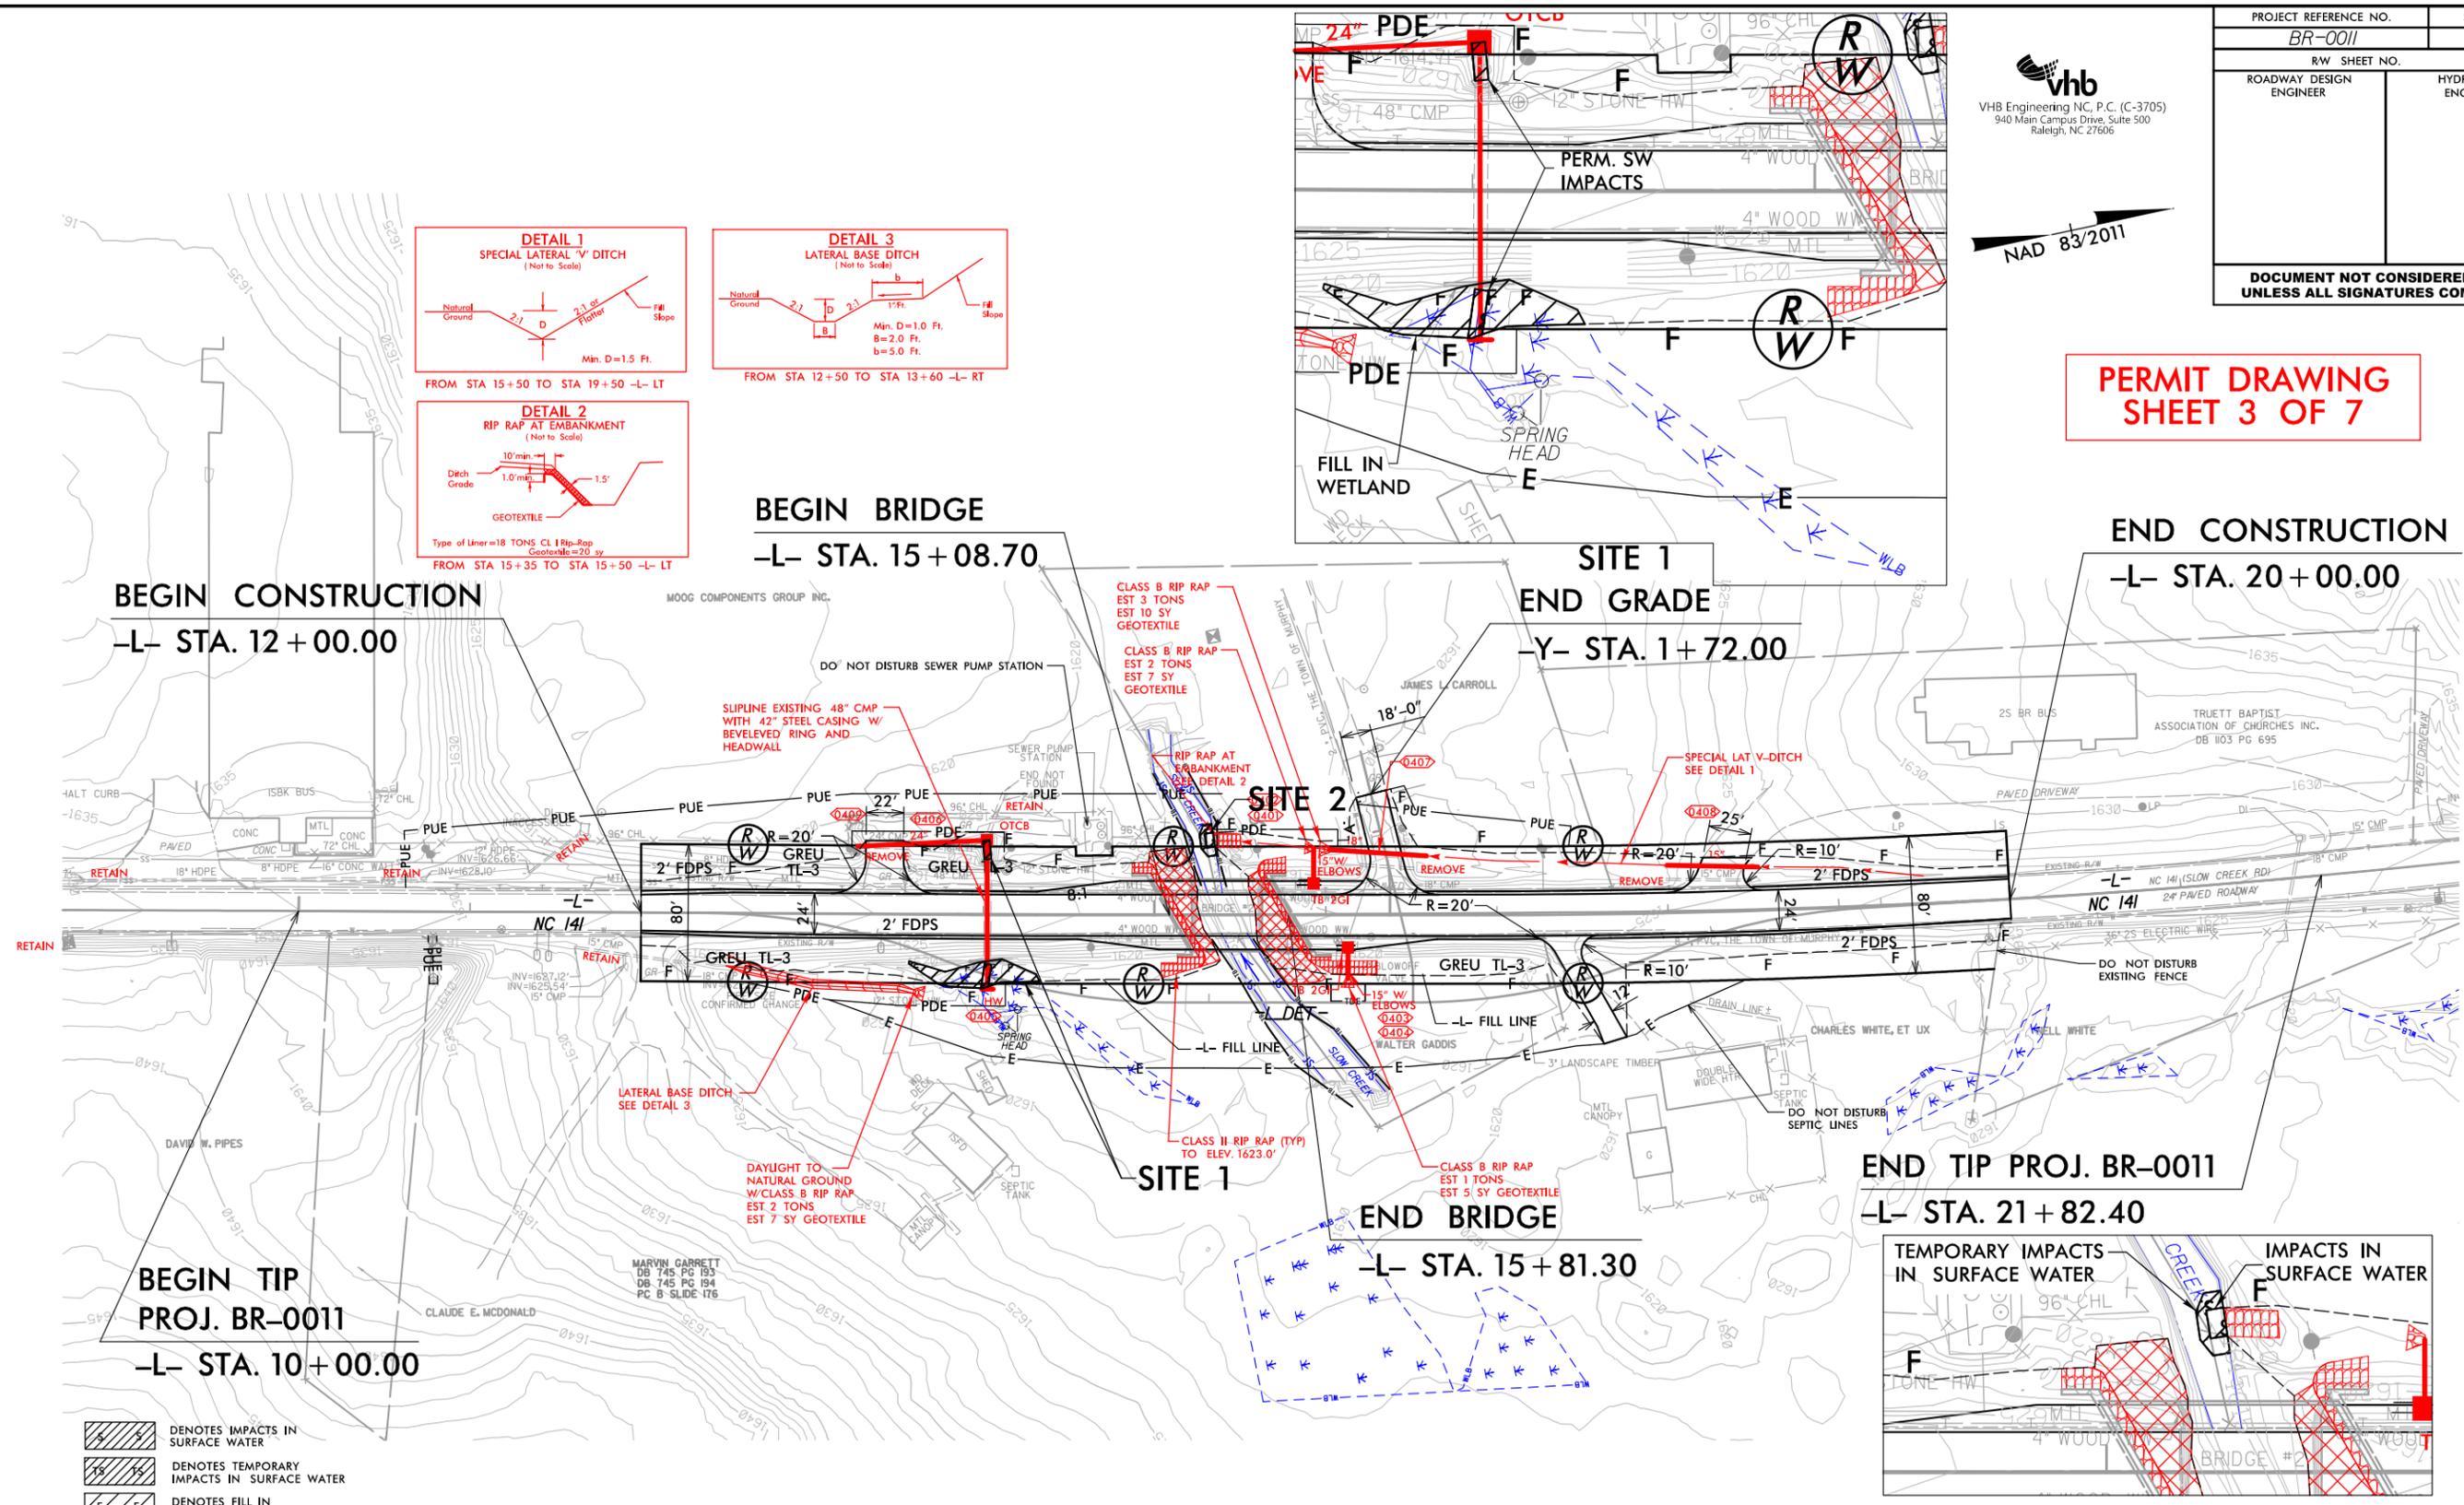
**PERMIT DRAWING
SHEET 3 OF 7**

- DENOTES IMPACTS IN SURFACE WATER
- DENOTES TEMPORARY IMPACTS IN SURFACE WATER
- DENOTES FILL IN WETLAND

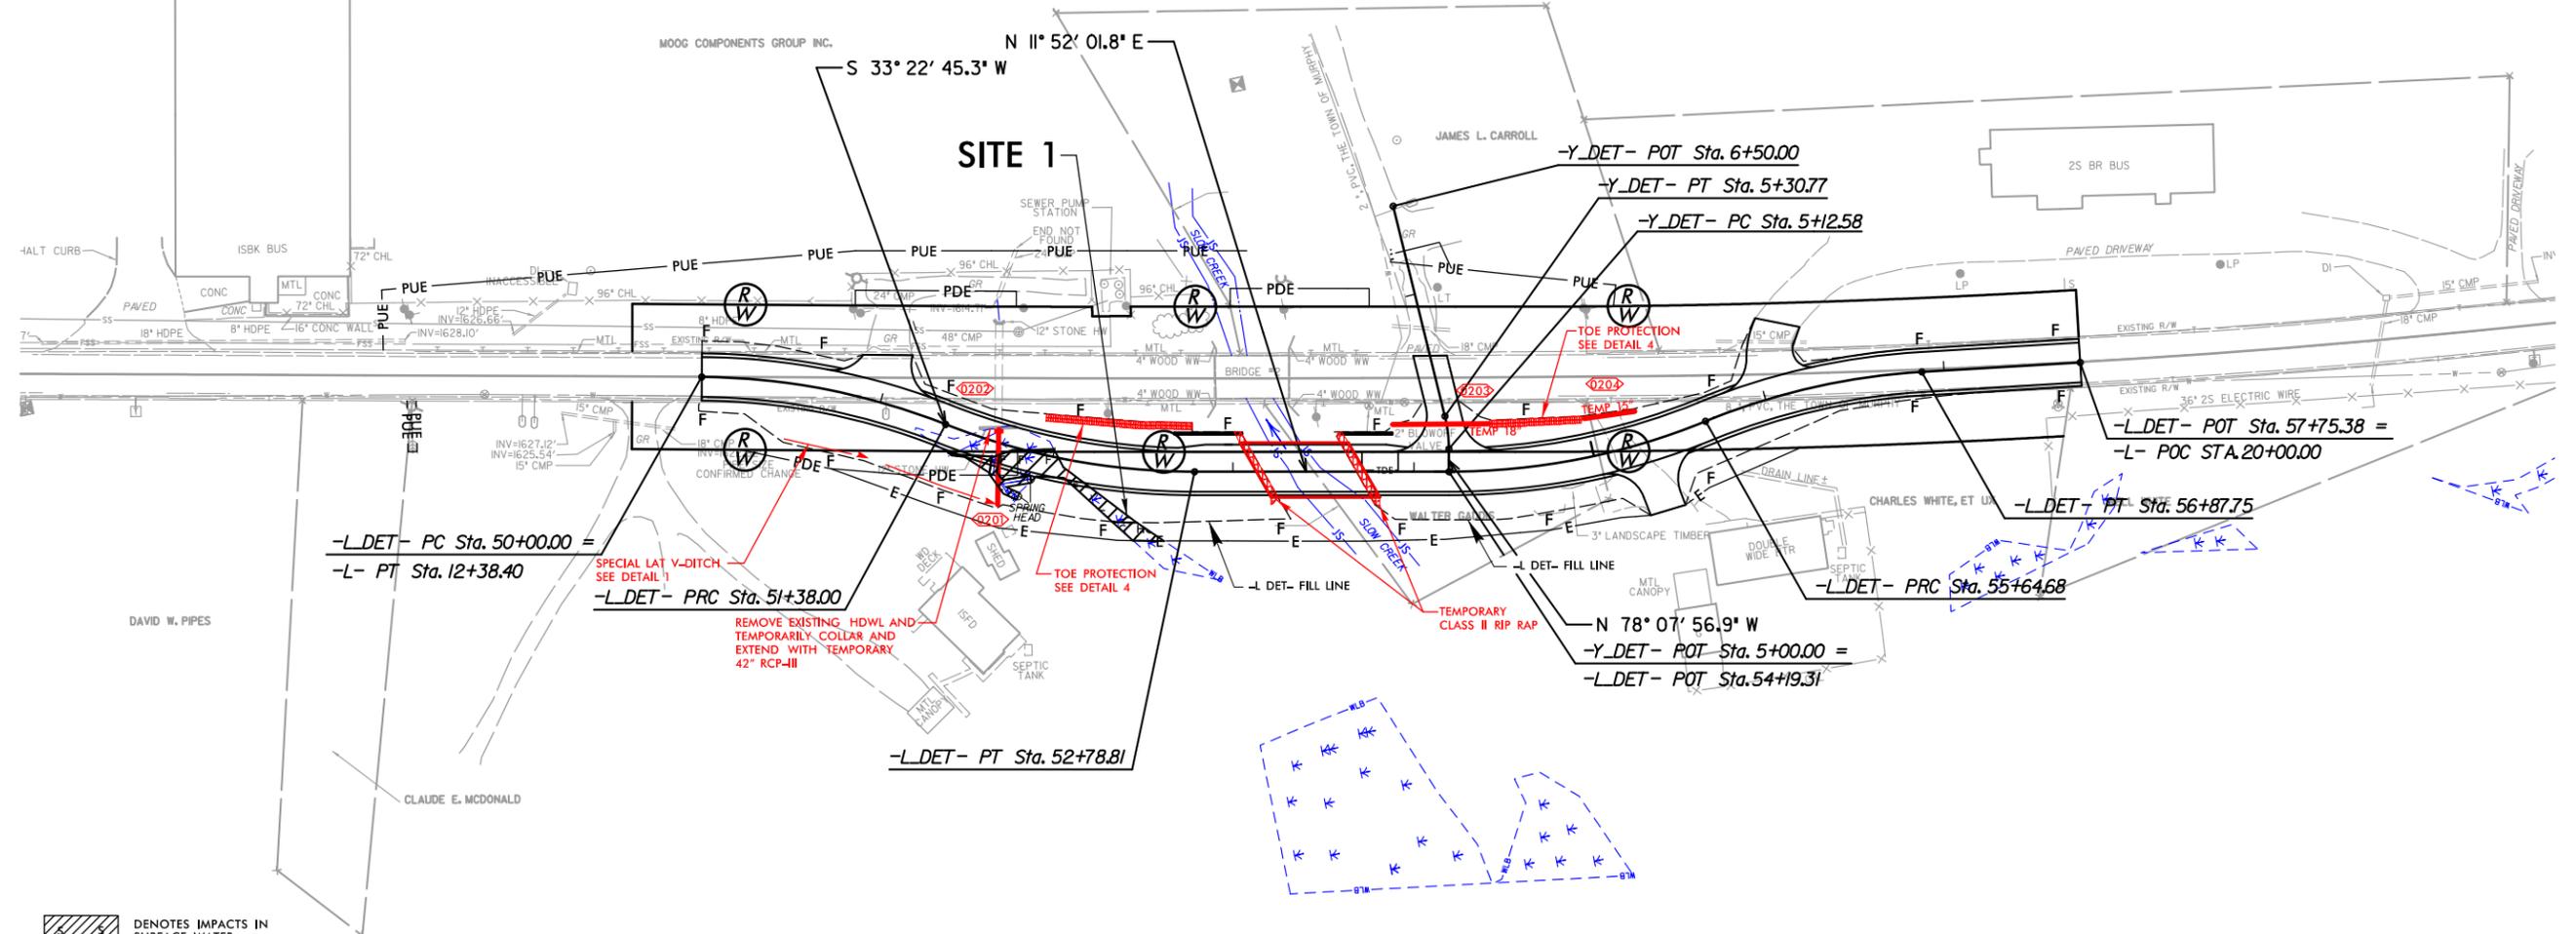
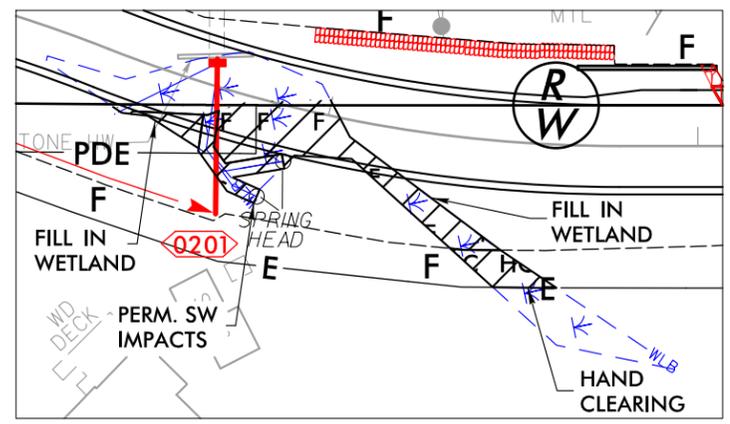
SITE 1

FROM STA 51+90 TO STA 52+78 -L-DET-RT
FROM STA 54+40 TO STA 55+00 -L-DET-RT

- DENOTES IMPACTS IN SURFACE WATER
- DENOTES HAND CLEARING
- DENOTES FILL IN WETLAND

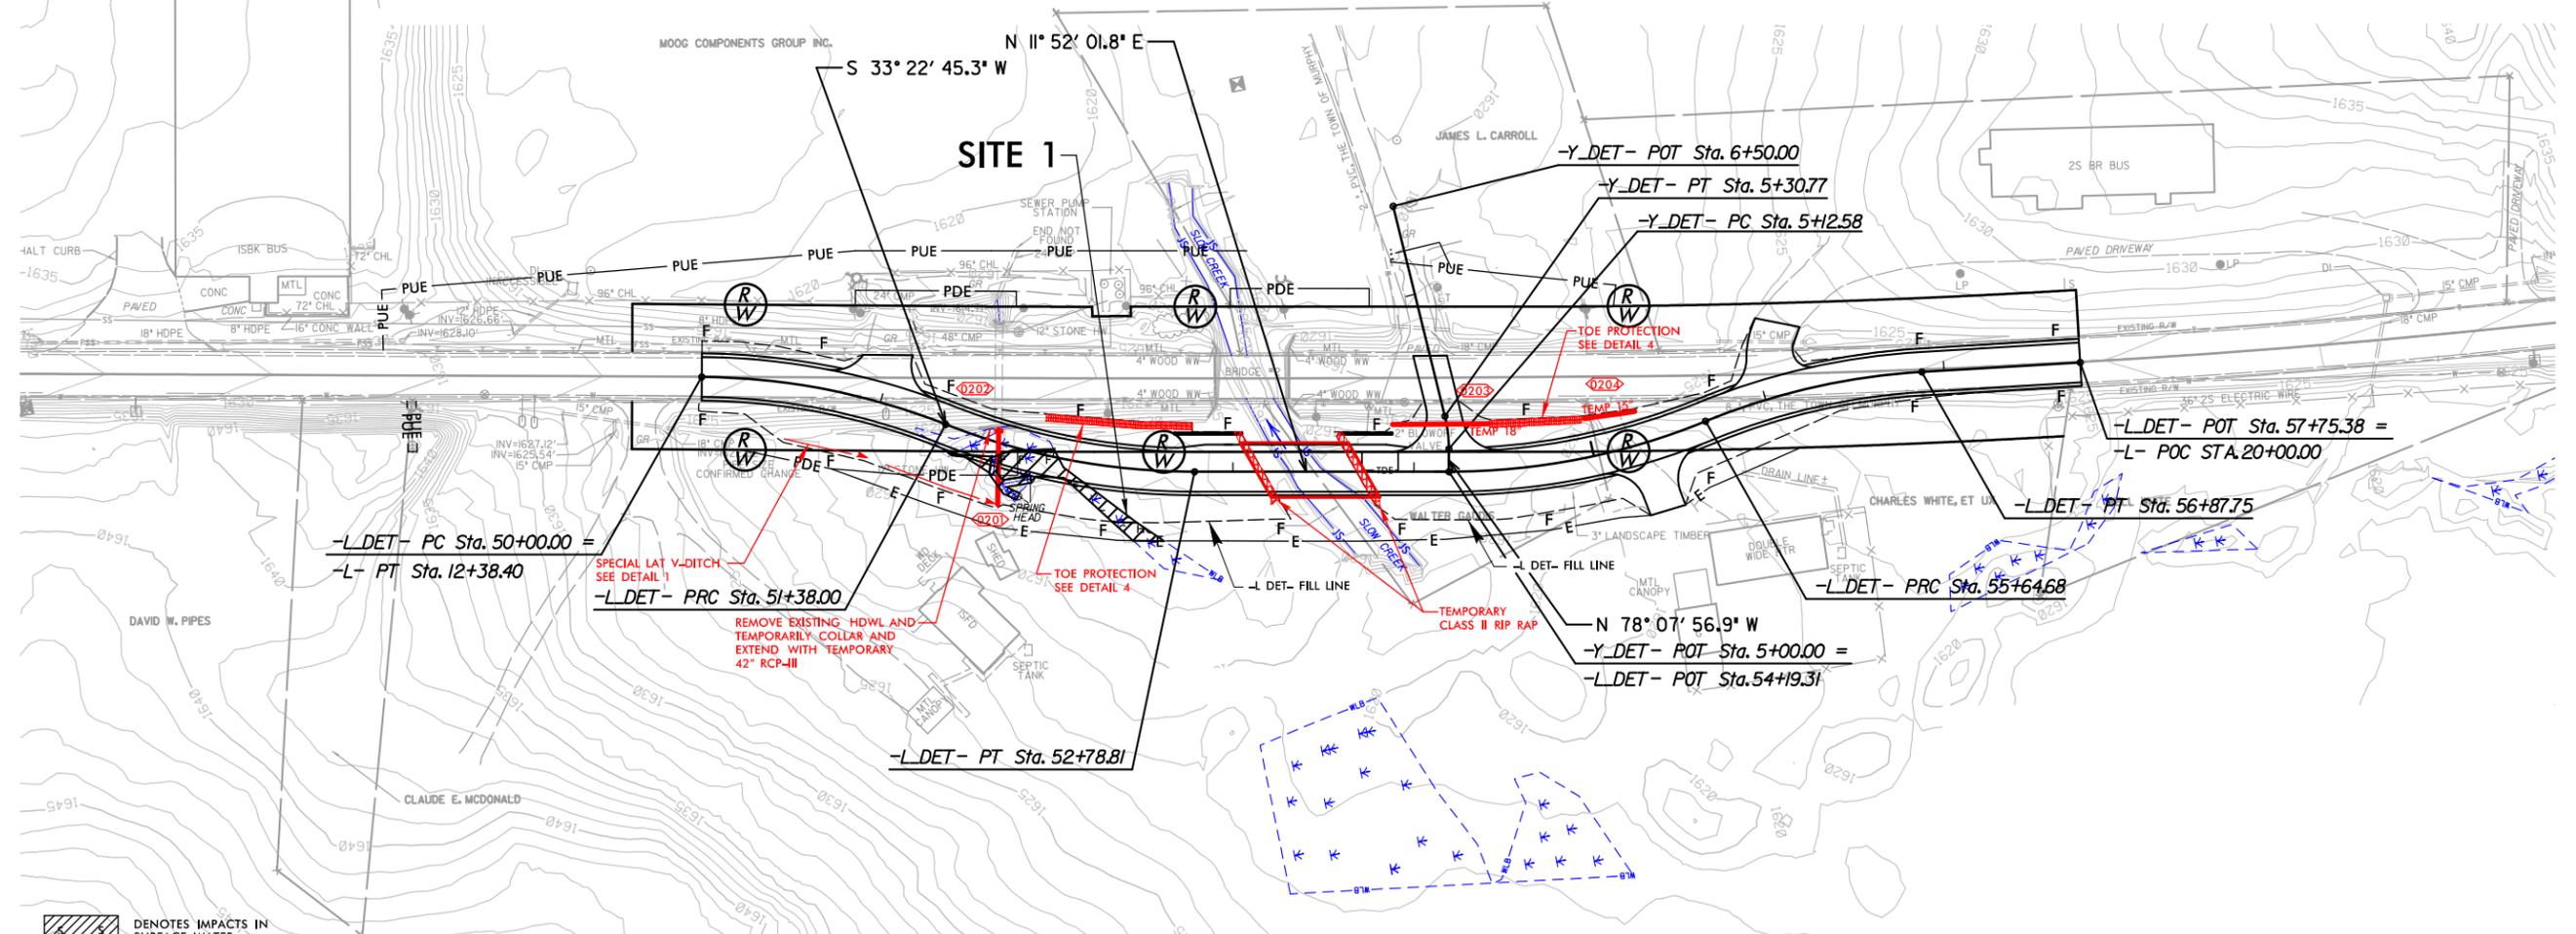
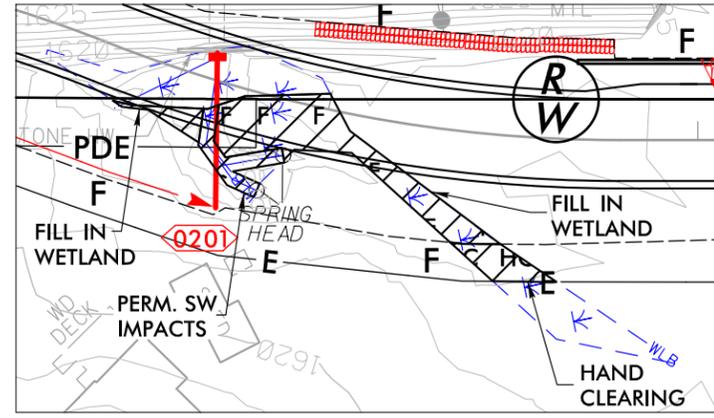
PERMIT DRAWING
SHEET 5 OF 7

Type of Liner = CLASS B Rip-Rap
FROM STA 51+90 TO STA 52+78 -L-DET-RT
FROM STA 54+40 TO STA 55+00 -L-DET-RT

- DENOTES IMPACTS IN SURFACE WATER
- DENOTES HAND CLEARING
- DENOTES FILL IN WETLAND

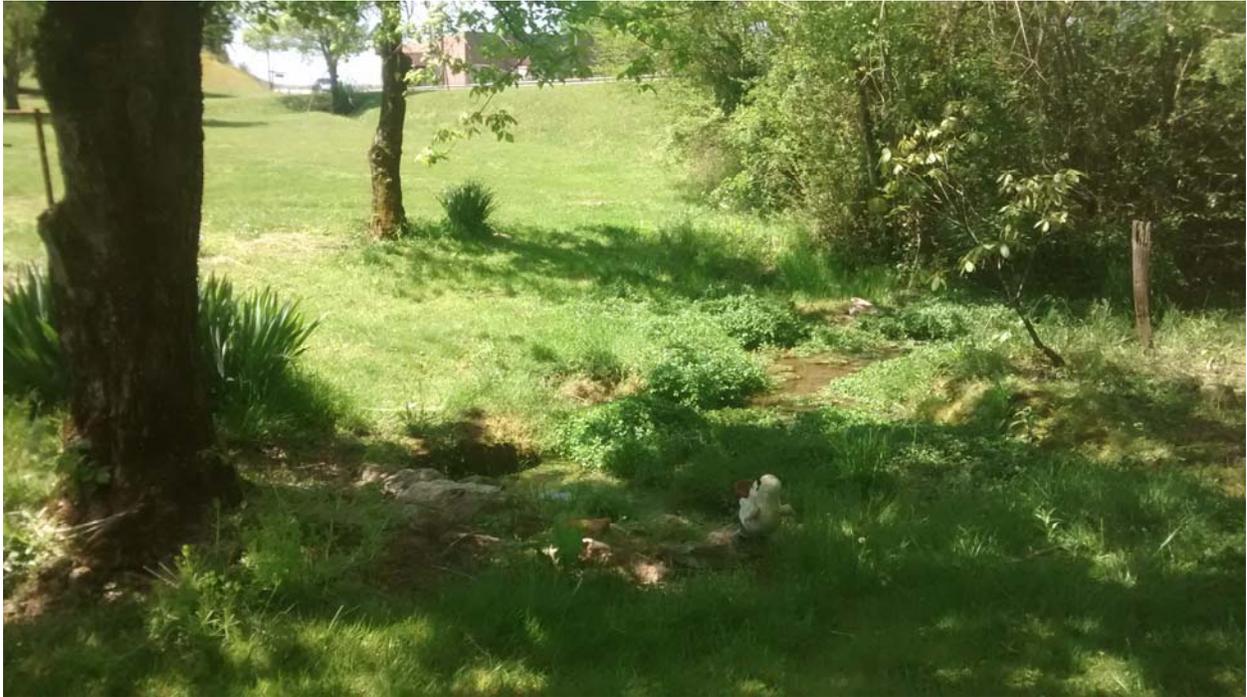
Figure 8. Map of Site 31CE853

Ten 15-meter-interval shovel tests were excavated during the survey and Site 31CE853 evaluation (Figure 8). These tests uncovered 30 centimeters of dark brown (10YR 3/3) silty clay overlying dark yellowish brown (10YR 4/4) clay subsoil (Figure 9). The lower depths of several tests nearest the spring and creek encountered the water table. Four tests yielded artifacts from depths of zero to 40 centimeters below ground surface and indicated the site measures 25x53 meters.

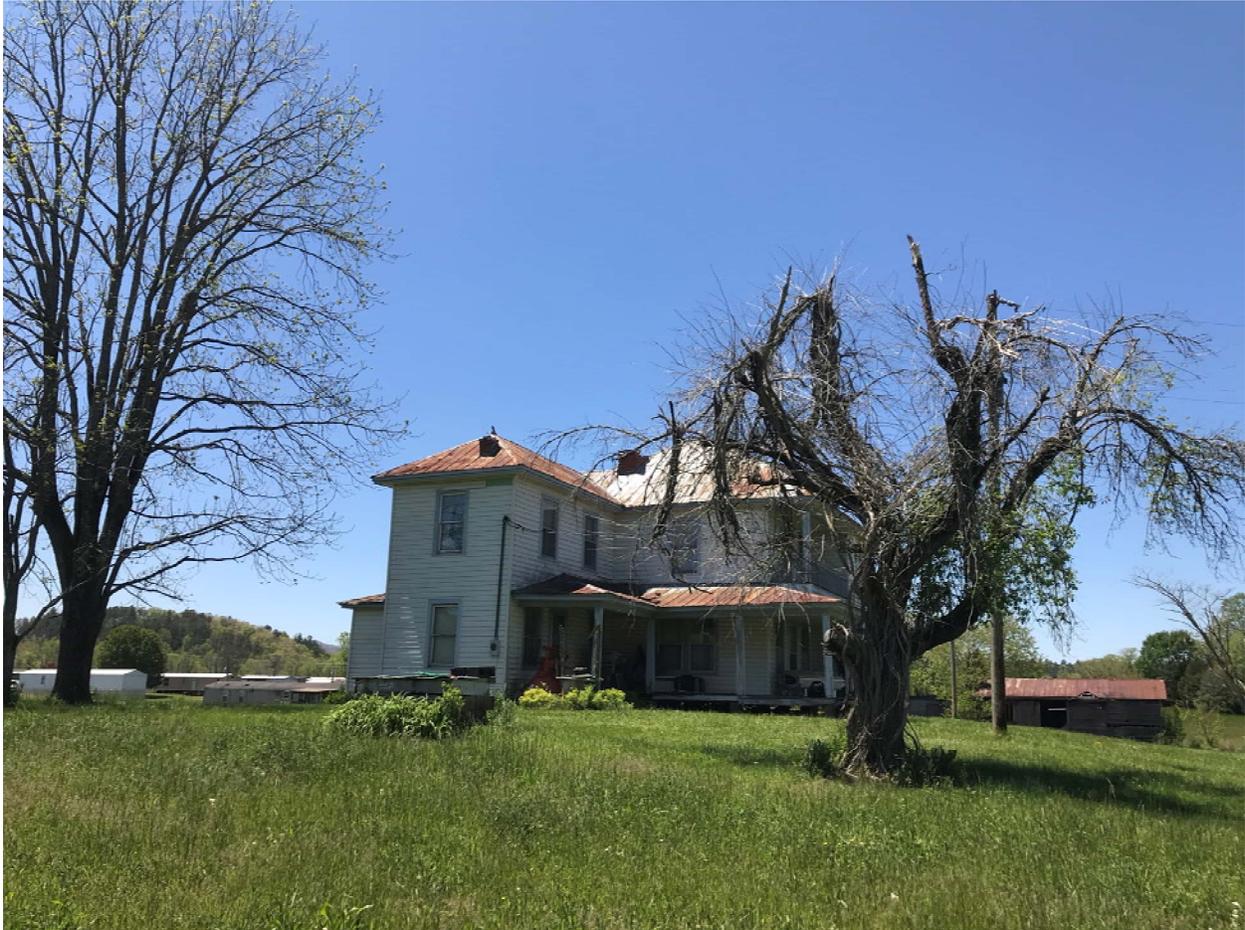
Figure 11. Map of Site 31CE854

Eleven 15-meter and 7.5-meter shovel tests were excavated at site 31CE854 (Figure 11). These tests revealed 15-35 centimeters of dark brown (7.5YR 3/3) clayey loam overlying five to 10 centimeters of reddish yellow (5YR 6/6) clay (Figure 12). All artifacts were collected from the upper strata (0-35 cmbs). Although no tests were excavated to the west of the APE boundary, the house, topography, and shovel test locations indicate site 31CE854 measures approximately 65 meters in diameter.

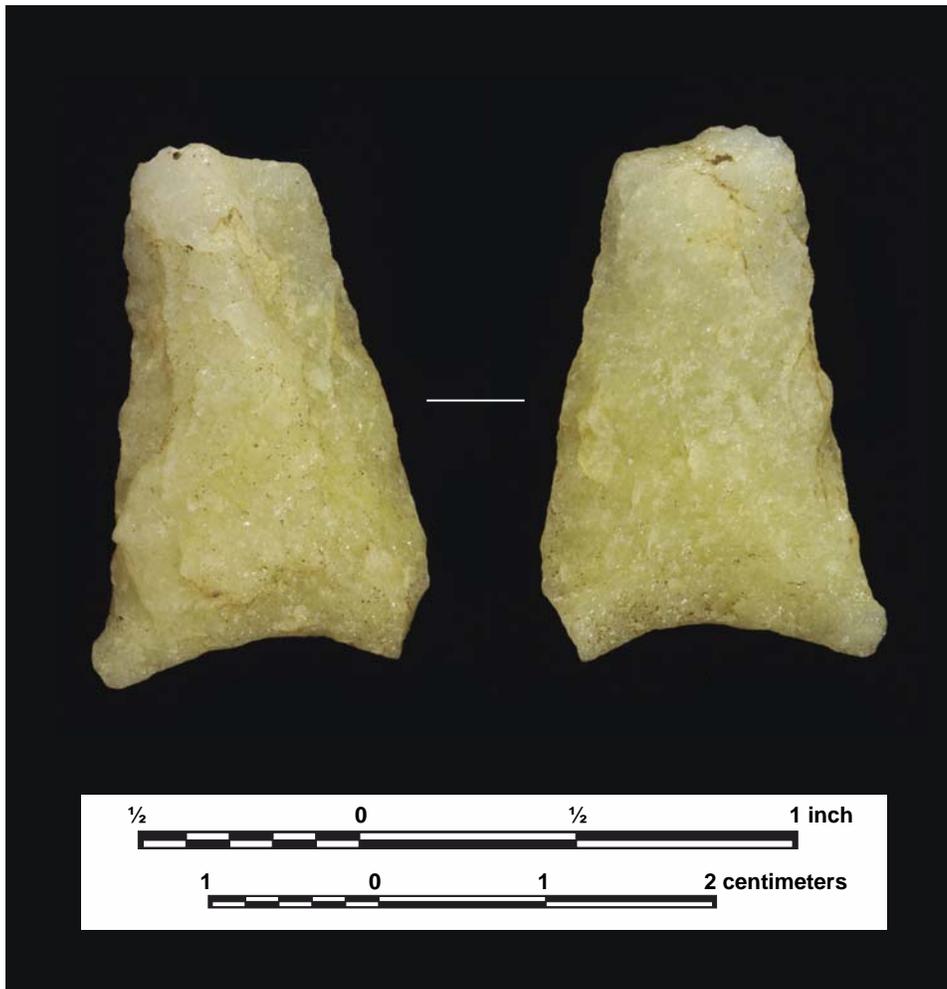
Figure 13. Garden Creek Triangular Projectile Point Fragment

There were 40 artifacts and five unmodified stones collected from six shovel tests at Site 31CE85 (Table 3). This assemblage includes one mostly complete quartzite triangular projectile point (Figure 13), which resembles the Middle Woodland period Garden Creek Triangular variety described by Keel (1987). There were also 39 historic artifacts collected from the site. Temporally diagnostic artifacts include cut nails, wire nails, amethyst glass, glass canning seals, whiteware, and plastic. The date ranges for these artifact types indicate a mid-nineteenth- to twentieth-century occupation date range (Miller et al. 2000; Nelson 1968). The 1921 Soil Survey Map of Cherokee County shows an occupied residence in the approximate location of the house. The current landowner, Mr. Douglas Sneed, also stated that his ancestor built the house in the early twentieth century. As the W.K. Johnson house stands close by, the historic artifact deposit likely resulted from household refuse disposal activity.

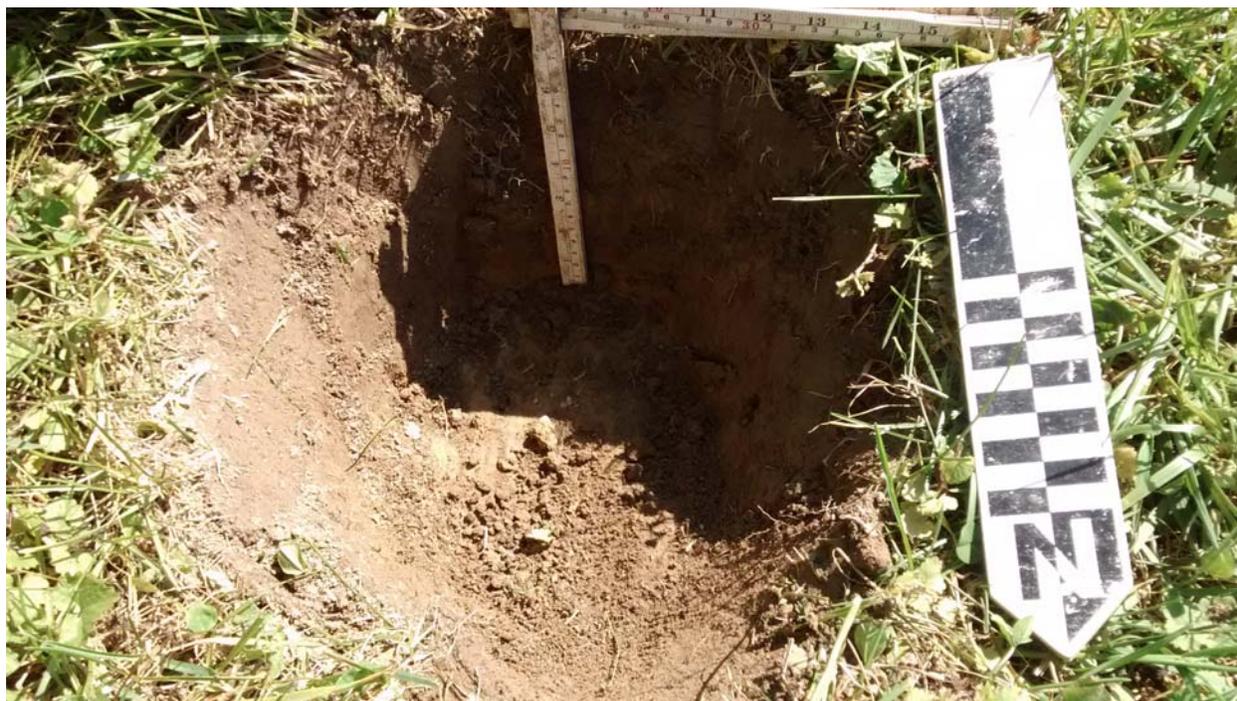
Figure 16. Site 31CE855 Shovel Test Profile

Twenty-two 15-meter- and 7.5-meter-interval shovel tests were excavated during the site delineation (Figure 15). These tests uncovered 15-34 centimeters of brown (10YR 5/3) silty loam overlying pale brown (10YR 6/3) or yellowish brown (10YR 5/4) clay subsoil (Figure 16). Seven tests, including the three survey tests, yielded artifacts between 0-25 centimeters below ground surface and indicated the site measures 58 meters in diameter.
