Subject: **Application for Modifications to Section 404 Individual Permit and Section 401 Water Quality Certification** for the proposed Havelock Bypass in Craven County.
TIP No. R-1015. Debit WBS 34360.1.2

TIP PROJECT: R-1015

PROJECT REFERENCE NO.	SHEET NO.
R-1015	UE-18B

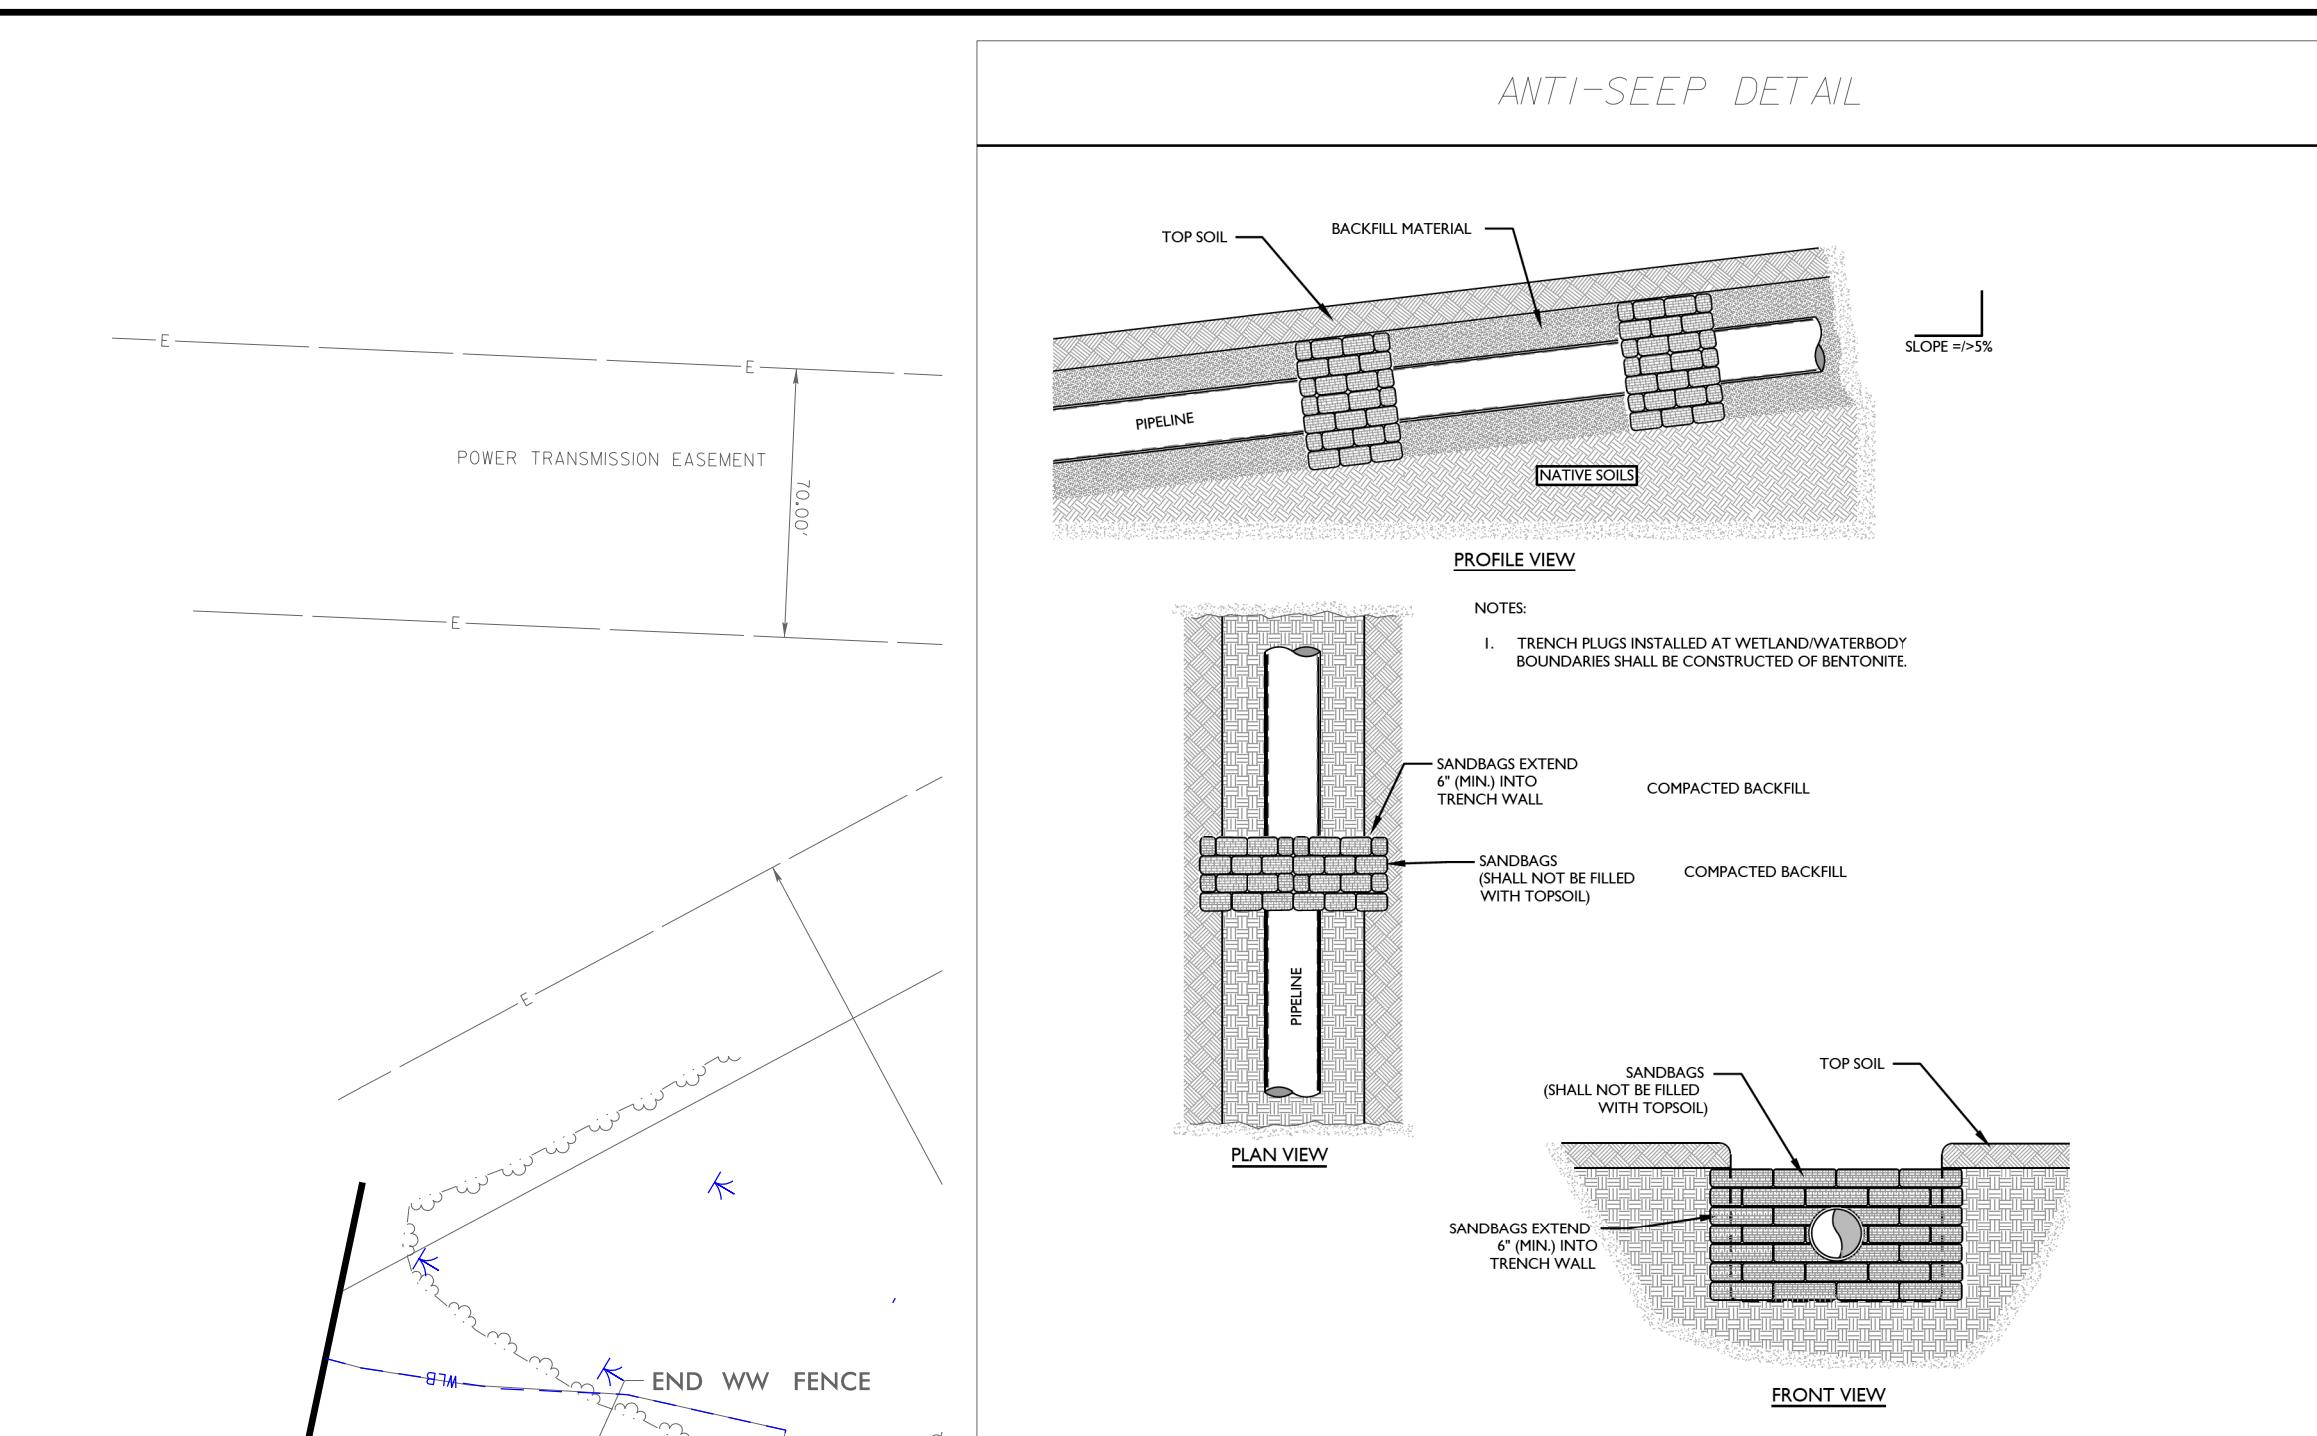
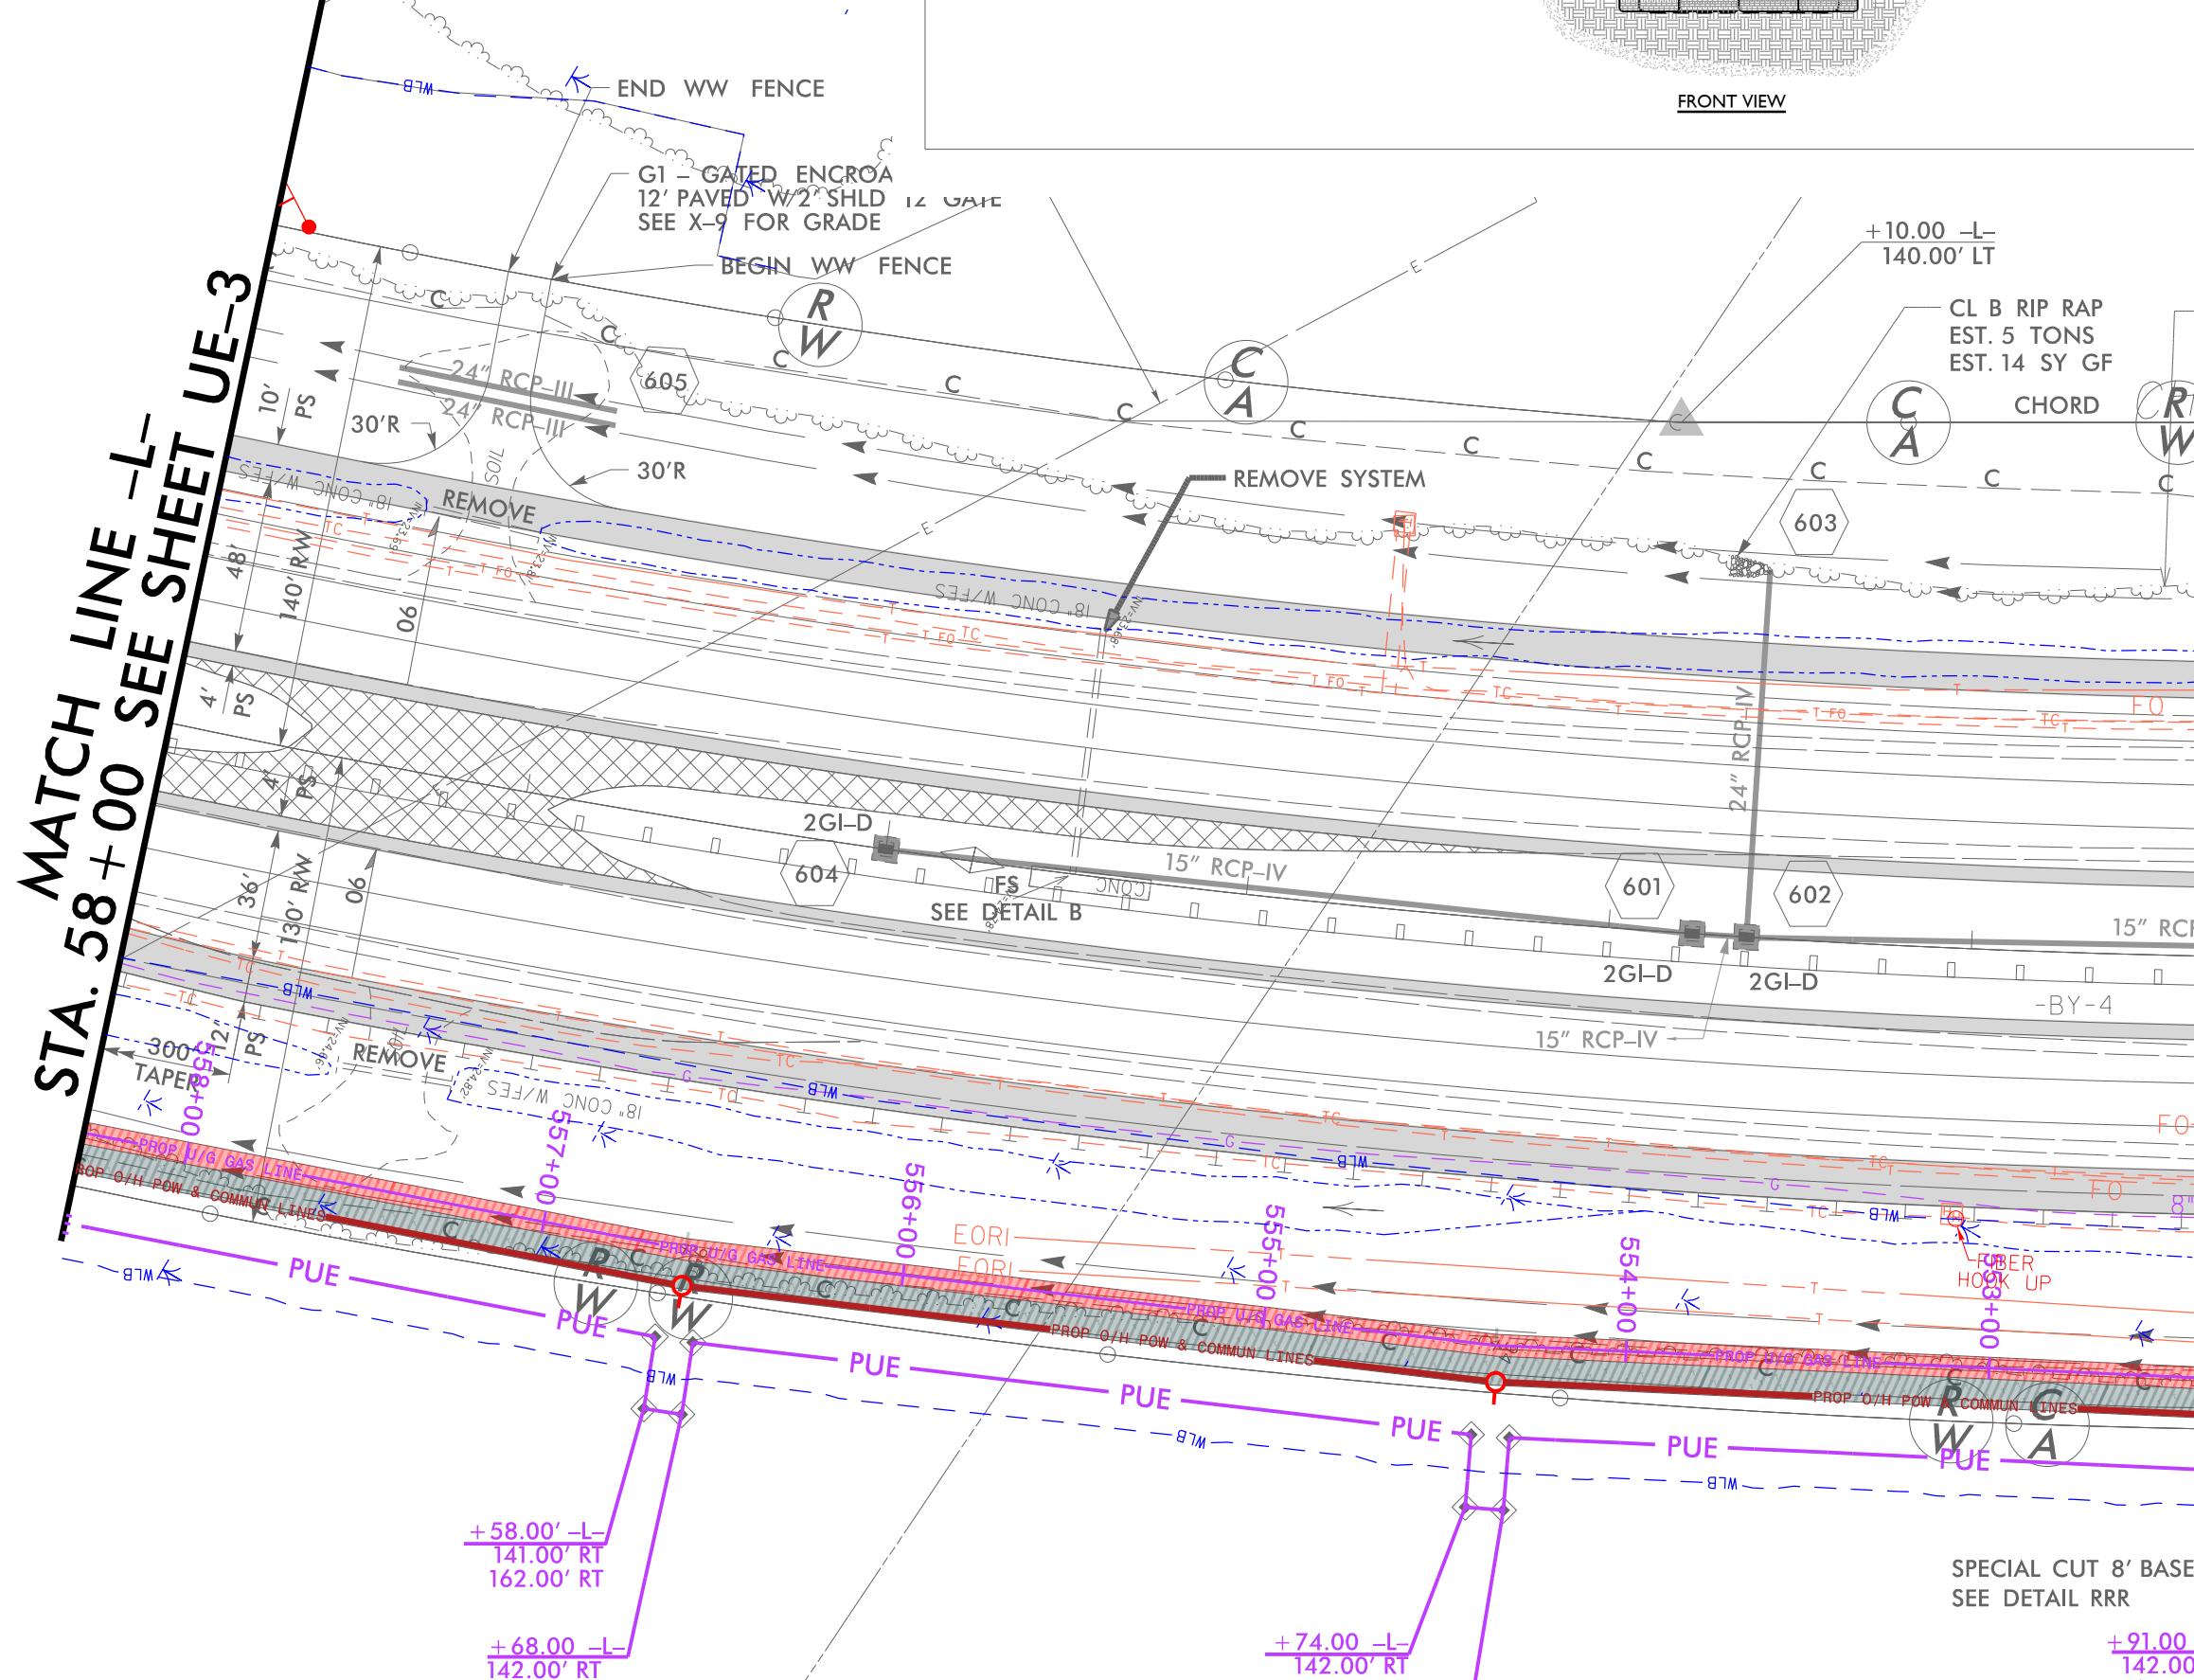
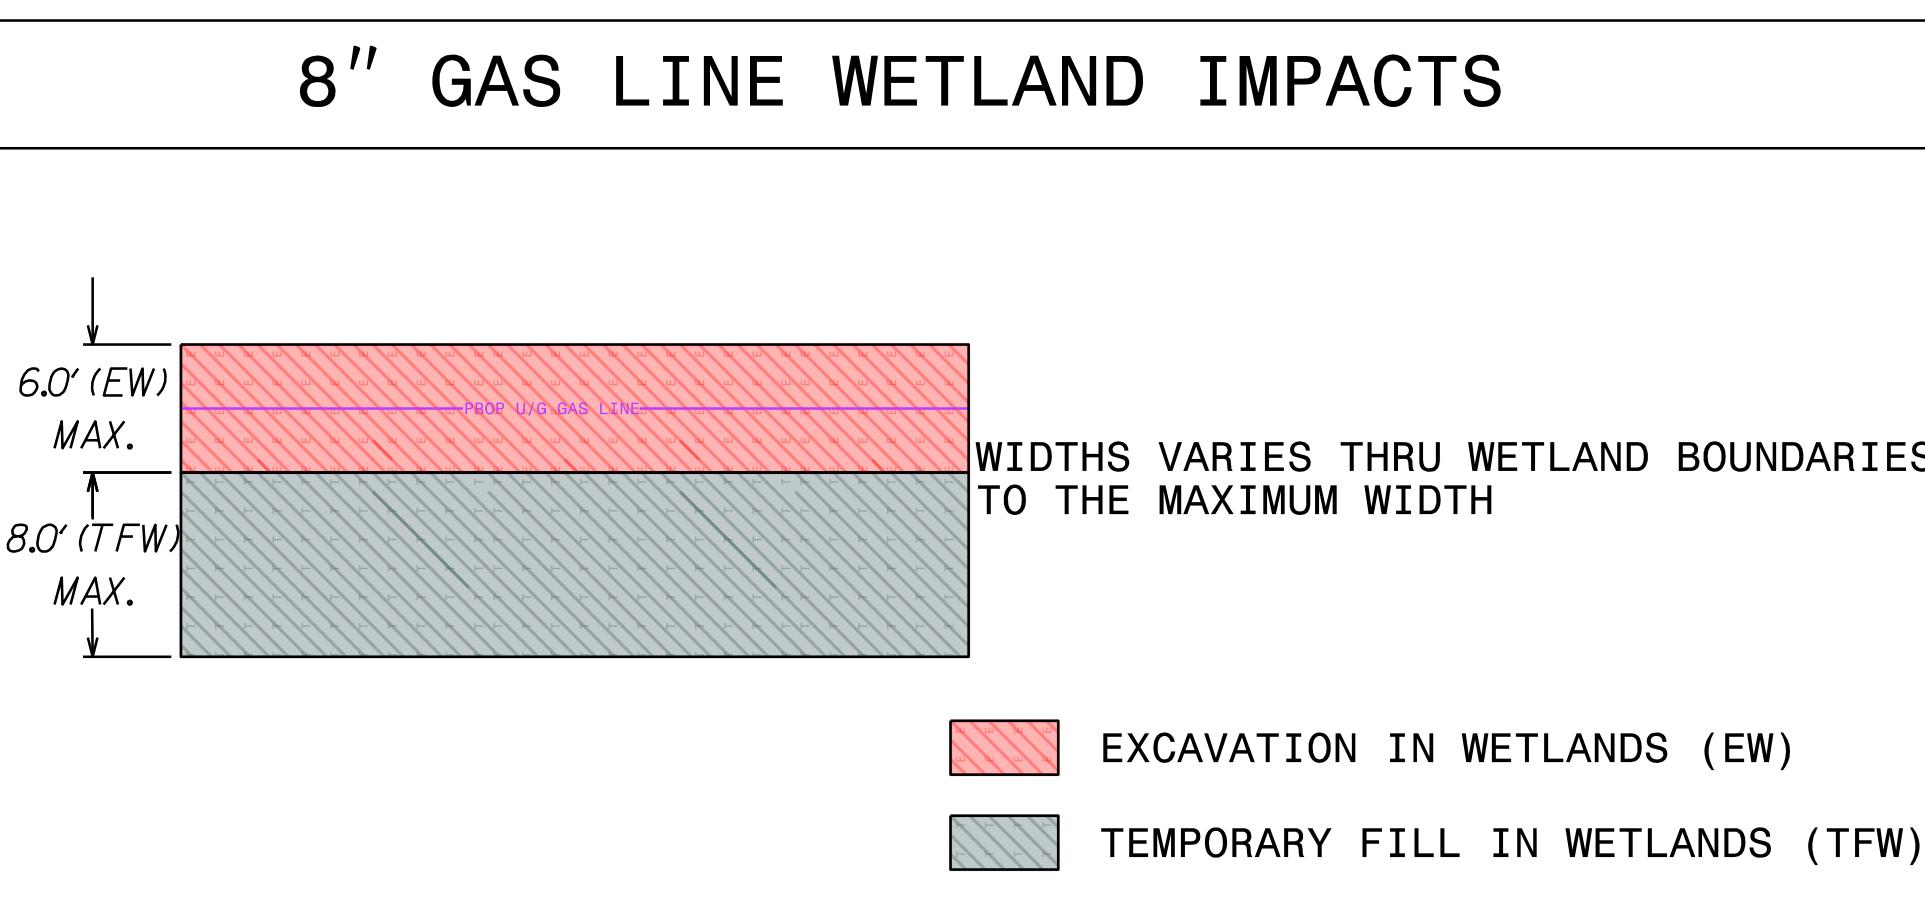
SITE 1

8" GAS LINE WETLAND IMPACTS

ANTI-SEEP COLLARS TO BE
INSTALLED EVERY 150' THRU
THE WETLANDS. ANTI-SEEP
COLLARS ARE NOT REQUIRED
FOR WETLAND CROSSINGS LESS
THAN 150'

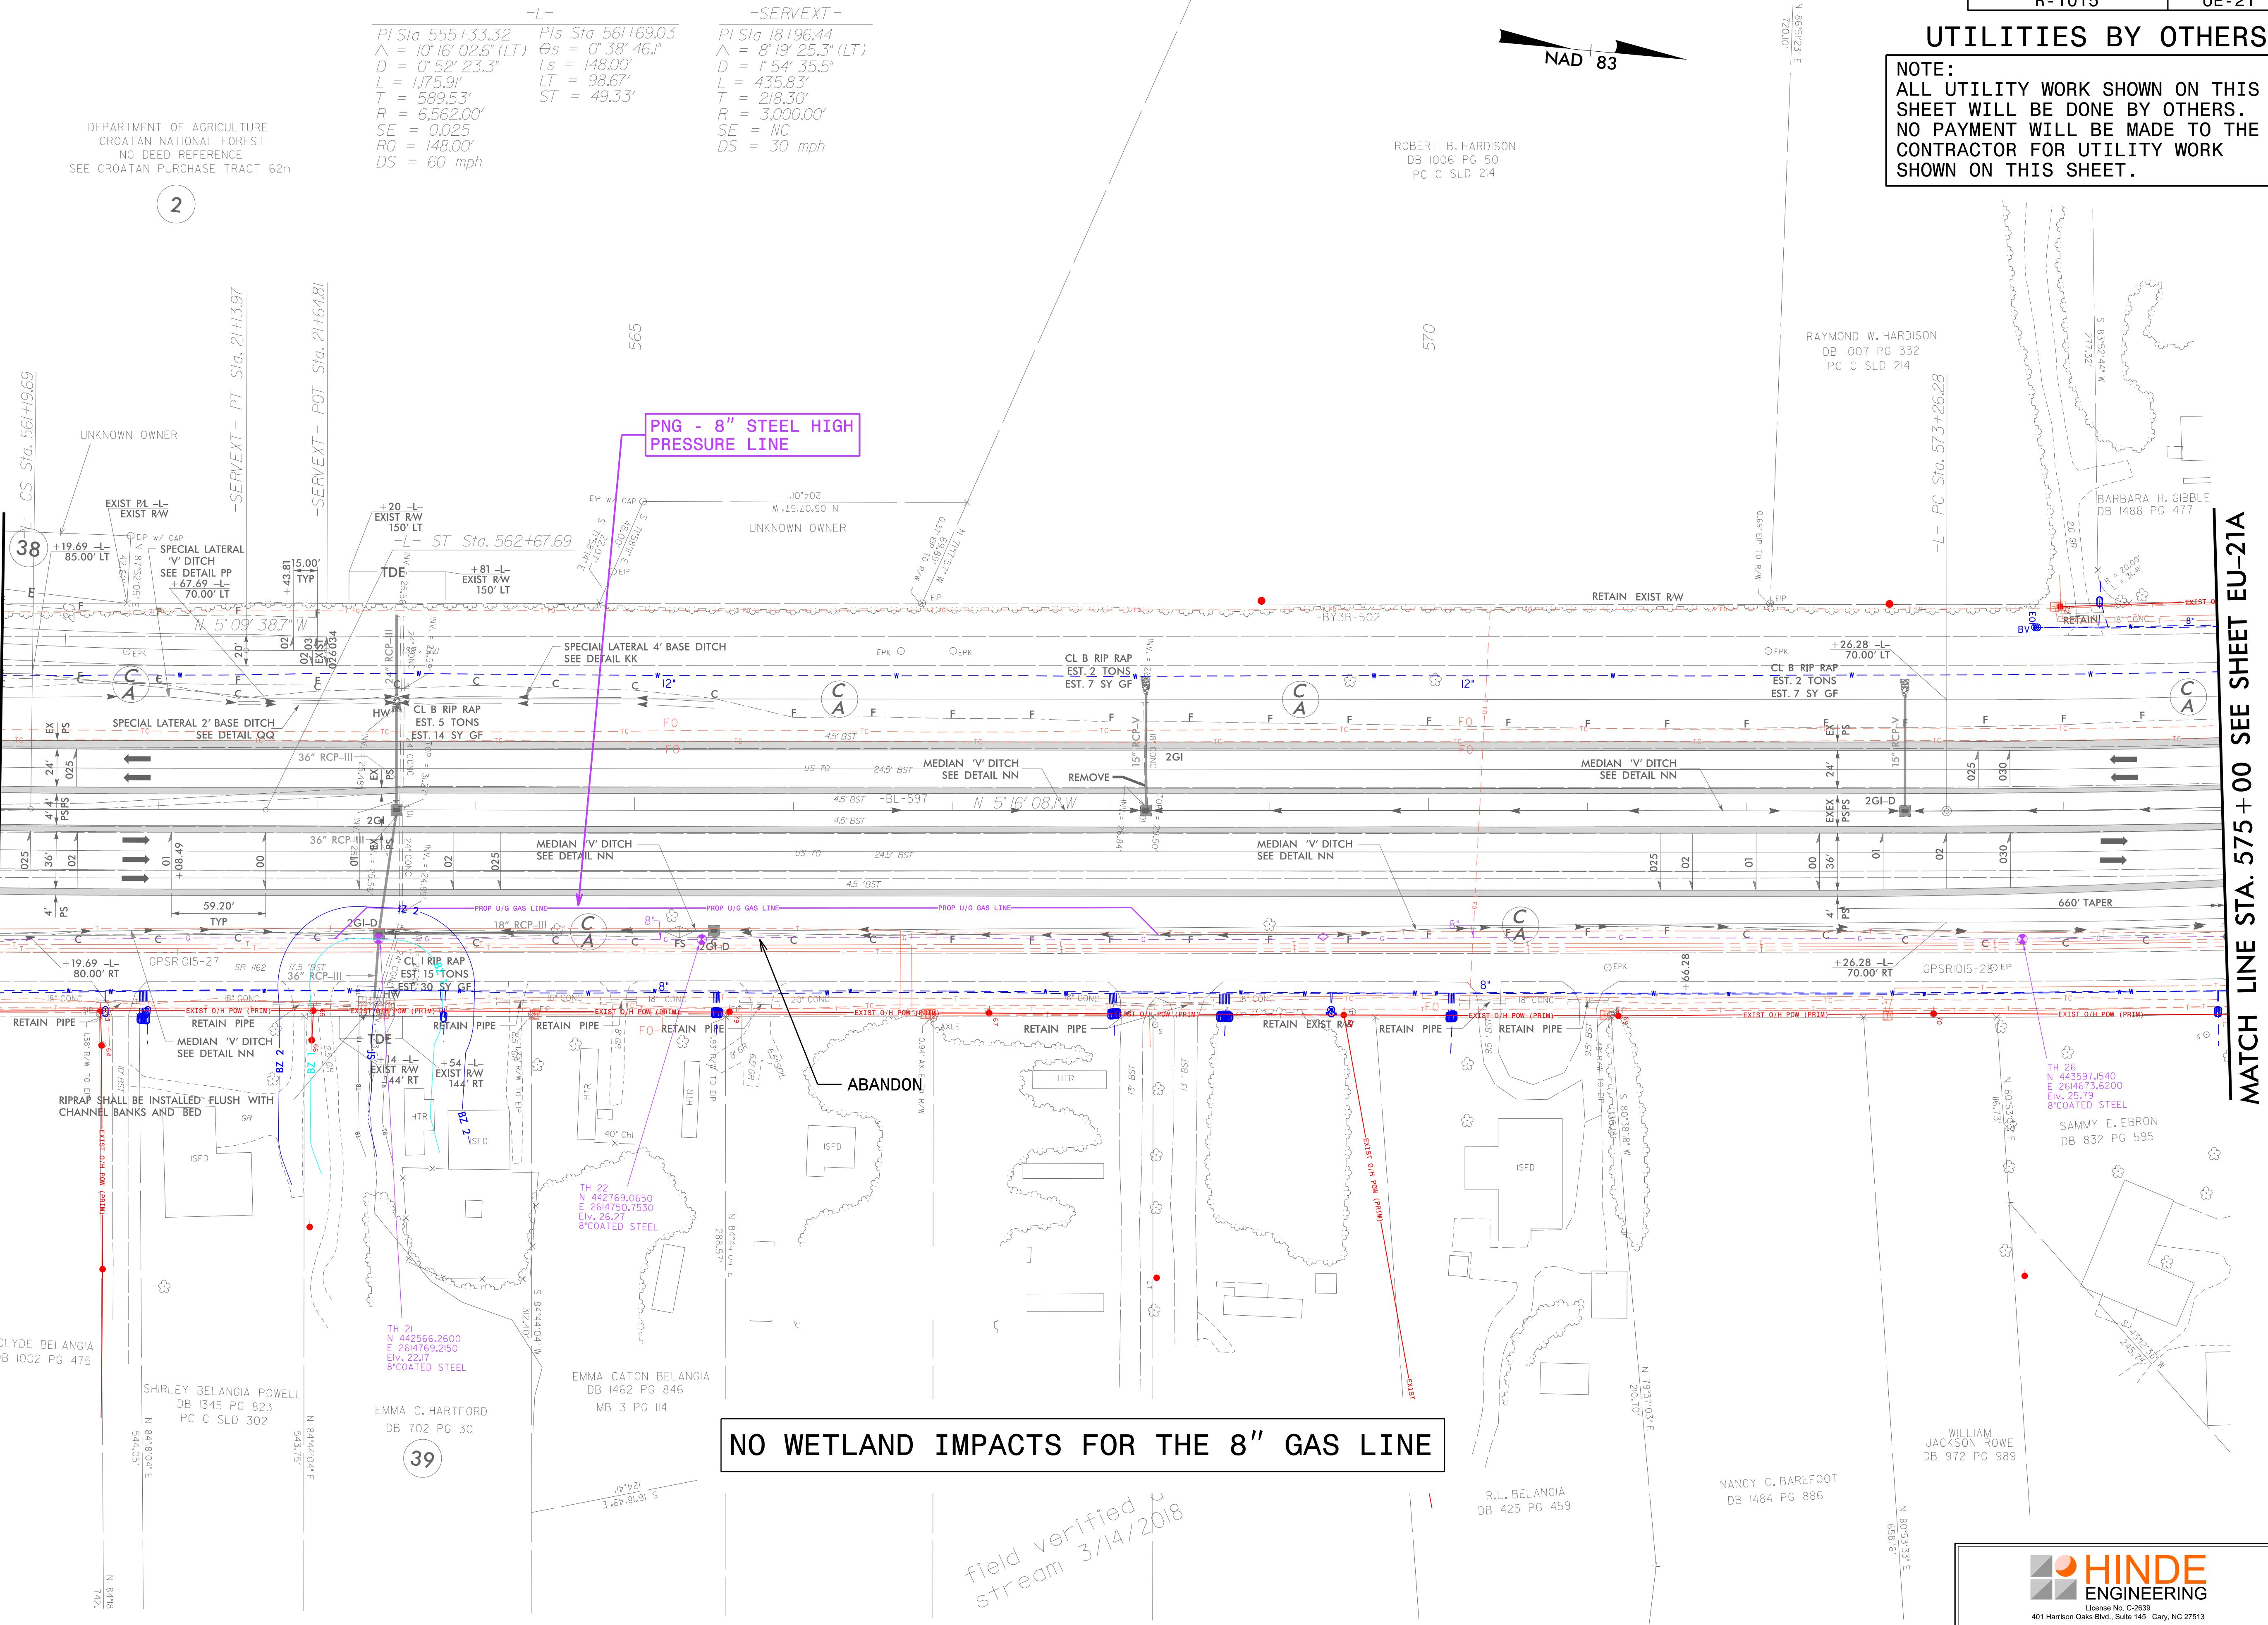
NO WETLAND IMPACTS FOR THE 8" GAS LINE

field verified
stream 3/14/2018

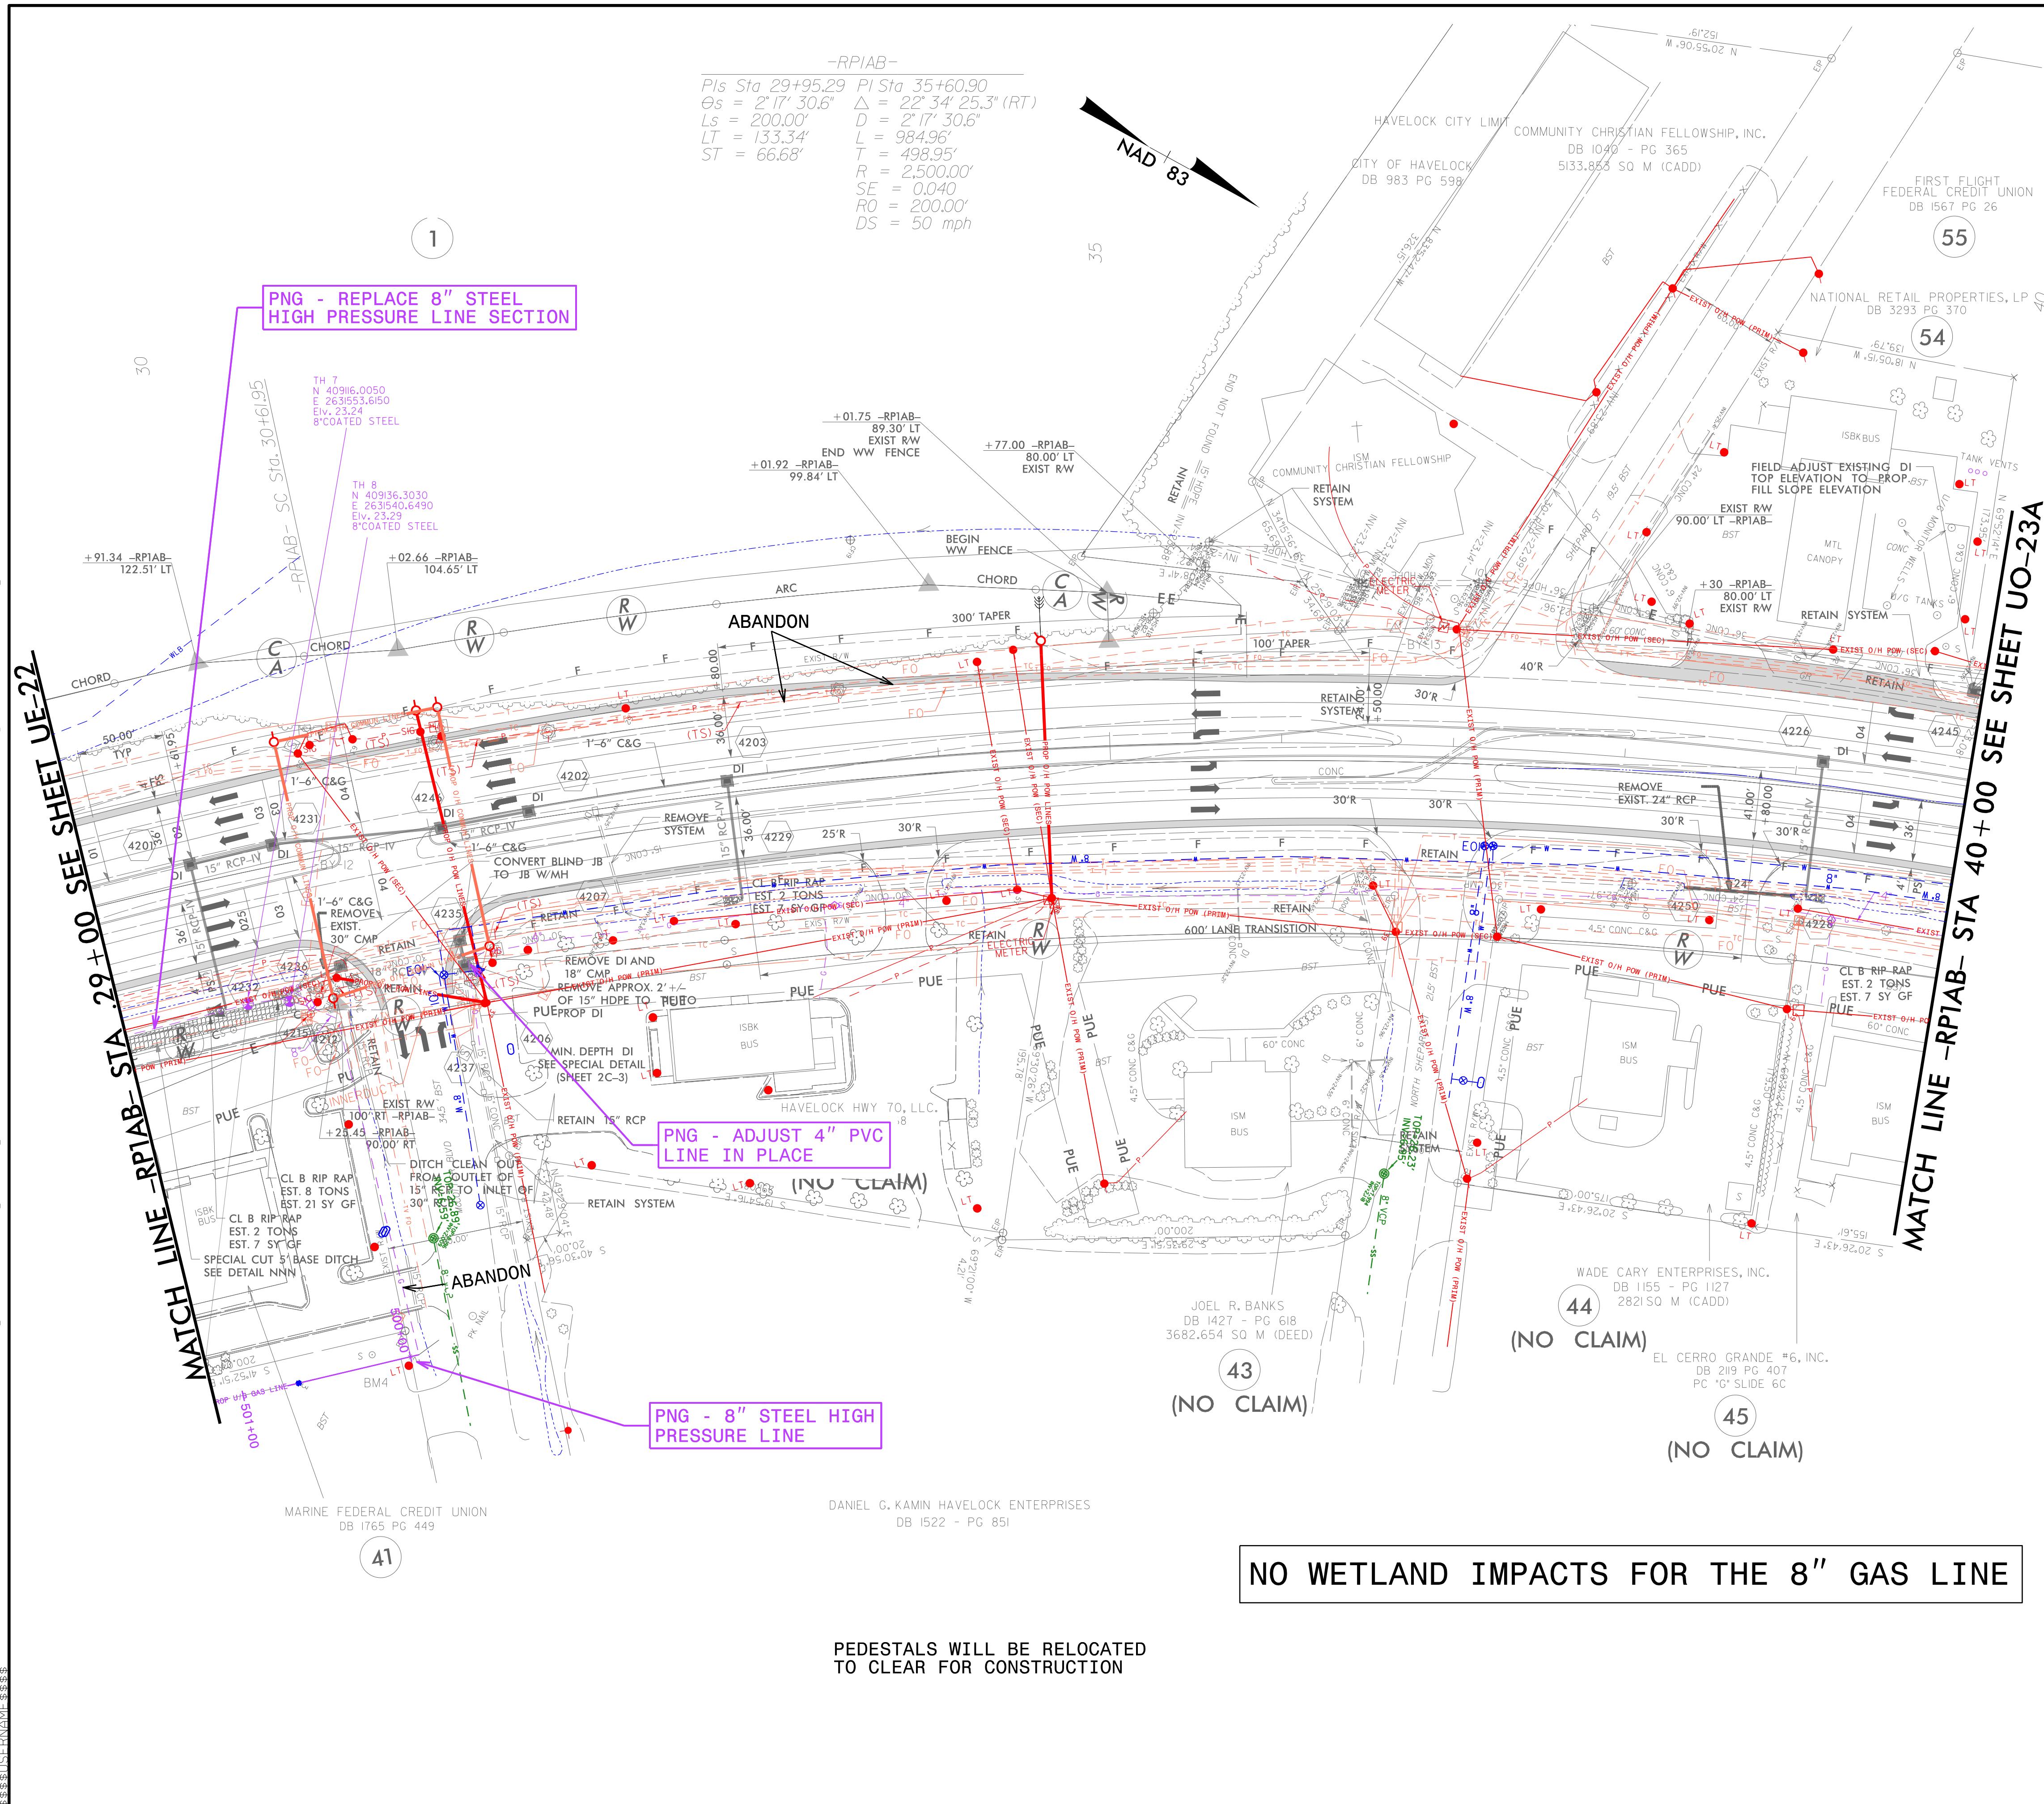
NO WETLAND IMPACTS FOR THE 8" GAS LINE

**PEDESTALS WILL BE RELOCATED
TO CLEAR FOR CONSTRUCTION**
