**Revised Mid-Currituck Bridge  
Submerged Aquatic  
Vegetation Mitigation Plan,  
July 24, 2024 (Final Revised)**

# Revised Mid-Currituck Bridge Submerged Aquatic Vegetation Monitoring Plan to Determine Mitigation

July 2024

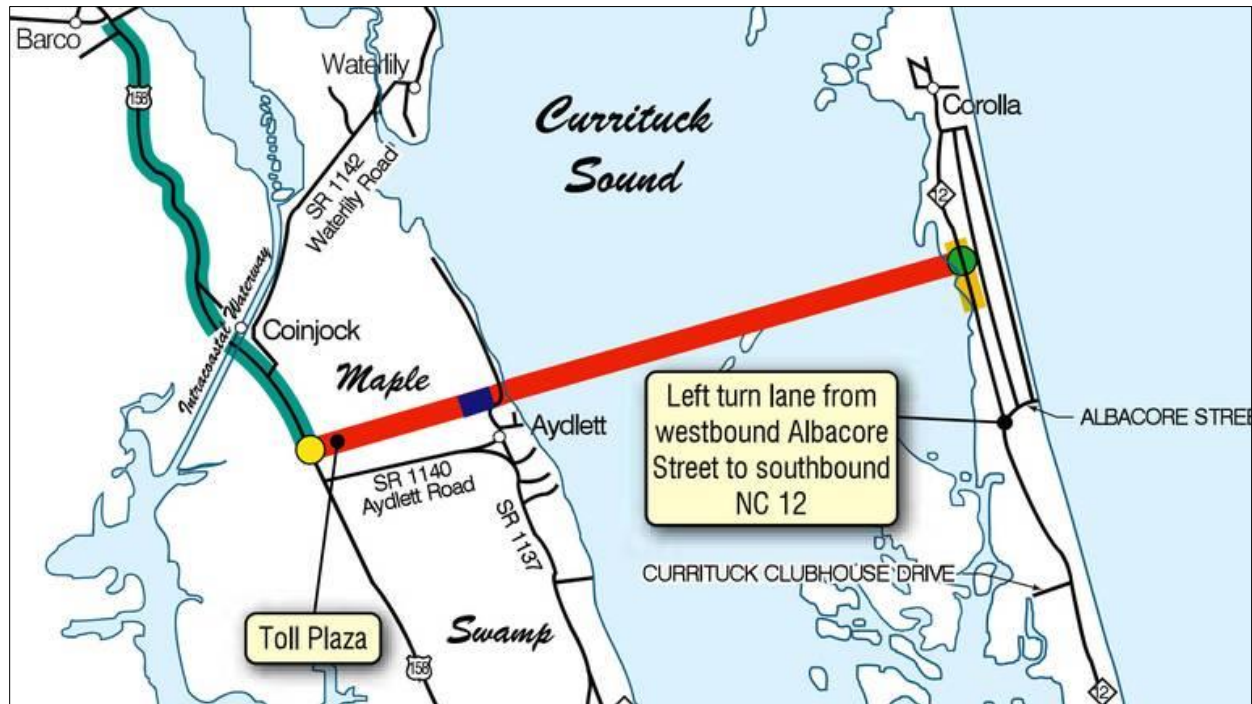
Figure 1. NCDOT Selected Alternative, alignment for the Mid-Currituck Bridge.

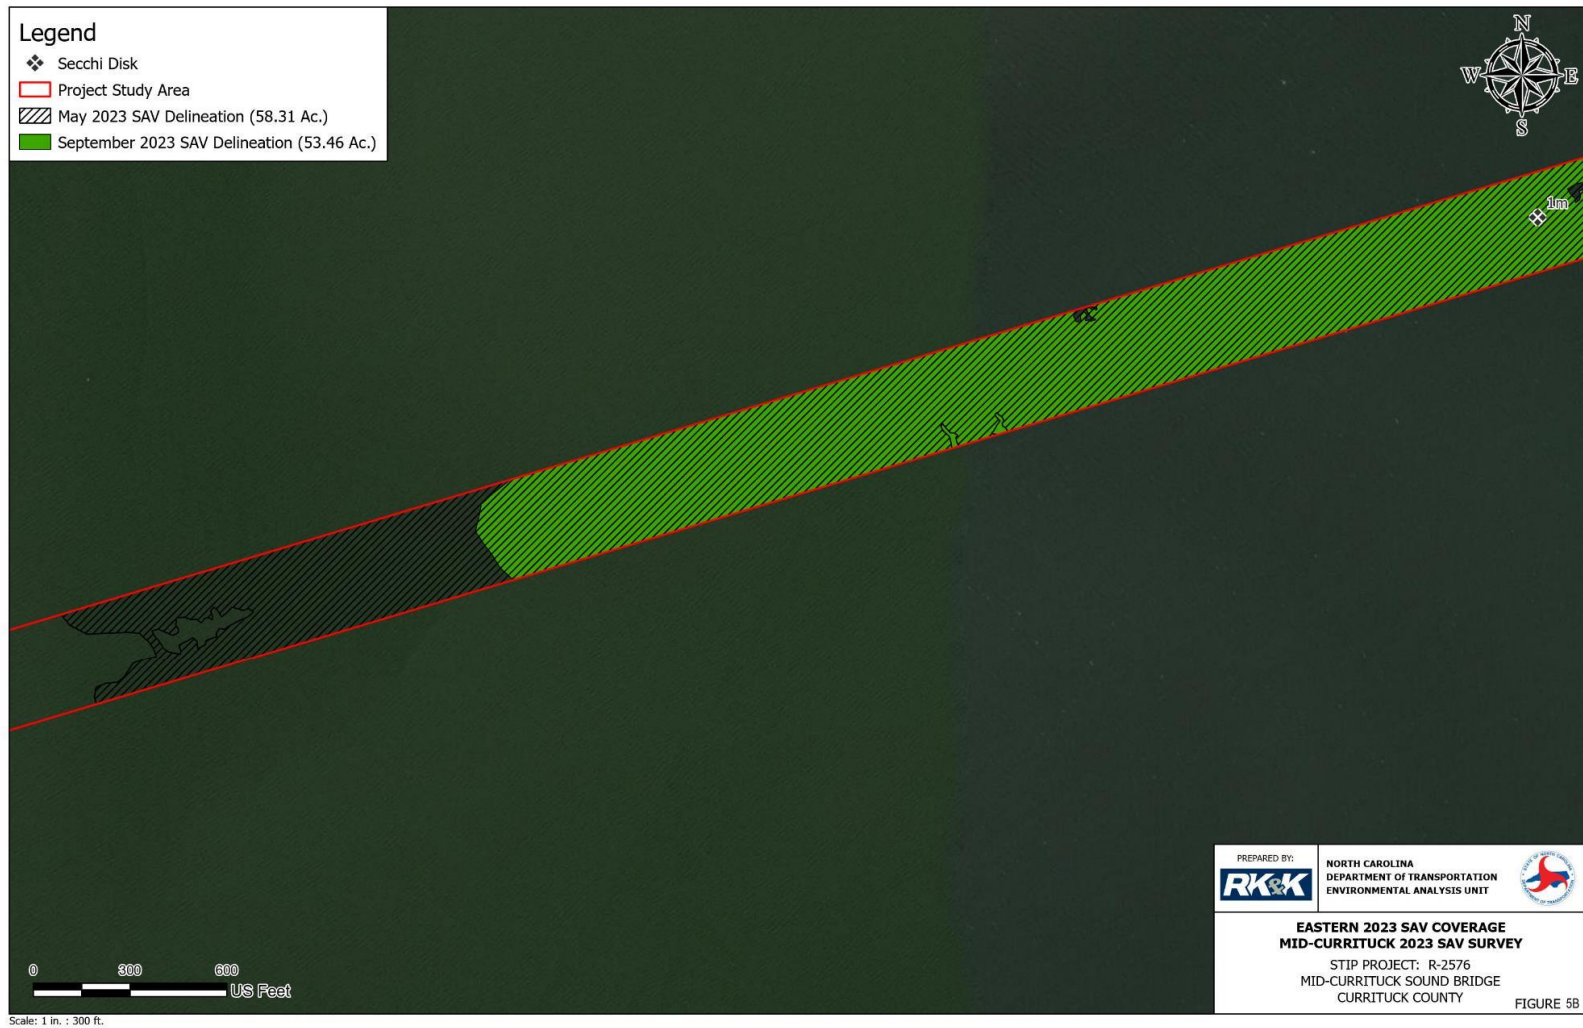
Figure 5b. Middle of the proposed Mid-Currituck Bridge alignment showing SAV cover in May and October 2023.

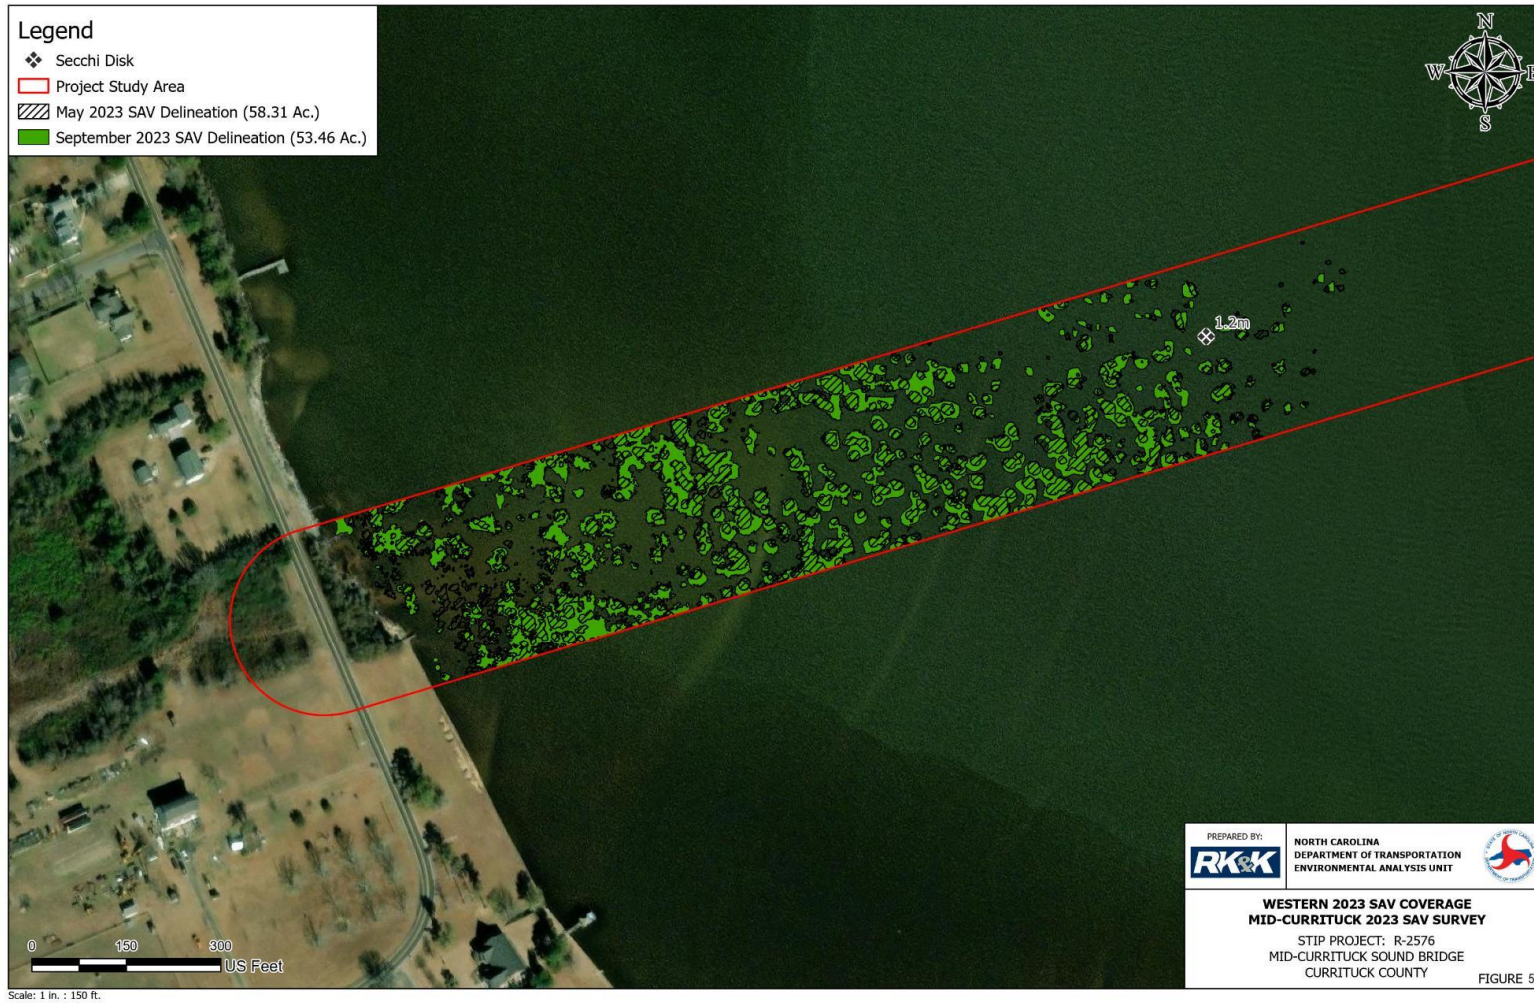
Figure 5c. Mainland (west) end of the proposed Mid-Currituck Bridge alignment showing SAV cover in May and October 2023.

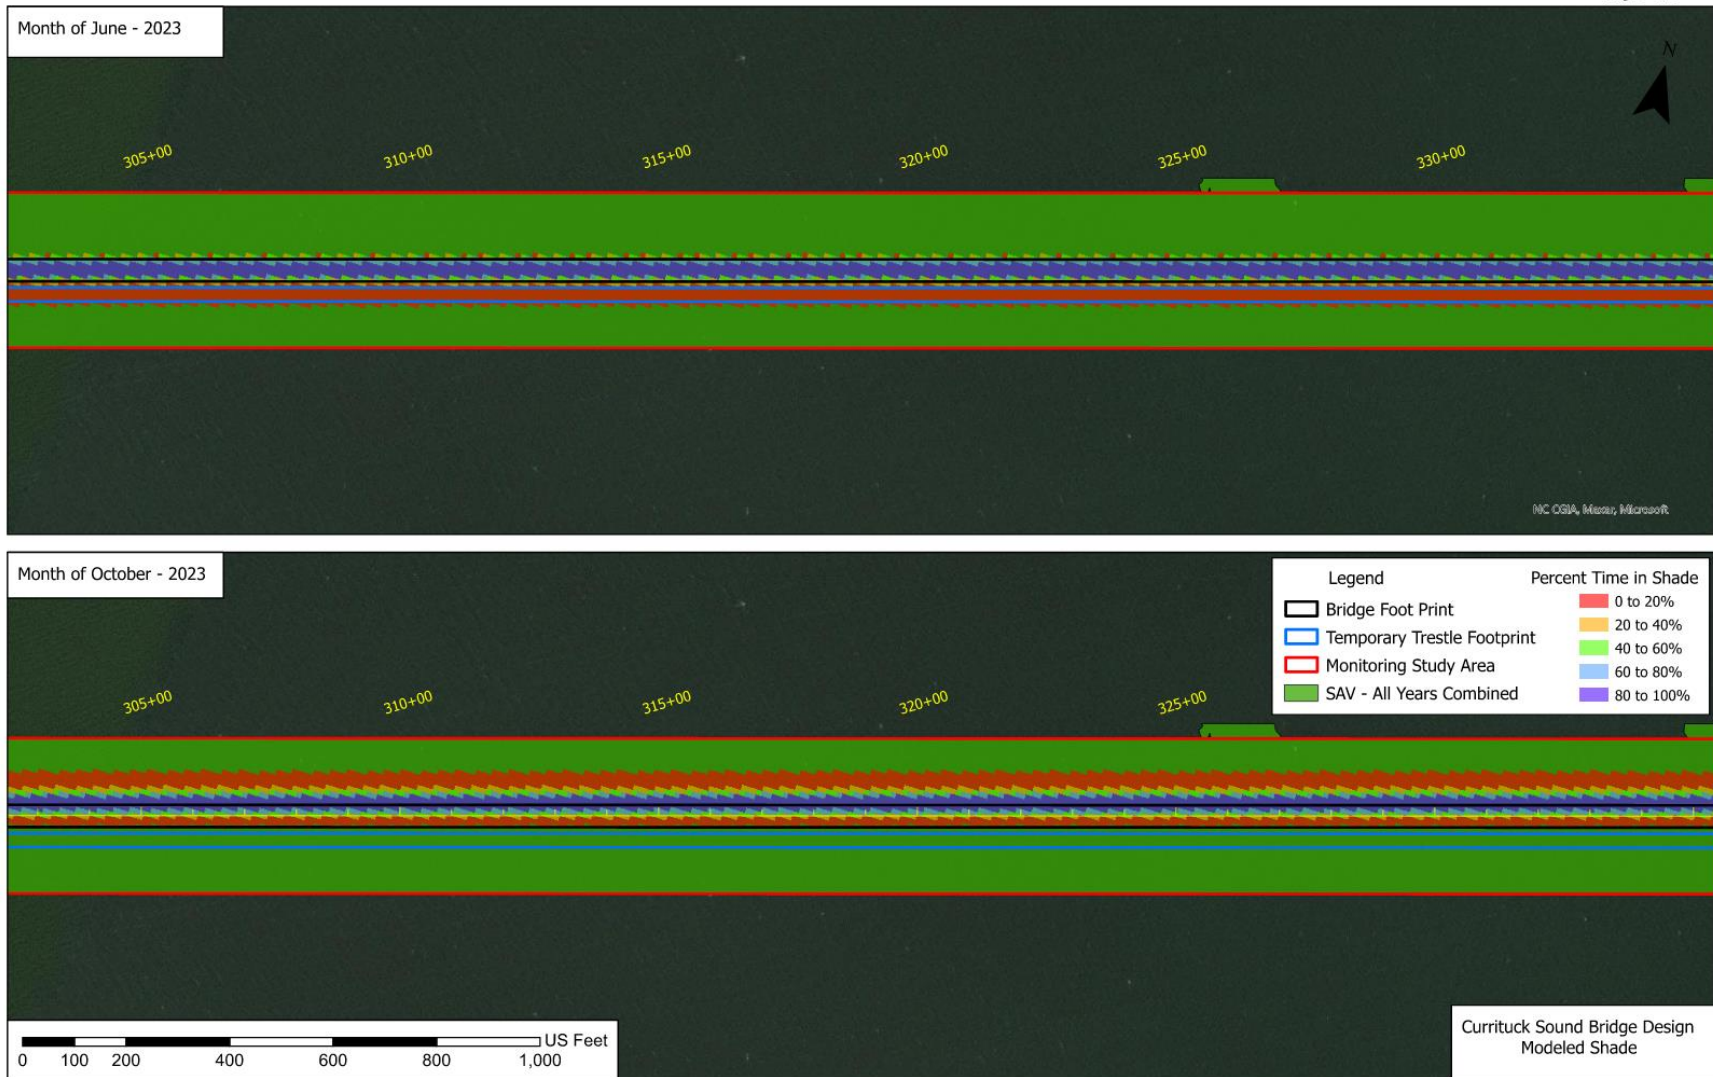
Figure 7c. Middle (east) of the proposed Mid-Currituck Bridge alignment showing SAV cover, and various gradations of shading predicted by the shading tool for June and October 2023. *Please zoom in on electronic version to better view legend.*
