Gray Bat Habitat Survey Report

TIP Project I-4400/I-4700

**Widening of I-26 from NC 225 (US 25 Connector) in
Henderson County to NC 280/I-40 in Buncombe County**

Alderman Environmental Services, Inc.

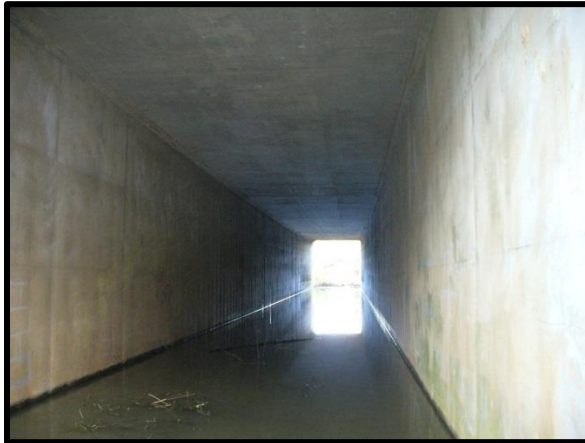
Picture 10B. Site #10.

There were 7 concrete box culverts identified and investigated in the project (Sites 10, 11, 19, 20, and 21). Four of these were constructed for vehicle traffic under the interstate and the remainder carry streams. The box culverts range from approximately six foot square to 10' X 12'. Every one of them is very smooth with no wood or other surfaces potentially useful to roosting bats, and with very few (if any) cracks or crevices. We found no evidence (guano or staining) of use by any bats in any of the box culverts. Generally, they are too big, open, and smooth to offer sheltered roosts, perhaps have too much disturbance, or have unsuitable air flow and temperature regimes to be used by bats. The pictures below show examples.

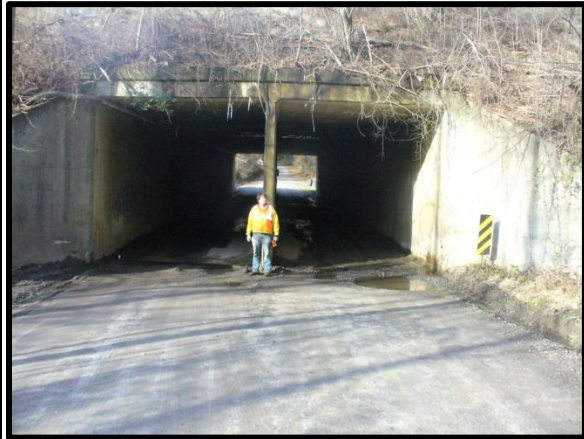
Picture 11B. Site #11.

11	2 side by side large box culverts for vehicles. Very smooth and open. No bat roosting potential. Stream immediately adjacent in metal culvert.
12	Very slight potential for bat roosts in expansion joints, but they have no good landing places. Abutments have wide/shallow crevices. River provides foraging habitat.
13	Small rock outcrop. 35'X10' high broken rock with many shallow crevices. No deep holes or extensive crevices. Could be summer roost for big brown or E. small footed, but not Gray bat.
e	Extensive wetlands at toe of slope between the highway and thin strip of ag fields immediately adjacent to the river. From this point to site 12. These wetlands & the river provide potential foraging habitat.
14	Only decent crevices are at sides of end wall with 1/2" wide and 8-10" deep crevices. Expansion joints too wide. No sign of bats though.
15	These twin bridges have no good crevices. None at endwalls, expansion joints are filled or too wide or blocked by steel girders

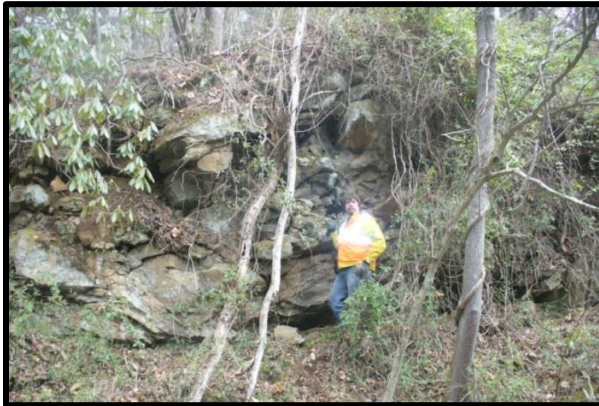
Picture 13A. Rock Outcrop at site #13.

We found 2 small rock outcrops within the project area (site #13 and Site #16). Neither rock outcrop included roosting habitat for gray bats. They did not have significant overhangs or any evidence of caves associated with them. They both possessed significant fracturing of the rock faces such that some of the smaller myotid bats (e.g., *Myotis leibii* or *Myotis septentrionalis*) may potentially utilize them; however, we found no evidence of bat use at either site. Table 1 (Appendix 1) references the picture number for all photographs taken on the project, including all of the bridges, culverts, rock outcrops, and foraging habitats.

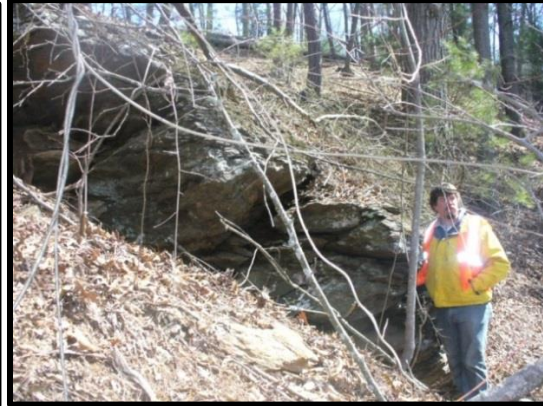
Picture 16A. Rock Outcrop at site #16.

16	Small rock outcrop. 15 X 12' high broken rock with several 4-12" deep 1/2 inch crevices, but no large crevices or cave. Could be used as summer roost by M. Leibii or other species, but not gray bat.
17	This is one bridge recently constructed that replaces the former twin bridges. The expansion joints in the rails are open, but most are ~1" wide so not likely to be used by bats.
18	Found 1 Myotis leibii roosting in SE corner in endwall crevice with small amount of guano below the area. Also noted scattered guano on SW end. Good potential for use of this bridge by bats, but not gray bats. Swallows on outside Girders (both north and south).
19	6' box culvert with stream running through it. Very smooth concrete with no large cracks or crevices. Vines obscure Western end. Little potential for bat use.
f	Large wetland between I-26 and river. From 35.49067/82.56399 to 35.48598/82.56151. This is known bog turtle wetland. Combined with adjacent River provides decent foraging habitat for bats including Gray bats.

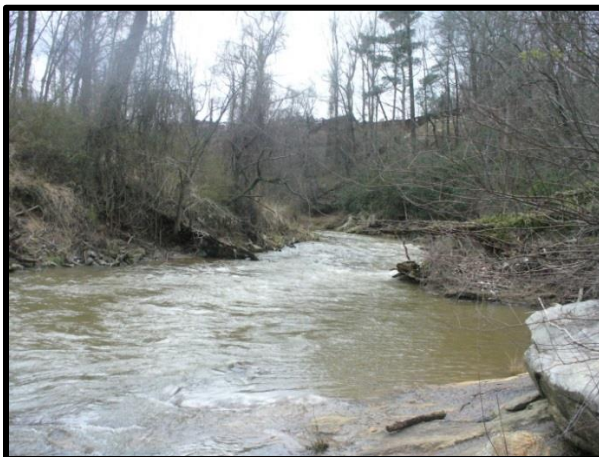
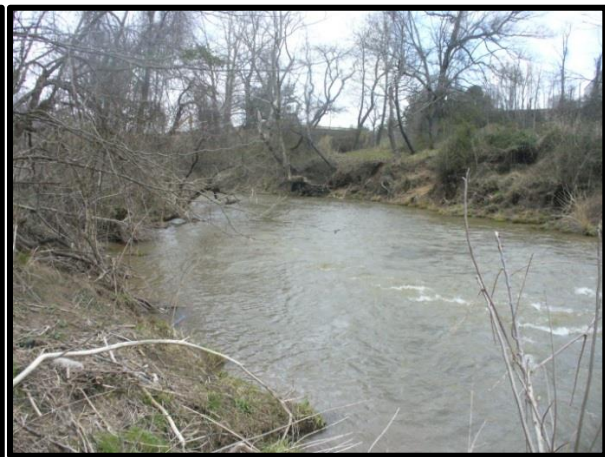
Picture 5A (upstream) and 5B (downstream) at site #5.

Gray bat foraging habitat consists of open water of larger rivers and lakes/reservoirs where adjacent shorelines are forested. We characterized the potential foraging habitat for gray bats in the project study area without regard to whether there are any gray bats in the area. In searching the project area for this habitat type, we found 5 areas of potential foraging habitat for gray bats (Figures 1-3). Hominy Creek (site #5, Figure 1) runs parallel to the interstate for approximately ½ mile. It is approximately 20-30 feet wide and partially bordered by woodlands. Its size and the amount of nearby development make it marginal foraging habitat for gray bats.

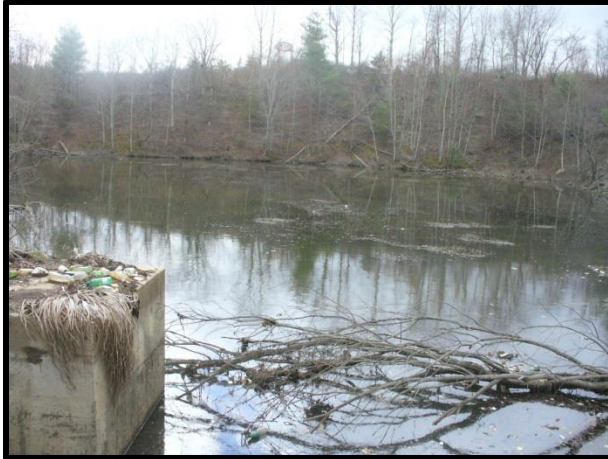
Picture 9A, site #9. Biltmore Mall drainage.

The next area of potential foraging habitat for gray bats is a complex of wetlands/ponds/lakes that includes the stormwater drainage pond for Biltmore Square Mall, immediately adjacent to the western side of I-26, connected by culvert to Westerly Lake of the Biltmore Estate, which is immediately adjacent to the eastern side of I-26 (site #9 and #b, Figure 1). These two ponds provide several acres of open water habitat and the drainage pond is somewhat surrounded by woodlands. These waterbodies would provide marginal foraging habitat at best, because of the small area, surrounding land use (vineyard in the case of Westerly Lake) and the fact that they are bisected by I-26.

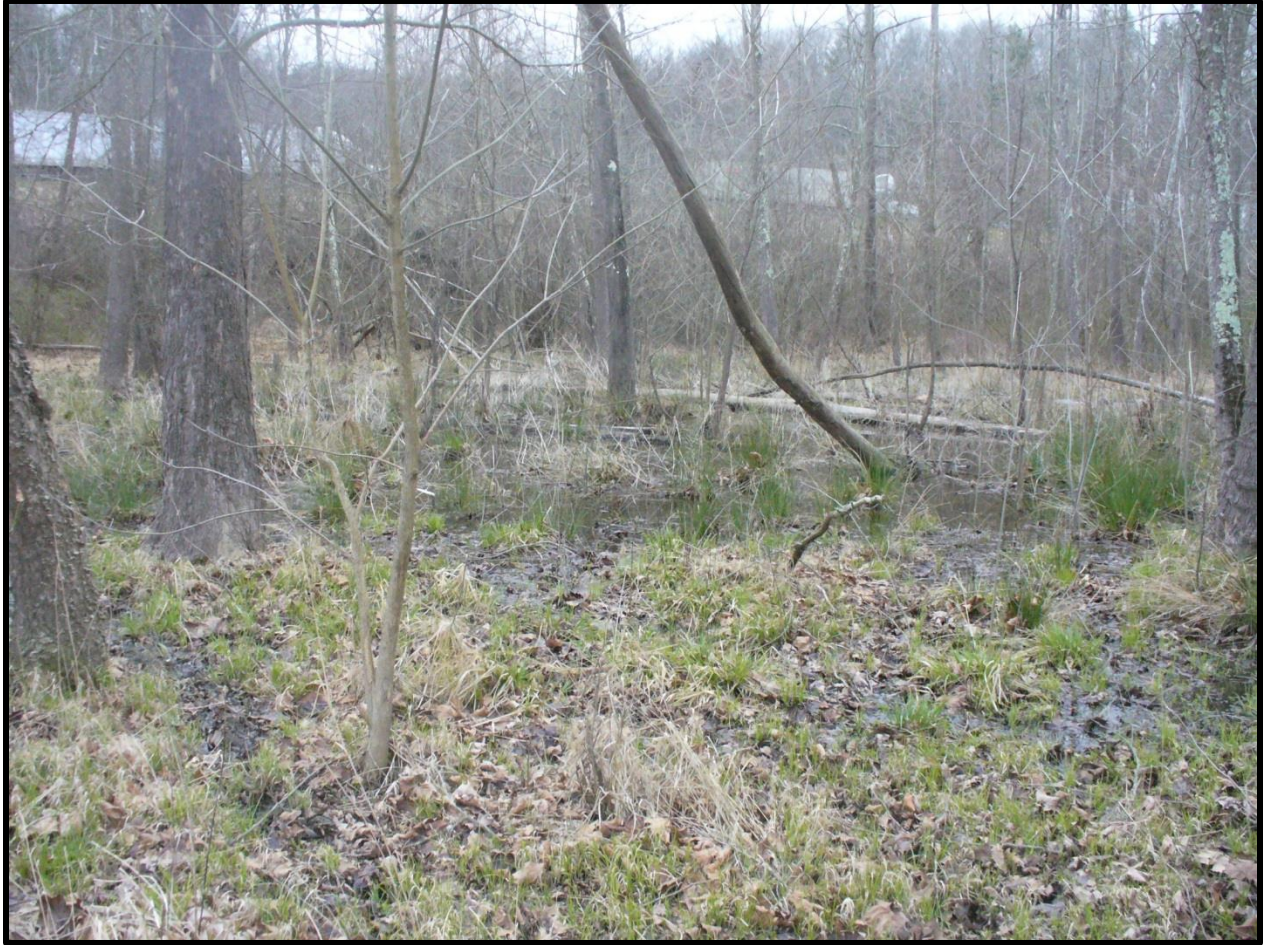
Picture eA. Site #e. Wetland adjacent to I-26 and French Broad River.

The remaining three potential foraging habitat sites for gray bats are similar in nature to each other in that they all are comprised of sizeable floodplain wetland complexes immediately adjacent to the French Broad River (see Figures 2 & 3, and site e, f, and g, in Table 1 in Appendix 1). In each case, the wetlands are fed by seepage from the toe of the hillslope as well as drainage from the highway, and run parallel to the river for several hundred yards. The French Broad River is good quality foraging habitat for gray bats due to its size (width, in particular), the substrate and water quality generally producing an abundance of aquatic insects, and its generally forested margins. Combining the river with these extensive wetland complexes only enhances the foraging habitat potential by adding to the insect foraging base and providing additional cover for predator avoidance while foraging over water. All three of these sites constitute good potential gray bat foraging habitat. In addition, site f is known to support bog turtles (*Glyptemys muhlenbergii*), a state Threatened species, further enhancing the ecological significance of these wetlands.
