SUBJECT: Preliminary Site Assessment Report
Parcel 26, VSO, Inc.
WBS Element No. 54035.1.1, TIP No. U-5757
NC 8 (Winston Road) from 9th Street to SR 1408 (Biesecker Rd) in Lexington. Widen to multi lanes
Kleinfelder Project No. 20201105.001A

PRELIMINARY SITE ASSESSMENT REPORT
PARCEL 26 VSO, INC.
PARCEL 110900000002B
1305 WINSTON ROAD
LEXINGTON, DAVIDSON COUNTY, NORTH CAROLINA

NCDOT WBS ELEMENT 54035.1.1
STATE PROJECT U-5757
NC 8 (WINSTON RD) FROM 9TH STREET TO SR 1408 (BIESECKER RD) IN LEXINGTON. WIDEN TO MULTI LANES

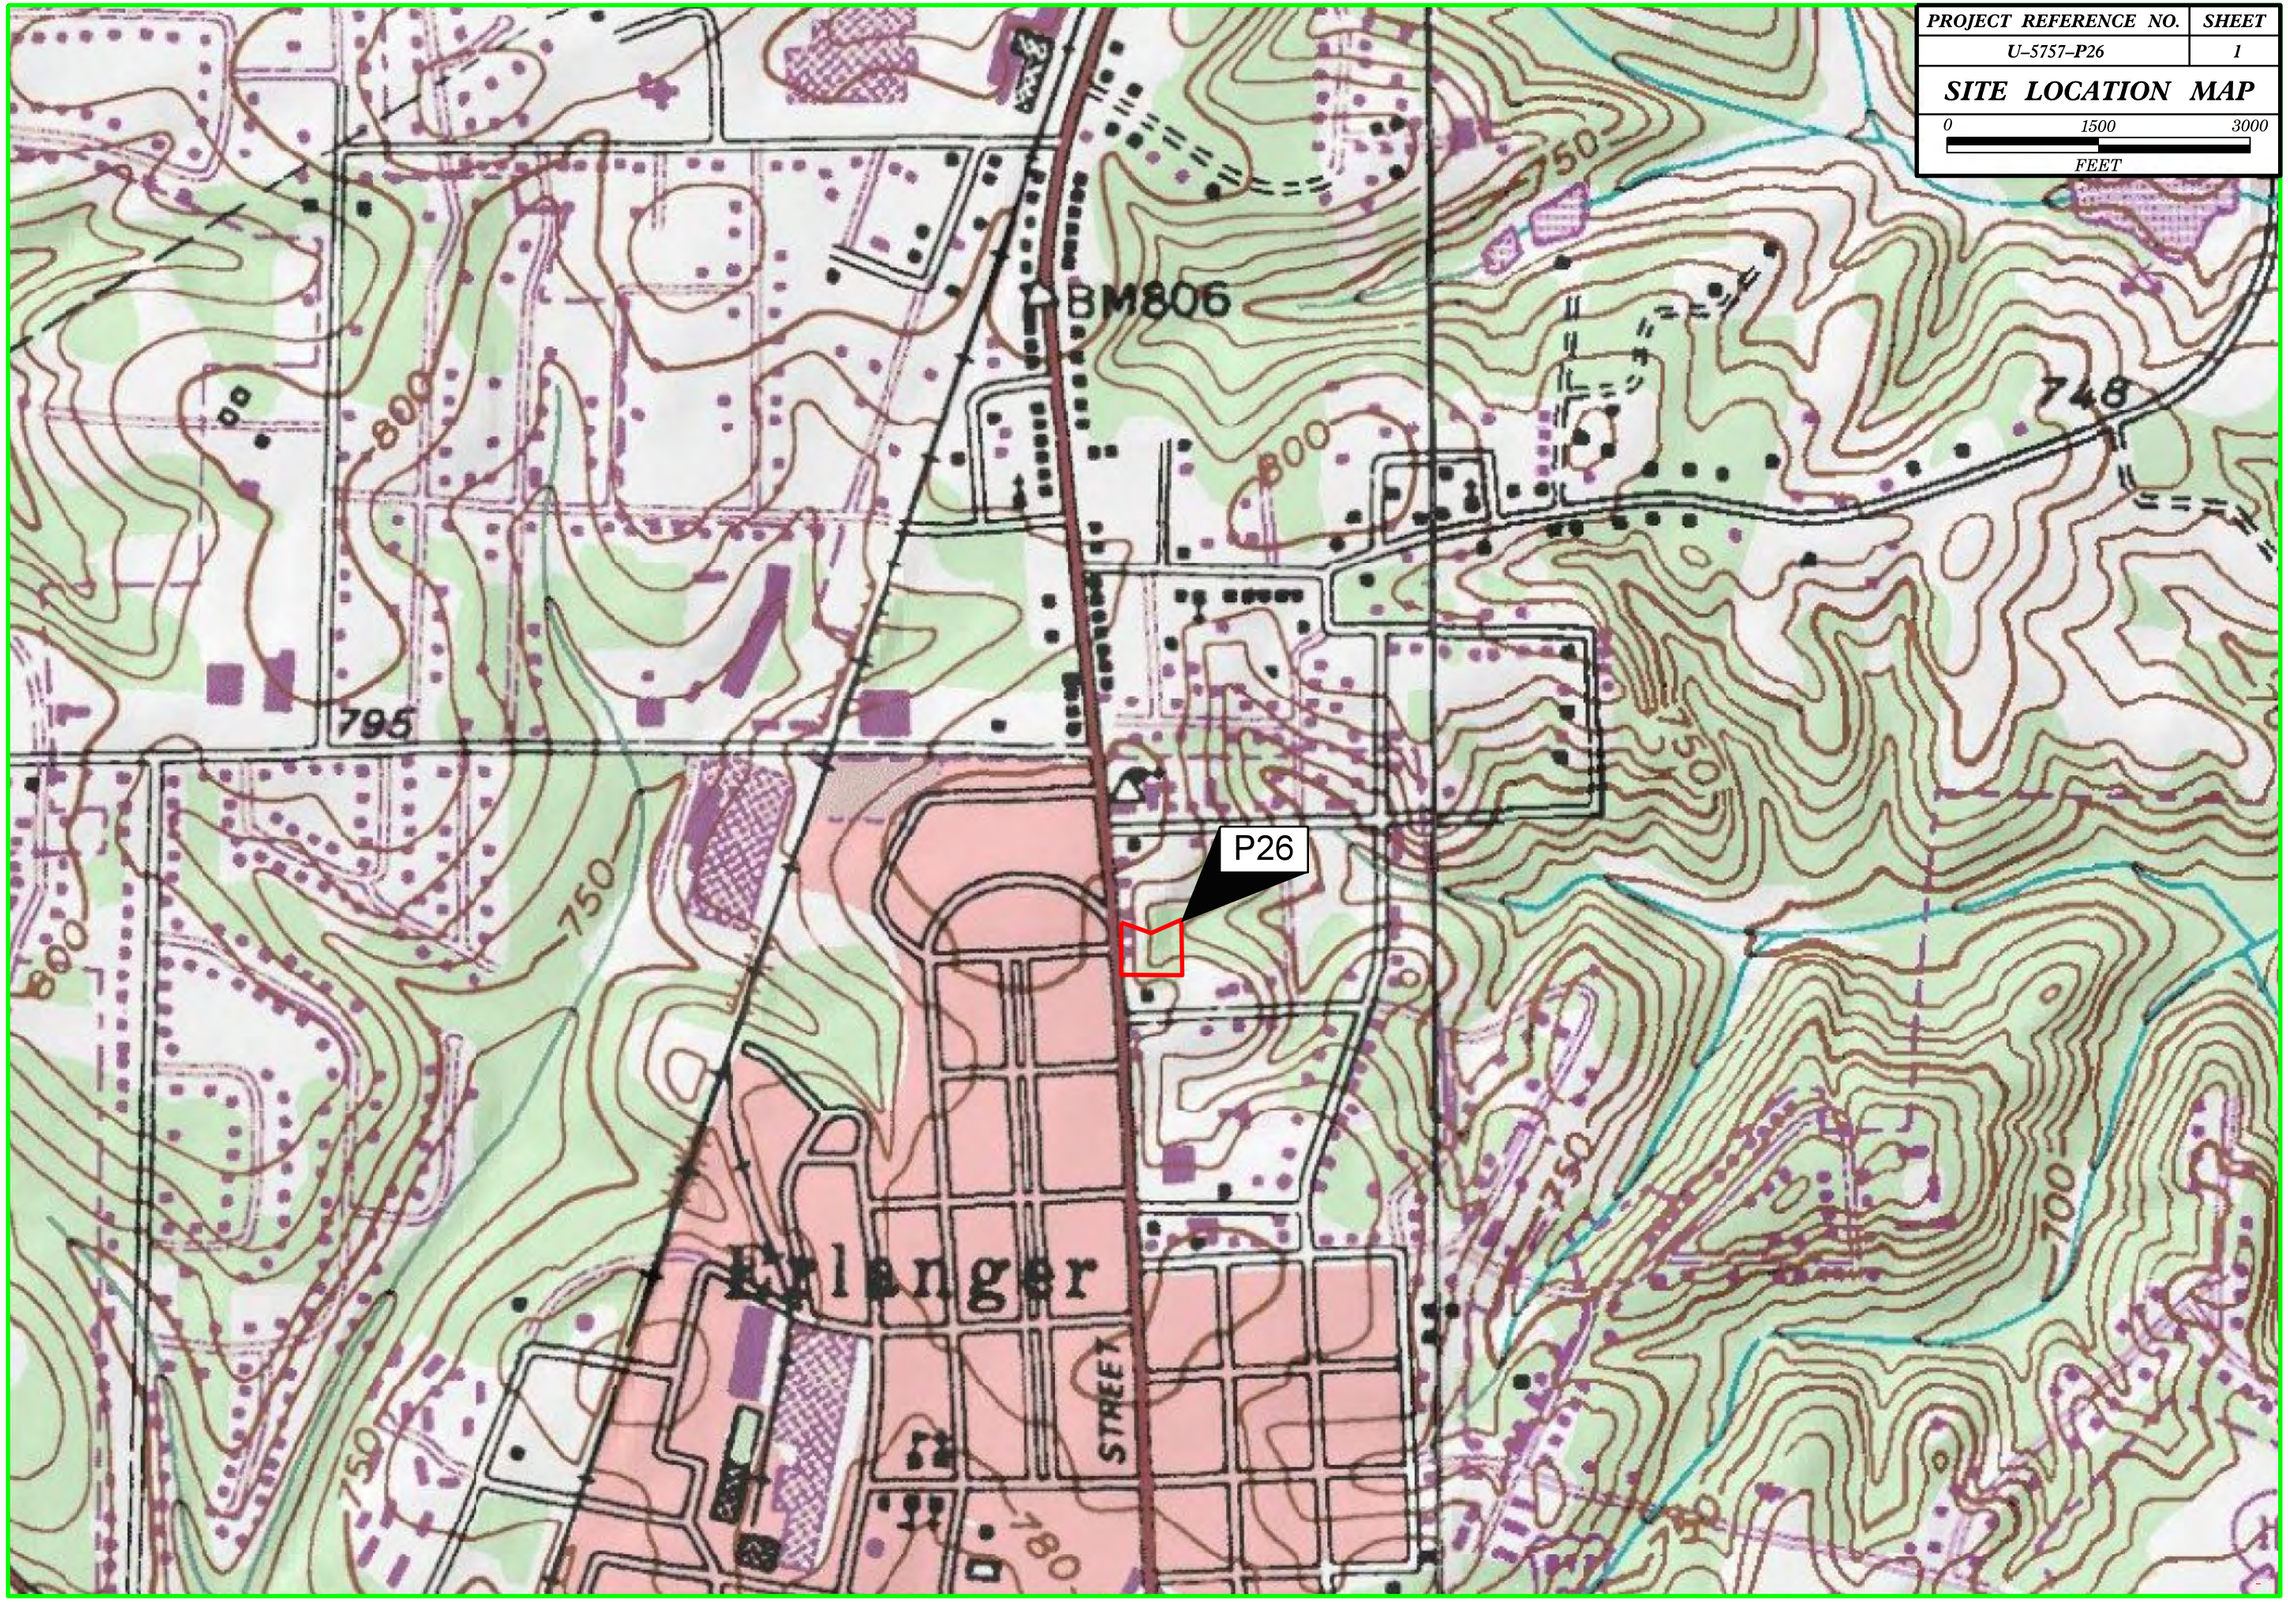
SITE PLAN

Based on previous reports reviewed for the site and site visits conducted as part of the PSA, there is one (1) monitoring well located on the property that is associated with LUST groundwater incident 13921. The monitoring well was located in the field with a GPS and is depicted on Figure 2.

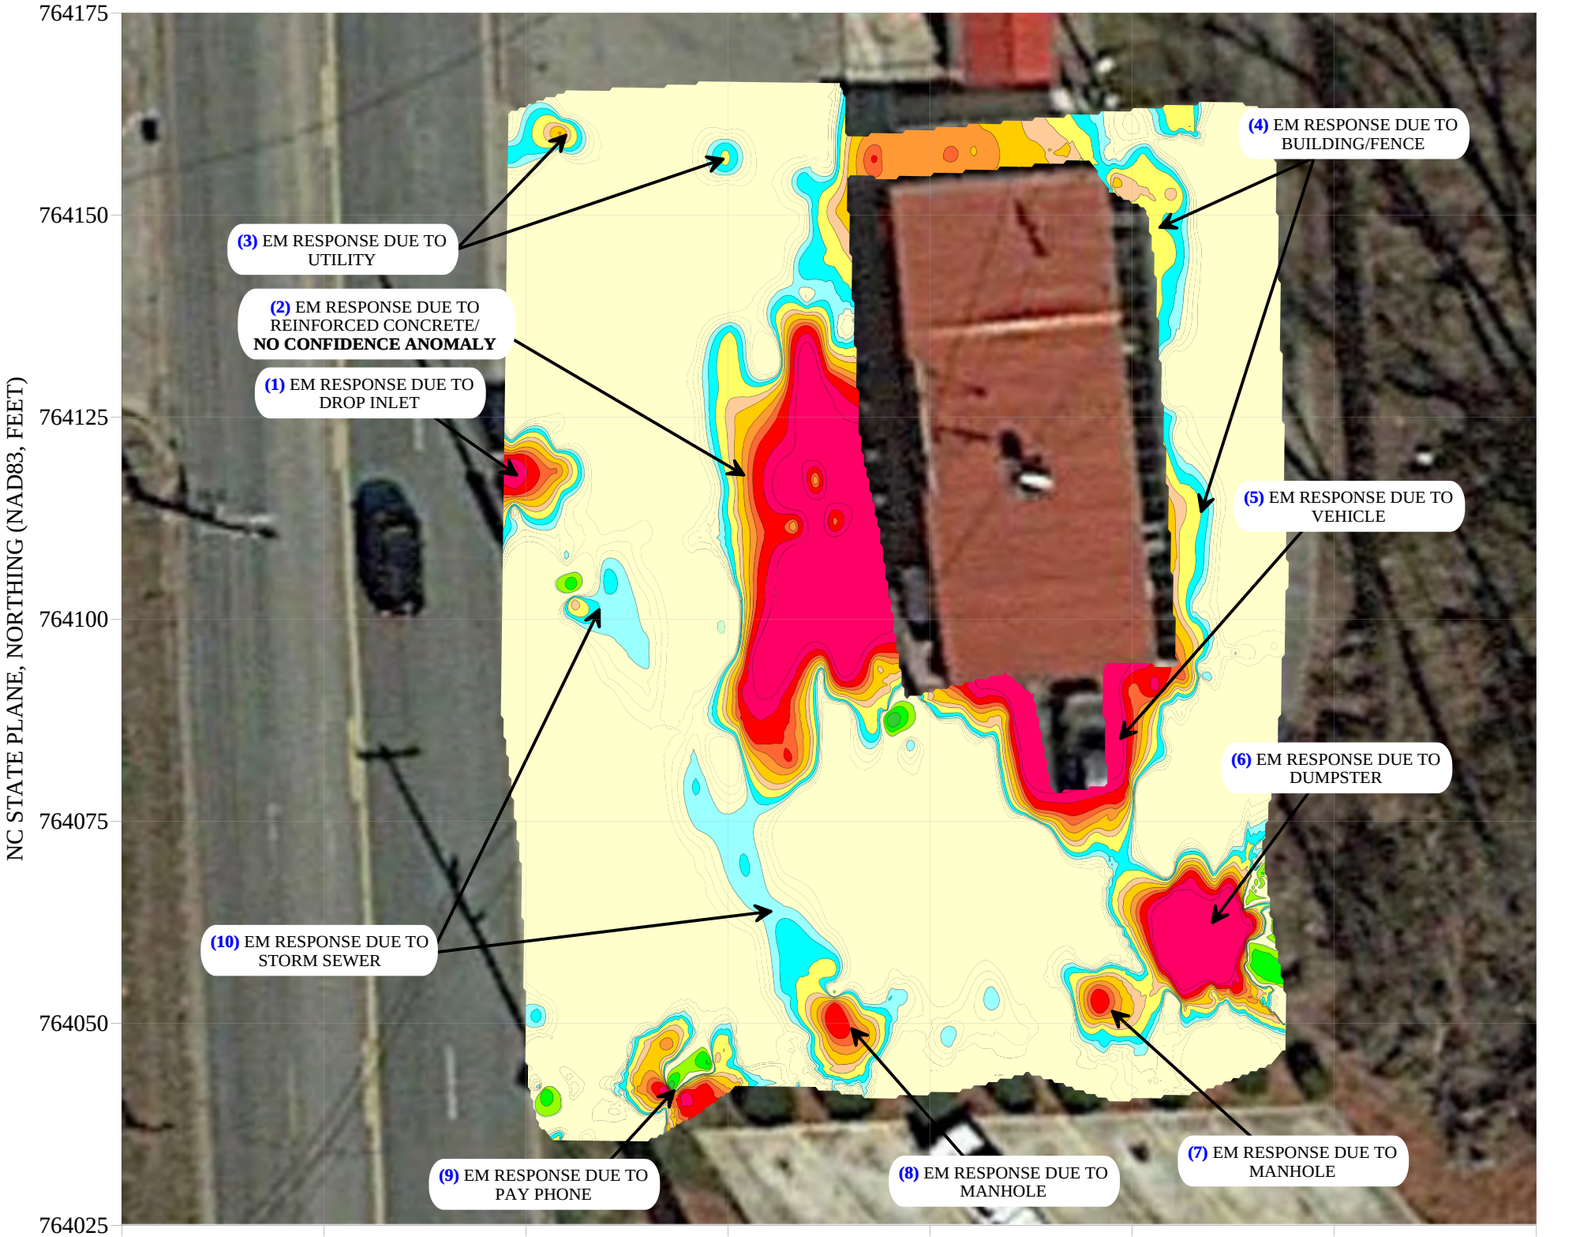
FIGURE 2

A contour plot of the EM61 results obtained across the survey area at the property is presented in **Figure 2**. Each EM anomaly is numbered for reference in the figure. The following table presents the list of EM anomalies and the cause of the metallic response, if known:

EVIDENCE OF ONE NO CONFIDENCE ANOMALY WAS OBSERVED.

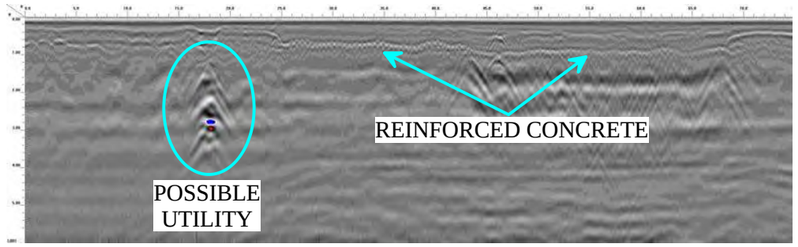
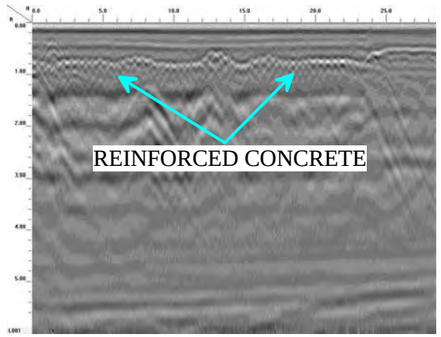
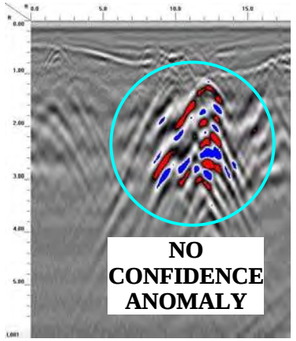
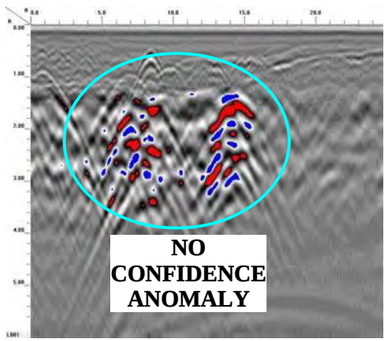
FIGURE 3

Figure 3 presents the locations of the formal GPR transects performed at the property as well as select transect images. All of the transect images are included in **Appendix A**. A total of thirteen formal GPR transects were performed at the site. GPR Transects 1-3 were performed across an area of interference caused by a vehicle (EM Anomaly 5). No evidence of buried structures such as USTs was observed.

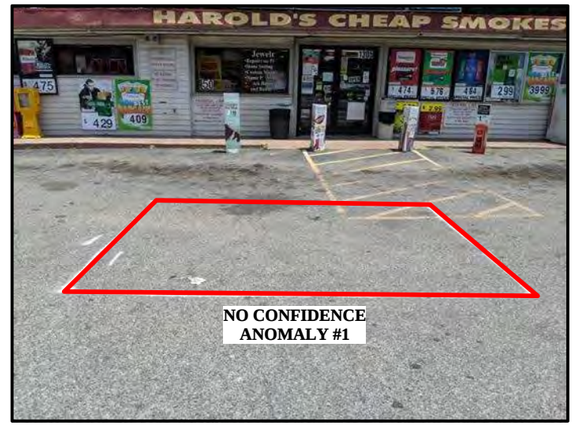
One (1) no confidence anomaly, approximately 12-feet long by 10-feet wide, was located west of the convenience store building on-site within the Project Study Area (No Confidence Anomaly #1). The anomaly lacks the lateral reflector typical of the long axis of a UST, thus the no confidence classification. There were no other EM responses that were not associated with known utilities, vehicles, or other previously known conditions.

View of One No Confidence Anomaly Facing Approximately East

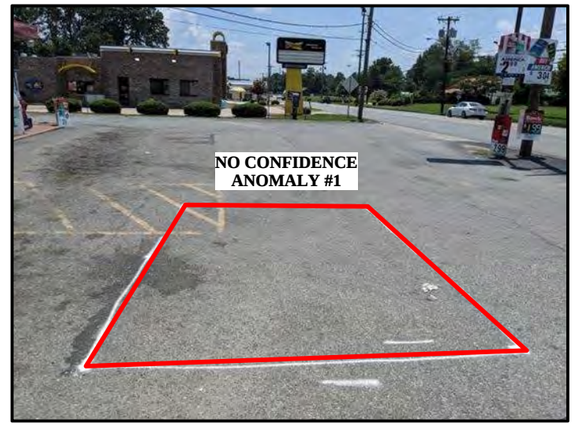
View of One No Confidence Anomaly Facing Approximately South

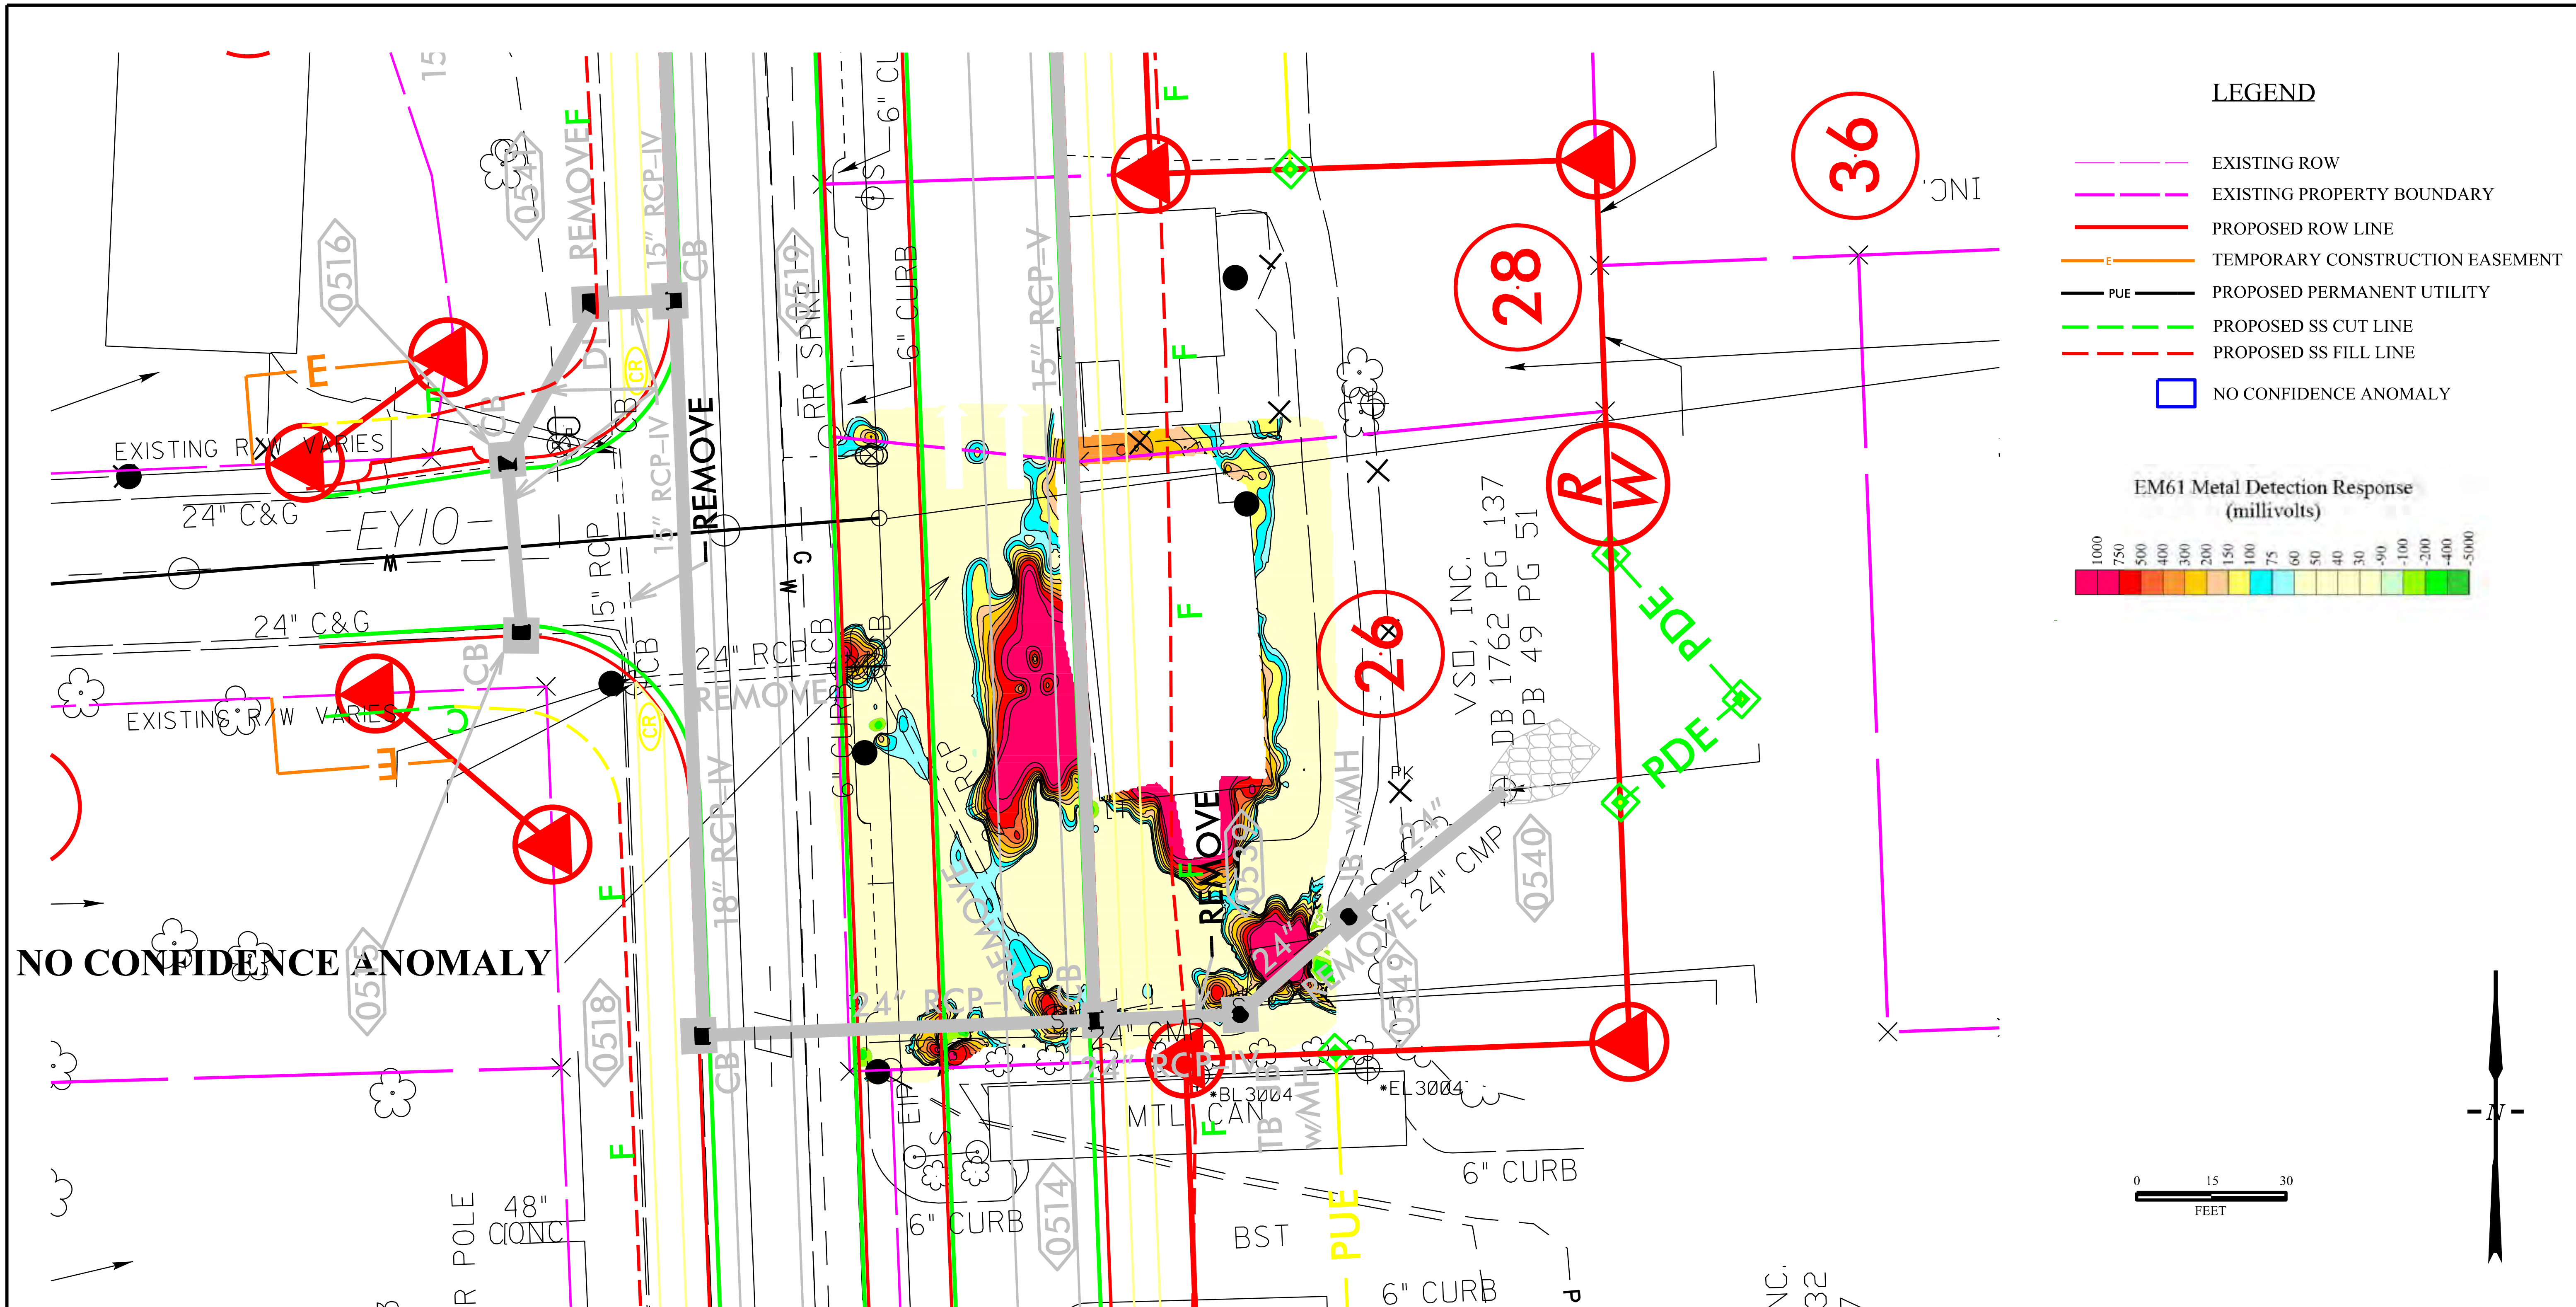
DATE: 08-13-2019	REVISION NO. 0
PYRAMID PROJECT NO. 2019-211	FIGURE NO. 5

Collectively, the geophysical data recorded evidence of one no confidence anomaly within the survey area at Parcel 26. **Figure 5** provides an overlay of the metal detection results and the location of the No Confidence anomaly on the NCDOT MicroStation engineering plans for reference.

OVERLAY OF METAL DETECTION RESULTS
AND ONE NO CONFIDENCE ANOMALY
ON NCDOT ENGINEERING PLANS
