LOCATION: HERBERT C. BONNER BRIDGE LOCATED AT THE OREGON INLET ALONG NC 12 IN DARE COUNTY.

TYPE OF WORK: REPAIR OF EXISTING PILE CAPS, COLUMNS, CAPS, GIRDERS, AND DECKS

PROJECT NO. B-5014

BONNER BRIDGE REPAIR
COVER SHEET

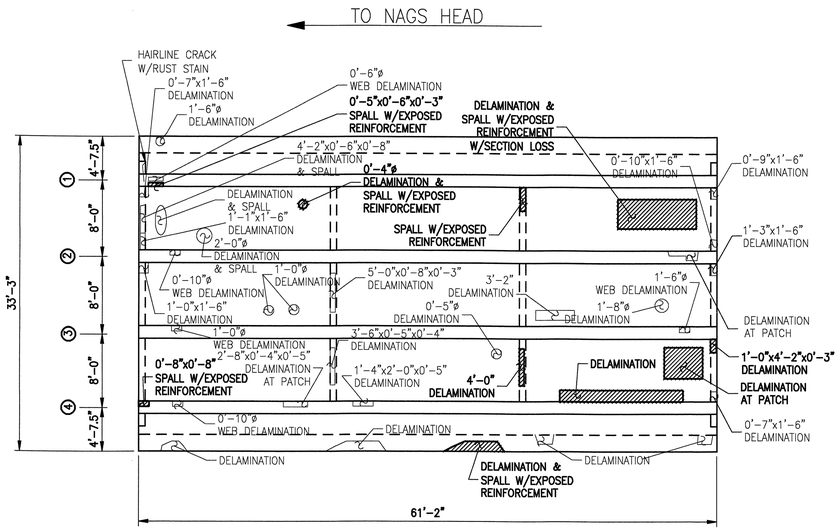
SPAN #174–UNDERSIDE

REPAIR TYPE	QUANTITIES UNIT		ACTUAL
HORIZONTAL SHOTCRETE	CF	–	
VERTICAL SHOTCRETE	CF	–	
OVERHEAD SHOTCRETE	CF	18	
ADDITIONAL REINFORCING	LBS	–	
EPOXY MORTAR (FORMED)	CF	1

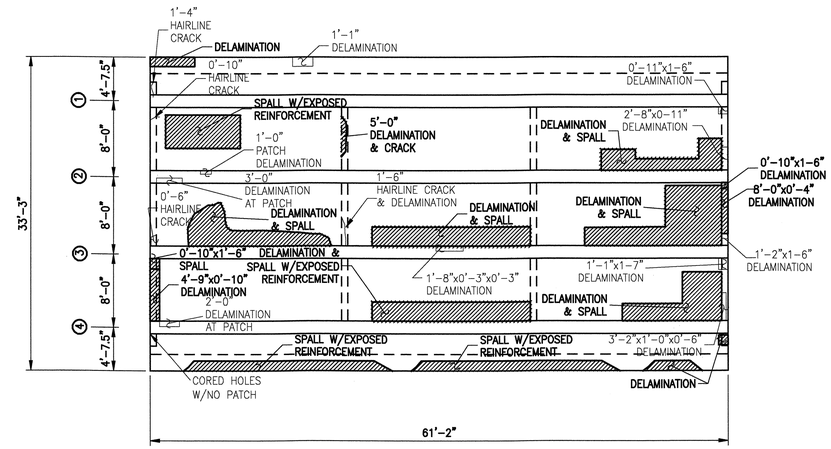
SPAN #175–UNDERSIDE

REPAIR TYPE	QUANTITIES UNIT		ACTUAL
HORIZONTAL SHOTCRETE	CF	–	
VERTICAL SHOTCRETE	CF	–	
OVERHEAD SHOTCRETE	CF	88	
ADDITIONAL REINFORCING	LBS	–	
EPOXY MORTAR (FORMED)	CF	–

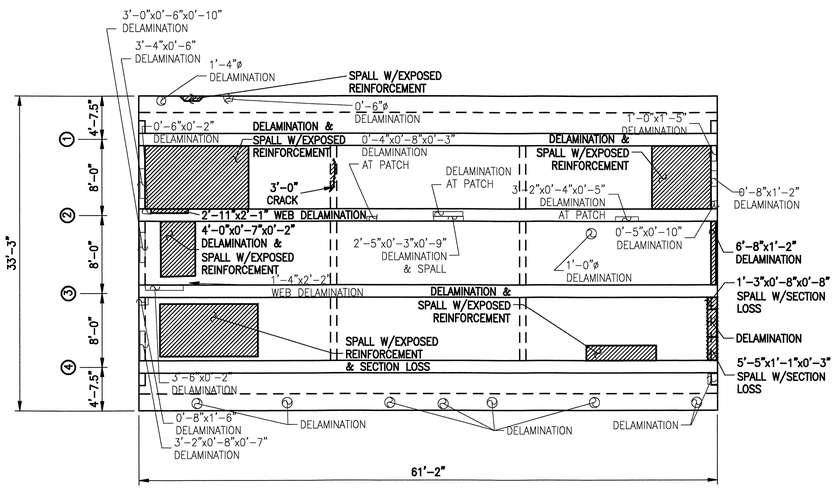
SPAN #176–UNDERSIDE

REPAIR TYPE	QUANTITIES UNIT		ACTUAL
HORIZONTAL SHOTCRETE	CF	–	
VERTICAL SHOTCRETE	CF	3	
OVERHEAD SHOTCRETE	CF	63	
ADDITIONAL REINFORCING	LBS	–	
EPOXY MORTAR (FORMED)	CF	1

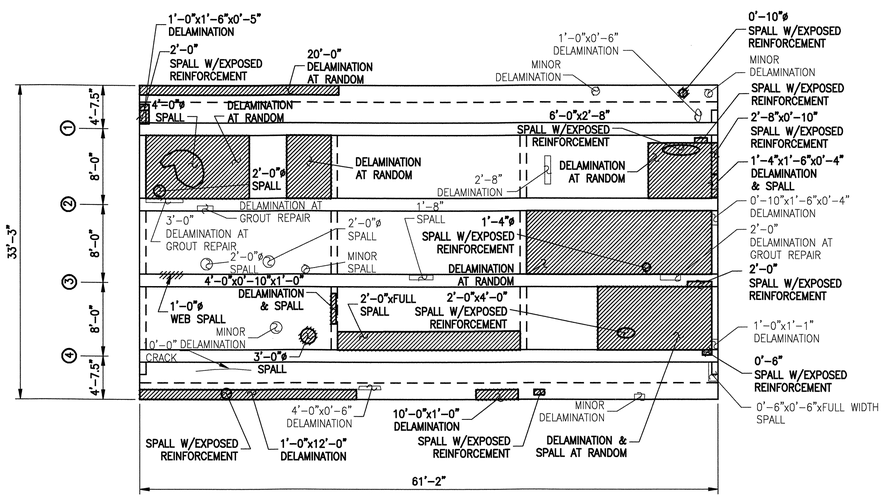
SPAN #177–UNDERSIDE

REPAIR TYPE	QUANTITIES UNIT		ACTUAL
HORIZONTAL SHOTCRETE	CF	–	
VERTICAL SHOTCRETE	CF	1	
OVERHEAD SHOTCRETE	CF	128	
ADDITIONAL REINFORCING	LBS	–	
EPOXY MORTAR (FORMED)	CF	1

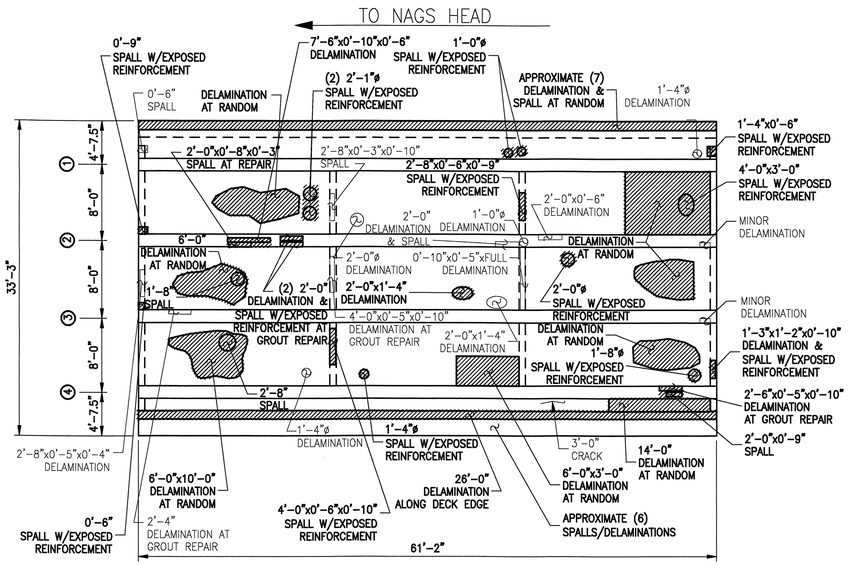
BENT #177 — SPAN #178–UNDERSIDE — BENT #178

REPAIR TYPE	QUANTITIES UNIT		ACTUAL
HORIZONTAL SHOTCRETE	CF	–	
VERTICAL SHOTCRETE	CF	1	
OVERHEAD SHOTCRETE	CF	91	
ADDITIONAL REINFORCING	LBS	–	
EPOXY MORTAR (FORMED)	CF	4

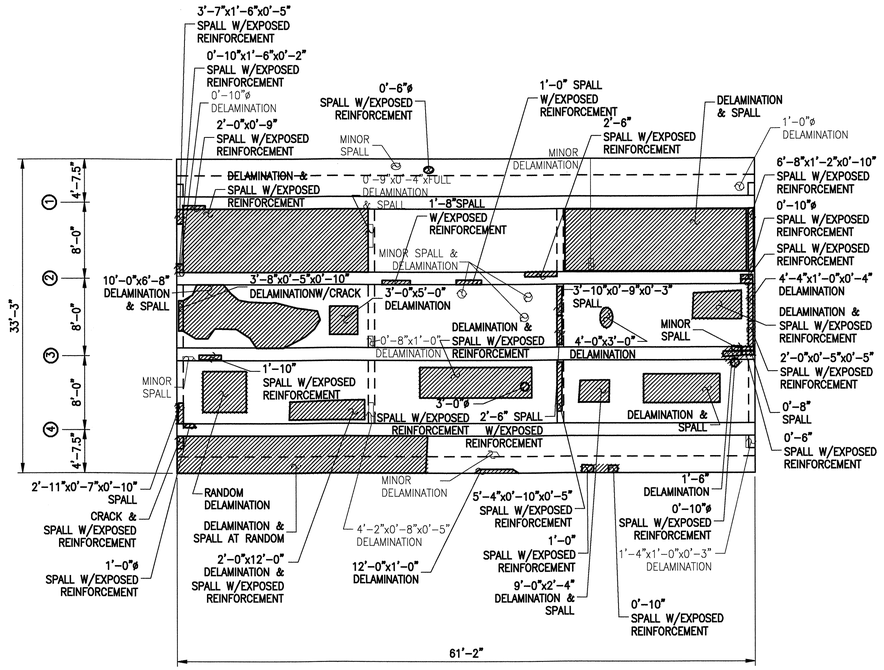
BENT #178 — SPAN #179–UNDERSIDE — BENT #179

REPAIR TYPE	QUANTITIES UNIT		ACTUAL
HORIZONTAL SHOTCRETE	CF	–	
VERTICAL SHOTCRETE	CF	1	
OVERHEAD SHOTCRETE	CF	170	
ADDITIONAL REINFORCING	LBS	–	
EPOXY MORTAR (FORMED)	CF	2

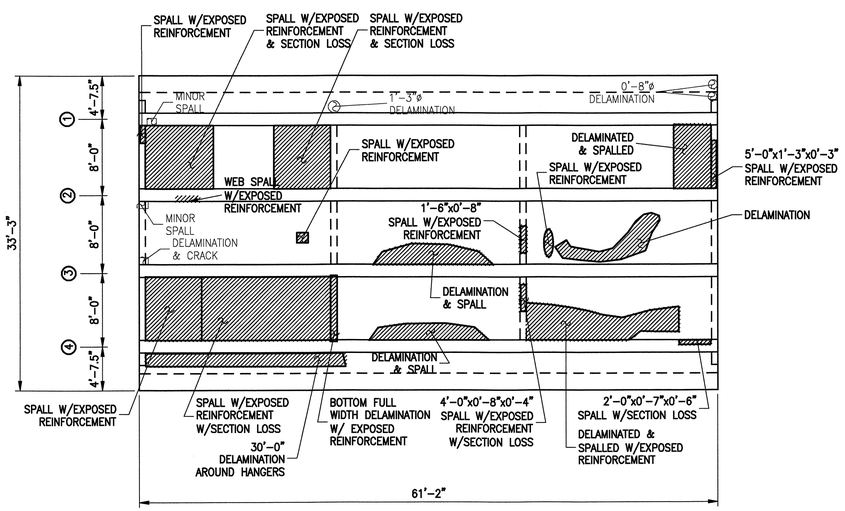
BENT #179 — SPAN #180–UNDERSIDE — BENT #180

REPAIR TYPE	QUANTITIES UNIT		ACTUAL
HORIZONTAL SHOTCRETE	CF	–	
VERTICAL SHOTCRETE	CF	–	
OVERHEAD SHOTCRETE	CF	119	
ADDITIONAL REINFORCING	LBS	–	
EPOXY MORTAR (FORMED)	CF	1

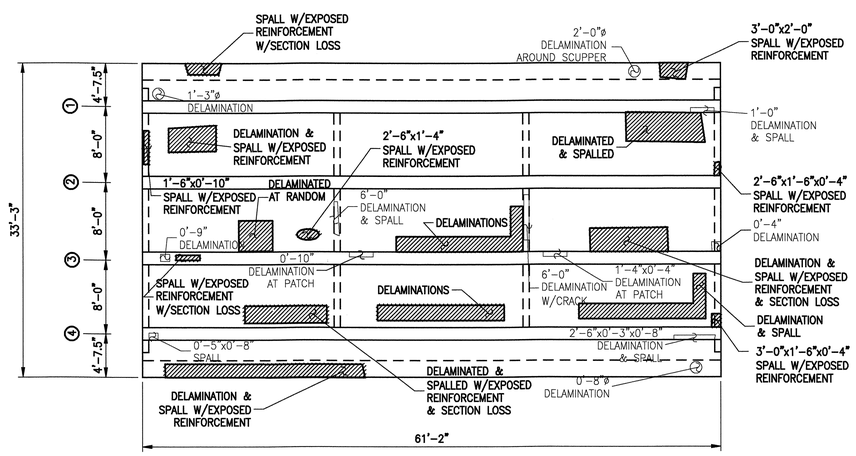
BENT #180 — SPAN #181–UNDERSIDE — BENT #181

REPAIR TYPE	QUANTITIES UNIT		ACTUAL
HORIZONTAL SHOTCRETE	CF	–	
VERTICAL SHOTCRETE	CF	–	
OVERHEAD SHOTCRETE	CF	50	
ADDITIONAL REINFORCING	LBS	–	
EPOXY MORTAR (FORMED)	CF	1

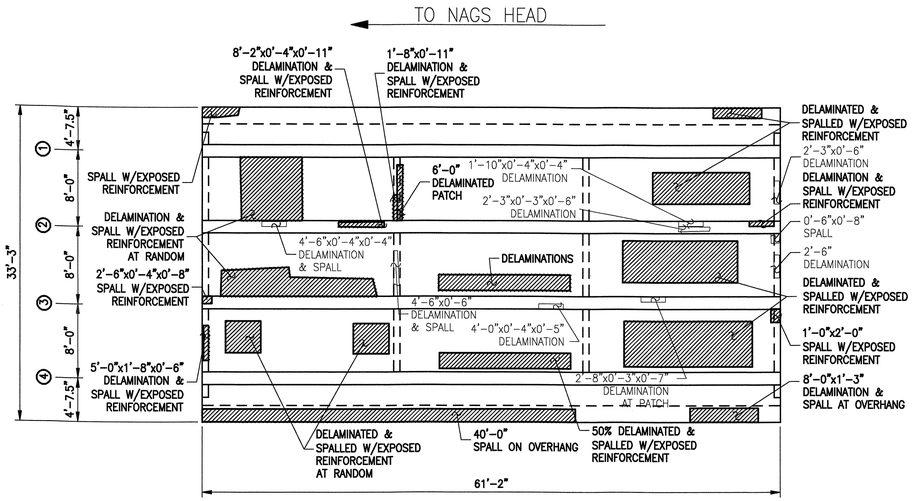
BENT #181 — SPAN #182–UNDERSIDE — BENT #182

REPAIR TYPE	QUANTITIES UNIT		ACTUAL
HORIZONTAL SHOTCRETE	CF	–	
VERTICAL SHOTCRETE	CF	–	
OVERHEAD SHOTCRETE	CF	99	
ADDITIONAL REINFORCING	LBS	–	
EPOXY MORTAR (FORMED)	CF	3

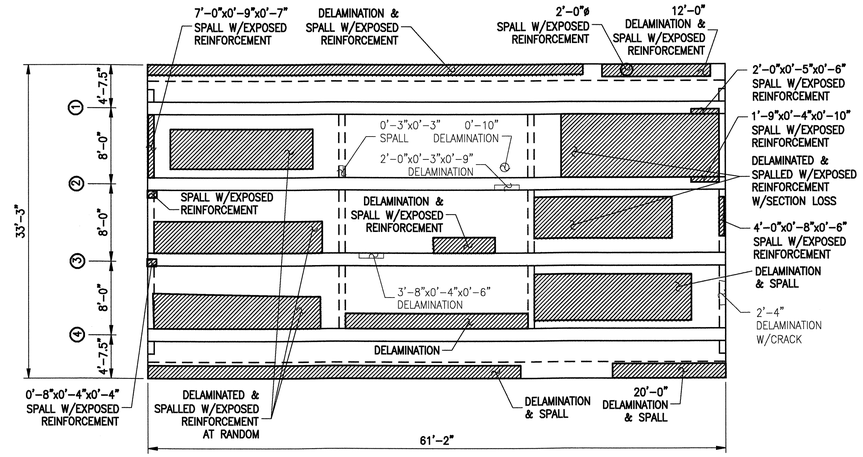
BENT #182 — SPAN #183–UNDERSIDE — BENT #183

REPAIR TYPE	QUANTITIES UNIT		ACTUAL
HORIZONTAL SHOTCRETE	CF	–	
VERTICAL SHOTCRETE	CF	1	
OVERHEAD SHOTCRETE	CF	162	
ADDITIONAL REINFORCING	LBS	–	
EPOXY MORTAR (FORMED)	CF	1

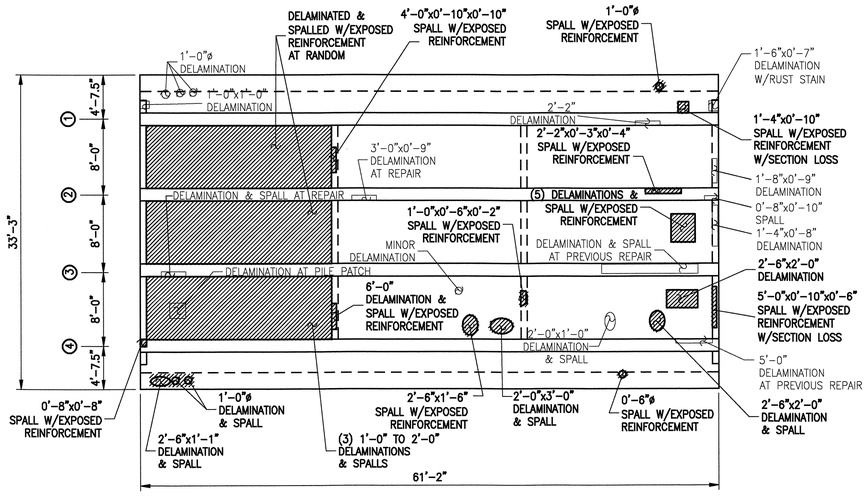
BENT #183 — SPAN #184–UNDERSIDE — BENT #184

REPAIR TYPE	QUANTITIES UNIT		ACTUAL
HORIZONTAL SHOTCRETE	CF	–	
VERTICAL SHOTCRETE	CF	1	
OVERHEAD SHOTCRETE	CF	168	
ADDITIONAL REINFORCING	LBS	–	
EPOXY MORTAR (FORMED)	CF	1

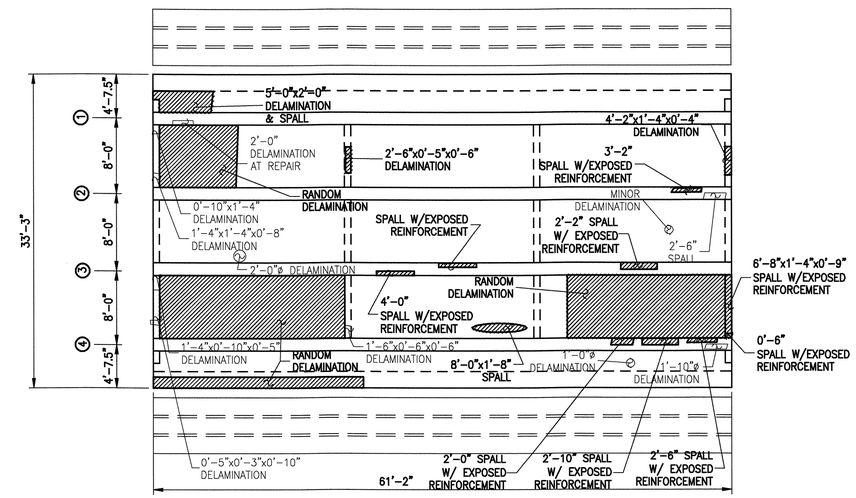
BENT #184 — SPAN #185–UNDERSIDE — BENT #185

REPAIR TYPE	QUANTITIES UNIT		ACTUAL
HORIZONTAL SHOTCRETE	CF	–	
VERTICAL SHOTCRETE	CF	1	
OVERHEAD SHOTCRETE	CF	103	
ADDITIONAL REINFORCING	LBS	–	
EPOXY MORTAR (FORMED)	CF	5

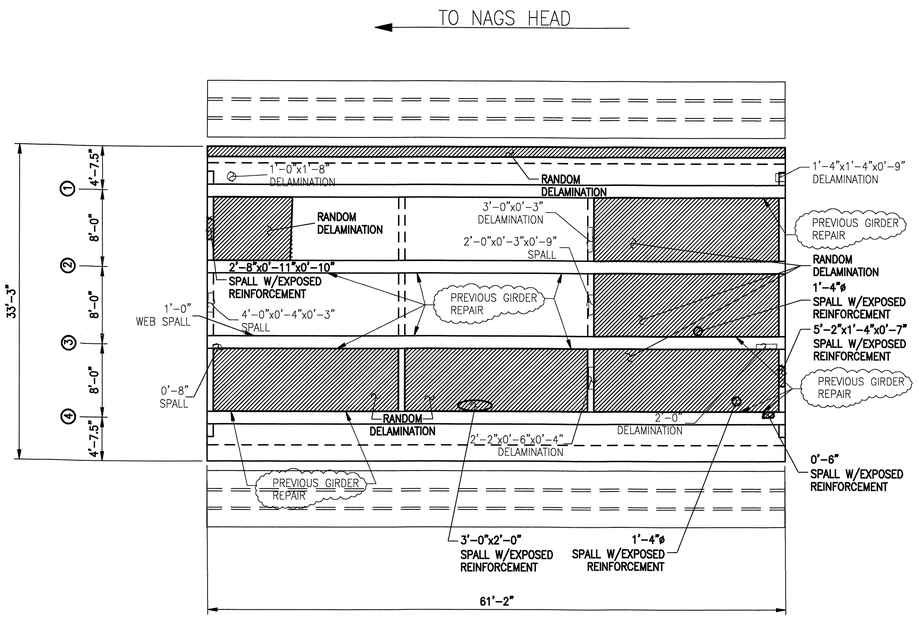
BENT #185 — SPAN #186–UNDERSIDE — BENT #186

SPAN #186			
REPAIR TYPE	QUANTITIES		
	UNIT		ACTUAL
HORIZONTAL SHOTCRETE	CF	–	
VERTICAL SHOTCRETE	CF	1	
OVERHEAD SHOTCRETE	CF	224	
ADDITIONAL REINFORCING	LBS	–	
EPOXY MORTAR (FORMED)	CF	1

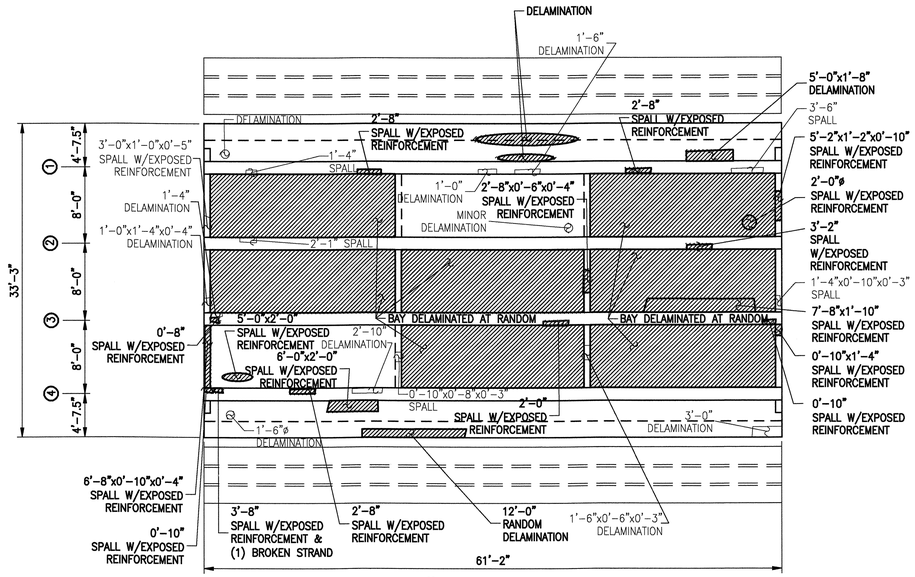
BENT #186 — SPAN #187–UNDERSIDE — BENT #187

SPAN #187			
REPAIR TYPE	QUANTITIES		
	UNIT		ACTUAL
HORIZONTAL SHOTCRETE	CF	–	
VERTICAL SHOTCRETE	CF	1	
OVERHEAD SHOTCRETE	CF	294	
ADDITIONAL REINFORCING	LBS	–	
EPOXY MORTAR (FORMED)	CF	2

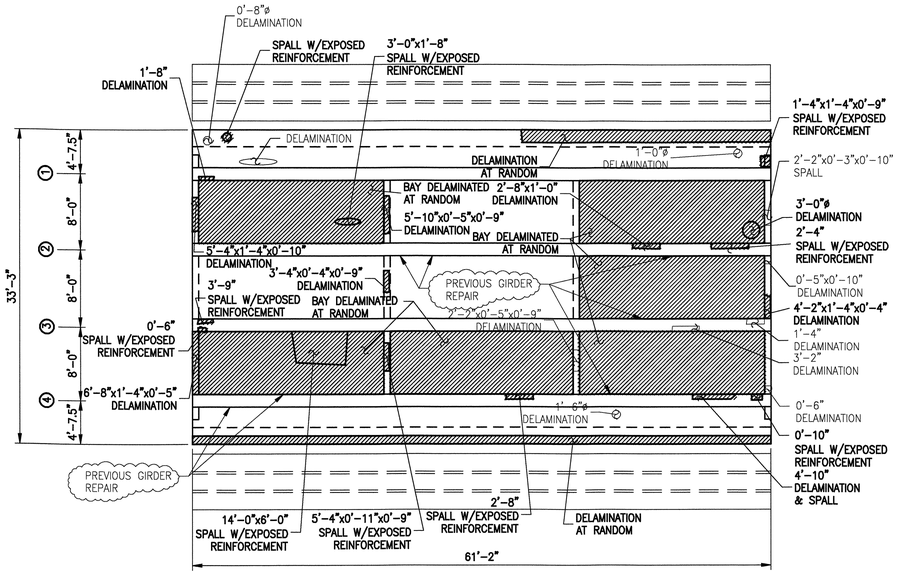
BENT #187 — SPAN #188–UNDERSIDE — BENT #188

SPAN #188			
REPAIR TYPE	QUANTITIES		
	UNIT		ACTUAL
HORIZONTAL SHOTCRETE	CF	–	
VERTICAL SHOTCRETE	CF	1	
OVERHEAD SHOTCRETE	CF	261	
ADDITIONAL REINFORCING	LBS	–	
EPOXY MORTAR (FORMED)	CF	2

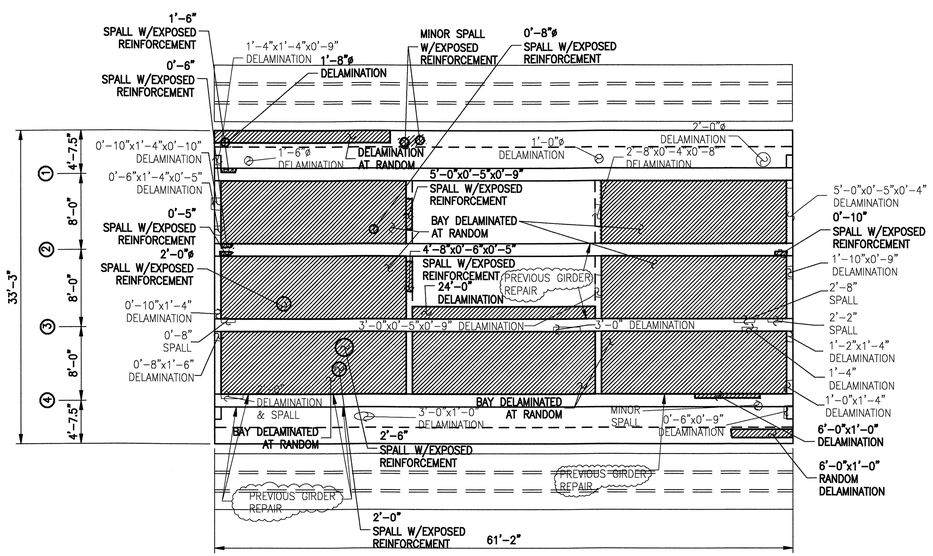
BENT #188 — SPAN #189–UNDERSIDE — BENT #189

SPAN #189			
REPAIR TYPE	QUANTITIES		
	UNIT		ACTUAL
HORIZONTAL SHOTCRETE	CF	–	
VERTICAL SHOTCRETE	CF	1	
OVERHEAD SHOTCRETE	CF	283	
ADDITIONAL REINFORCING	LBS	–	
EPOXY MORTAR (FORMED)	CF	2

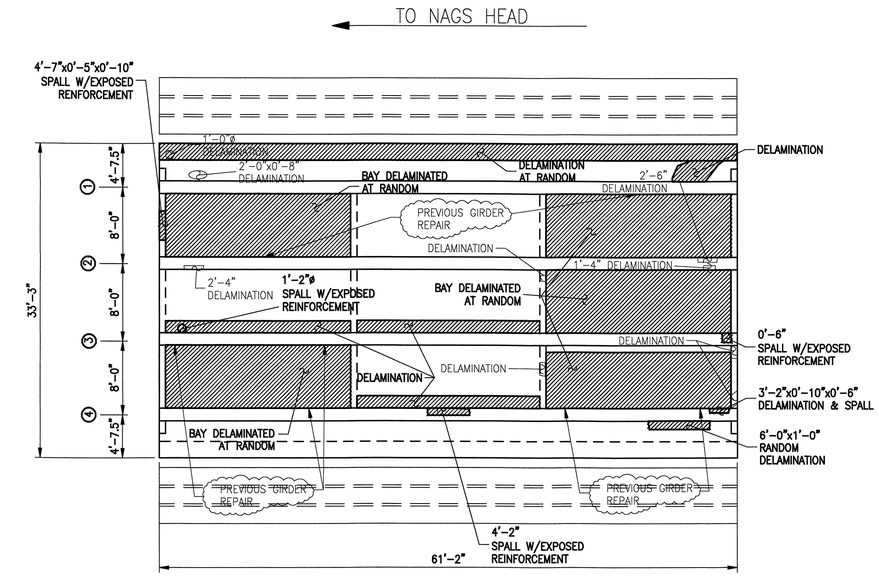
BENT #189 — SPAN #190–UNDERSIDE — BENT #190

REPAIR TYPE	QUANTITIES UNIT		ACTUAL
HORIZONTAL SHOTCRETE	CF	–	
VERTICAL SHOTCRETE	CF	1	
OVERHEAD SHOTCRETE	CF	233	
ADDITIONAL REINFORCING	LBS	–	
EPOXY MORTAR (FORMED)	CF	1

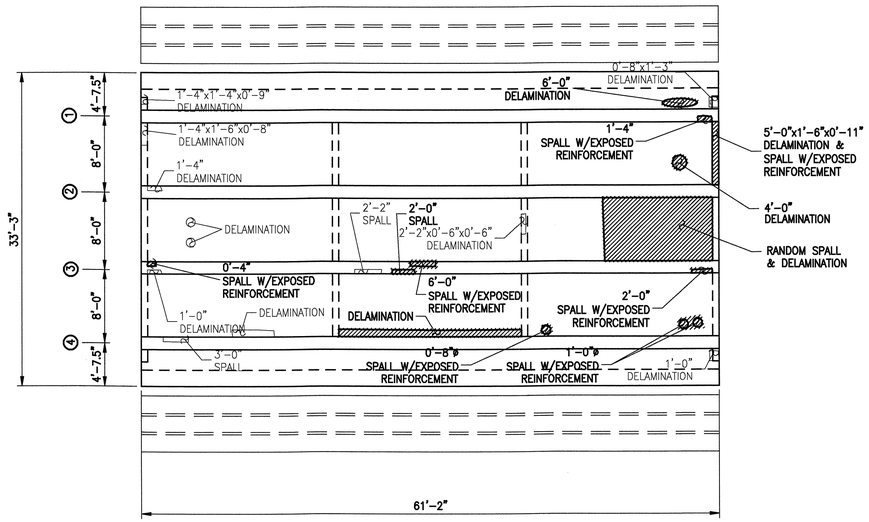
BENT #190 — SPAN #191–UNDERSIDE — BENT #191

REPAIR TYPE	QUANTITIES UNIT		ACTUAL
HORIZONTAL SHOTCRETE	CF	–	
VERTICAL SHOTCRETE	CF	1	
OVERHEAD SHOTCRETE	CF	32	
ADDITIONAL REINFORCING	LBS	–	
EPOXY MORTAR (FORMED)	CF	1

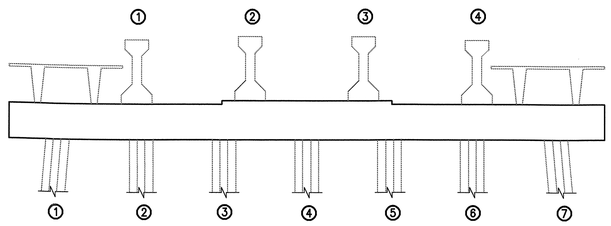
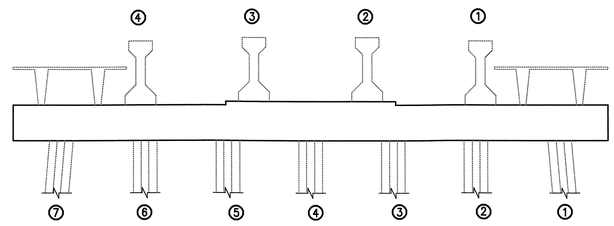
BENT #6			
REPAIR TYPE	QUANTITIES		
	UNIT		ACTUAL
HORIZONTAL SHOTCRETE	CF	–	
VERTICAL SHOTCRETE	CF	–	
OVERHEAD SHOTCRETE	CF	–	
ADDITIONAL REINFORCING	LBS	–	
EPOXY MORTAR (FORMED)	CF	–

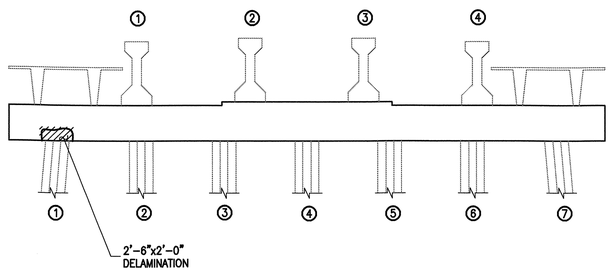
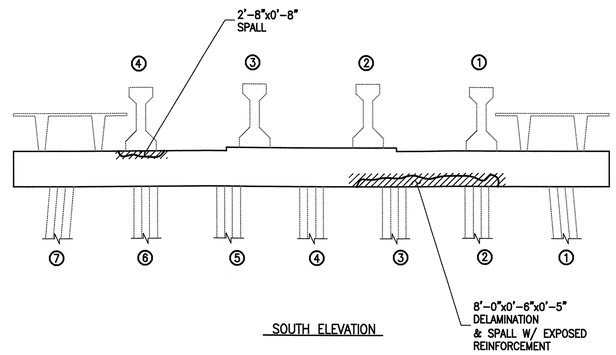
BENT #7			
REPAIR TYPE	QUANTITIES		
	UNIT		ACTUAL
HORIZONTAL SHOTCRETE	CF	–	
VERTICAL SHOTCRETE	CF	2	
OVERHEAD SHOTCRETE	CF	2	
ADDITIONAL REINFORCING	LBS	7	
EPOXY MORTAR (FORMED)	CF	–

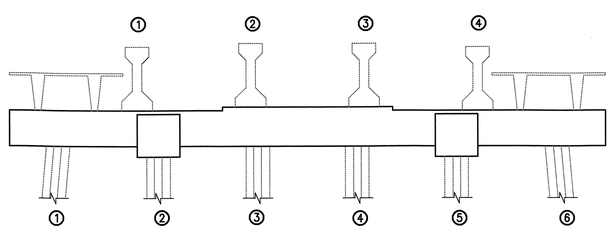
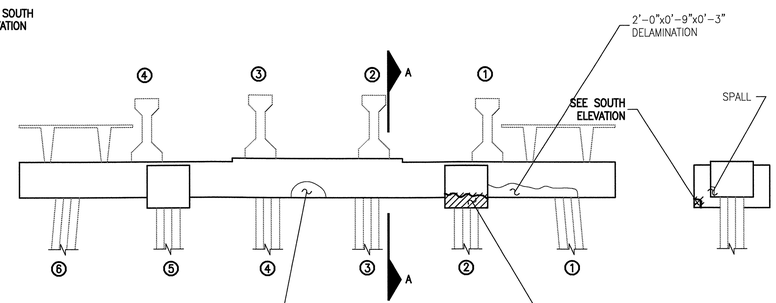
BENT #8			
REPAIR TYPE	QUANTITIES		
	UNIT		ACTUAL
HORIZONTAL SHOTCRETE	CF	–	
VERTICAL SHOTCRETE	CF	1	
OVERHEAD SHOTCRETE	CF	1	
ADDITIONAL REINFORCING	LBS	–	
EPOXY MORTAR (FORMED)	CF	–

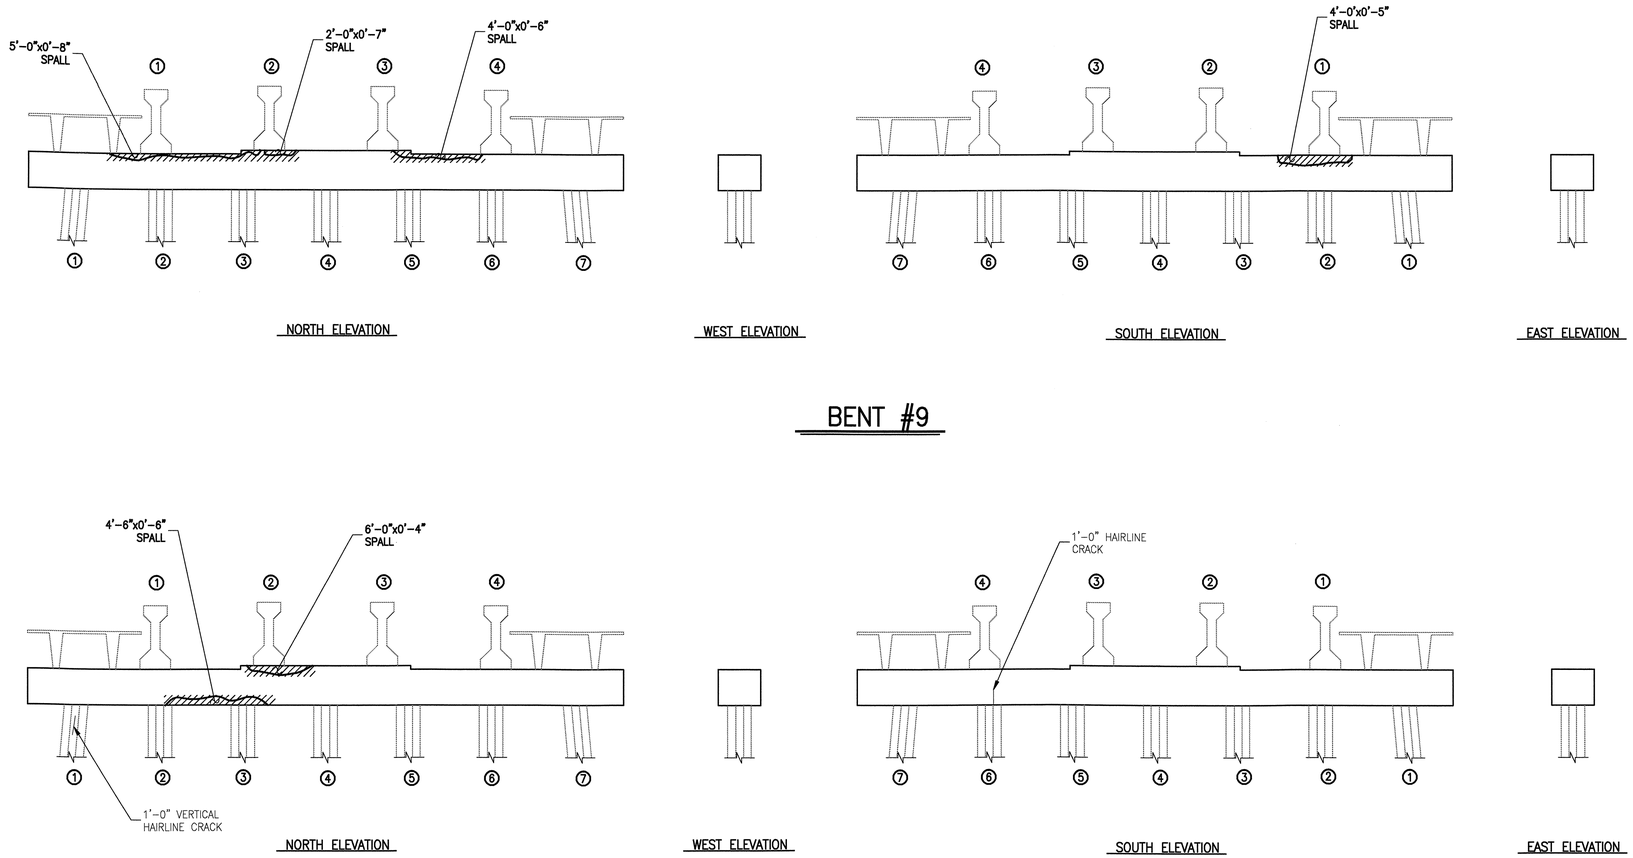
BENT #9			
REPAIR TYPE	QUANTITIES		
	UNIT		ACTUAL
HORIZONTAL SHOTCRETE	CF	–	
VERTICAL SHOTCRETE	CF	3	
OVERHEAD SHOTCRETE	CF	–	
ADDITIONAL REINFORCING	LBS	40	
EPOXY MORTAR (FORMED)	CF	–

BENT #10			
REPAIR TYPE	QUANTITIES		
	UNIT		ACTUAL
HORIZONTAL SHOTCRETE	CF	–	
VERTICAL SHOTCRETE	CF	1	
OVERHEAD SHOTCRETE	CF	1	
ADDITIONAL REINFORCING	LBS	16	
EPOXY MORTAR (FORMED)	CF	–

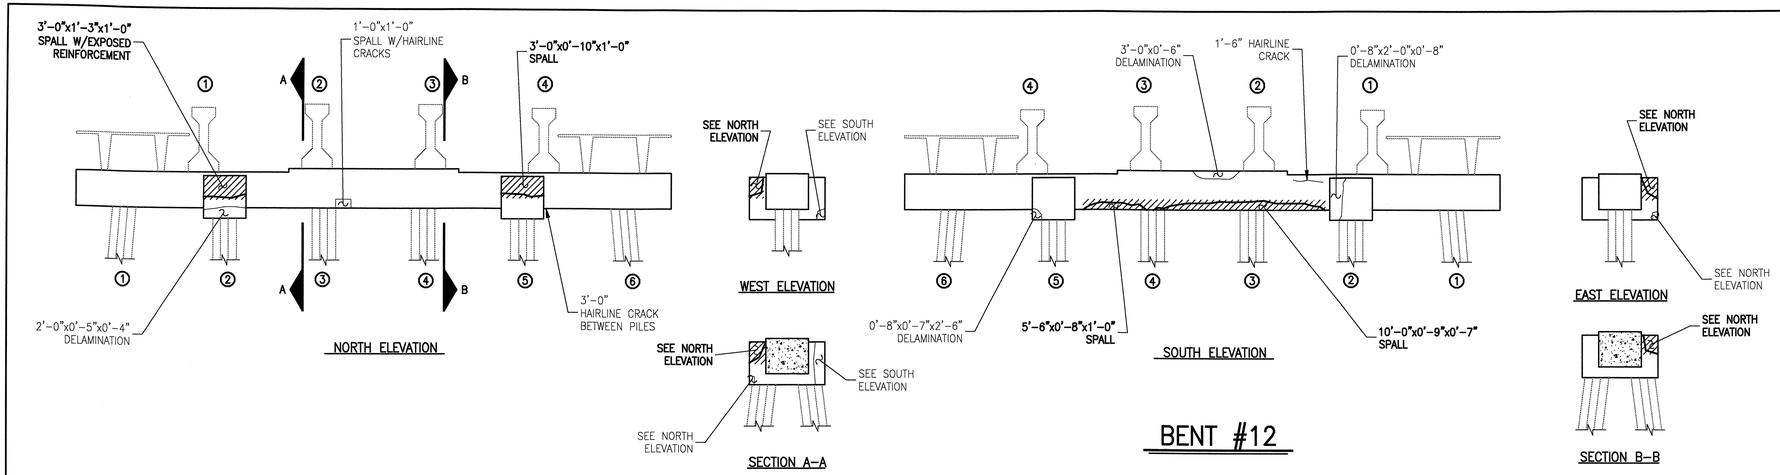
BENT #12			
REPAIR TYPE	QUANTITIES		
	UNIT		ACTUAL
HORIZONTAL SHOTCRETE	CF	1	
VERTICAL SHOTCRETE	CF	5	
OVERHEAD SHOTCRETE	CF	5	
ADDITIONAL REINFORCING	LBS	–	
EPOXY MORTAR (FORMED)	CF	–

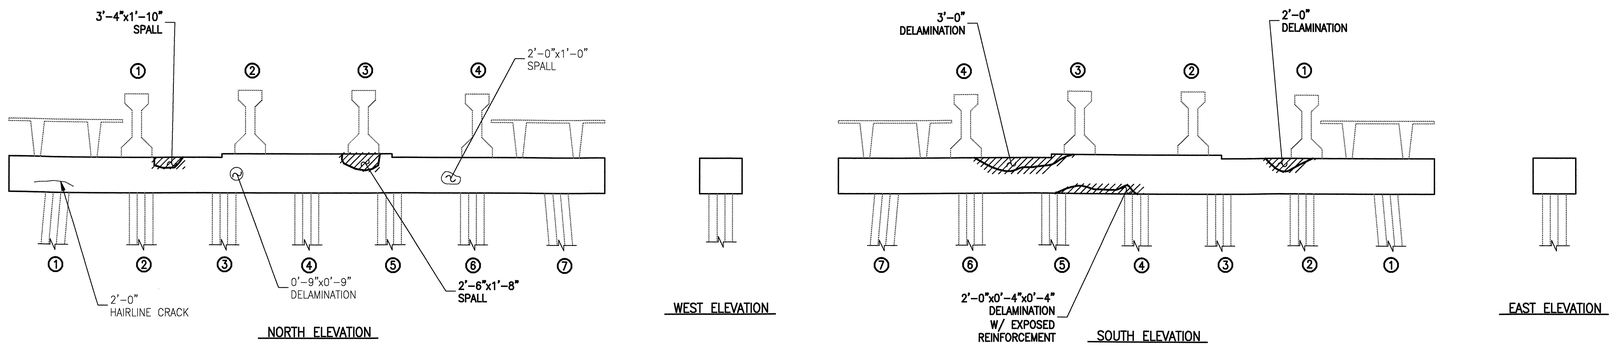
BENT #13			
REPAIR TYPE	QUANTITIES		
	UNIT		ACTUAL
HORIZONTAL SHOTCRETE	CF	–	
VERTICAL SHOTCRETE	CF	5	
OVERHEAD SHOTCRETE	CF	1	
ADDITIONAL REINFORCING	LBS	22	
EPOXY MORTAR (FORMED)	CF	–

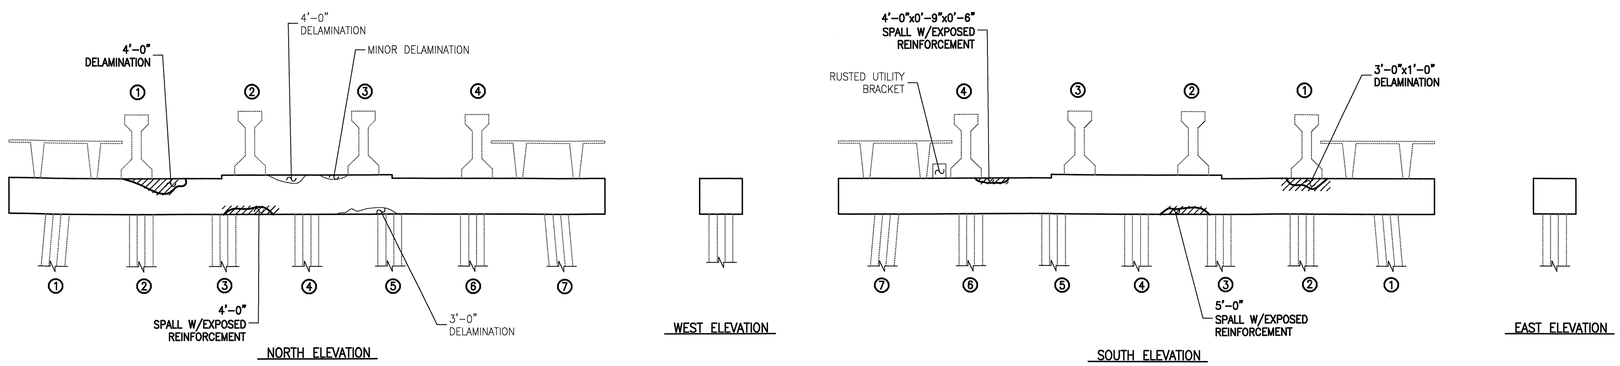
BENT #14			
REPAIR TYPE	QUANTITIES		
	UNIT		ACTUAL
HORIZONTAL SHOTCRETE	CF	–	
VERTICAL SHOTCRETE	CF	4	
OVERHEAD SHOTCRETE	CF	1	
ADDITIONAL REINFORCING	LBS	29	
EPOXY MORTAR (FORMED)	CF	–

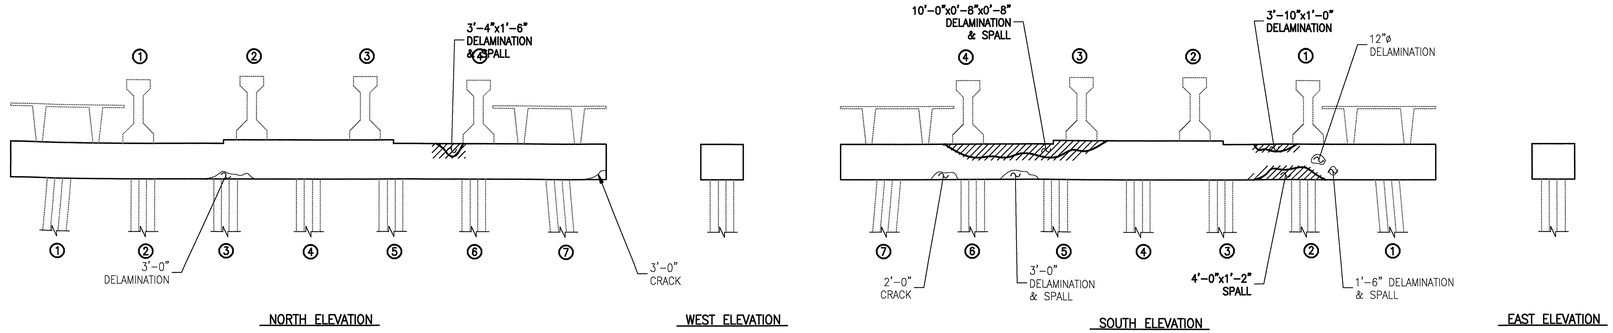
BENT #15			
REPAIR TYPE	QUANTITIES		
	UNIT		ACTUAL
HORIZONTAL SHOTCRETE	CF	1	
VERTICAL SHOTCRETE	CF	7	
OVERHEAD SHOTCRETE	CF	1	
ADDITIONAL REINFORCING	LBS	46	
EPOXY MORTAR (FORMED)	CF	–

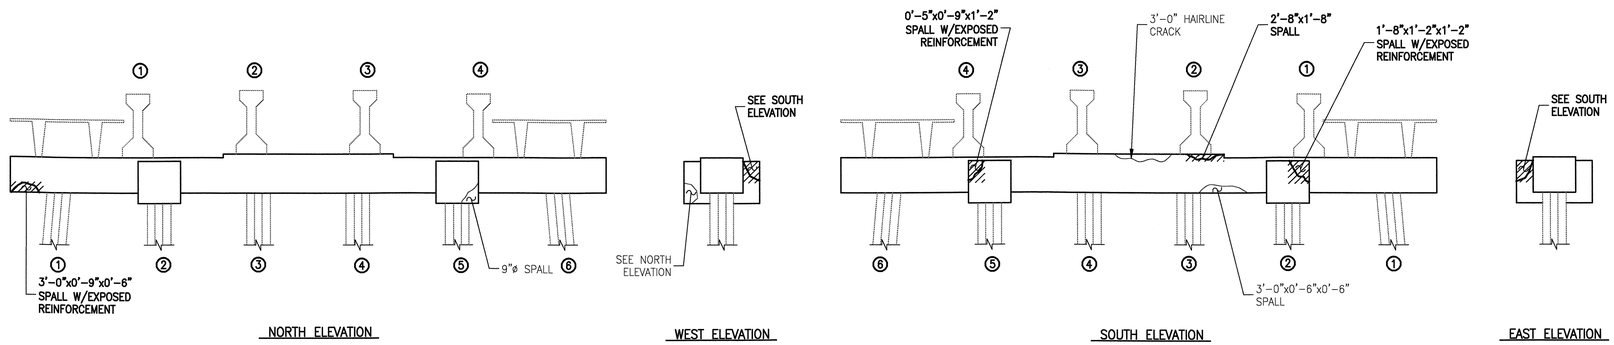
BENT #16			
REPAIR TYPE	QUANTITIES		
	UNIT		ACTUAL
HORIZONTAL SHOTCRETE	CF	1	
VERTICAL SHOTCRETE	CF	3	
OVERHEAD SHOTCRETE	CF	1	
ADDITIONAL REINFORCING	LBS	7	
EPOXY MORTAR (FORMED)	CF	–

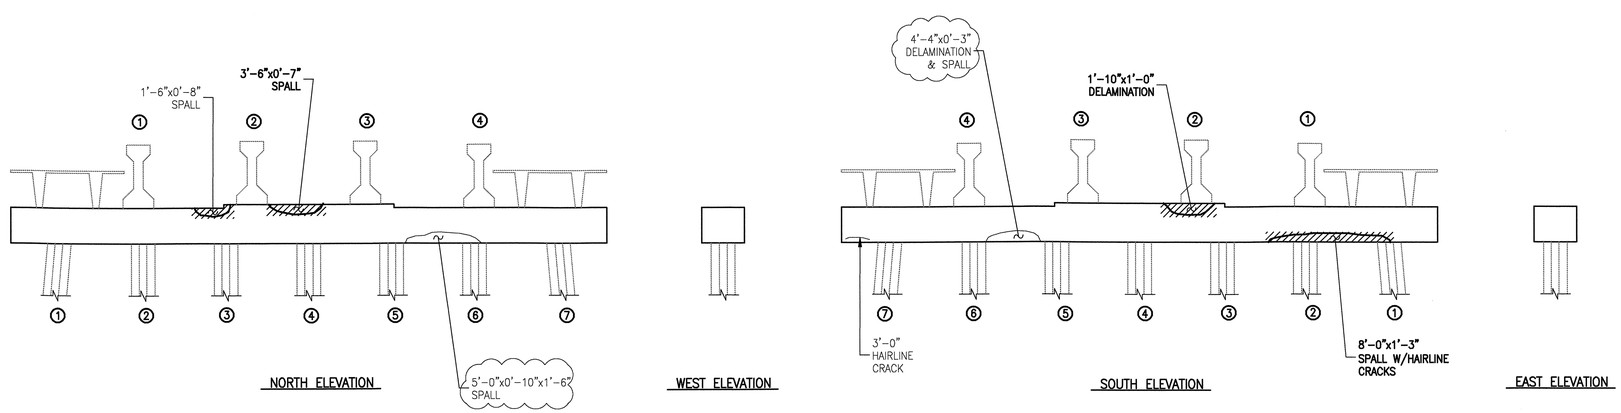
BENT #17			
REPAIR TYPE	QUANTITIES		
	UNIT		ACTUAL
HORIZONTAL SHOTCRETE	CF	–	
VERTICAL SHOTCRETE	CF	3	
OVERHEAD SHOTCRETE	CF	1	
ADDITIONAL REINFORCING	LBS	14	
EPOXY MORTAR (FORMED)	CF	–

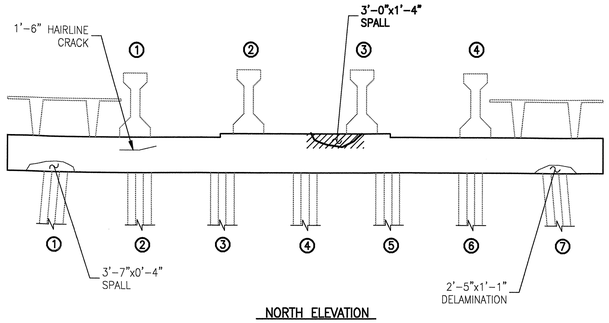
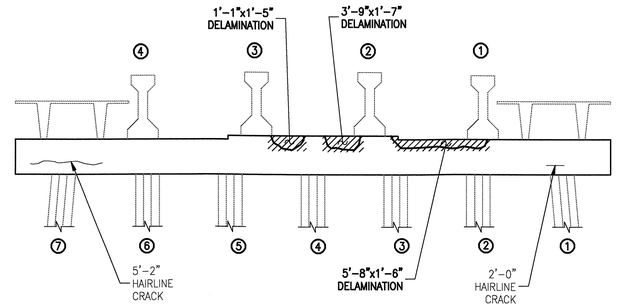
BENT #18			
REPAIR TYPE	QUANTITIES		
	UNIT		ACTUAL
HORIZONTAL SHOTCRETE	CF	–	
VERTICAL SHOTCRETE	CF	7	
OVERHEAD SHOTCRETE	CF	–	
ADDITIONAL REINFORCING	LBS	36	
EPOXY MORTAR (FORMED)	CF	–

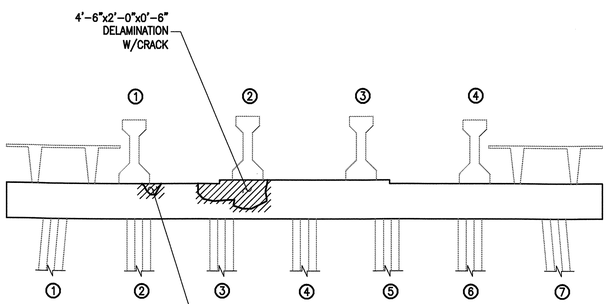
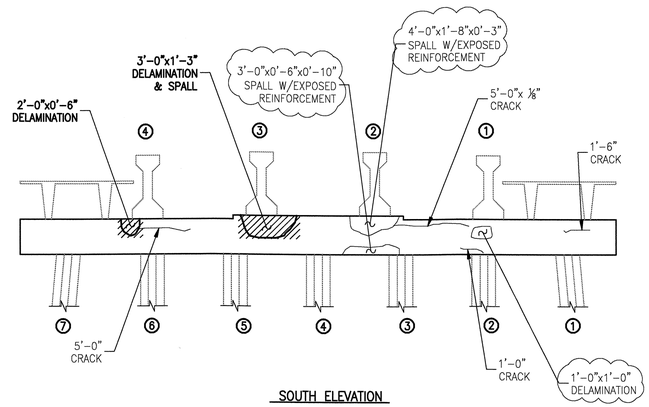
BENT #19			
REPAIR TYPE	QUANTITIES		
	UNIT		ACTUAL
HORIZONTAL SHOTCRETE	CF	–	
VERTICAL SHOTCRETE	CF	5	
OVERHEAD SHOTCRETE	CF	–	
ADDITIONAL REINFORCING	LBS	27	
EPOXY MORTAR (FORMED)	CF	–

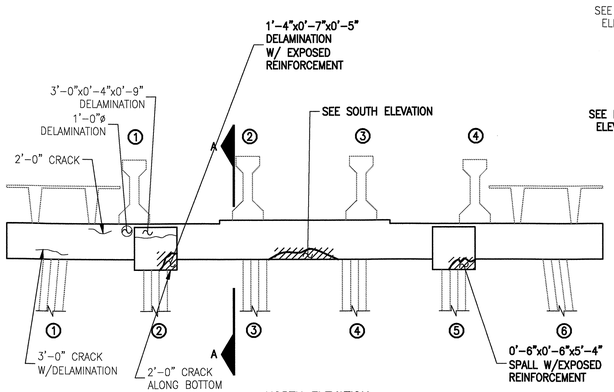
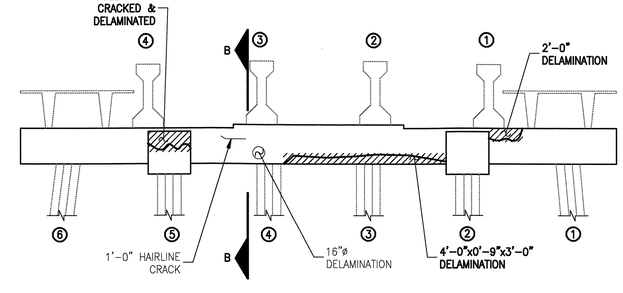
BENT #20			
REPAIR TYPE	QUANTITIES		
	UNIT		ACTUAL
HORIZONTAL SHOTCRETE	CF	1	
VERTICAL SHOTCRETE	CF	2	
OVERHEAD SHOTCRETE	CF	6	
ADDITIONAL REINFORCING	LBS	5	
EPOXY MORTAR (FORMED)	CF	–
