Reference: Preliminary Site Assessment
Helen Faircloth Properties Property (Parcel #34)
121 S. Bragg Blvd.
Spring Lake, Cumberland County, North Carolina
NCDOT Tip No. U-4444B
WBS Element 36492.1.2
AECOM Project No. 60158550

GEOPHYSICAL INVESTIGATION REPORT

HELEN FAIRCLOTH PROPERTIES INC. SITE (PARCEL 34)
South Bragg Boulevard
Spring Lake, North Carolina

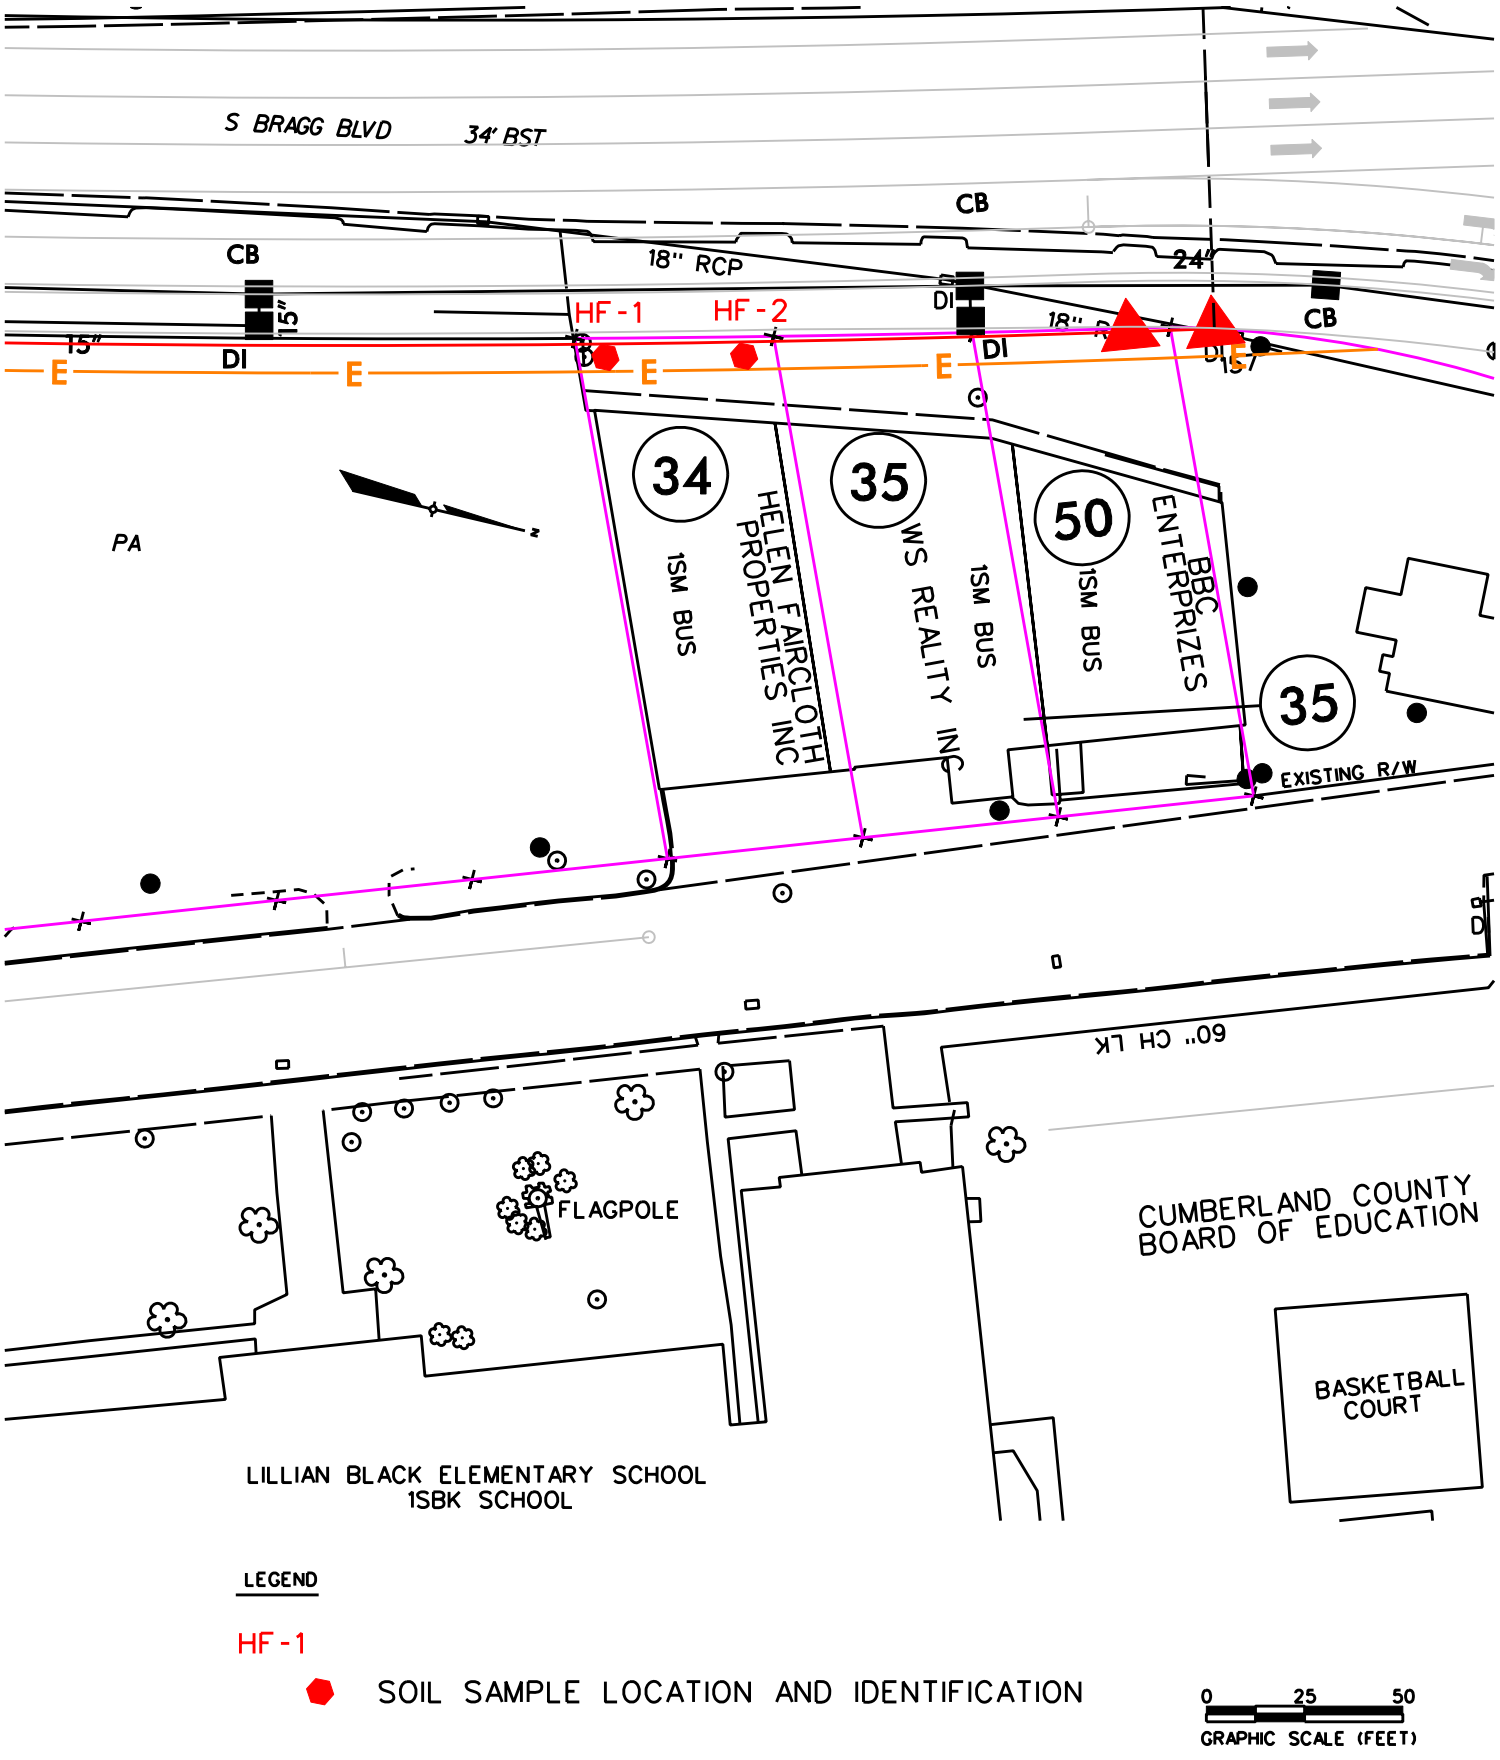
FIGURE 2
SITE MAP

Two direct-push holes (HF-1 and HF-2) were advanced within the right-of-way to a depth of 10 feet as shown in Figure 2 and Attachment B. The borings were located to evaluate the conditions within the proposed right-of-way/easements (Attachment C). The lithology encountered by the direct-push samples generally was consistent throughout the site. The ground surface was covered with about 2 to 3 inches of asphalt. Below the surface to a depth of 8 feet was a medium brown, loose, coarse-grained sand. Underlying this material was a medium brown sand/clay. No bedrock was encountered in any of the borings. The "Geologic Map of North Carolina" dated 1985 indicates that the site is underlain by the Middendorf and Cape Fear Formations, each of which consists predominantly of sand and mudstone. The soil observed at the site is consistent with this parent rock. The borings were terminated at a depth of 10 feet. No groundwater was observed in any of the borings. Based on field screening, soil samples were submitted for laboratory analyses, which are summarized in Table 1. Following completion, each boring was backfilled in accordance with 15A NCAC 2C.

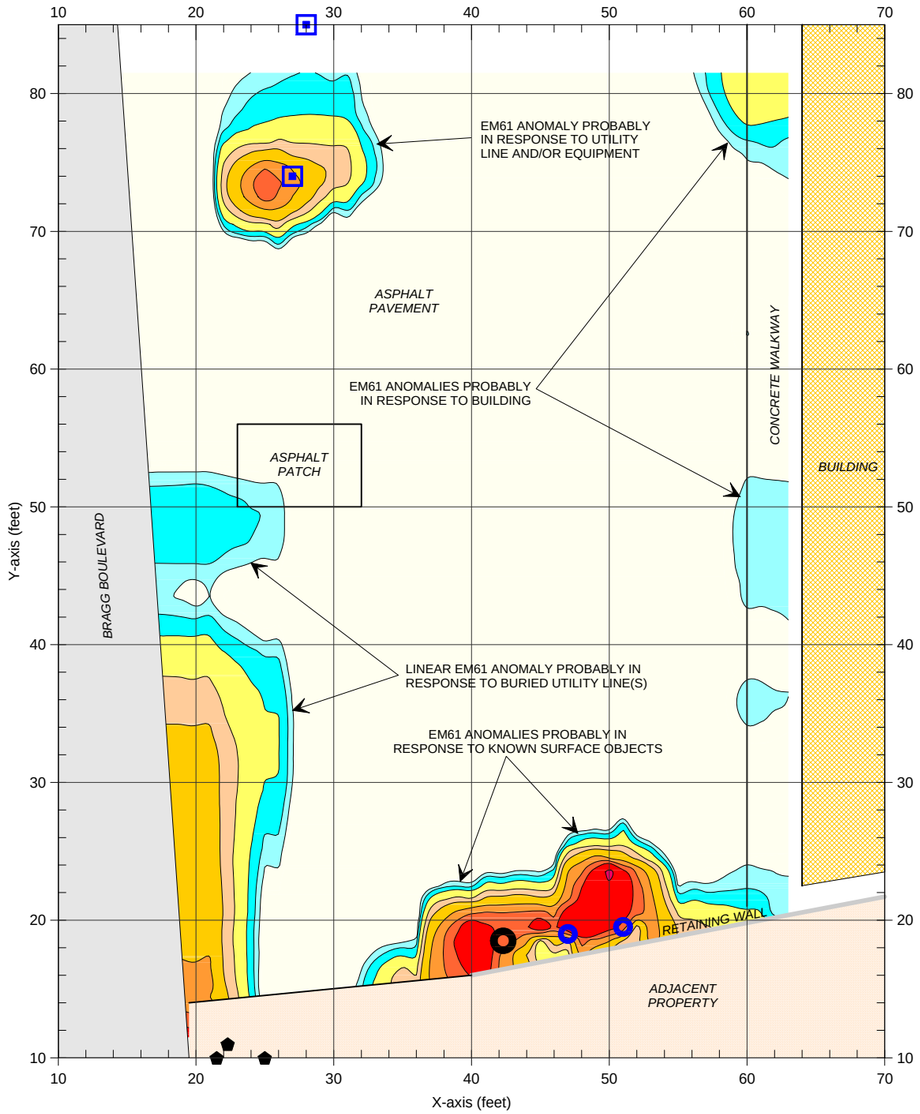
BOTTOM COIL RESULTS

The linear EM61 bottom coil anomaly intersecting grid coordinates X=20 Y=30 is probably in response to a buried utility line(s). The bottom coil anomalies centered near grid coordinates X=62 Y=35, X=62 Y=47 and X=62 Y=80 are probably in response to the building and concrete walkway.

- The linear EM61 bottom coil anomaly intersecting grid coordinates X=20 Y=30 is probably in response to a buried utility line(s).

The contour plots show the bottom coil (most sensitive) response and the differential response of the EM61 instrument in millivolts (mV). The bottom coil response shows buried metallic objects regardless of size. The differential response focuses on larger, buried metallic objects such as drums and USTs and ignores smaller miscellaneous, buried, metal debris. The EM61 survey was collected on July 22, 2010 using a Geonics EM61 instrument. Due to an absence of EM61 differential anomalies not in response to known surface objects, ground penetrating radar (GPR) surveys were not conducted at this site.

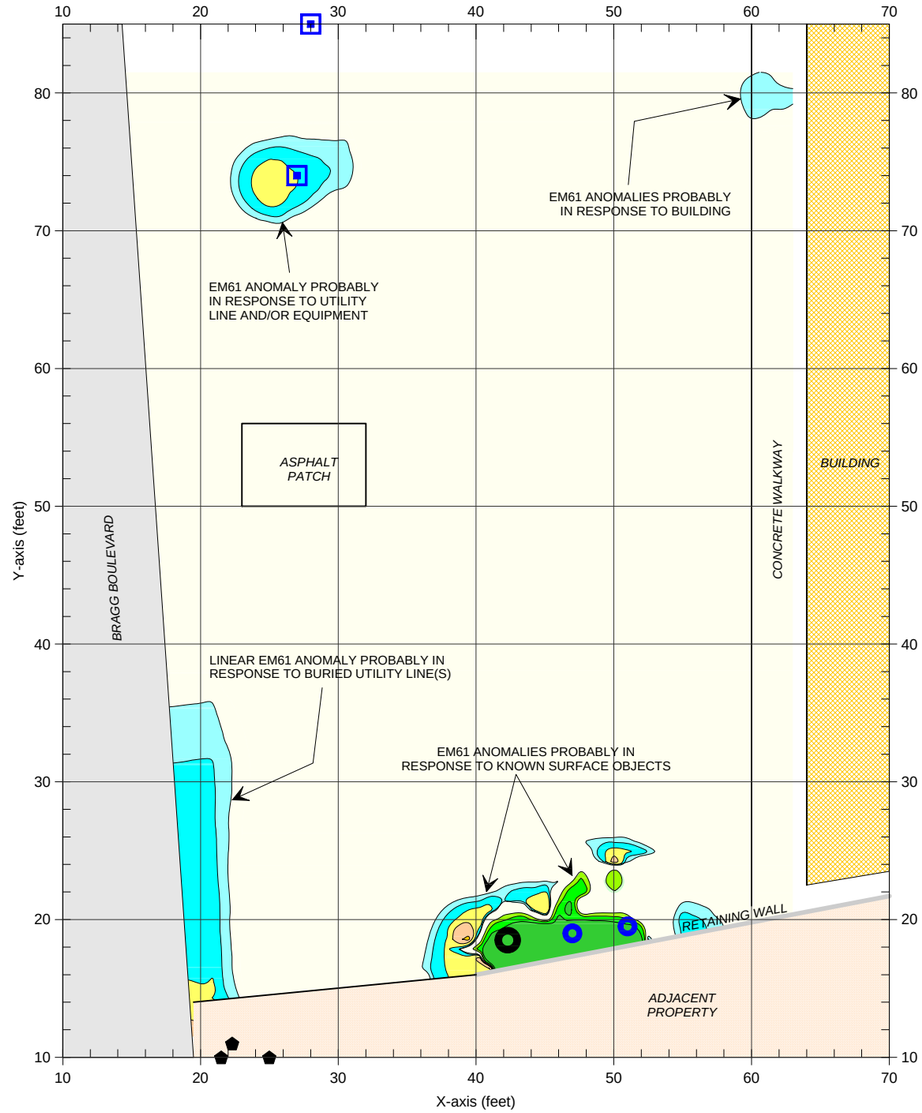
DIFFERENTIAL RESULTS

The EM61differential anomaly centered near grid coordinates X=25 Y=73 is in response to the storm sewer grate. The differential anomaly centered near grid coordinates X=44 Y=18 is probably in response to the business sign poles, the business sign and a 6 inch diameter segment of conduit cut off at the surface. The geophysical investigation suggests the proposed ROW area at Parcel 34 does not contain unknown, metallic USTs.

- The EM61differential anomaly centered near grid coordinates X=25 Y=73 is in response to the storm sewer grate. The differential anomaly centered near grid coordinates X=44 Y=18 is probably in response to the business sign poles, the business sign and a 6 inch diameter segment of conduit cut off at the surface.

The geophysical investigation suggests the proposed ROW area of the site does not contain metallic USTs.
