PRELIMINARY SITE ASSESSMENT

BALLARD LIVING TRUST PROPERTY (PARCEL #8)
6659 US Highway 401
Kipling, NC
State Project: R-5523
WBS Element: 45548.1.1
F&R Project #66R-3222

June 9, 2014

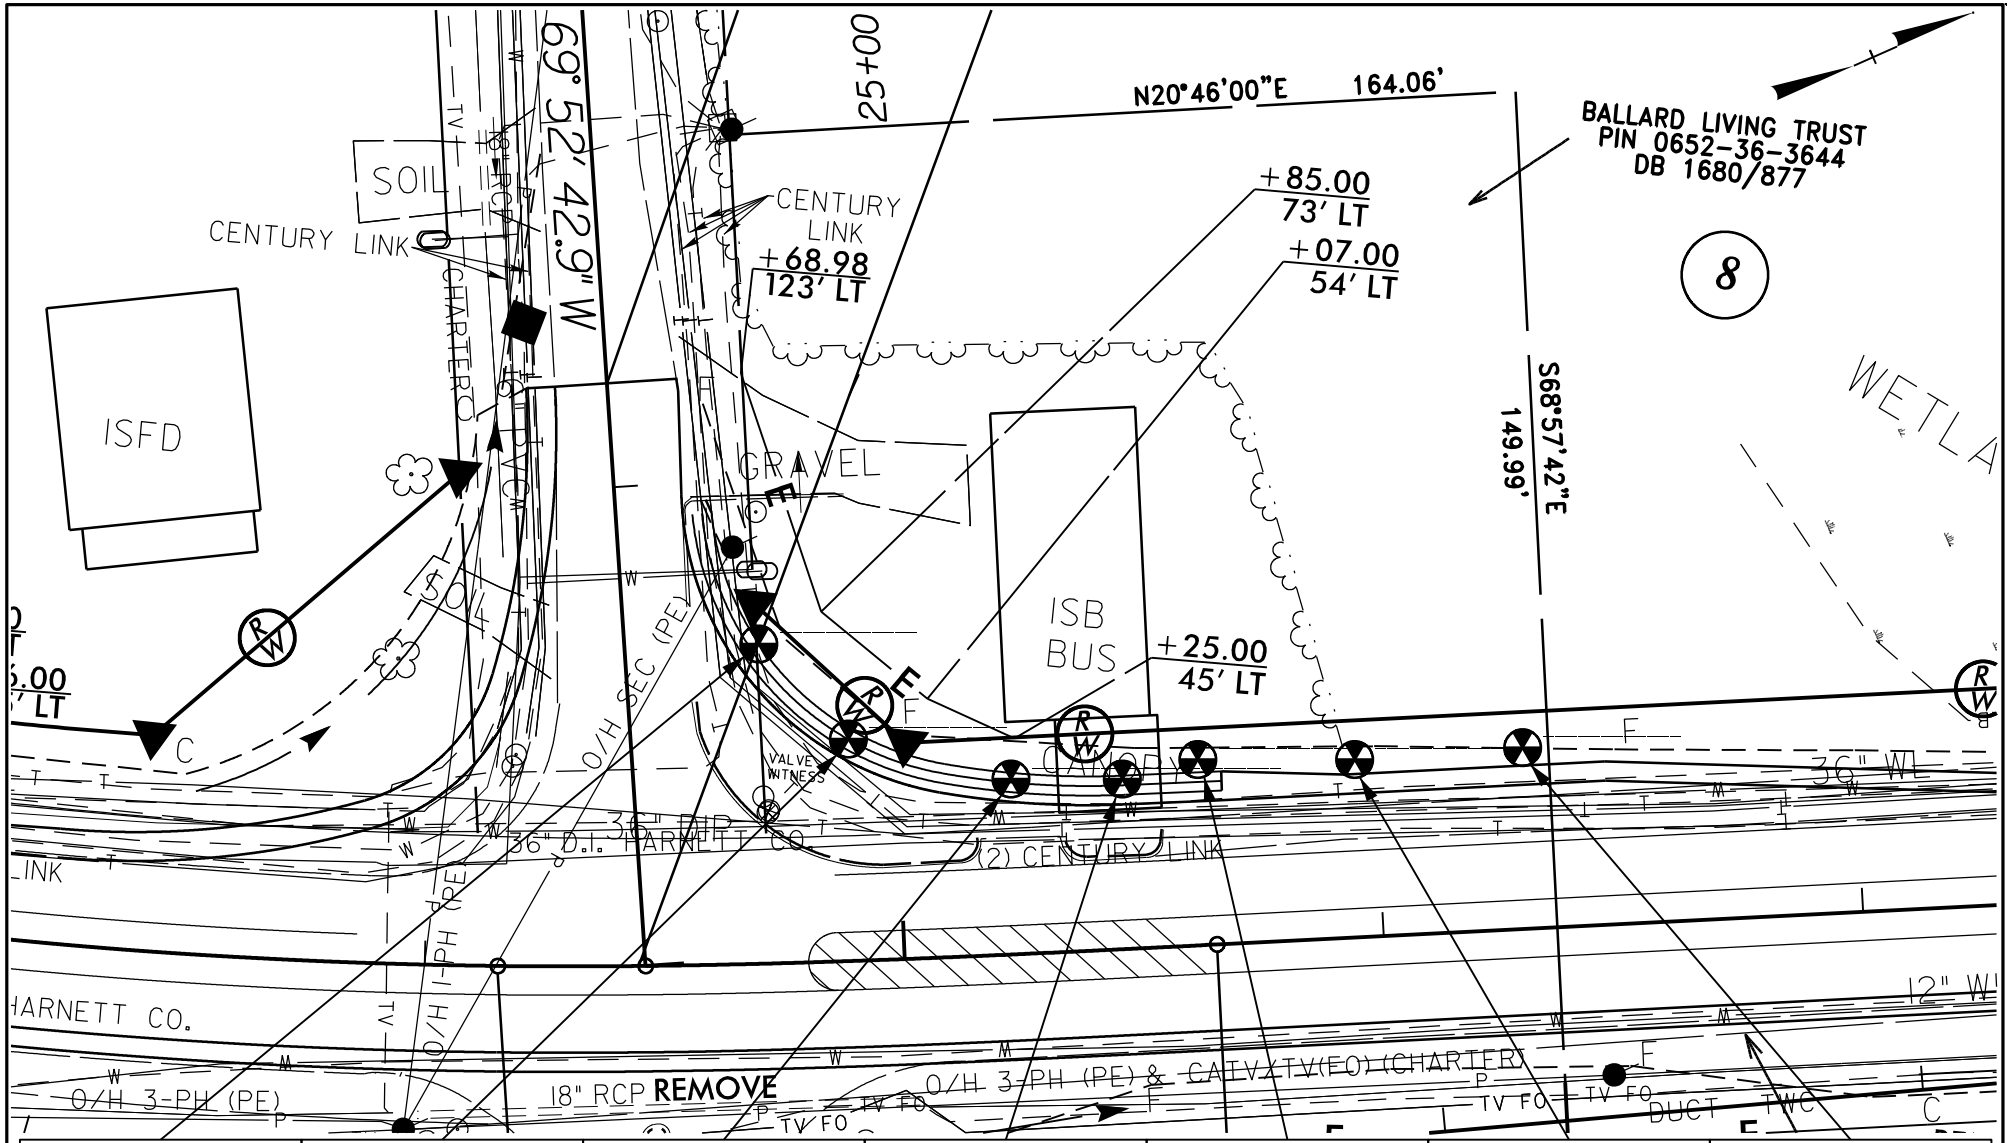
LABORATORY RESULTS & BORING LOCATION PLAN

Petroleum hydrocarbons identified as DRO were encountered in the soil at six of the boring locations (B-1 through B-6) at depths ranging from one foot (Boring B-1) to at least six feet (Boring B-5) feet below ground surface. The laboratory results indicate the soil sample collected from Boring B-6 exceeded the NC DENR Action level of 10 mg/kg for DRO (25.2 mg/kg DRO). The laboratory results for the soil samples collected at Borings B-1, B-2, B-3, B-4 and B-5 indicated DRO levels just below the NC DENR Action Level (2.6 mg/kg, 2.8 mg/kg, 6.9 mg/kg, 6.2 mg/kg, and 0.8 mg/kg DRO, respectively).

Petroleum hydrocarbons identified as GRO were encountered at two of the boring locations (B-5 and B-6) at depths ranging from four feet (Boring B-6) to at least six feet (Boring B-5) below ground surface. The laboratory results indicate the soil sample collected from Boring B-6 exceeded the NC DENR Action level of 10 mg/kg for GRO (77 mg/kg GRO). The laboratory results for the soil sample collected at Boring B-5 indicated GRO levels below the NC DENR Action Level (0.77 mg/kg GRO).

B-7: 4.0'-5.0' DRO=<0.3 mg/kg GRO=<0.1 mg/kg TOTAL BTEX=<0.1 mg/kg 16 EPA PAHs=<0.1 mg/kg BaP=<0.01 mg/kg	**B-6: 4.0'-5.0'** DRO=25.2 mg/kg GRO=77 mg/kg TOTAL BTEX=47.1 mg/kg 16 EPA PAHs=0.02 mg/kg BaP=<0.01 mg/kg	**B-5: 5.0'-6.0'** DRO=0.8 mg/kg GRO=0.77 mg/kg TOTAL BTEX=<0.1 mg/kg 16 EPA PAHs=<0.1 mg/kg BaP=<0.01 mg/kg	**B-4: 3.0'-4.0'** DRO=6.2 mg/kg GRO=<0.1 mg/kg TOTAL BTEX=<0.1 mg/kg 16 EPA PAHs=0.06 mg/kg BaP=<0.01 mg/kg	**B-3: 4.0'-5.0'** DRO=6.9 mg/kg GRO=<0.3 mg/kg TOTAL BTEX=<0.3 mg/kg 16 EPA PAHs=0.12 mg/kg BaP=<0.01 mg/kg	**B-2: 2.0'-3.0'** DRO=2.8 mg/kg GRO=<0.1 mg/kg TOTAL BTEX=<0.2 mg/kg 16 EPA PAHs=0.1 mg/kg BaP=0.018 mg/kg	**B-1: 1.0'-2.0'** DRO=2.6 mg/kg GRO=<0.1 mg/kg TOTAL BTEX=<0.1 mg/kg 16 EPA PAHs=0.16 mg/kg BaP=0.028 mg/kg

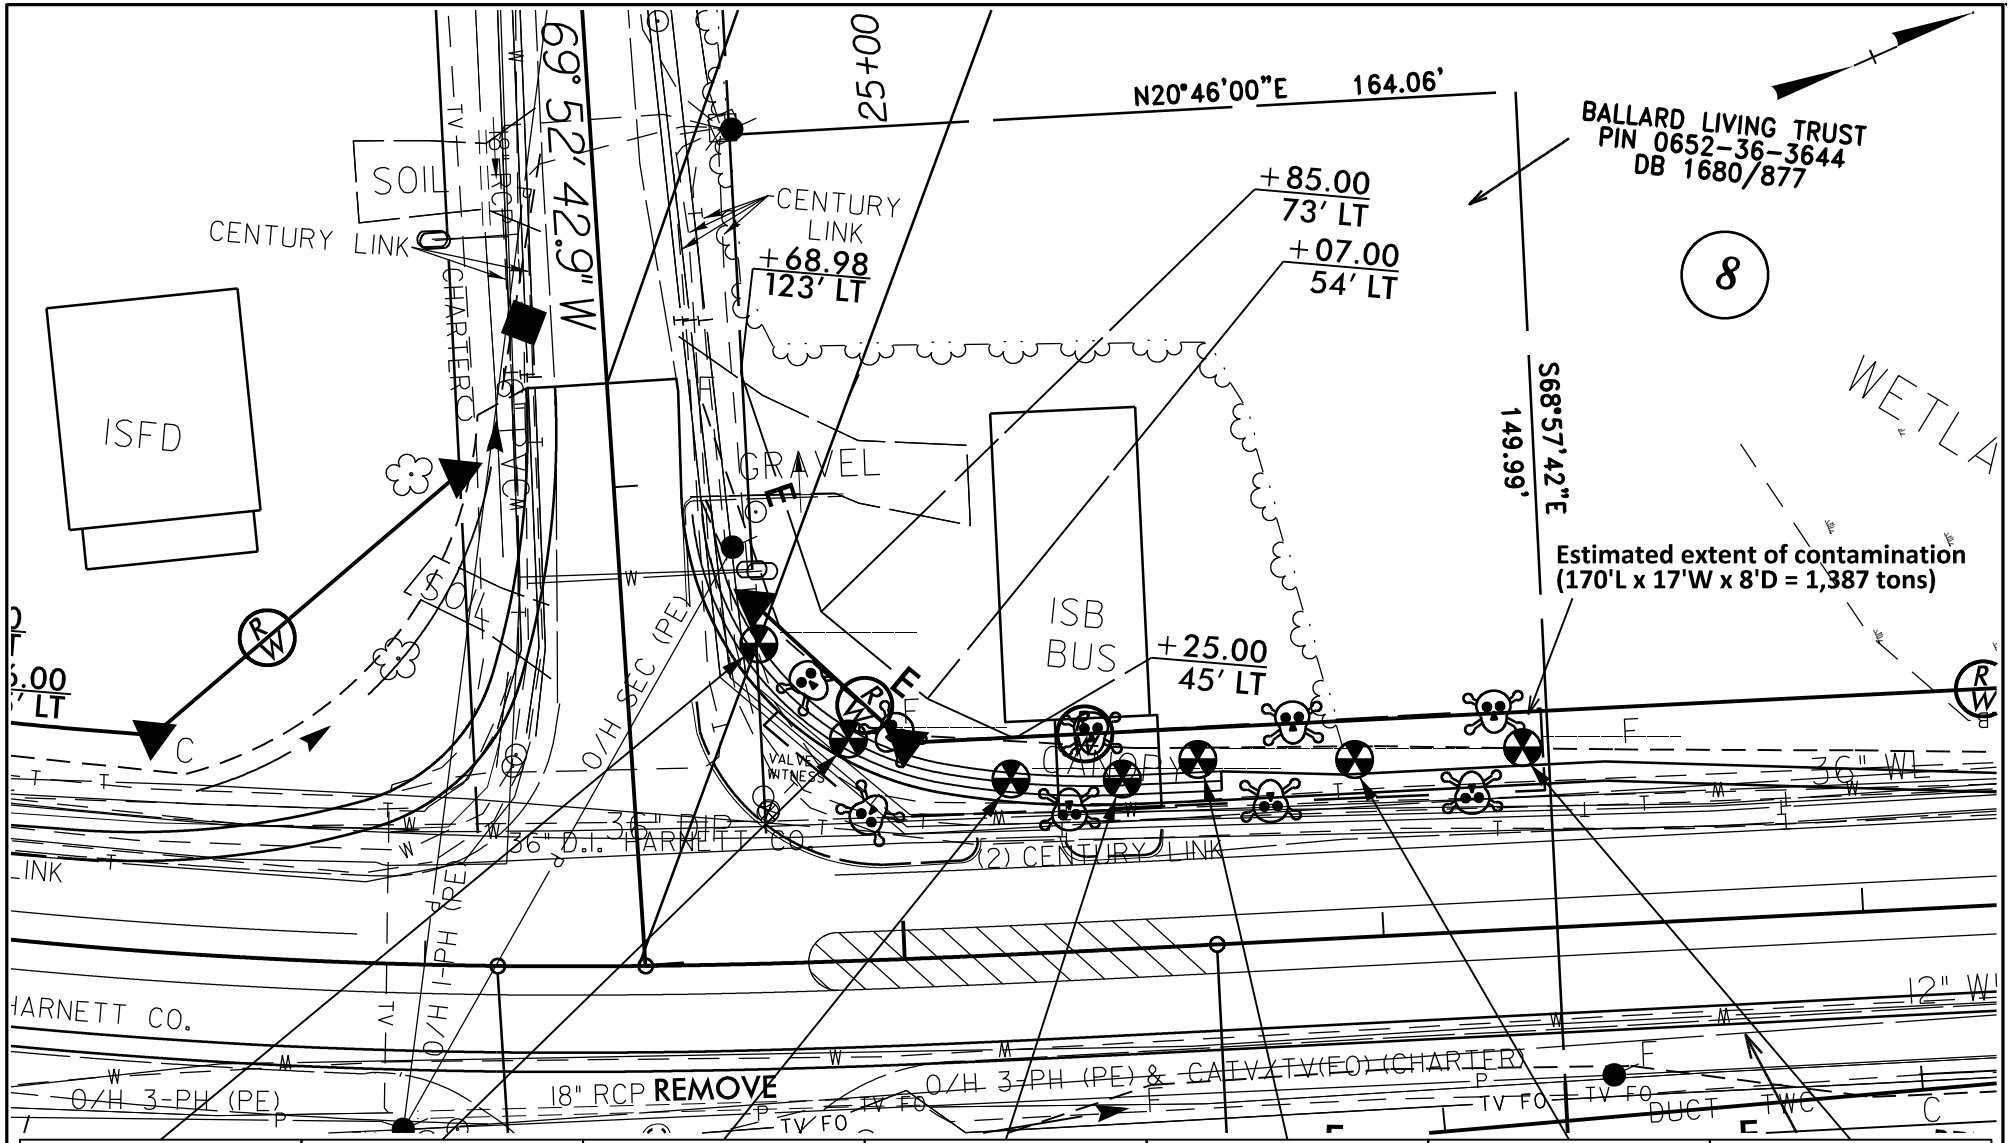
ESTIMATED EXTENTS OF SOIL CONTAMINATION

In regards to the proposed construction, it is estimated that petroleum impacted soils are present from existing ground surface to a depth of at least eight feet below existing ground surface in the vicinity of Borings B-1 through B-6 based on laboratory analysis and PID readings.

Based on the depths at which soil contamination was observed, PID readings and our experience, it appears one area of contaminated soil exists at the site as shown in Figure 4. Using the dimensions in the below table, and assuming a 17 foot wide area from edge of existing pavement to the right-of-way, it can be approximated that the quantity of petroleum impacted soil which may be encountered during the above mentioned activities to be approximately 1,387 tons. Petroleum impacted soils that are removed should be properly managed and disposed of in accordance with all NCDENR rules and regulations.

B-7: 4.0'-5.0'	B-6: 4.0'-5.0'	B-5: 5.0'-6.0'	B-4: 3.0'-4.0'	B-3: 4.0'-5.0'	B-2: 2.0'-3.0'	B-1: 1.0'-2.0'
DRO=<0.3 mg/kg	DRO=25.2 mg/kg	DRO=0.8 mg/kg	DRO=6.2 mg/kg	DRO=6.9 mg/kg	DRO=2.8 mg/kg	DRO=2.6 mg/kg
GRO=<0.1 mg/kg	GRO=77 mg/kg	GRO=0.77 mg/kg	GRO=<0.1 mg/kg	GRO=<0.3 mg/kg	GRO=<0.1 mg/kg	GRO=<0.1 mg/kg
TOTAL BTEX=<0.1 mg/kg	TOTAL BTEX=47.1 mg/kg	TOTAL BTEX=<0.1 mg/kg	TOTAL BTEX=<0.1 mg/kg	TOTAL BTEX=<0.3 mg/kg	TOTAL BTEX=<0.2 mg/kg	TOTAL BTEX=<0.1 mg/kg
16 EPA PAHs=<0.1 mg/kg	16 EPA PAHs=0.02 mg/kg	16 EPA PAHs=<0.1 mg/kg	16 EPA PAHs=0.06 mg/kg	16 EPA PAHs=0.12 mg/kg	16 EPA PAHs=0.1 mg/kg	16 EPA PAHs=0.16 mg/kg
BaP=<0.01 mg/kg	BaP=<0.01 mg/kg	BaP=<0.01 mg/kg	BaP=<0.01 mg/kg	BaP=<0.01 mg/kg	BaP=0.018 mg/kg	BaP=0.028 mg/kg

It should be noted that a delineation of the soil contamination was not performed, as this was not included in the proposed scope of work. The above estimates are based on interpretations of soil analytical results, PID readings and our experience with similar petroleum UST releases. The amount of impacted soil can only be determined after excavation or by advancing additional borings at the site to possibly delineate the extents (horizontal and vertical) of contamination.

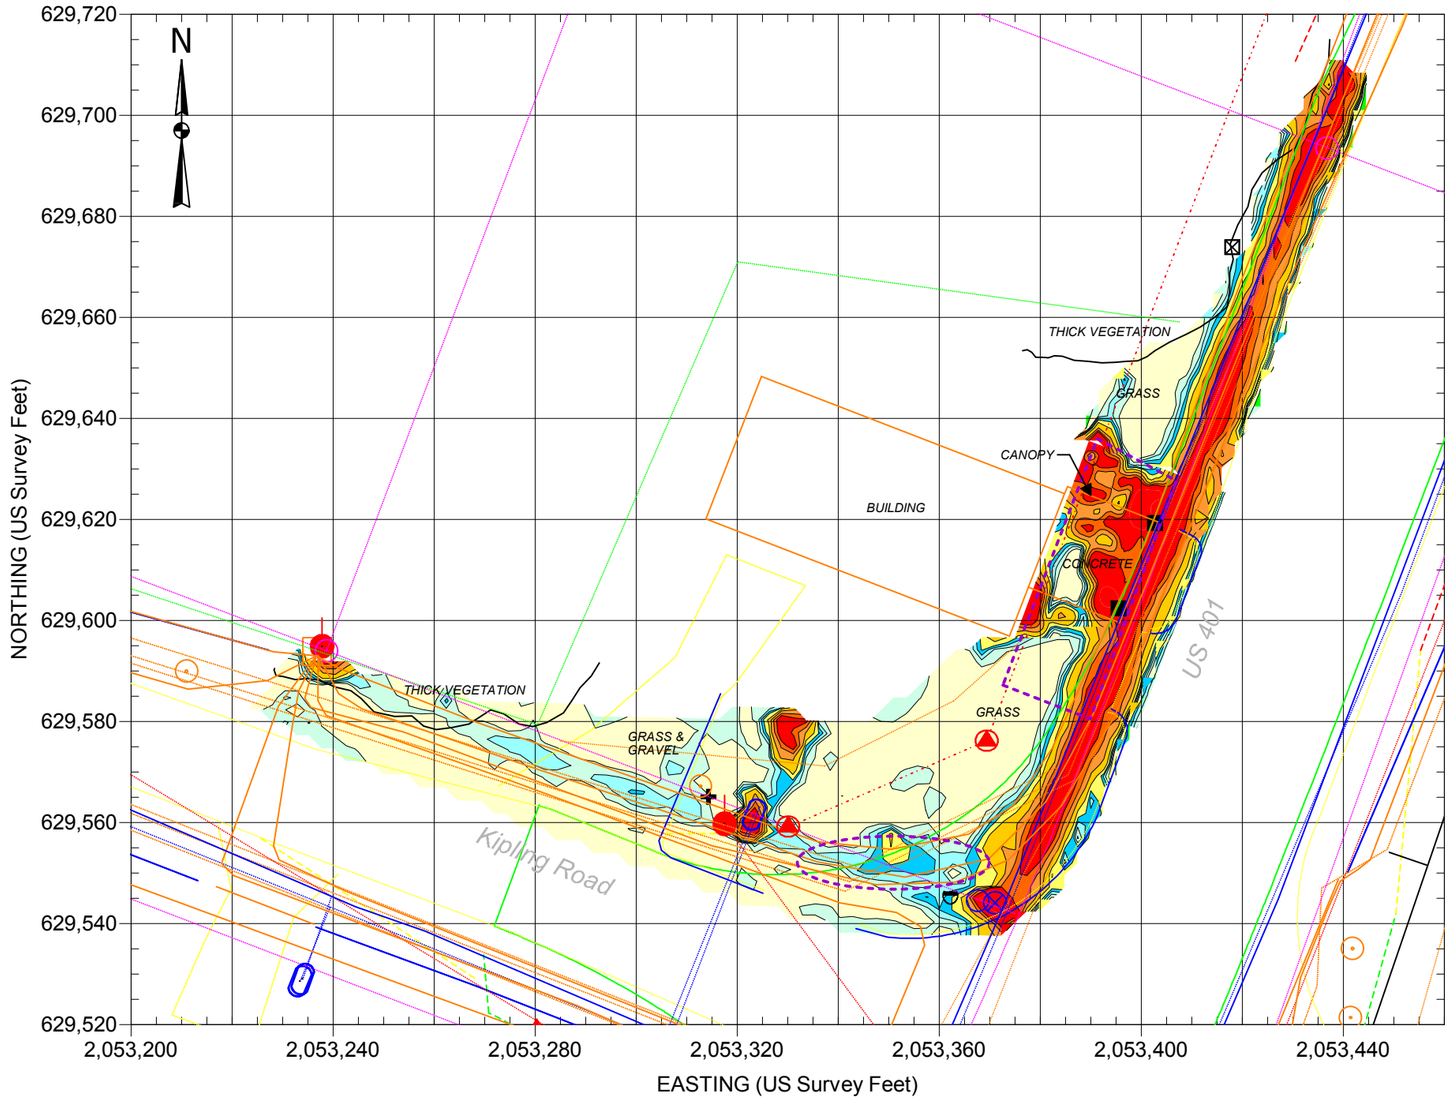
FIGURE 3

The contoured EM61 data collected over Parcel 8 and the GPR survey locations are shown on Figure 3, EM61 Early Time Gate Response, and Figure 4, EM61 Differential Response. Areas outside the colored, contoured EM61 data were not surveyed. Early time data refer to the response measured at a short time after the initial EM pulse is generated. Early time data typically contain responses from all metal objects, small or large and shallow or deep, within the sensitivity range of the instrument. Differential data represent the difference in response between the top and bottom coils of the EM61 instrument at a later time after the initial pulse than early time data. Differential data naturally tend to filter out the effect of surface and very shallowly buried metallic objects. Typically, the differential response emphasizes anomalies from deeper and larger objects such as USTs.

We were not able to access an area in the northern portion of the planned survey due to the presence of thick vegetation. The EM data contain multiple anomalies that we investigated with GPR (as shown on Figures 3 and 4), all of which appear to be the result of buried utilities, reinforced concrete, or other metal objects at the ground surface or at shallow depths. The geophysical data collected at the site do not indicate the presence of metallic USTs within the areas surveyed.

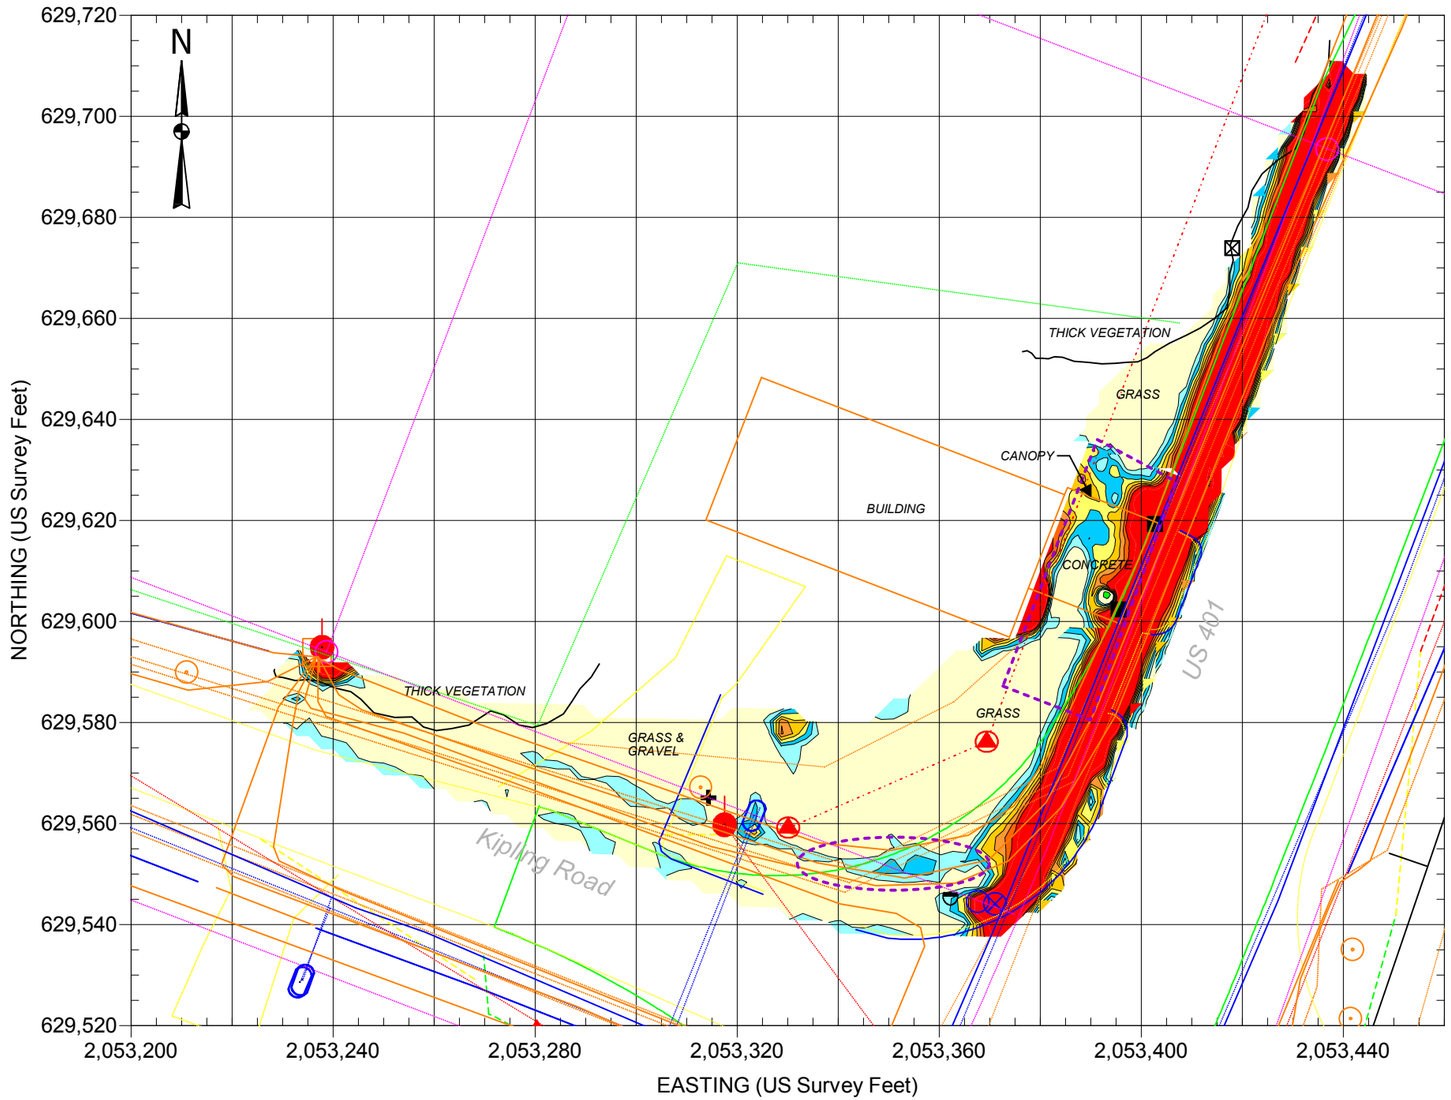
Note: The contour plot shows the difference, in millivolts (mV), between the readings from the top and bottom coils of the EM61. The difference is taken to reduce the effect of shallow metal objects and emphasize anomalies caused by deeper metallic objects, such as drums and tanks. The EM data were collected on April 3, 2014, using a Geonics EM61-MK2 instrument. Positioning for the EM61 survey was provided using a submeter Trimble ProXRS DGPS system. Coordinates are in the US State Plane 1983 System, North Carolina 3200 Zone, using the NAD 1983 datum. GPR data were acquired on April 8, 2014, using a Geophysical Survey Systems SIR 3000 equipped with a 400 MHz antenna.

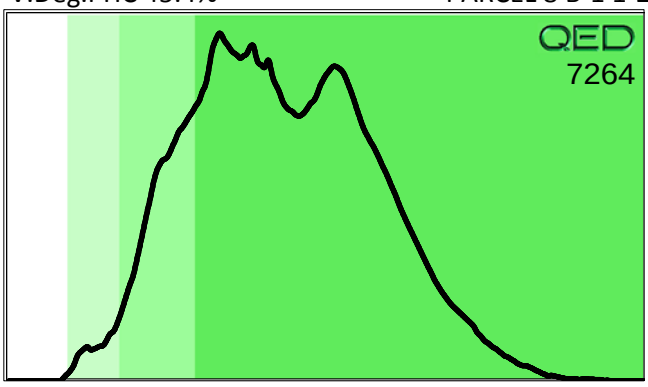
V.Deg.PHC 45.4% PARCEL 8 B-1 1-2

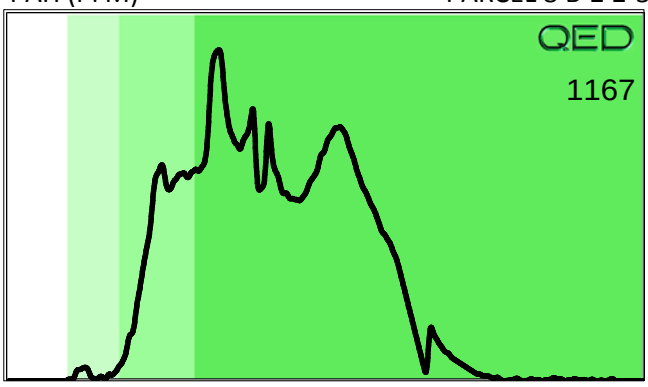
PAH (PFM) PARCEL 8 B-2 2-3

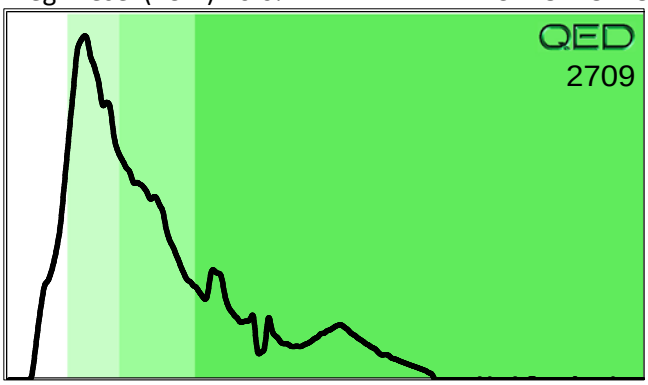
Deg.Diesel (FCM) 76.6% PARCEL 8 B-3 2-3

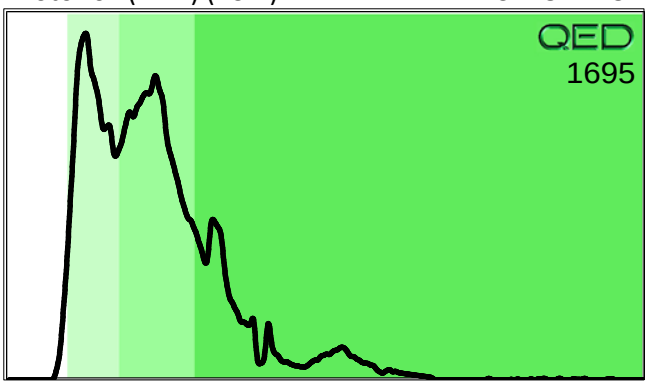
motor oil (PFM) (FCM) PARCEL 8 B-4 3-4

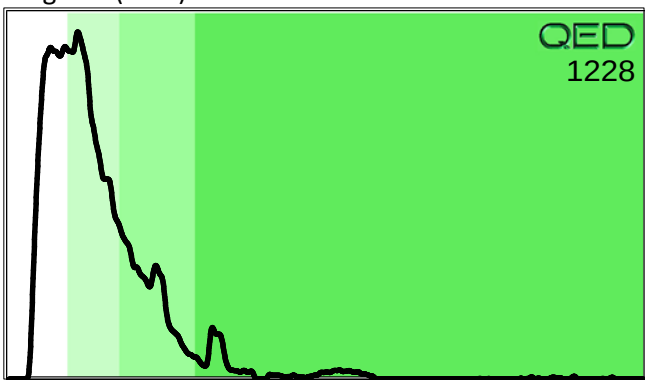
Deg.Gas (FCM) 85.7% PARCEL 8 B-5 5-6

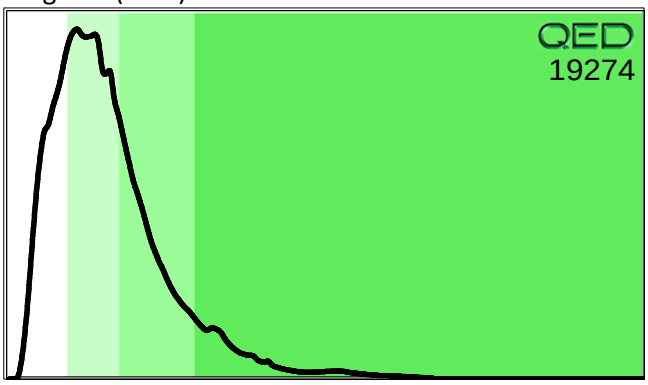
Deg.Gas (FCM) 82.4% PARCEL 8 B-6 4-5

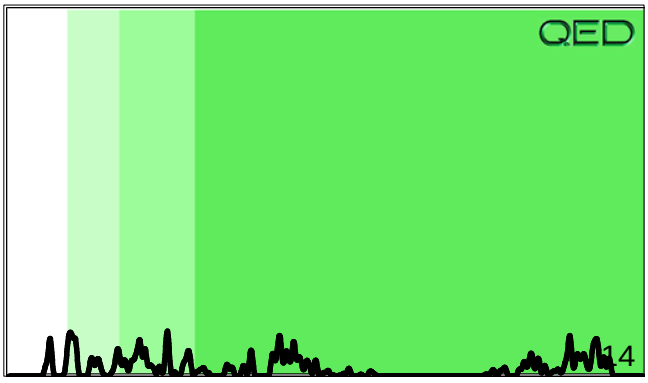
TPH not detected PARCEL 8 B-7 4-5
