PROJECT NO. I-0914BA
VANCE COUNTY
BRIDGE NO. 57

SHEET 4 OF 4

SUBSTRUCTURE REPAIRS

BENT 4

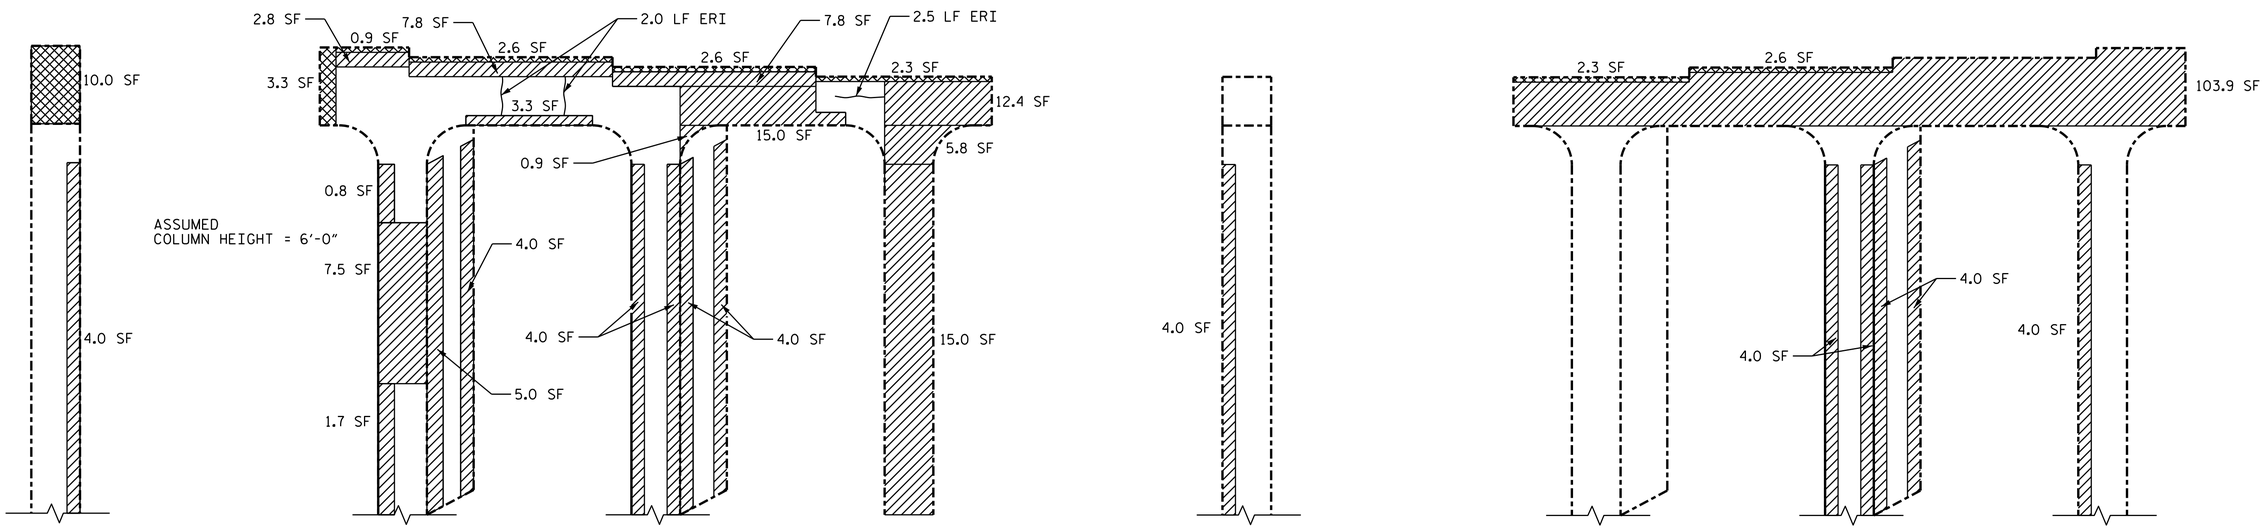
REPAIRS BENT 4	QUANTITIES			
	ESTIMATE		ACTUAL	
SHOTCRETE REPAIRS	AREA SF.	VOLUME CF.	AREA SF.	VOLUME CF.
CAP (VERTICAL FACE)	153.0	51.0		
CAP (HORIZONTAL FACE)	32.6	10.9		
COLUMN (VERTICAL FACE)	84.7	28.2		
CONCRETE REPAIRS	92.8	30.9		
EPOXY RESIN INJECTION		LN. FT.		LN. FT.
CAP		6.5		
COLUMN		0		
EPOXY COATING		SQ. FT.		SQ. FT.
TOP OF CAP		86

VALUES IN CHART REPRESENT ESTIMATED REPAIR TOTALS AFTER REMOVAL OF UNSOUND CONCRETE, MIN. OF 1" BEHIND REBAR AND MIN. 1" CL TO SAWCUT. SEE REPAIR DETAILS.

FOR STRUCTURE REPAIRS, SEE "TYPICAL REPAIR DETAILS" SHEET.

EPOXY COATING SHALL BE APPLIED TO THE TOP FACE OF THE BENT CAPS AND ENDS OF GIRDERS.
